## Preliminary Assessment Report

### Camp Ripley, Minnesota

Perfluorooctane-Sulfonic Acid (PFOS) and Perfluorooctanoic Acid (PFOA) Impacted Sites  
ARNG Installations, Nationwide

November 2019

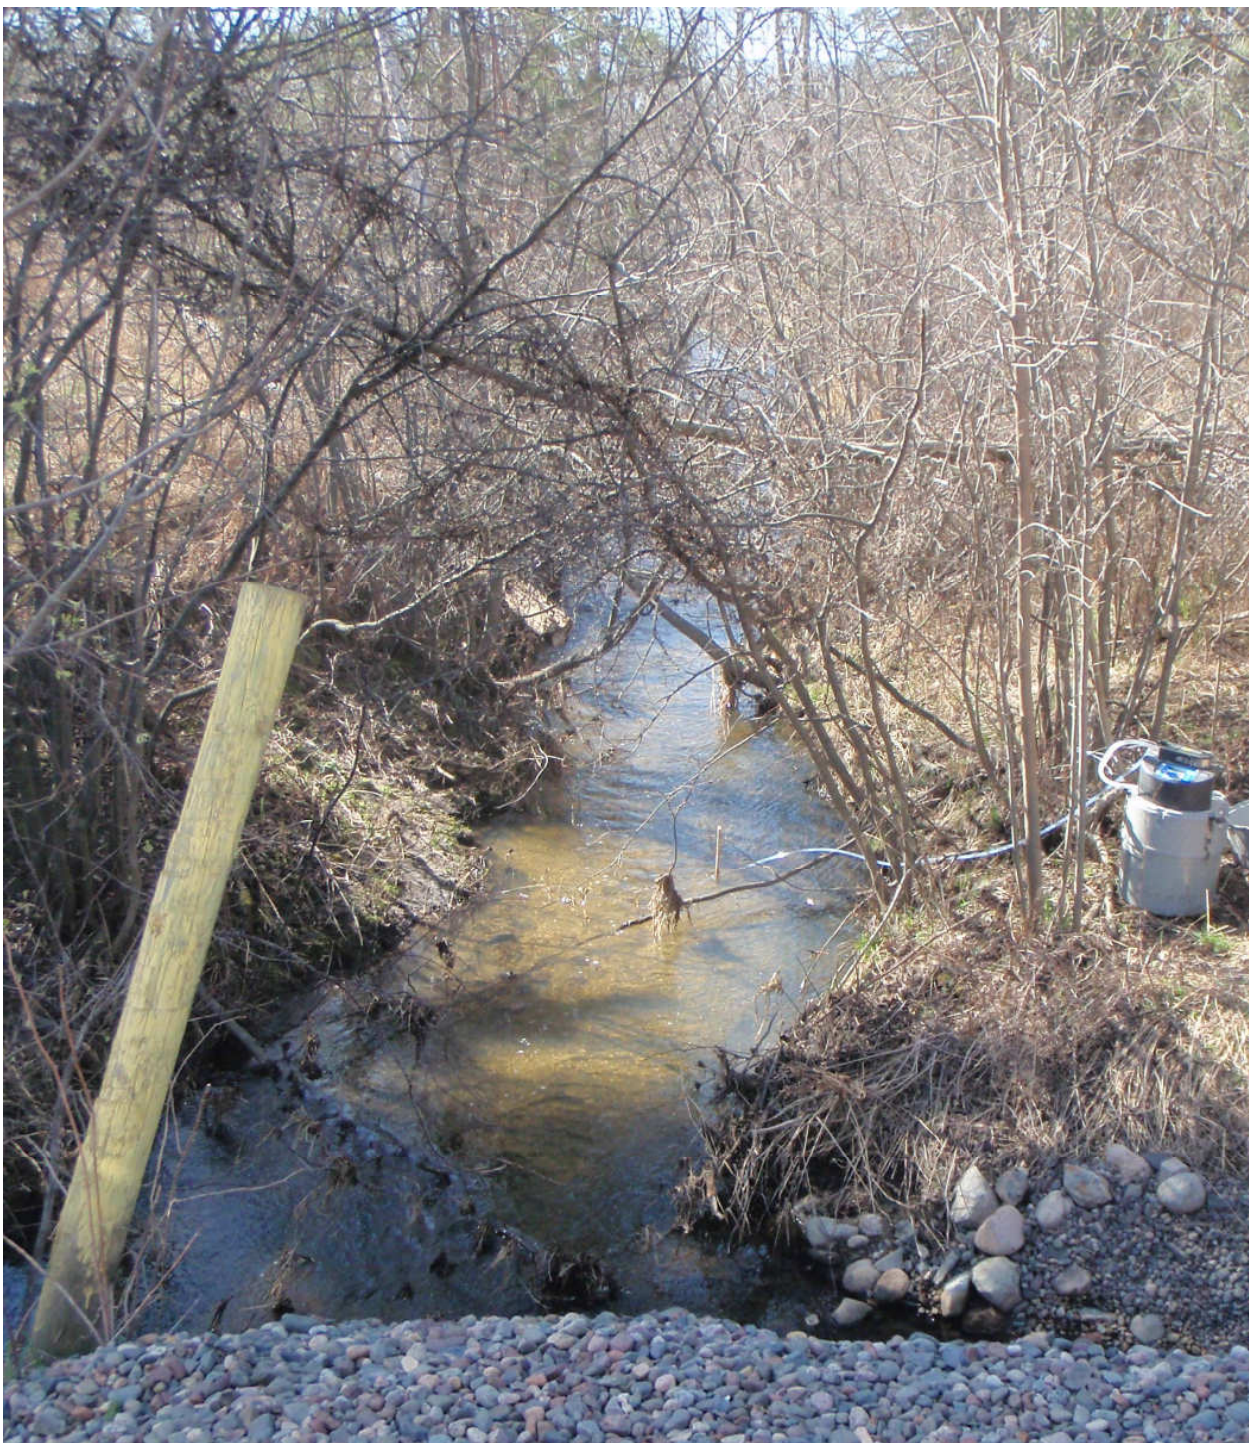
**Location:** Camp Ripley, Sample Location RP04

View of sampling location RP04 taken on 3 April 2012. Photograph is taken facing west (upstream).

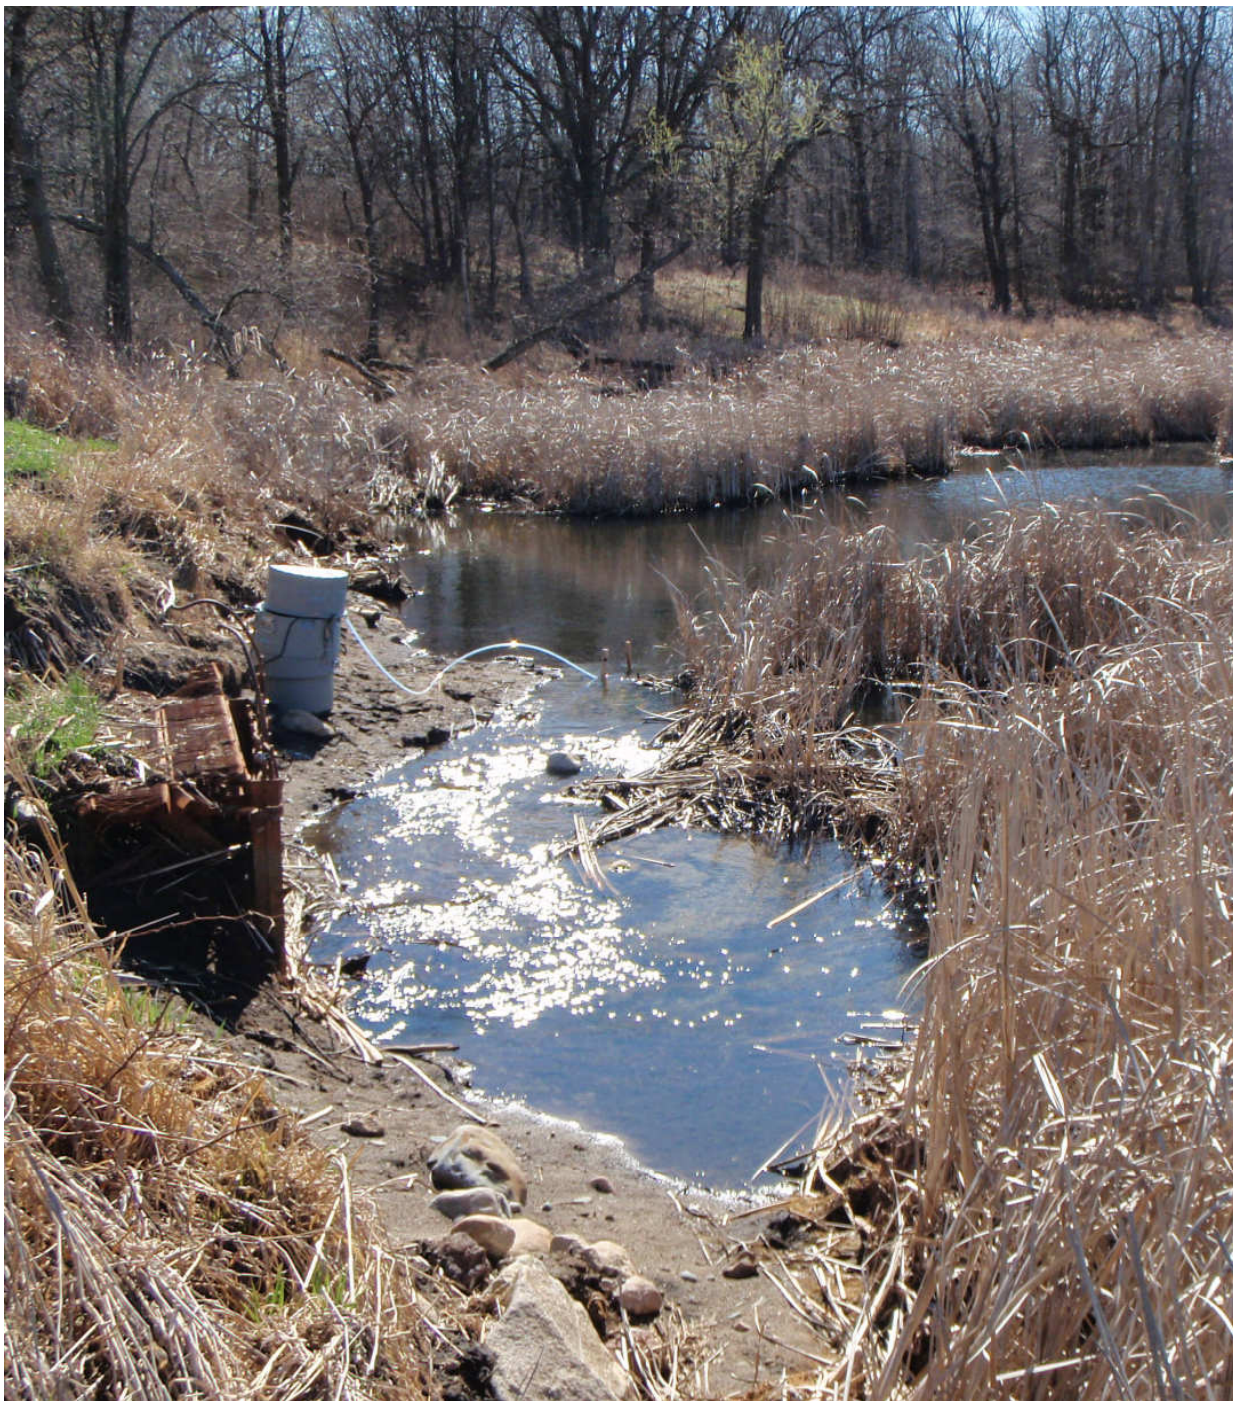
**Location:** Camp Ripley, Sample Location RP05

View of sampling location RP05 taken on 3 April 2012. Photograph is taken facing south. Upstream is west (to the right of the picture).

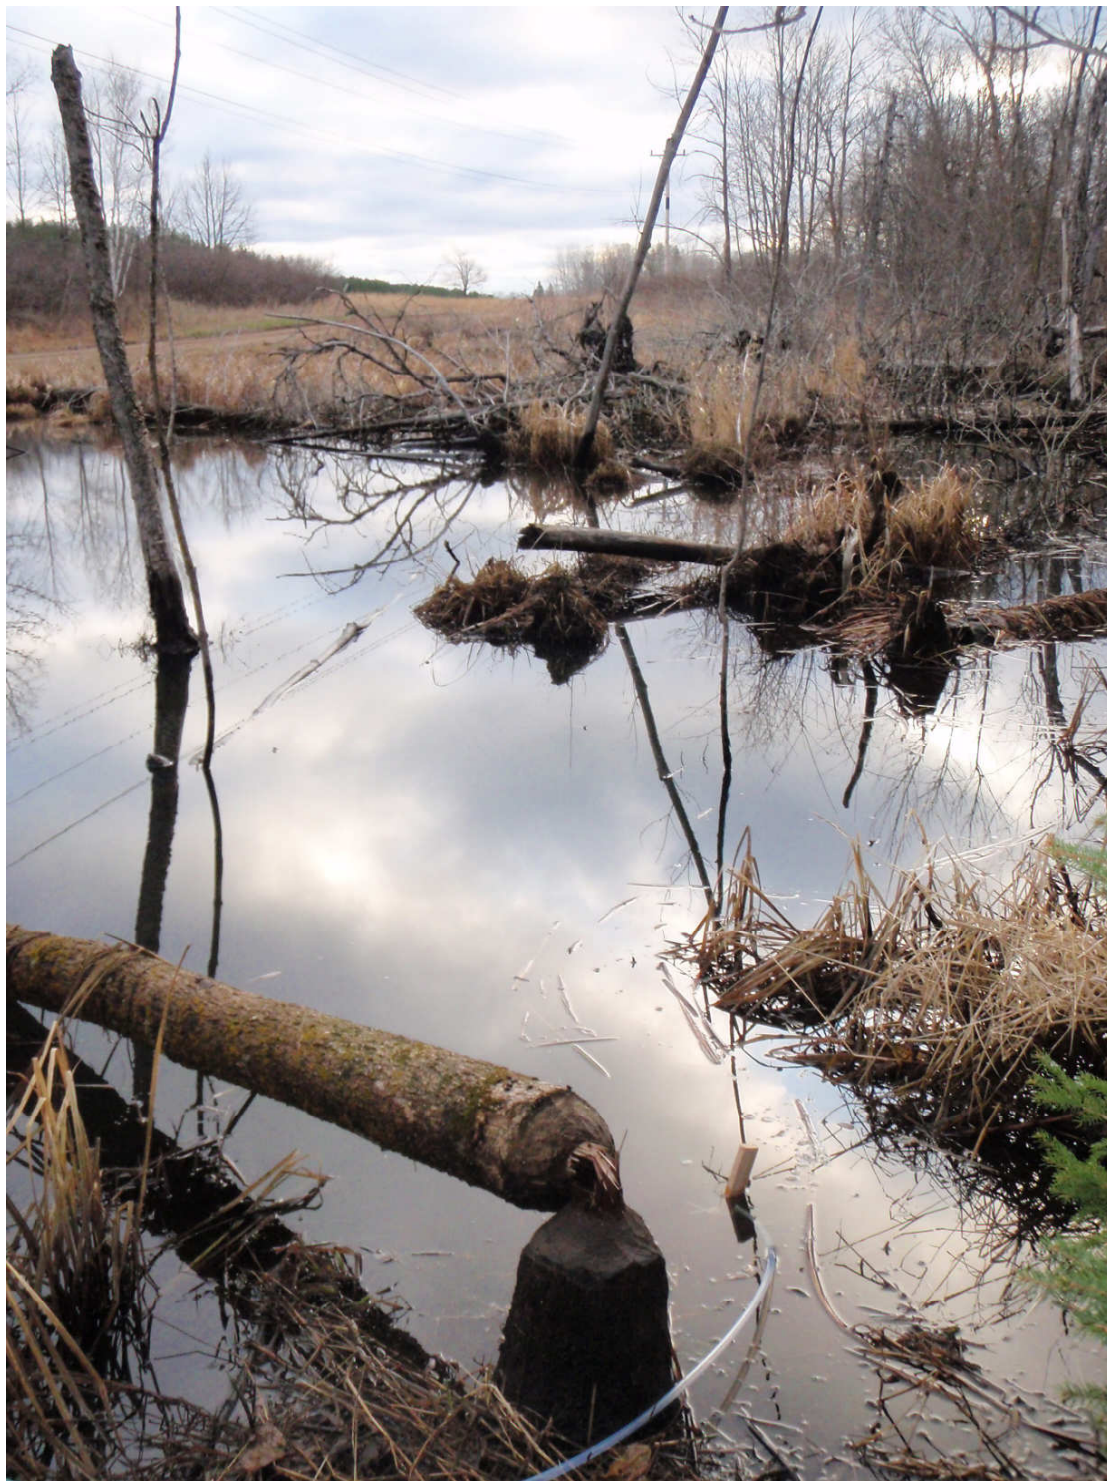
**Location:** Camp Ripley, Sample Location RP06

View of sampling location RP06 taken on 5 April 2012. Photograph is taken facing east. Upstream is south (to the right of the picture).

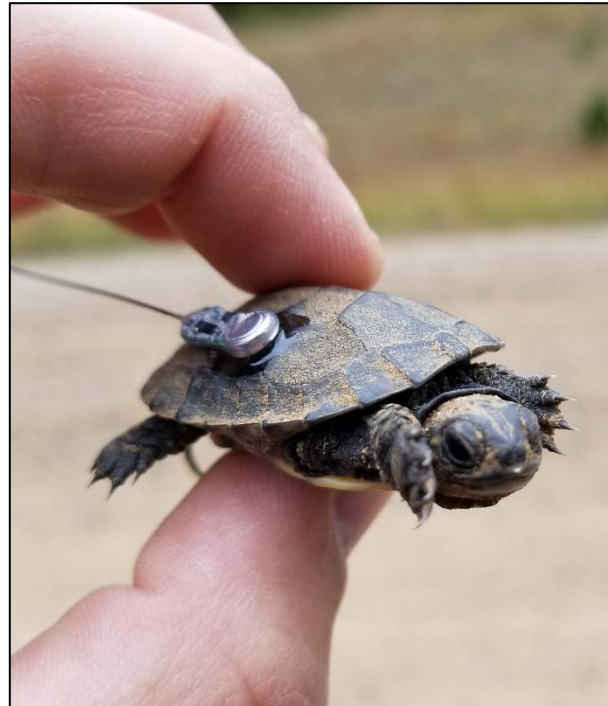
Transmitters used on the selected hatchlings were model R1614 (Advanced Telemetry Systems, Isanti, Minnesota, USA; 0.3 g) (Figure 36). Each transmitter weighed no more than 5% of the hatchlings’ body mass and transmitters had a maximum battery capacity of 24 days (30 ppm). Transmitters were affixed using a fast drying (5 minutes) epoxy compound. Prior to fitting the transmitter, the carapace of the hatchling was cleaned using water, and time was allowed for the carapace to dry to assure the transmitter set properly. The epoxy was applied to the carapace approximately midway down the turtle between the dorsal line and the marginal scutes. The turtles were then set in buckets individually to allow the epoxy to set. Though the recommended wait time to allow the epoxy to set was 5 minutes, turtles were held for approximately one hour prior to release. Six hatchlings were subsequently escorted to two wetland complexes that support adult conspecifics and where previous cohorts were released: Range Marsh and Goose Lake. From the hatchlings chosen to be tracked, three hatchlings were randomly (Damon and Harvey 1987) selected to be distributed in Goose Lake (H\_PW02, H\_PW03, H\_PW04) and three hatchlings were spread throughout Range Marsh (H\_PW01, H\_PW05, H\_PW06). The remaining two hatchlings were released at the nest site as a pilot study for 2018 (H\_AKY01, H\_AKY02).

Figure 36. Blanding’s turtle hatchling with radio-transmitter, Camp Ripley Training Center, Minnesota, 2017.

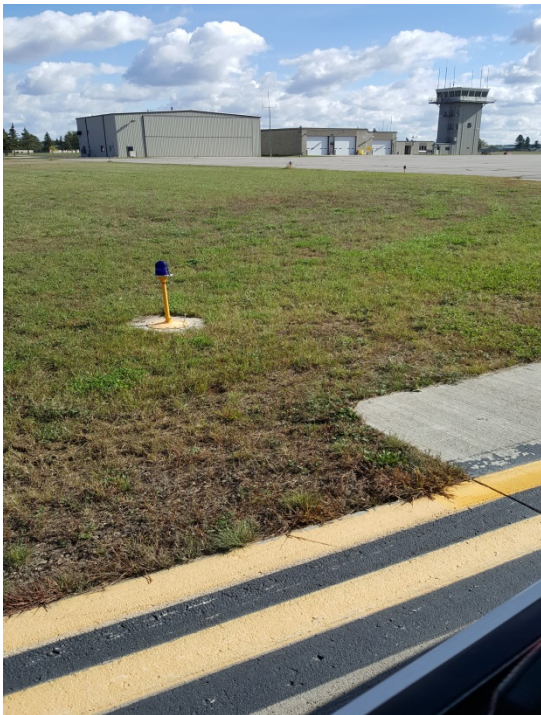
Army National Guard, Preliminary Assessment for PFAS		Camp Ripley, Minnesota	Little Falls, Minnesota
<b>Photograph No. 5</b>  <b>Description:</b> Facing north. TriMax Discharge Area.

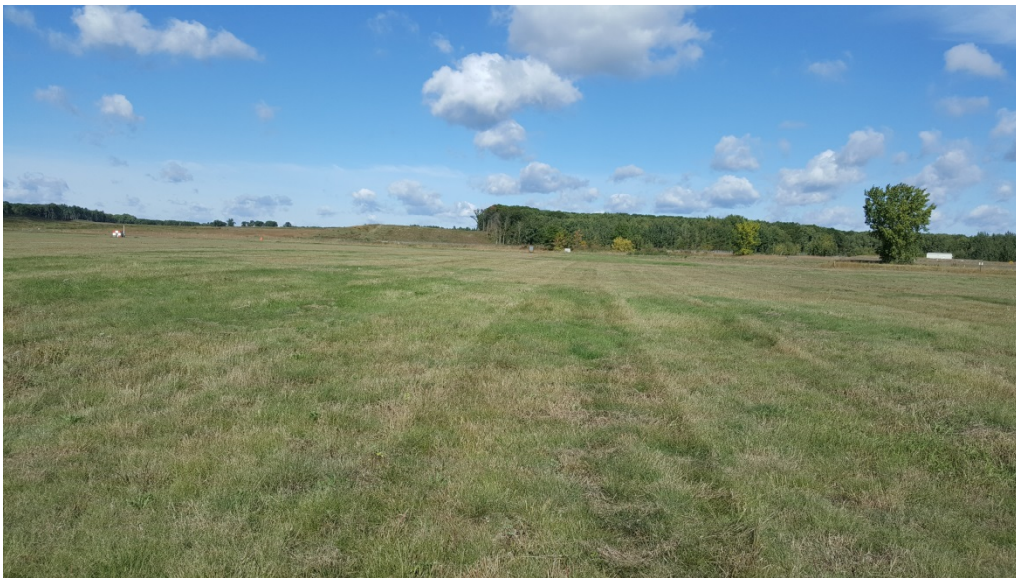
<b>Photograph No. 6</b>  <b>Description:</b> Facing northwest. Burn Pit Fire Training Area.

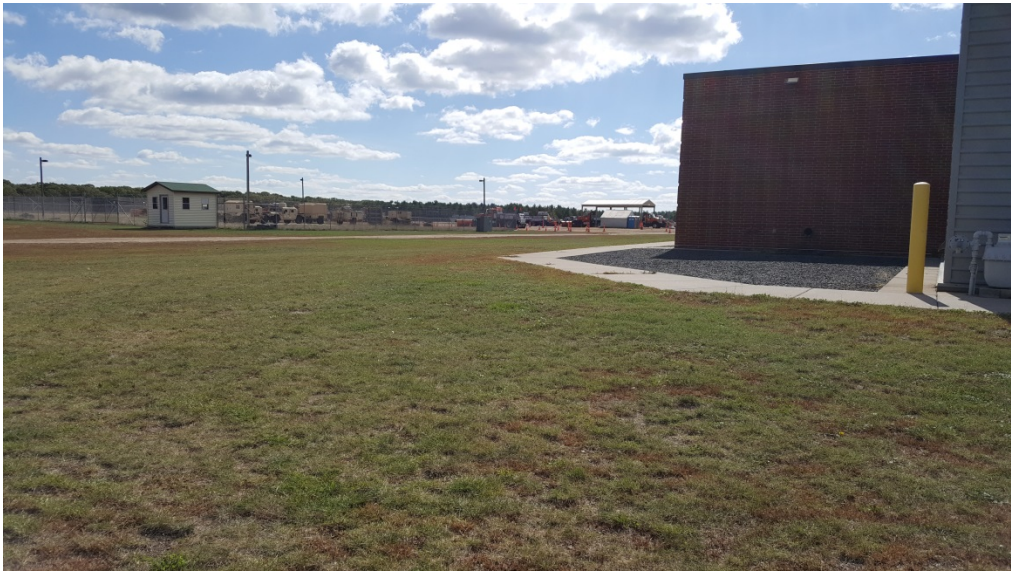
Army National Guard, Preliminary Assessment for PFAS		Camp Ripley, Minnesota	Little Falls, Minnesota
<b>Photograph No. 7</b>  <b>Description:</b> Facing southeast. Minnesota Public Safety Division of the Department of Homeland Security Demonstration Area.

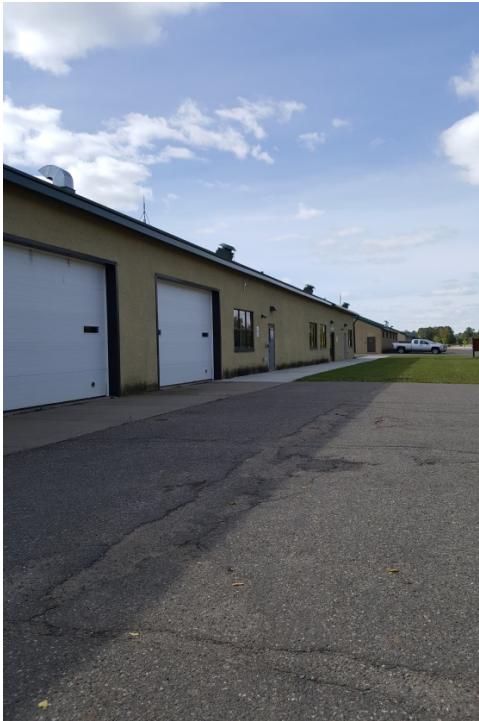
<b>Photograph No. 8</b>  <b>Description:</b> Facing west. Building 2-203.

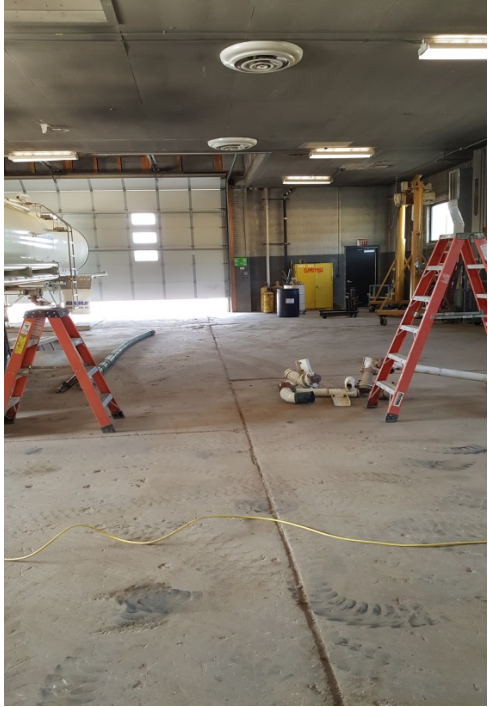
APPENDIX C – Photographic Log		
Army National Guard, Preliminary Assessment for PFAS	Camp Ripley, Minnesota	Little Falls, Minnesota
<b>Photograph No. 9</b> <b>Description:</b> Facing east. United States Air Force 133 <sup>rd</sup> Airlift Wing Fire Truck Storage Area.

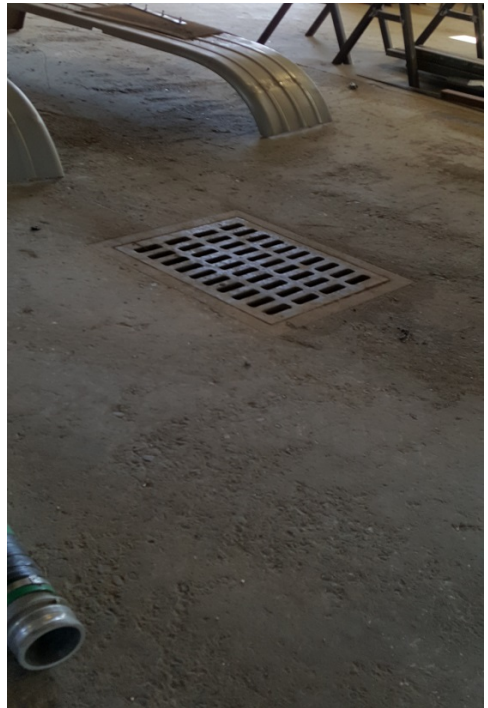
<b>Photograph No. 10</b> <b>Description:</b> Facing southwest. Floor Drain in Building 2-272.

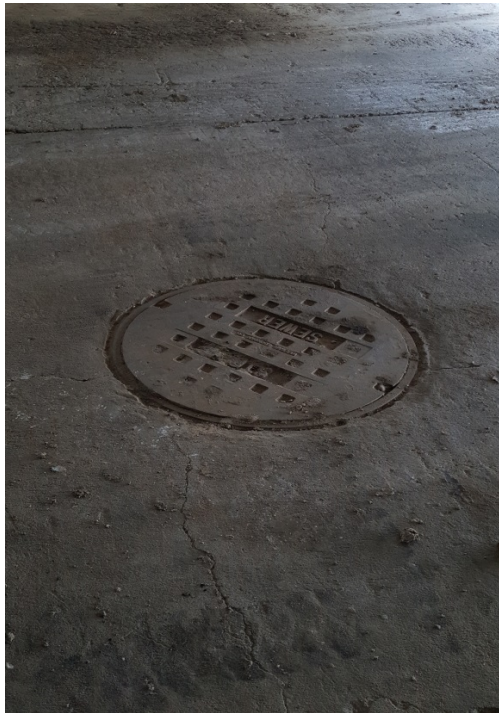
Army National Guard, Preliminary Assessment for PFAS		Camp Ripley, Minnesota	Little Falls, Minnesota
<b>Photograph No. 11</b>

<b>Description:</b>  Facing southwest. Storm Sewer in Building 2-272.			
<b>Photograph No. 12</b>

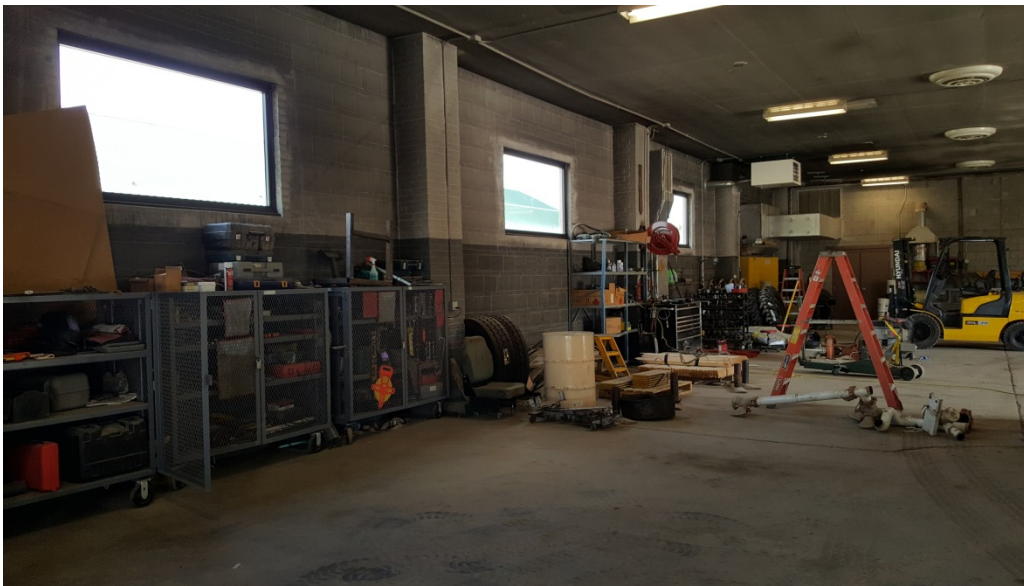
<b>Description:</b>  Facing northeast. Bulk AFFF Storage Area in Building 2-272.
