# FINAL Preliminary Assessment Report Camp McCain Grenada, Mississippi

Perfluorooctanesulfonic Acid (PFOS) and Perfluorooctanoic  
Acid (PFOA) Impacted Sites  
ARNG Installations, Nationwide

September 2020

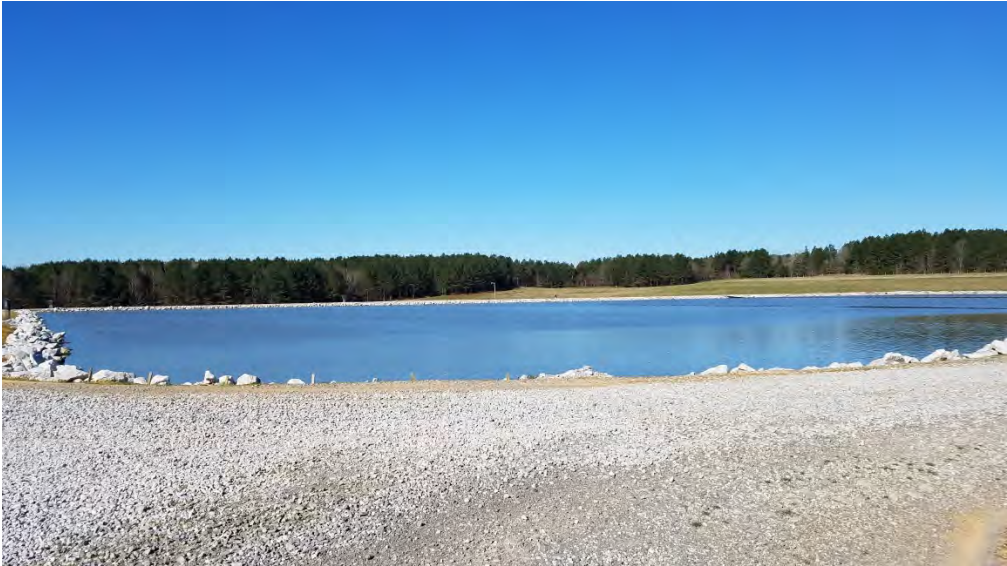
APPENDIX C – Photographic Log		
Army National Guard, Preliminary Assessment for PFAS		Grenada, Mississippi
<b>Photograph No. 1</b>  <b>Description:</b> <p>Camp McCain Waste Water Treatment Plant (WWTP). Eastern most stabilization lagoon, location where out-of-date AFFF was disposed of between 2009-2011. Standing on southeastern corner facing northwest.</p> <b>Date Taken:</b> <p>6 March 2019</p>

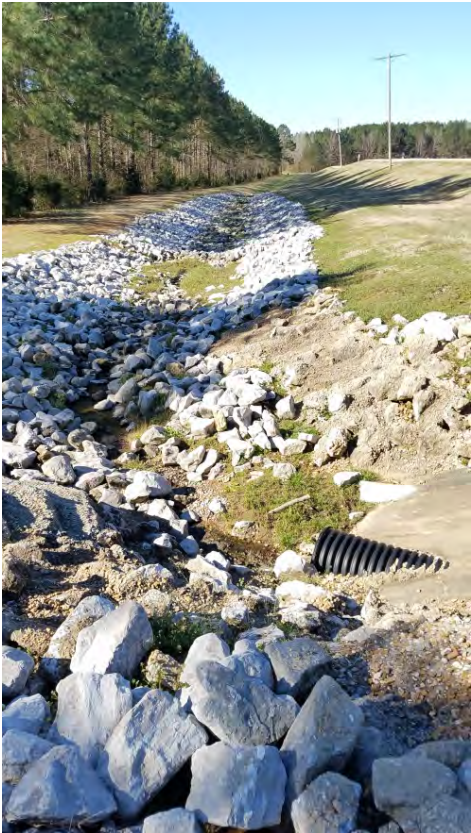
<b>Photograph No. 2</b>  <b>Description:</b> <p>WWTP: Southern drainage ditch. Black piping from WWTP effluent treatment facility visible in the lower righthand corner. Standing on eastern end facing southwest.</p> <b>Date Taken:</b> <p>6 March 2019</p>

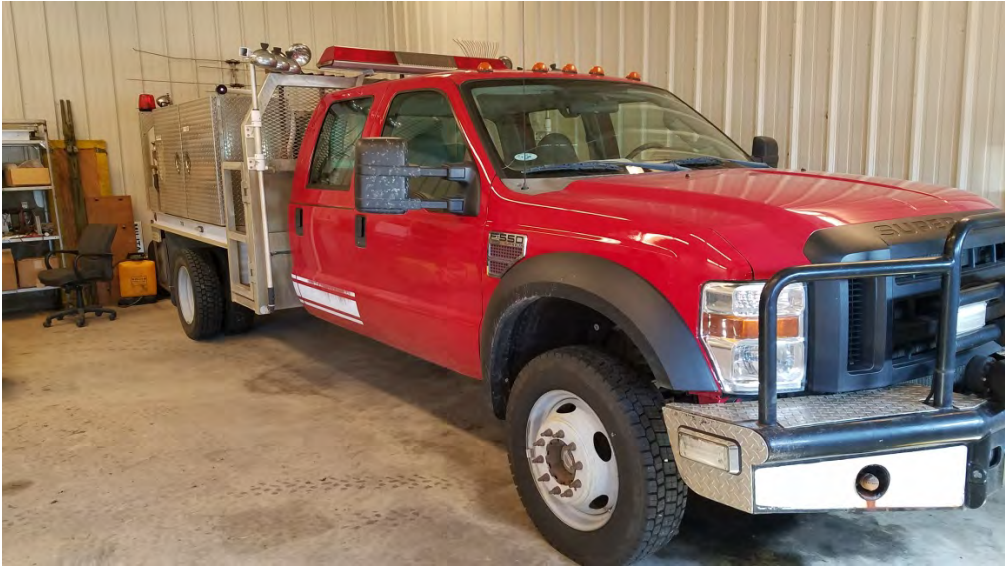
Army National Guard, Preliminary Assessment for PFAS	Camp McCain	Grenada, Mississippi
<p><b>Photograph No. 3</b></p> <p><b>Description:</b> Camp McCain Fire Station.</p> <p><b>Date Taken:</b> 6 March 2019</p>	 	
<p><b>Photograph No. 4</b></p> <p><b>Description:</b> Camp McCain firetruck, this fire truck is not foam capable. A portable Class A foam backpack is stored within its cabinets.</p> <p><b>Date Taken:</b> 6 March 2019</p>

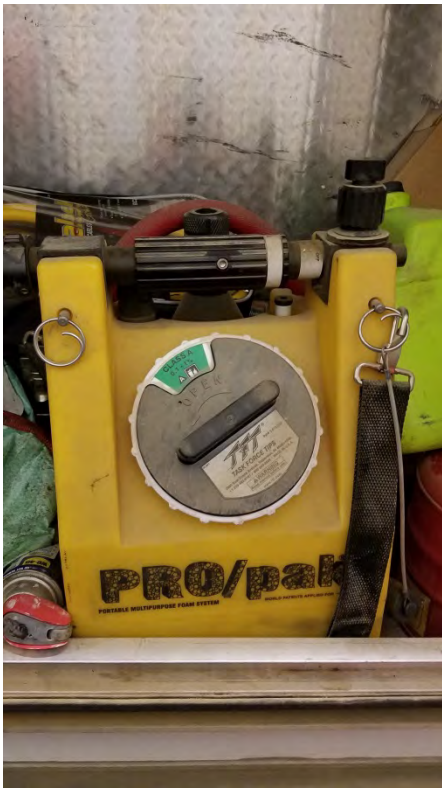
APPENDIX C – Photographic Log		
Army National Guard, Preliminary Assessment for PFAS		Grenada, Mississippi
<b>Photograph No. 5</b>  <b>Description:</b>  Class A foam portable backpack unit stored in firetruck storage cabinet.  <b>Date Taken:</b> 6 March 2019

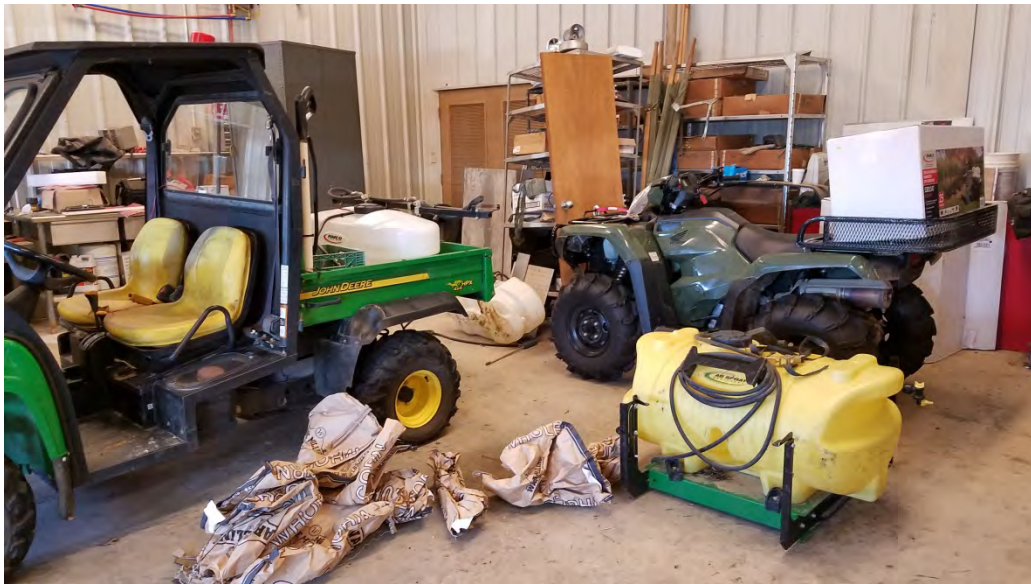
Army National Guard, Preliminary Assessment for PFAS	Camp McCain	Grenada, Mississippi
<p><b>Photograph No. 7</b></p> <p><b>Description:</b></p> <p>Gator utility vehicle unit (not foam capable) stored in the fire station. Not shown in photograph is the M1 Gator that has foam capability.</p> <p><b>Date Taken:</b></p> <p>6 March 2019</p>

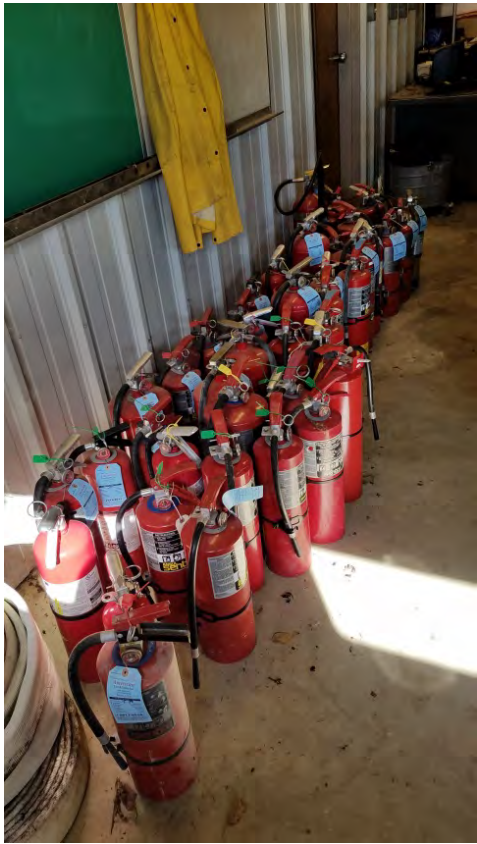
<p><b>Photograph No. 8</b></p> <p><b>Description:</b></p> <p>Portable dry chemical fire extinguishers stored within the fire station.</p> <p><b>Date Taken:</b></p> <p>6 March 2019</p>

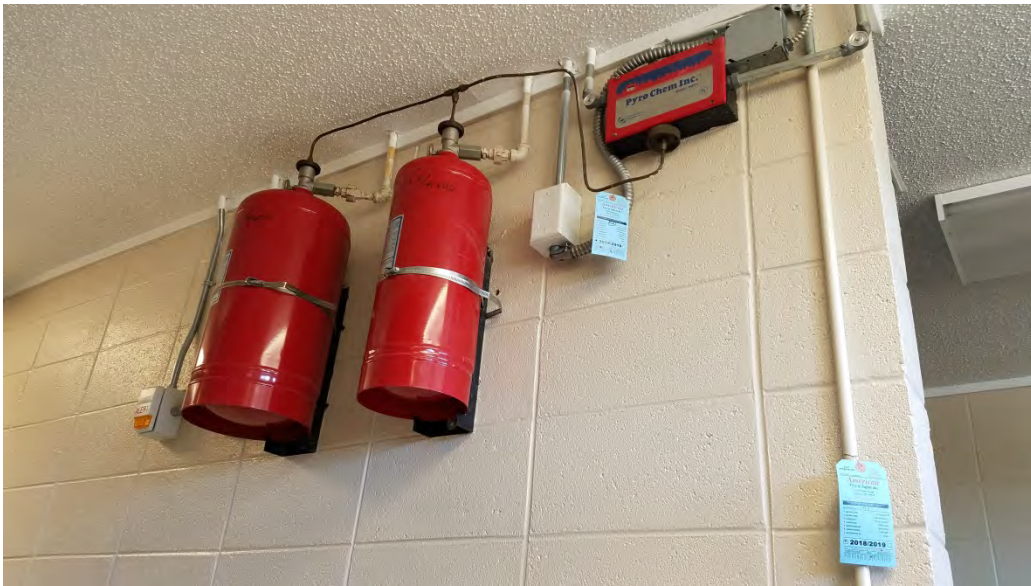
Army National Guard, Preliminary Assessment for PFAS	Camp McCain	Grenada, Mississippi
<p><b>Photograph No. 9</b></p> <p><b>Description:</b></p> <p>Kitchen within DAFC.          PyroChem K-class (potassium carbonate-based) fire suppression system.</p> <p><b>Date Taken:</b></p> <p>6 March 2019</p>

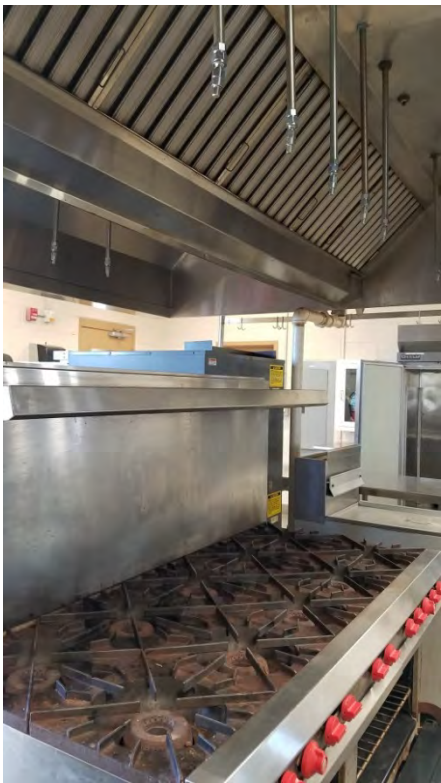
<p>The photograph shows two large red fire suppression cylinders mounted vertically on a light-colored tiled wall. To the right of the cylinders is a red and black control panel with a digital display and various buttons. A white electrical box is also visible on the wall. A blue tag with the date '2019-03-19' is attached to the wall near the cylinders.</p>	
<p><b>Photograph No. 10</b></p> <p><b>Description:</b></p> <p>Kitchen within DFAC:          Cooking Range Hood with          PyroChem K-class (potassium carbonate-based) fire suppression system sprinklers.</p> <p><b>Date Taken:</b></p> <p>6 March 2019</p>
