FINAL Preliminary Assessment Report Jackson Army Aviation Support Facility #1 Jackson, Mississippi

Perfluorooctanesulfonic Acid (PFOS) and Perfluorooctanoic Acid
(PFOA) Impacted Sites
ARNG Installations, Nationwide

September 2020

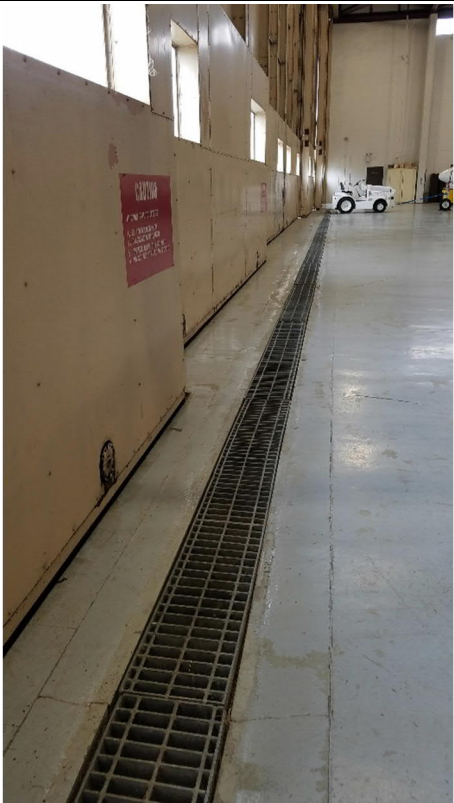
Army National Guard, Preliminary Assessment for PFAS	Jackson ASSF	Jackson, Mississippi
<p>Photograph No. 1</p> <p>Description:</p> <p>Floor drains within the AASF hangar.</p>

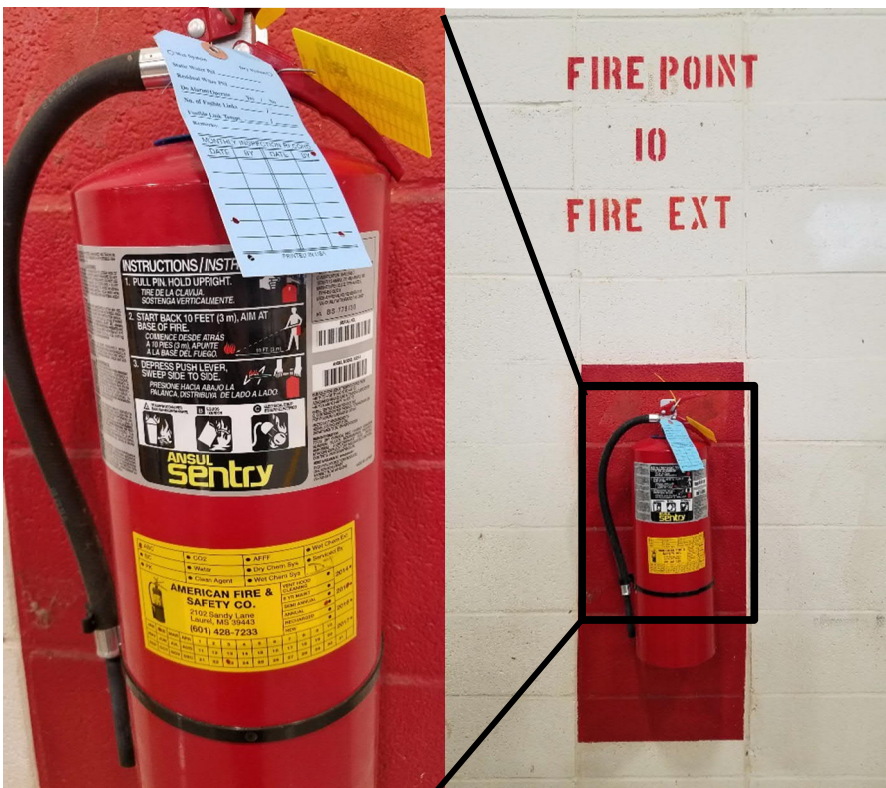
<p>Photograph No. 2</p> <p>Description:</p> <p>Fire extinguisher in hallway.</p>
