FINAL Preliminary Assessment Report Camp Shelby Joint Forces Training Center, Mississippi

Perfluorooctanesulfonic Acid (PFOS) and Perfluorooctanoic
Acid (PFOA) Impacted Sites
ARNG Installations, Nationwide

September 2020

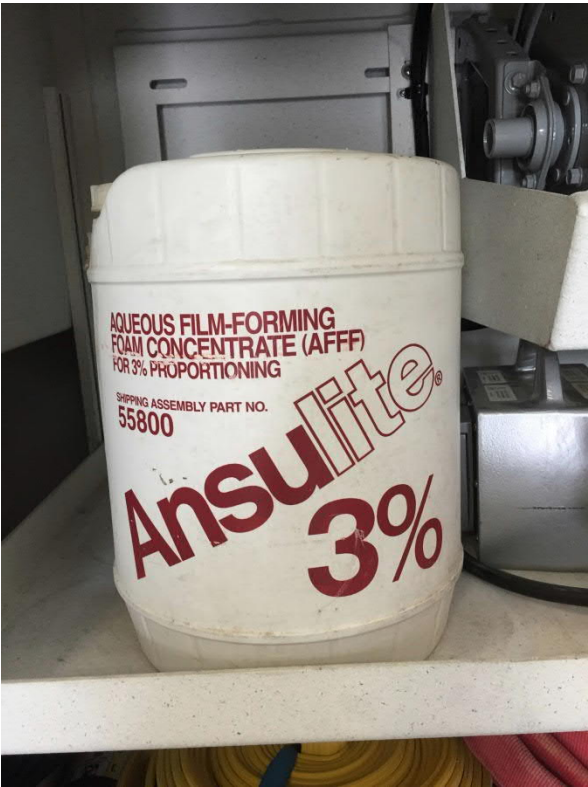
The Current Fire Station is located on the north end of the installation. According to aerial imagery, the Current Fire Station was built between 2012 and 2013. There have been no reported AFFF releases at the building. During the VSI, two 5-gallon buckets of AFFF were noted in storage on one of the firetrucks. Personnel at the station reported no knowledge of AFFF releases during the entirety of the Current Fire Station's existence.

Five-gallon bucket of AFFF
on truck at current fire
station (two buckets total on
vehicle).

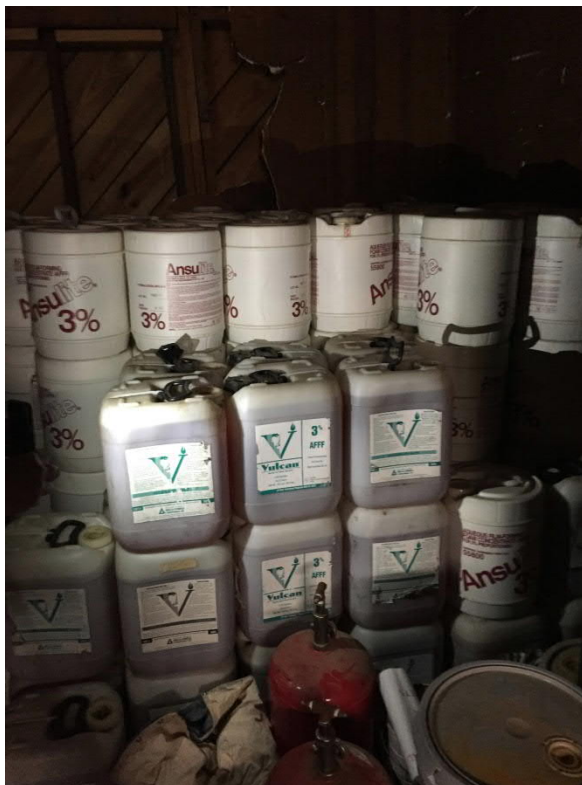
The Warehouse – Building 6519 is located on the southwestern end of the installation, near the Old Fire Station. During the VSI, a stock of 5-gallon buckets of Vulcan and Ansulite 3% AFFF was noted in the Warehouse; approximately 675-gallons were observed. There was no evidence of leaks or spills noted during the VSI, and drains were not present in the building. The building has a wooden floor, which is elevated about 3 feet above ground surface. Site personnel reported no knowledge of leaks or spills of AFFF in the Warehouse from at least 1985 to present.

Stockpile of AFFF in warehouse (Building 6519) near Old Fire Station location.

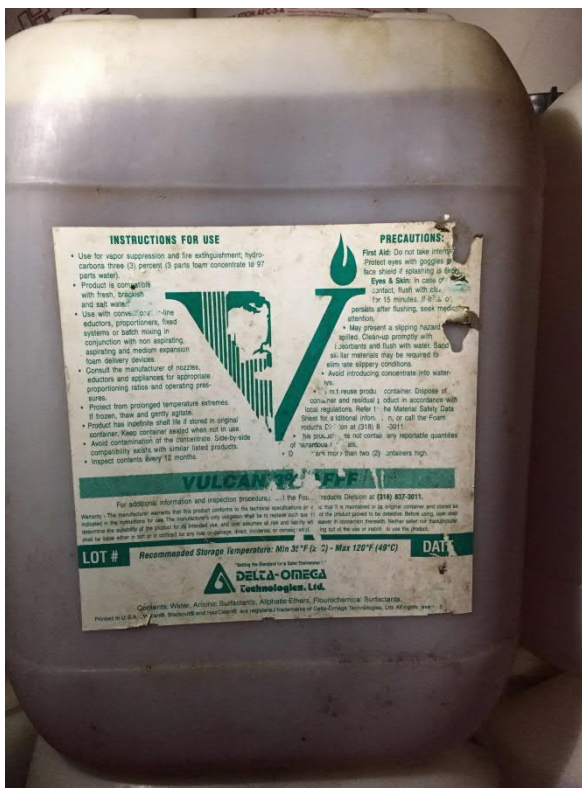
Photograph No. 4

Vulcan AFFF label.

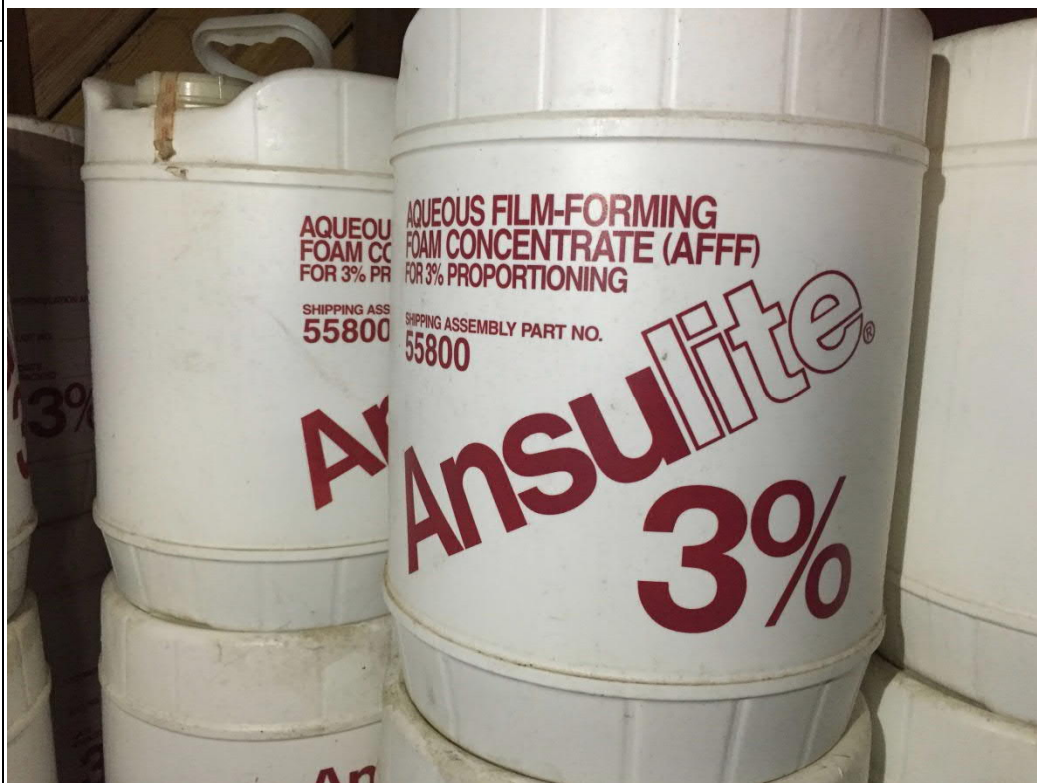
Ansulite AFFF label.

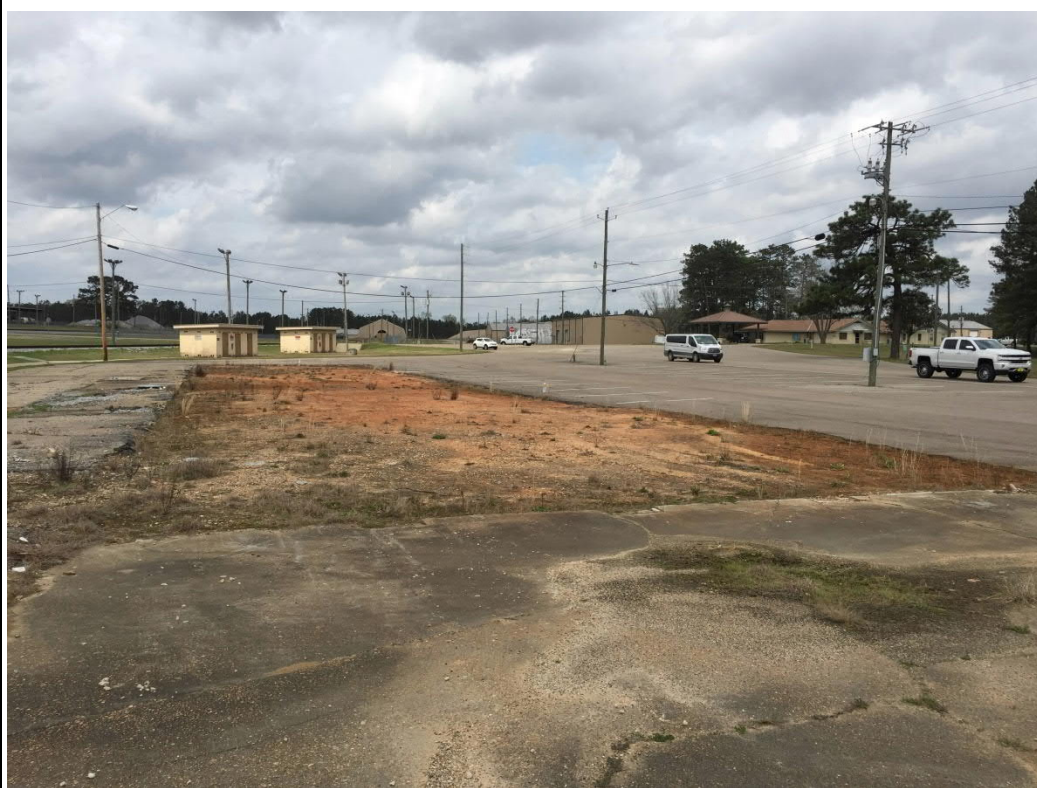
Photograph No. 6

According to the former Fire Inspector and Emergency Services Coordinator and the current Fire Chief, the Old Fire Station housed one firetruck that held between 150 to 200 gallons of AFFF until 2004. Enough AFFF 5-gallon buckets were stored at the station to be able to refill the truck. There were no reported historical releases or spills of AFFF, but there is uncertainty given the regular handling of AFFF that reportedly occurred. Nozzle testing was performed with water. During the VSI, a storm drain was noted in the corner of the parking lot adjacent to the footprint of the former building, as well as a cement-lined drainage ditch. Storm drains in the vicinity of the Old Fire Station discharge to an unnamed tributary to Geiger Lake (MSARNG, 2017).

Footprint of Old Fire
Station (demolished).

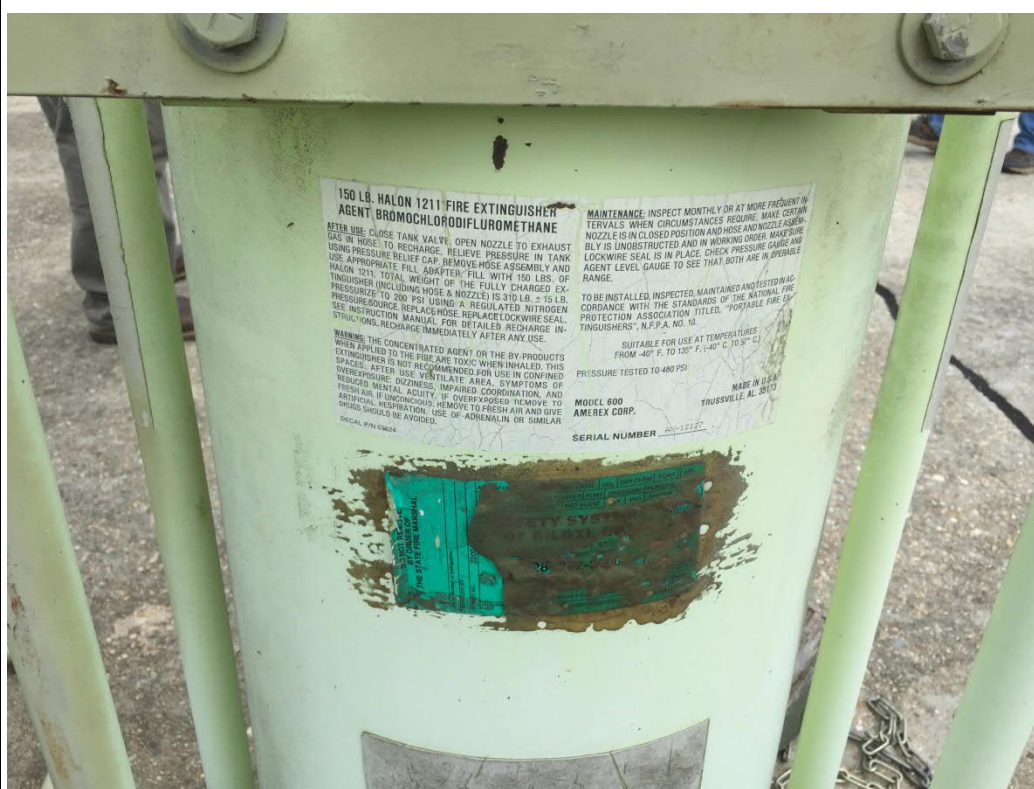
The Old Hagler Airfield Fire Station now functions as an operations and drone hangar building. During the VSI, seven Halon fire extinguishers were noted on the drone flight line adjacent to the building. No AFFF was present in the building during the VSI.

Halon fire extinguisher at
Haglar Airfield (current
drone hangar and
heliport).

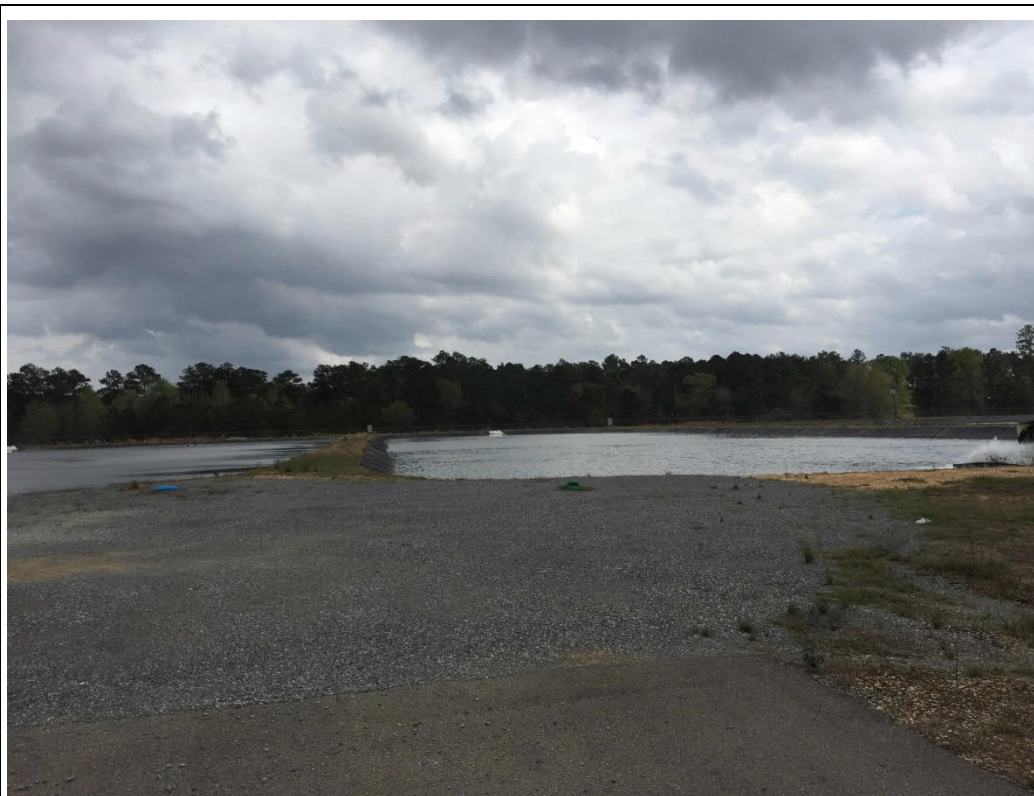
Photograph No. 8

The Waste Water Treatment Plant (WWTP) is located on the north end of the Cantonment area. Prior to 2008, the WWTP was a Class IV system with sludge drying beds (Release Area C). After 2008, the current WWTP, which is a Class II aerated system, began operating (Release Area D). After 2008, sludge was no longer produced by the WWTP. The Class II system currently discharges to the Leaf River after treatment, while the old Class IV system historically discharged to a tributary to Weldy Creek.

Waste Water Treatment
Plant holding ponds.

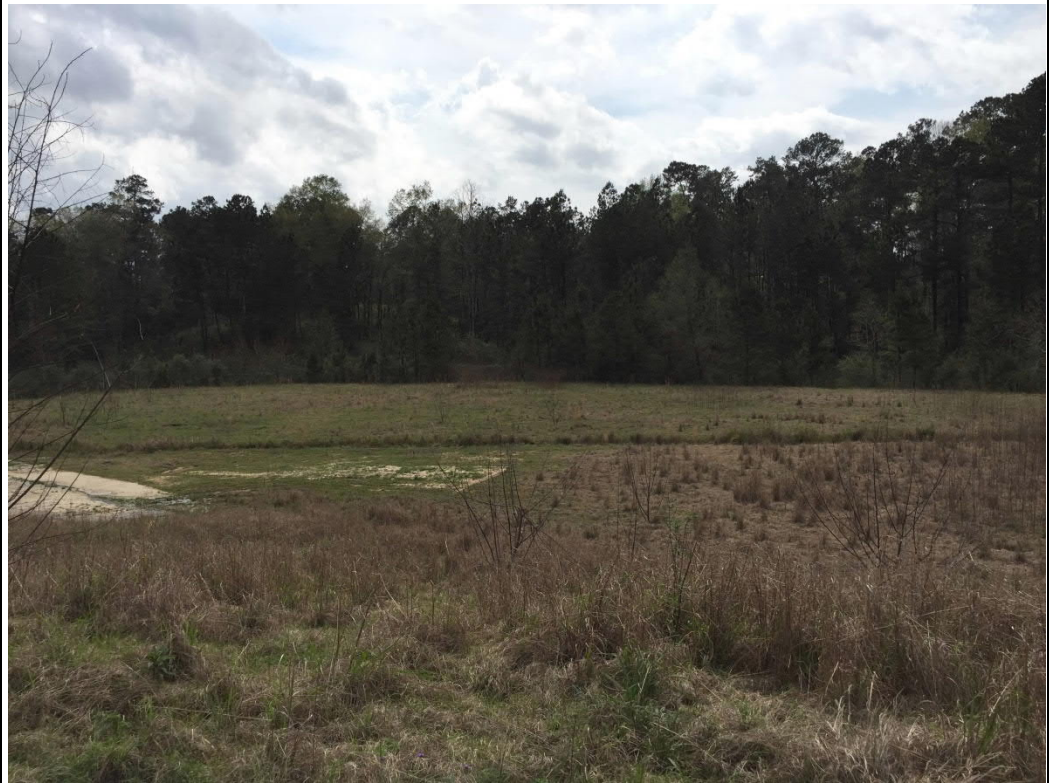
Sludge Drying Beds area.
