# FINAL Preliminary Assessment Report Army Aviation Support Facility Reno, Nevada

Perfluorooctane-Sulfonic Acid (PFOS) and Perfluorooctanoic  
Acid (PFOA) Impacted Sites  
ARNG Installations, Nationwide

July 2020

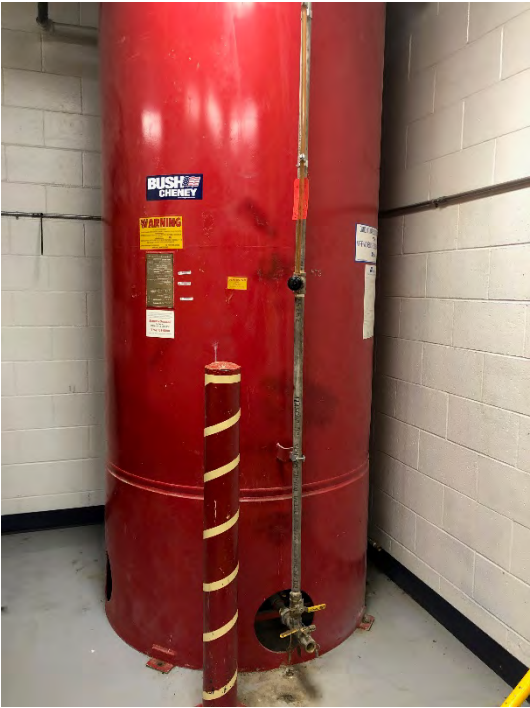
Army National Guard, Preliminary Assessment for PFAS	Army Aviation Support Facility Reno	Reno, Nevada
<p><b>Photograph No. 1</b></p> <p><b>Description:</b></p> <p>Facing West. Fire suppression tank in South Hangar.</p> <p>Photo Date: 09/18/2019 0945</p>

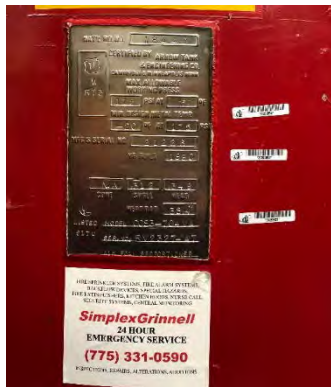
<p><b>Photograph No. 2</b></p> <p><b>Description:</b></p> <p>Facing West. Fire suppression tank in South Hangar.</p> <p>Photo Date: 09/18/2019 0945</p>

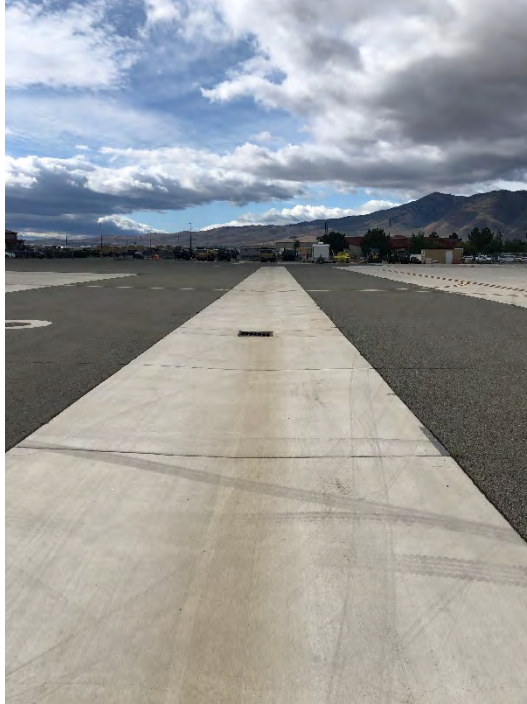
APPENDIX C – Photographic Log		
Army National Guard, Preliminary Assessment for PFAS	Army Aviation Support Facility Reno	Reno, Nevada
<b>Photograph No. 3</b>  <b>Description:</b> Facing South. Drain line direction through the flight line and ramps. Photo Date: 09/18/2019 0951

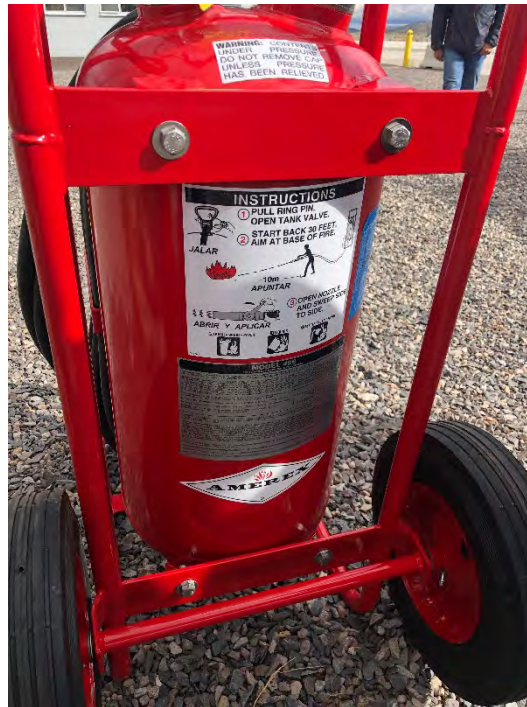
Facing North. New fire  
extinguishers on flight line.

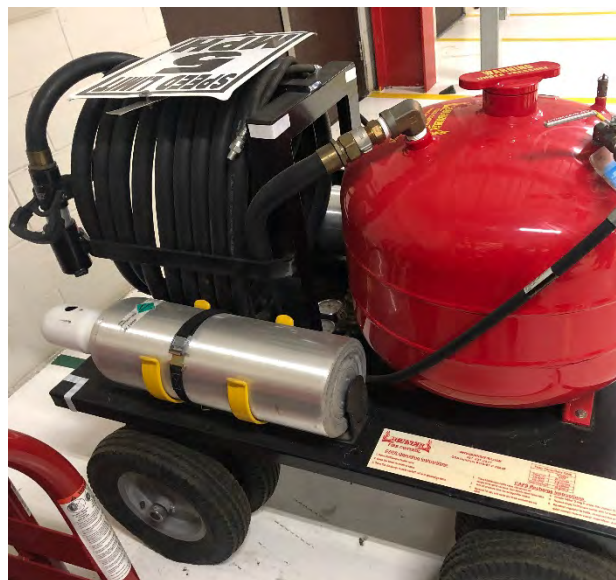
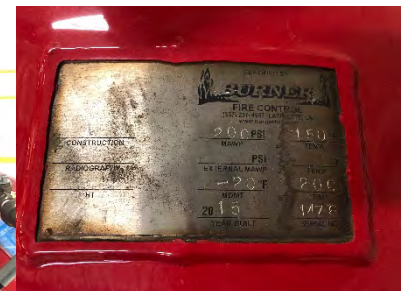
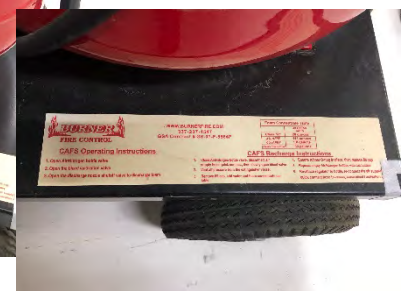
**Photograph No. 6**

Callouts contain detailed information on specs.
