FINAL Preliminary Assessment Report Cheyenne Army Aviation Support Facility Las Vegas, Nevada

Perfluorooctanesulfonic Acid (PFOS) and Perfluorooctanoic
Acid (PFOA) Impacted Sites
ARNG Installations, Nationwide

July 2020

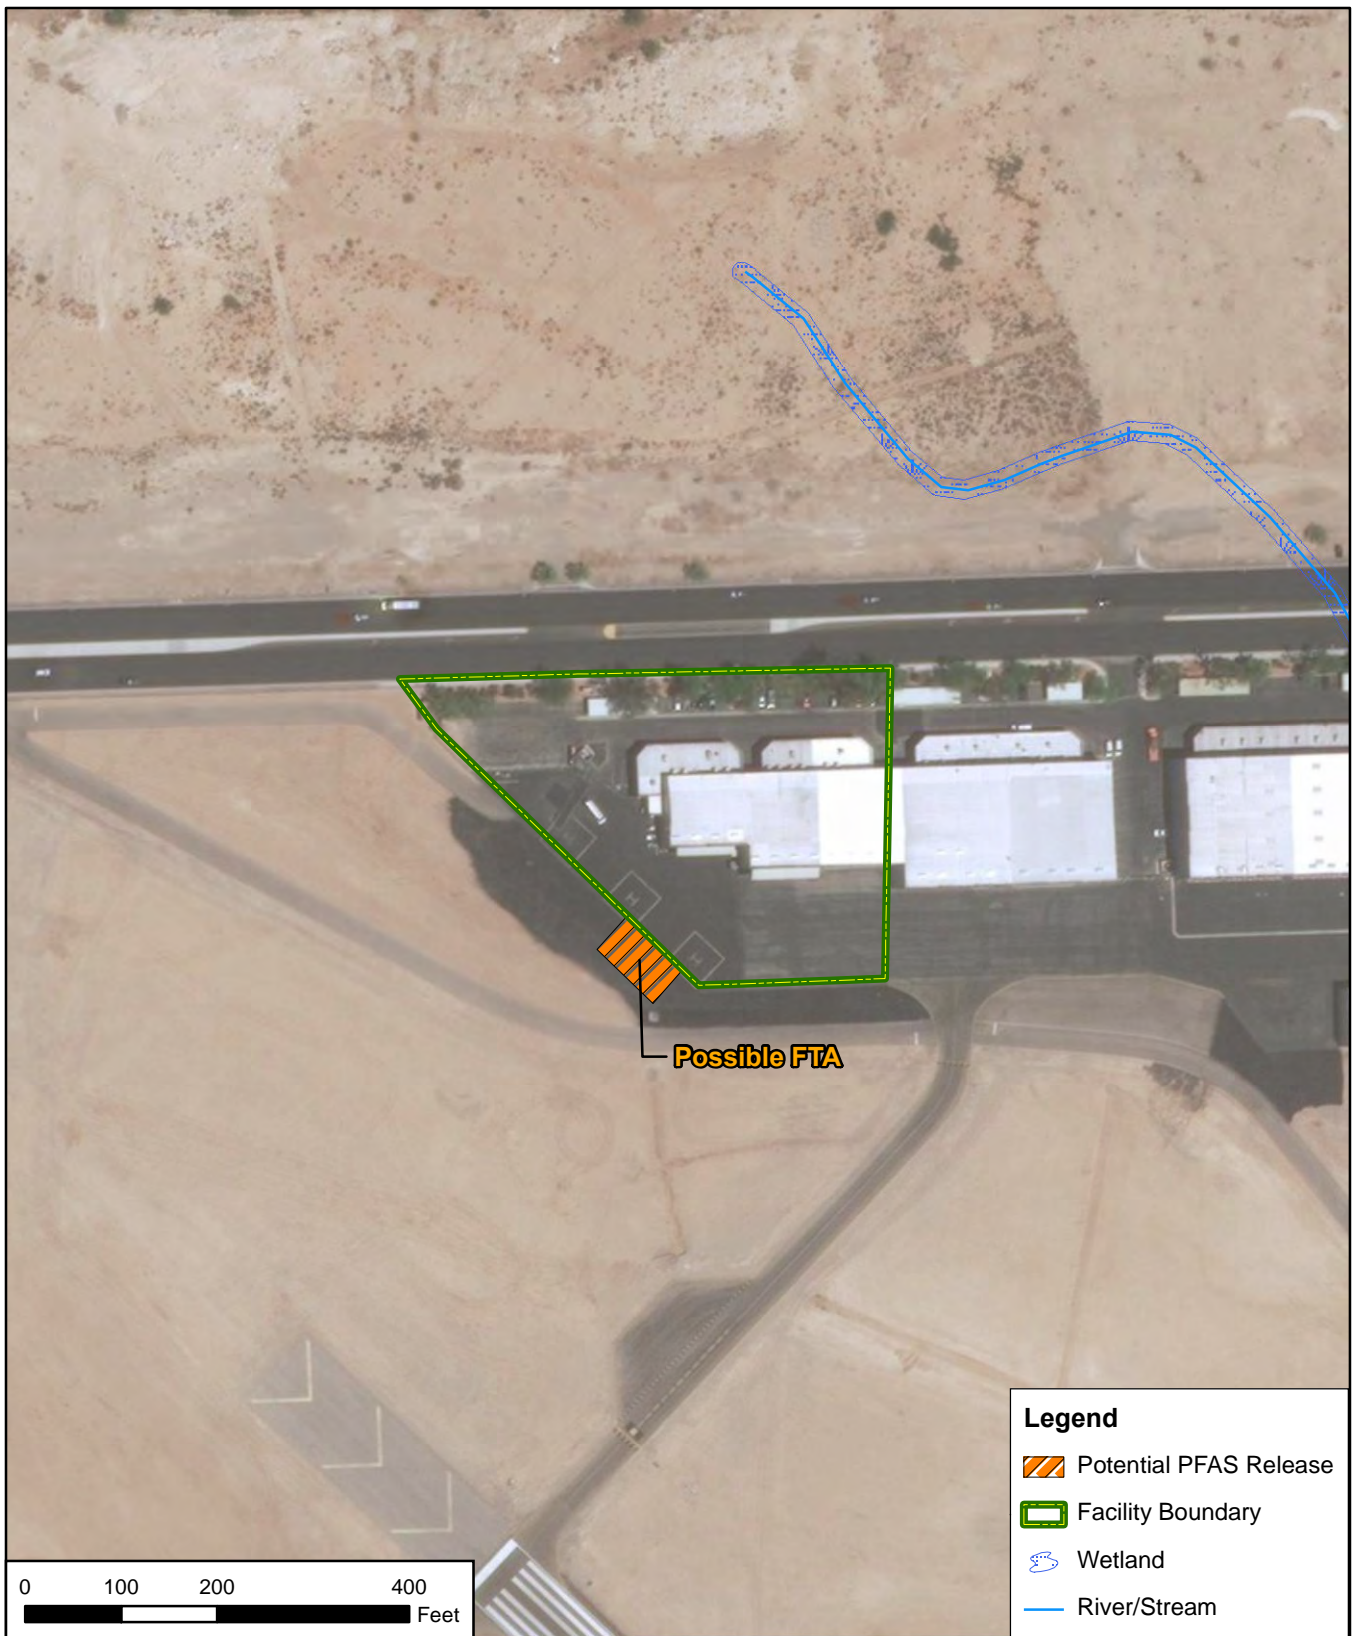
12420 Milestone Center Drive Germantown, MD 20876	Figure 2-1
REVISED	3/12/2020	GIS BY	HO	3/12/2020			
SCALE	1:2,400	CHK BY	MW	3/12/2020			
Base Map: Source: Esri, DigitalGlobe, GeoEye, Earthstar Geographics, CNES/Airbus DS, USDA, USGS,		PM	RG	3/12/2020

Personnel had anecdotal knowledge that a fire extinguisher may have been discharged by a guardsman on the unpaved sandy area at the southwest edge of the asphalt helipads as part of an unofficial training exercise. Interviewees believe that dawn dish soap was likely used if this was the case, but there is no documentation to confirm this (**Figure 2-1**). A specific timeframe for this event was not given; however, personnel indicated it would have been prior to 2003, before any of the interviewees were stationed at this AASF. Because details are not specifically recalled, this training event is considered a potential AFFF release. A polymer coating and drainage swale which runs south underneath the adjacent access road into an empty soil patch was added to this area in 2016 to reduce the spread of dust during helicopter take-off and landings. Interview records appear in **Appendix B**.

Fire Training Areas	
NOTES Preliminary Assessment for PFAS at AASF Las Vegas Cheyenne

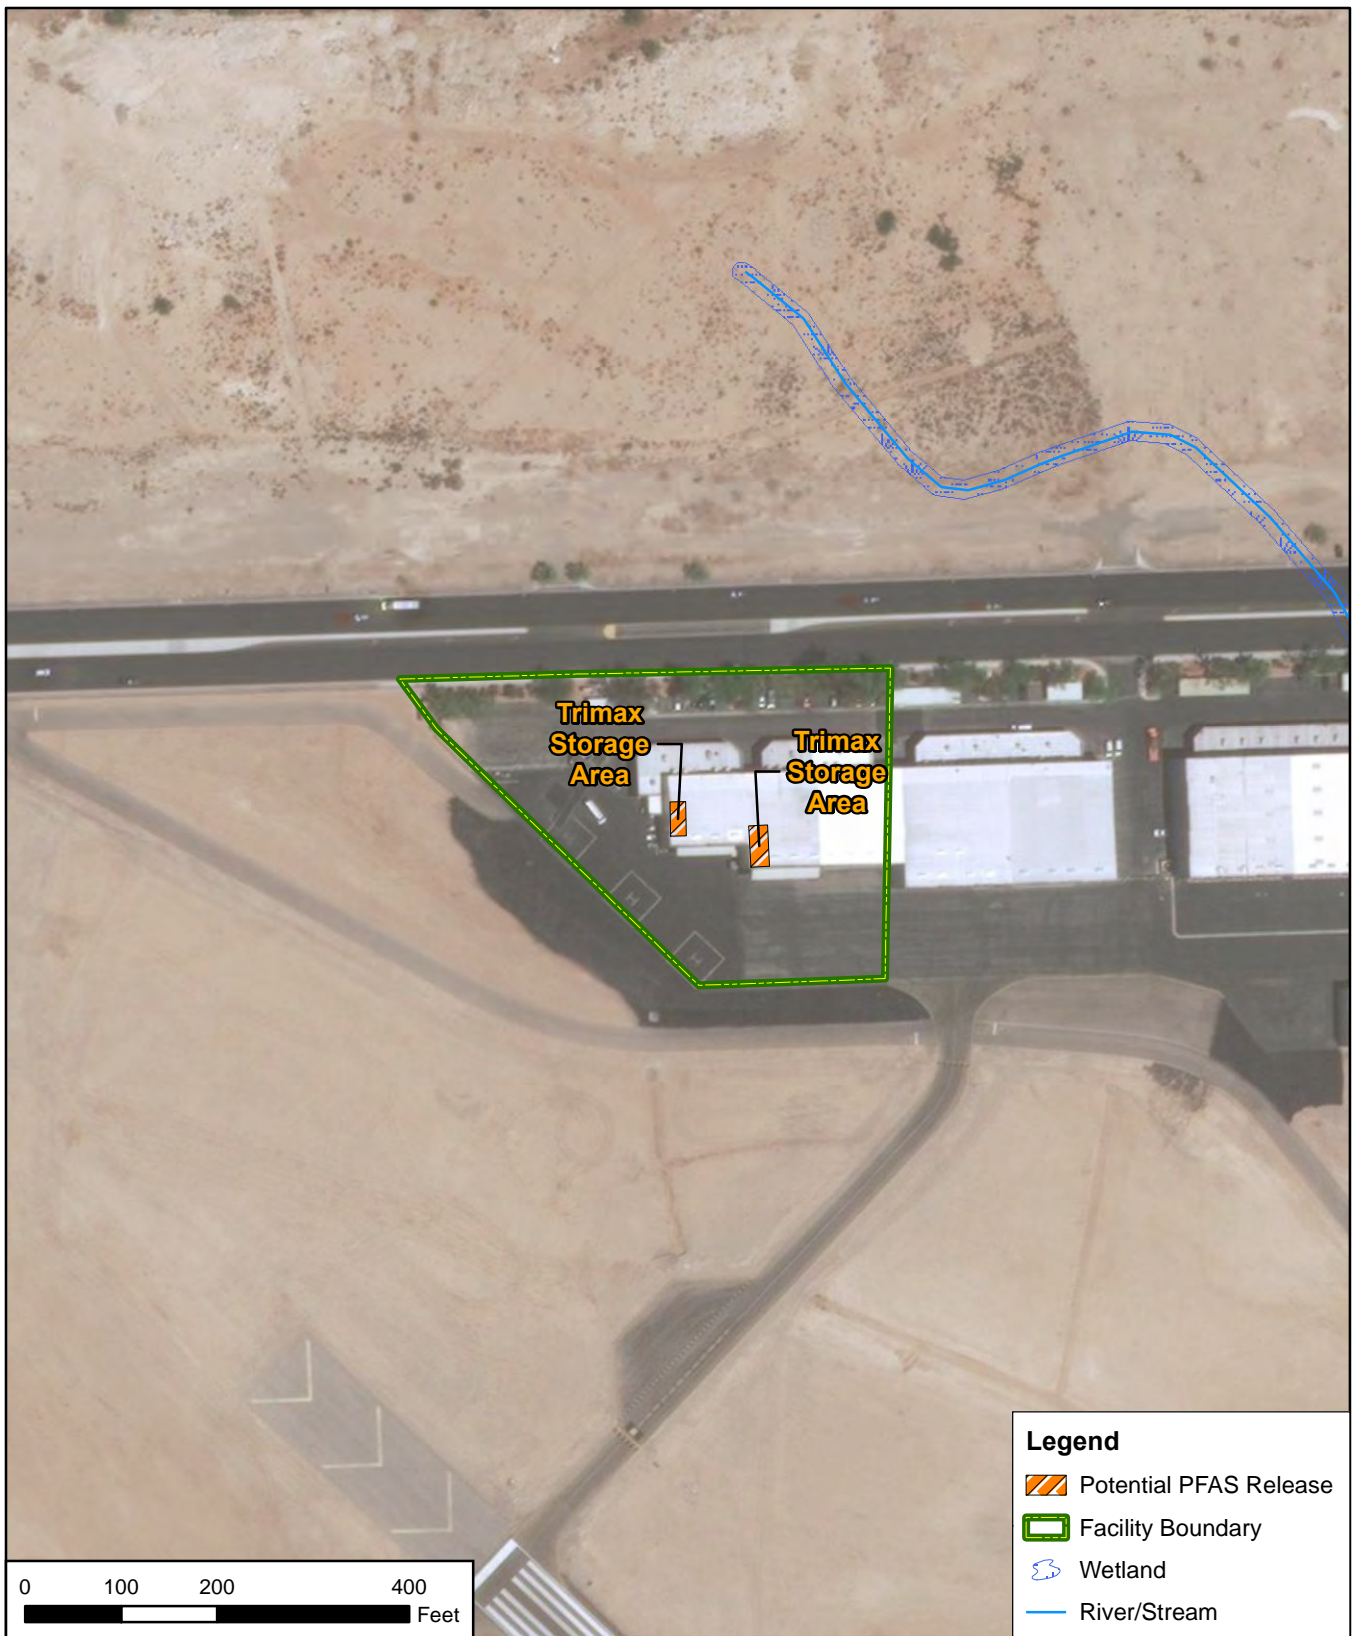
Figure 3-1

Hangar 1 formerly housed a single Tri-Max™ hand-truck that was stored in various locations around the structure. The two primary storage areas are shown in **Figure 3-1**. This Tri-Max™ unit was on site from the early 2000s until 2016, when it was sent back to the Carson City Warehouse Defense Reutilization and Marketing Office. The unit was regularly serviced by a safety officer in Reno contracted through ABC until sometime between 2008 and 2010. According to interviews, there are no records or recollection of the hand-truck ever being used for fire training or emergency response.

Non-Fire Training Areas

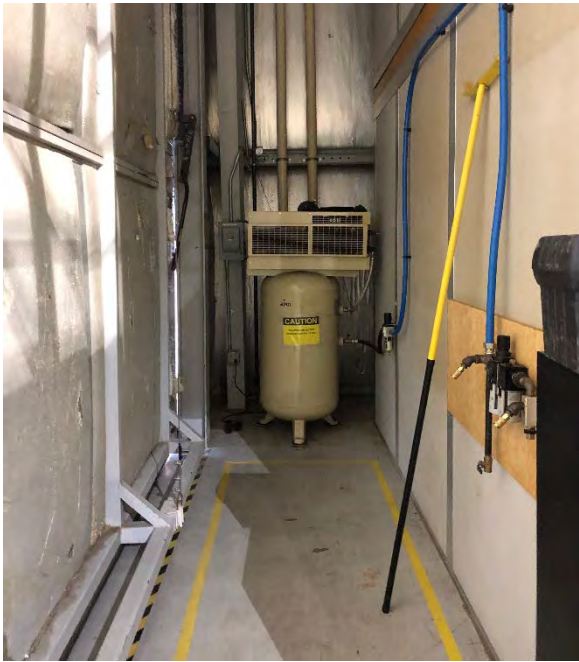
Army National Guard, Preliminary Assessment for PFAS	Cheyenne Army Aviation Support Facility	Las Vegas, Nevada
<p>Photograph No. 1</p> <p>Description:</p> <p>Facing West. Former Trimex storage area</p> <p>Photo Date: 09/20/2019 0914</p>

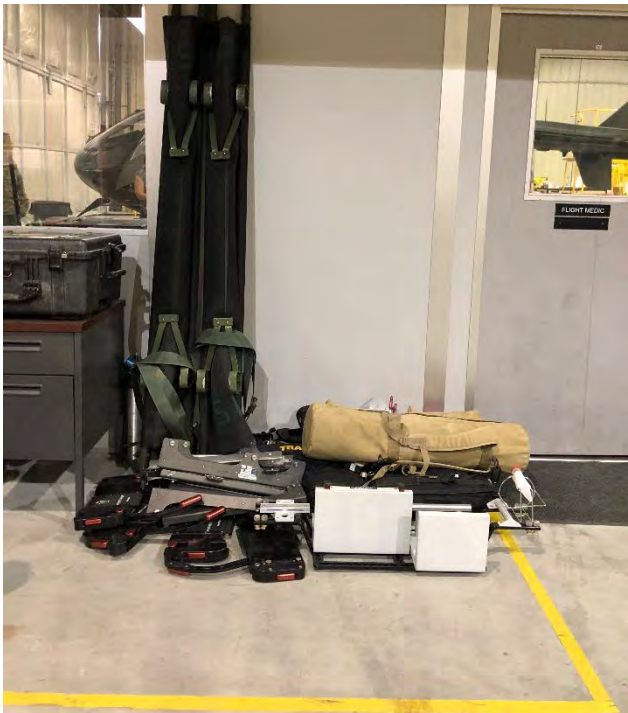
<p>Photograph No. 2</p> <p>Description:</p> <p>Facing West. Former Trimex storage area</p> <p>Photo Date: 09/20/2019 0915</p>

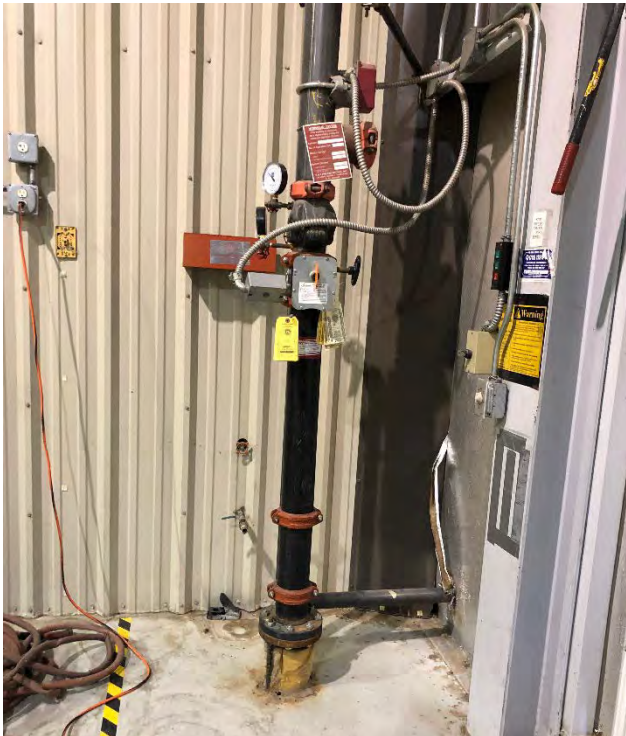
Army National Guard, Preliminary Assessment for PFAS	Cheyenne Army Aviation Support Facility	Las Vegas, Nevada
<p>Photograph No. 3</p> <p>Description:</p> <p>Facing East. Water sprinkler system.</p> <p>Photo Date: 09/20/2019 0916</p>

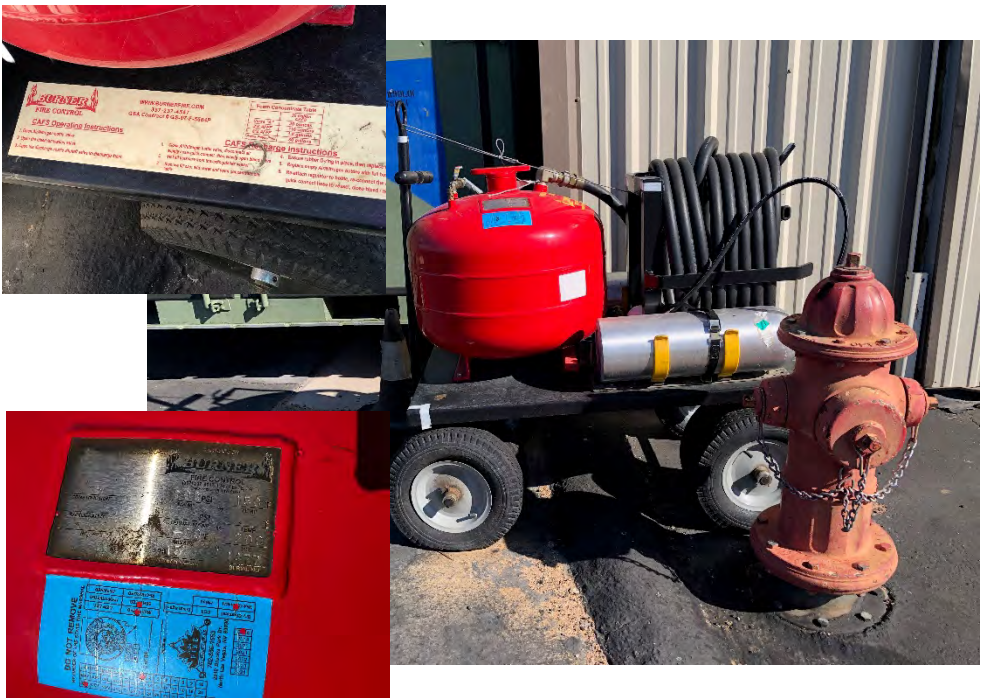
<p>Photograph No. 4</p> <p>Description:</p> <p>Facing North. New fire extinguisher which also contains AFFF.</p> <p>Photo Date: 09/20/2019 0922</p>
