FINAL Preliminary Assessment Report State Military Reservation Concord, New Hampshire

Perfluorooctane-Sulfonic Acid (PFOS) and
Perfluorooctanoic Acid (PFOA) Impacted Sites
ARNG Installations, Nationwide

November 2019

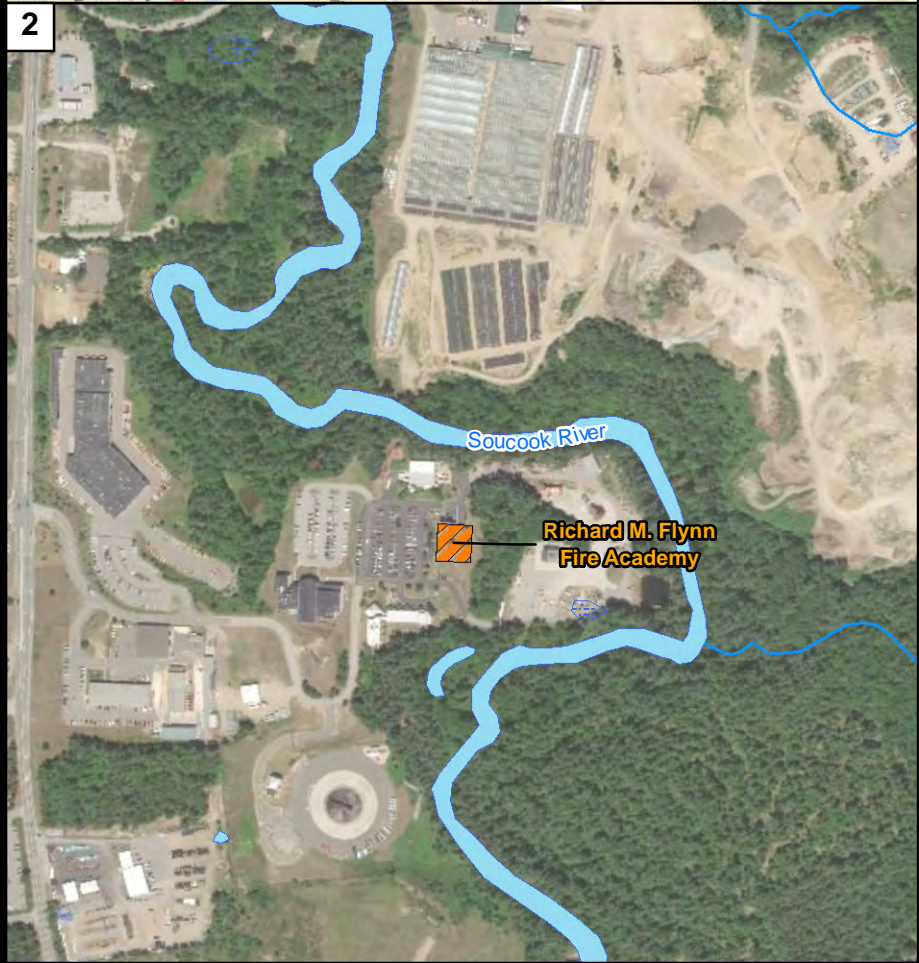
CLIENT		ARNG			
Preliminary Assessment for PFAS at the State Military Reservation, NH					
REVISED		10/30/2019	GIS BY	MS	10/30/2019
SCALE		1:8,281	CHK BY	JZ	10/30/2019
Base Map: Sources: Esri, HERE, Garmin, USGS, Intermap, INCREMENT P, NRCan, Esri Japan, METI, Esri China (Hong Kong), Esri Korea, Esri (Thailand), NGCC, (c)			PM	RG	10/30/2019

- Area of Interest
- Potential PFAS Release
- Facility Boundary
- Stream/River
- Wetland
- River/Stream

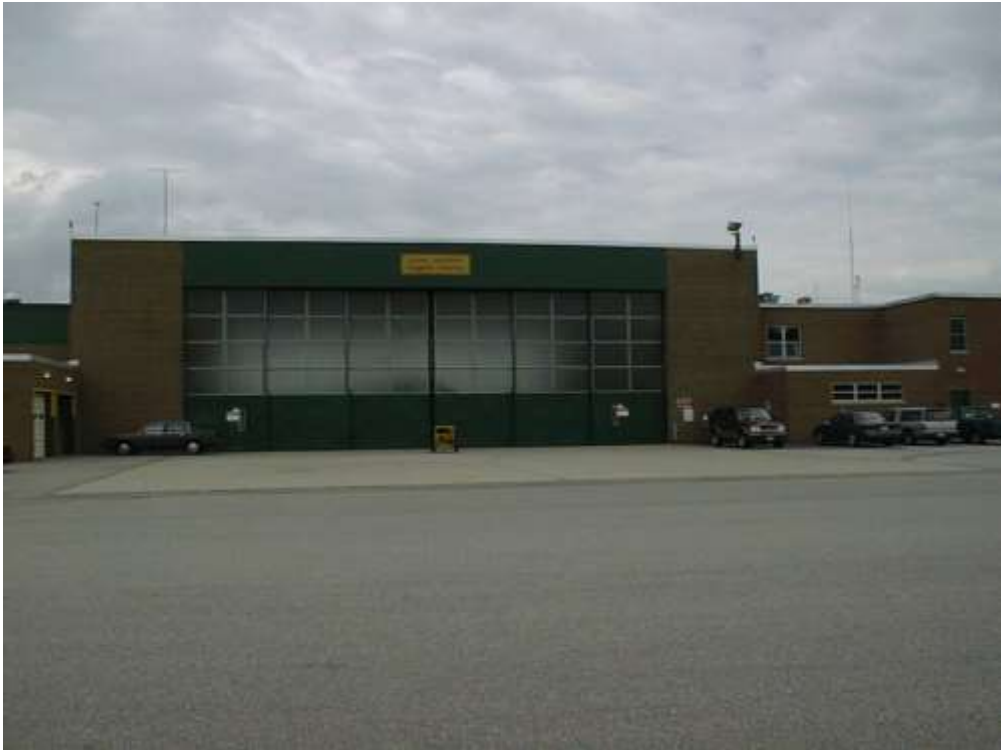
Appendix C - Photographic Log		
Army National Guard, Preliminary Assessment for PFAS	State Military Reservation	Concord, New Hampshire
Photograph No. 01 Date 5/25/1999 Time Unknown Description: Front of the former Building K AASF Hangar. Orientation: West

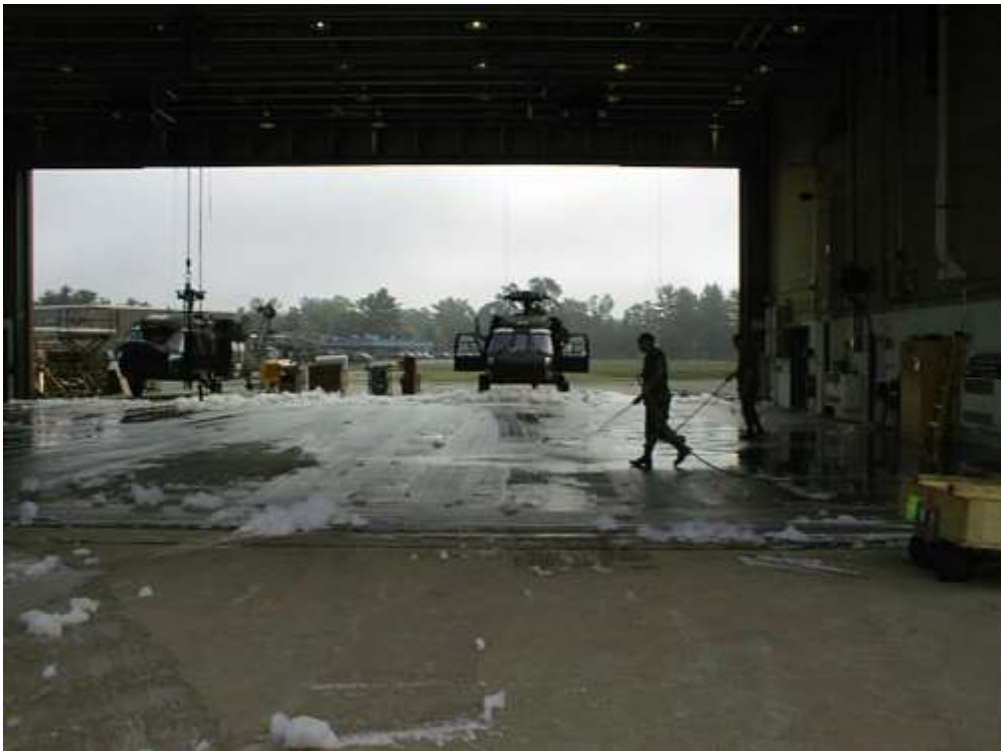
Photograph No. 02 Date 7/23/1999 Time Unknown Description: AFFF foam release from the former AASF Hangar (former Building K). Orientation: East

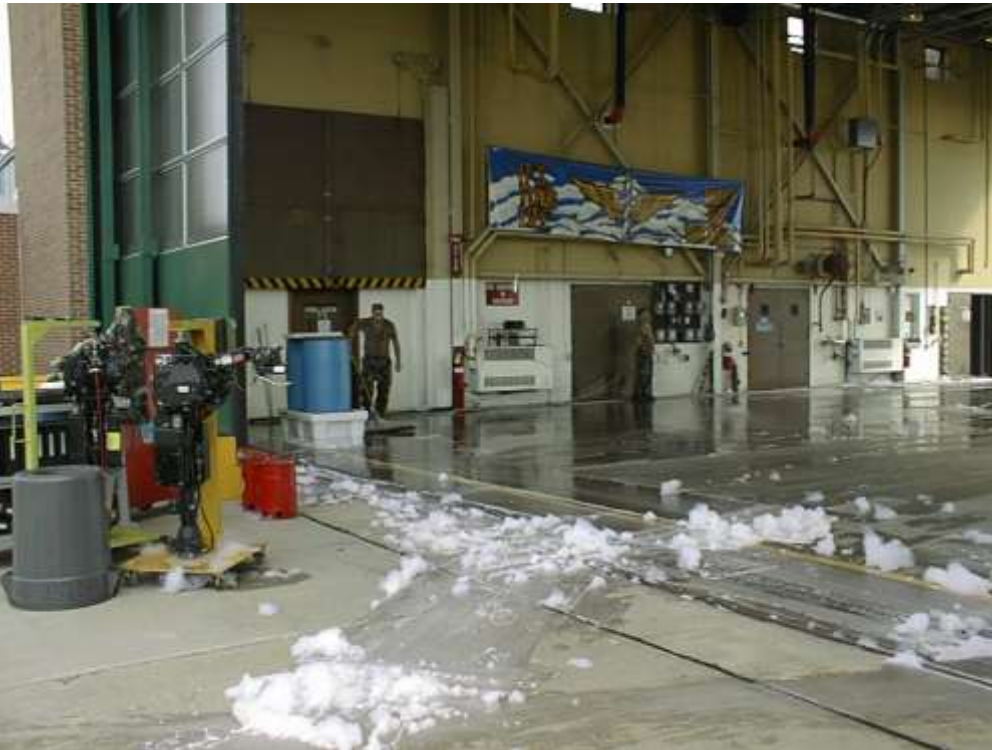
Army National Guard, Preliminary Assessment for PFAS	State Military Reservation	Concord, New Hampshire
<p>Photograph No. 03</p> <p>Date 7/23/1999 Time Unknown</p> <p>Description: AFFF foam release from the former AASF Hangar (former Building K). Personnel washed foam down drain in the main hangar which led to the municipal sewer system.</p> <p>Orientation: NA</p>

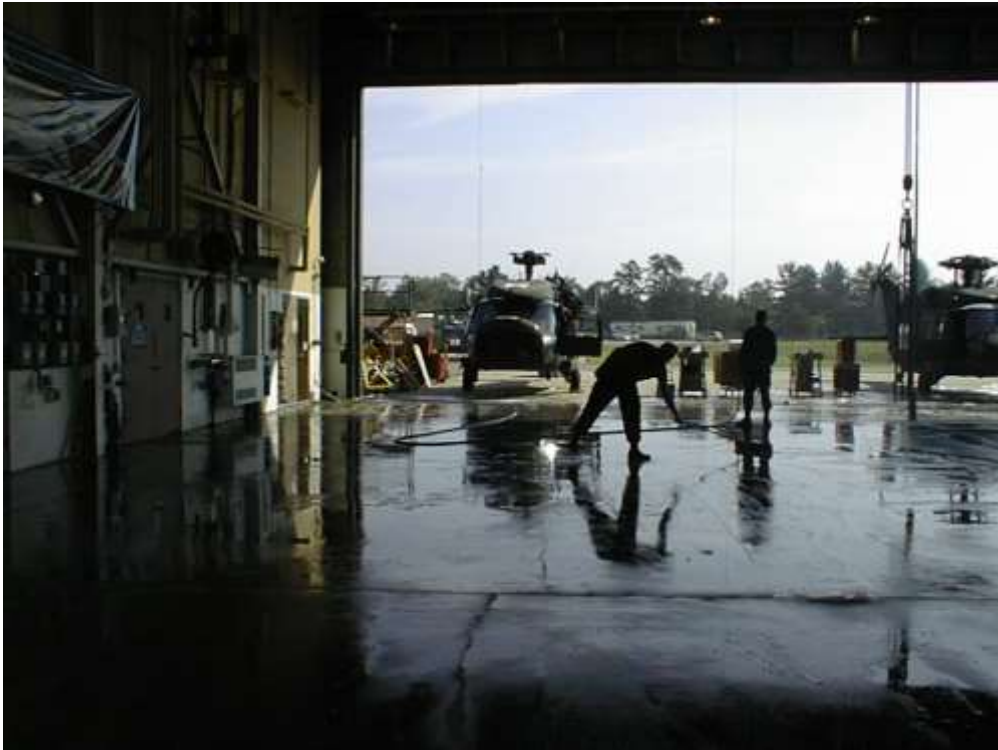
Appendix C - Photographic Log		
Army National Guard, Preliminary Assessment for PFAS	State Military Reservation	Concord, New Hampshire
Photograph No. 05 Date 7/23/1999 Time Unknown Description: AFFF foam release from the former AASF Hangar (former Building K). AFFF foam release from the former AASF Hangar (former Building K). Personnel washed foam down drain in the main hangar which led to the municipal sewer system. Orientation: East

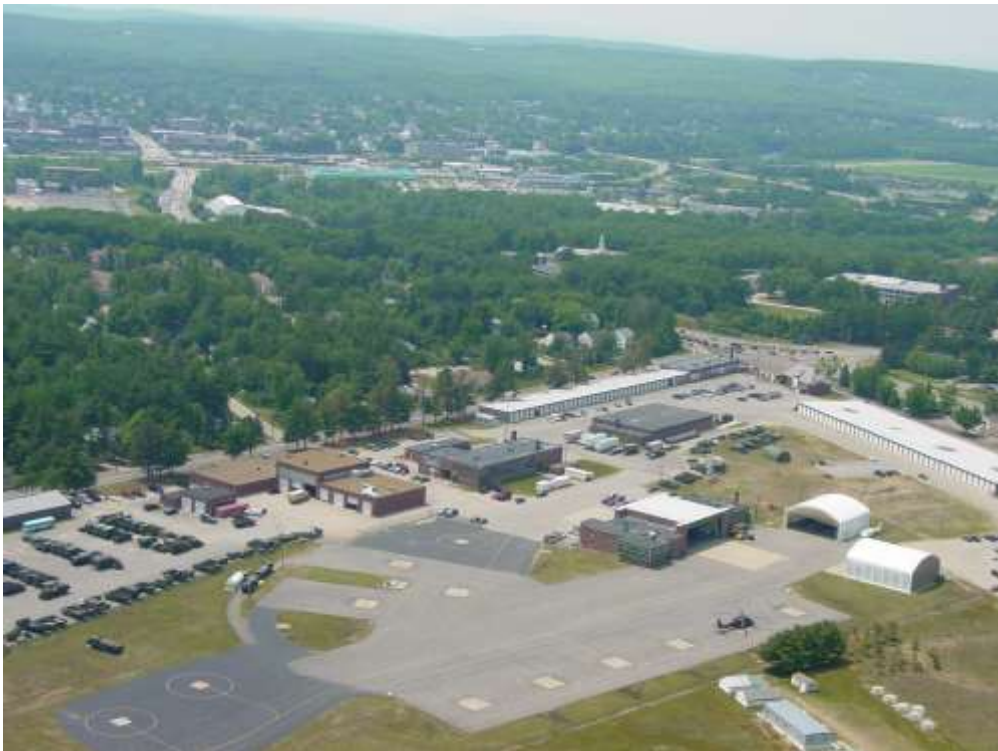
Army National Guard, Preliminary Assessment for PFAS	State Military Reservation	Concord, New Hampshire
<p>Photograph No. 07</p> <p>Date 6/25/2003 Time 15:35</p> <p>Description: Aerial photograph collected by the NHARNG of the former AASF.</p> <p>Orientation: Southwest</p>
