FINAL Preliminary Assessment Report New Hampshire National Guard Training Site Center Strafford, New Hampshire

Perfluorooctane-Sulfonic Acid (PFOS) and Perfluorooctanoic
Acid (PFOA) Impacted Sites
ARNG Installations, Nationwide

December 2019

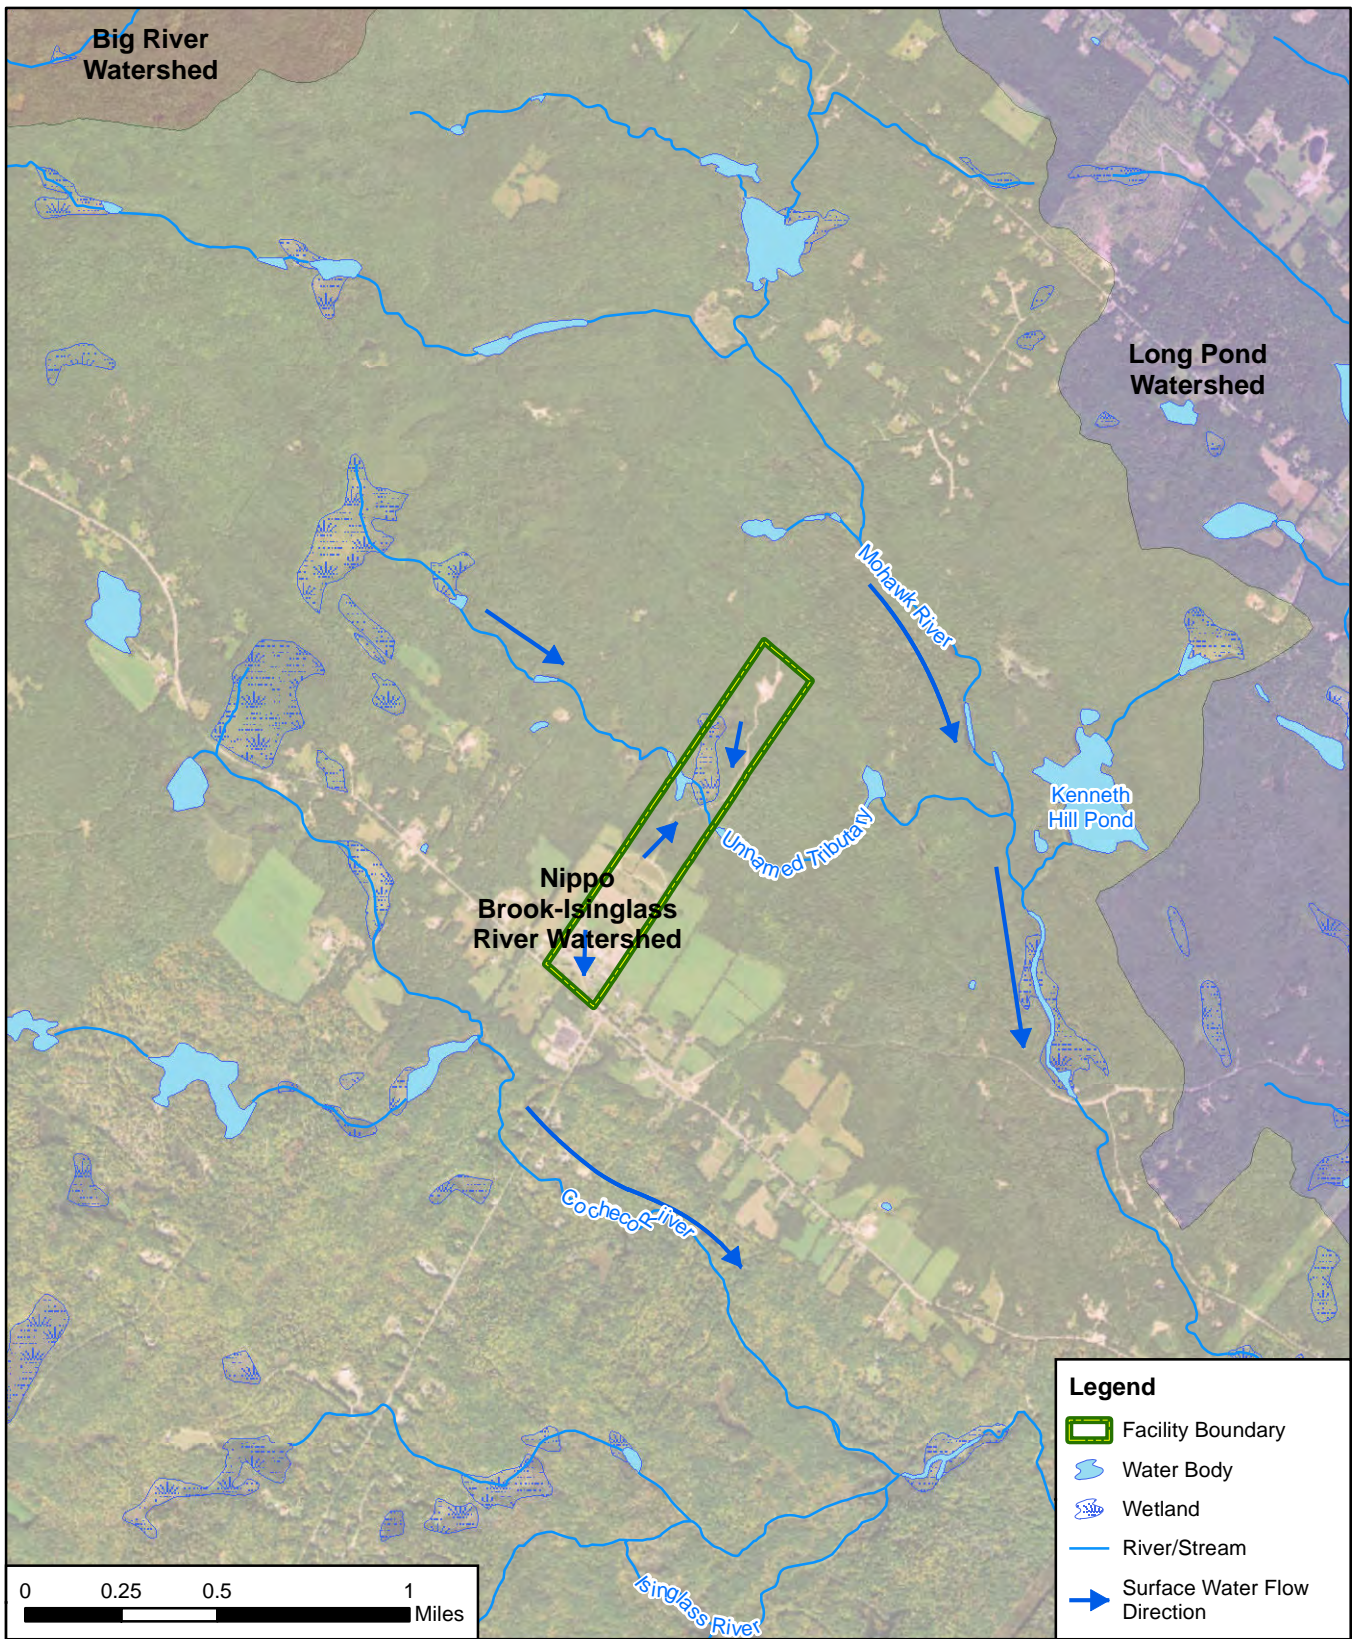
The installation lies within the Nippo Brook - Isinglass River sub watershed of the Cocheco River watershed. Surface water from most of the site flows southeast via a small tributary to the Mohawk River, which eventually joins the Isinglass River (NHARNG, 2014). The elevation of the Mohawk River is below the elevation of the surface of the groundwater near the installation. Therefore, groundwater flow from the installation is likely to flow into the Mohawk River, which acts as boundary preventing groundwater from the installation interacting with drinking water wells east of the Mohawk River (ERA, 2008). Surface water features in the vicinity of the facility are shown on **Figure 1-3**.

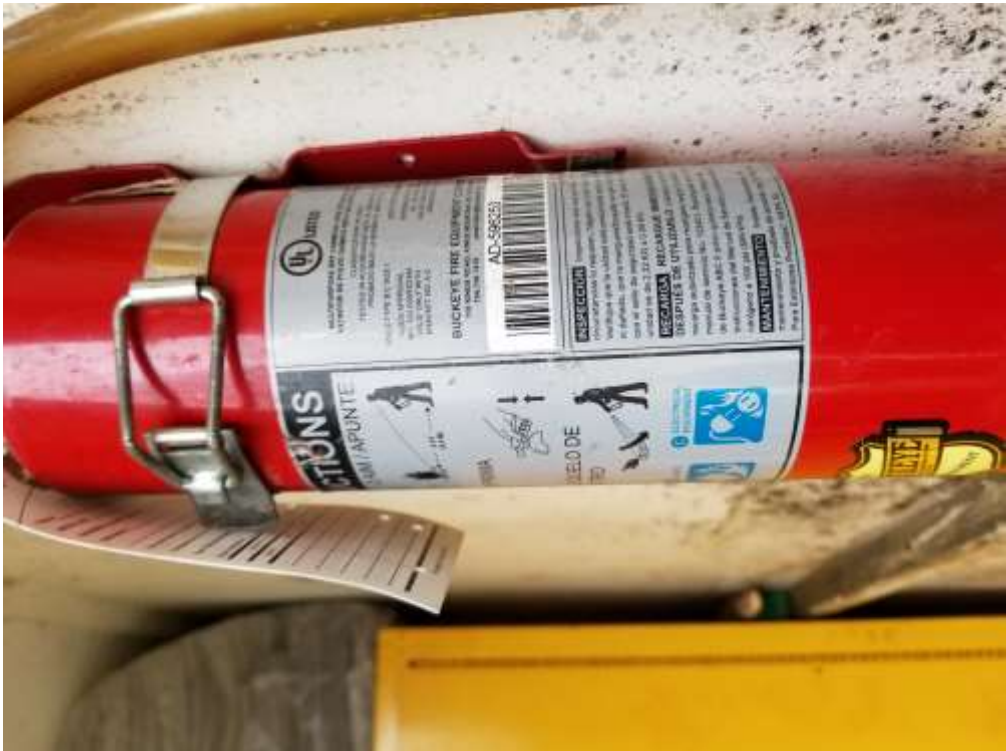
Photograph No. 02

Date 4/23/2019 Time 8:18		
Description: Fire Extinguisher (chemical) in NHNGTS Flammables Shed (close-up of label).		
Orientation: NA

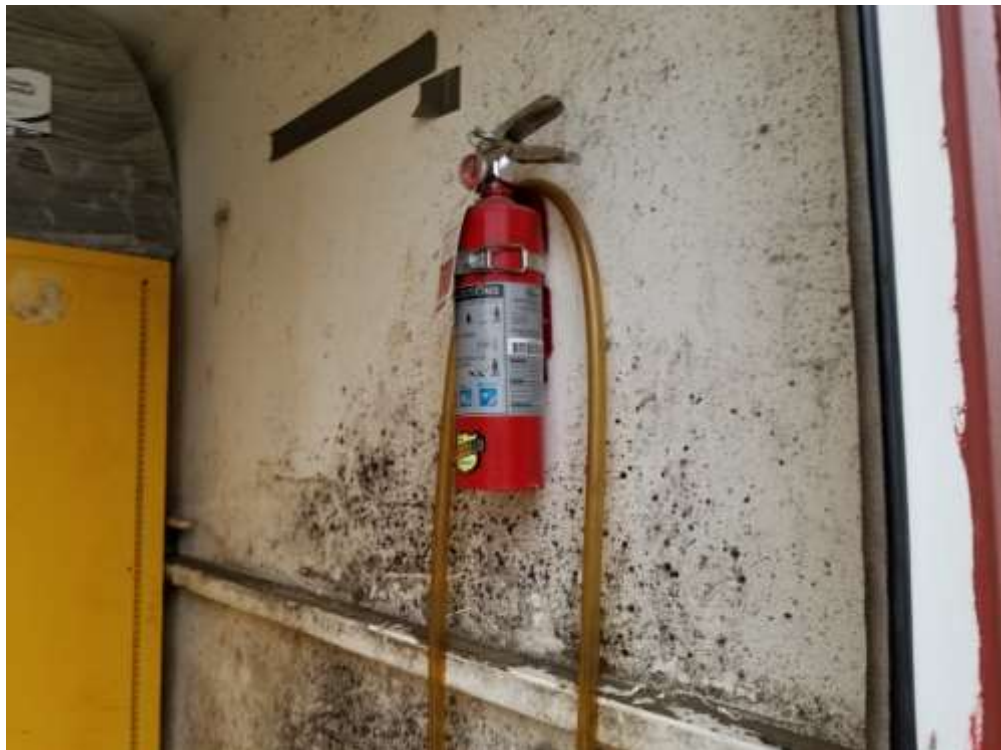
Photograph No. 04

Inside of NHNGTS
Flammables Shed. No
additional fire extinguishers or
storage of PFAS-containing
materials noted.

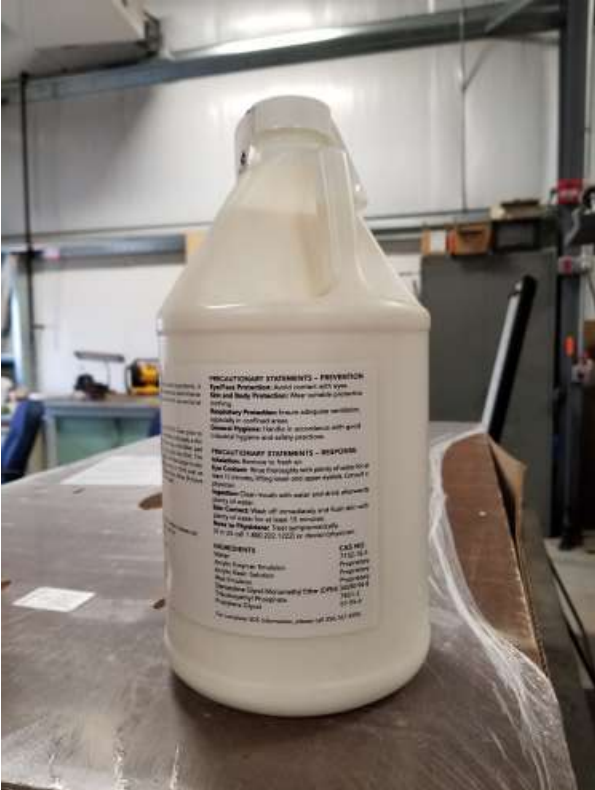
Army National Guard, Preliminary Assessment for PFAS	New Hampshire National Guard Training Site	Strafford, New Hampshire
<p>Photograph No. 05</p> <p>Date 4/23/2019 Time 8:20</p> <p>Description: CENTIfinish floor polish bottle - back.</p> <p>Orientation: NA</p>

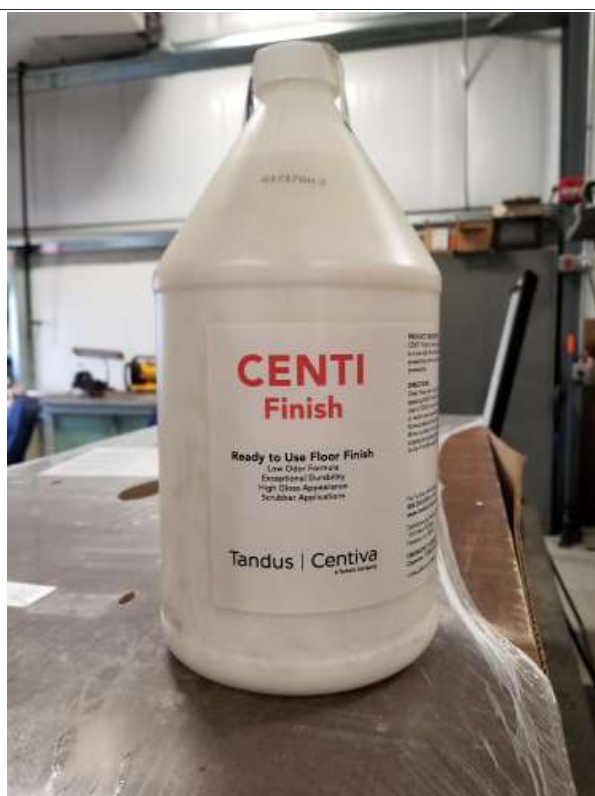
<p>Photograph No. 06</p> <p>Date 4/23/2019 Time 8:20</p> <p>Description: CENTIfinish floor polish bottle - front.</p> <p>Orientation: NA</p>

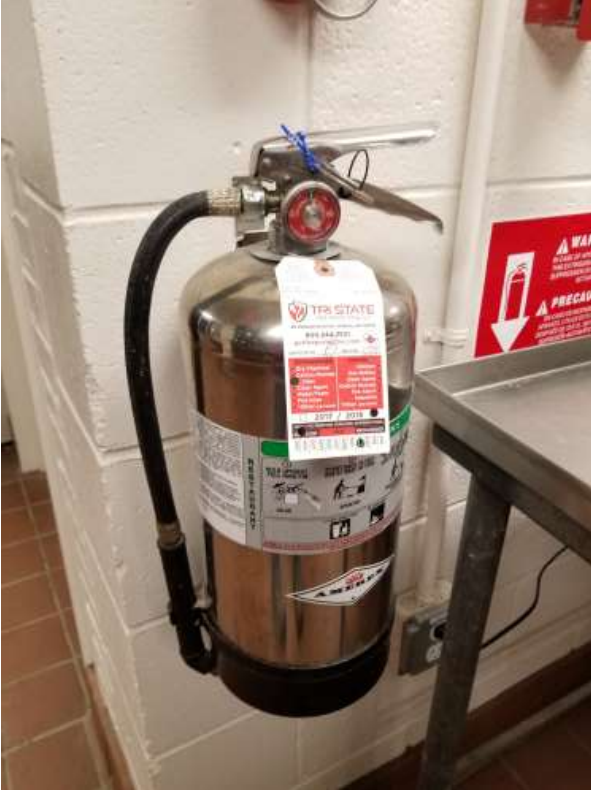
Army National Guard, Preliminary Assessment for PFAS	New Hampshire National Guard Training Site	Strafford, New Hampshire
<p>Photograph No. 07</p> <p>Date 4/23/2019 Time 8:24</p> <p>Description: Fire extinguisher (#1) in the NHNGTS kitchen, chemical Class K.</p> <p>Orientation: NA</p>

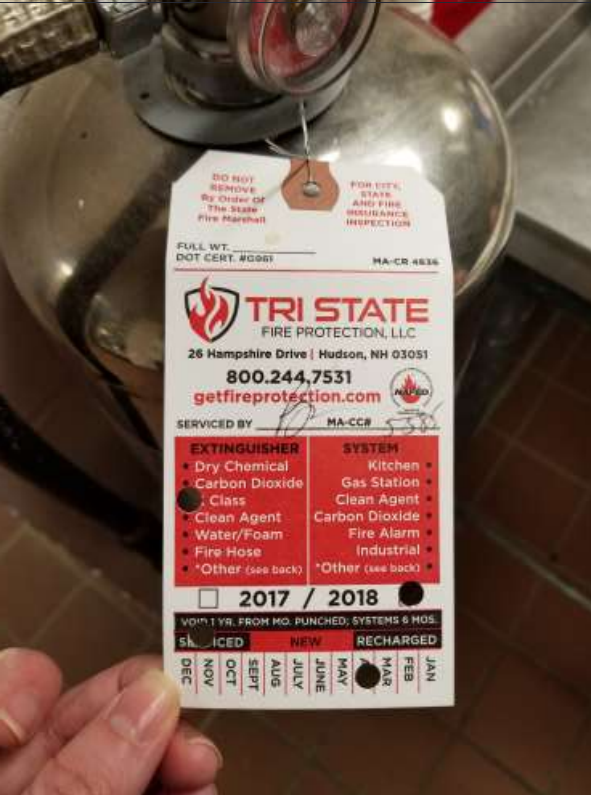
<p>Photograph No. 08</p> <p>Date 4/23/2019 Time 8:25</p> <p>Description: Fire extinguisher (#1) in the NHNGTS kitchen, chemical Class K, close-up of the label.</p>

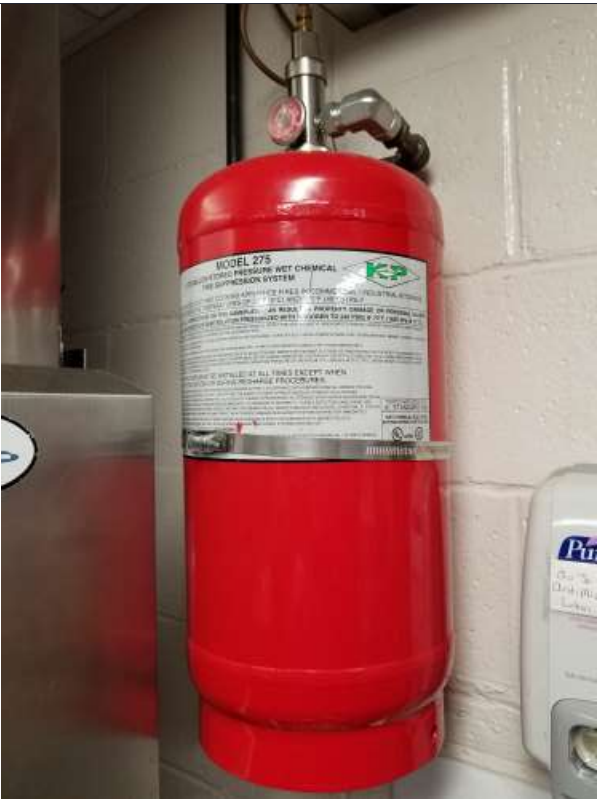
<p>Photograph No. 09</p> <p>Date 4/23/2019</p> <p>Time 8:34</p> <p>Description: Hood fire suppression system (#1) in the NHNGTS kitchen, wet chemical.</p>

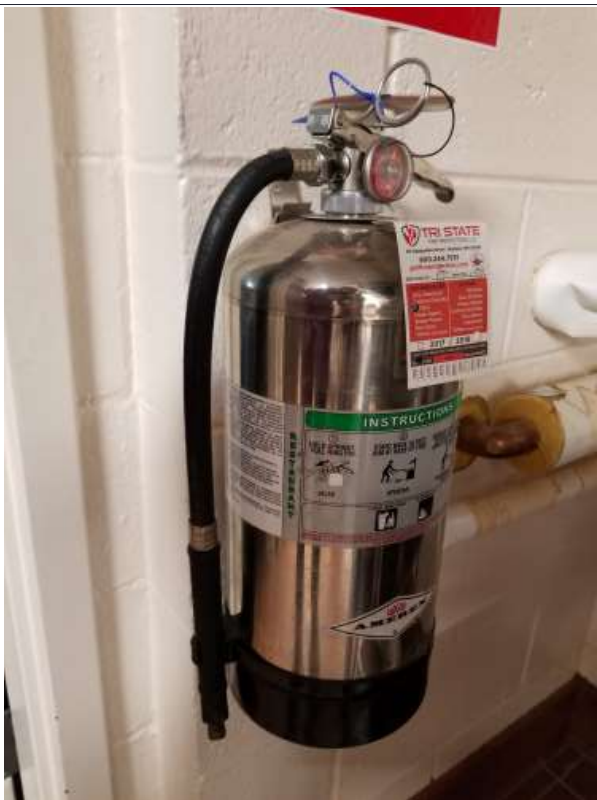
<p>Photograph No. 10</p> <p>Date 4/23/2019</p> <p>Time 8:35</p> <p>Description: Fire extinguisher (#2) in the NHNGTS kitchen, chemical Class K.</p>

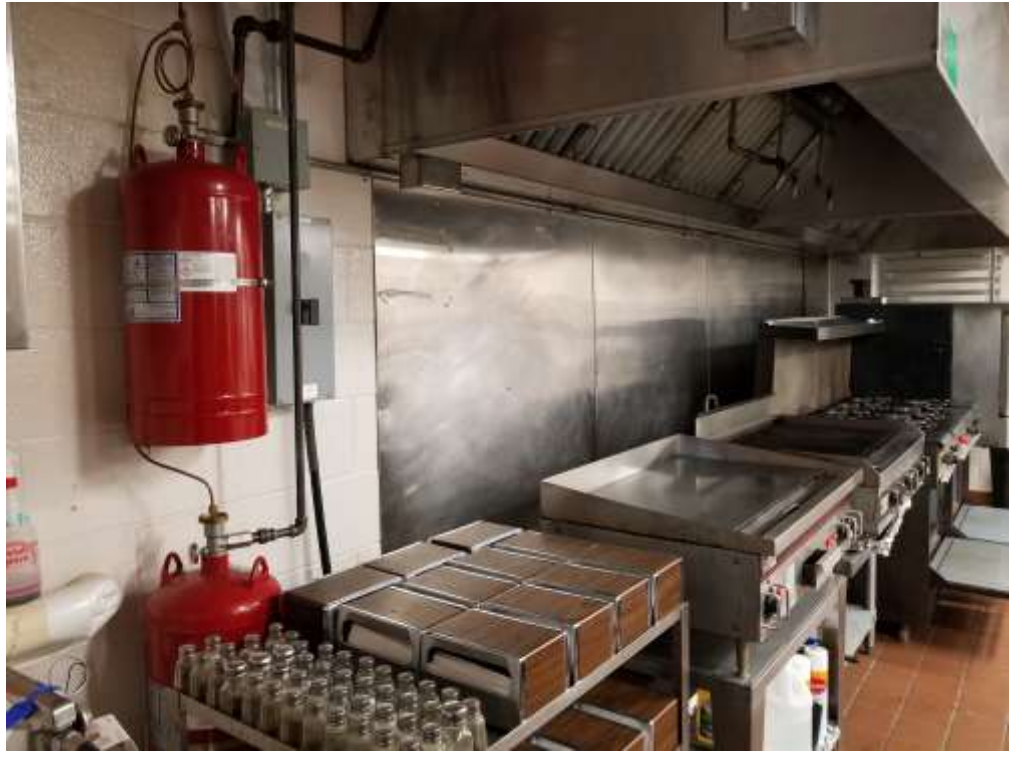
<p>Date 4/23/2019 Time 8:35</p>		
<p>Description: Hood fire suppression system (#2) in the NHNGTS kitchen, wet chemical, located over grills. CENTIFinish floor polish is used on floor in kitchen.</p>		
<p>Orientation: NA</p>

The kitchen at the NHNGTS was inspected as part of the VSI. Two hood fire suppression systems and two fire extinguishers were noted. However, because the hood fire suppression systems and the fire extinguishers in the kitchen were wet chemical or Class K, the kitchen is not considered a potential release area.

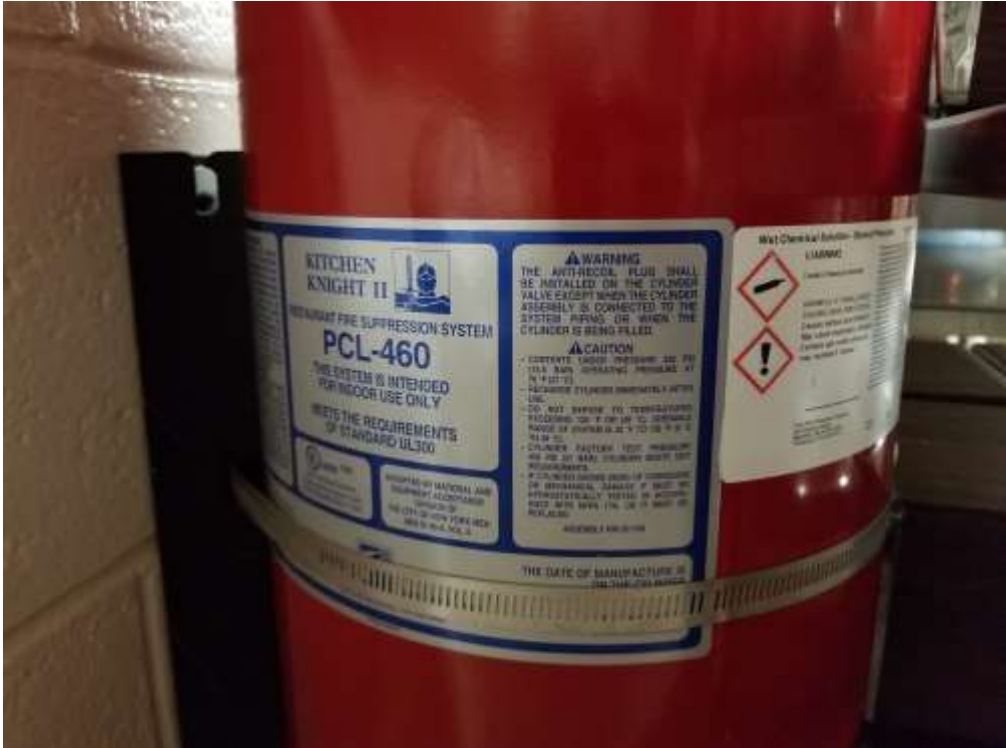
Army National Guard, Preliminary Assessment for PFAS	New Hampshire National Guard Training Site	Strafford, New Hampshire
<p>Photograph No. 13</p> <p>Date 4/23/2019</p> <p>Time 8:35</p> <p>Description: Hood fire suppression system (#2) in the NHNGTS kitchen, wet chemical, located over grills, close-up of bottom tank label.</p> <p>Orientation: NA</p>

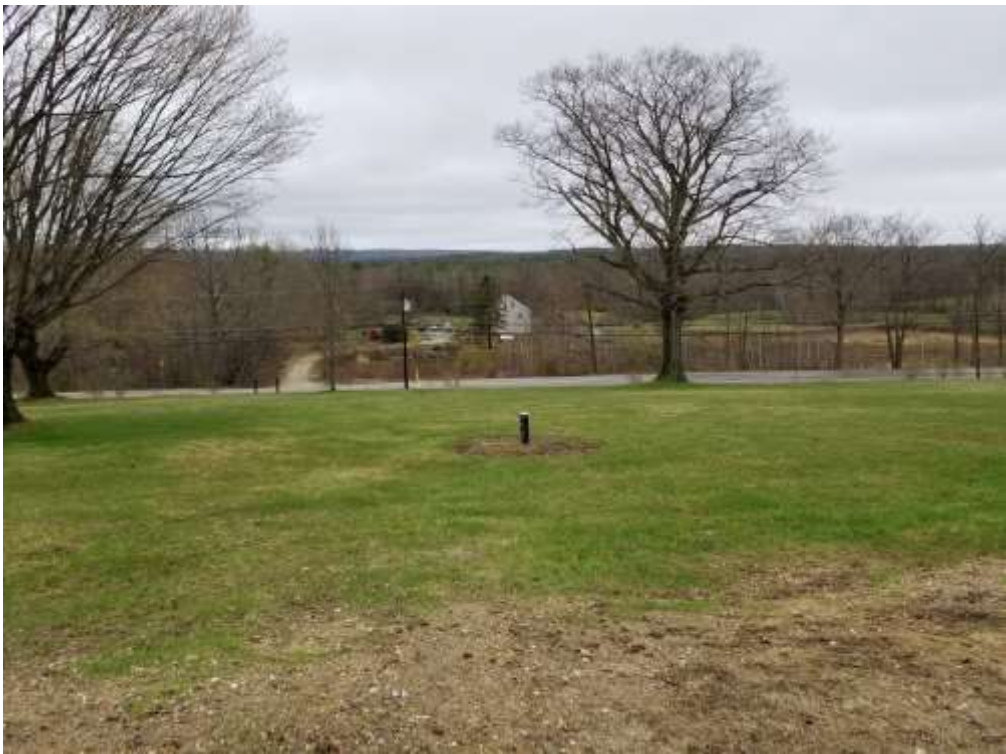
<p>Photograph No. 14</p> <p>Date 4/23/2019</p> <p>Time 8:44</p> <p>Description: View of Bedrock Well #4 looking Southwest.</p> <p>Orientation: Southwest</p>

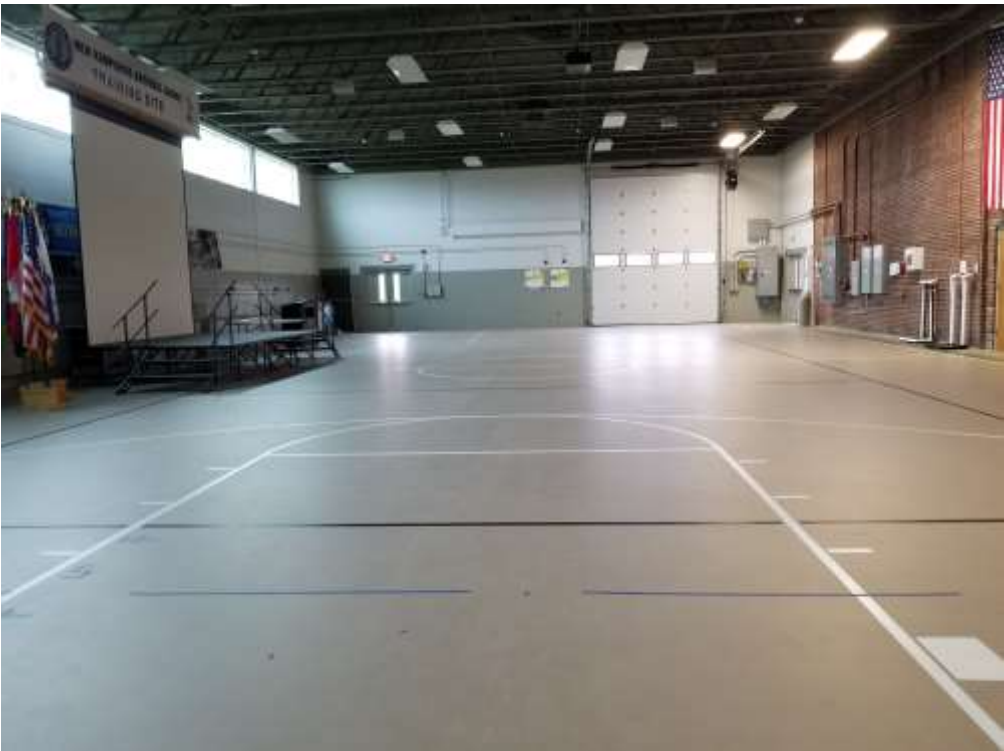
Photograph No. 16

Date 4/23/2019 Time 8:45	
Description: NHNGTS Drill Hall looking East. CENTIFinish floor polish is used on floor.	
Orientation: East

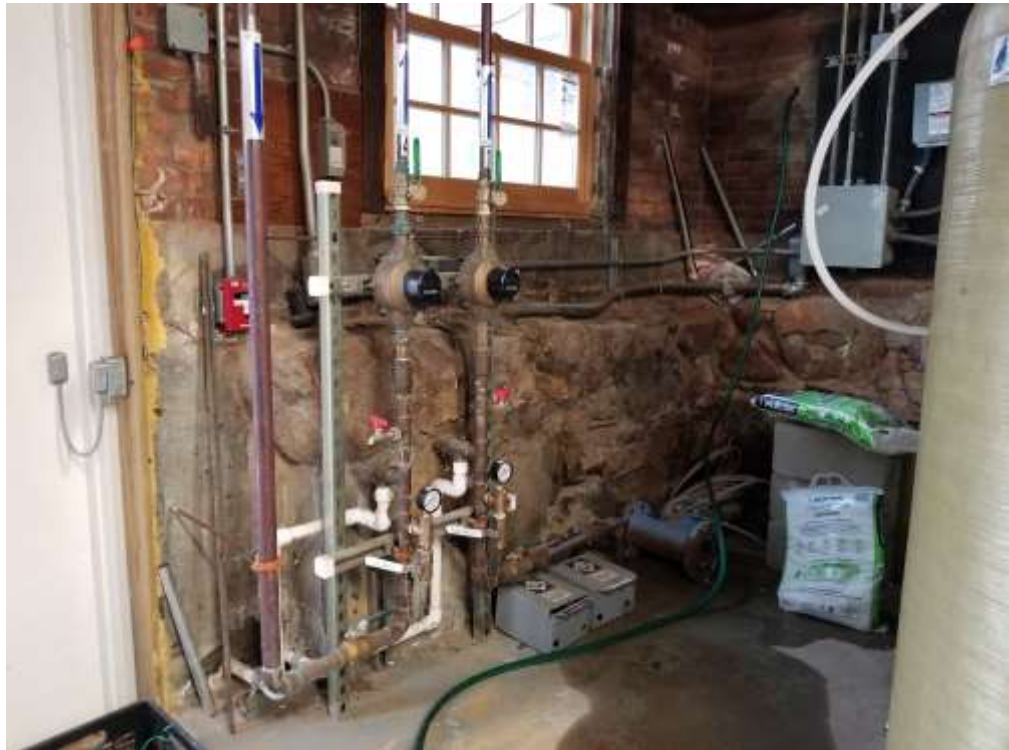
Army National Guard, Preliminary Assessment for PFAS	New Hampshire National Guard Training Site	Strafford, New Hampshire
<p>Photograph No. 17</p> <p>Date 4/23/2019 Time 8:49</p> <p>Description: Flow meters and taps for Well #4 and Well #1 in NHHGTS pump room. March 2017 groundwater samples for PFAS were collected at these taps.</p> <p>Orientation: West</p>
