Preliminary Assessment Report

Former Crash Fire Station, Newington, New Hampshire

Perfluorooctane-Sulfonic Acid (PFOS) and
Perfluorooctanoic Acid (PFOA) Impacted Sites
ARNG Installations, Nationwide

December 2019

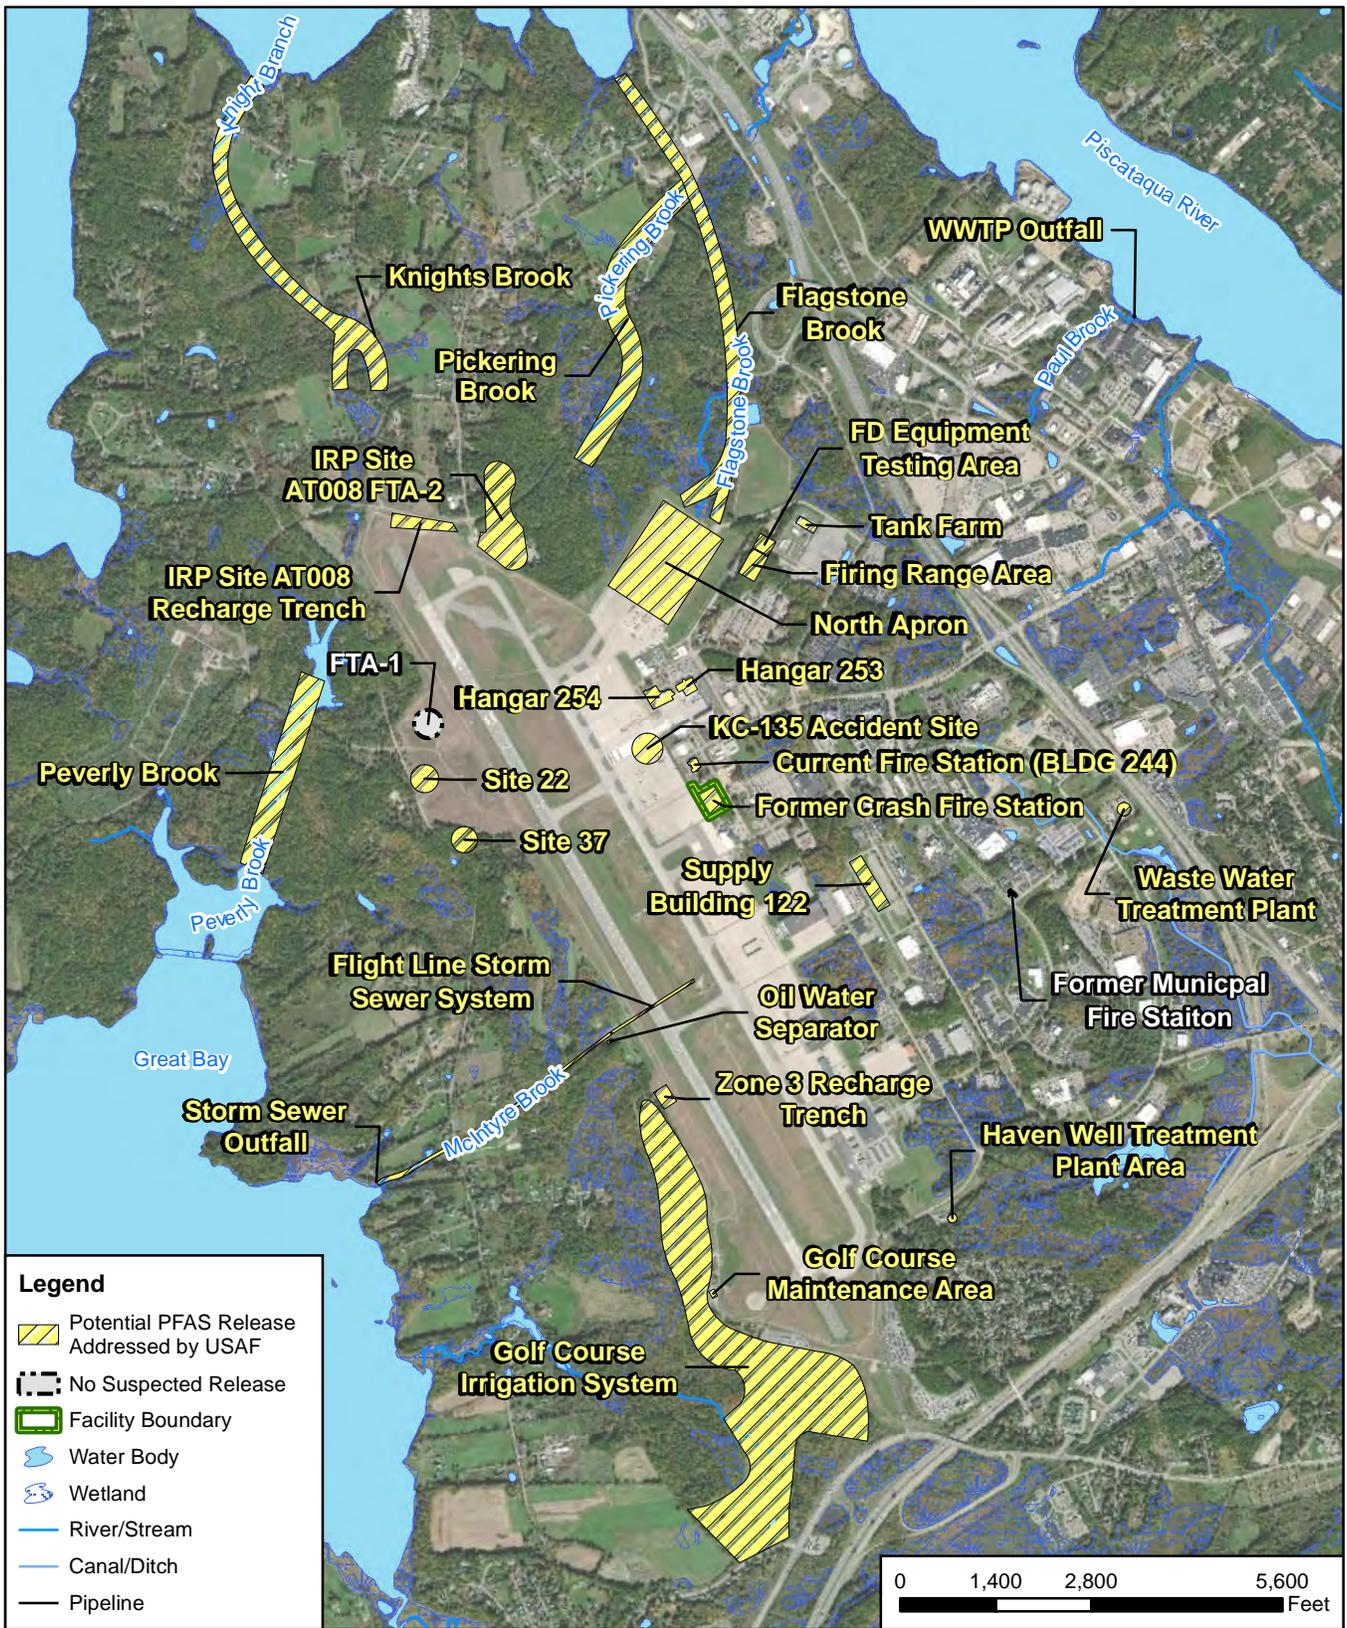
Figure ES-1

During this PA, AFFF releases were identified at the former Crash Fire Station during use by the United States Air Force (USAF) at the former Pease Air Force Base (AFB) and later during use by the New Hampshire Air National Guard (NHANG) at the Pease ANGB. No releases have occurred since the property was transferred to the New Hampshire Army National Guard (NHARNG) in 2013. The former Crash Fire Station is shown on **Figure ES-1** and described below:

Name	Used By	Release Dates	Potential Future Action
Former Crash Fire Station (Former Building 241)	USAF (Pease AFB) and NHANG (Pease ANGB)	~1974 - 2006	Potential releases to soil and groundwater being addressed by the USAF

Summary of Findings

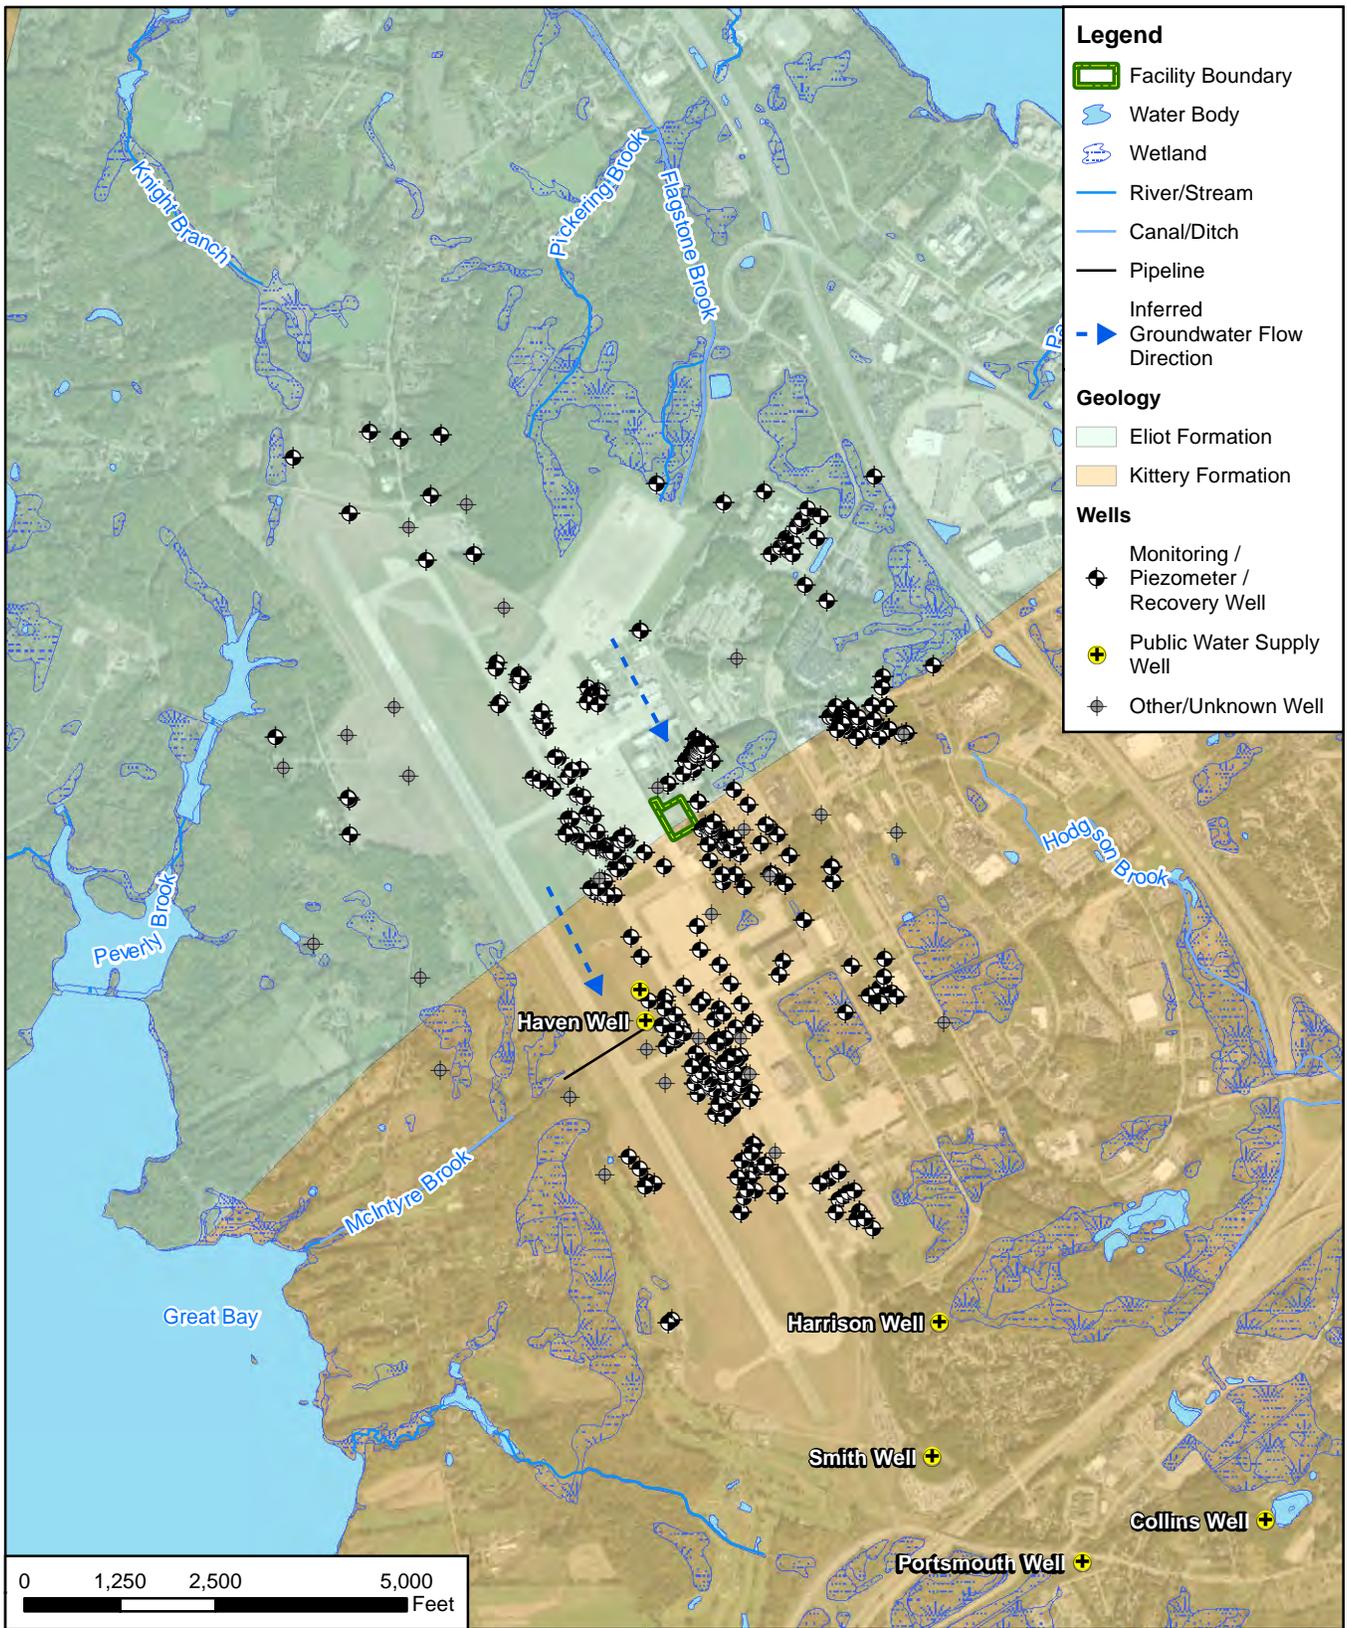
Groundwater Features	
AECOM 12420 Milestone Center Drive Germantown, MD 20876	Figure 1-2

northwest of the installation, and six groundwater wells located throughout the municipalities mentioned above. The Harrison and Smith wells are still in service and are located on the former Pease AFB property; the Collins and Portsmouth wells are located within 0.5 miles southeast of the installation, and the Greenland well is located approximately 1.7 miles southwest of the installation. The Haven well was in operation until May 2014, after which it was shut down due to detectable levels of PFAS, including PFOS above USEPA HA (Amec Foster Wheeler, 2015). Locations of the wells are shown on **Figure 1-2**.

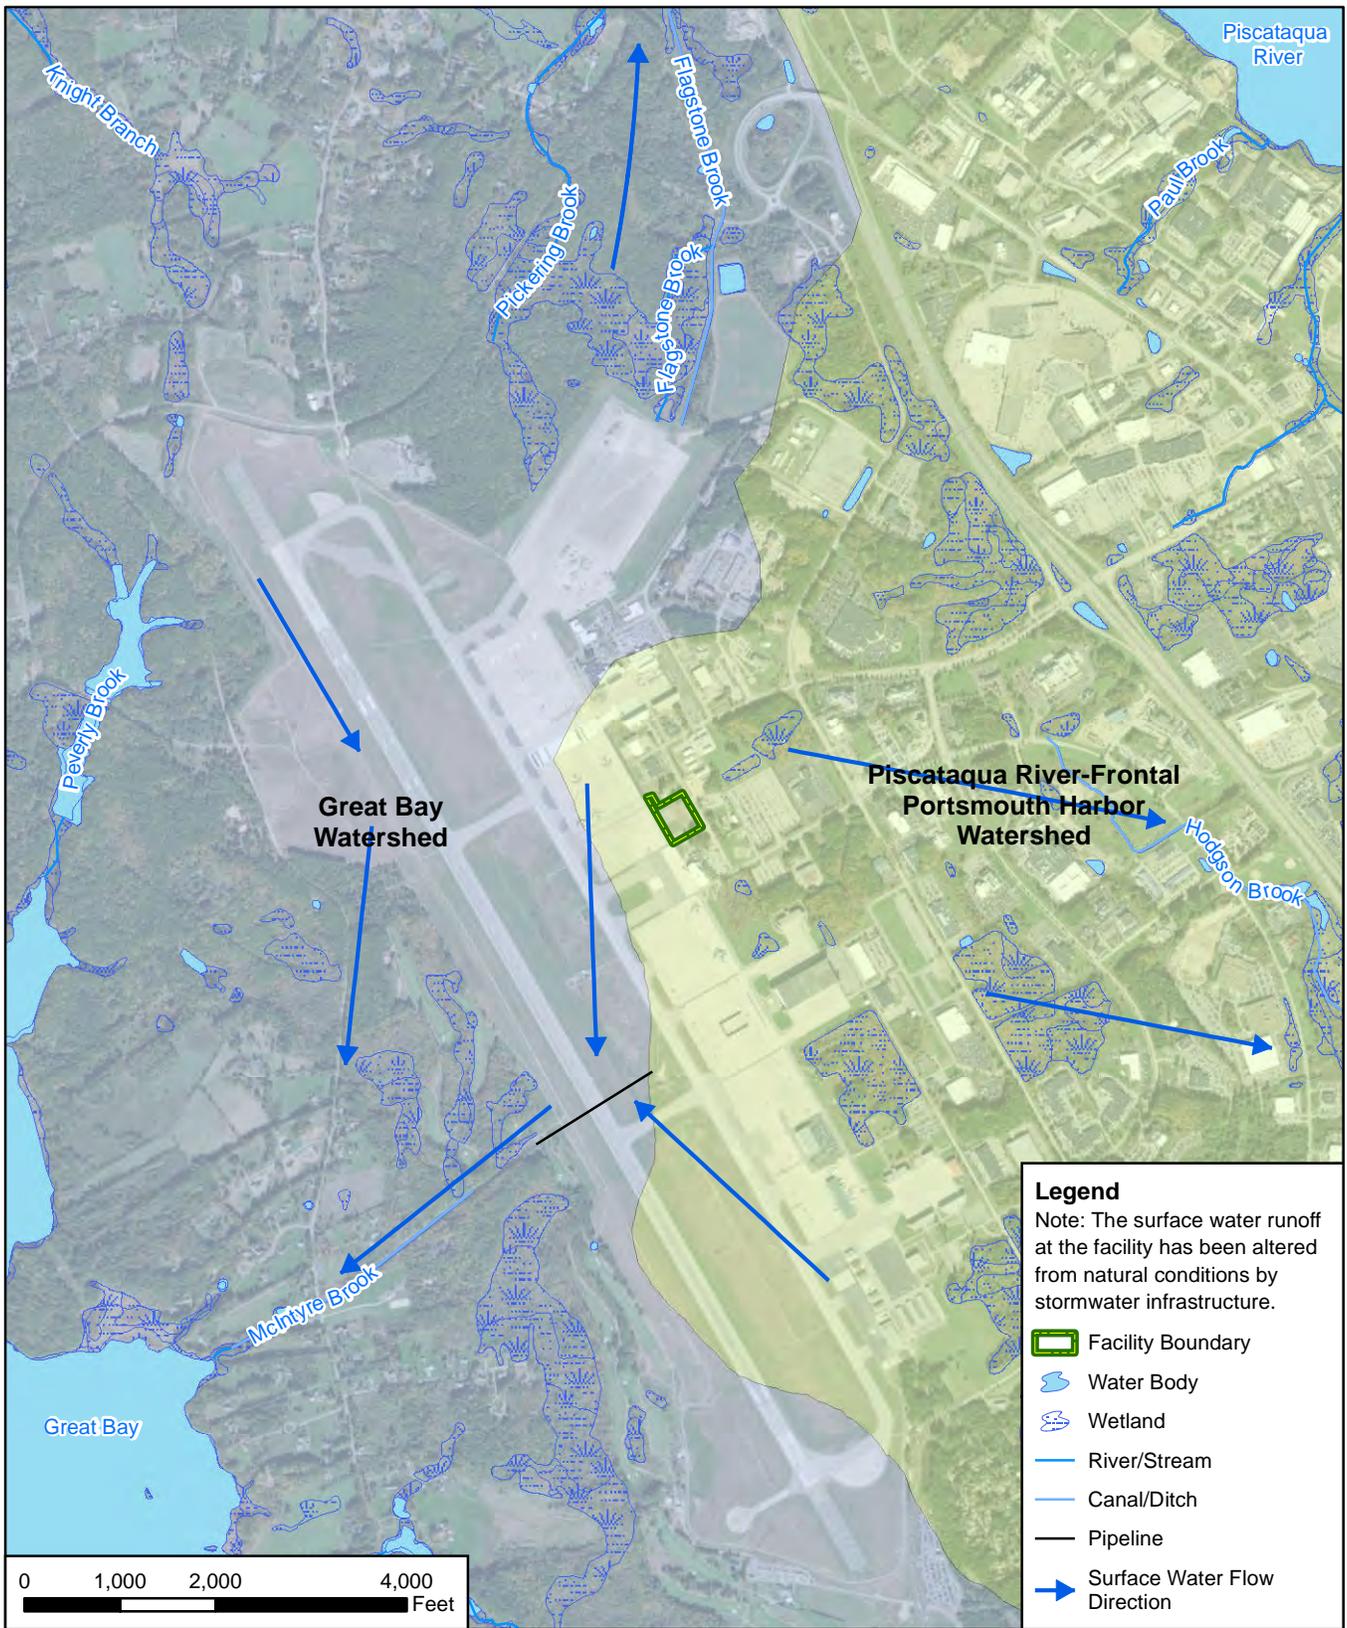
Figure 1-3

The facility is located on a peninsula in the Piscataqua River Basin, approximately 2 miles southwest of the Piscataqua River (**Figure 1-3**). The river is a 13-mile long, tidally-influenced river that drains approximately 1,020 square miles of southern Maine and southeastern New Hampshire, prior to discharging to the Atlantic Ocean (ANG, 2005). The Great Bay, a 6,000-acre tidal estuary, is located approximately 1.5 miles west of the facility and flows into the Piscataqua River. The North Mill pond, also tidally influenced, is located approximately 2.5 miles east of the facility and also discharges to the Piscataqua River.

Legend
 Note: The surface water runoff at the facility has been altered from natural conditions by stormwater infrastructure.

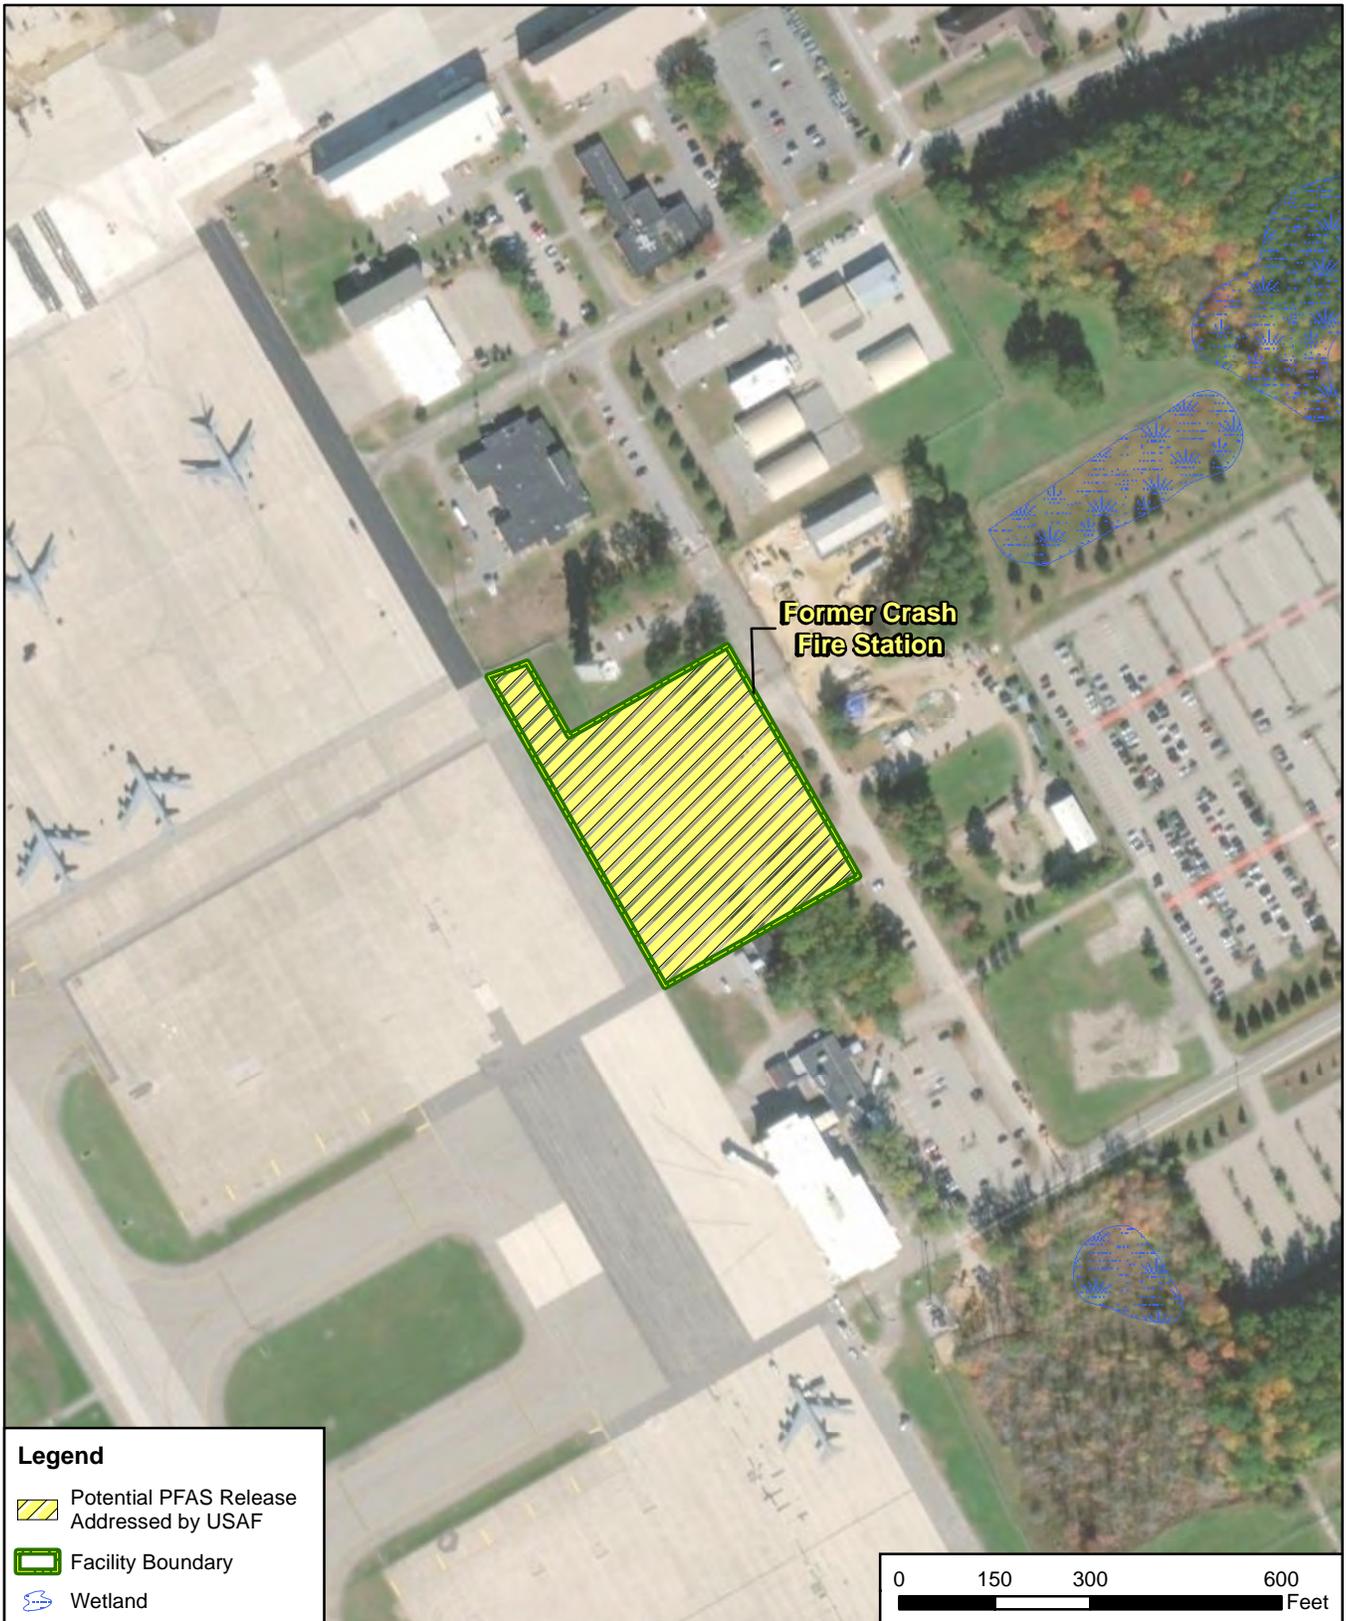
Soil and groundwater samples were collected at the former Crash Fire Station as part of the 2017 SI. PFAS were detected in soil and groundwater at elevated concentrations. In groundwater, PFOS was detected at 1000 J (estimated value) to 19,000 ppt, and PFOA was detected at 160 to 1500 ppt, all of which exceed the current USEPA HA of 70 ppt and the New Hampshire MCLs/AGQS of 15 ppt (PFOS) and 12 ppt (PFOA). The SI Report also concluded that the distribution of PFAS across the former AFB in combination with the flow patterns derived from the groundwater model suggested that the former Crash Fire Station was one of four areas that were the primary contributors to PFAS concentrations in groundwater at Pease (Amec Foster Wheeler, 2017).

In June 2018, an Action Memorandum was prepared to document the approval and decision by the USAF to conduct an ERA in response to the presence of PFOA and PFOS in private drinking water wells in Newington, New Hampshire and surrounding areas of the former Pease AFB (USAF, 2018). The USAF is continuing to address PFAS at the former Crash Fire Station as part of the ongoing PFAS response activities at the former Pease AFB, in accordance with USEPA *Administrative Order SDWA-01-2015-0061*. An Airfield Interim Mitigation System (AIMS) is currently being implemented in response to the Administrative Order to treat groundwater in the vicinity of the airfield, including the groundwater at the former Crash Fire Station.

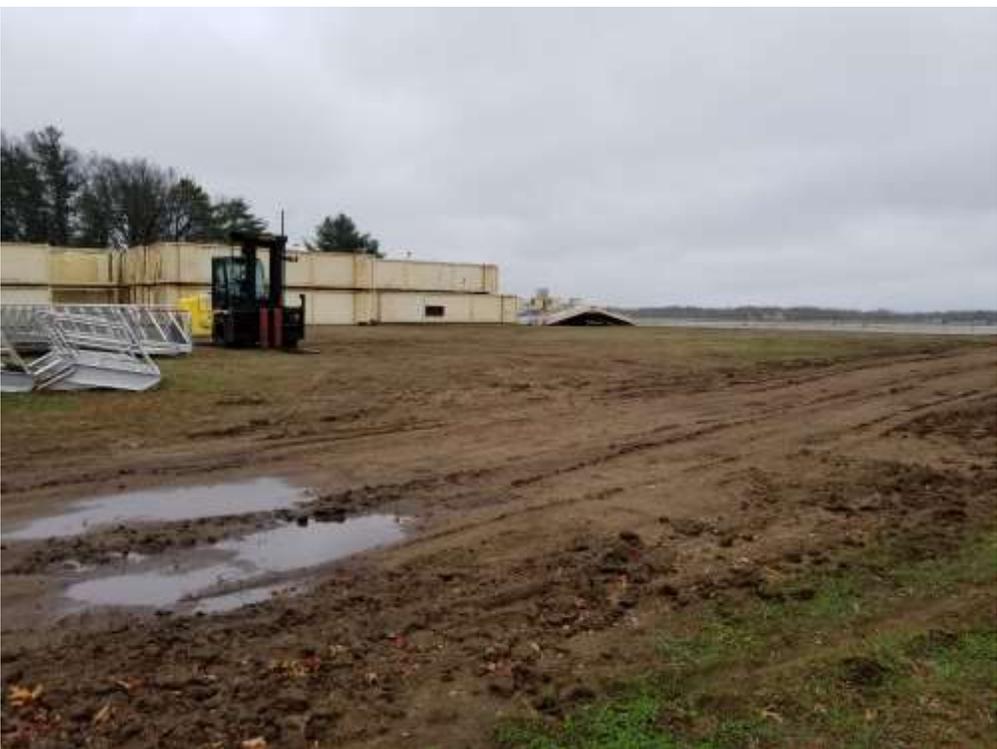
Photograph No. 01

Date 4/23/2019 Time 10:01	
Description: Location of Former Crash Fire Station (Building 241). Former building has been demolished. Property is currently fenced and used for storage by the Department of the Navy.	
Orientation: Southwest

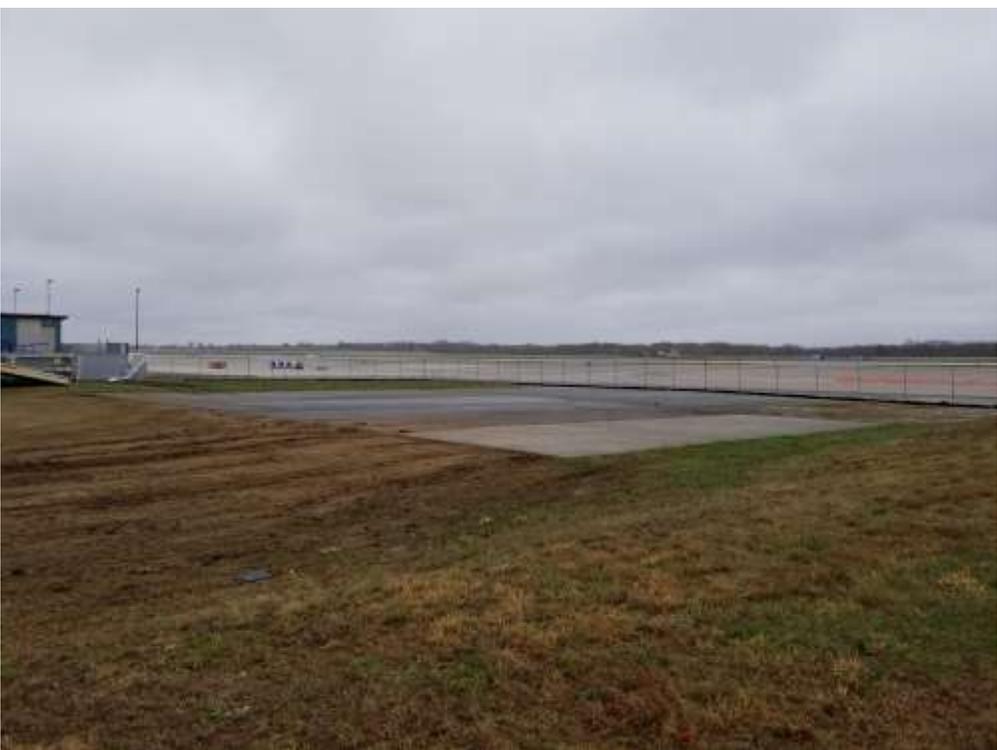
Photograph No. 02

Date 4/23/2019 Time 10:02	
Description: Location of Former Crash Fire Station (Building 241) with Portsmouth International Airport runway in the background. Former building has been demolished but asphalt parking area is still present.	
Orientation: Southwest

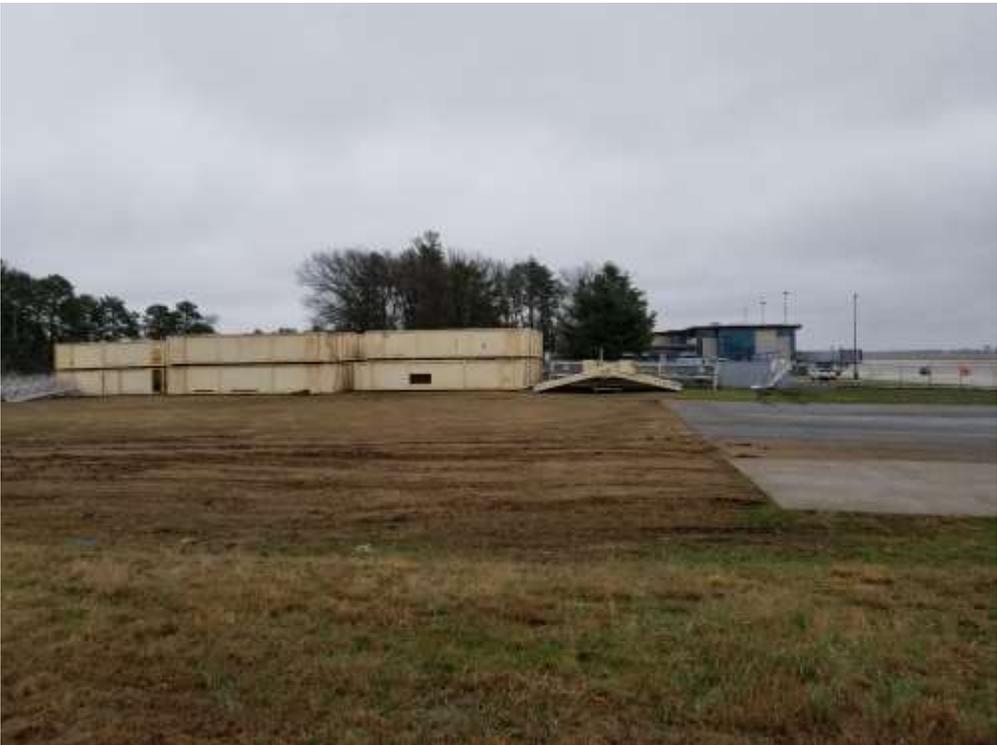
Photograph No. 03

Date 4/23/2019 Time 10:02	
Description: Location of Former Crash Fire Station (Building 241). Former building has been demolished. Property is currently fenced and used for storage by the Department of the Navy.	
Orientation: South

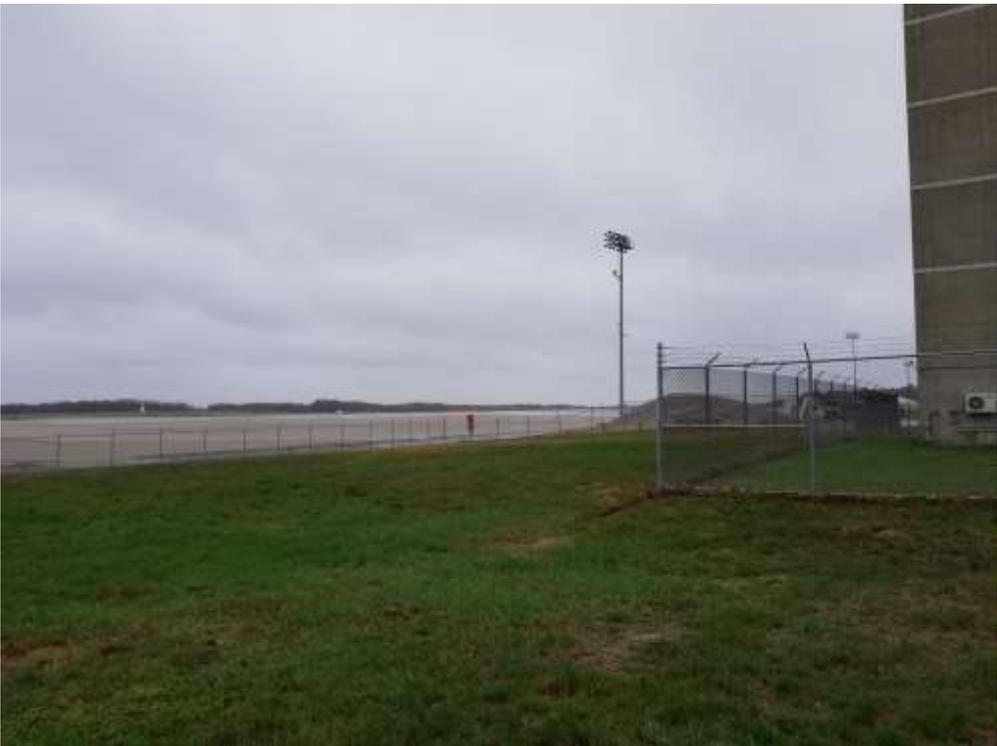
Photograph No. 04

Date 4/23/2019 Time 10:03	
Description: Former Crash Fire Station (Building 241) property, grassy area west of Portsmouth International Airport control tower.	
Orientation: Northwest

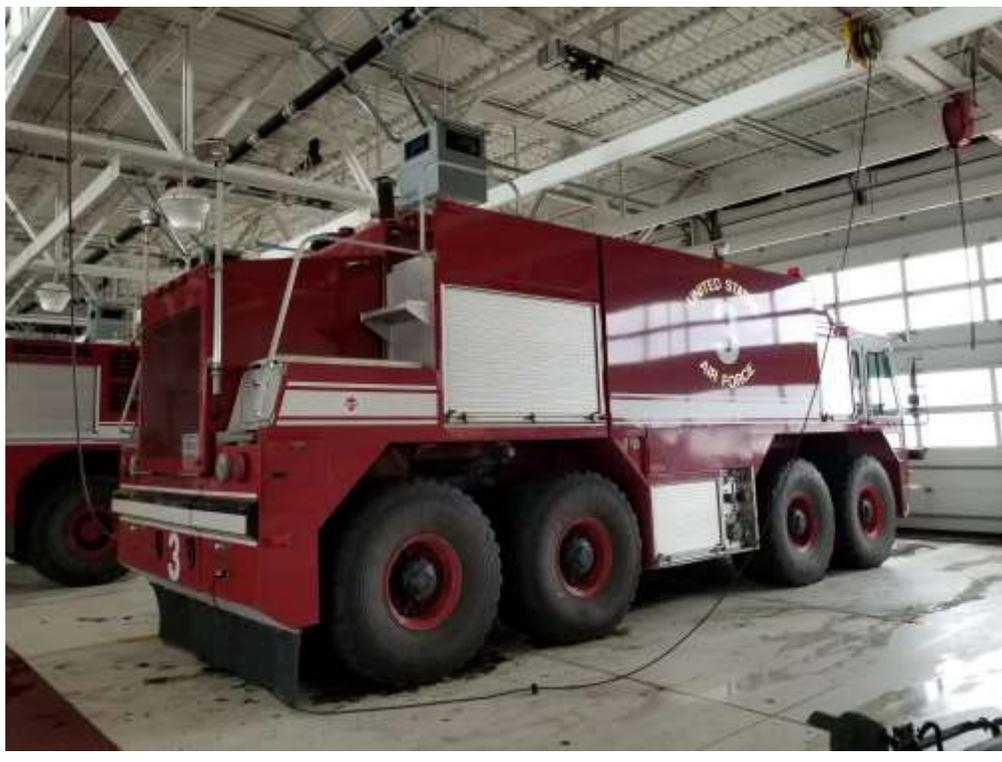
<p>Date 4/23/2019 Time 11:32</p>		
<p>Description: Firetruck (Engine #3) at the new Pease Air National Guard Base Fire Station. This engine was previously housed at the Former Crash Fire Station (Building 241) and is equipped with at 300-gallon AFFF tank.</p>		
<p>Orientation: Southwest</p>

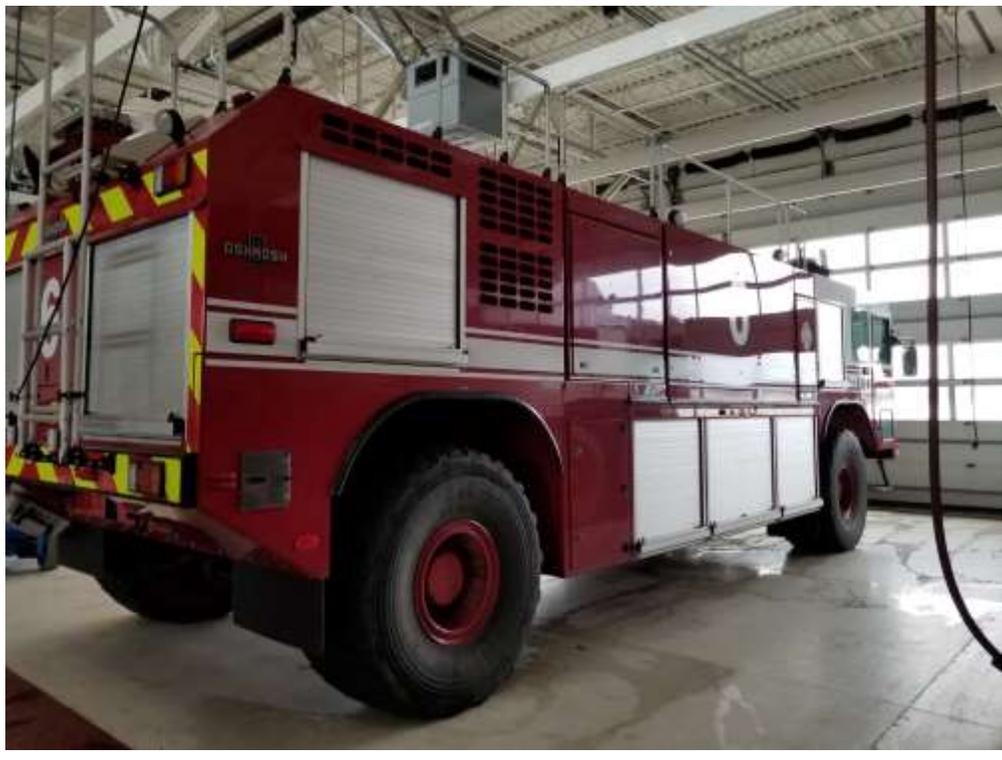
<p>Photograph No. 06</p>

<p>Date 4/23/2019 Time 11:32</p>		
<p>Description: Firetruck (Engine #8) at the new Pease Air National Guard Base Fire Station. This engine was previously housed at the Former Crash Fire Station (Building 241) and is equipped with at 500-gallon AFFF tank.</p>		
<p>Orientation: Southwest</p>

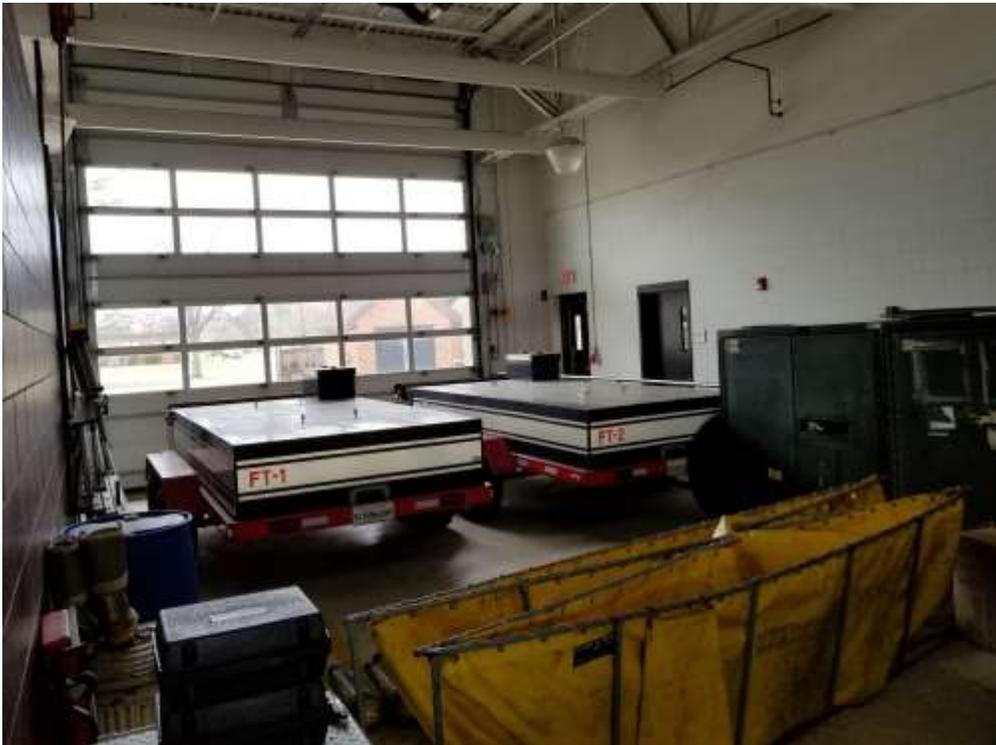
Date 4/23/2019 Time 11:33		
Description: Two AFFF trailer tanks used for refilling AFFF tanks on firetrucks at the new Pease Air National Guard Base Fire Station. These trailer tanks are new but the Former Crash Fire Station would have had similar trailer tanks used to refill firetrucks on the property.		
Orientation: East

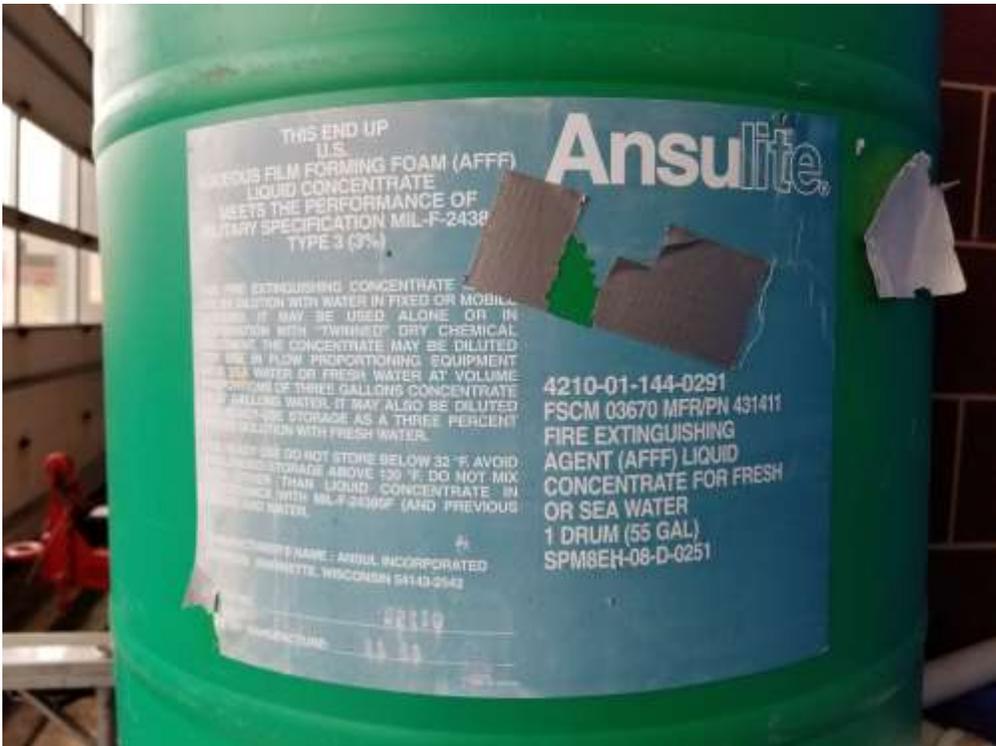
Photograph No. 08

Date 4/23/2019 Time 11:35	
Description: Drum (55-gallon) that previously contained 3% Ansulite AFFF, which would have been used at the Former Crash Fire Station. According to interviewee, this drum was likely moved to the new facility from the Former Crash Fire Station.	
Orientation: NA

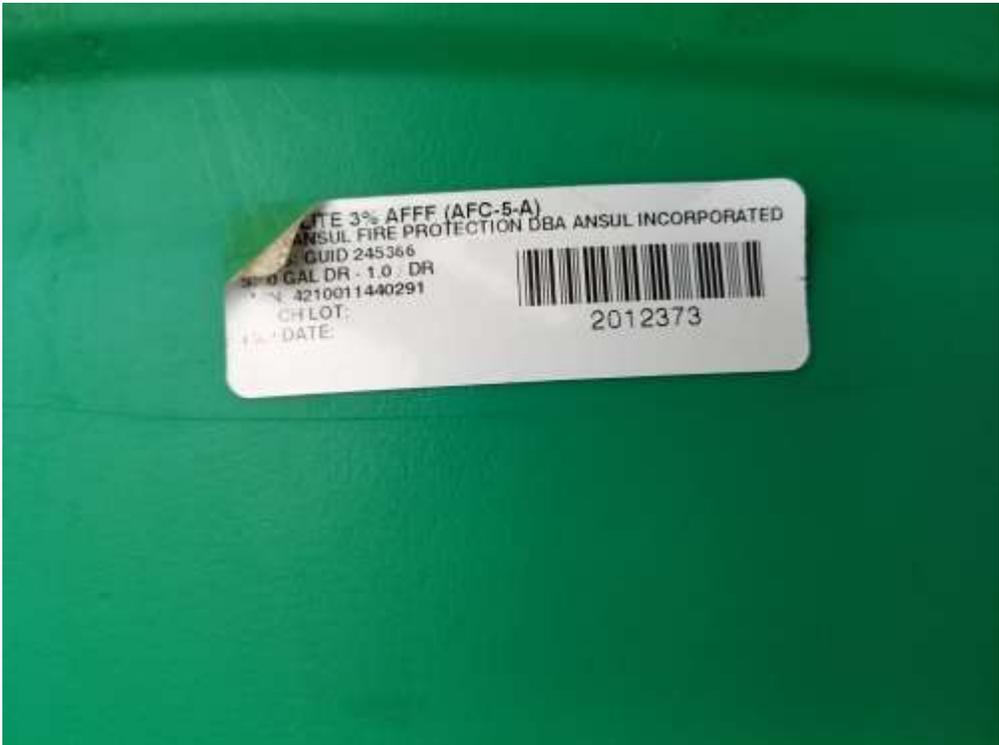
Date 4/23/2019		
Time 11:35		
Description: Label information for 55-gallon drum that previously contained 3% Ansulite AFFF, which would have been used at the Former Crash Fire Station.		
Orientation: NA
