FINAL Preliminary Assessment Report Army Aviation Support Facility Concord Concord, New Hampshire

Perfluorooctane-Sulfonic Acid (PFOS) and
Perfluorooctanoic Acid (PFOA) Impacted Sites
ARNG Installations, Nationwide

November 2019

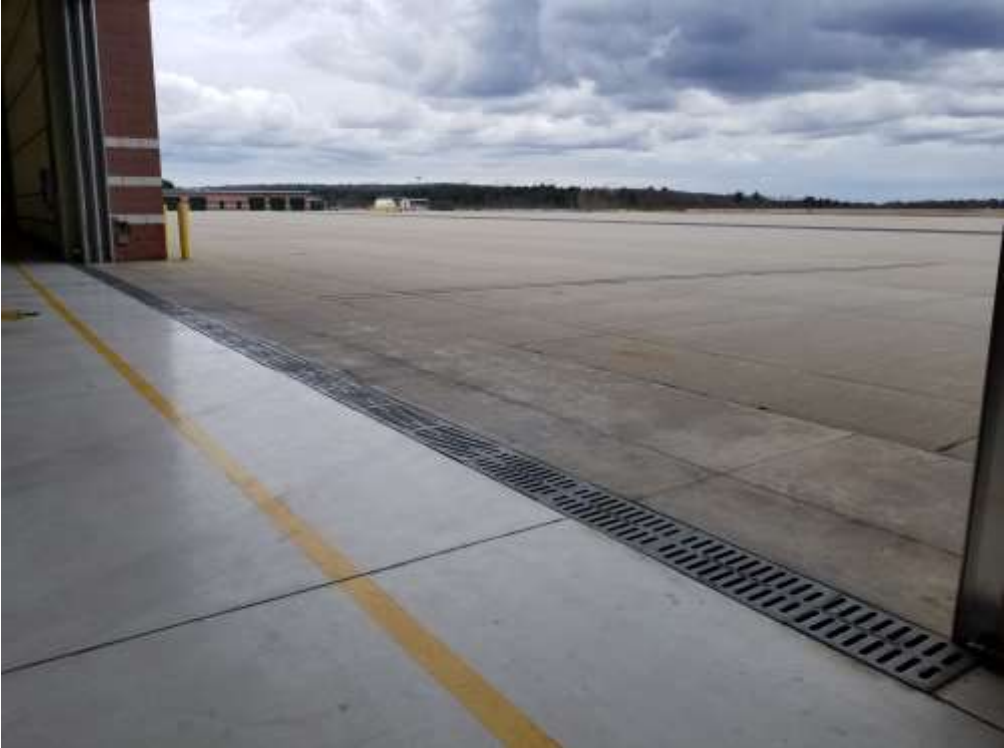
Photograph No. 01

Date 4/22/2019 Time 14:11	
Description: View of apron from main hanger at AASF from bay door. Note floor/trench drain along doorway.	
Orientation: Southeast

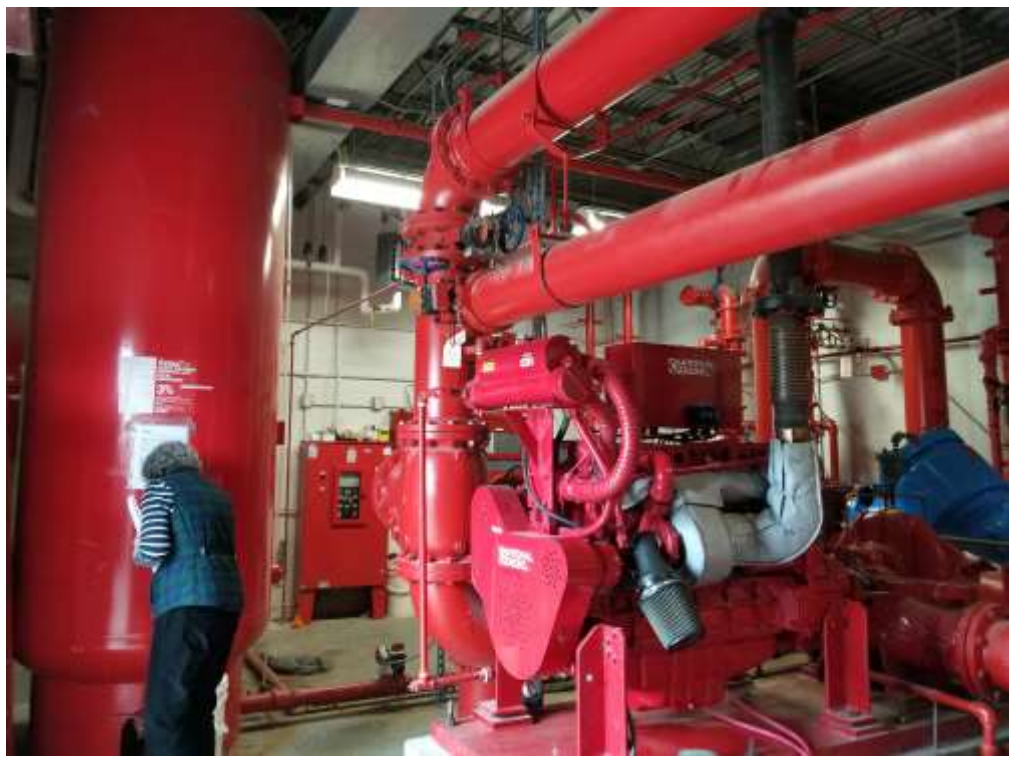
Description:
 AFFF tank (900 gallons) and piping for the Hanger fire suppression system in the tank/pump room.

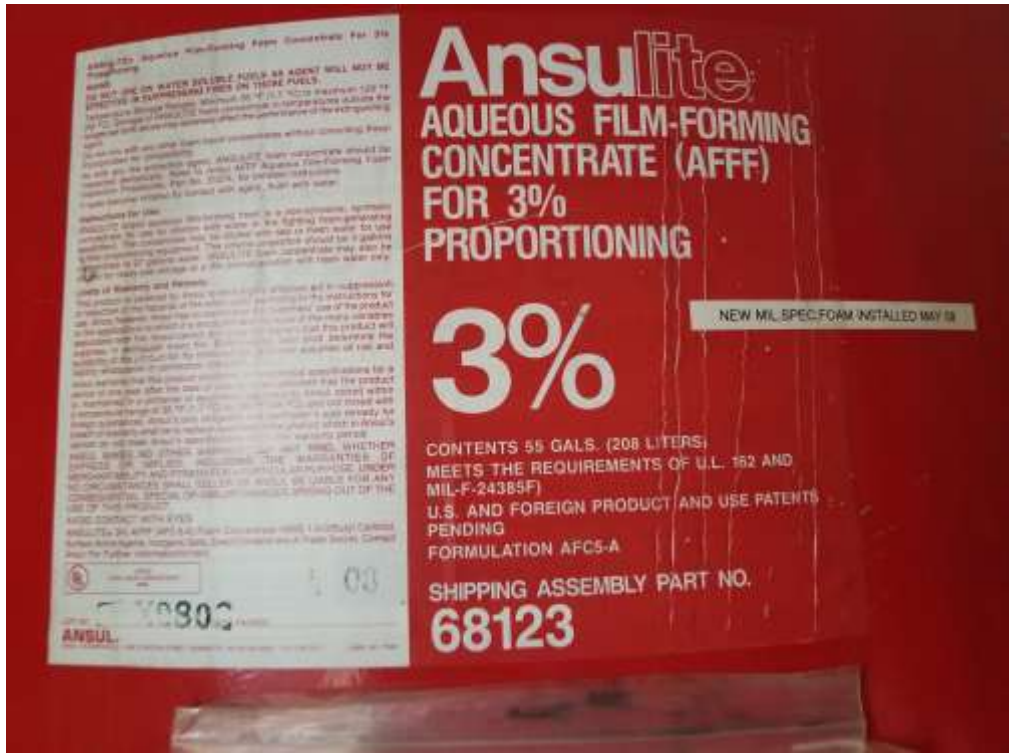
Photograph No. 04

Description:
 Label details for the AFFF tank for the Hanger fire suppression system in the tank/pump room. This label appears to have been removed from a 55-gallon AFFF drum and placed on the 900-gallon AFFF tank.

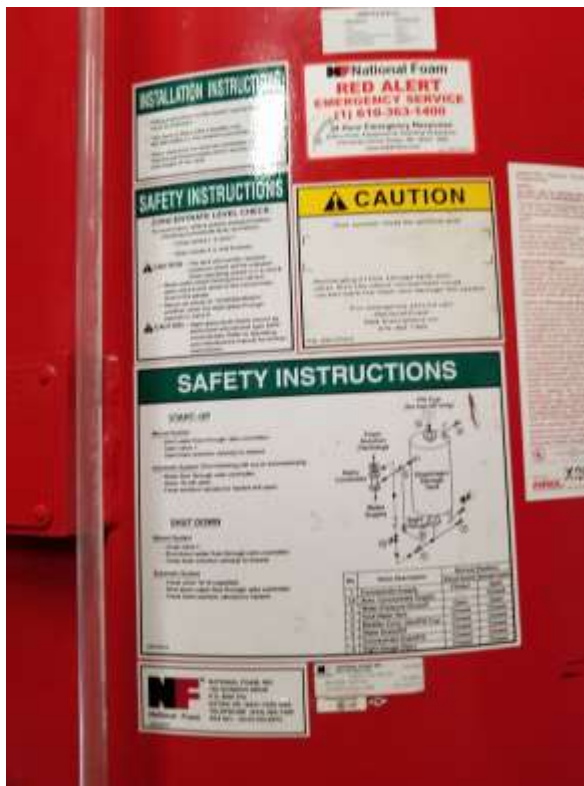
Photograph No. 05
Date 4/22/2019 Time 14:23
Description: Label details for the 900-gallon AFFF tank for the Hanger fire suppression system in the tank/pump room.
Orientation: NA

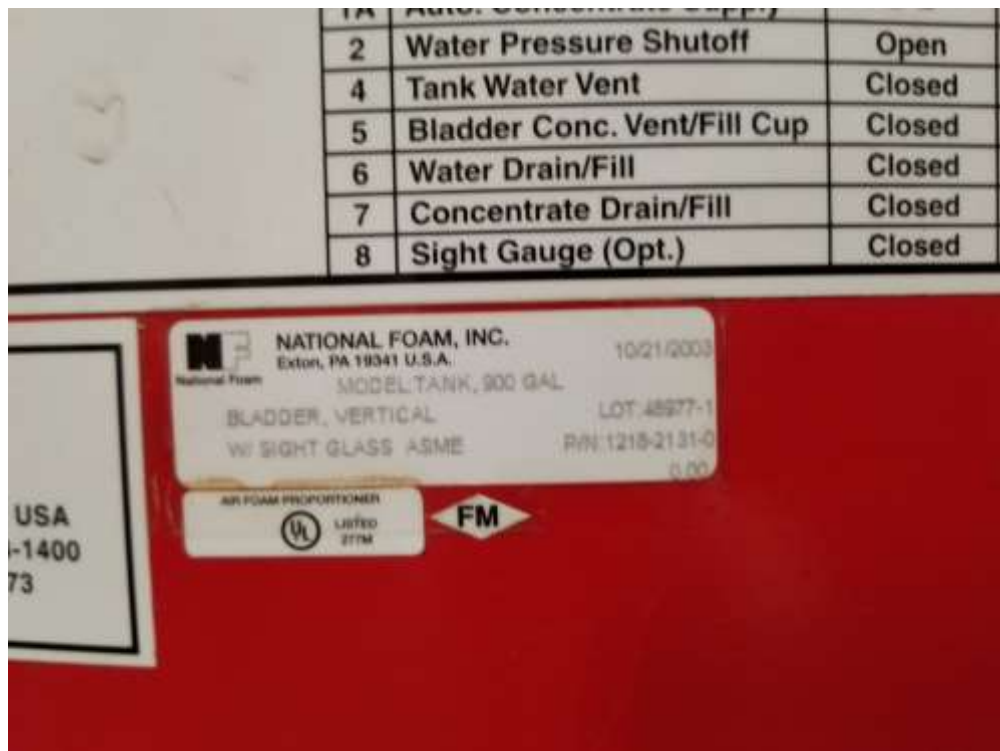
Photograph No. 06
Date 4/22/2019 Time 14:23
Description: Label details for the 900-gallon AFFF tank for the Hanger fire suppression system in the tank/pump room.
Orientation: NA

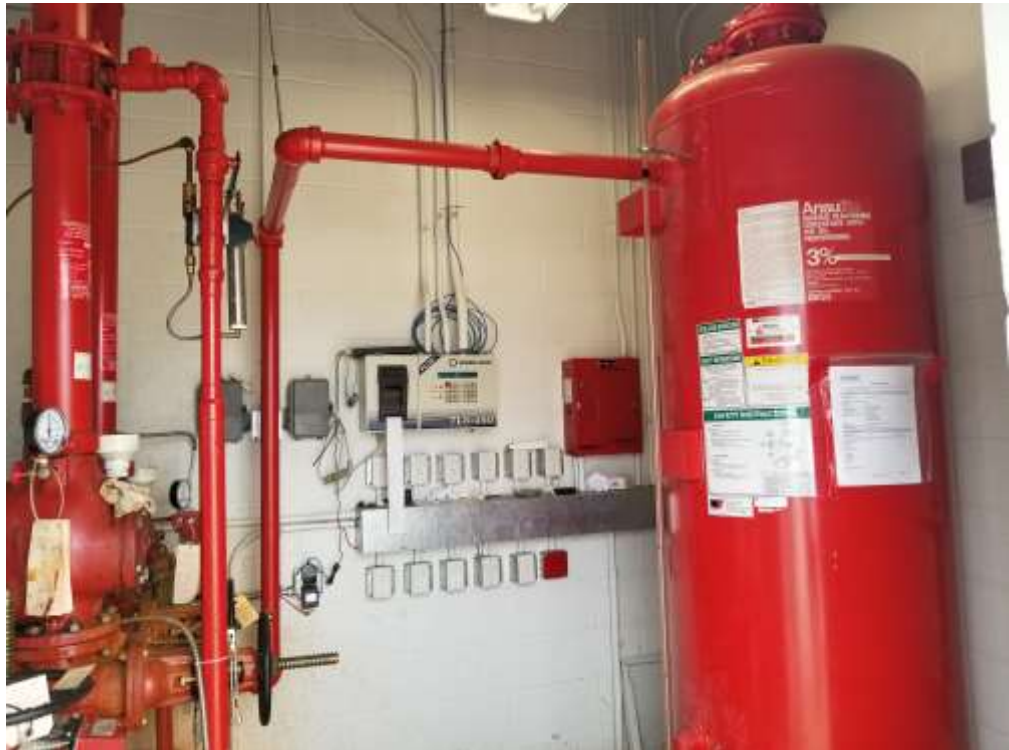
Description:
 AFFF tank (200 gallons) and piping for the Fuel Truck Storage Building fire suppression system in the tank/pump room.

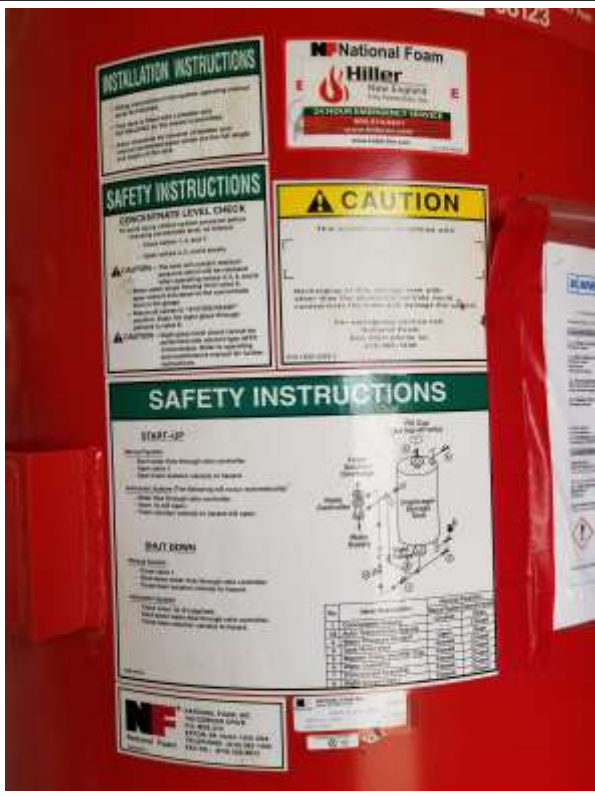
Photograph No. 08

Description:
 Label details for the 200-gallon AFFF tank for the Fuel Truck Storage Building fire suppression system in the tank/pump room.

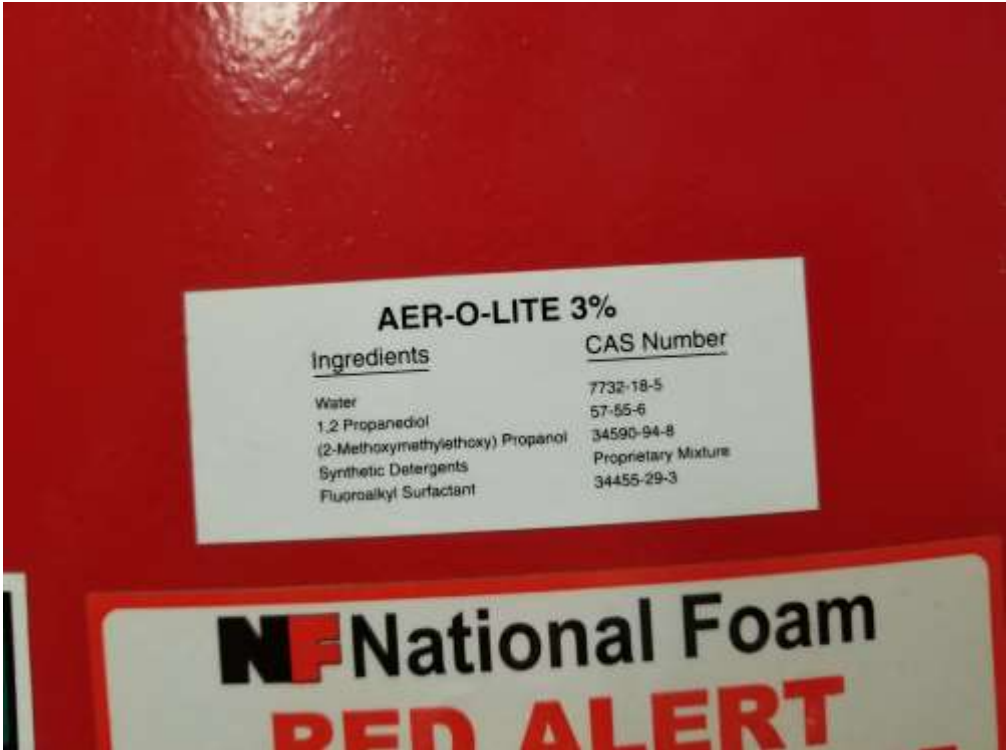
Photograph No. 09

Date 4/22/2019 Time 14:37	
Description: Label details for the 200-gallon AFFF tank for the Fuel Truck Storage Building fire suppression system in the tank/pump room.	
Orientation: NA

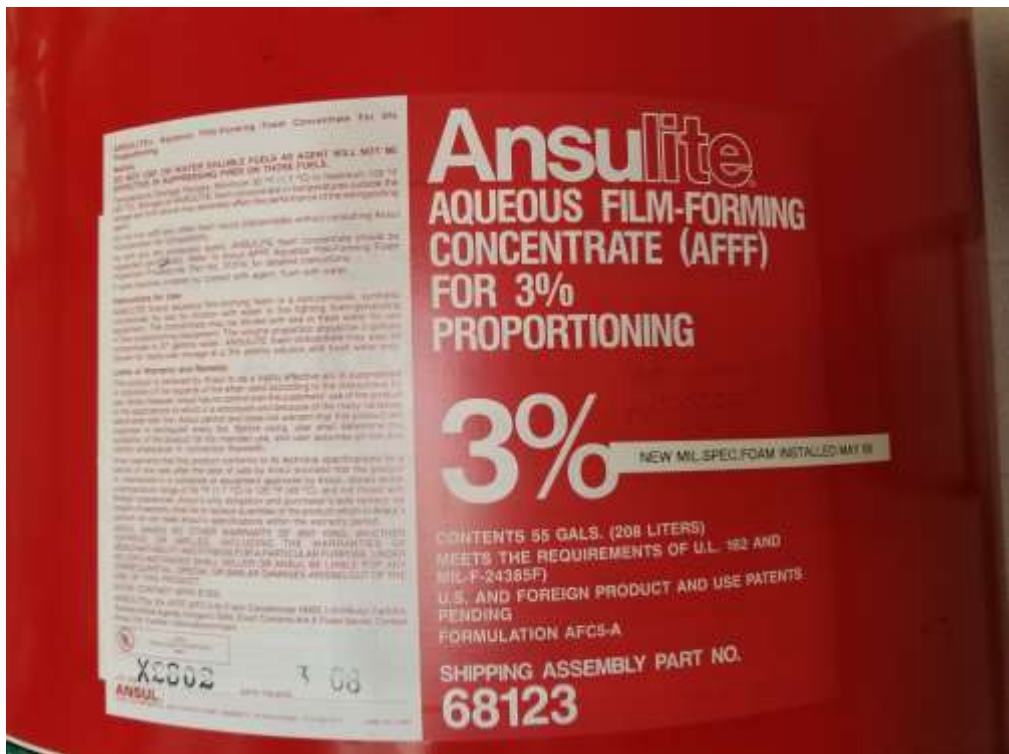
Photograph No. 11
Date 4/22/2019
Time 14:37
Description: Label details for the 200-gallon AFFF tank for the Fuel Truck Storage Building fire suppression system in the tank/pump room. This label appears to have been removed from a 55-gallon AFFF drum and placed on the 900-gallon AFFF tank.
Orientation: NA

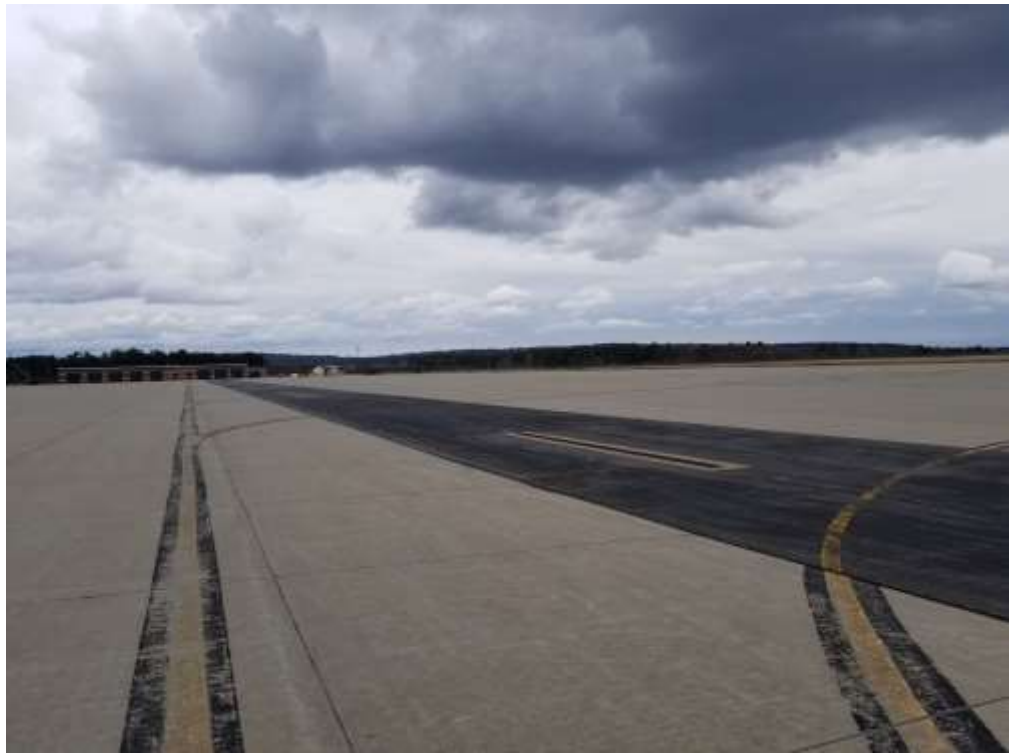
Photograph No. 12
Date 4/22/2019
Time 14:45
Description: Drain in center of AASF apron, which flows west to a underground basin, Vortex oil-water seperator, and then an on-site infiltration gallery.
Orientation: Southeast

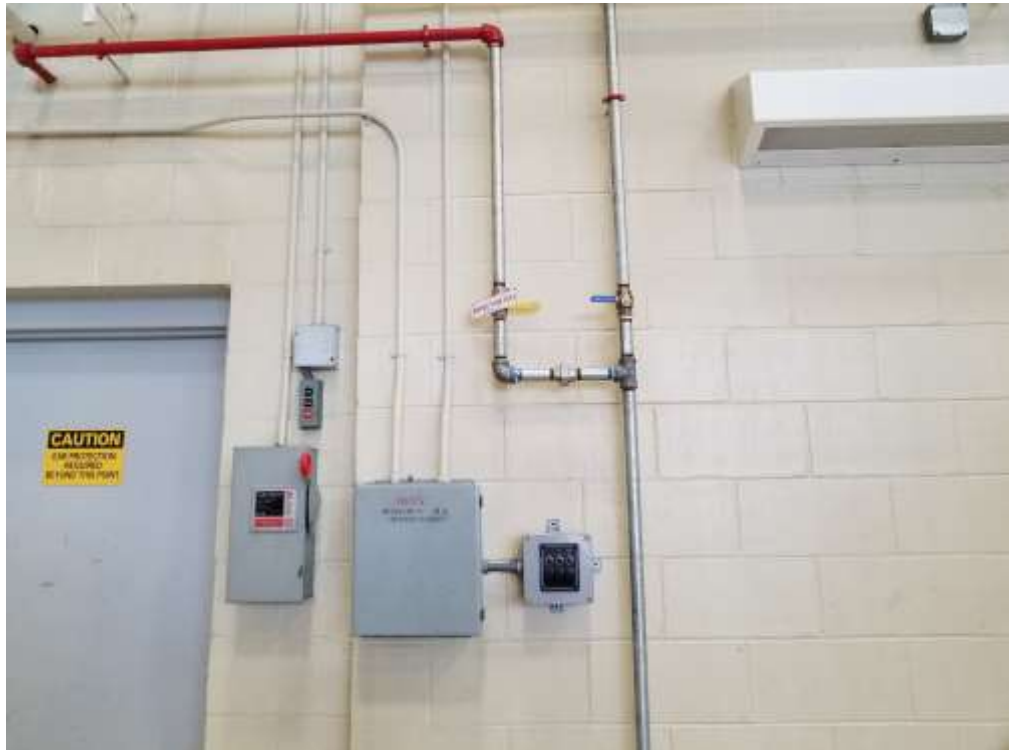
Description:
 Pipes in wash rack of main AASF Hanger which froze and burst in January 2019, resulting in a foam release (Ansulite 3% AFFF).

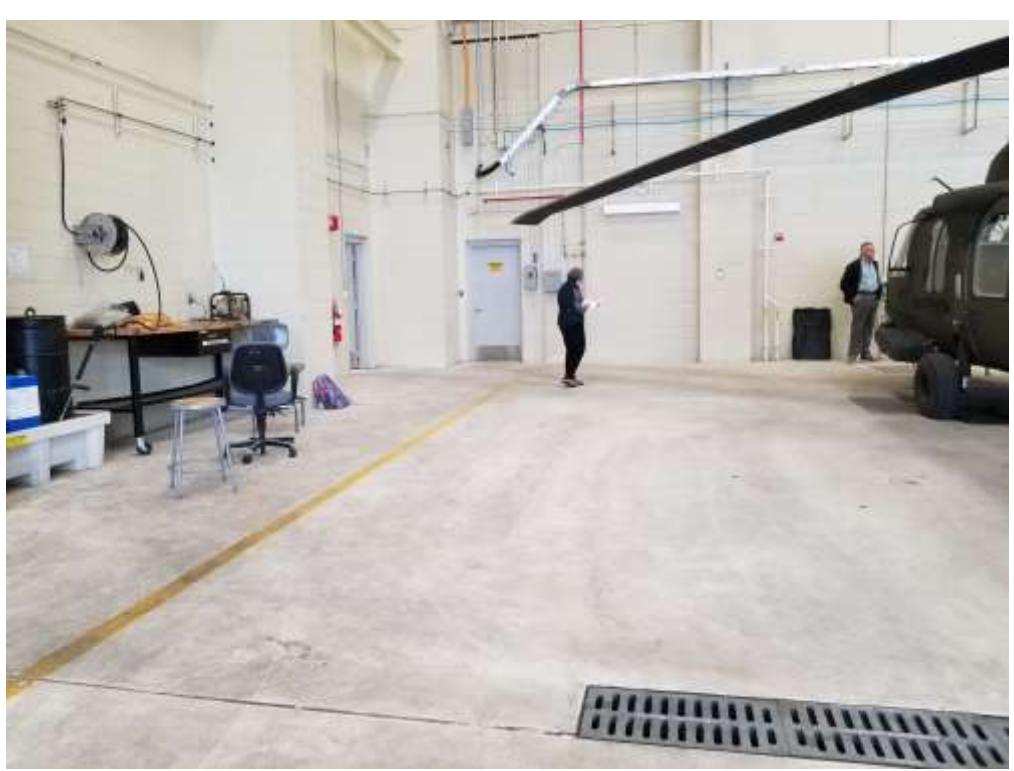
Photograph No. 18

Description:
 Area of Wash Rack in main AASF Hanger which had a foam release (Ansulite 3% AFFF) in January 2019. Pipes (shown on back wall) froze and burst, resulting in a foam release. The foam was approximately chest-high and extended from the back wall to about half the width (to the center drain) and half the length of the wash rack.

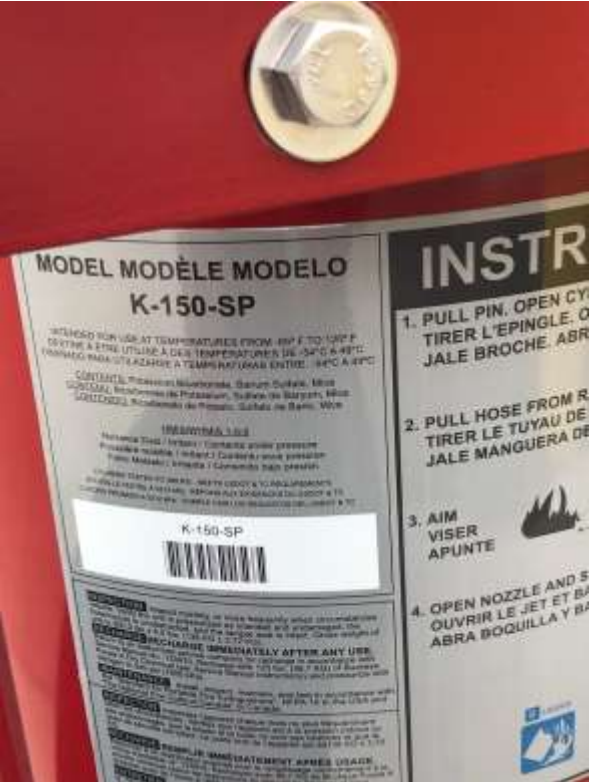
Army National Guard, Preliminary Assessment for PFAS	AASF Concord	Concord, New Hampshire
<p>Photograph No. 19</p> <p>Date 4/22/2019 Time 15:33</p> <p>Description: Fire extinguisher (#1) on AASF apron near Fuel Tank Storage Building, chemical.</p> <p>Orientation: NA</p>
