## Site Inspection Report

### State Military Reservation

### Concord, New Hampshire

Site Inspection for Perfluorooctanoic Acid (PFOA), Perfluorooctanesulfonic Acid (PFOS), Perfluorohexanesulfonic Acid (PFHxS), Perfluorononanoic Acid (PFNA), Hexafluoropropylene Oxide Dimer Acid (HFPO-DA), and Perfluorobutanesulfonic Acid (PFBS)  
ARNG Installations, Nationwide

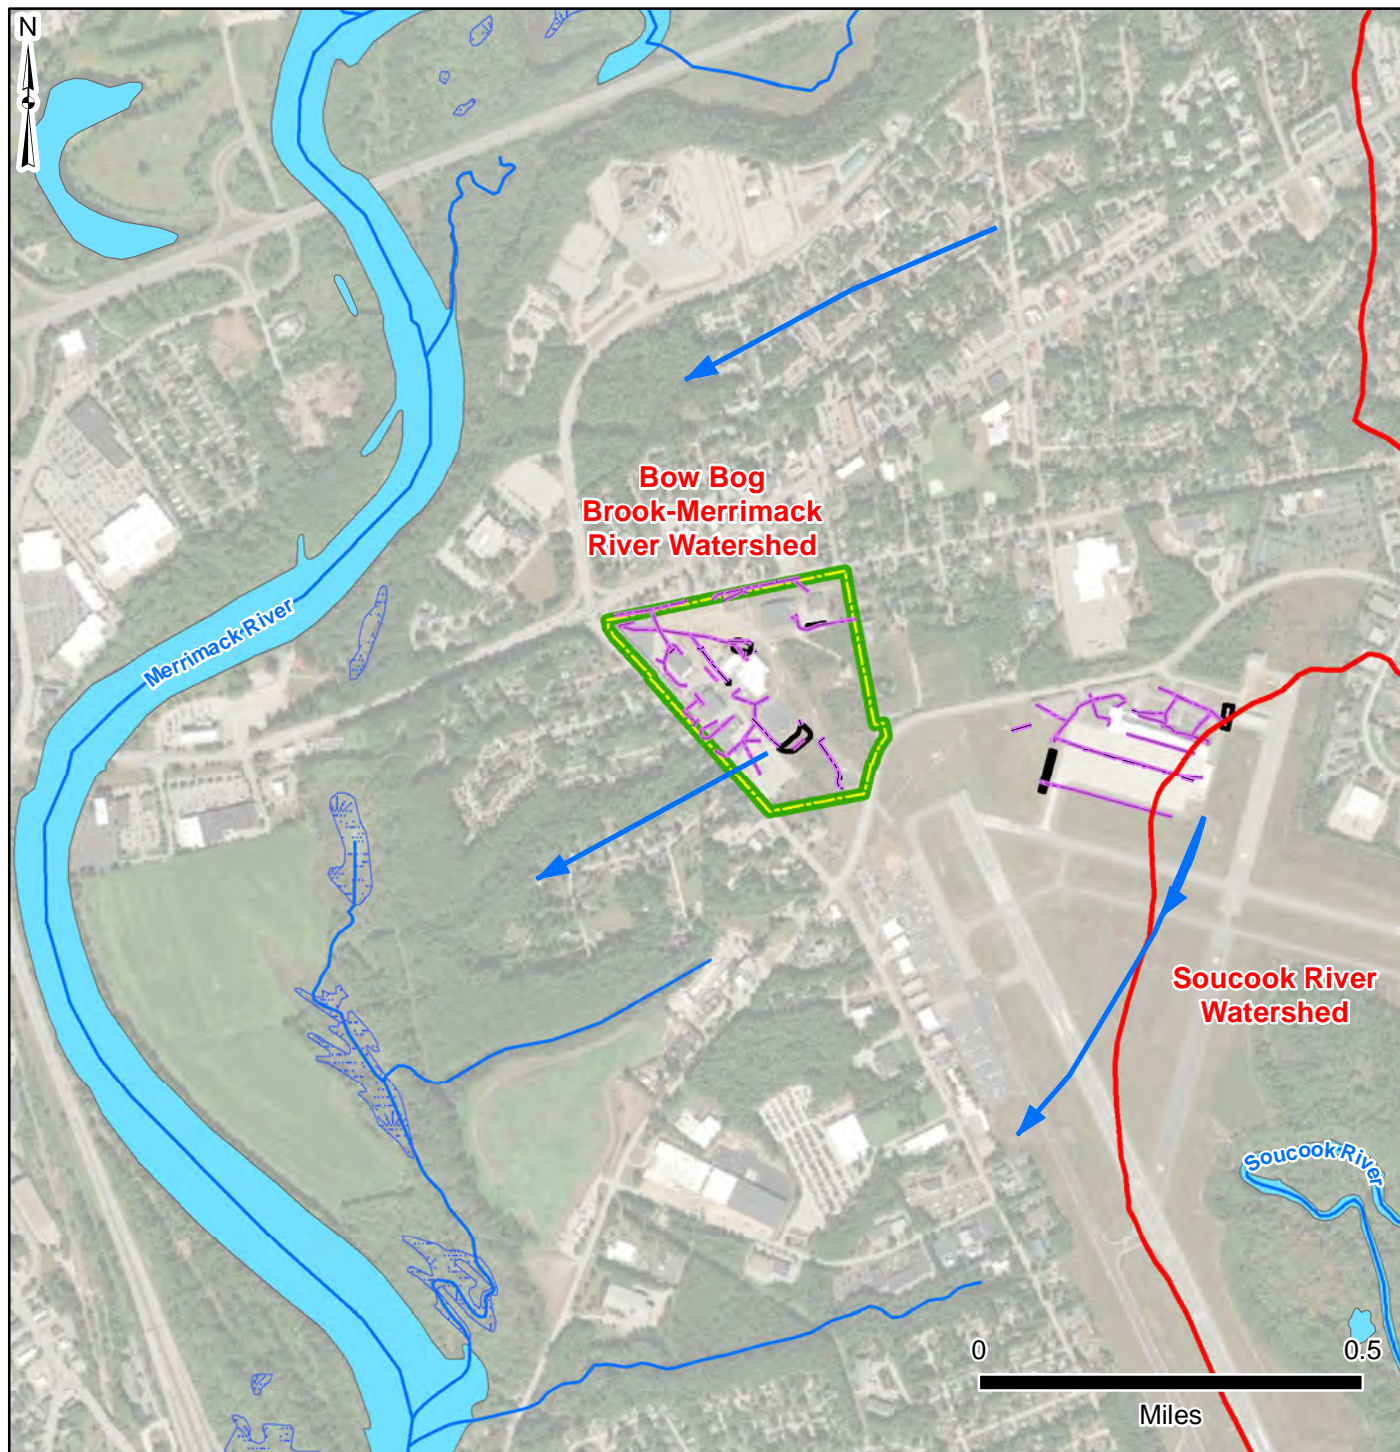
Figure 2-4  
Surface Water Features

The topography of the Facility and in the surrounding area is relatively flat. Much of the Facility is paved with either asphalt or concrete, with unpaved grassy areas along the boundaries of the Facility. Surface water in the general vicinity flows westerly towards the Merrimack River. Stormwater at the SMR is currently managed utilizing a series of drainage basins and trenches for infiltration, which allow the majority of stormwater to infiltrate into the ground onsite. The Combined Support Maintenance Shop (CSMS) and unit vehicle parking area are outfitted with oil-water separator (OWS)-equipped catch basin drains that precede discharge to the Concord municipal storm drain system on Airport Road. The drainage within the storm drain system from Airport Road flows westward down Loudon Road and then to the Merrimack River, which is approximately 0.5 miles to the west of the SMR. Storm drains in the northeast corner of the SMR are also connected to the Concord municipal storm drainage system. In the northern portion of the Facility, stormwater runoff flows into scattered catch basins that discharge to the storm drain in Pembroke Road. This stormwater also flows westward into the storm drain system on Loudon Road and ultimately to the Merrimack River (VHB, 1993; Stone & Webster Environmental Technology & Services, 1998; AECOM, 2019).
