FINAL Preliminary Assessment Report Roswell Readiness Center Roswell, New Mexico

Perfluorooctanesulfonic Acid (PFOS) and Perfluorooctanoic
Acid (PFOA) Impacted Sites
ARNG Installations, Nationwide

August 2020

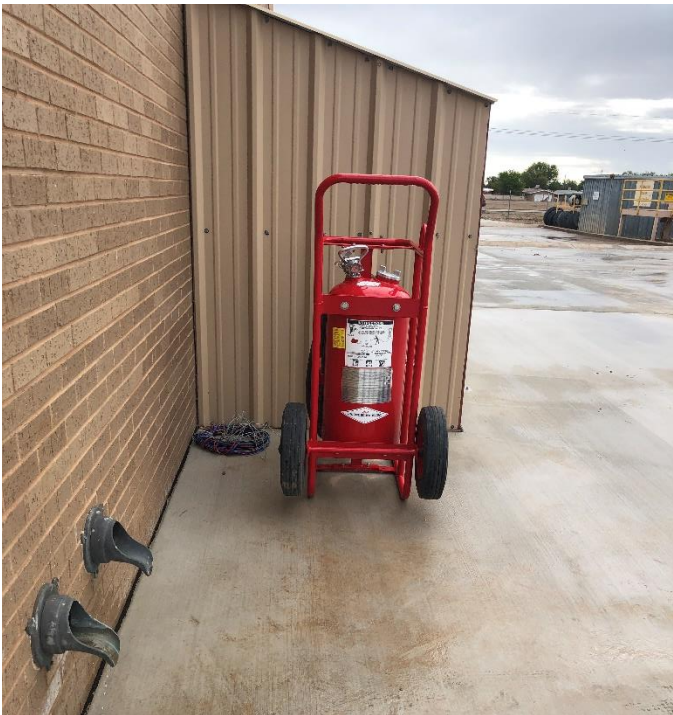
Army National Guard, Preliminary Assessment for PFAS	Roswell Readiness Center	Roswell, New Mexico
<p>Photograph No. 1</p> <p>Description:</p> <p>Facing East. New Fire extinguisher that replaced the former Tri-Max™ hand truck.</p> <p>Photo Date: 10/02/2019 0940</p>

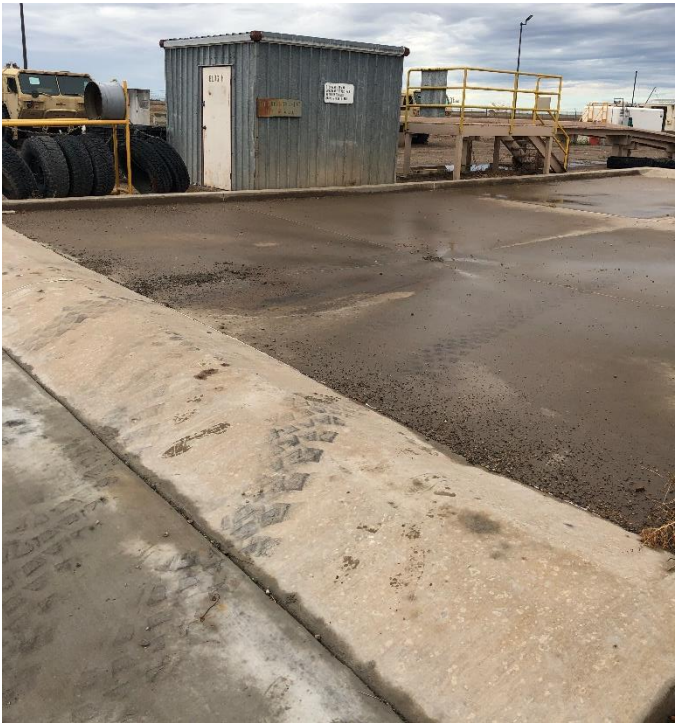
APPENDIX C – Photographic Log		
Army National Guard, Preliminary Assessment for PFAS	Roswell Readiness Center	Roswell, New Mexico
Photograph No. 3

Description: Facing Southwest. Drain in wash rack we concrete berms around it. Photo Date: 10/02/2019 1002
