## Site Inspection Report

### Roswell Field Maintenance Shop

### Roswell, New Mexico

Site Inspection for Perfluorooctanoic Acid (PFOA), Perfluorooctanesulfonic Acid (PFOS), Perfluorohexanesulfonic Acid (PFHxS), Perfluorononanoic Acid (PFNA), Hexafluoropropylene Oxide Dimer Acid (HFPO-DA), and Perfluorobutanesulfonic Acid (PFBS)  
ARNG Installations, Nationwide

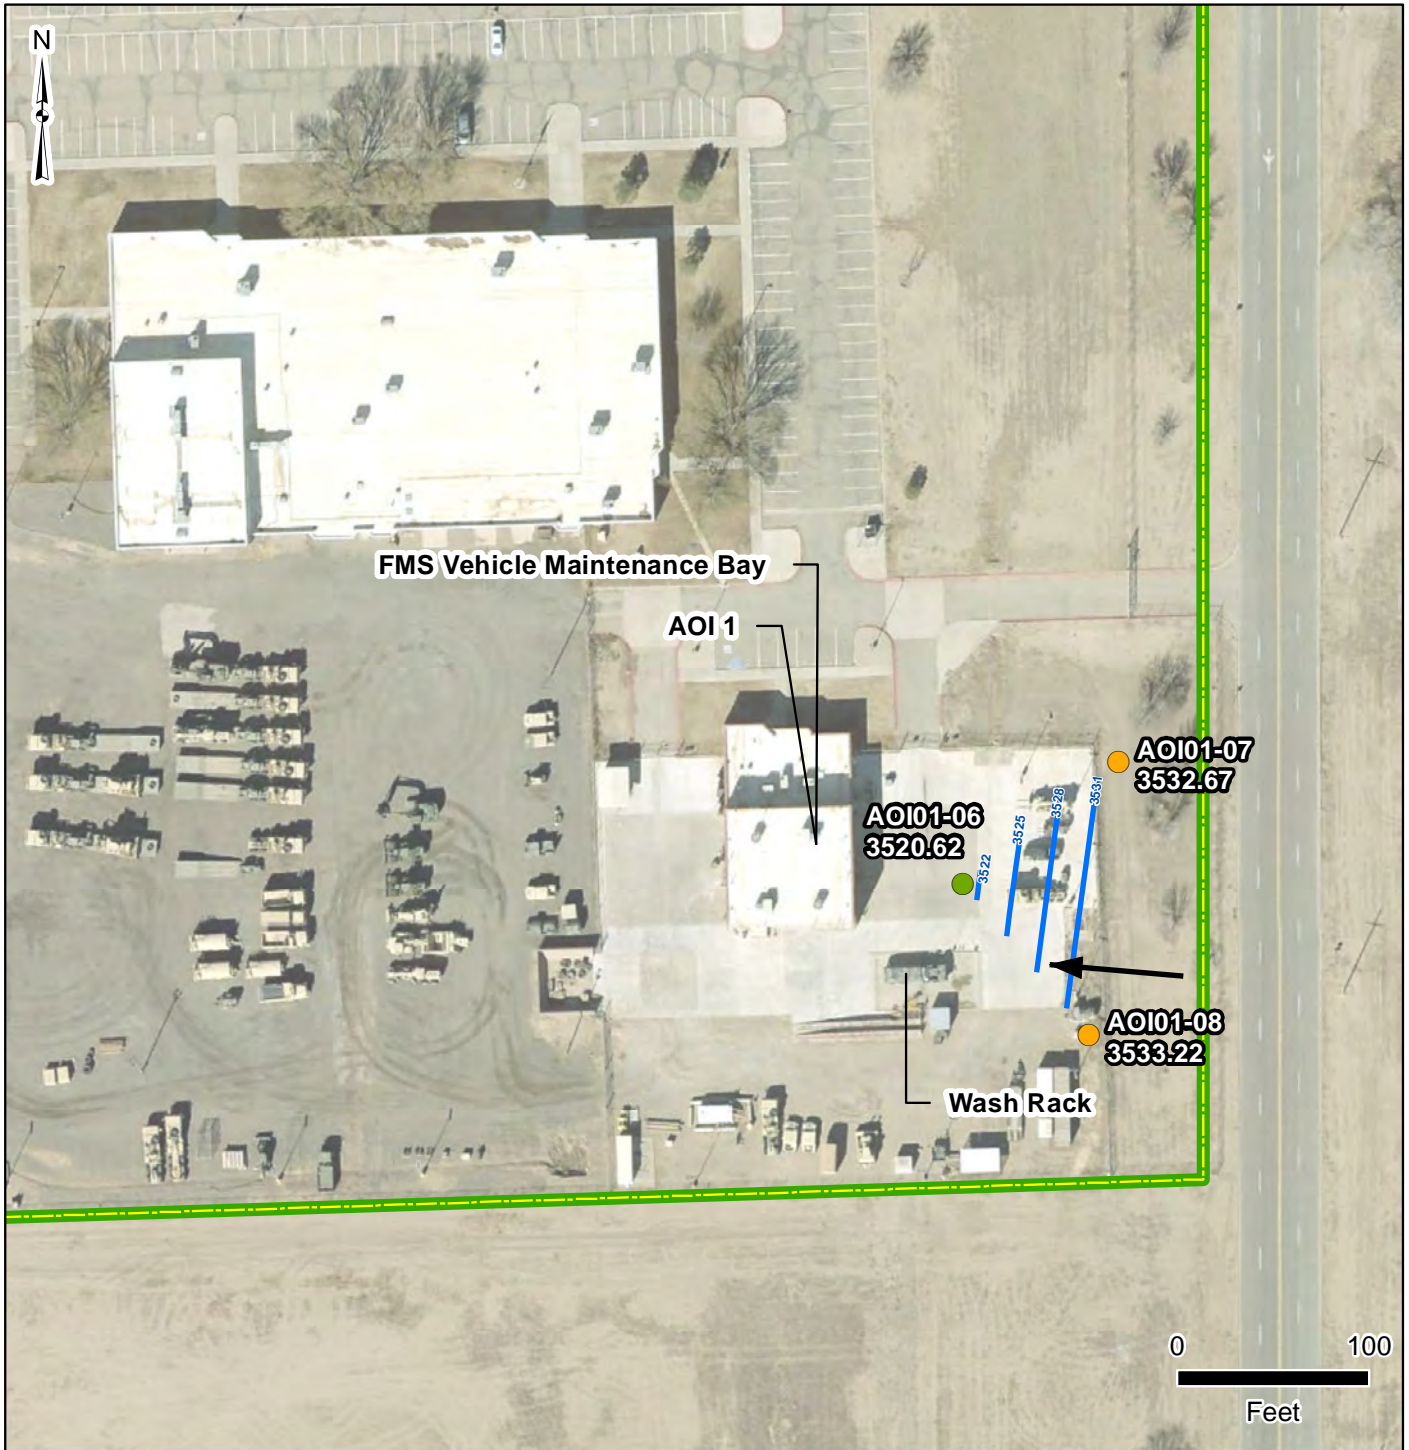
Figure 2-4  
 Groundwater Elevations

The PA Report (AECOM, 2020) included a search of wells within a 4-mile radius of the Facility. Although the PA Report indicated a potential depth to groundwater of 500 ft bgs at the Facility, a review of drillers' logs for wells installed in the vicinity between 2015 and 2020 indicates a regional depth to water in the shallow alluvial aquifer of between approximately 100 and 200 ft bgs, with an average of approximately 130 ft bgs (AECOM, 2020). The depth to groundwater in June 2022 observed during the SI ranged from approximately 117 to 132 ft bgs. Groundwater elevations from the SI are presented on **Figure 2-4**. The regional groundwater flow identified in the PA is likely pertaining to the deeper Roswell Artesian aquifer and flows generally eastward. Based on groundwater elevations calculated using depth to groundwater measurements and survey data collected during the SI, groundwater flow at the Facility during the SI generally flows to the west toward AOI01-06 with an approximate gradient of 0.017 foot per foot (ft/ft). The shallow alluvial aquifer encountered during the SI is likely influenced by local structures,

localized subsurface anomalies, and nearby groundwater usage. The SI was performed during a rain event, and while AOI01-06 is located within a paved parking lot, AOI01-07 and AOI01-08 are located in areas that do not have impervious surfacing (**Figure 2-4**). The extension of the concrete surface surrounding the FMS building is shown on **Figure 2-4**. Nearby water supply wells are completed in the Roswell artesian aquifer, with the closest well located approximately 0.45 miles to the east, between West (W) Earl Cummings Boulevard (Blvd) and W Byrne Street (St) and to the south of W Hobson Road (Rd). Private wells located to the northwest and northeast within the vicinity of the Facility tend to be completed within the alluvial aquifer (New Mexico Environment Department [NMED] Drinking Water Bureau, 2019). The closest wells are located approximately 0.22 miles to the northwest and 0.28 miles to the northeast.

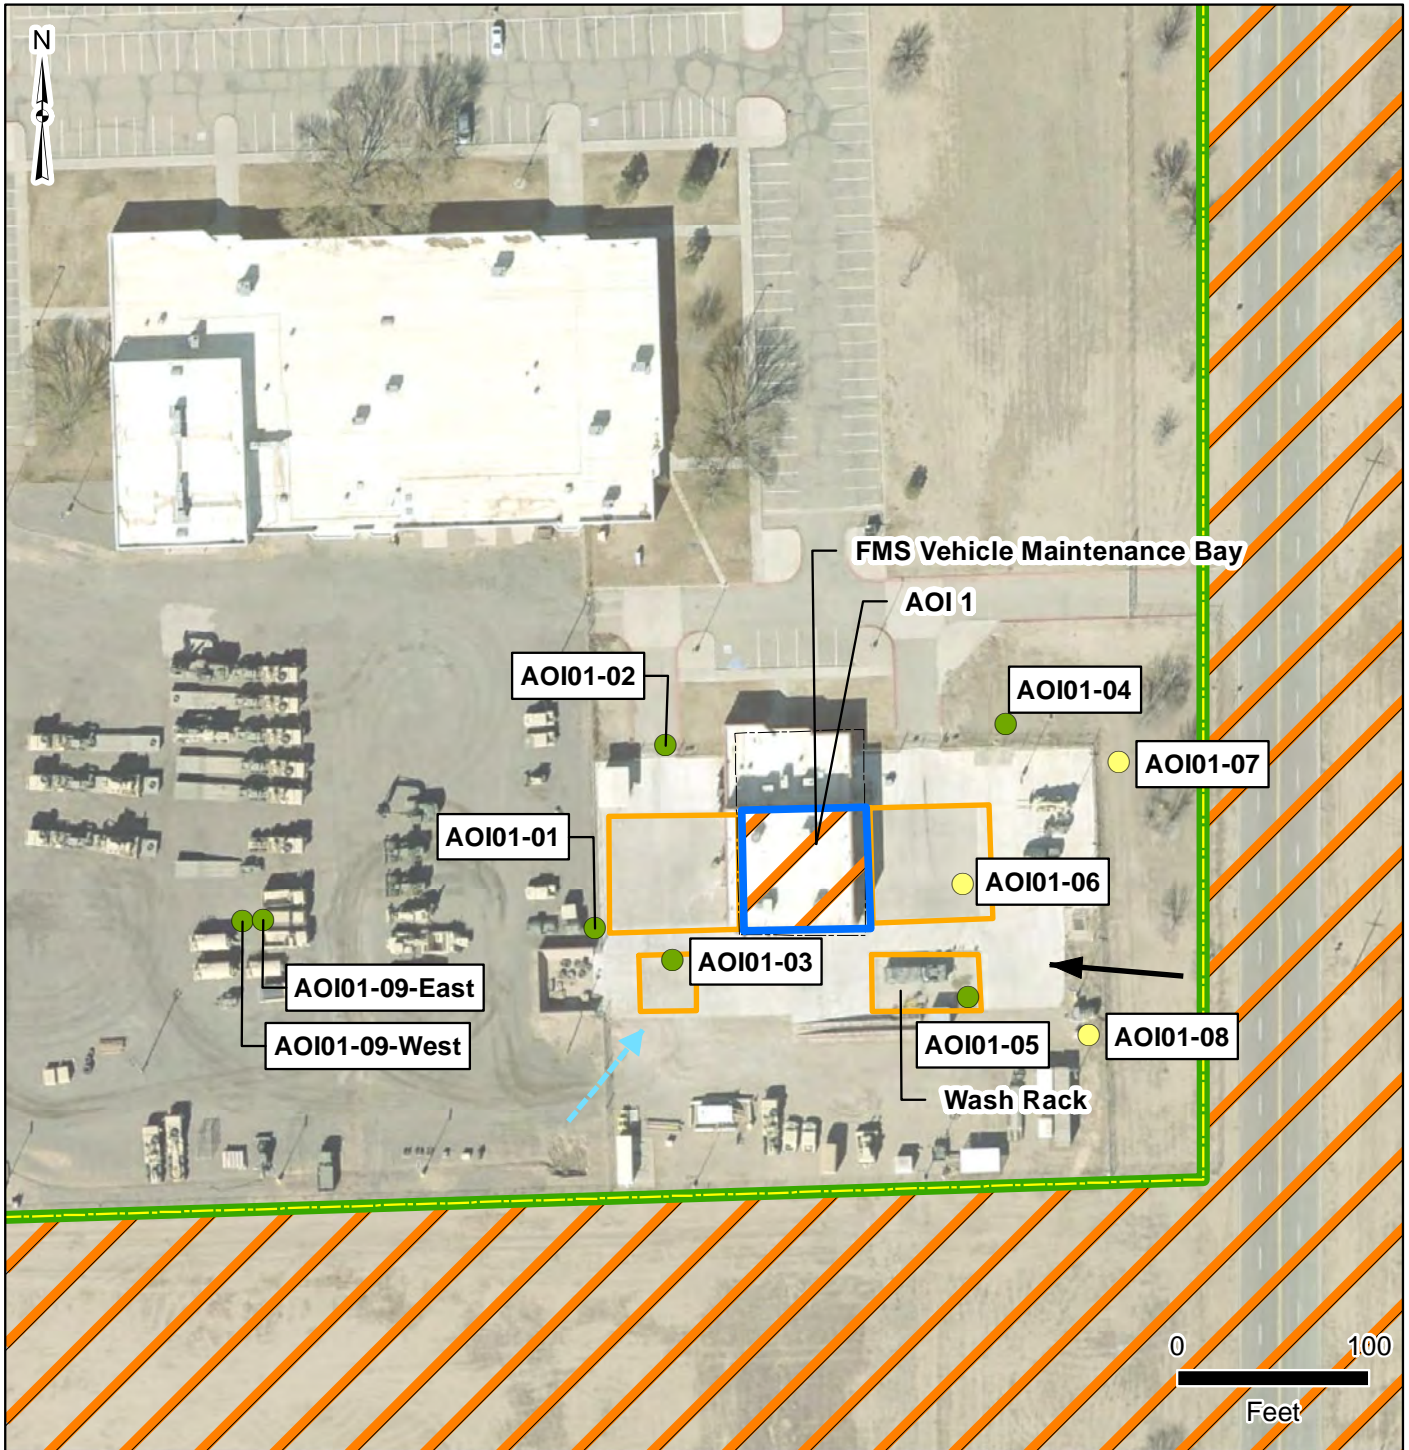
Figure 5-1  
Site Inspection Sample Locations

soil boring locations are shown on **Figure 5-1**, and boring sample depths are provided in **Table 5-1**. Several boring locations were adjusted within a 50-ft offset for reasons including drill rig access, utility avoidance and bias toward sampling within observed drainage features.
