# FINAL Preliminary Assessment Report Ronkonkoma Army Aviation Support Facility #1, Ronkonkoma, New York

Perfluorooctanesulfonic Acid (PFOS) and Perfluorooctanoic  
Acid (PFOA) Impacted Sites  
ARNG Installations, Nationwide

August 2020

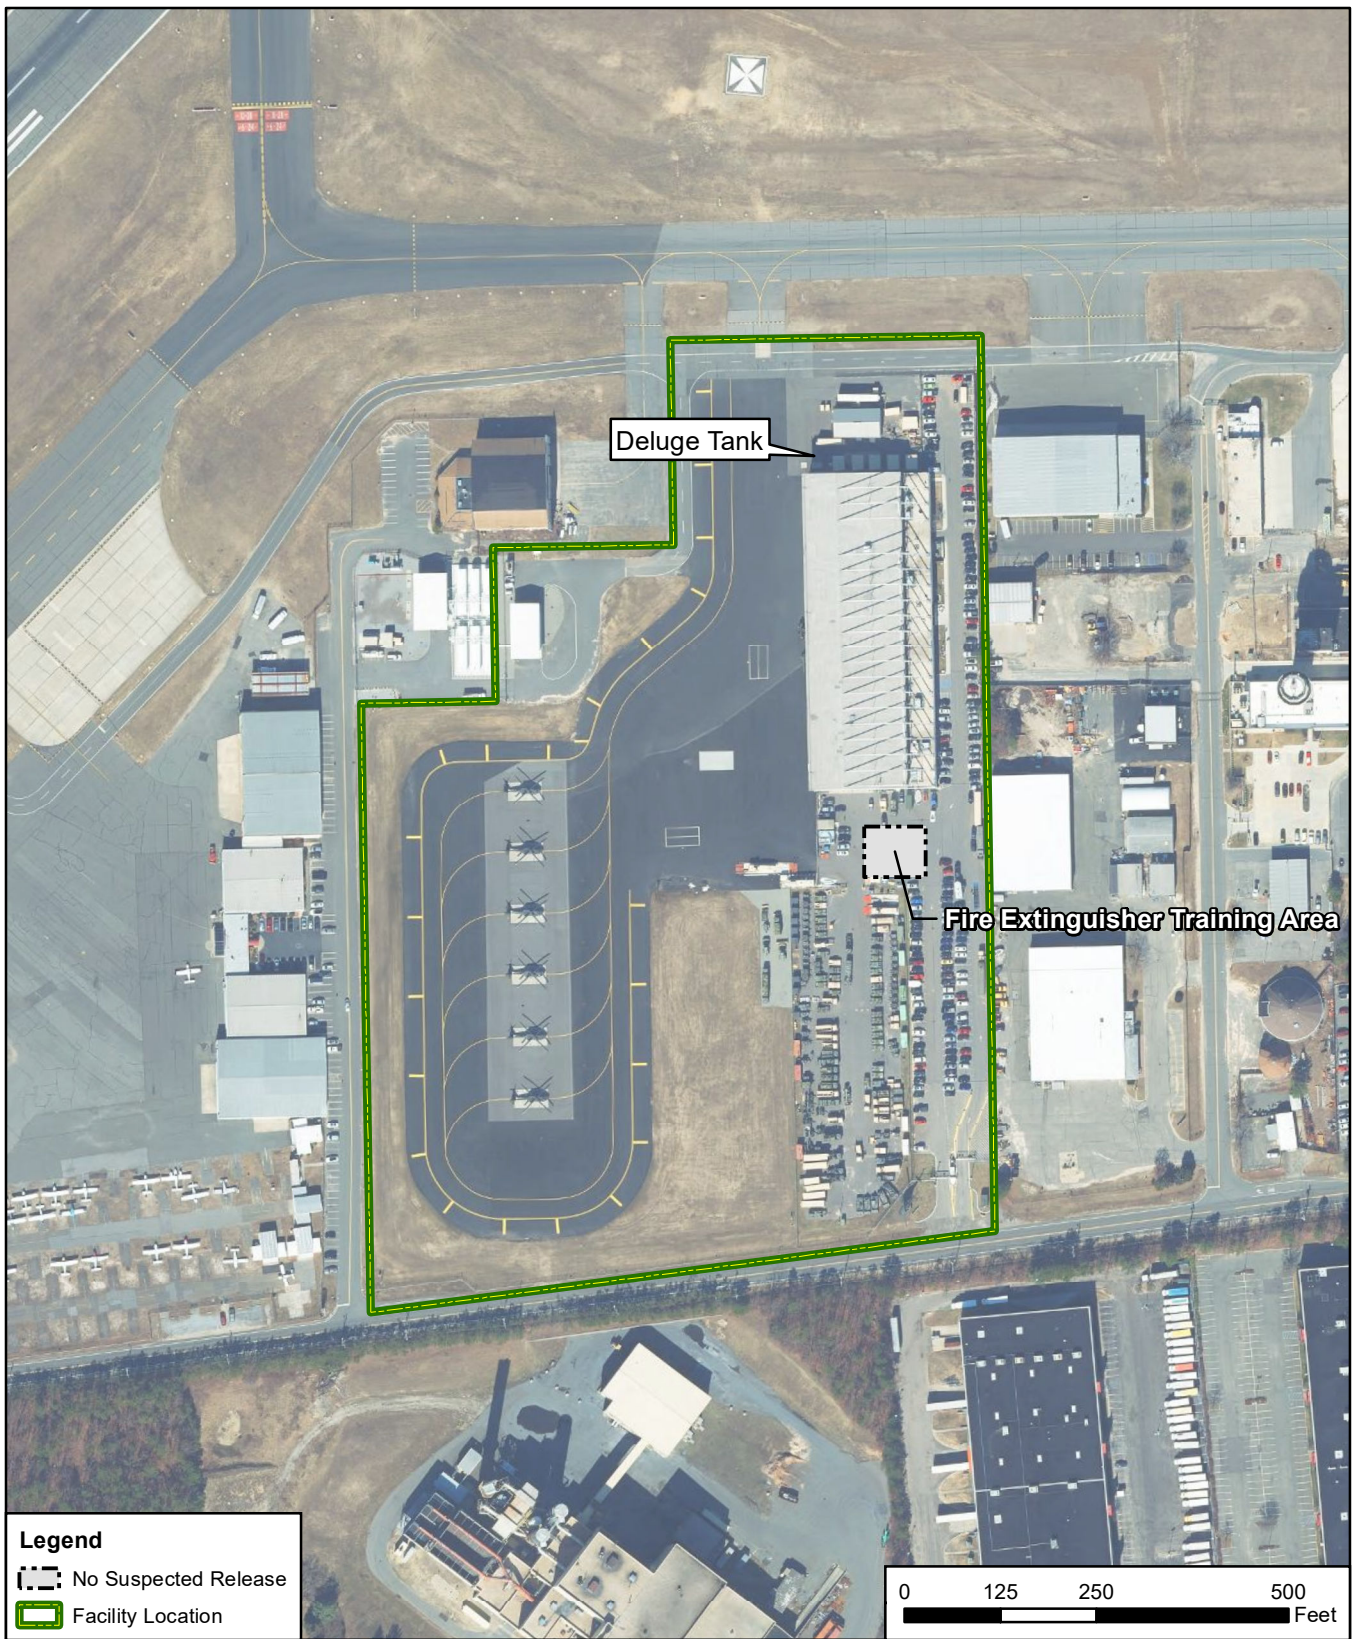
12420 Milestone Center Drive Germantown, MD 20876	Figure 2-1
REVISED	7/20/2020	GIS BY	MS	7/20/2020				
SCALE	1:3,000	CHK BY	BP	7/20/2020				
Base Map: NYS Digital Ortho-imagery Program (NYSDOP), 2016		PM	RG	7/20/2020

One FTA was identified at the Ronkonkoma AASF #1 during the PA. According to an interview with staff during the VSI, the NYARNG has never maintained an internal fire department. A description of the FTA is presented below, and the FTA location is shown on **Figure 2-1**.

Annual NYARNG fire extinguisher training is performed jointly with the fire department at the AASF. According to interviewees, those activities do not use AFFF. The location of the FTA is shown on **Figure 2-1**; however, because AFFF is not used in the training, this FTA is not considered a potential release area.

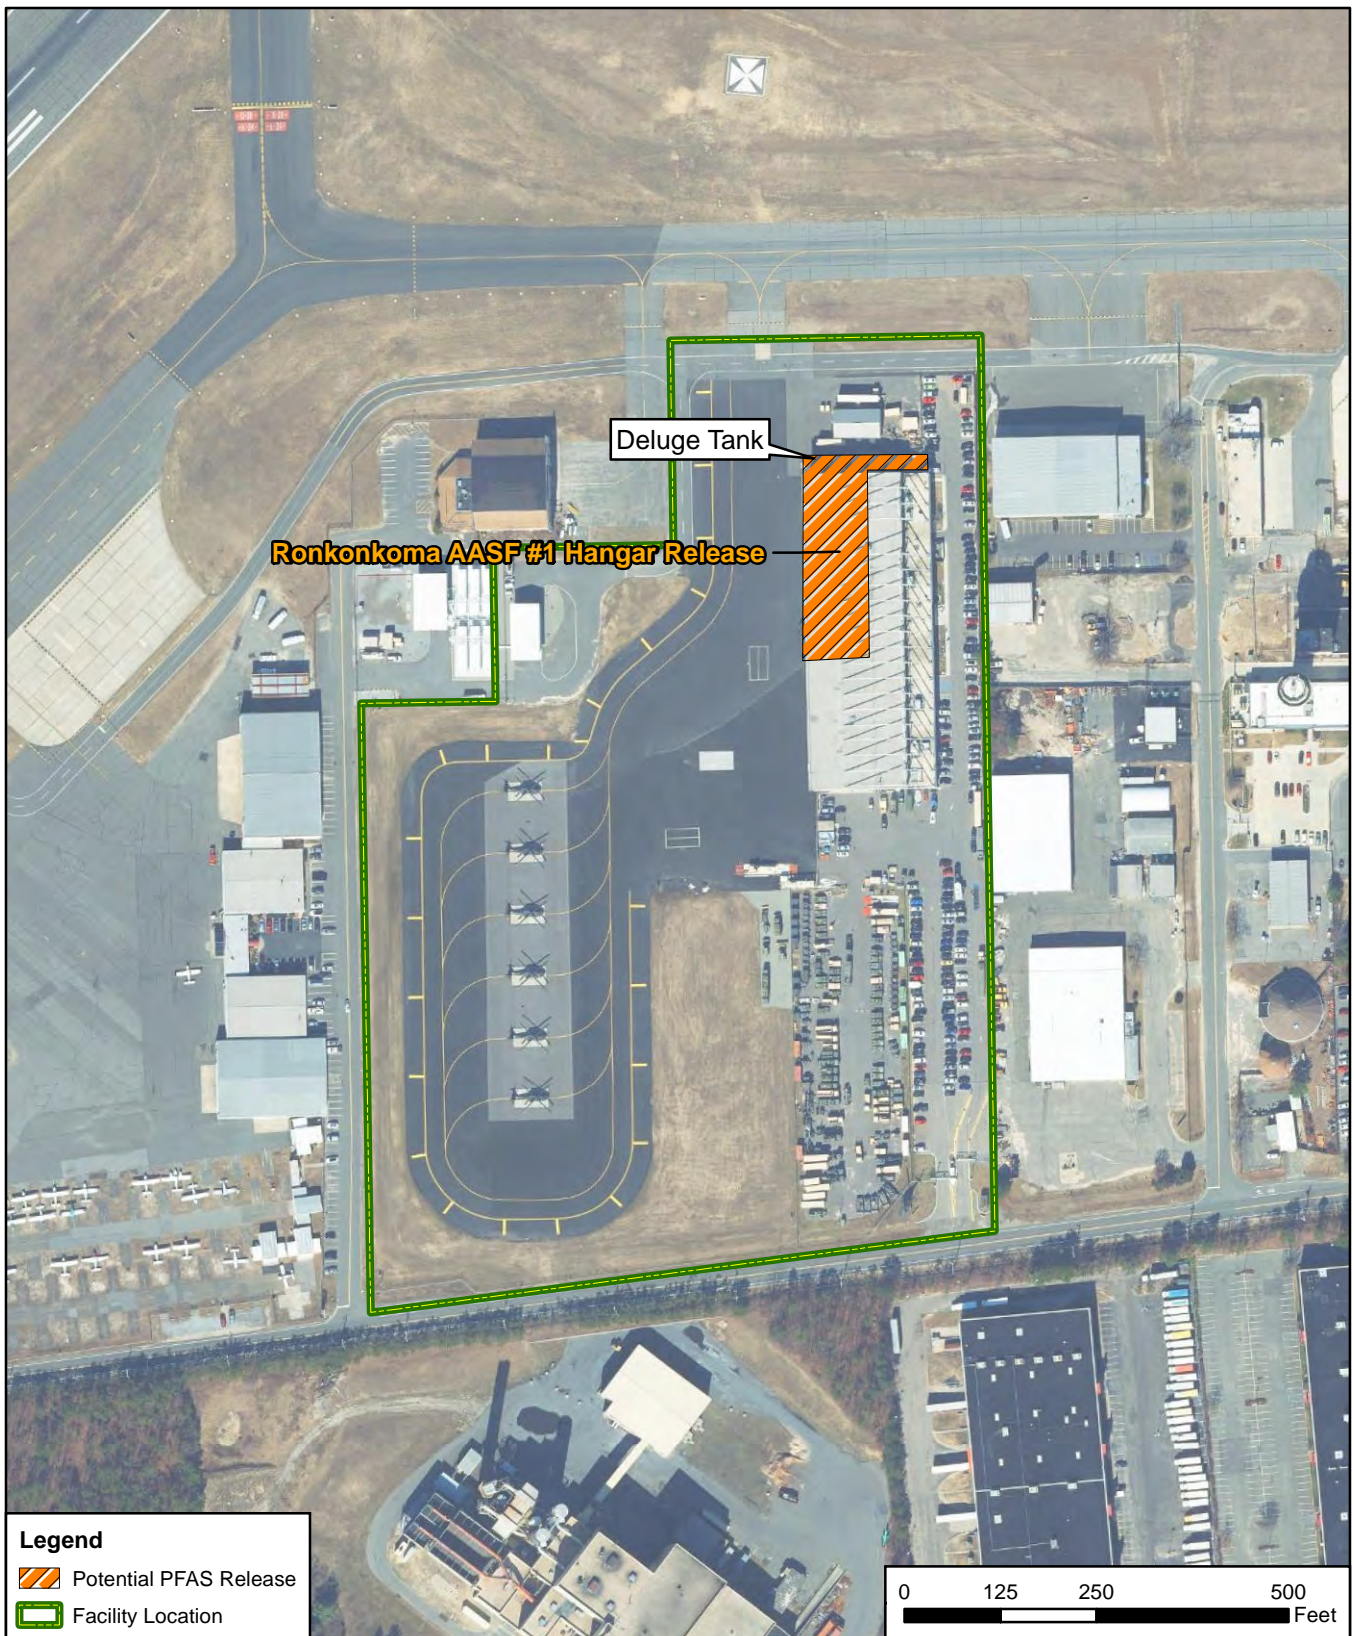
Figure 3-1	
REVISED	5/8/2020	GIS BY	MS	5/8/2020				
SCALE	1:3,000	CHK BY	BP	5/8/2020				
Base Map: NYS Digital Ortho-imagery Program (NYSDOP), 2016		PM	RG	5/8/2020

The Ronkonkoma AASF #1 hangar was built between 1966 and 1980. The NYARNG moved to the location in the 1970s. In 2007, the hangar was equipped with a fire suppression deluge system containing AFFF high expansion foam. This system contains a steel-lined draining trench in the hangar floor, 1 mile of heat tape that triggers at 140°F or a manual pull, a 25,000-gallon concrete-lined dual-wall storage tank, and two emergency shut-offs. Two 500-gallon tanks filled with AFFF are connected to the deluge system. An interviewee indicated that the deluge system has only been tested one time shortly after its installation in 2007. This deluge test was documented in a 2.5-minute video and captures the entire discharge of 3% concentration Ansul AFFF. Both 500-gallon AFFF tanks were used in the test, though the actual quantity of AFFF released is unknown. The hangar is divided into different sections and only a small area of the hangar was involved and affected by the deluge system test, which is shown in **Figure 3-1**. The AFFF was flushed with water and drained out to the underground deluge storage tanks and was then pumped onto a truck and transported for disposal. NYARNG staff stated, with no evidence to the contrary, that all AFFF was properly contained, and the deluge system test was successfully drained and pumped out of the facility with no spillage or leakage. However, due to the potential for undocumented spills or leaks, the Ronkonkoma AASF Hangar #1 is considered a potential release area.

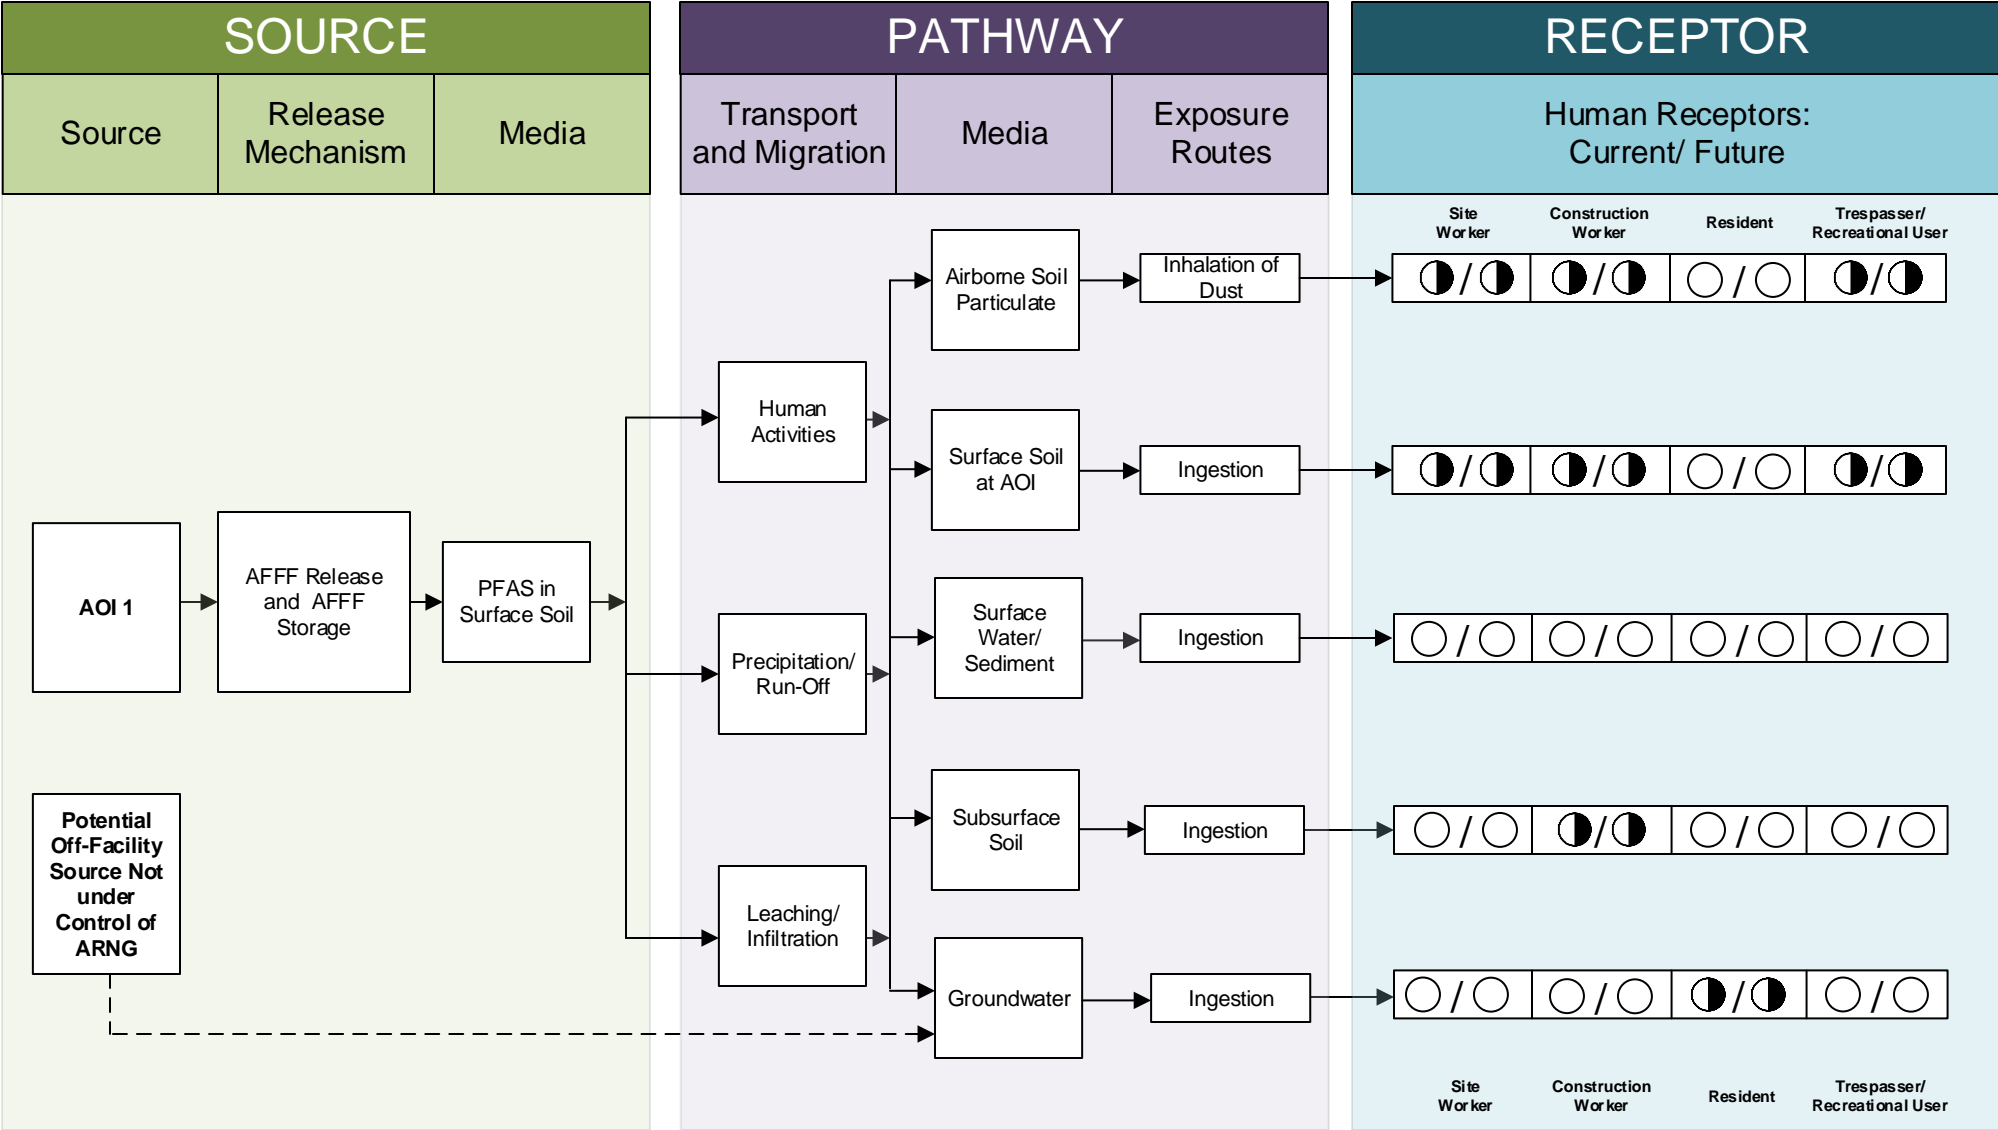
While the known release of AFFF occurred and was contained within the AASF #1 hangar, it is possible that unknown or undocumented releases of AFFF occurred at AOI 1 on paved areas and grassy surfaces nearby. AFFF releases could have occurred directly onto surface soil but may also have infiltrated subsurface soil via cracks in pavement or joints between areas that are paved with different materials. Therefore, ground-disturbing activities in these areas could result in site worker, construction worker, and trespasser exposure to potential PFAS contamination via inhalation of dust or ingestion of surface soil. Additionally, ground-disturbing activities to subsurface soil could result in construction worker exposure via ingestion. Therefore, the exposure pathways for inhalation of soil particles and ingestion of soil are considered potentially complete for these receptors.

PFAS are water soluble and can migrate readily from soil to groundwater via leaching. The inferred groundwater flow is to the south/southeast. There are no potable wells at Ronkonkoma AASF #1 or at the Long Island MacArthur Airport. The facility receives water from the SCWA, and there were no private drinking water wells identified within 4 miles downgradient of the facility (**Figure 1-2**). However, due to the potential for unidentified residential wells downgradient of the facility, the ingestion exposure pathway for groundwater is potentially complete for off-facility residents that are located downgradient of AOI 1. Due to the depth to groundwater (approximately 35.6 feet to 40.95 feet), the groundwater ingestion exposure pathway for construction workers is considered incomplete.

No surface water features flow through the AOI, nor are there any surface water features within or nearby the facility boundary. Therefore, the surface water and sediment exposure pathways are incomplete for both on- and off-facility receptors. The preliminary CSM for AOI 1 is presented on **Figure 6-2**.

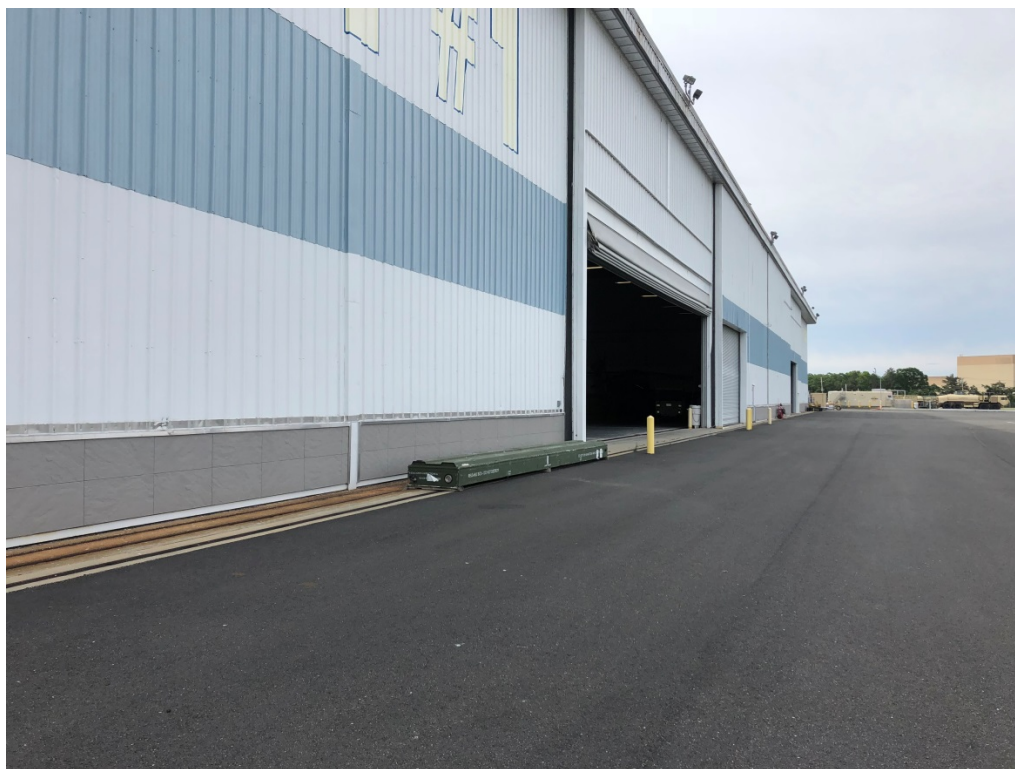
View of the front entrance to the Ronkonkoma AASF #1 hangar

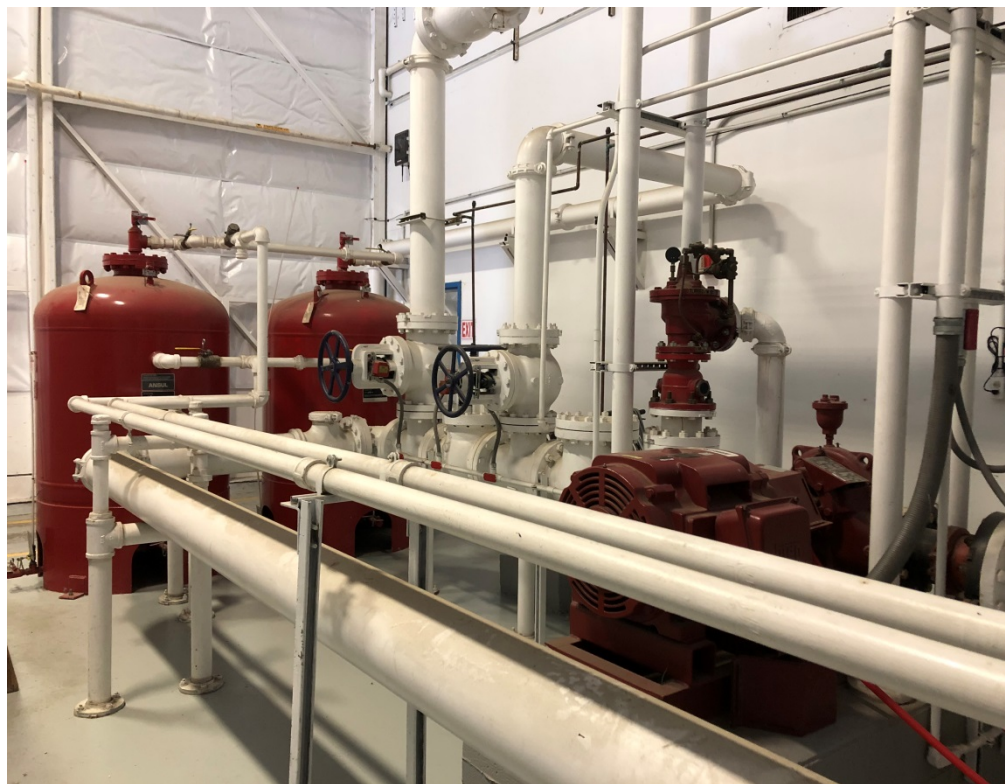
### Photograph No. 2

These two 500 gallon tanks of Ansul are connected directly to the deluge system

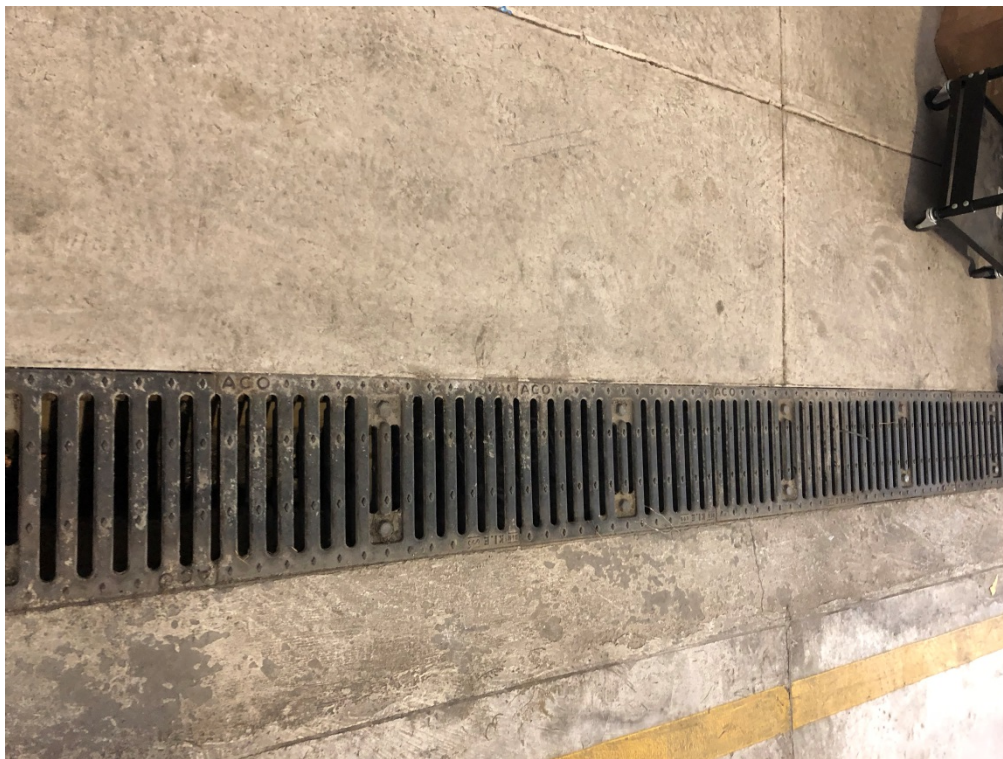
After the deluge system completes, the Ansul will flow out through this drainage system, and straight to the 25,000 gallon storage tanks outside.

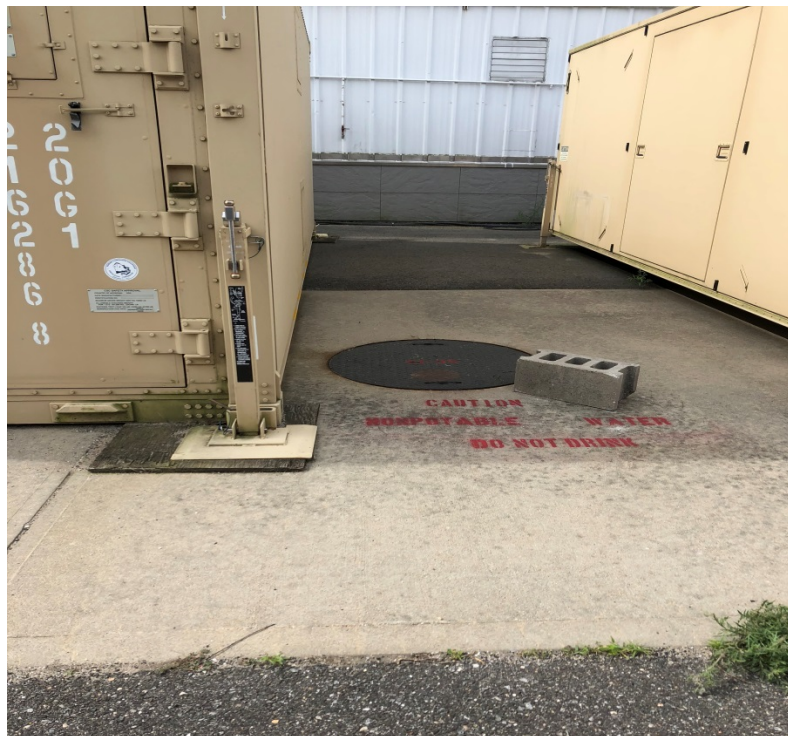
### Photograph No. 4

This is the 25,000 gallon underground storage tank. The manhole cover is removed and the contents are carefully pumped out onto a truck to be transported and properly disposed of.

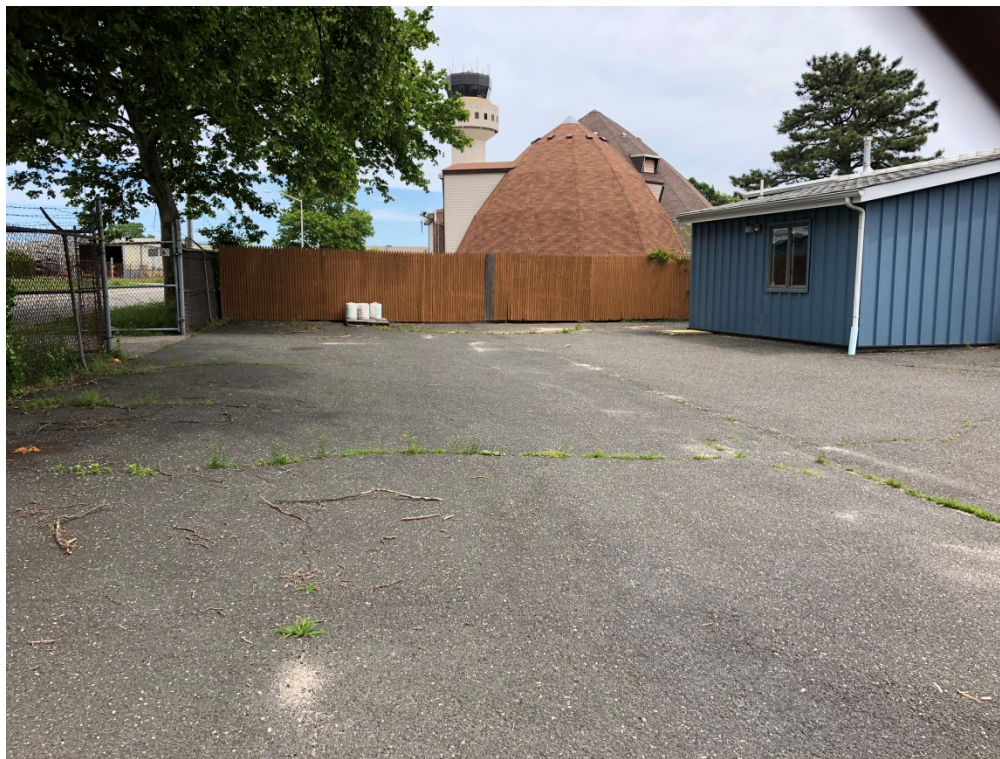
Second image of off-site parking lot containing 5 gallon buckets marked Ansul; Town of Islip HAZMAT Response Team.

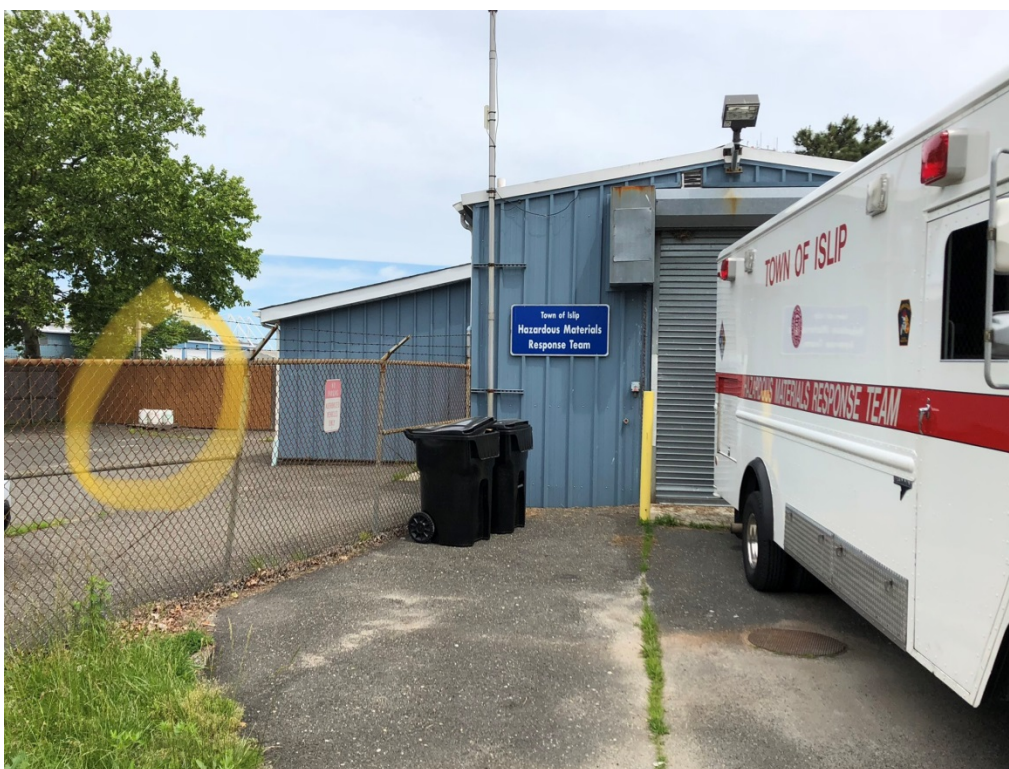
### Photograph No. 6

The Town of Islip Hazardous Materials (Hazmat) Response Team works in tandem with the Long Island MacArthur Airport Fire Department. During the VSI, a pallet of 5-gallon buckets that were labeled as Ansul products was observed approximately 600 ft south of the fire department in the Town of Islip Hazmat Response Team parking lot, on the northeast corner of Clark and Schaefer Drives. Photographs of the pallet are included in **Appendix C**. Access to the Town of Islip Hazmat Response Team parking area was not permitted during the site visit. Although there is no evidence to suggest a PFAS release has occurred at this location, the history of storage and use of AFFF at this location is unknown. Therefore, the Town of Islip Hazmat Response Team is considered a potential adjacent off-facility source of PFAS.

Pallet of 5 gallon buckets of Ansul at the adjacent off-site PFAS location: Town of Islip HAZMAT Response Team parking lot.
