FINAL Preliminary Assessment Report Camp Smith Training Facility Cortlandt, New York

Perfluorooctane-Sulfonic Acid (PFOS) and Perfluorooctanoic
Acid (PFOA) Impacted Sites
ARNG Installations, Nationwide

May 2019

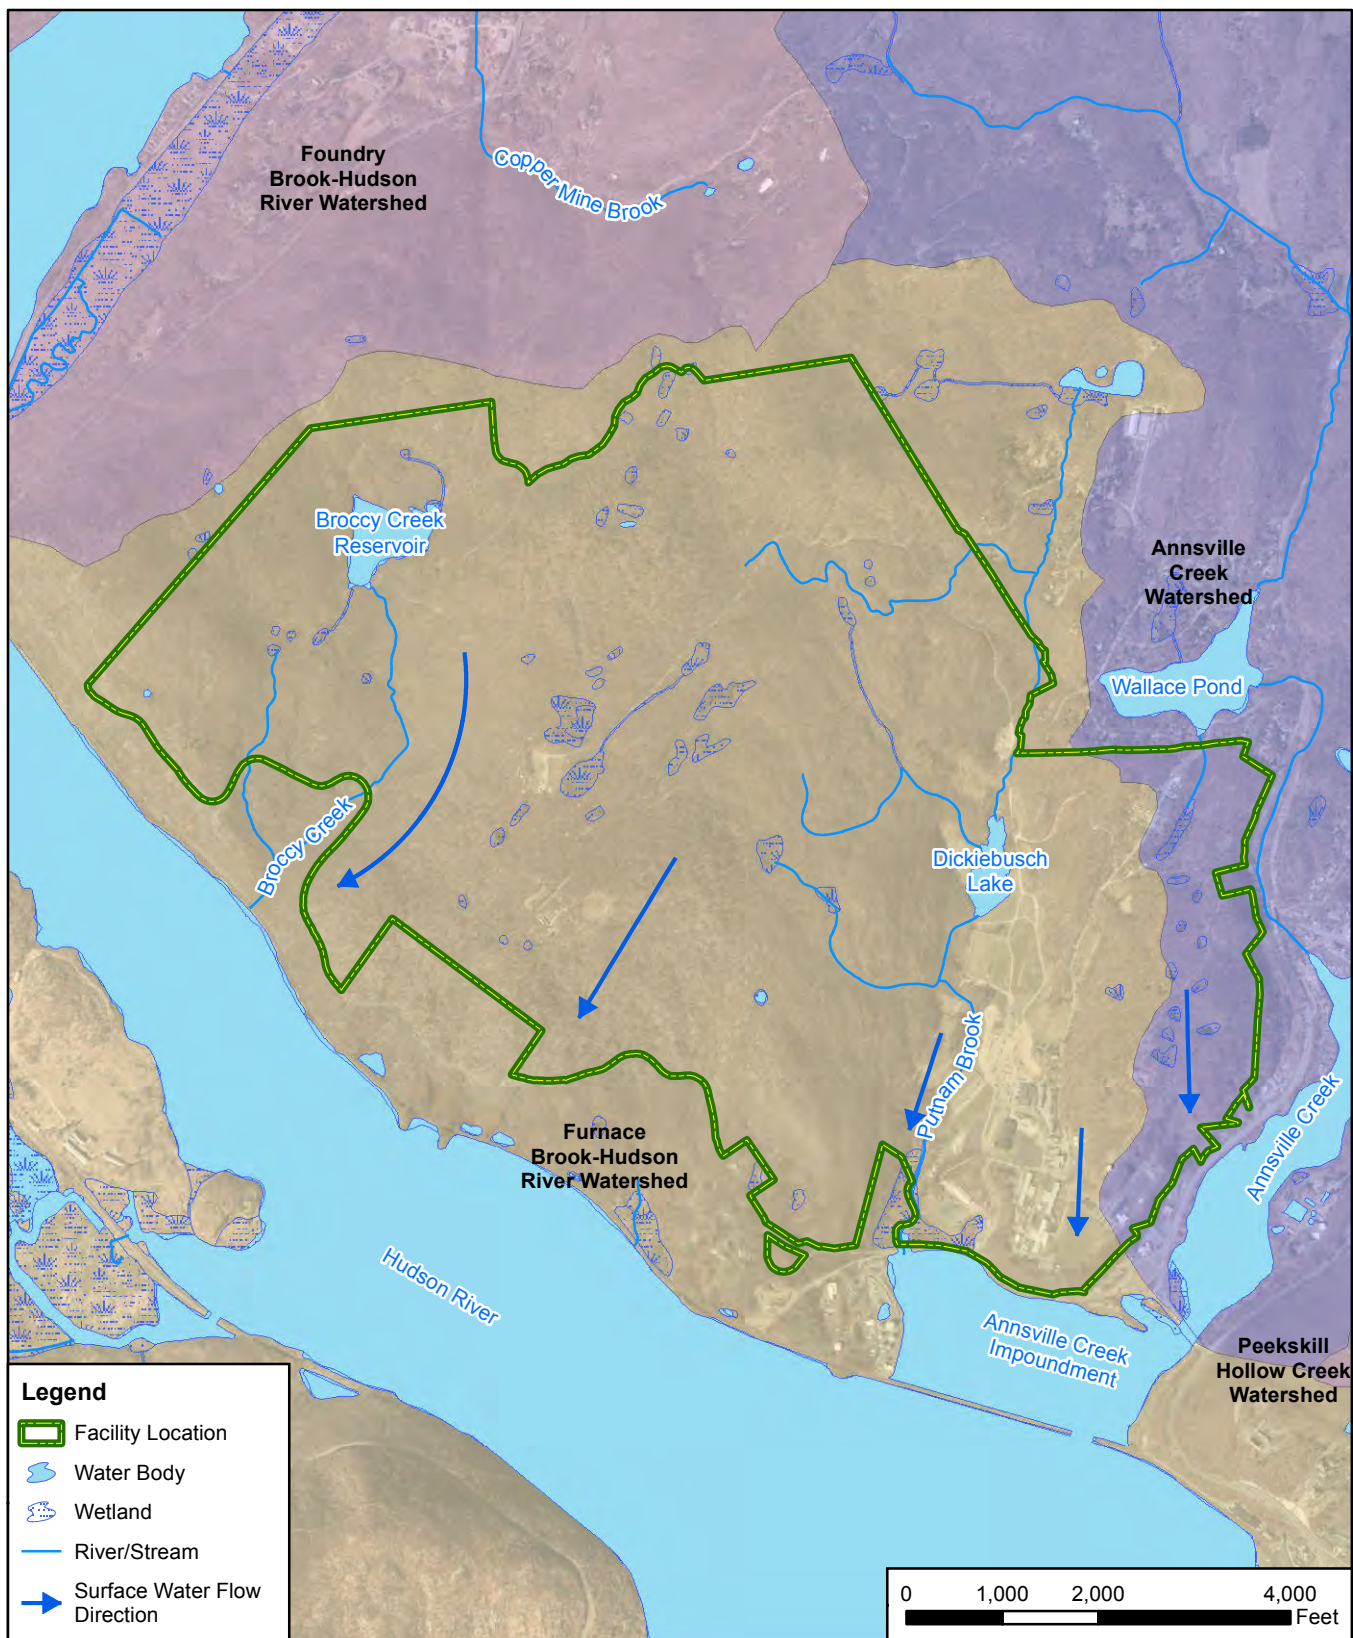
Dickiebusch Lake is on the northeastern end of Camp Smith (**Figure 1-2** and **1-3**). Dickiebusch Lake covers approximately six acres and is connected to several streams, one of which is Putnam Brook. The headwaters of Putnam Brook flow into the northern-most portion of Dickiebusch Lake, which then drains south, bordering Camp Smith on the west, before draining into the Annsville Creek impoundment. Annsville Creek borders Camp Smith on the eastern side of the facility before turning southwest to border the southern portion.

The confluence of the Annsville Creek and Putnam Brook at the Annsville Creek impoundment is tidally influenced, as this impoundment is connected to the Hudson River (**Figure 1-3**). This small bay/impoundment/tidal wetland was artificially created by a railroad berm.

Surface Water Features	
NOTES		Preliminary Assessment for PFAS at Camp Smith, NY					
REVISED	5/6/2019	GIS BY	MS	5/6/2019

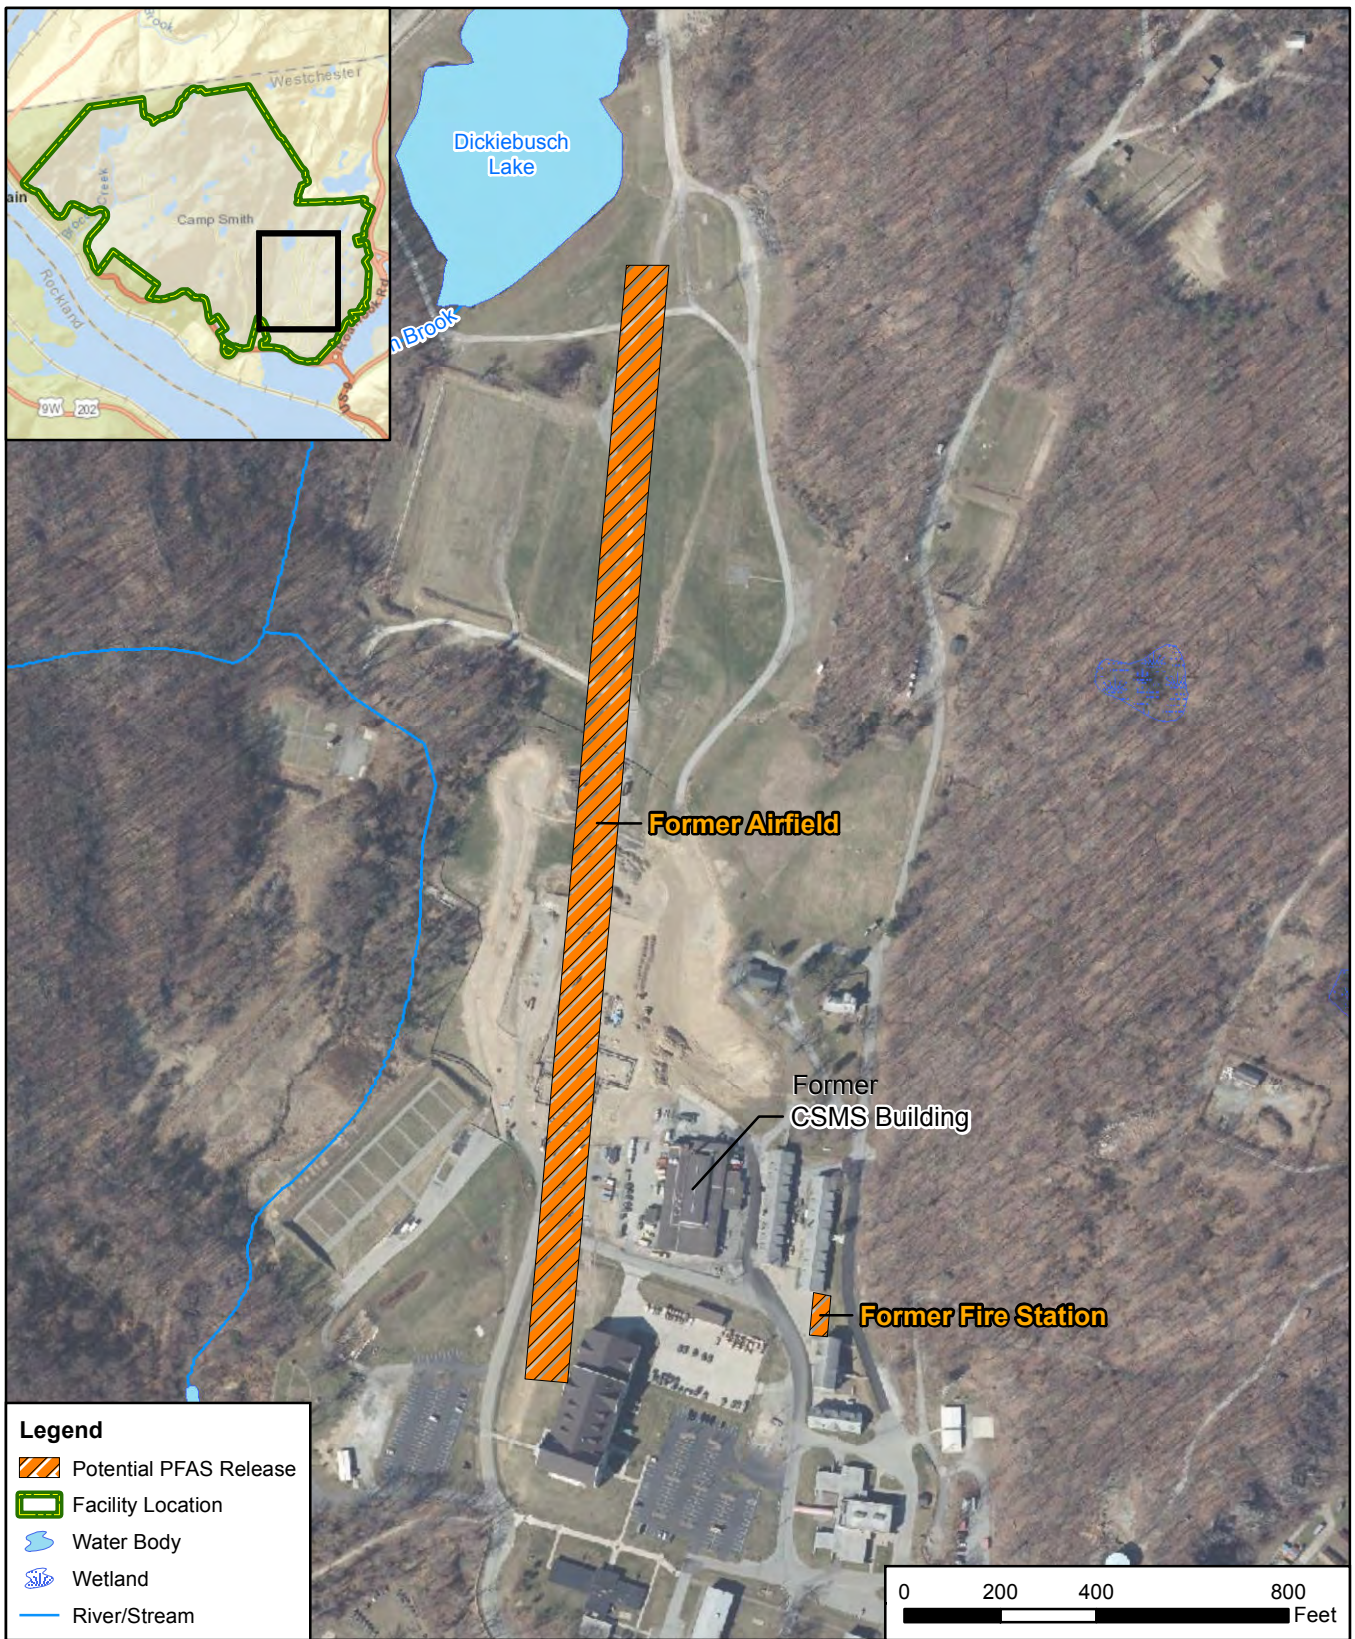
Three non FTAs were identified during the PA. A description of the non-FTAs is presented below, and the non-FTAs' locations are shown on **Figure 3-1**. Interview records appear in **Appendix B**. Photographs of the non-FTAs appear in **Appendix C**.

The Former CSMS building was adjacent to the Former Firehouse from approximately 1976, until a new building was finished in 2018 (**Figure 3-1**). The interviewee stated there were no documents confirming AFFF storage, discharge, or use in the former CSMS building. A 2009 NYARNG Camp Smith Standard Operating Procedure (SOP) mandated that firefighting equipment be stored on-site and ready for use during refueling activities, but no firefighting equipment was observed during the VSI. The SOP was unclear as to what type of firefighting equipment was required. The interviewee also indicated that the CSMS personnel were the first to respond to any minor fire-related incidents that occurred after 1996.

Non-Fire Training Areas	
 12420 Milestone Center Drive Germantown, MD 20876	Figure 3-1

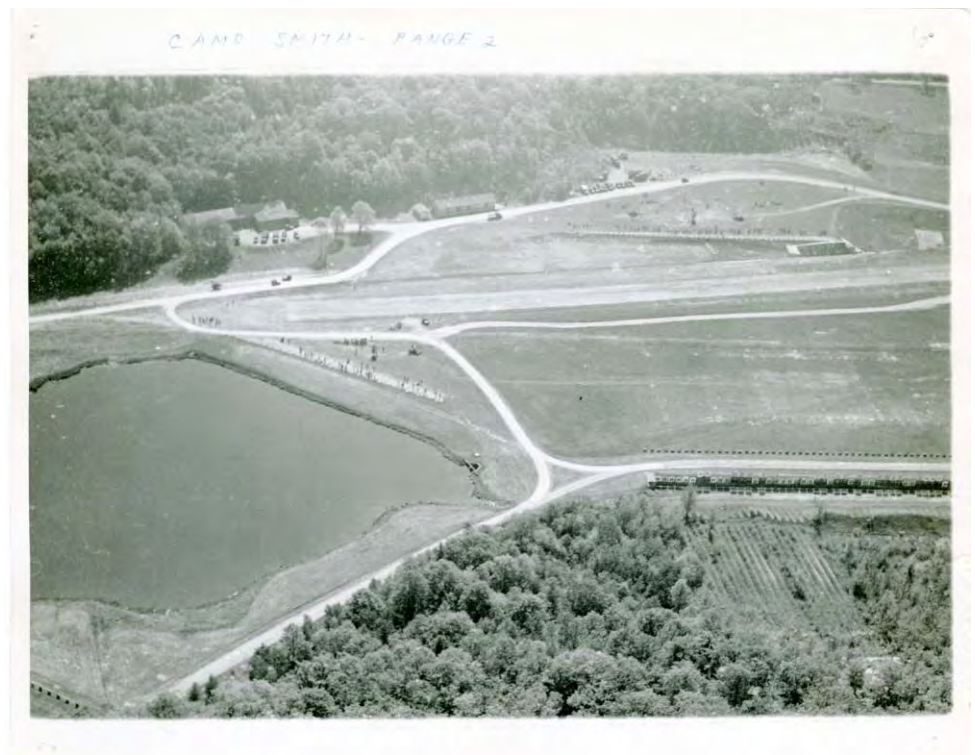
Area:	Air Strip
Location:	Cortlandt, New York
Photo ID:	1
Description: Looking West - View of former Airstrip, Vietnam era - 1960s

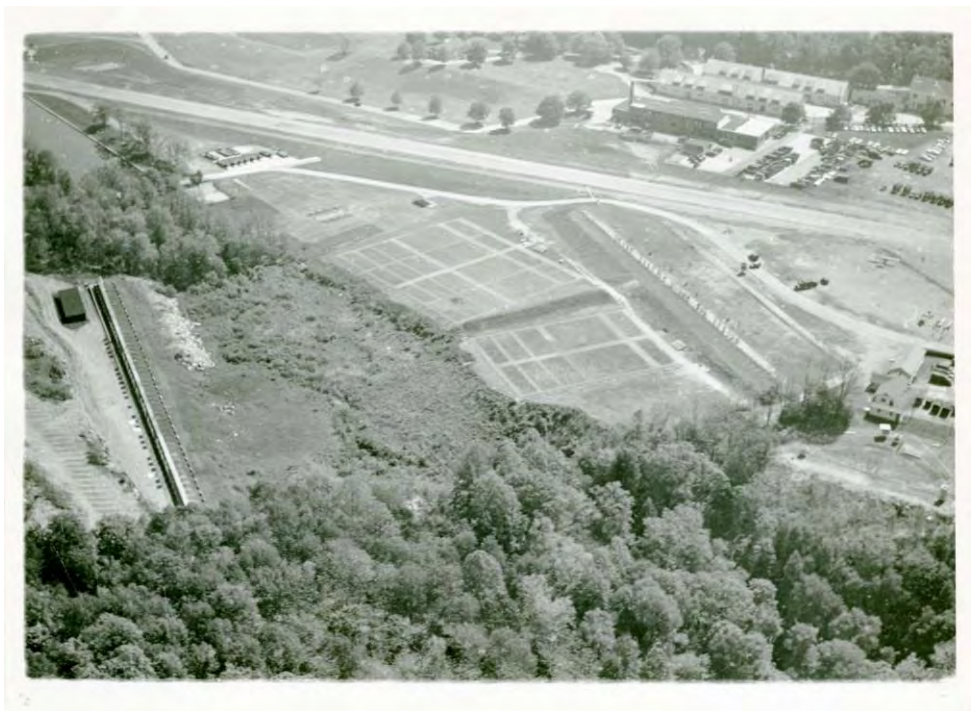
Area:	Air Strip
Location:	Cortlandt, New York
Photo ID:	2
Description: Looking North - View of former Airstrip, Vietnam Era - 1960s

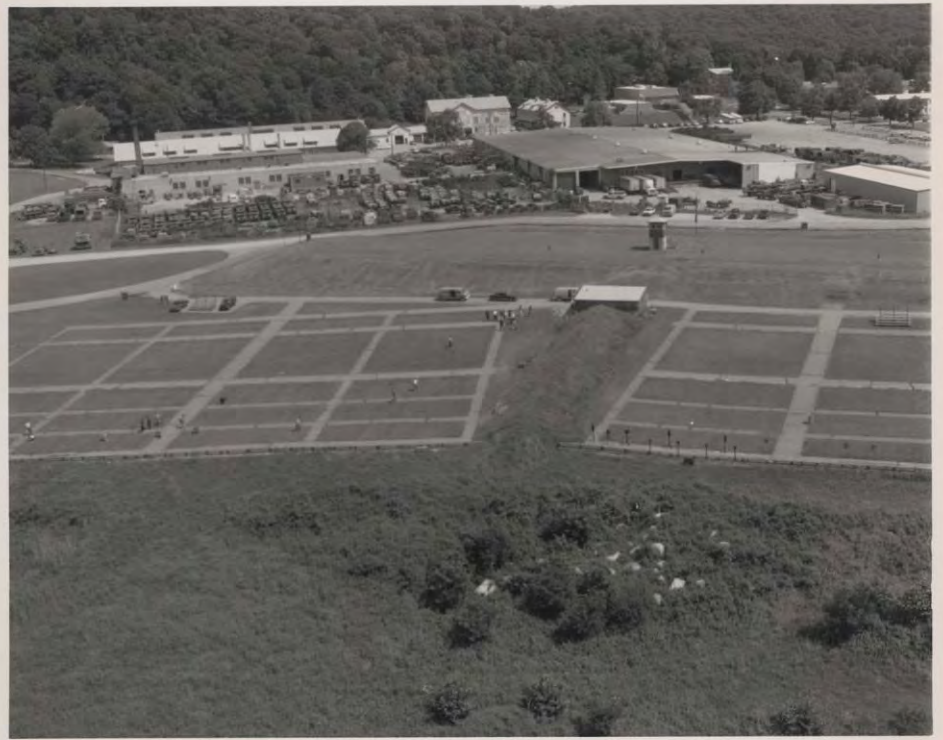
Area:	Former fire house
Location:	Cortlandt, New York
Photo ID:	3
Description: View of former CSMS building (far top left) and former firehouse (adjacent to CSMS on the right)

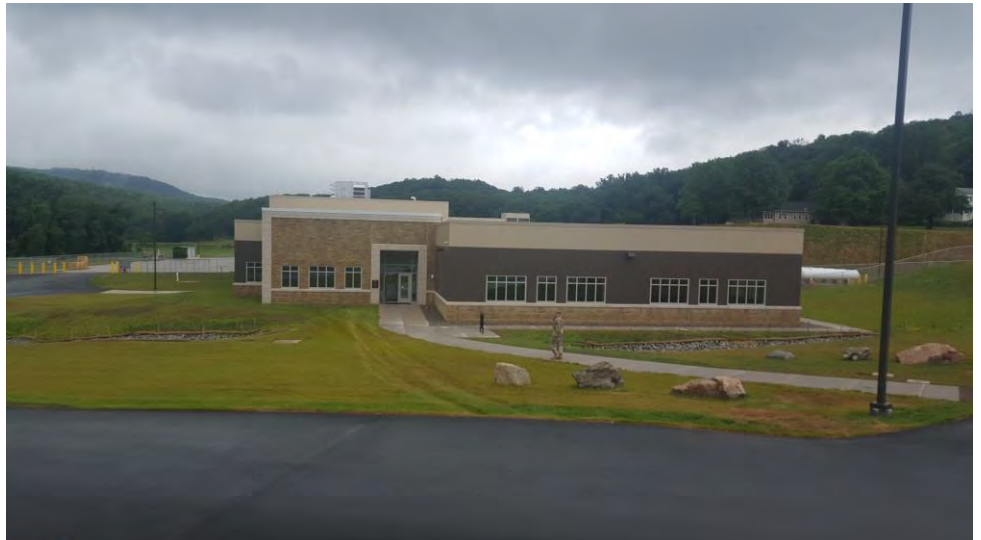
Area:	CSMS
Location:	Cortlandt, New York
Photo ID:	4
Description: Side-view of new CSMS building

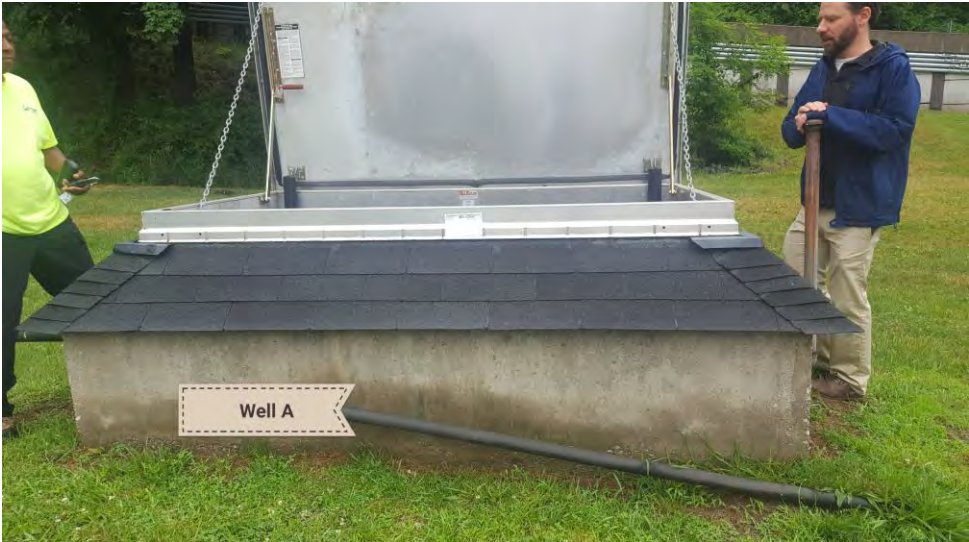
Area: Well A

Location: Cortlandt, New York	
Photo ID: 5	
Description: Well A location, southern portion of Camp Smith
