FINAL Site Inspection Report Camp Smith Training Site Cortlandt, New York

Perfluorooctanesulfonic Acid (PFOS) and
Perfluorooctanoic Acid (PFOA) Impacted Sites
ARNG Installations, Nationwide

June 2022

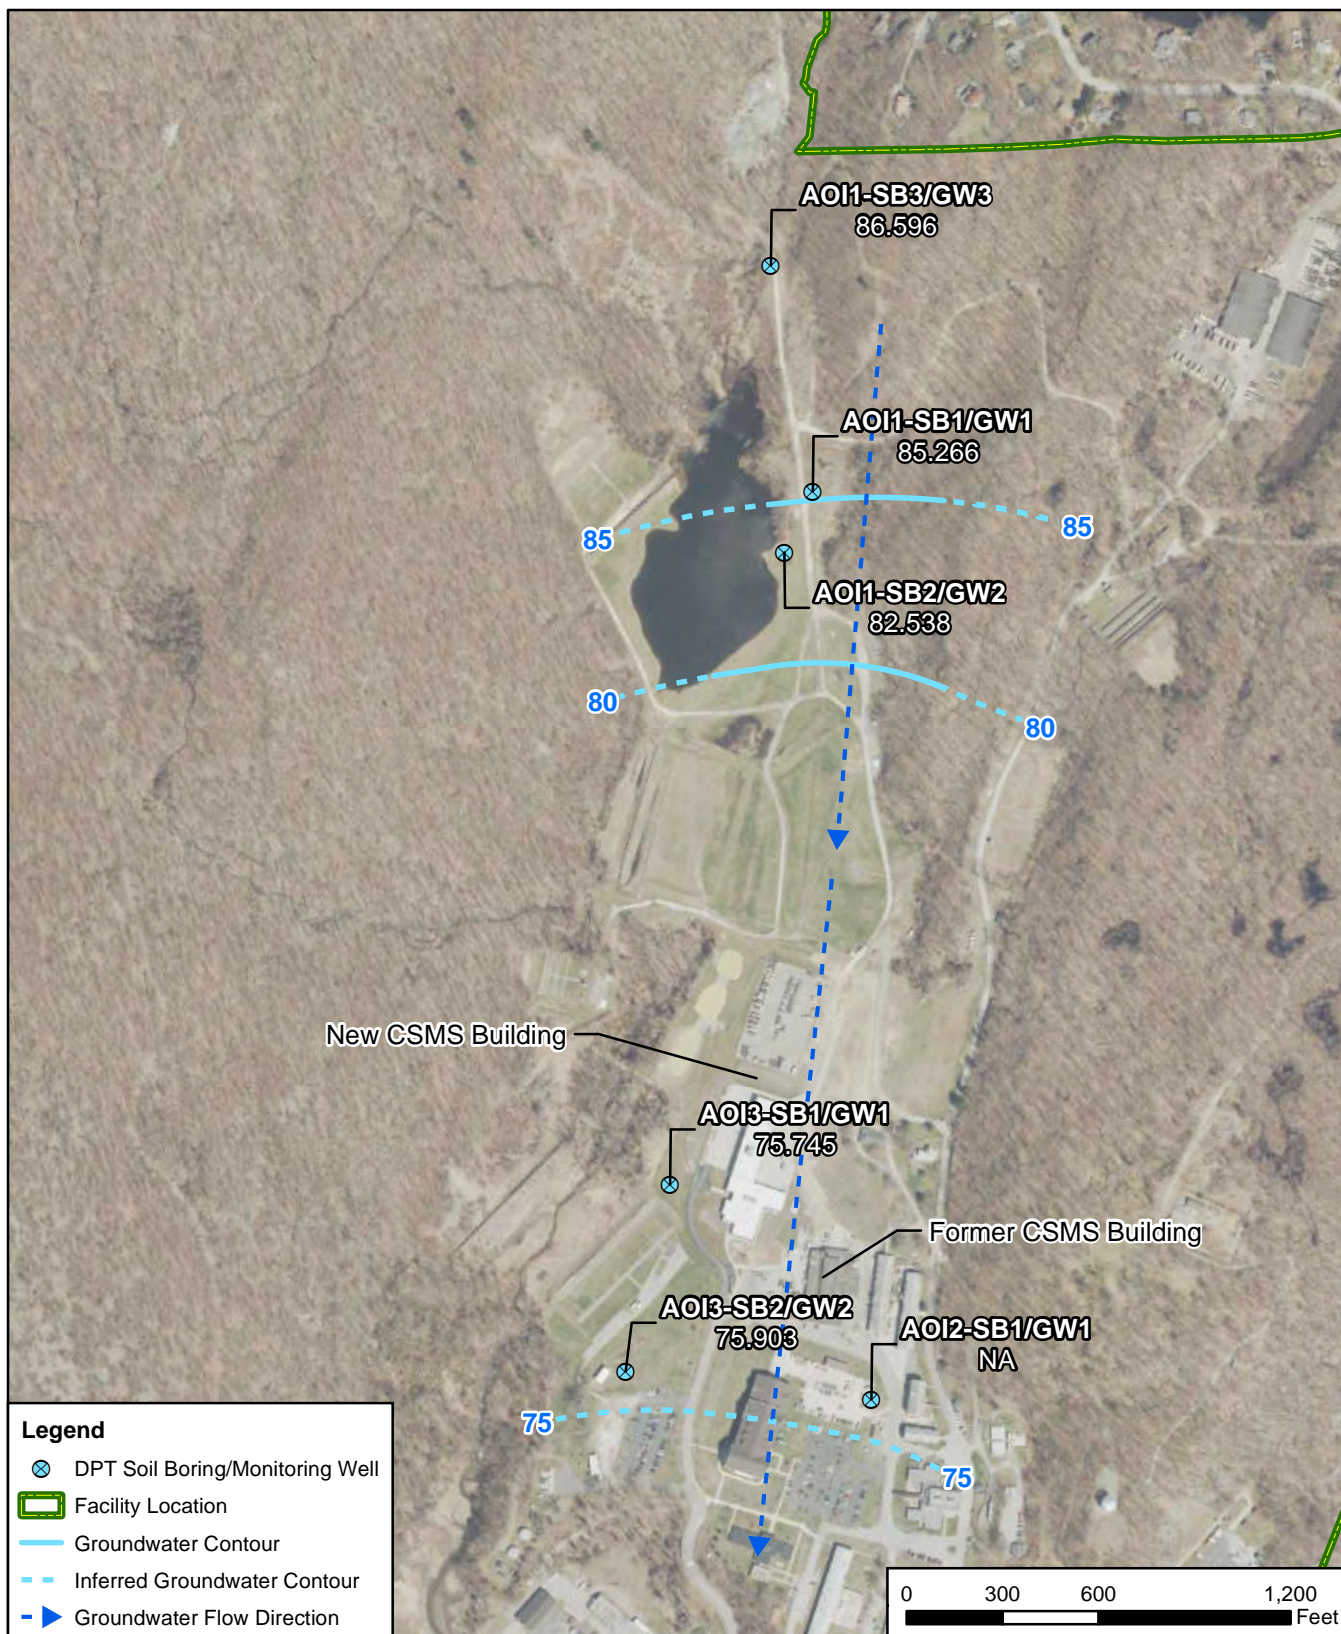
Figure 2-4

Depth to groundwater was observed to range from 0.5 to 22.2 feet bgs in December 2019 during SI Mobilization 1 field activities and 7.19 to 79.76 feet bgs during the July 2021 SI Mobilization 2 field activities. The observed depth to water at CS-MW002D (79.76 feet bgs) is significantly deeper than the other depths to water measured in monitoring wells across the facility. This could be due to semi-confined conditions at depth; however, results from the SI could not confirm. Additional deep borings and monitoring wells would be needed to evaluate the hydrogeology of the facility further. The Groundwater contour maps from Mobilization 1 and 2 are provided in **Figure 2-4** and **Figure 2-5**.
