# FINAL Site Inspection Report Morrisville Army Aviation Support Facility #1, North Carolina

Site Inspection for Perfluorooctanoic acid (PFOA),  
Perfluorooctanesulfonic acid (PFOS), Perfluorohexanesulfonic  
acid (PFHxS), Perfluorononanoic acid (PFNA),  
Hexafluoropropylene oxide dimer acid (HFPO-DA), and  
Perfluorobutanesulfonic acid (PFBS) at ARNG Installations,  
Nationwide

August 2023

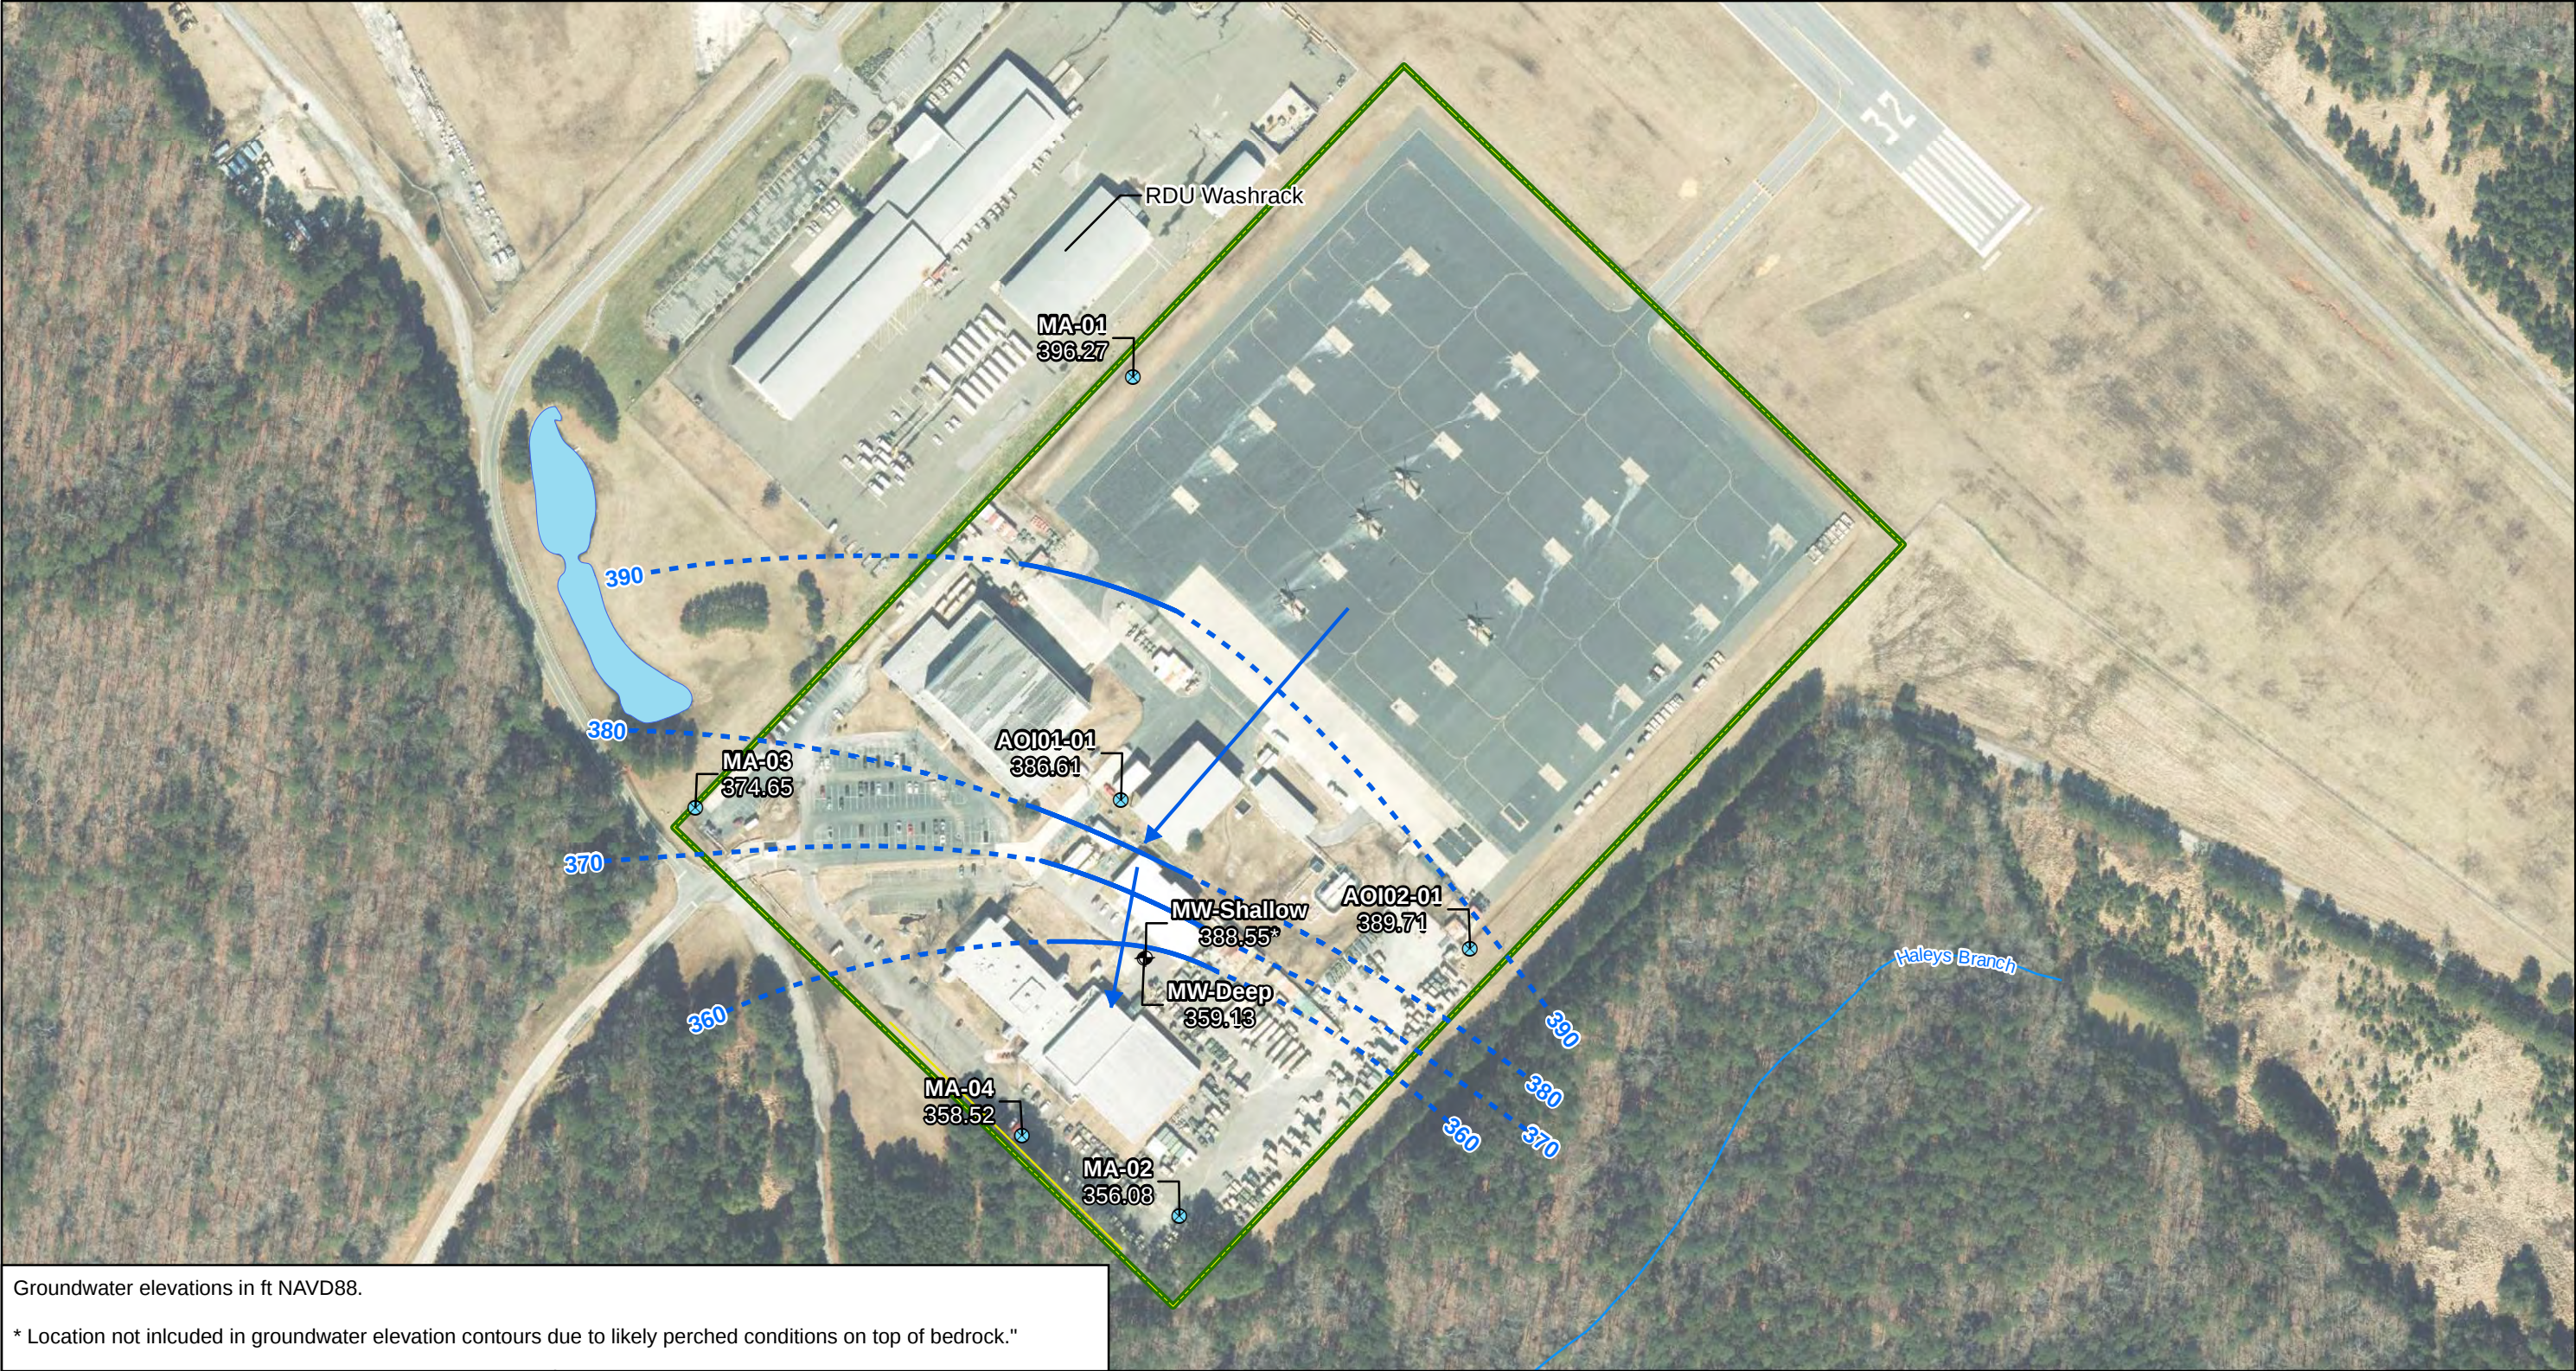
Groundwater elevations in ft NAVD88.

\* Location not included in groundwater elevation contours due to likely perched conditions on top of bedrock."
