## Site Inspection Report

### Bismarck Army Aviation Support Facility #1

### Bismarck, North Dakota

Site Inspection for Perfluorooctanoic Acid (PFOA), Perfluorooctanesulfonic Acid (PFOS), Perfluorohexanesulfonic Acid (PFHxS), Perfluorononanoic Acid (PFNA), Hexafluoropropylene Oxide Dimer Acid (HFPO-DA), and Perfluorobutanesulfonic Acid (PFBS)  
ARNG Installations, Nationwide

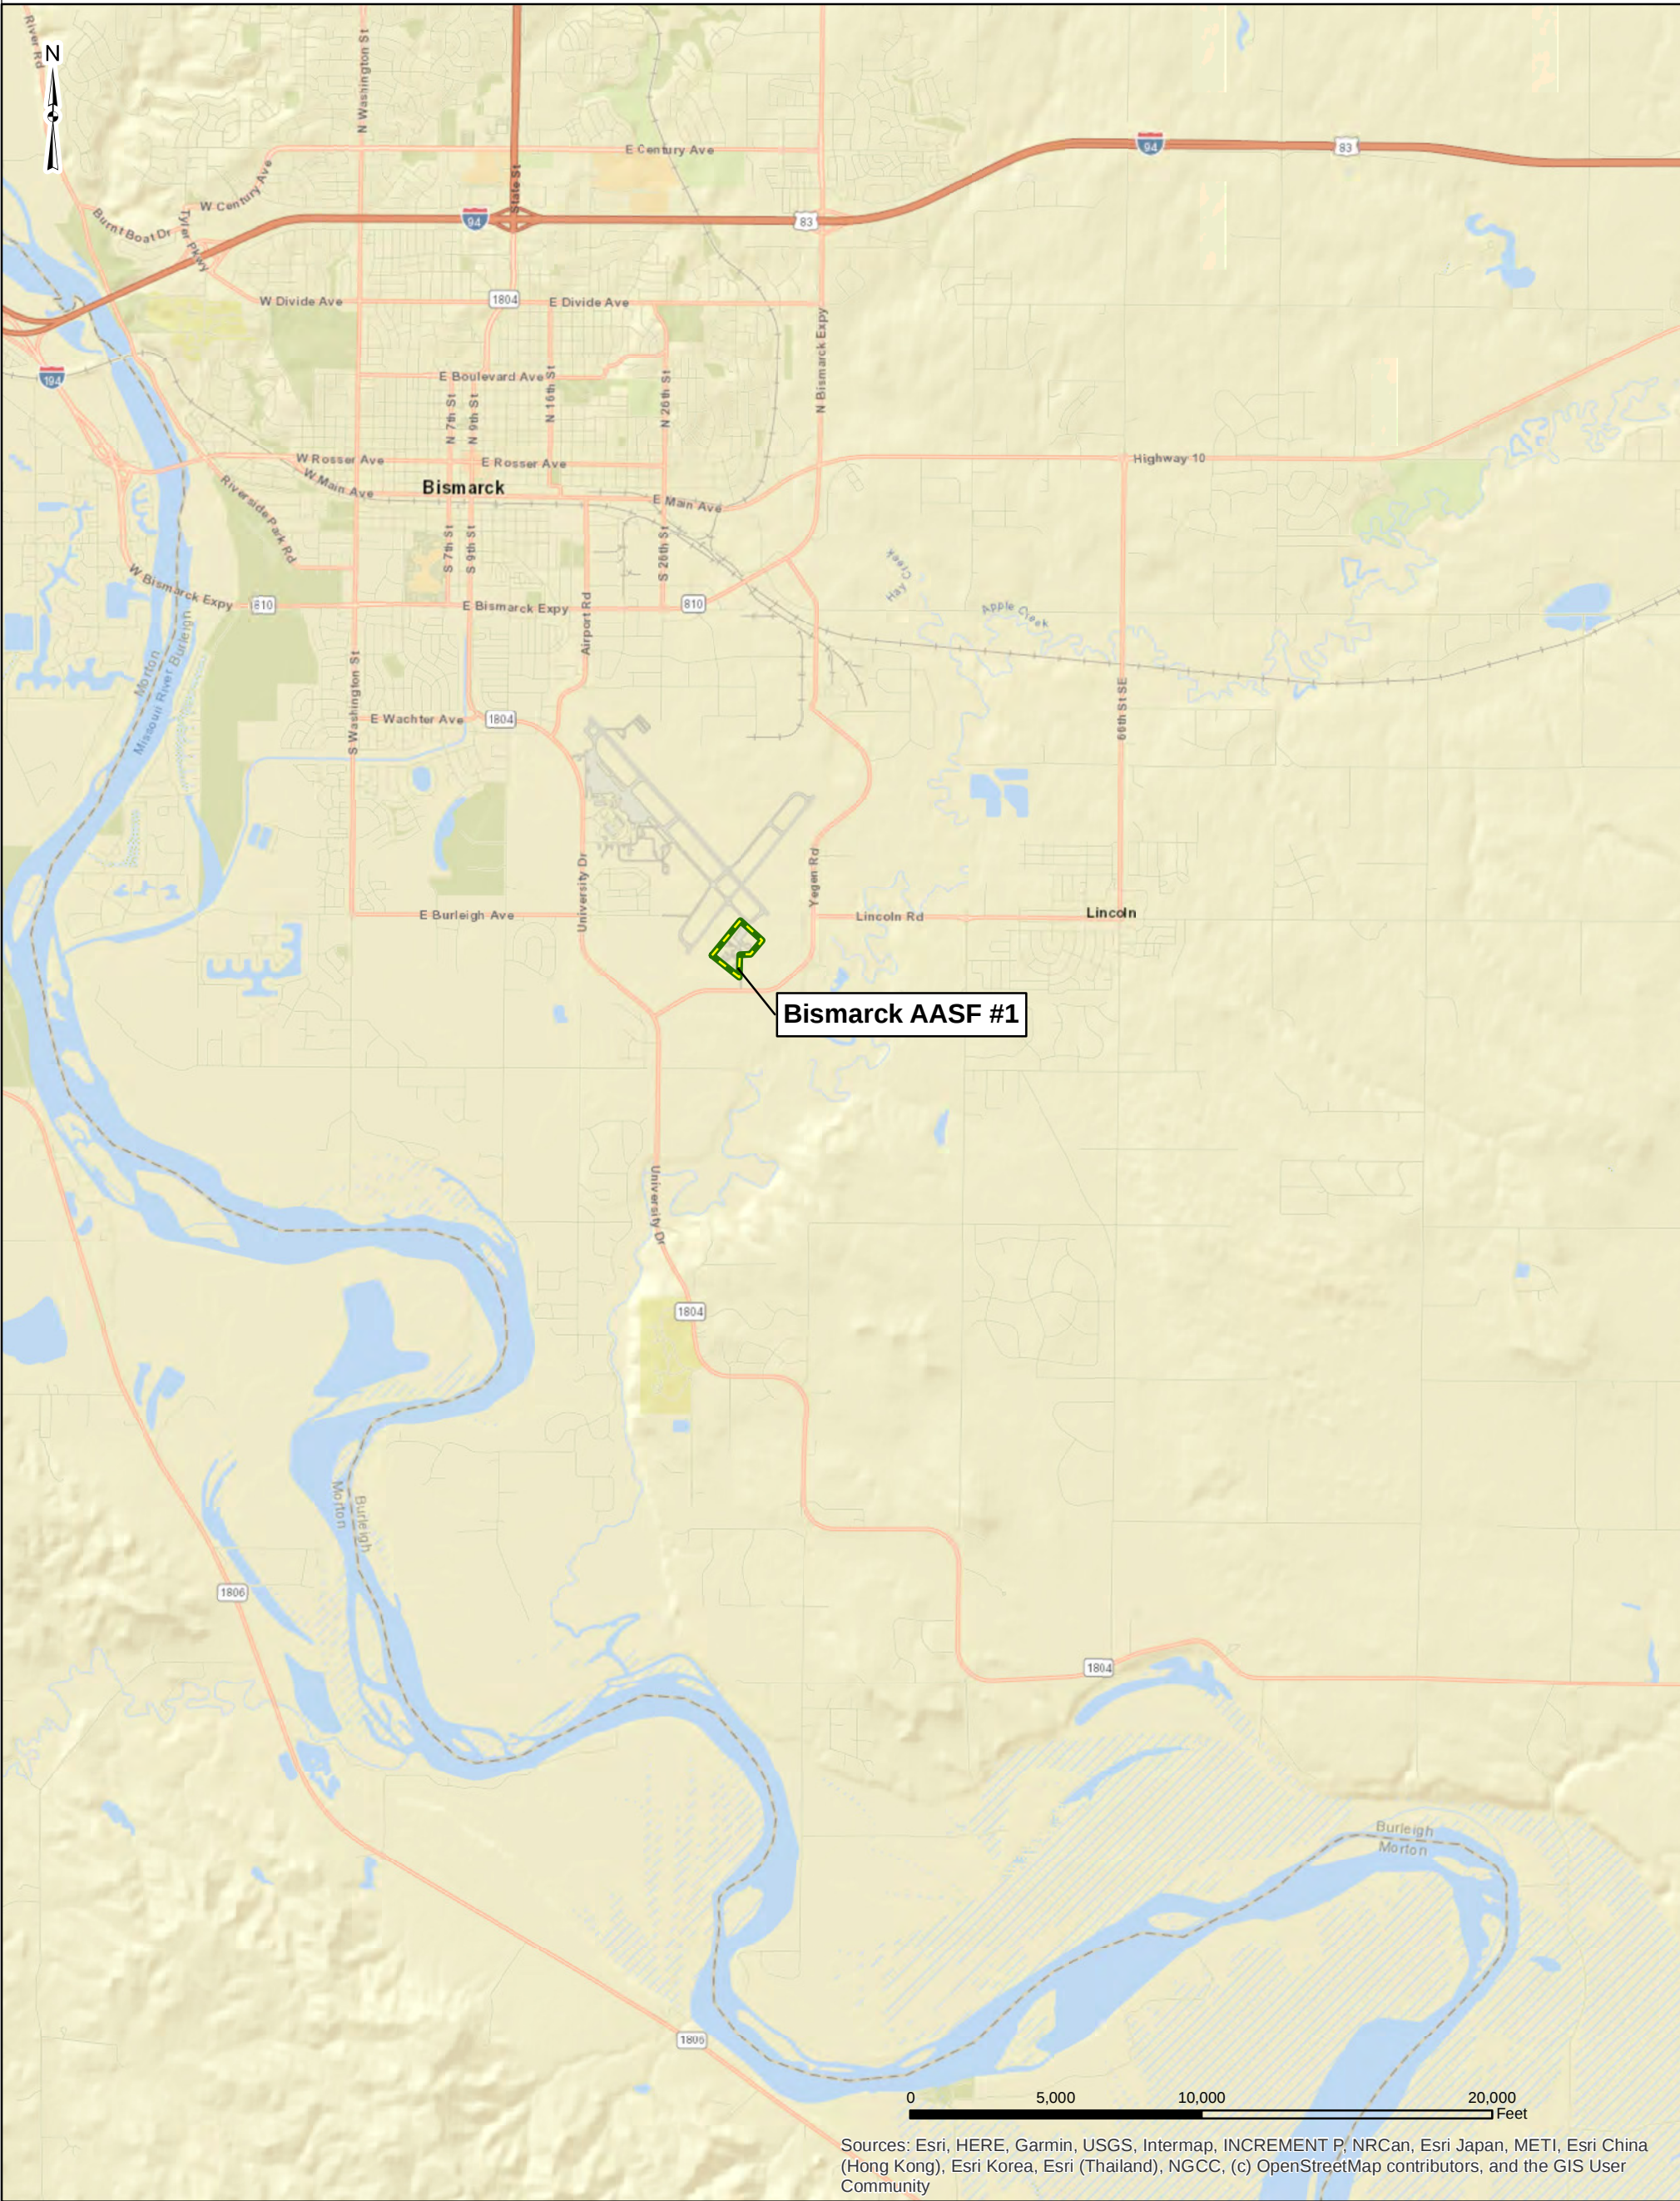
Figure 2-1

The Facility is in Burleigh County, approximately three miles south of Bismarck, North Dakota and located on the Bismarck Municipal Airport property (**Figure 2-1**). The Facility is accessible from Yegen Road from the south off of Airway Avenue. The Facility is constructed on a parcel of land that has been leased and operated by the North Dakota Army National Guard (NDARNG) since 1996. The Facility comprises approximately 33.65 acres of land owned by the City of Bismarck. The term of the lease began in 1996 with a 50-year duration (AECOM, 2020).

Facility Location

The scope of the SI was bounded horizontally by the property limits of the Facility (**Figures 2-1 and 2-2**). Off-facility sampling was not included in the scope of this SI. If future off-facility sampling is required, the proper stakeholders will be notified, and necessary rights of entry will be obtained by ARNG with property owner(s). The scope of the SI was vertically bounded as follows: groundwater (11 ft bgs) and soil from direct-push technology (DPT) borings (15 ft bgs). Temporal boundaries were limited to the earliest available time field resources were available to complete the study.

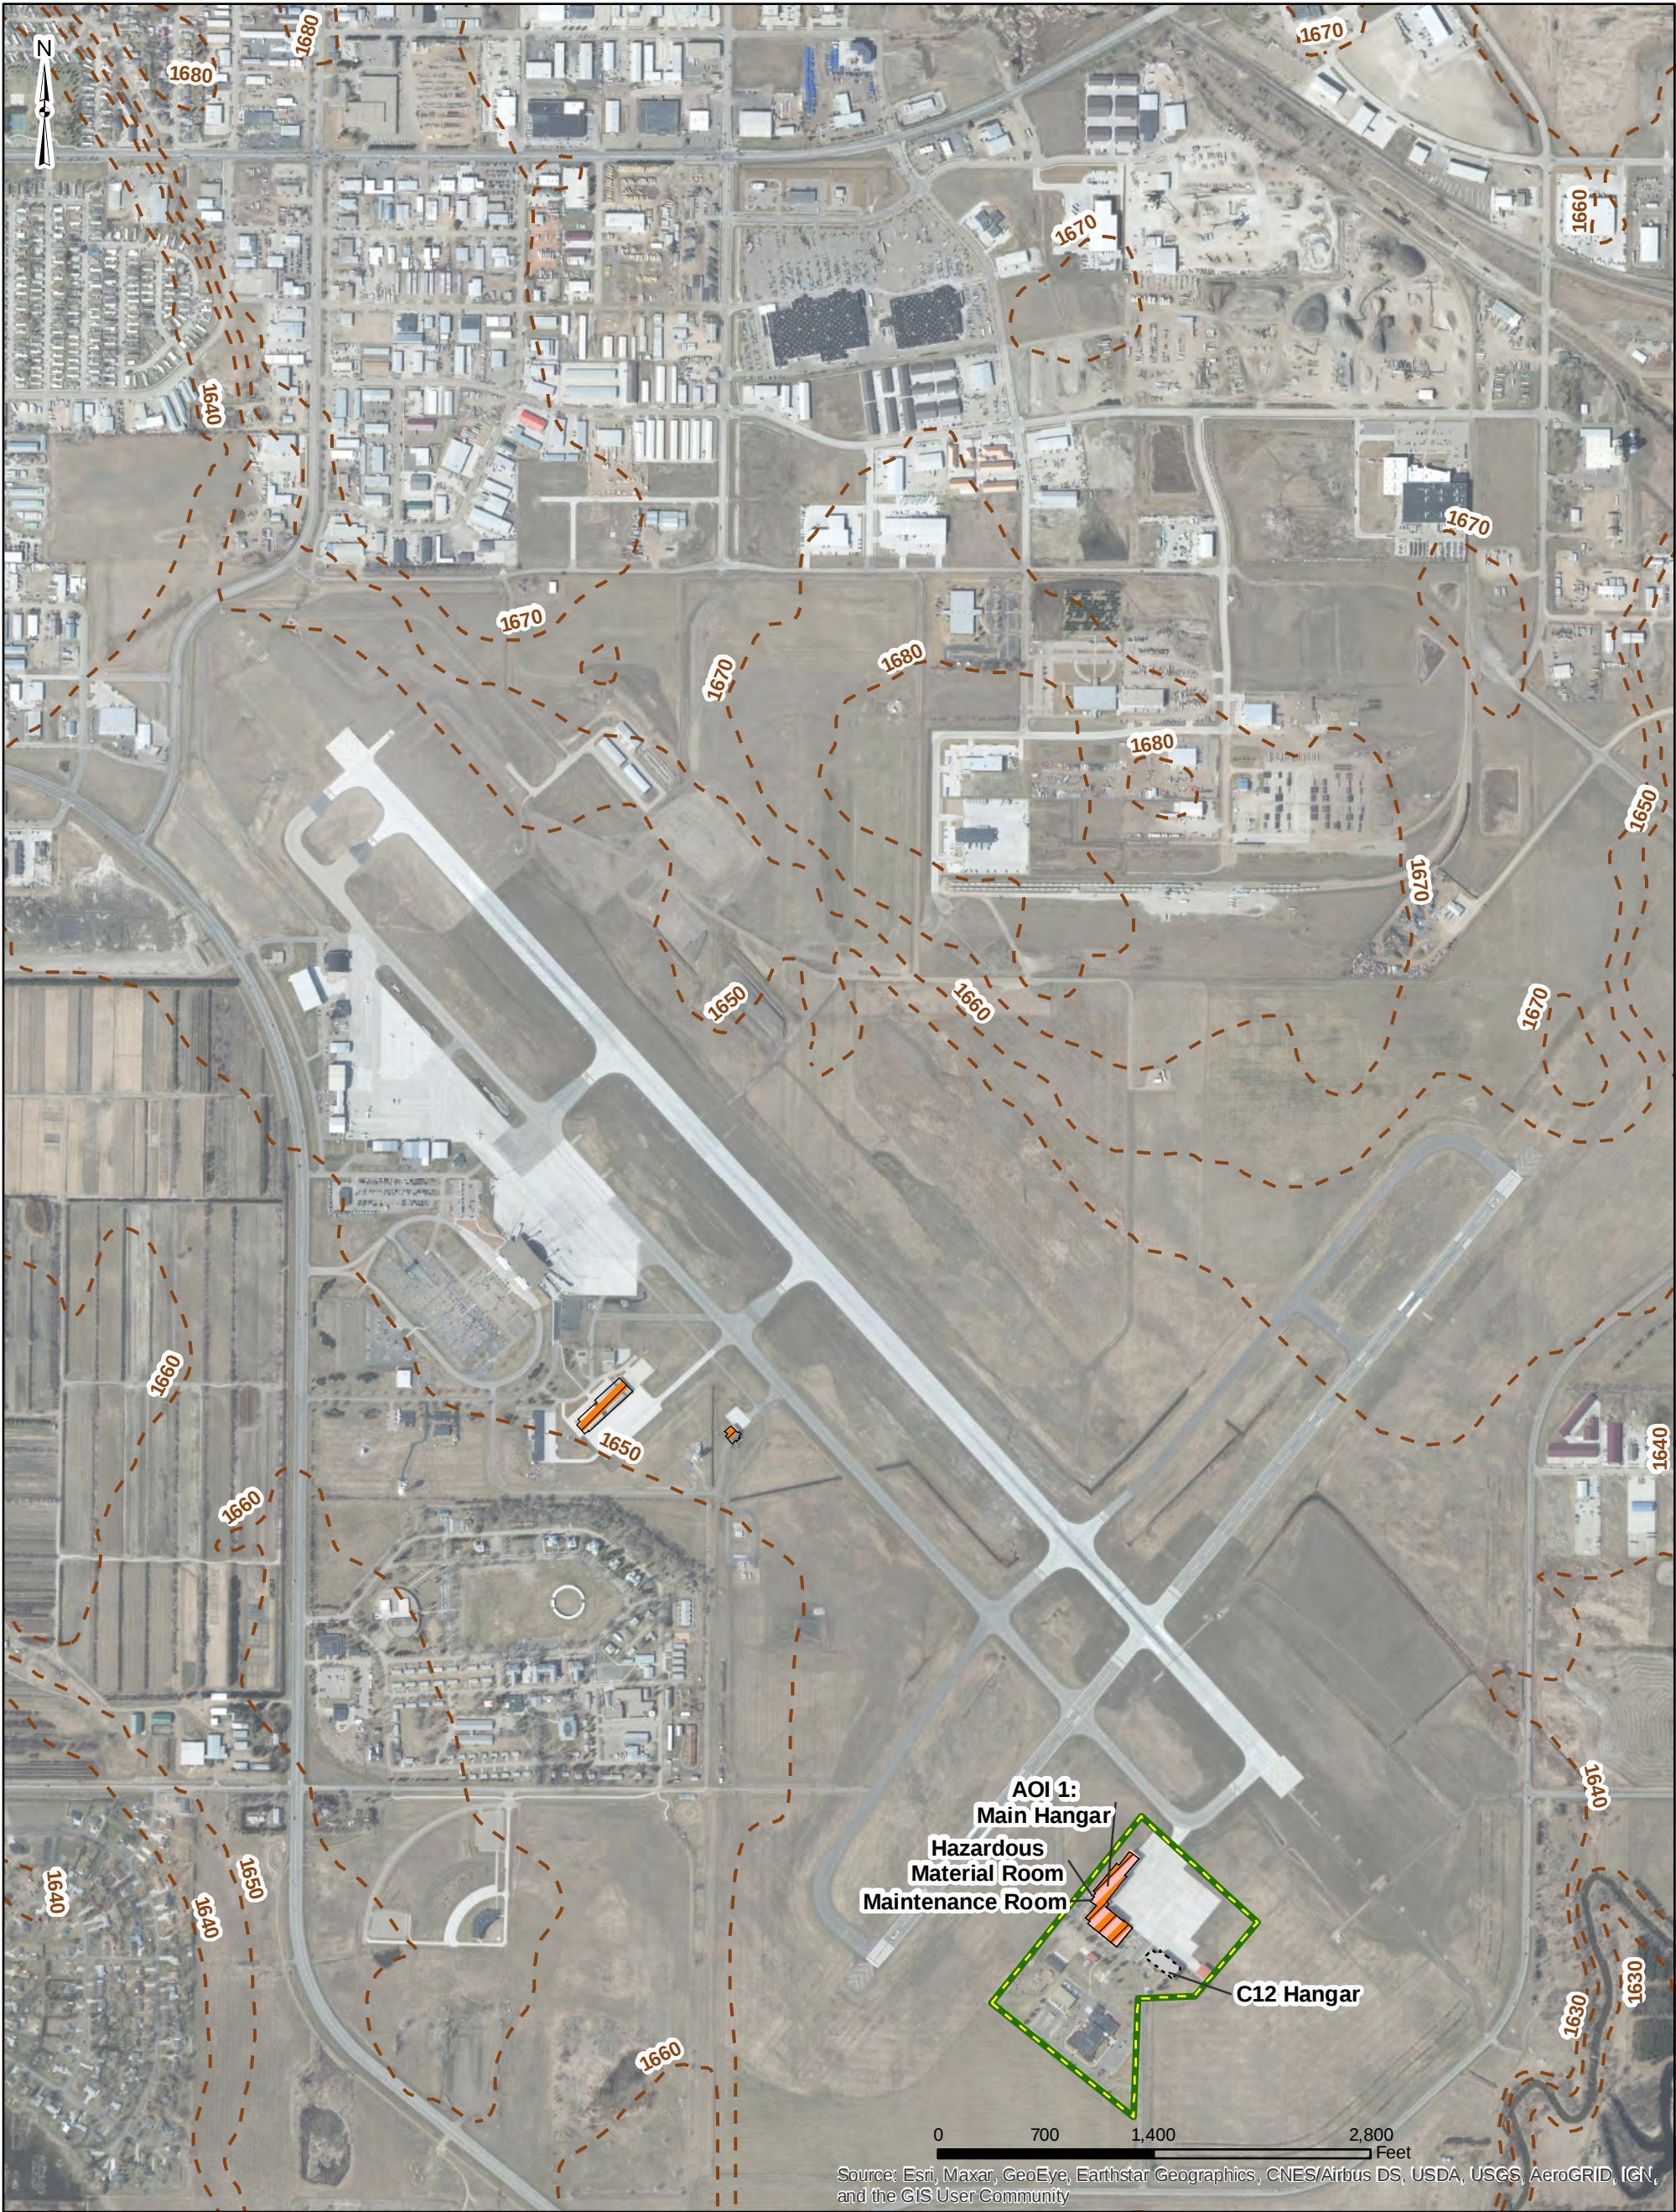
Figure 2-2  
Facility Topography

The following sections include information on geology, hydrogeology, hydrology, climate, and current and future land use. The topography at the Facility is shown on **Figure 2-2**. The regional geology and groundwater features are shown on **Figure 2-3**. The regional surface water features and drainage basins are shown on **Figure 2-4**. Groundwater elevations and contours are presented on **Figure 2-5**.

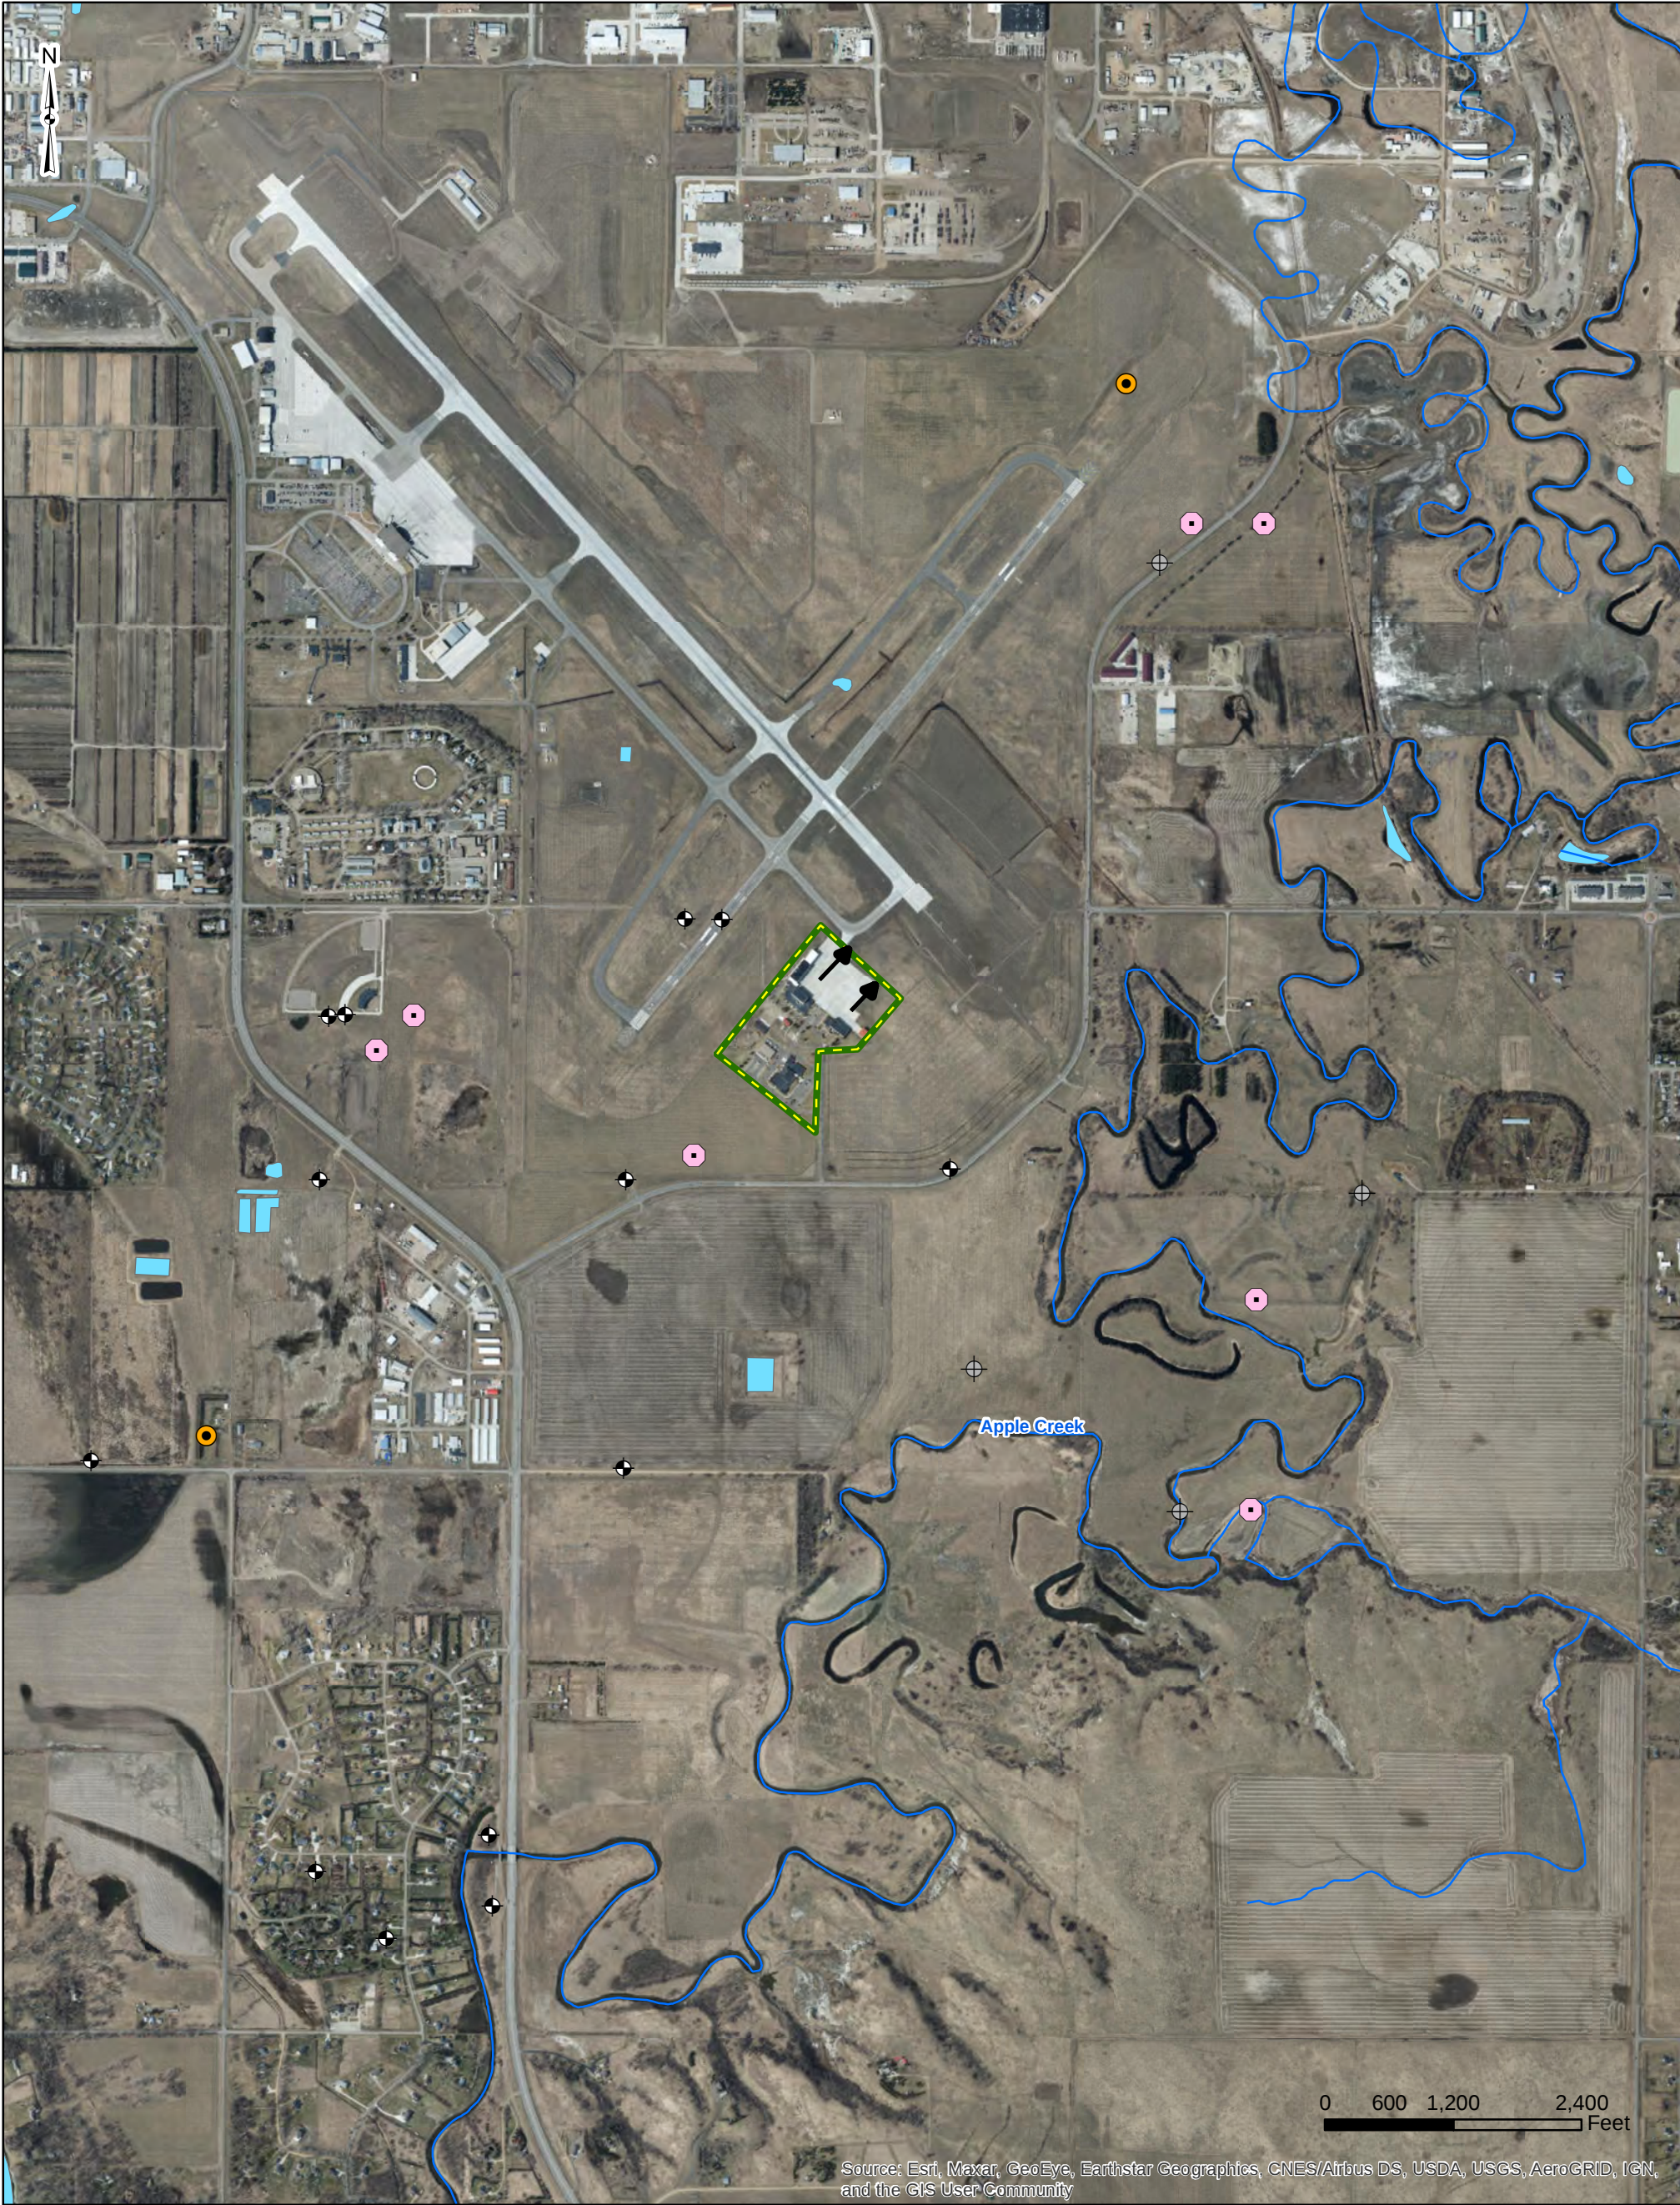
Figure 2-3  
Groundwater Features

As part of the PA, a search of available environmental records was conducted by Environmental Data Resources, Inc. (EDR™), which included a well search within a one-mile radius surrounding the Facility. Additionally, online resources, such as state and local Geographic Information Systems (GIS) databases were used to expand the well search to a four-mile radius around the Facility. No potable water wells are located within the boundary of the AASF. Two domestic, seven irrigation, 13 monitoring, and four wells of unknown use are located within a two-mile radius of the Facility (AECOM, 2020). The regional groundwater flow direction within the surficial aquifer was inferred to be easterly based on the location of surficial water bodies, namely Apple Creek located east of the facility. From a review of the North Dakota Department of Water Resources MapServices there are four wells (one domestic well, two irrigation wells, and an unknown well) that are within approximately one mile of the facility and potentially downgradient (**Figure 2-3**). According to the North Dakota Department of Water Resources MapServices, the domestic well is screened from 0 to 163 ft bgs, one irrigation well is screened from 77 to 87 ft bgs, the second irrigation well is screened from 0 to 81 ft bgs, and the unknown well is screened from 0 to 87 ft bgs (North Dakota, 2022). All other wells located within a two-mile radius of the Facility are located upgradient and cross-gradient of the Facility.

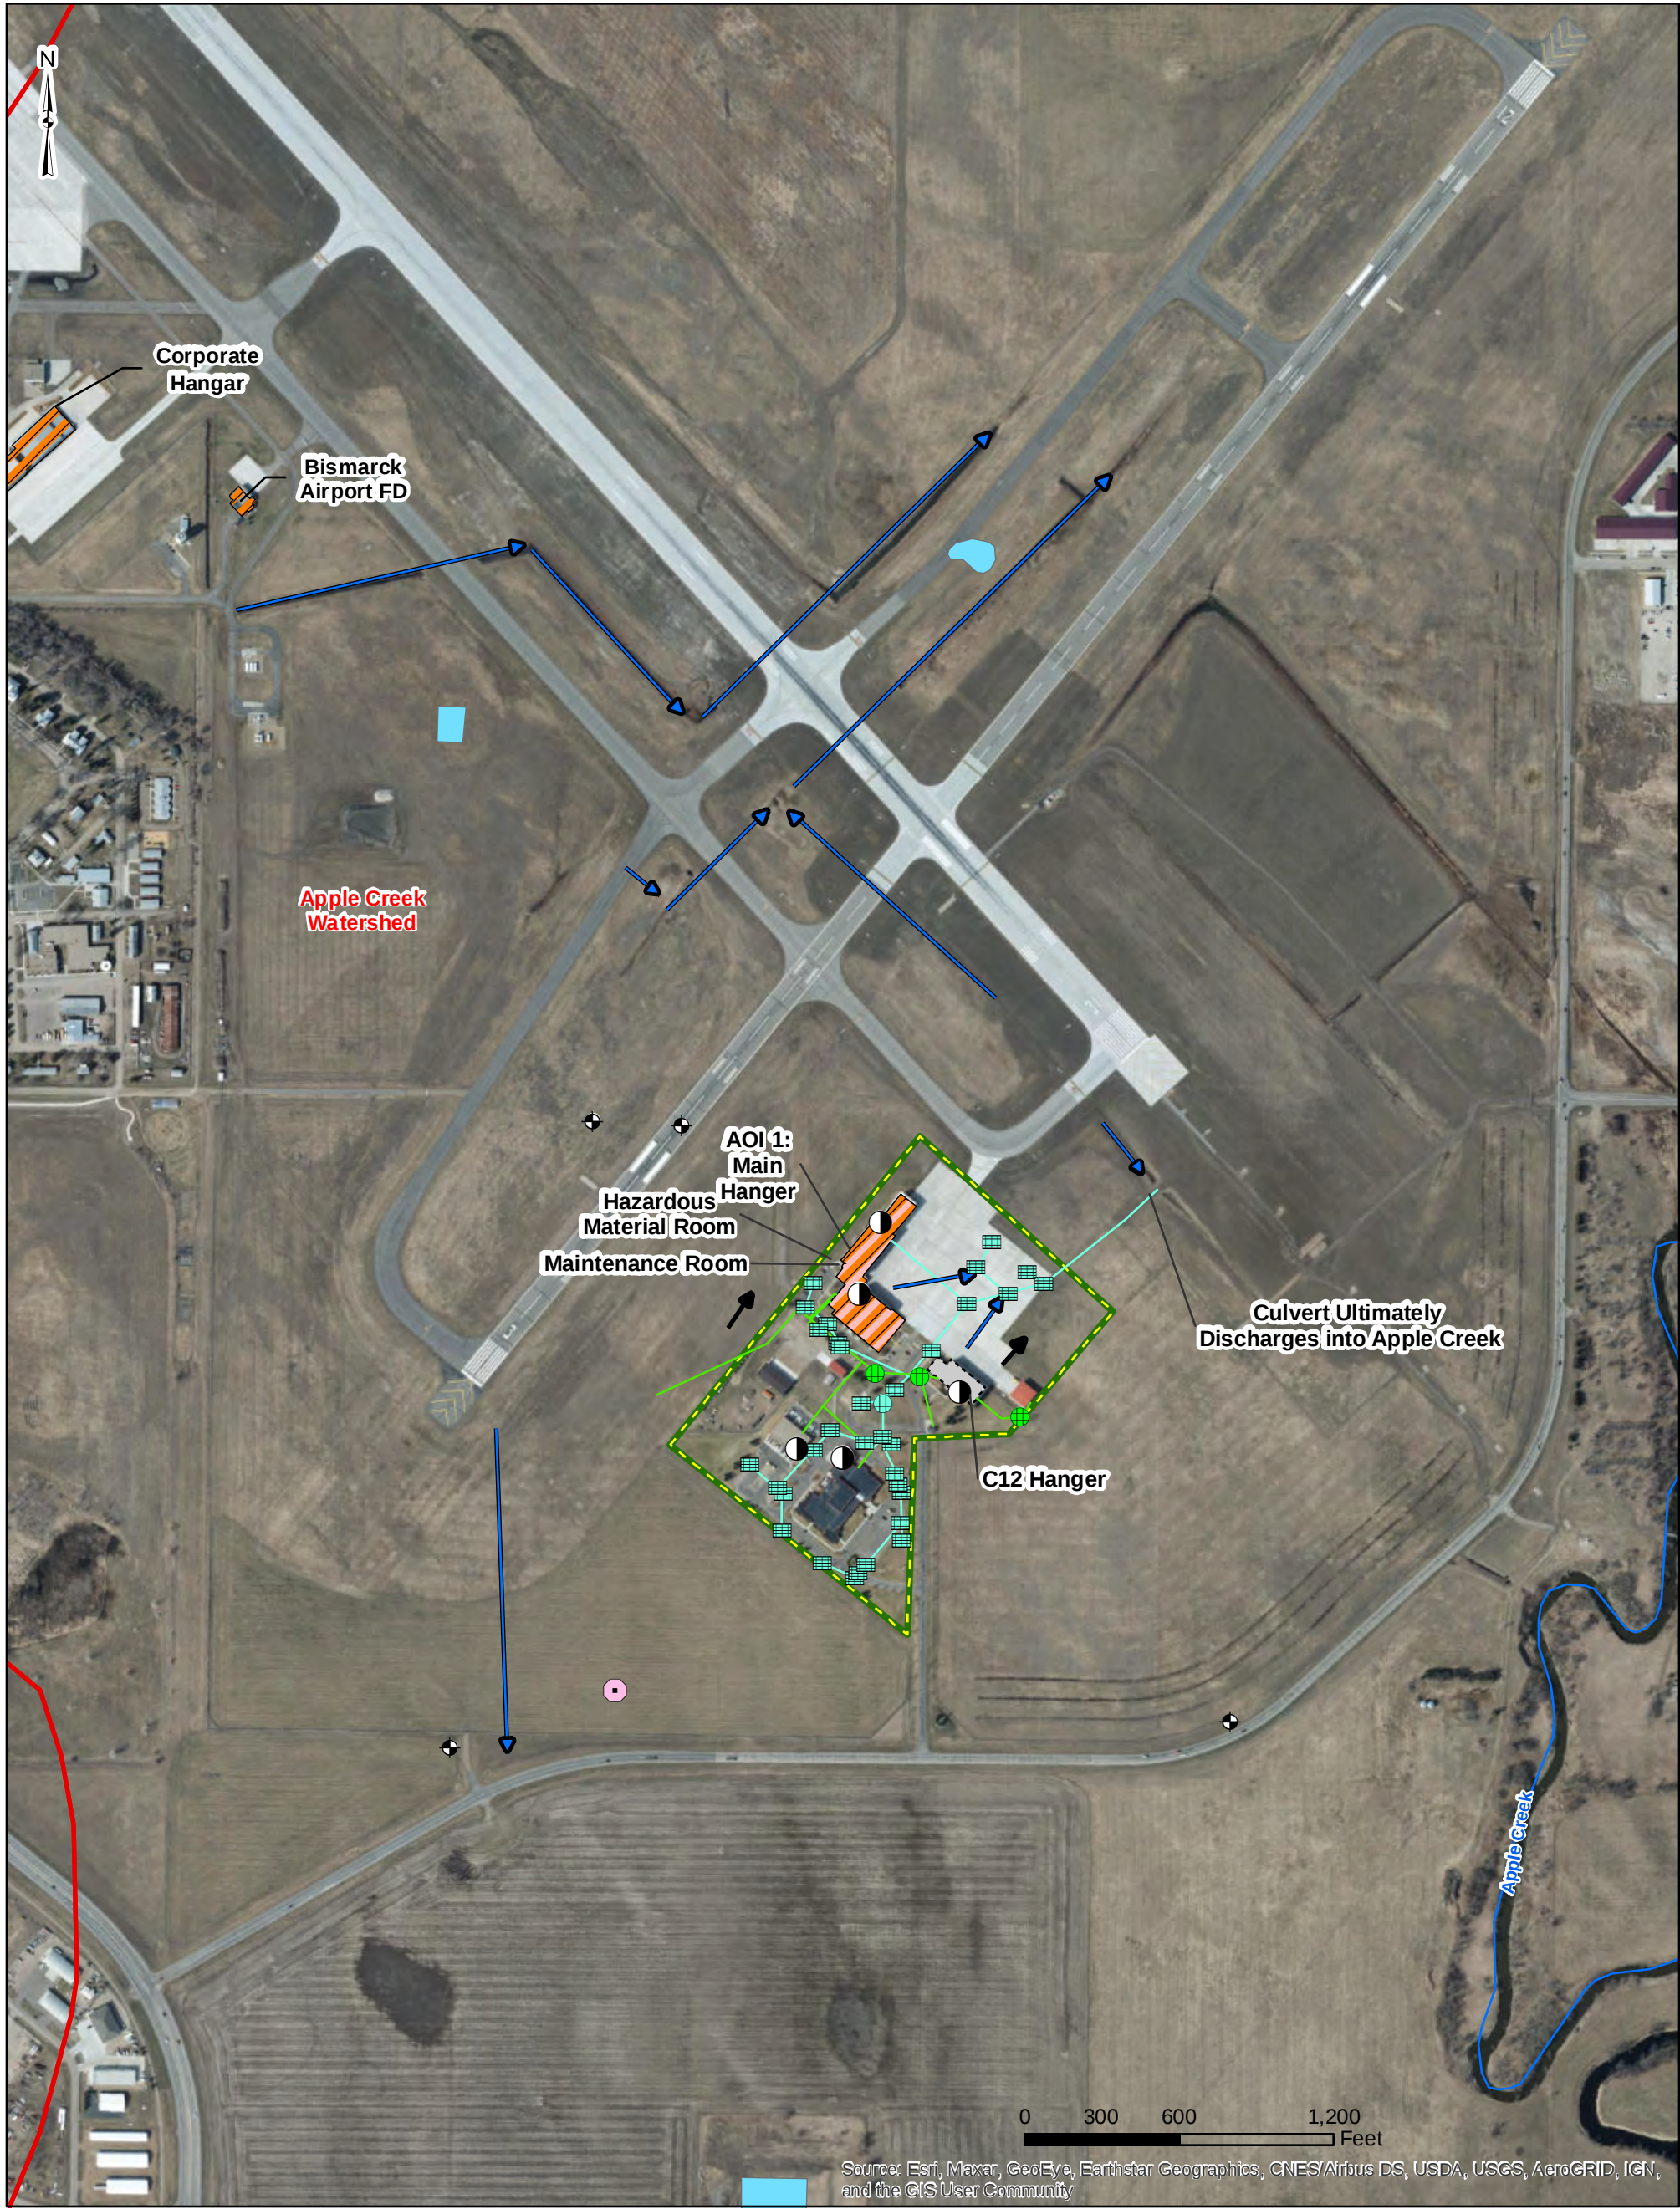
Figure 2-4  
Surface Water Features

The Facility is located just to the east of the Missouri River, within the drainage basin of Apple Creek, which is part of the Missouri River Basin. Apple Creek is located approximately 0.5 miles to the east of the Facility, which flows to the south and discharges to the Missouri River. The Facility is connected to the Bismarck City Sewer System which leads to the Bismarck City wastewater treatment plant. At the Facility, surface runoff flows toward the catch basins located throughout the Facility (**Figure 2-4**). Surface runoff at the Facility exits to the northeast and enters the shared airport stormwater system and then ultimately discharges into Apple Creek located east of the Facility (AECOM, 2020).

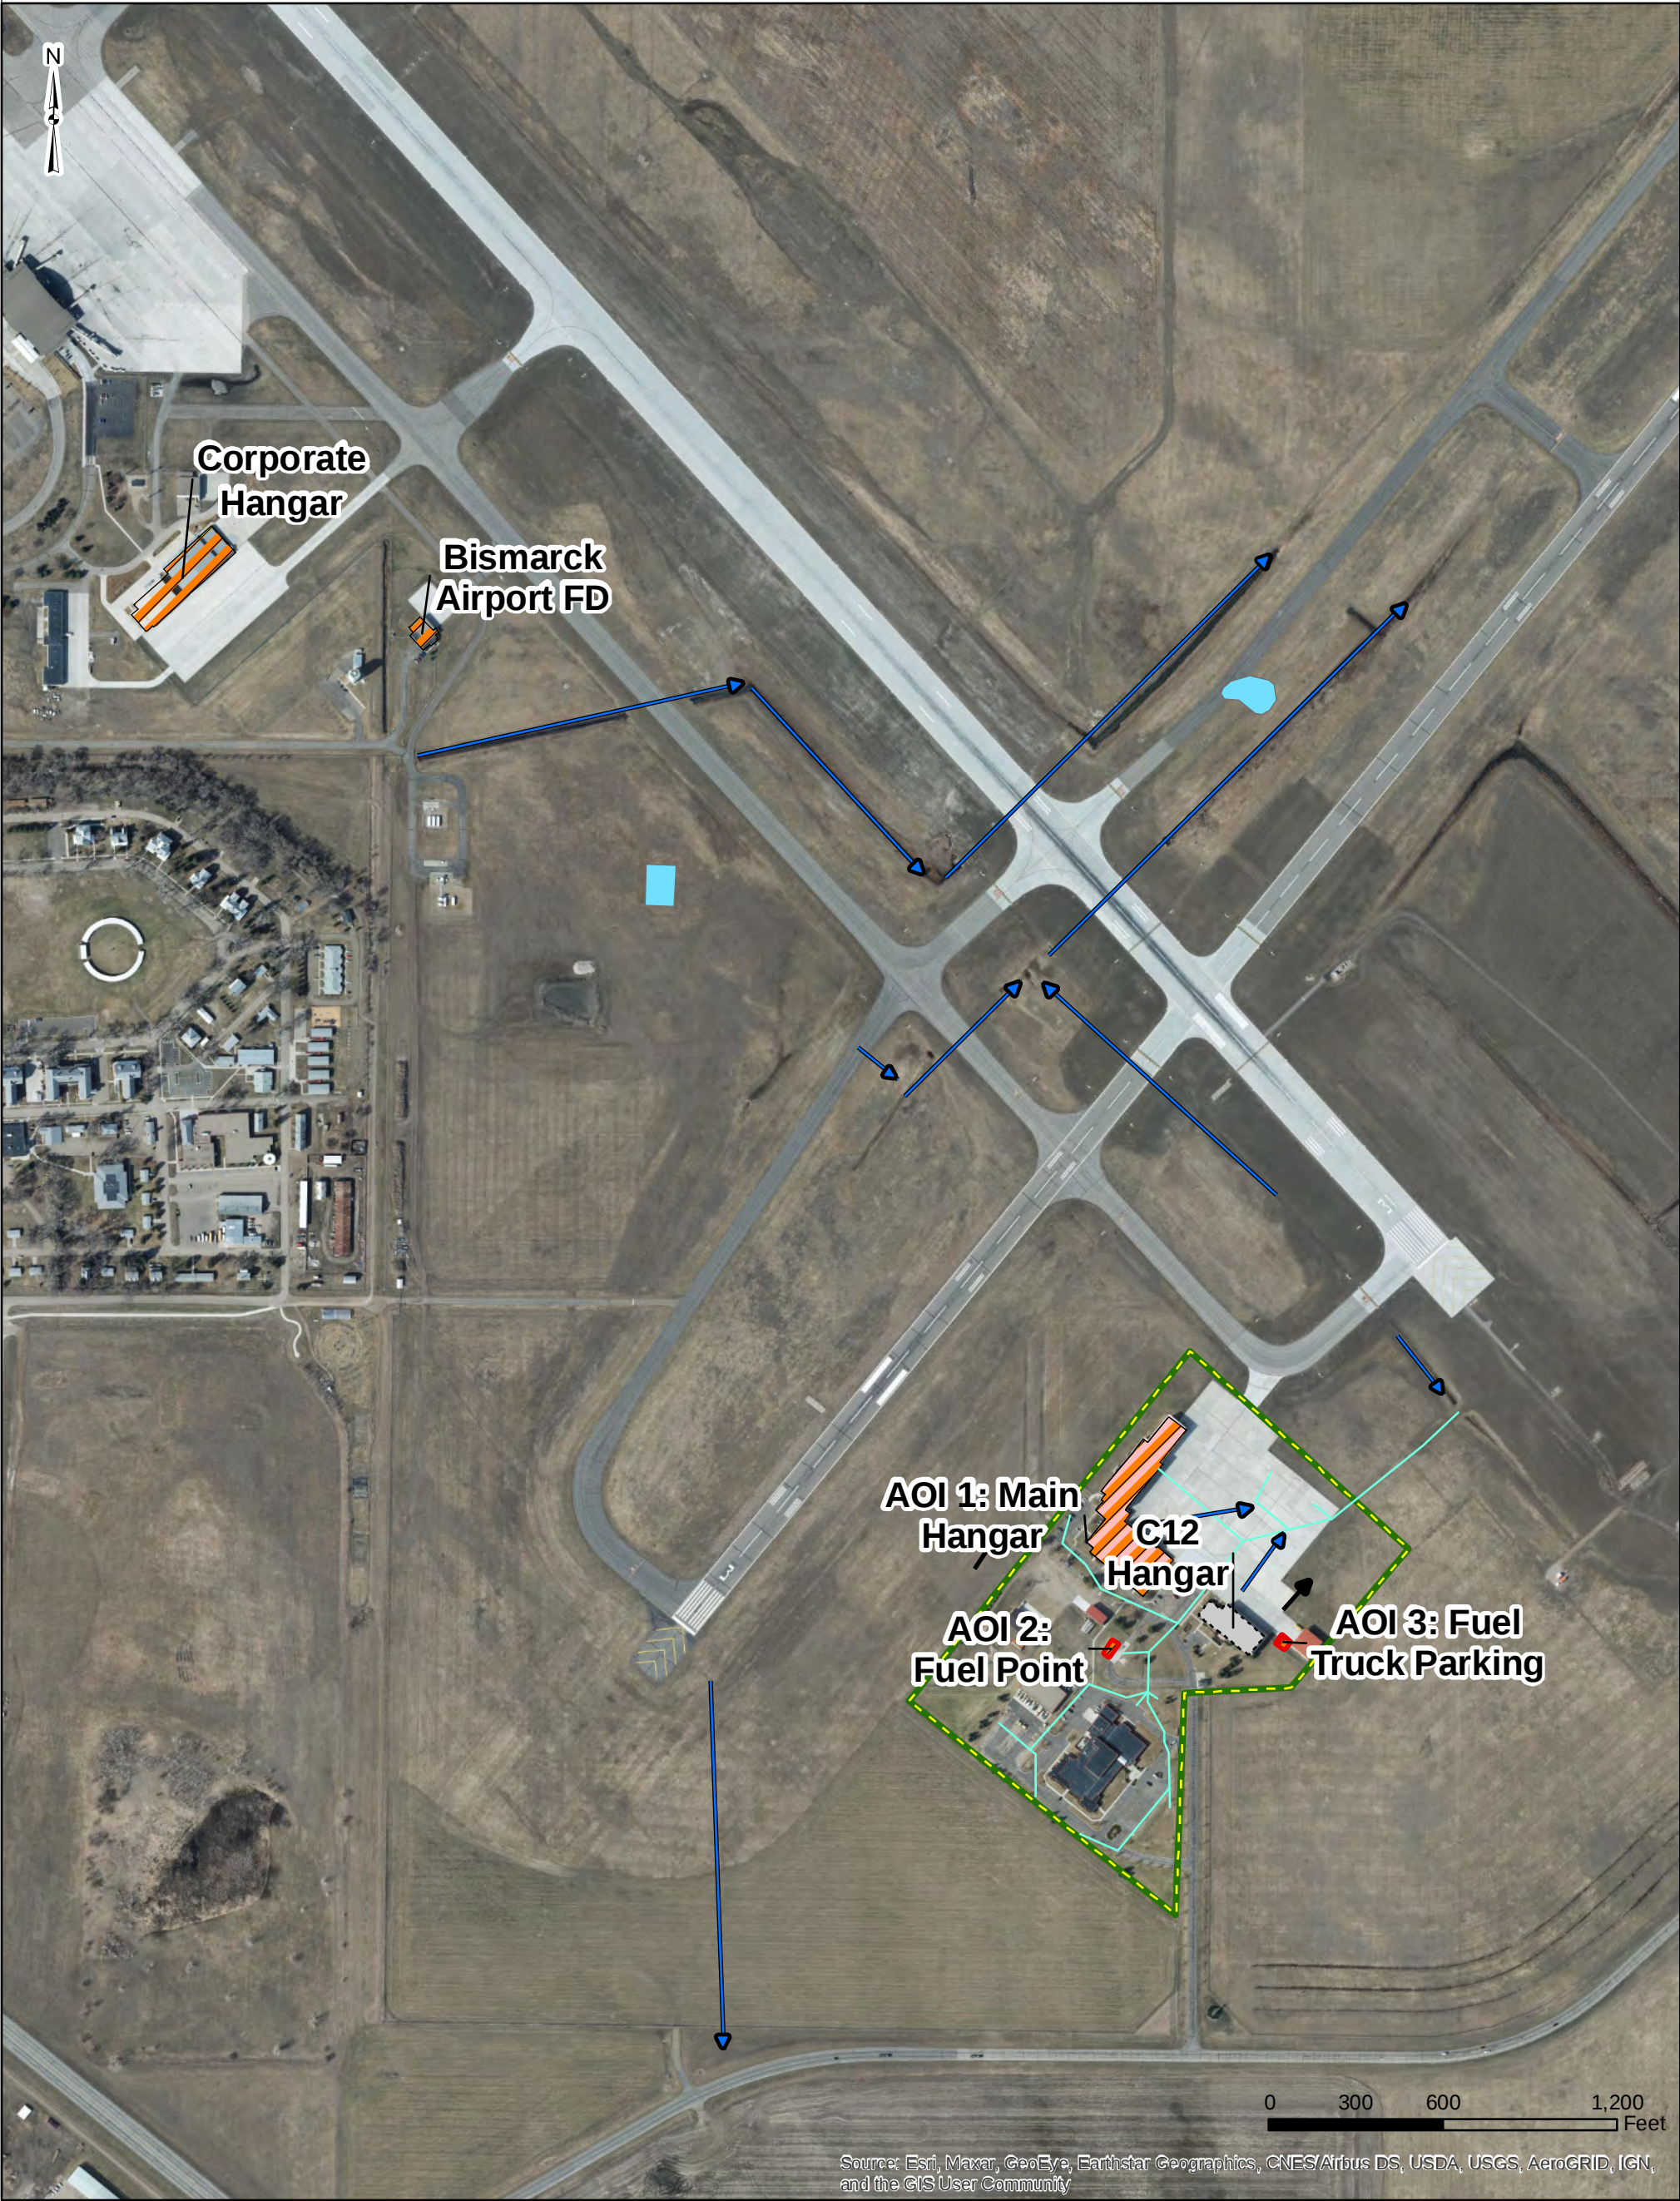
Figure 3-1  
Areas of Interest

Fourteen TriMax30™ fire extinguishers filled with AFFF were observed in the Main Hangar during the PA facility visit. Some of these fire extinguishers were taken out on the ramp for very short durations for operations. Disposal records document the disposal of 10 TriMax30™ fire extinguishers. A thorough search has been conducted at the facility, and no TriMax30™ fire extinguishers remain. The four TriMax30™ fire extinguishers that remain unaccounted for may have been shipped elsewhere between the PA Facility visit and the disposal of the 10 TriMax30™ fire extinguishers.

Approximately 100 gallons of bulk 6% AFFF, for use during overland firefighting response, was also historically stored in the Hazardous Materials Room, located in the northern section of the Main Hangar. Potential releases identified at the Facility may have occurred on paved surfaces.

AFFF releases to the paved surfaces could have infiltrated the subsurface via cracks in the pavement or joints between areas that are paved. If the 2006 release of 2% C2 HEF was not contained within the Main Hangar, 2% C2 HEF runoff could have traveled to the unpaved surface and infiltrated the soil into the groundwater, or to the stormwater catch basins located at the ramp area. The stormwater lines ultimately discharge to Apple Creek (AECOM, 2020).
