## Site Inspection Report

### Bismarck Army Aviation Support Facility #1

### Bismarck, North Dakota

Site Inspection for Perfluorooctanoic Acid (PFOA), Perfluorooctanesulfonic Acid (PFOS), Perfluorohexanesulfonic Acid (PFHxS), Perfluorononanoic Acid (PFNA), Hexafluoropropylene Oxide Dimer Acid (HFPO-DA), and Perfluorobutanesulfonic Acid (PFBS)  
ARNG Installations, Nationwide

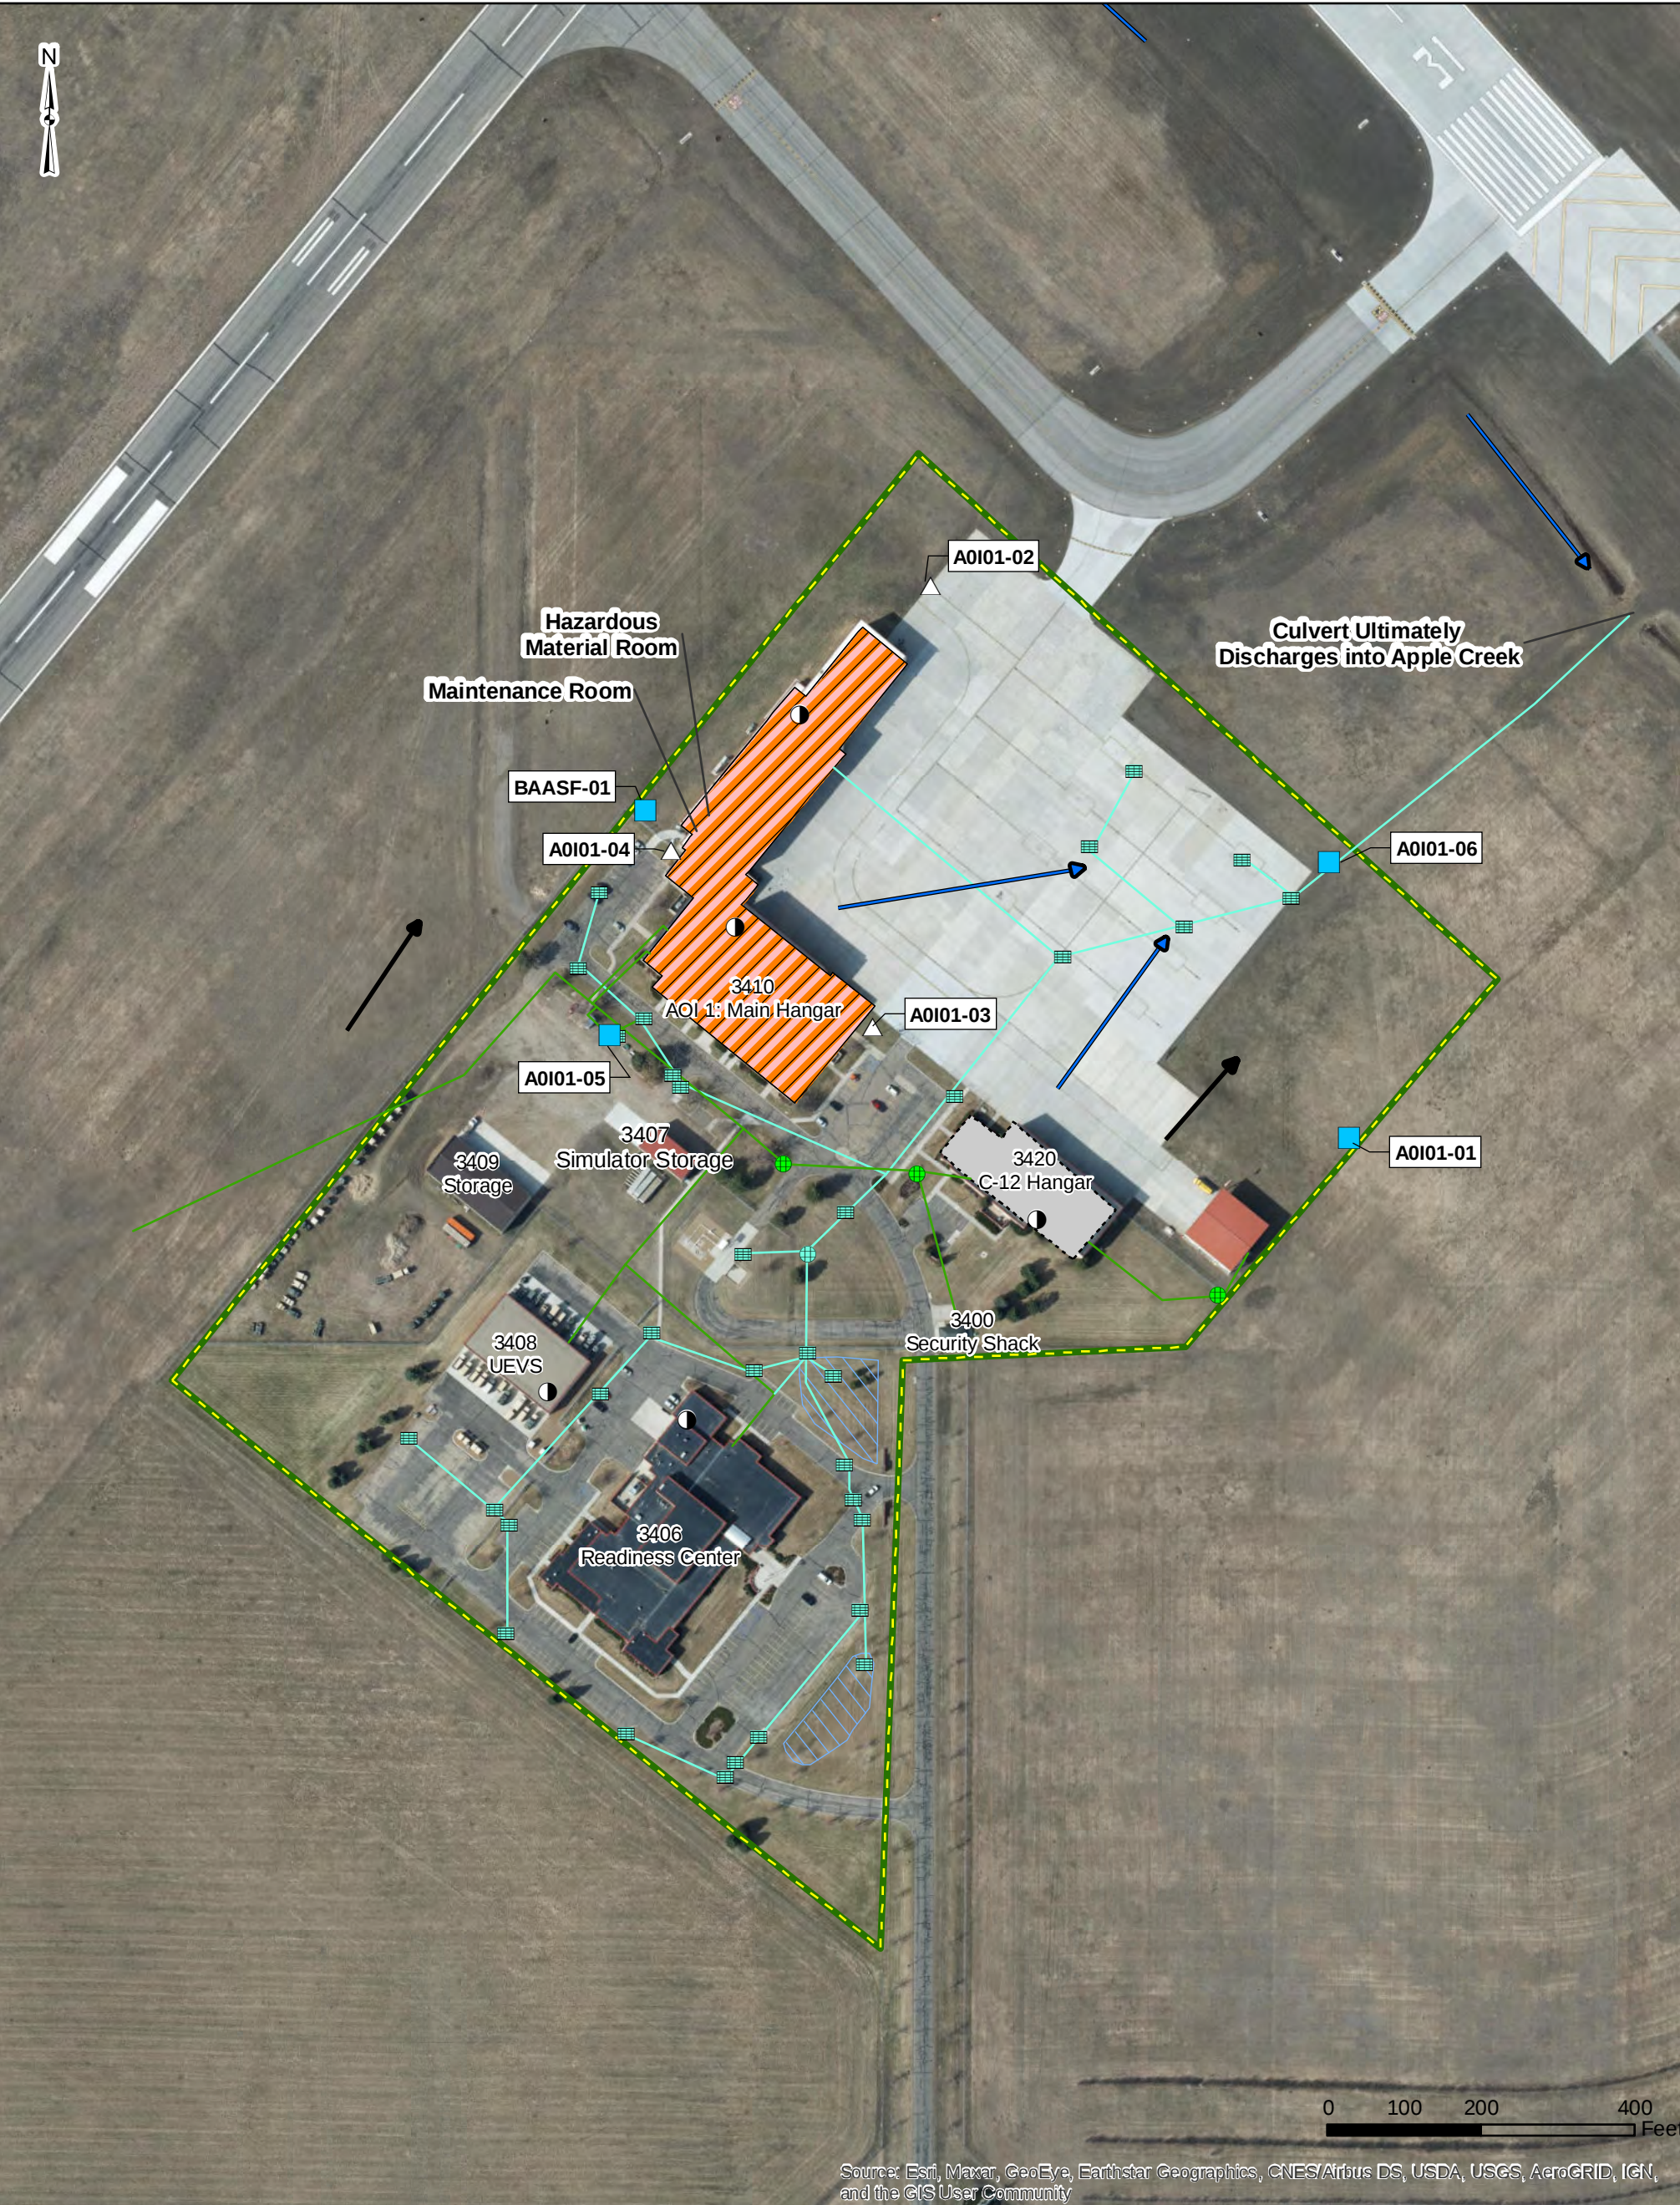
Figure 5-1  
Site Inspection Sample Locations

- The location of AOI01-02 was adjusted approximately 80 ft northeast of the proposed location to avoid a potential conflict with an underground watermain in that area. The new location was in a low point of a drainage swale that is adjacent to the concrete apron. Facility personnel noted that this was likely the drainage path of any foam that would have escaped Building 3410. A field change request form documenting the relocation was submitted to USACE and ARNG on 2 November 2021. The approved field change request form is included in **Appendix B4**.
