FINAL Site Inspection Report Army Aviation Support Facility 1 Green Township, Summit County, Ohio

Perfluorooctanesulfonic Acid (PFOS) and Perfluorooctanoic Acid (PFOA) Impacted Sites ARNG Installations, Nationwide

December 2022

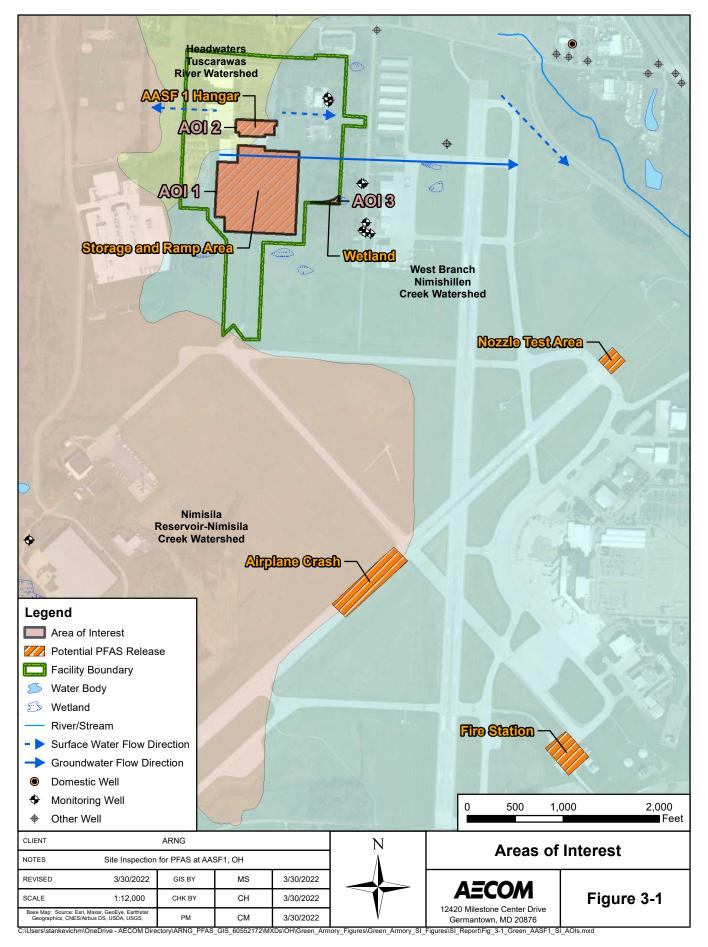
This section presents a summary of each potential PFAS release area by AOI. Based on the PA findings, three potential PFAS release areas, the Storage and Ramp Area, Green AASF1 Hangar, and Wetland, were identified at Green AASF1 and grouped into three AOIs (AECOM, 2020). The potential PFAS release areas are shown on **Figure 3-1**.

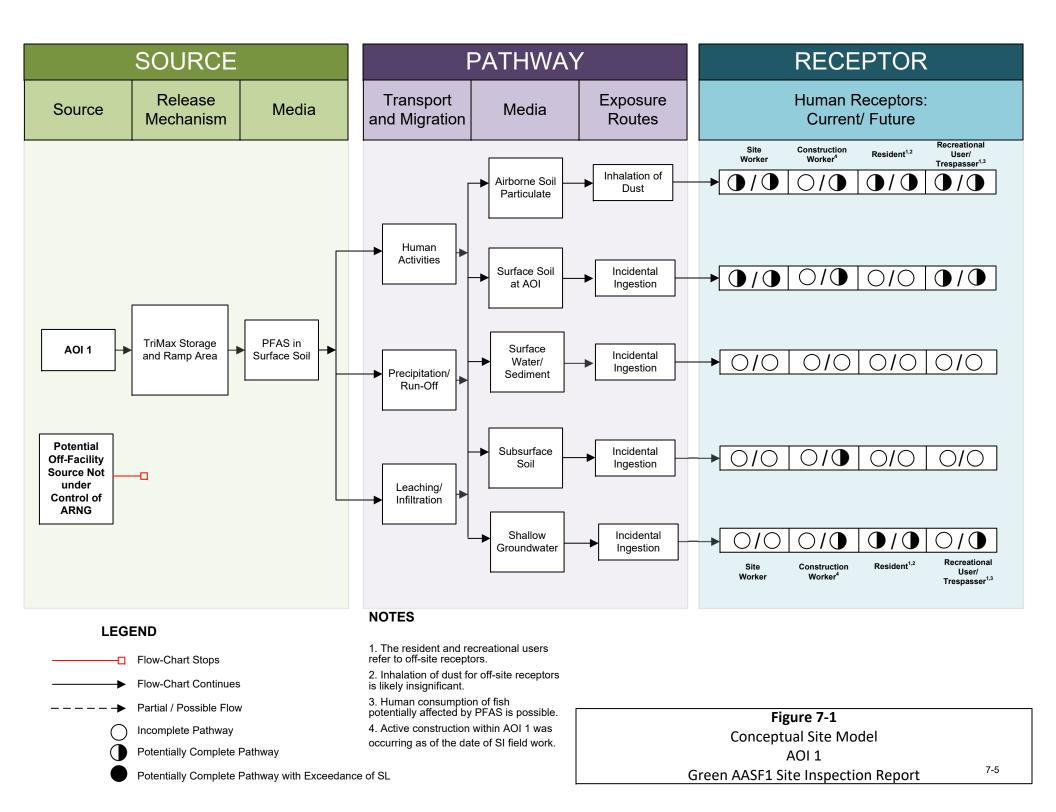
The CSMs for each AOI, revised based on the SI findings, are presented on **Figure 7-1** through **Figure 7-3**. A CSM presents the current understanding of the site conditions with respect to known and suspected sources, potential transport mechanisms and migration pathways, and potentially exposed human receptors. A human exposure pathway is considered potentially complete when the following conditions are present:

From at least 2006 to 2018, PFAS were potentially released at the TriMax[™] Storage and Ramp area due to leaks or spills. PFOA, PFOS, and PFBS were detected below the SLs in soil at AOI 1 and confirm the release of PFAS to soil.

Based on the results of the SI in AOI 1, ground-disturbing activities could potentially result in site worker, construction worker, or trespasser exposure to PFOA, PFOS, and PFBS via inhalation of dust. Off-facility recreational users may be potentially exposed to PFOA, PFOS, and PFBS via inhalation of dust caused by on-facility ground disturbing activities. Ground-disturbing activities could also potentially result in site worker, construction worker, or trespasser exposure via ingestion of surface soil. Lastly, ground-disturbing activities could also potentially result in

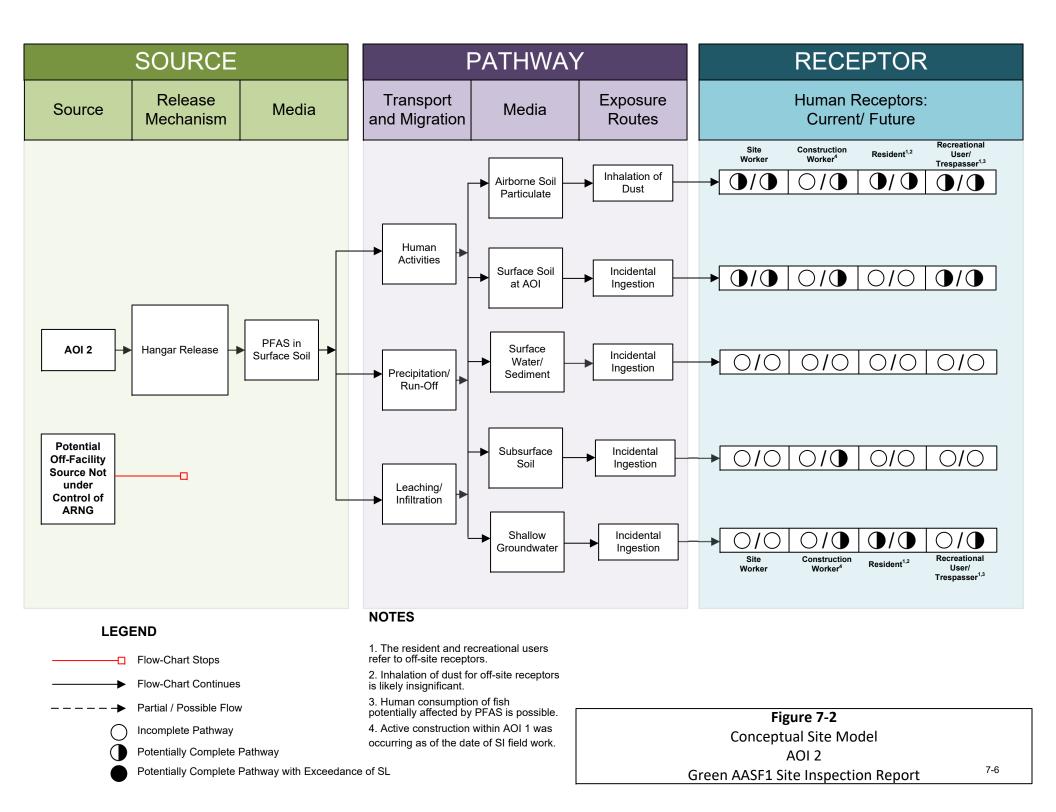
Based on the results of the SI in AOI 2, ground-disturbing activities could potentially result in site worker and future construction worker exposure to PFOA, PFOS, and PFBS via inhalation of dust or ingestion of surface soil, and future construction worker exposure to PFOA, PFOS, and PFBS in subsurface soil. No construction is currently occurring at AOI 2; however, future construction activities may include ground disturbing activities. Off-facility residents and recreational users may be potentially exposed to PFOA, PFOS, and PFBS via inhalation of dust caused by on-facility ground disturbing activities, but this exposure is likely insignificant. The CSM for AOI 2 is presented on **Figure 7-2**.

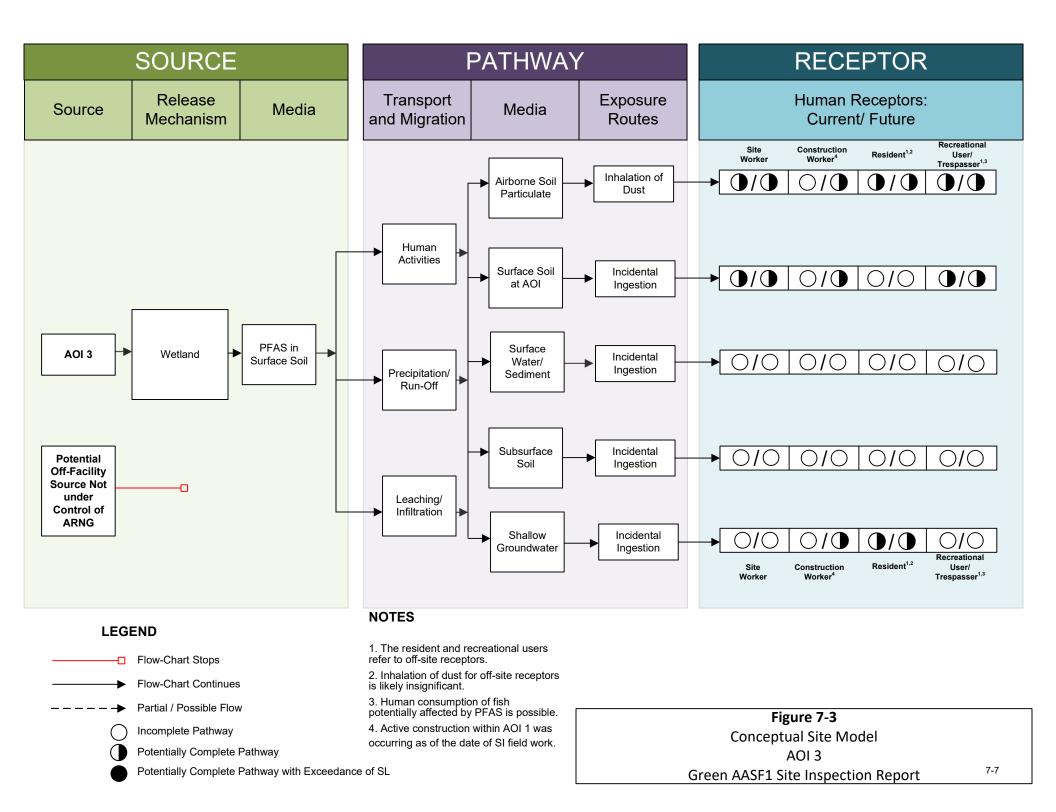
PFOA, PFOS, and PFBS were detected in the groundwater at the lone temporary monitoring well at AOI 3. Though detected, PFOA, PFOS, and PFBS concentrations were all below their respective SLs. The ingestion exposure pathway for off-facility residents from downgradient potable wells is potentially complete. The ingestion pathway for site workers and trespassers is incomplete due to on-facility water being provided by a public utility company. There is no ongoing construction at the facility, but the exposure pathway for future construction workers is potentially complete as groundwater at the facility may be encountered during construction activities. The CSM for AOI 3 is presented on **Figure 7-3**.
