FINAL Site Inspection Report Tulsa Army Aviation Support Facility #2, Oklahoma

Site Inspection for Perfluorooctanoic acid (PFOA),
Perfluorooctanesulfonic acid (PFOS), Perfluorohexanesulfonic
acid (PFHxS), Perfluorononanoic acid (PFNA),
Hexafluoropropylene oxide dimer acid (HFPO-DA), and
Perfluorobutanesulfonic acid (PFBS) at ARNG Installations,
Nationwide

May 2023

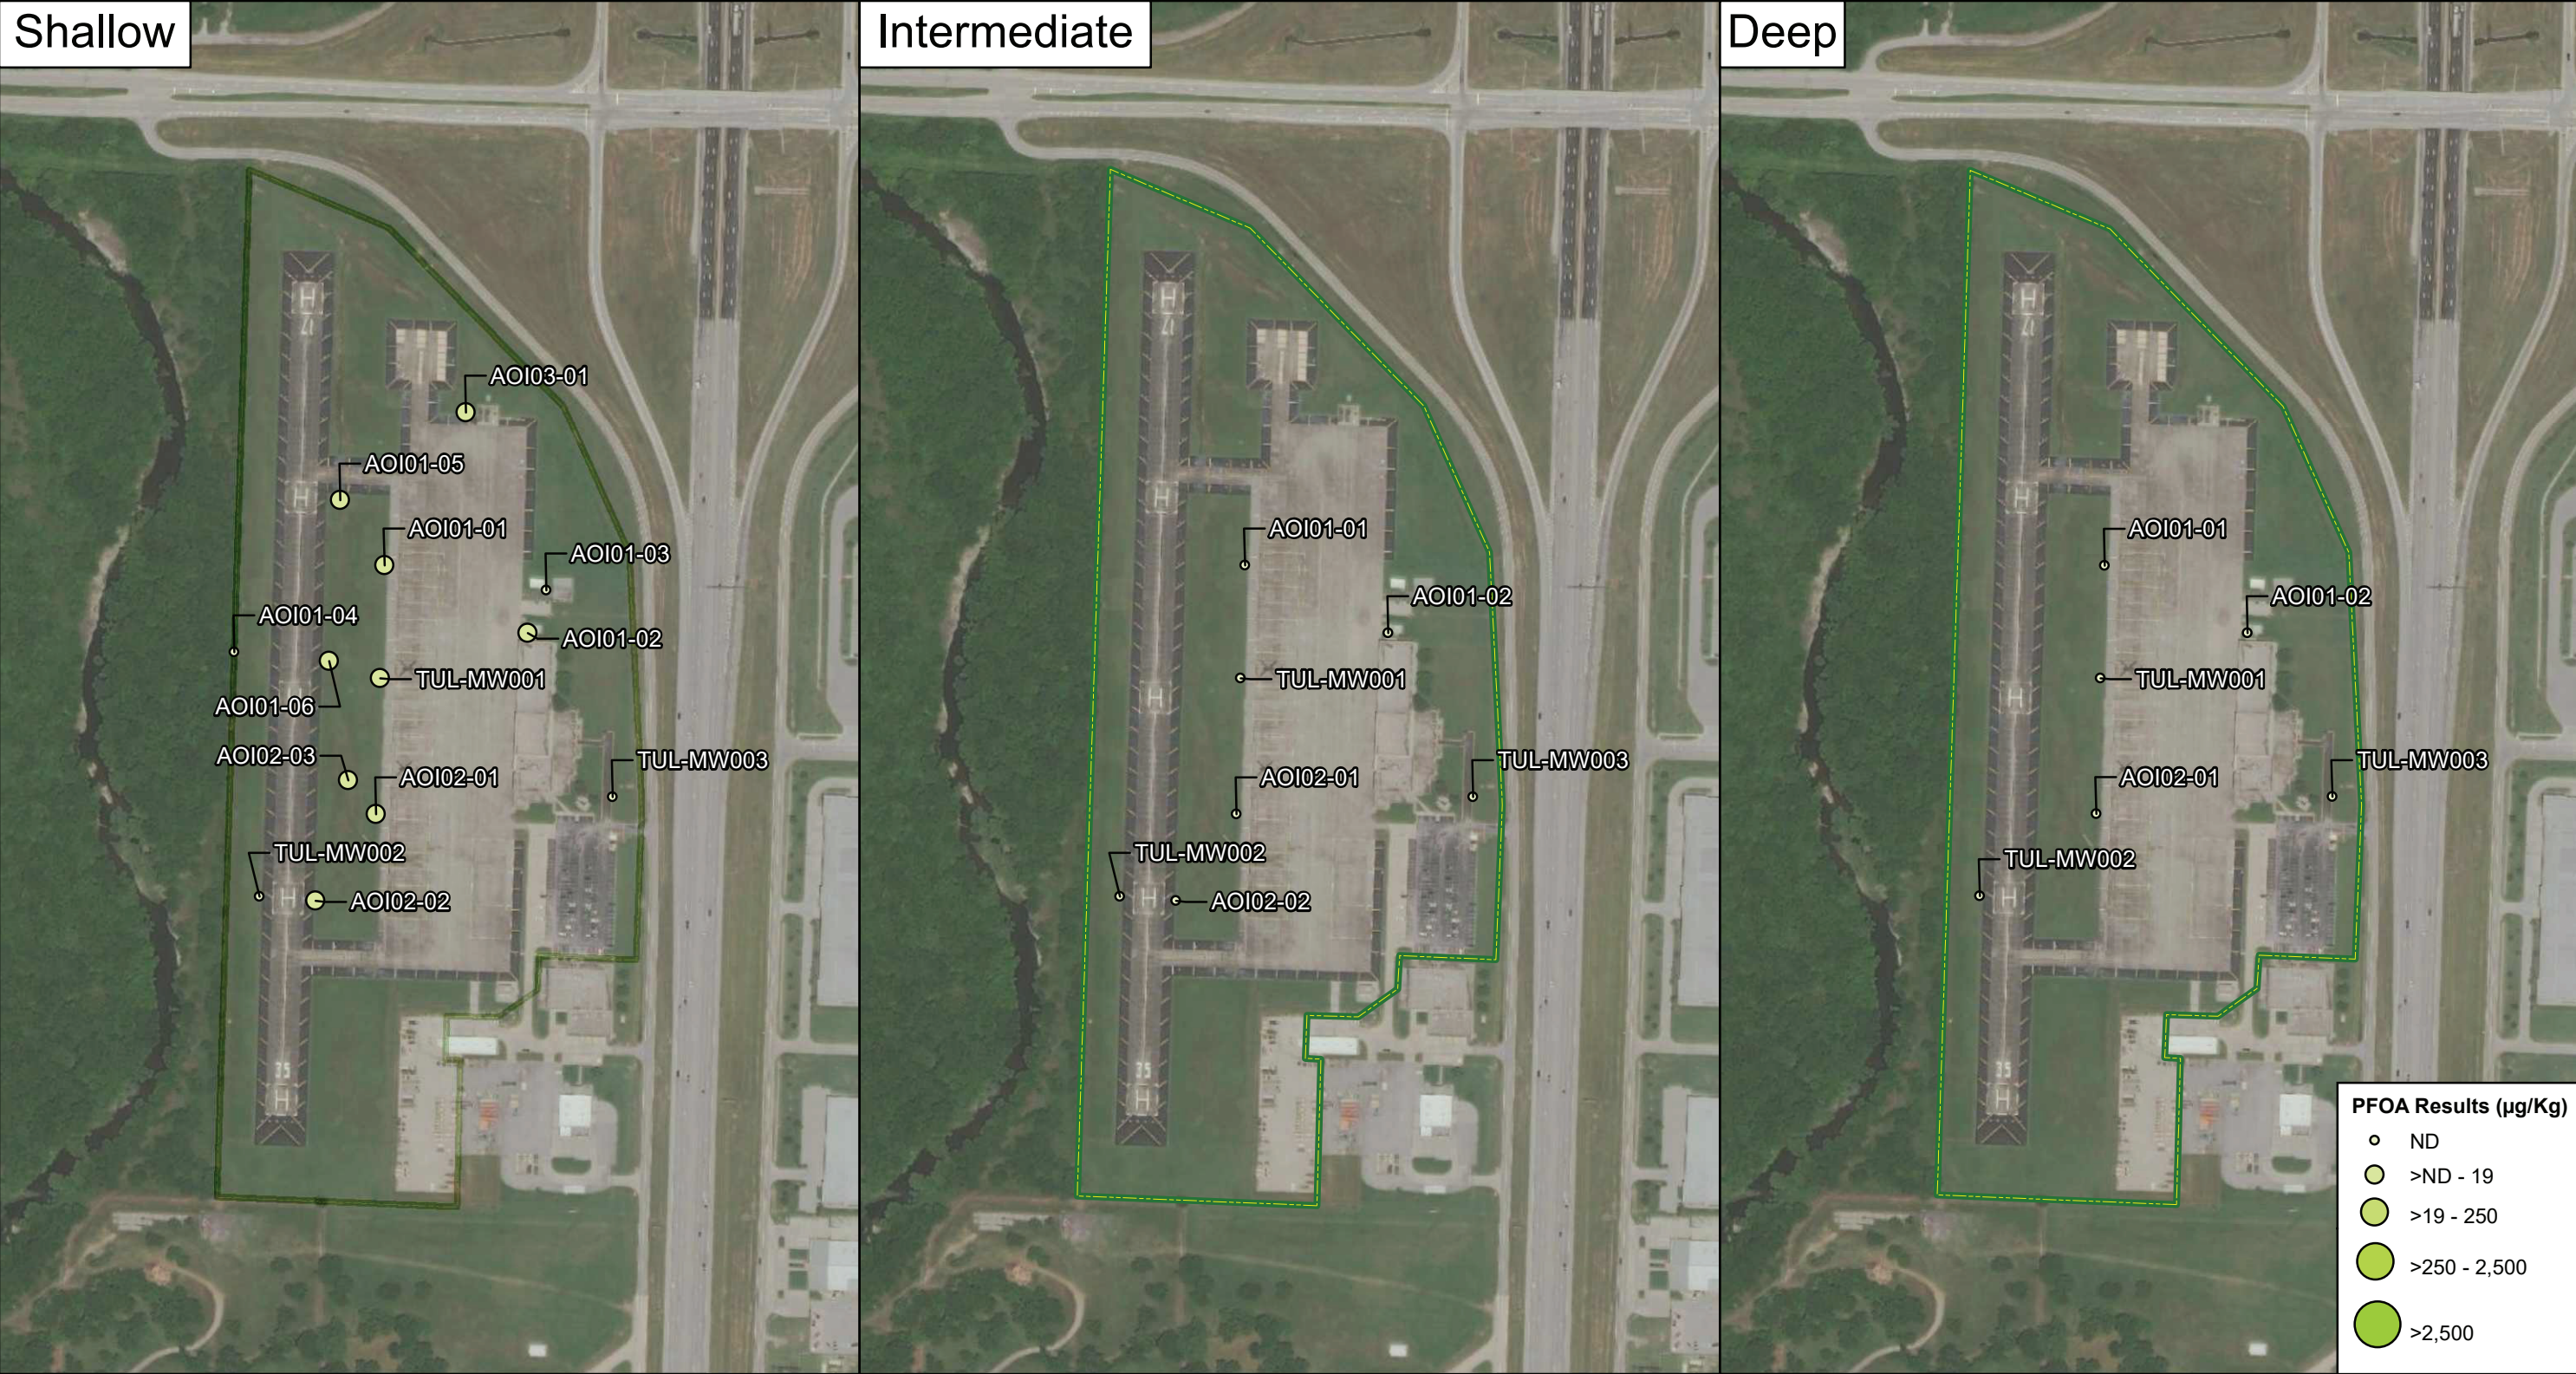
CLIENT					ARNG					<div><div>Legend</div><div><div><div></div></div> Facility Boundary</div><div>Exceedances of the OSD SL are depicted with a yellow halo. Depth intervals shown represent respective sampling position within a given soil boring location.</div></div> <div><div>0200400800</div><div>Feet</div></div> <div><div>N</div><div></div></div>	PFOA Detections in Soil													
PROJECT											Site Inspection at Tulsa AASF #2, OK													
REVISED					9/13/2022						GIS BY		MS		9/13/2022									
SCALE					1:4,800						CHK BY		VG		9/13/2022									
Base Map: Source: Esri, Maxar, Earthstar Geographics, and the GIS User Community											PM		CM		9/13/2022									
															<div><div>AECOM</div><div>12420 Milestone Center Drive Germantown, MD 20876</div></div>					Figure 6-1

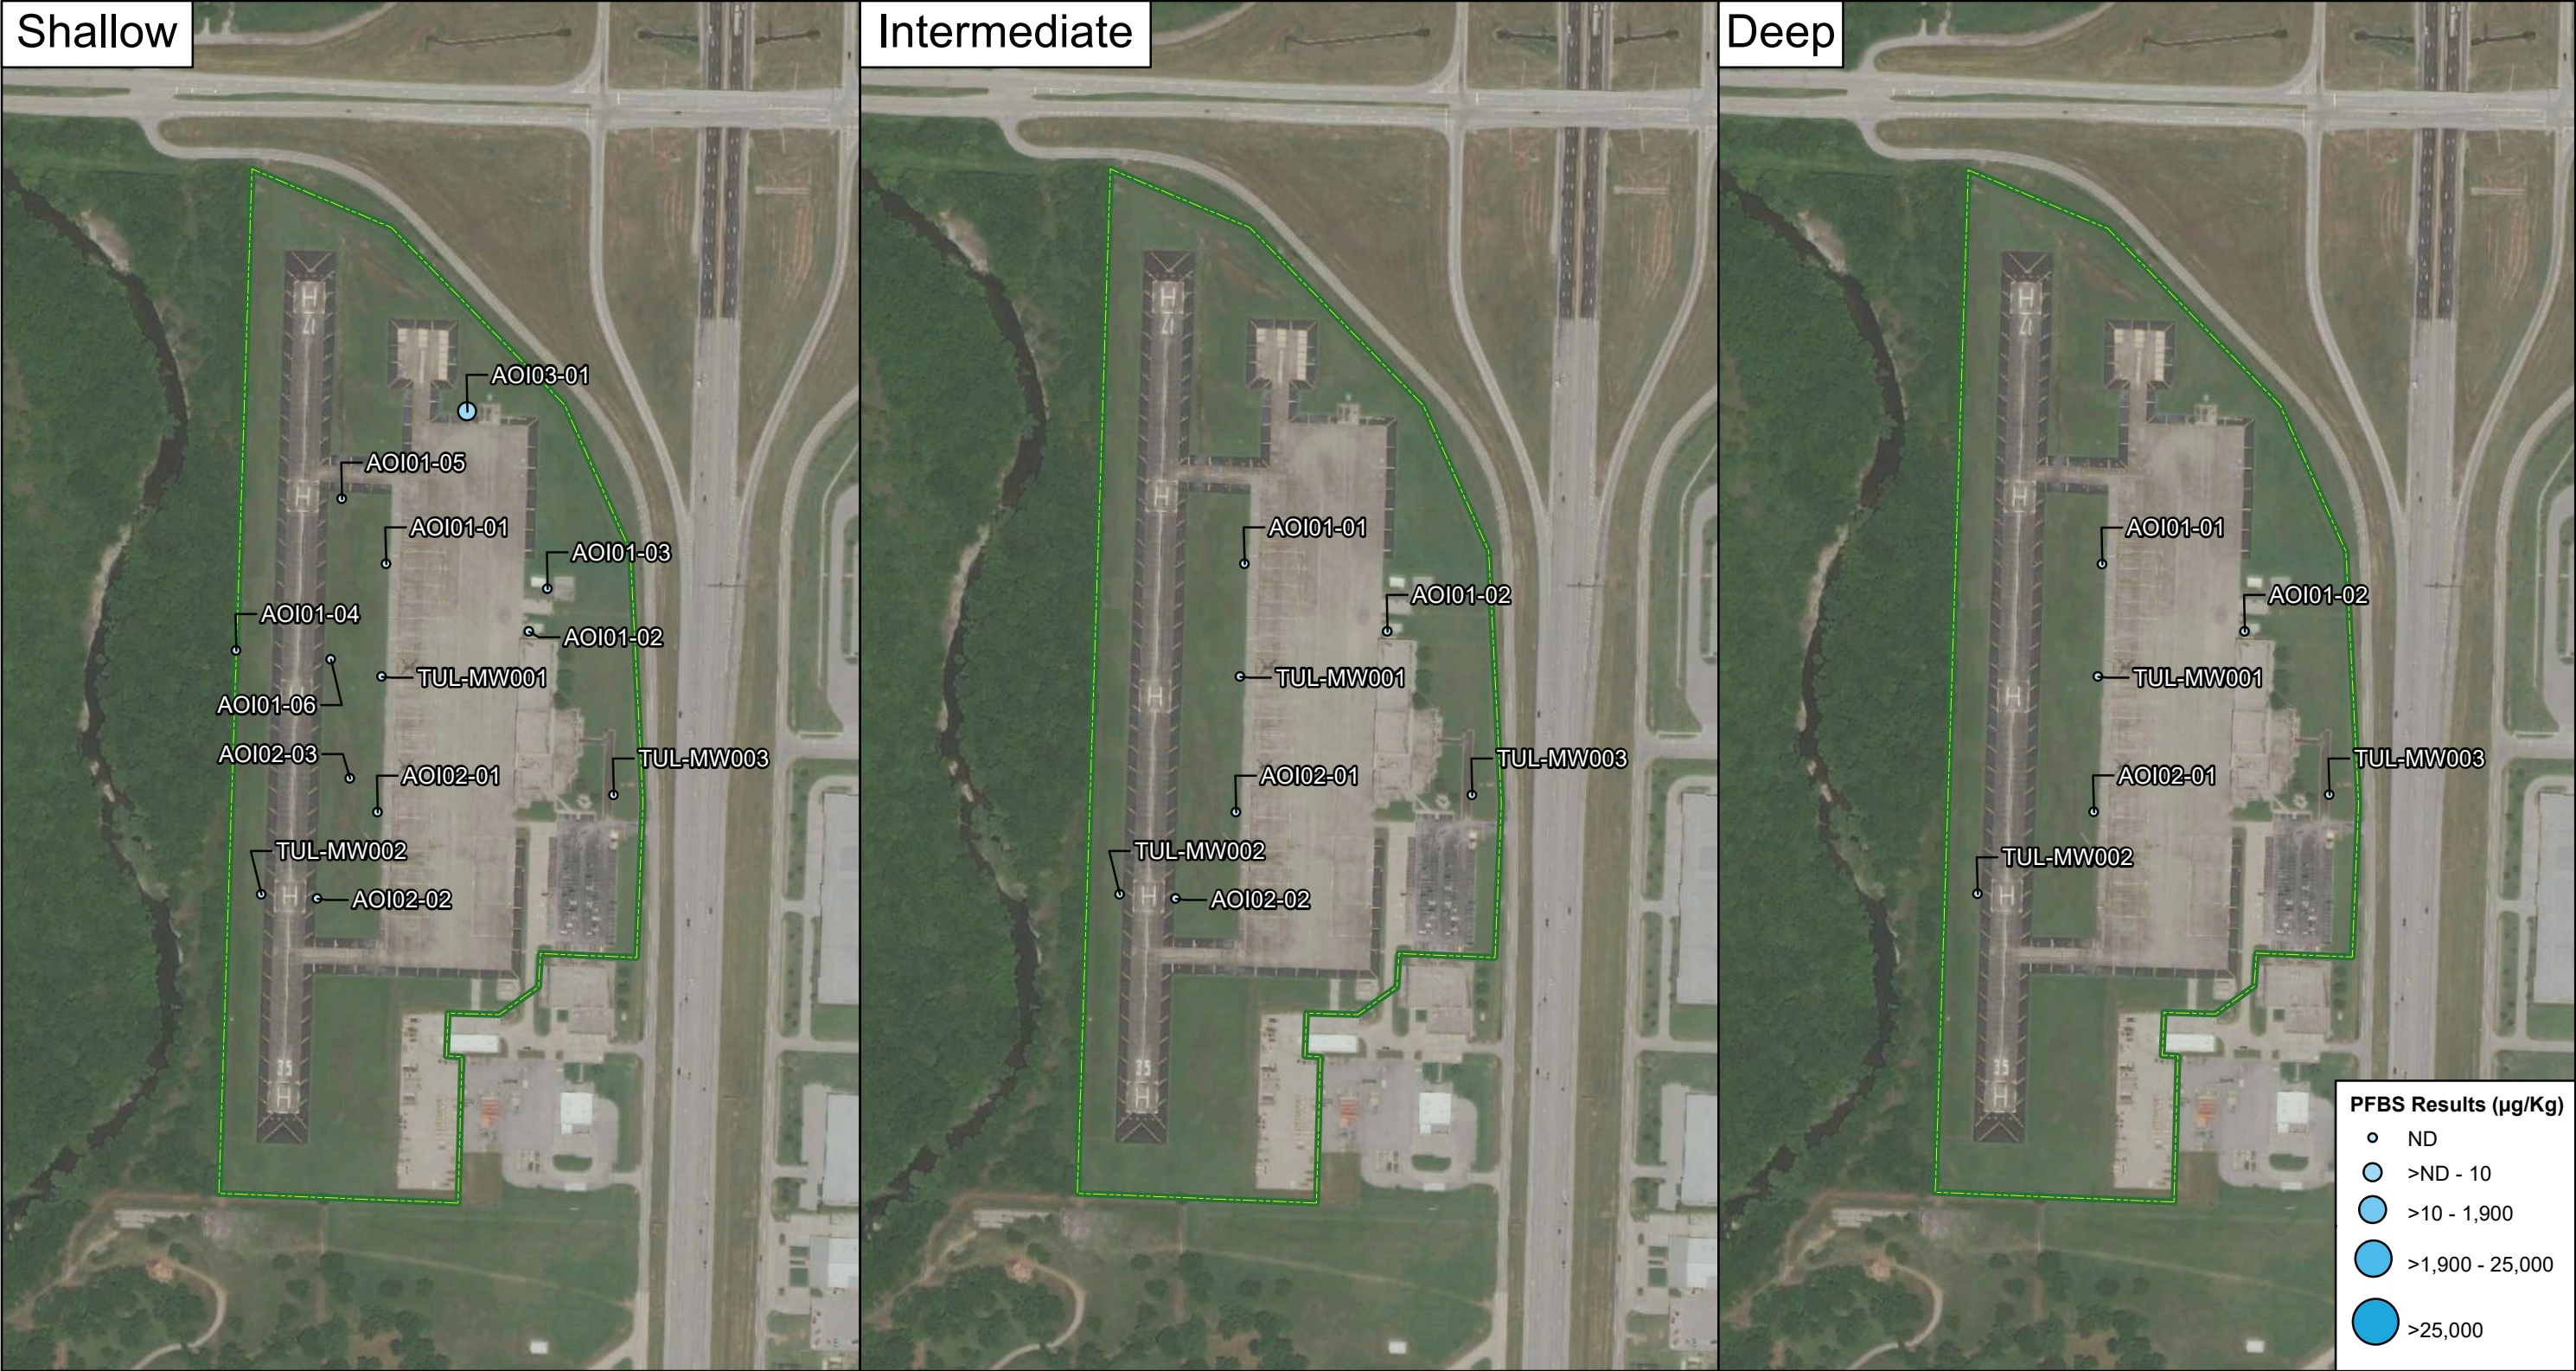
Figure 6-2

CLIENT ARNG					<div><div>Legend</div><div><div><div></div></div> Facility Boundary</div><div><div>0200400800</div><div>Feet</div></div></div> <div><div>Exceedances of the OSD SL are depicted with a yellow halo.</div><div>Depth intervals shown represent respective sampling position within a given soil boring location.</div></div>	<div><div>N</div><div></div></div>	PFBS Detections in Soil	
PROJECT Site Inspection at Tulsa AASF #2, OK							<div><div><div>AECOM</div><div>12420 Milestone Center Drive Germantown, MD 20876</div></div><div>Figure 6-3</div></div>	
REVISED9/13/2022	GIS BY	MS	9/13/2022					
SCALE1:4,800	CHK BY	VG	9/13/2022					
Base Map: Source: Esri, Maxar, Earthstar Geographics, and the GIS User Community		PM	CM	9/13/2022

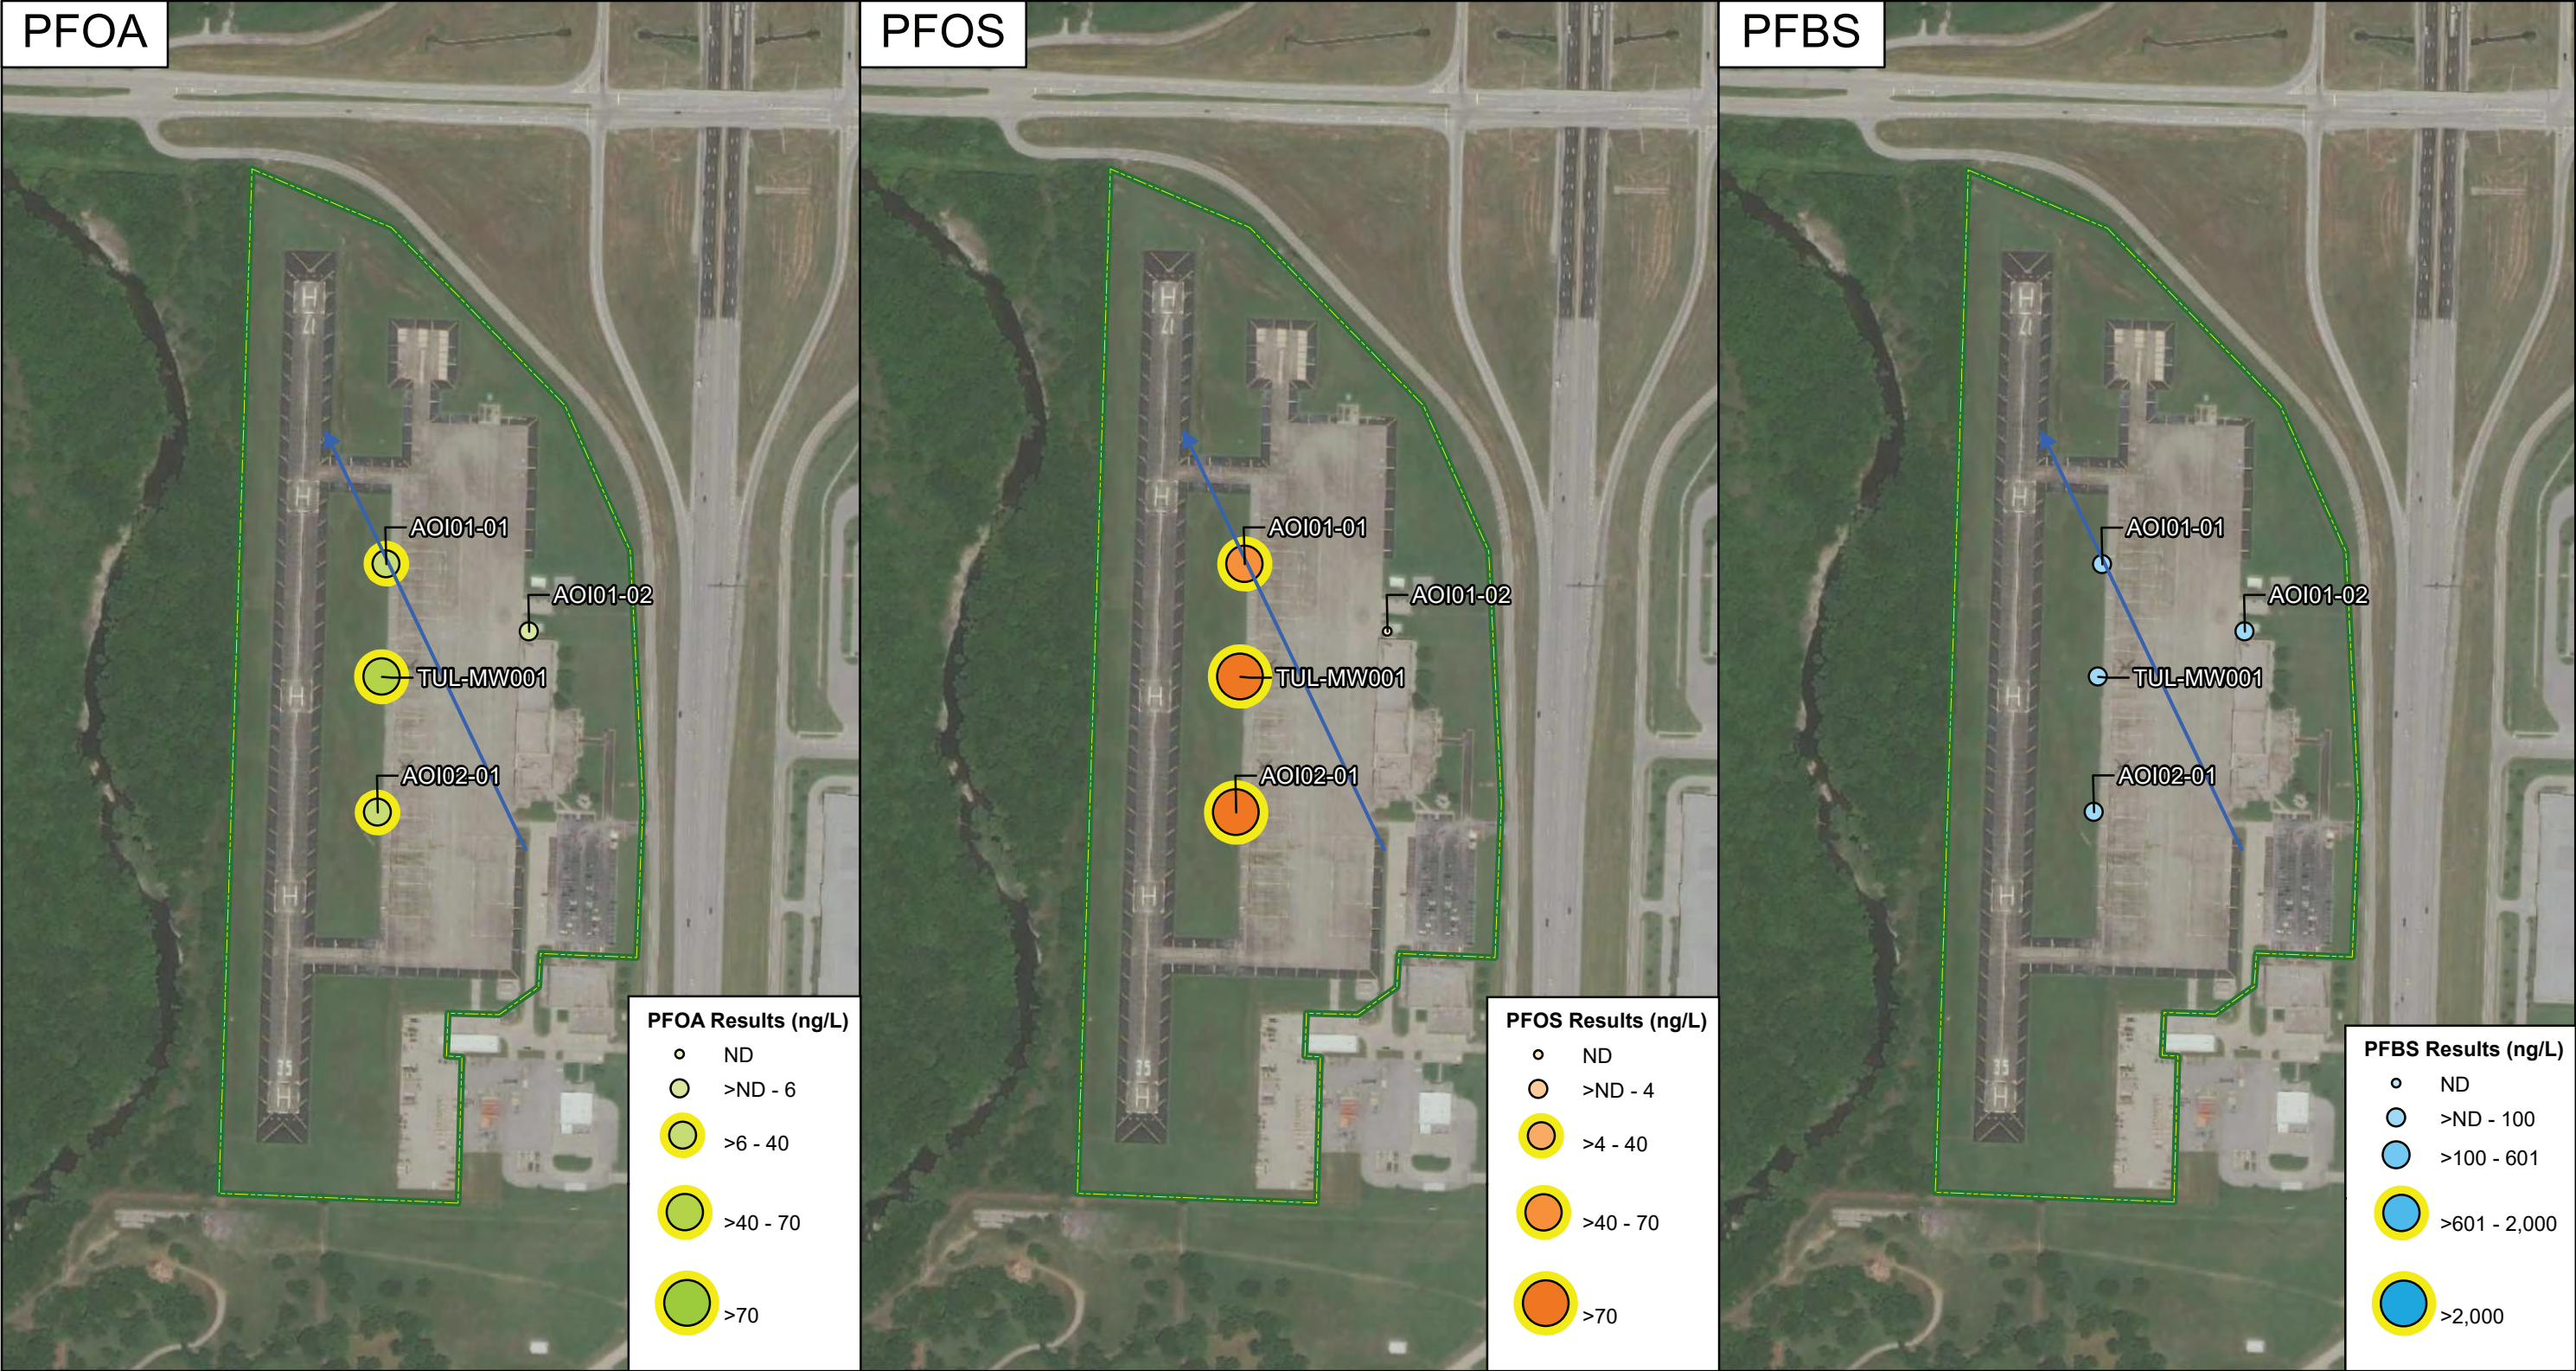
Figure 6-5

CLIENTARNG					<div>Legend<ul style="list-style-type: none"> Facility Boundary Groundwater Flow Direction</div> <div>0200400800Feet</div> <div>Exceedances of the OSD SL are depicted with a yellow halo.</div>	<div>N</div>	PFOA, PFOS, and PFBS Detections in Groundwater	
PROJECTSite Inspection at Tulsa AASF #2, OK							12420 Milestone Center Drive Germantown, MD 20876	Figure 6-6
REVISED	10/10/2022	GIS BY	MS	10/10/2022				
SCALE	1:4,800	CHK BY	VG	10/10/2022				
Base Map: Source: Esri, Maxar, Earthstar Geographics, and the GIS User Community								
		PM	CM	10/10/2022
