FINAL Site Inspection Report Lexington Army Aviation Support Facility #1 Lexington, Oklahoma

Site Inspection for Perfluorooctanoic acid (PFOA),
Perfluorooctanesulfonic acid (PFOS), Perfluorohexanesulfonic
acid (PFHxS), Perfluorononanoic acid (PFNA),
Hexafluoropropylene oxide dimer acid (HFPO-DA), and
Perfluorobutanesulfonic acid (PFBS) at ARNG Installations,
Nationwide

May 2023

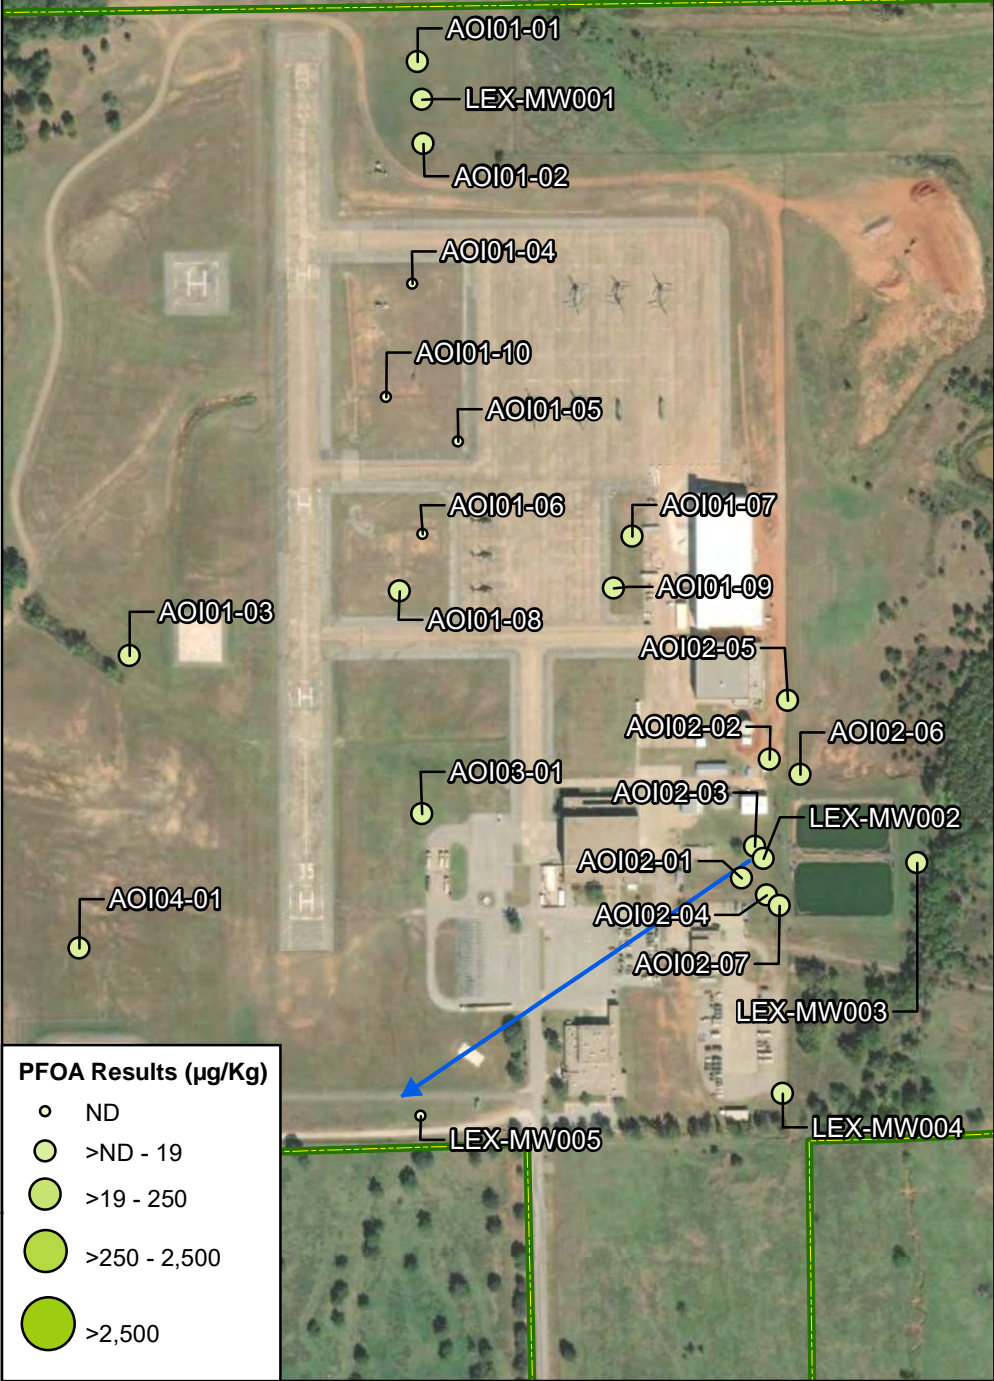
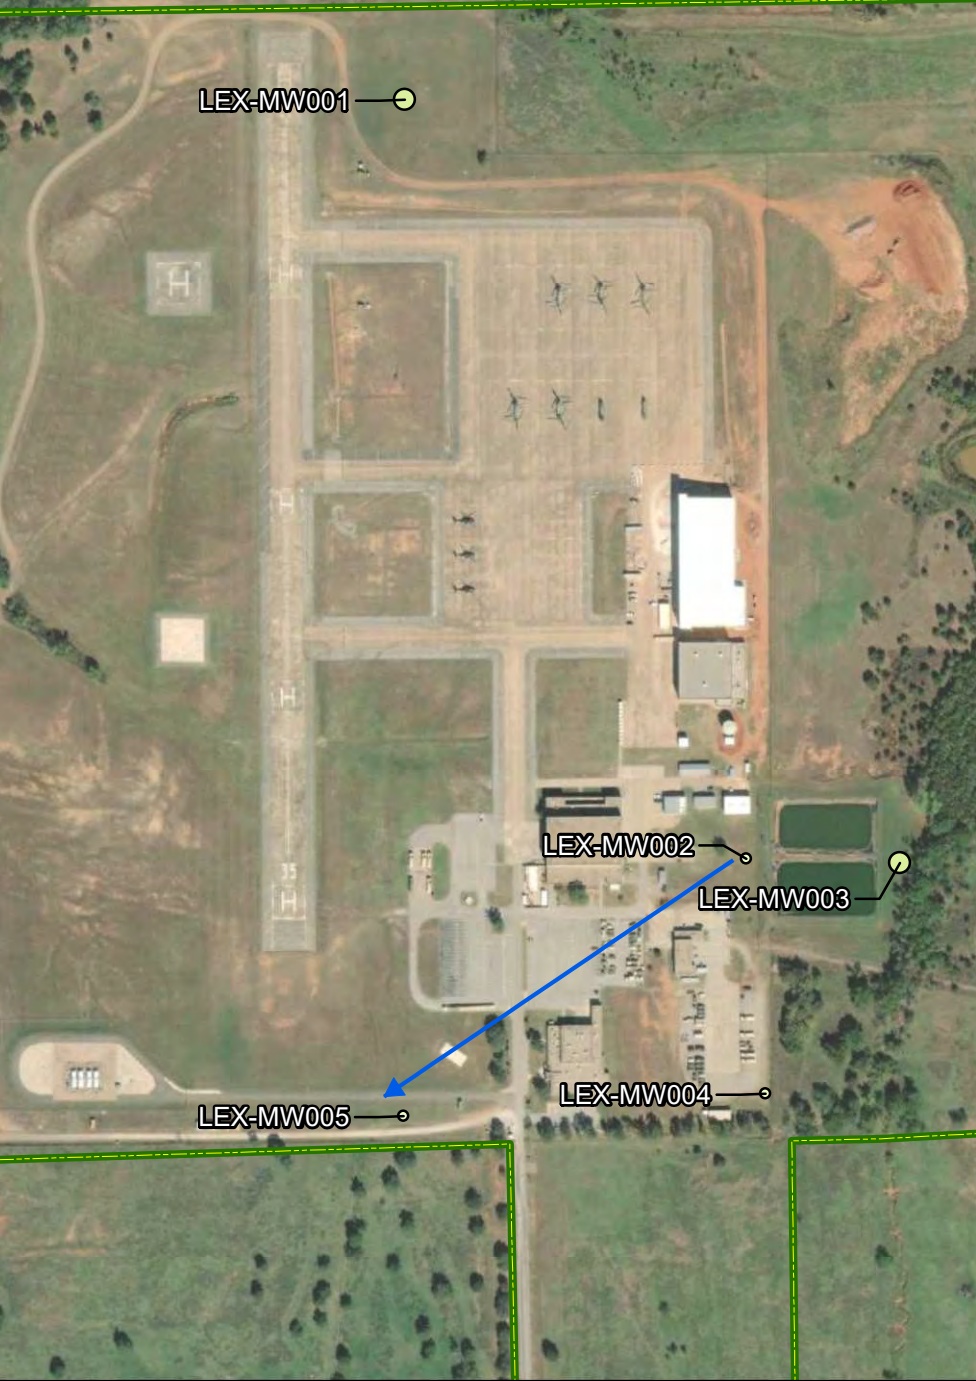
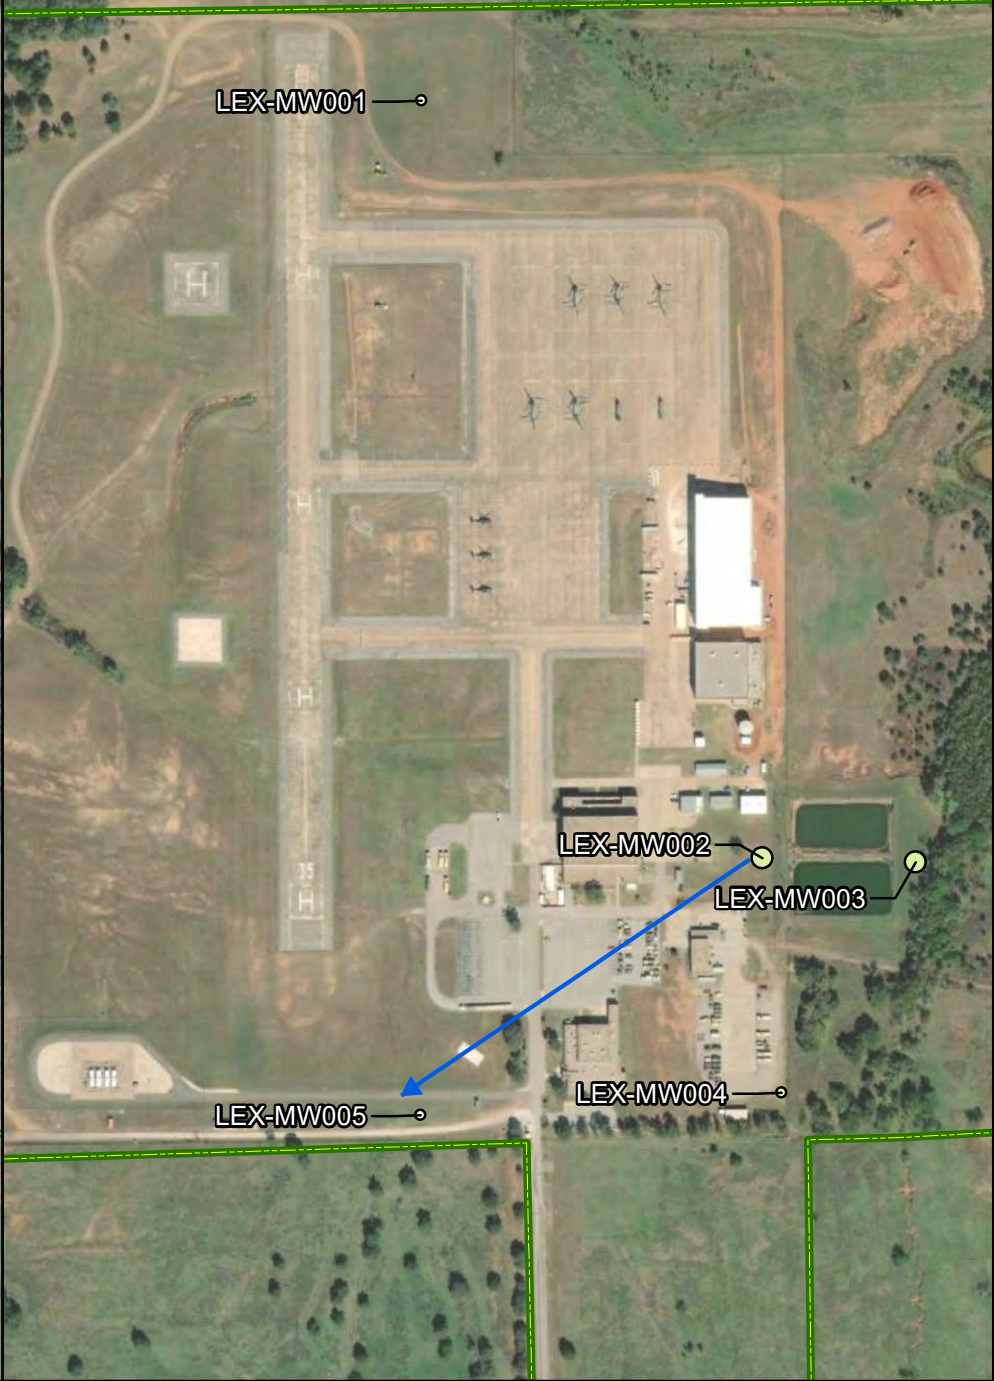
Figure 6-1

AOI01-01, AOI01-02, and LEX-MW001 were collected in the vicinity of the Burn Pit. AOI01-04, AOI01-05, and AOI01-10 were located across the taxiway south of the burn pit. In the vicinity of the Flight Line fire training area, AOI01-06 and AOI01-08 were located to the west, while AOI01-07 and AOI01-09 were located to the east. AOI01-03 was located in the dry swale west-southwest of AOI 1, where most of the surface runoff from AOI 1 appeared to flow before accumulating in a ditch. **Figure 6-1** through **Figure 6-5** present the ranges of detections in soil. **Table 6-2** through **Table 6-4** summarize the soil results.

PFOA Results (µg/Kg)

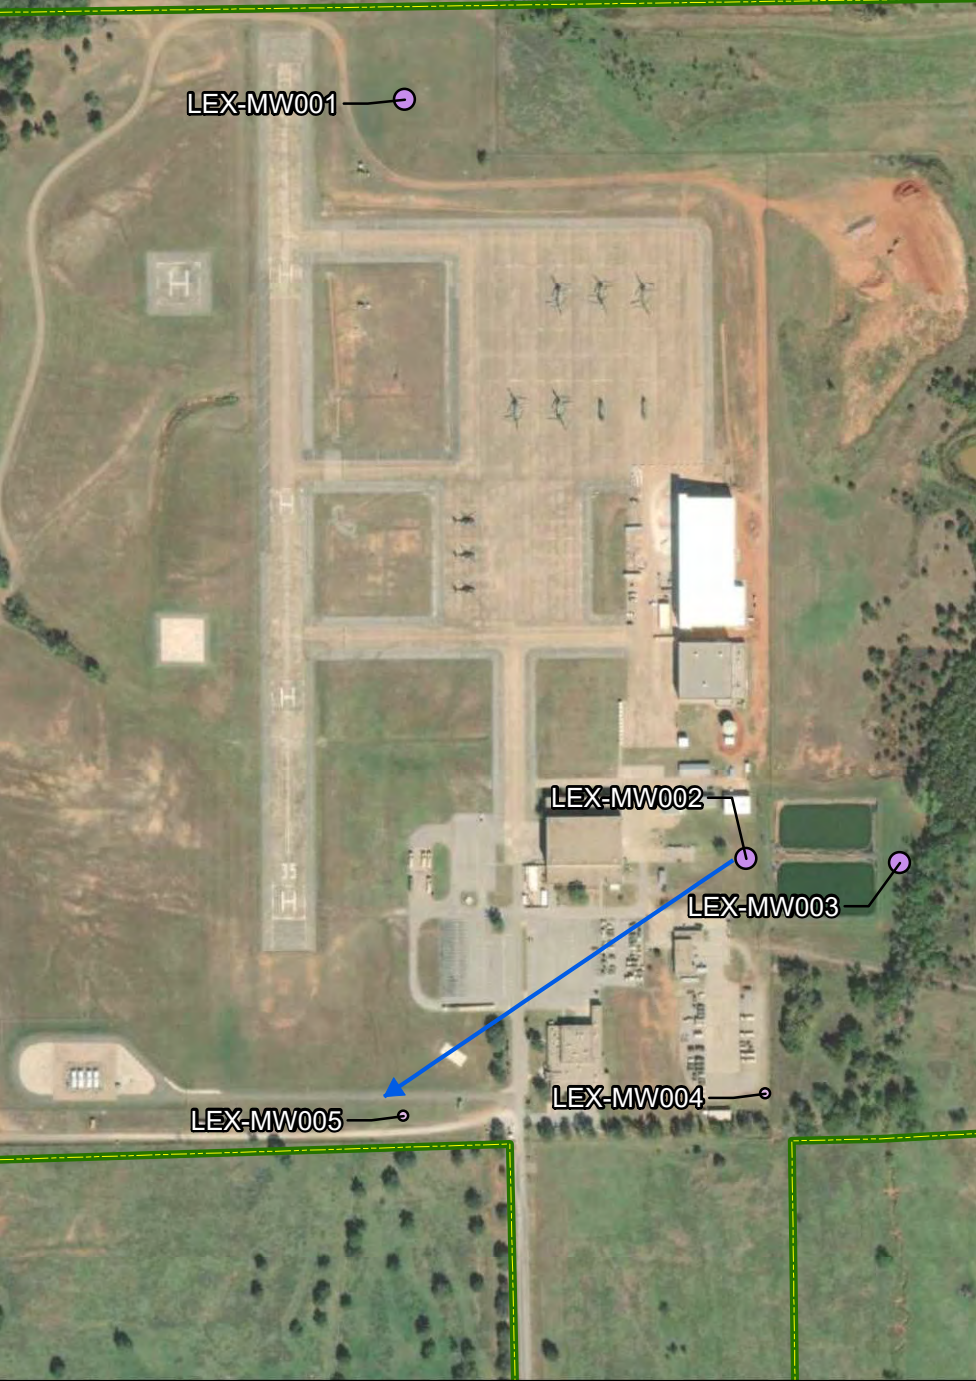
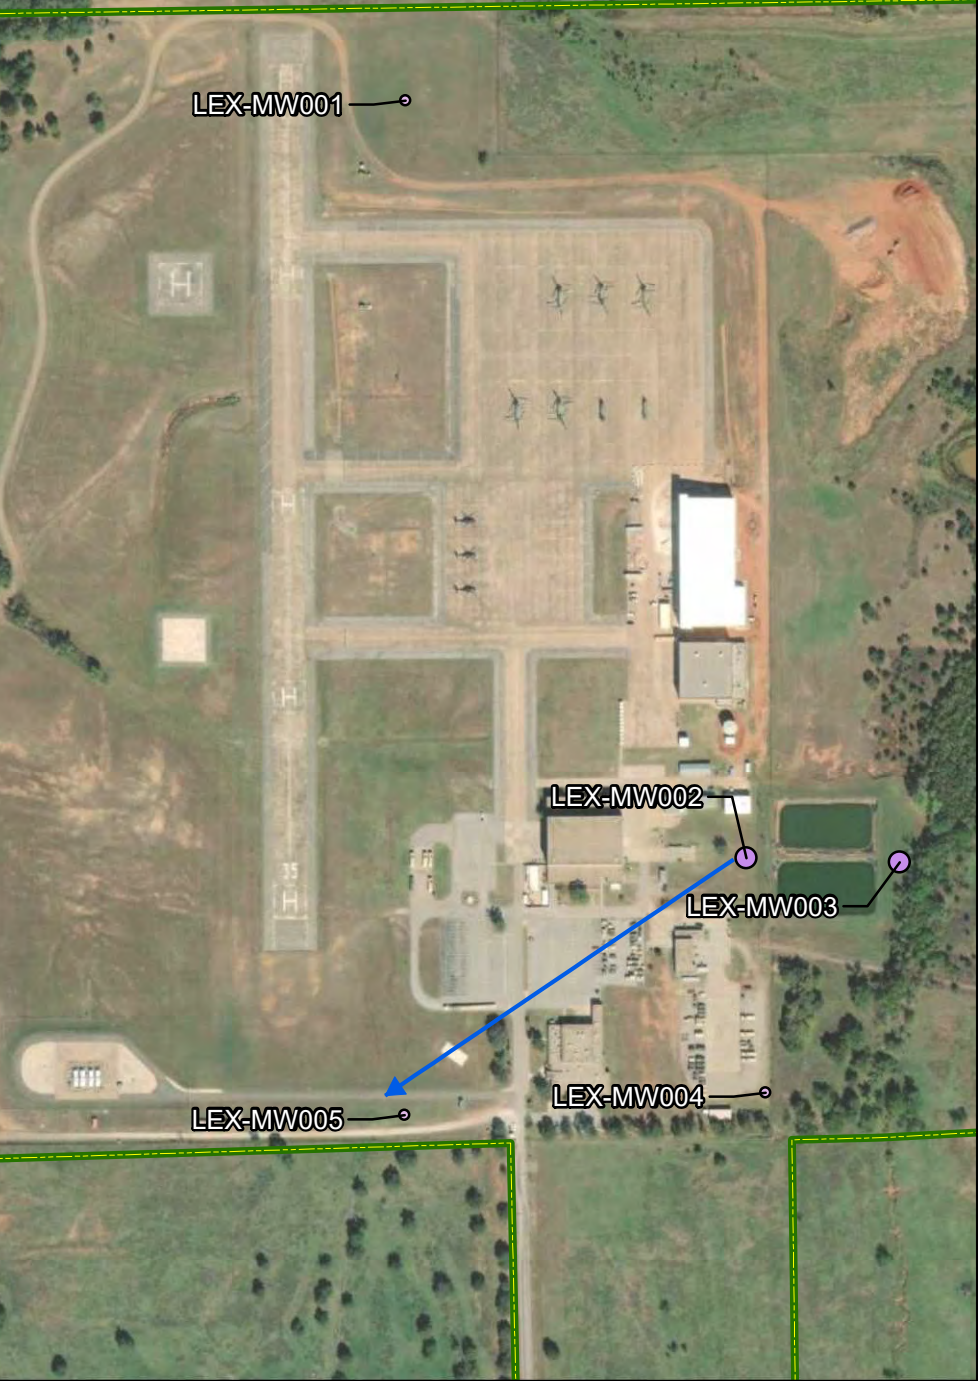
Figure 6-4

PFHxS Results (µg/Kg)
