FINAL Preliminary Assessment Report Camp Pendleton, Virginia Virginia Army National Guard

Perfluorooctanesulfonic Acid (PFOS) and Perfluorooctanoic
Acid (PFOA) Impacted Sites
ARNG Installations, Nationwide

August 2020

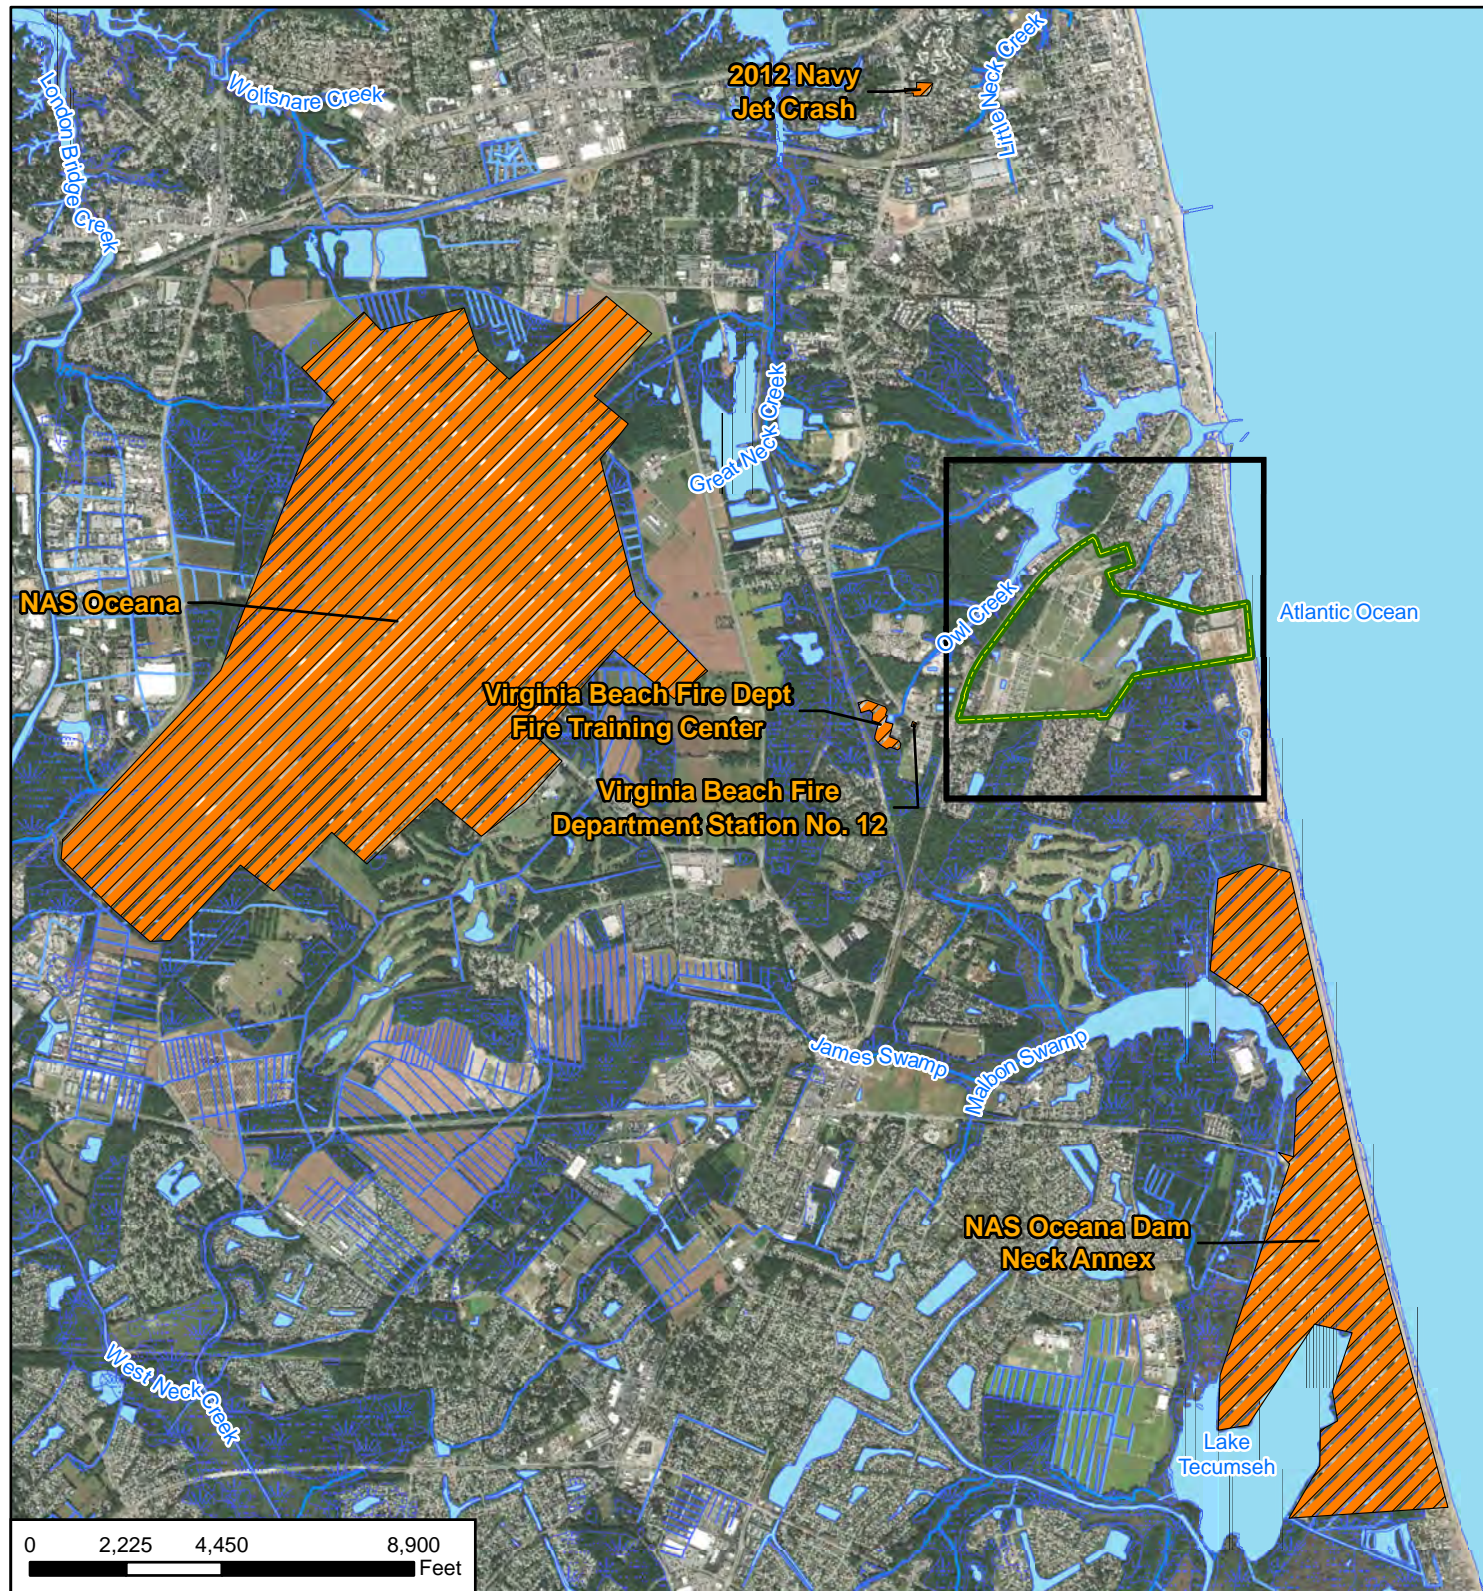
Summary of Findings	
AECOM	12420 Milestone Center Drive Germantown, MD 20876
Figure ES-1

Three AOIs related to potential PFAS releases were identified at Camp Pendleton based on PA data (**Figure ES-1**) and is summarized in **Table ES-1** below:

Additionally, several adjacent sources of potential PFAS release were identified in areas surrounding Camp Pendleton including Naval Air Station (NAS) Oceana, the Virginia Beach Fire Department Fire Station Number 12, and numerous jet crash emergency response locations. It is possible that a potential PFAS release at one of the adjacent sources identified may have contributed to PFAS within environmental media at Camp Pendleton. Adjacent off-facility potential PFAS sources are shown on **Figure ES-1**.

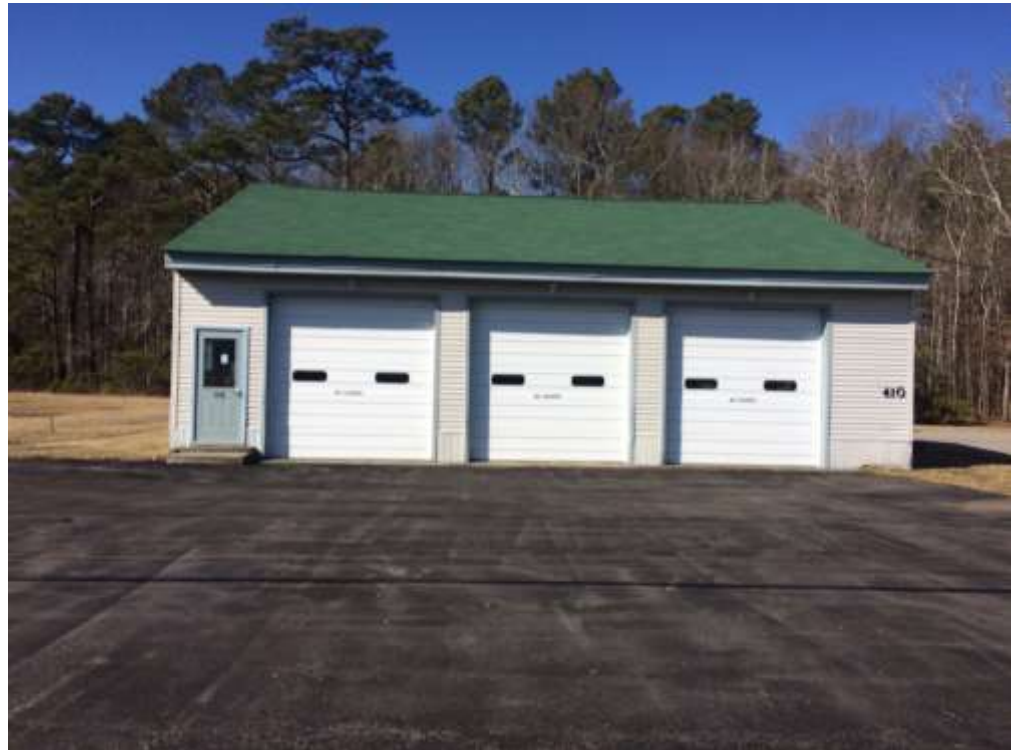
Building 410; former fire
station at Camp Pendleton

Building 410 served as the Camp Pendleton Fire Department prior to the 1970s and is currently used as a classroom and storage building. Building 410 is located in the central portion of Camp Pendleton (**Figure 3-1**), and its approximate geographic coordinates are 36°81'64.79"N; 75°98'36.06"W. According to interviewees, Building 410 has never been a place for storage or use of AFFF products, nor does it have an AFFF fire suppression system. During the site visit, hoses stamped in 1976 were observed at Building 410 and appeared to have function for water only; use of PFAS for firefighting purposes by the Department of Defense began in 1969. Based on the date stamped on firehoses, Building 410 may have been used as the Camp Pendleton Fire Department after the introduction of PFAS-containing materials to the ARNG. Although no evidence gathered for Building 410 indicates that AFFF was ever used or stored at the building, it is possible that undocumented storage or use of PFAS-containing materials occurred at the building based on its uncertain dates of use. Building 410 is considered a potential PFAS release area.

AOI 3 is Building 410, the former Camp Pendleton Fire Department. Although there are no documented AFFF releases from the fire station building, the dates of use for the Fire Department indicate that it is possible that AFFF could have been used or stored at the AOI.

Any released AFFF may have occurred within Building 410 or on the grassy areas surrounding the building. Stormwater runoff at Building 410 drains to Owl Creek and its tributaries. The pathways and receptors for AOI 3 are the same as described in **Section 6.1**. The preliminary CSM for AOI 3 is shown on **Figure 6-2**.

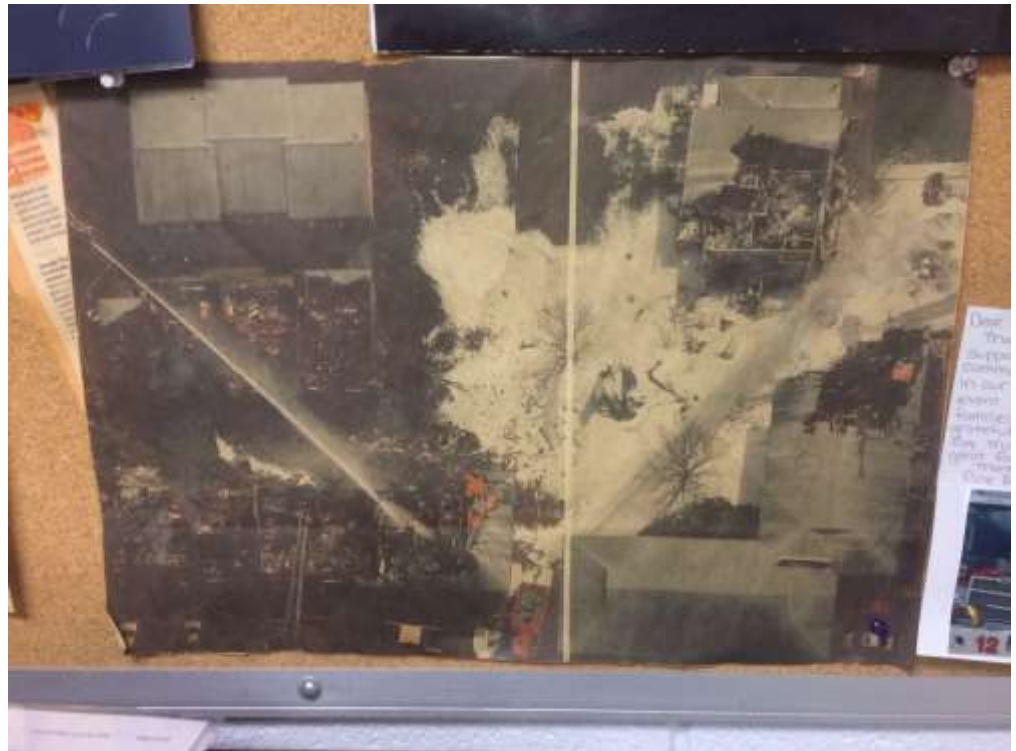
Historical photo of AFFF use
in response to an off-facility
Navy jet crash circa 2013.
Photo shows an aerial image
of damaged apartment build-
ings, an active jet of foam at
the left, and white foam
residue covering much of the
ground pictured.

crash scene. The volume and type of AFFF used in response to the fire is unknown. Photo number 2 in **Appendix C** shows the discharged AFFF at the scene of the crash.

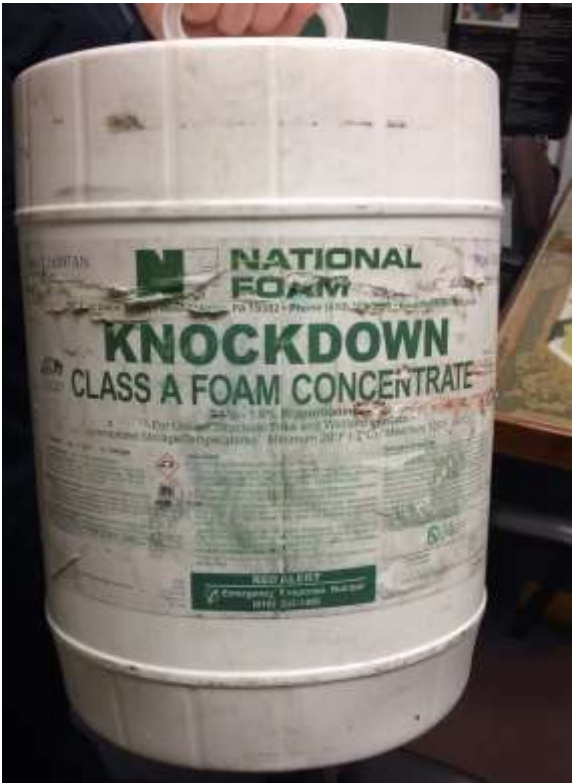
Photograph No. 3

Date 2/6/2019 Time 12:26	
Description: Class A foam stored at the off-facility Virginia Beach Fire Station Number 12	
Orientation: South

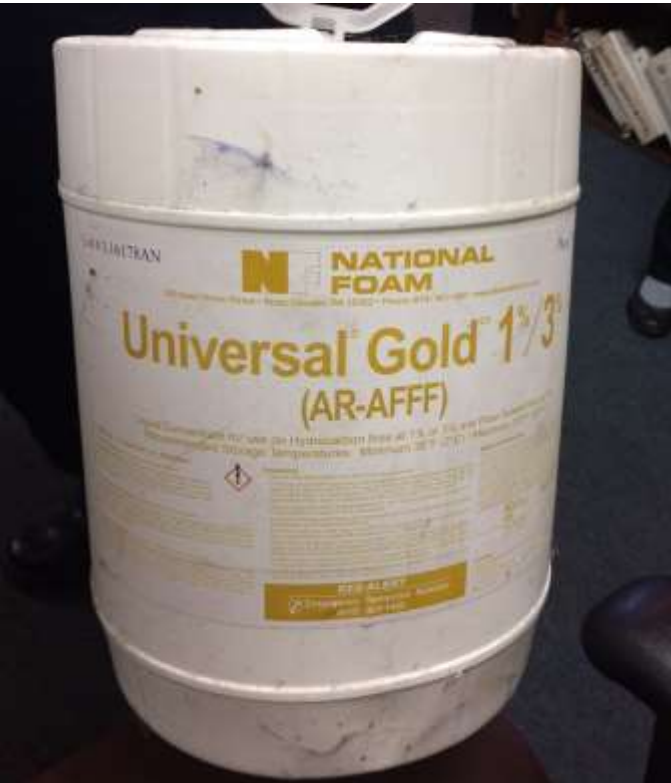
Photograph No. 4

Date 2/6/2019 Time 12:27	
Description: National Foam Universal Gold AFFF stored at the off-facility Virginia Beach Fire Station Number 12	
Orientation: South
