Preliminary Assessment Report Army Aviation Support Facility #1 Salem, Oregon

Perfluorooctane-Sulfonic Acid (PFOS) and Perfluorooctanoic
Acid (PFOA) Impacted Sites
ARNG Installations, Nationwide

August 2019

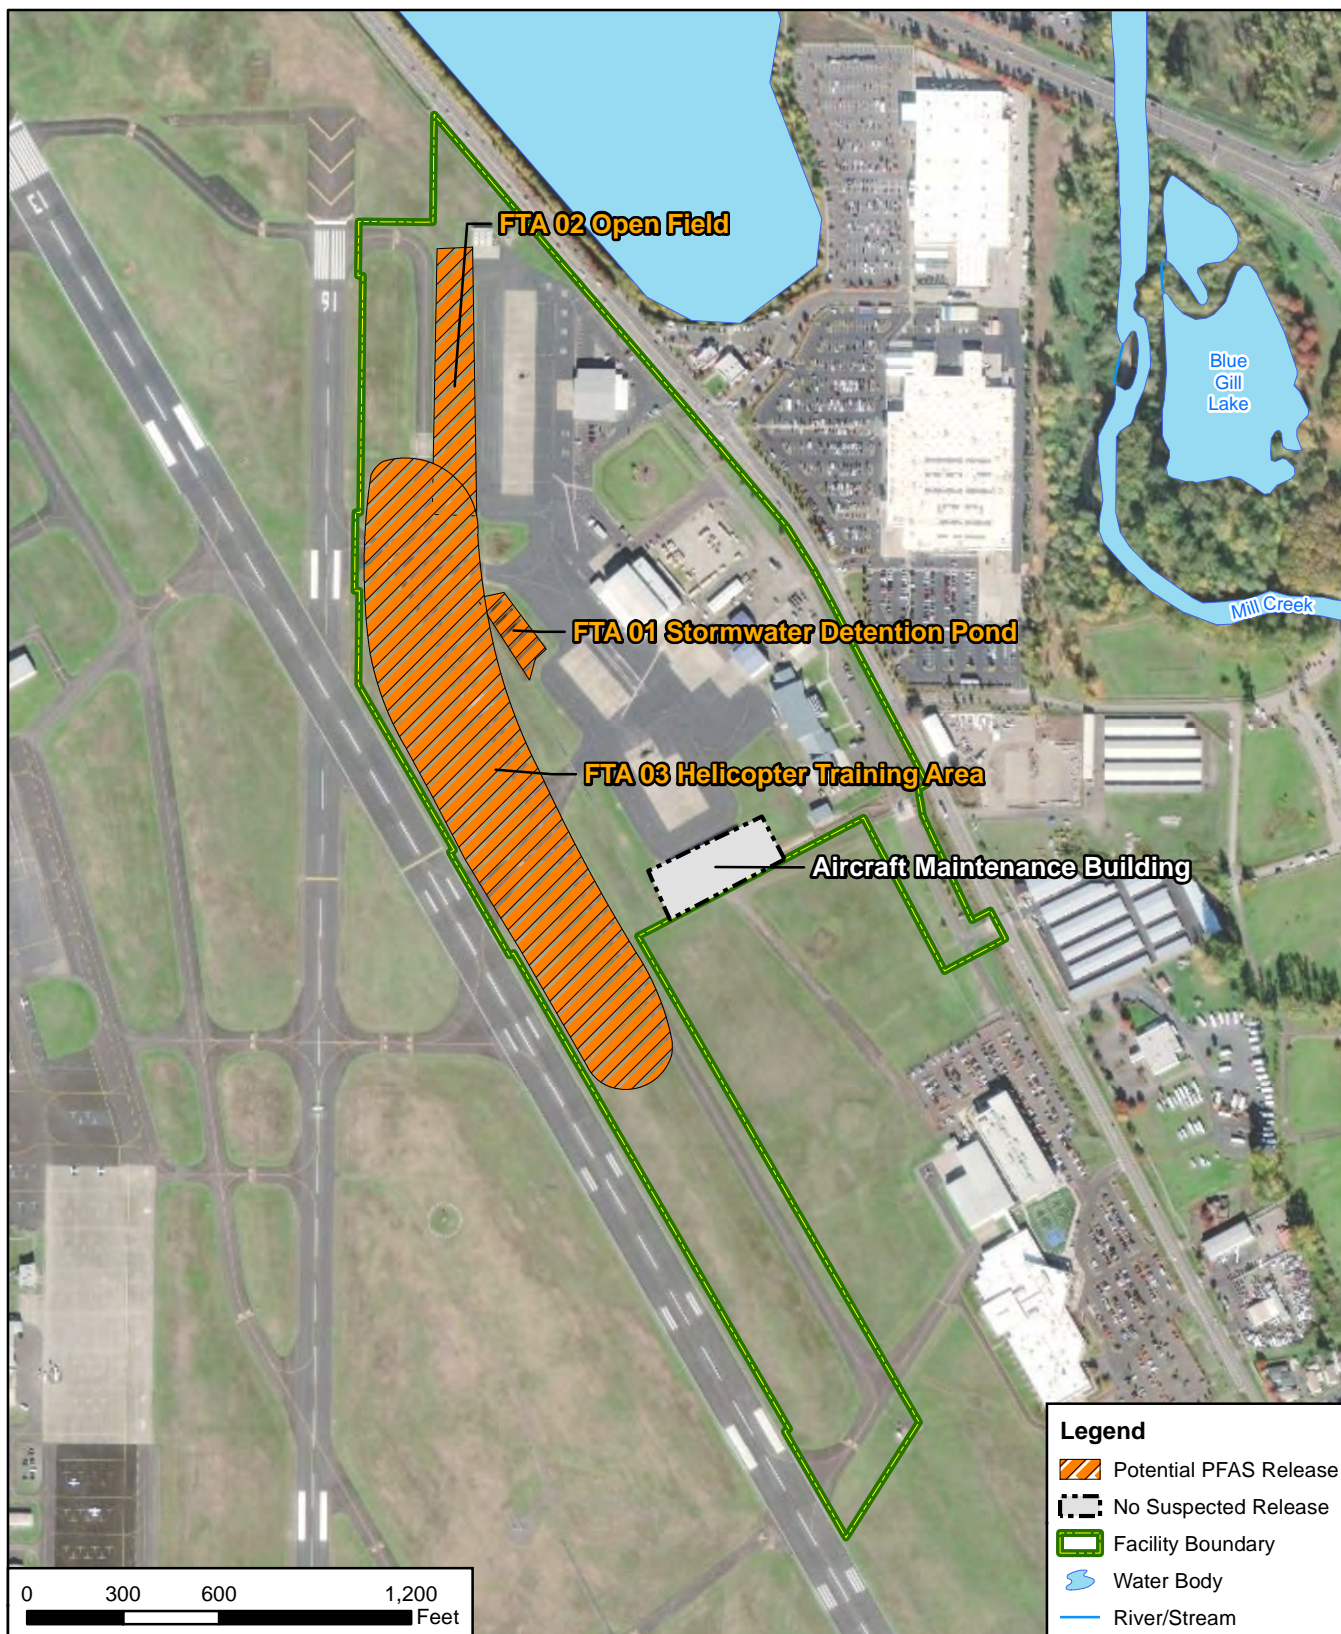
Fire Training Areas

FTA 01 is one of two stormwater retention ponds located west of Hangar 2, across the paved aircraft parking area. Annual fire training would occur at this designated location in which approximately one gallon of 3% concentrated AFFF from each of the six TriMax 30 tanks would be dispensed in this detention pond. This training was intended to teach personnel how to operate the nozzles on the TriMax 30 tanks. Additionally, it was noted during interviews that personnel at the AASF along with personnel from the City of Salem fire department would conduct annual controlled barrel burns within this stormwater detention pond. Wood and other organic debris would be burned in 55-gallon drums and extinguished using non-PFAS containing portable fire extinguishers (either Class A or Class ABC fire extinguishers).

During interviews, it was noted that from approximately 1989 through 1991, annual fire training activities involving AFFF would occur in a large grassy field to the west of Hangar 1. During fire training activities, controlled burns using wood and other organic debris would occur in this area over the course of a weekend. Multiple ORARNG facilities would participate in this training by bringing their own firetrucks pre-filled with AFFF and using the open field for fire training activities. A firetruck at Salem with an AFFF tank capacity of approximately 50 gallons would also be used during these annual trainings; however, exact AFFF quantities used during each event and concentration of AFFF are unknown.

During interviews, personnel noted that annual firefighting training activities occurred just outside the aircraft maintenance building, located on the south end of the facility. Following construction of the aircraft maintenance building in approximately 2013, joint annual trainings with personnel from the AASF and the local Salem Fire Department would occur outside this building. Firetrucks were used by both ORARNG and Salem Fire Department to conduct fire training activities. Interviewees stated that this training only involved water, and did not involve the use of AFFF. There are no suspected releases of AFFF at or within the vicinity of the aircraft maintenance building.

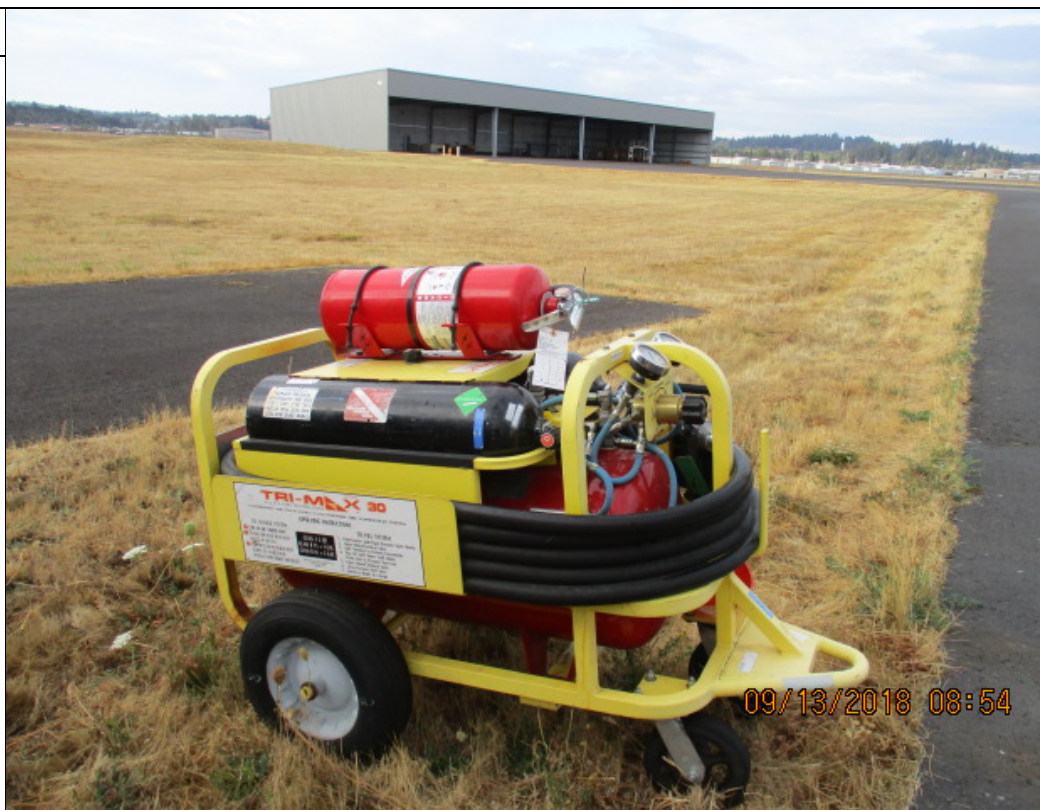
Facing south. One of the six full TriMax 30 tanks, collocated with non-PFAS containing portable fire extinguishers, located along the flightline.

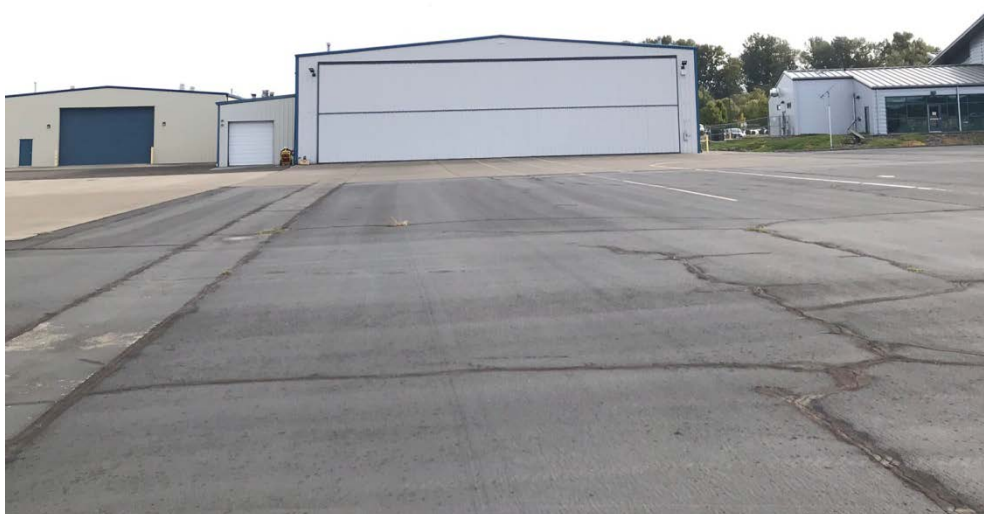
Photograph No. 2

Facing East. The building directly in front is Hangar 3. The TriMax 30 tank is stored outside, to the left of the hangar. The small building just to the left of the TriMax 30 houses the oil water separator (OWS) evaporator.

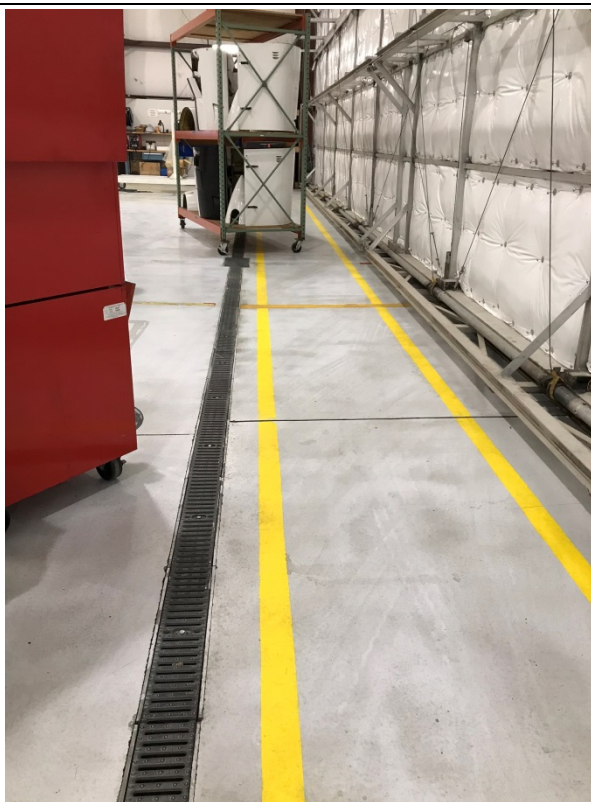
Floor drains inside of Hangar 3. These drains lead to the local sanitary sewer which is sent to the Willow Lake Wastewater Treatment Plant before being discharged into the Willamette River.

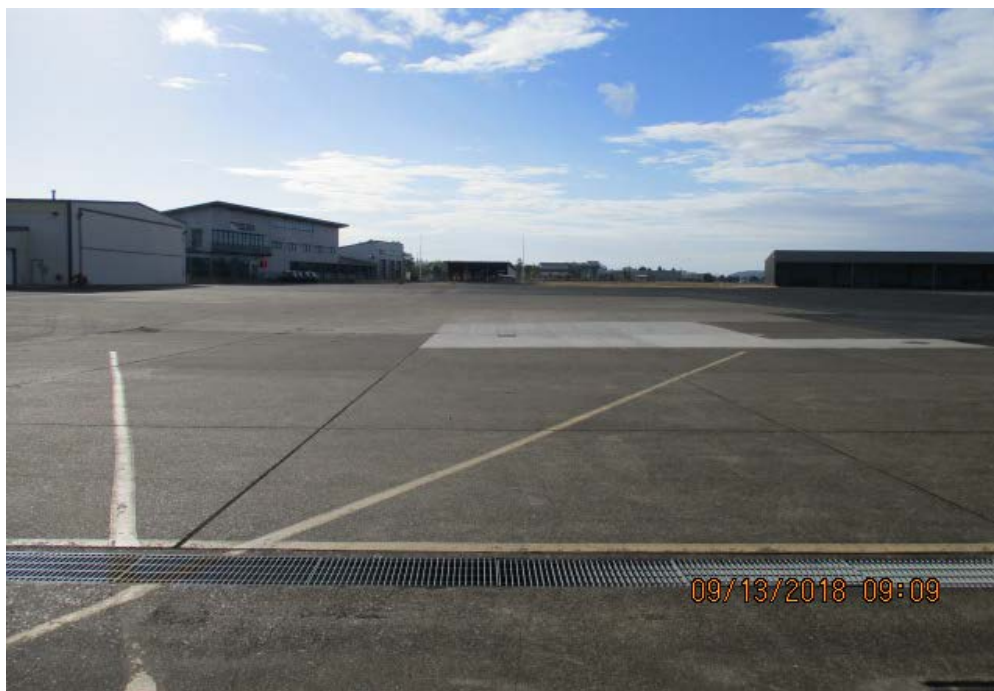
Photograph No. 4

Facing Southeast. One of the two grate drains present at the south end entrance of Hangar 2. The trench drains discharge to the OWS..

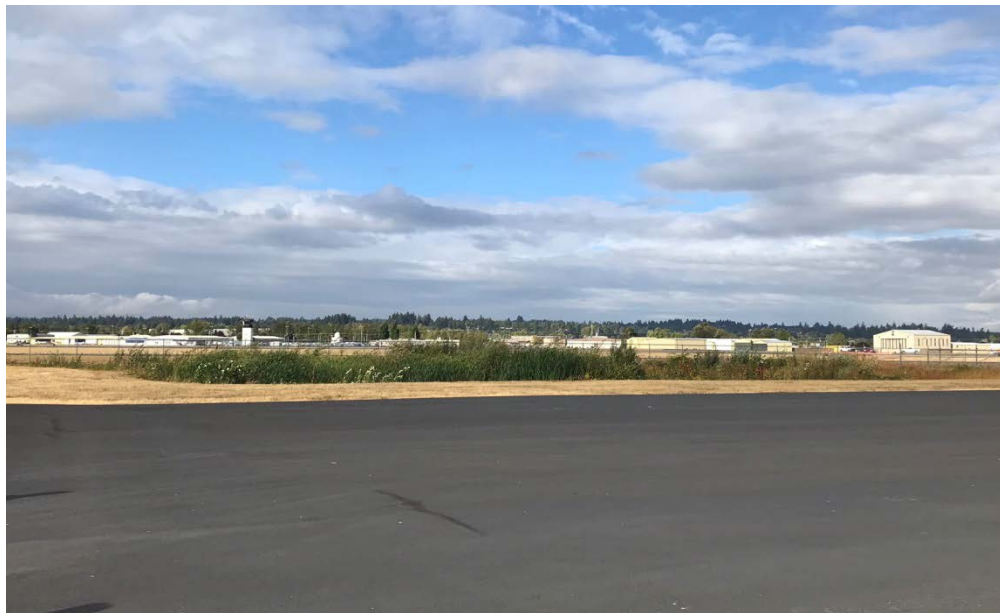
Facing West. One of the two stormwater management ponds located at Salem AASF #1.

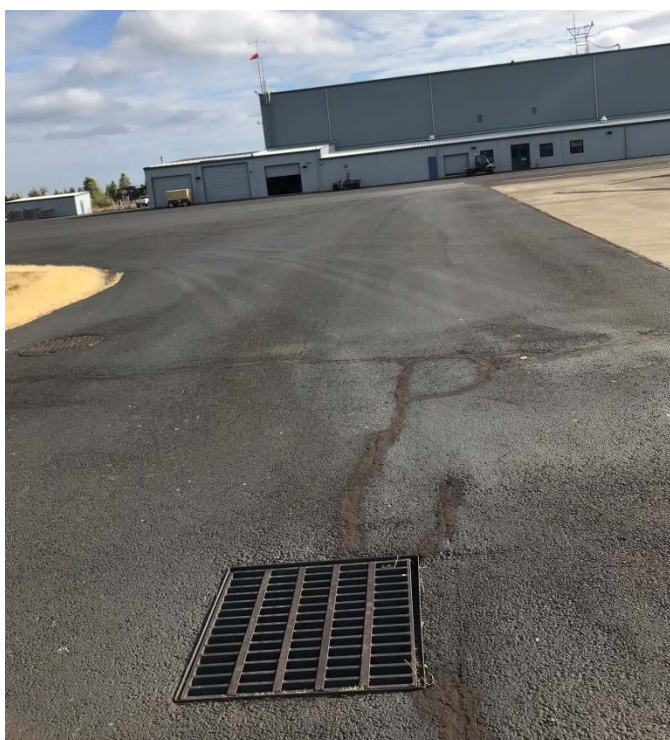
Photograph No. 6

Facing Northeast, towards Hangar 2. One of the stormwater drains directly outside the stormwater management pond..

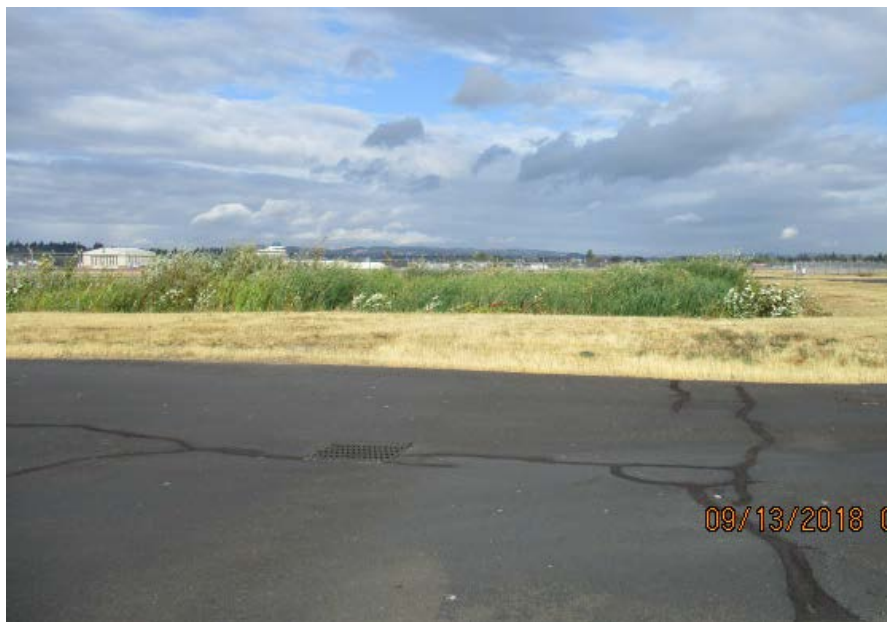
Facing Northwest towards
AOI 1. One of the storm
drains directly outside the
stormwater management pond.
.

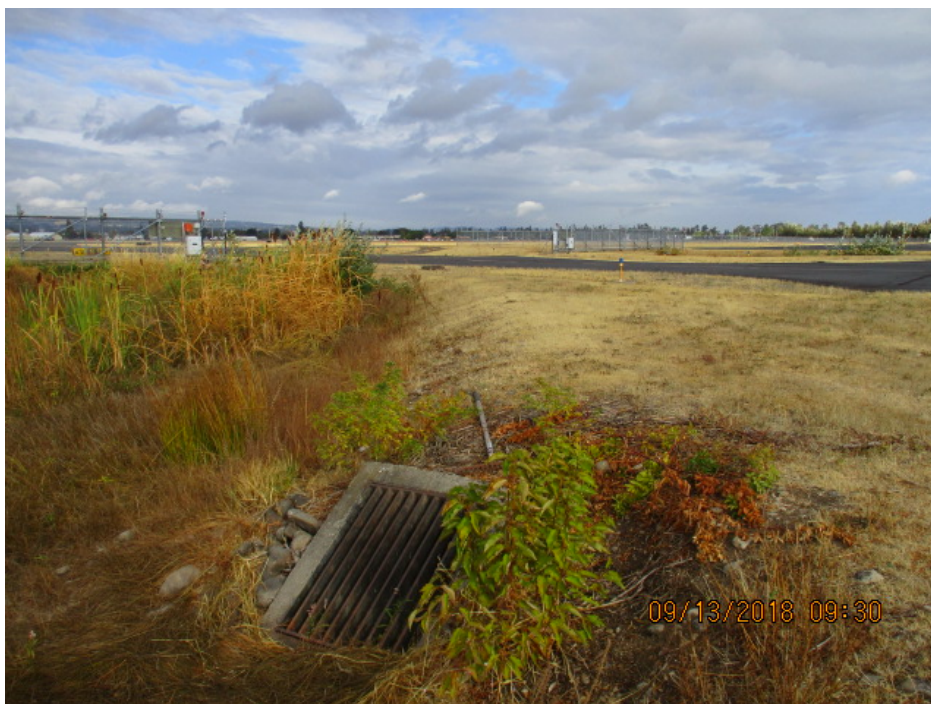
Photograph No. 8

Facing North. One of the two
storm drains located within the
stormwater management pond.
This storm drain leads to the
stormwater outfall just outside
the northeast boundary of the
facility.

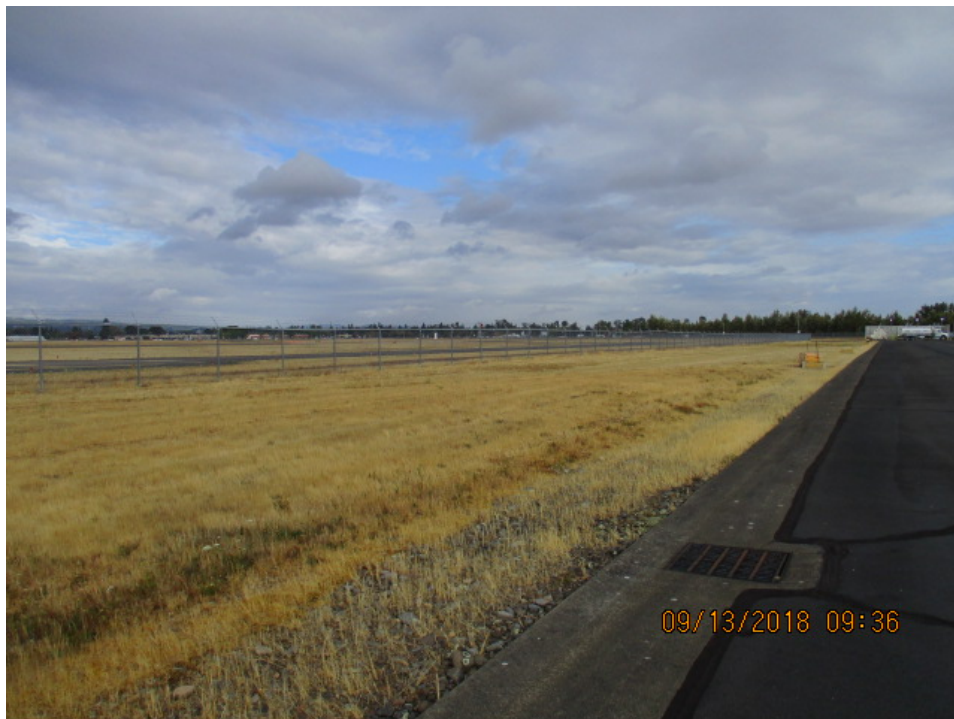
Facing Northwest, towards AOI 2. Stormwater and surface runoff collected in this drain discharges to the stormwater outfall just outside the northeast boundary of the facility.

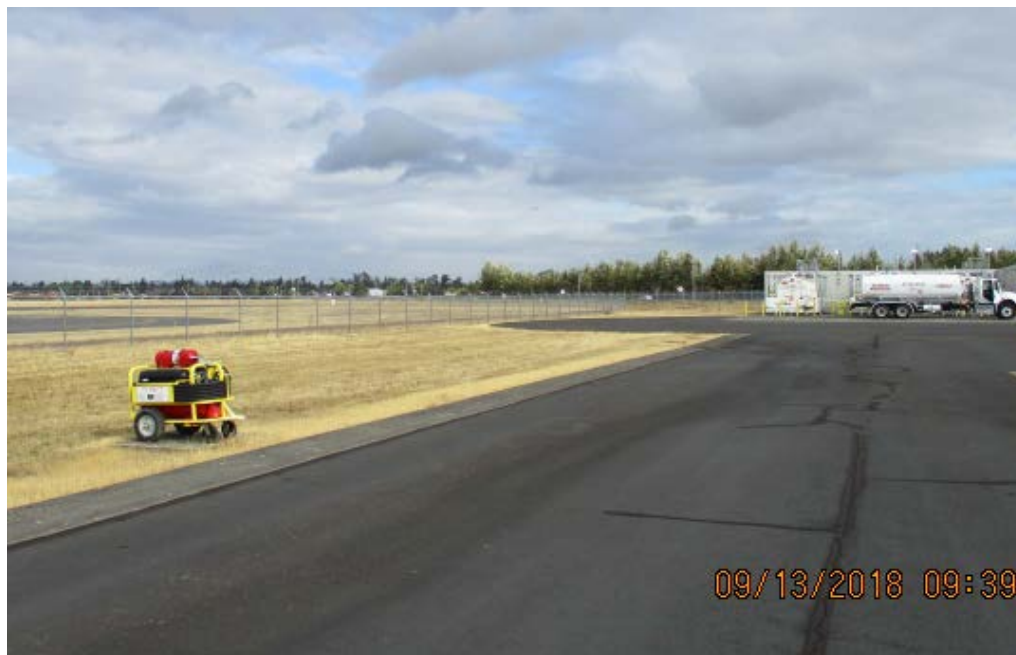
Photograph No. 10

Facing Northwest. One TriMax 30 tank located within AOI 2, the current fueling station can be seen on the right hand side of the picture.

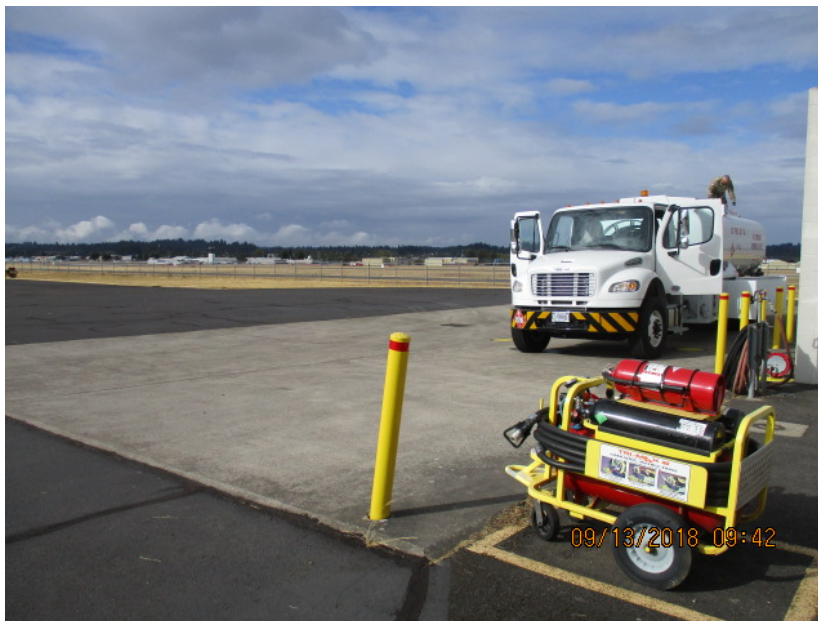
Facing Southwest. Location of the fueling point located on the northern tip of the facility.

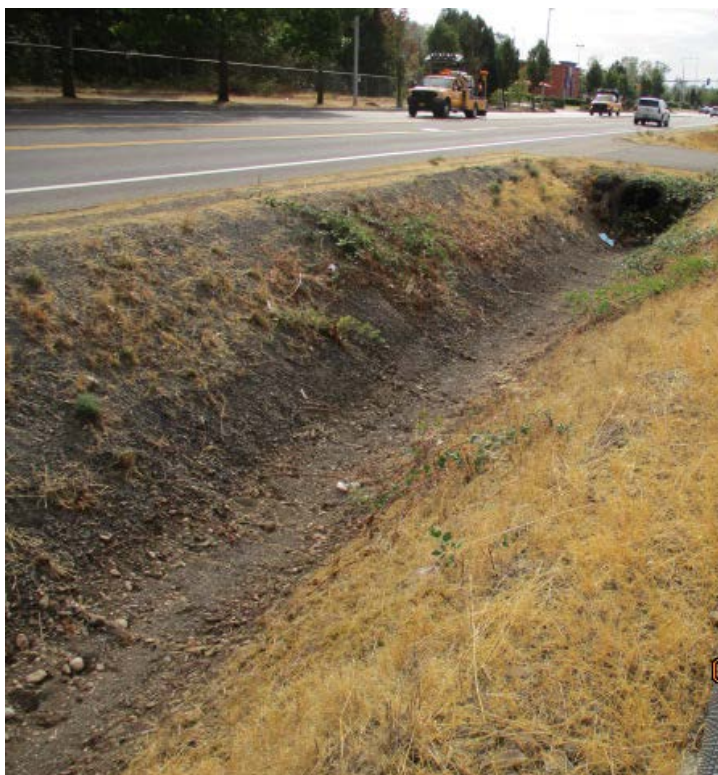
Photograph No. 112

Facing Southeast. Pictured is Mission Ditch, where all stormwater and surface runoff from the facility is discharged. This off-site ditch flows west/northwest discharging into Pringle Creek, and eventually flowing into the Willamette River.

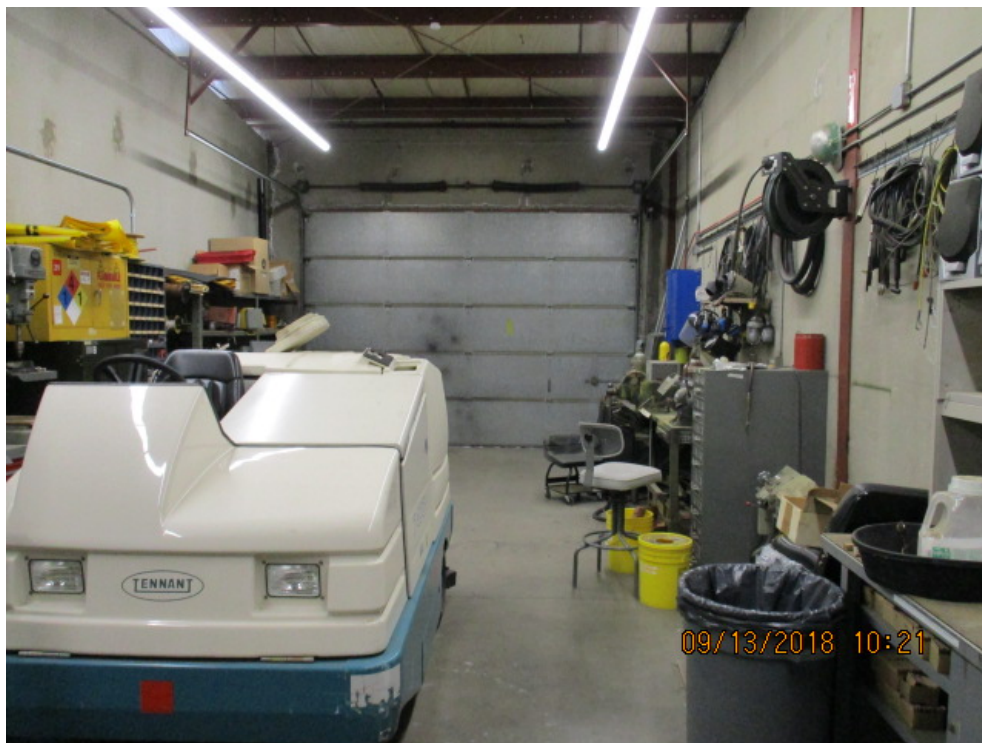
The previous firetruck storage area within Hangar 2. No drains are located within this storage area.

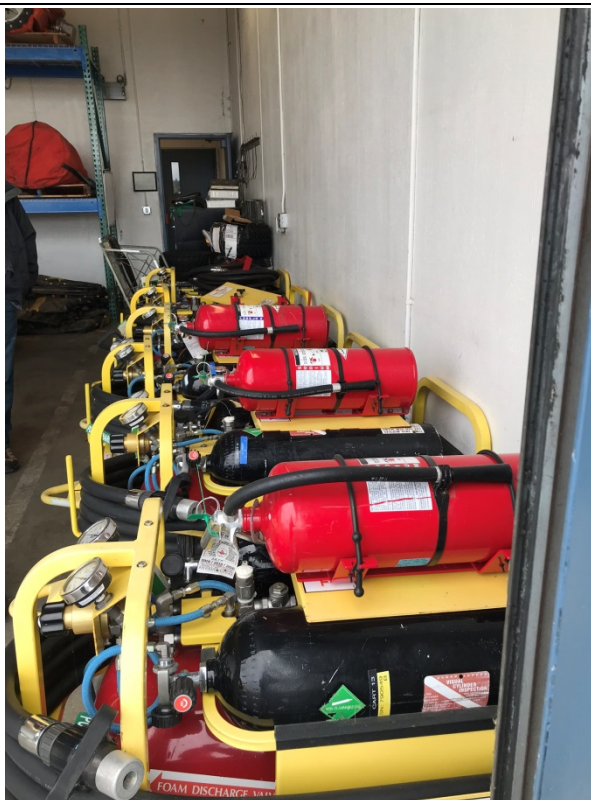
Photograph No. 14

Six empty TriMax 30 tanks stored within a non-climate controlled room of Hangar 2.
