Preliminary Assessment Report

Christmas Valley Radar Site

Christmas Valley, Oregon

Perfluorooctane-Sulfonic Acid (PFOS) and Perfluorooctanoic Acid (PFOA) Impacted Sites
ARNG Installations, Nationwide

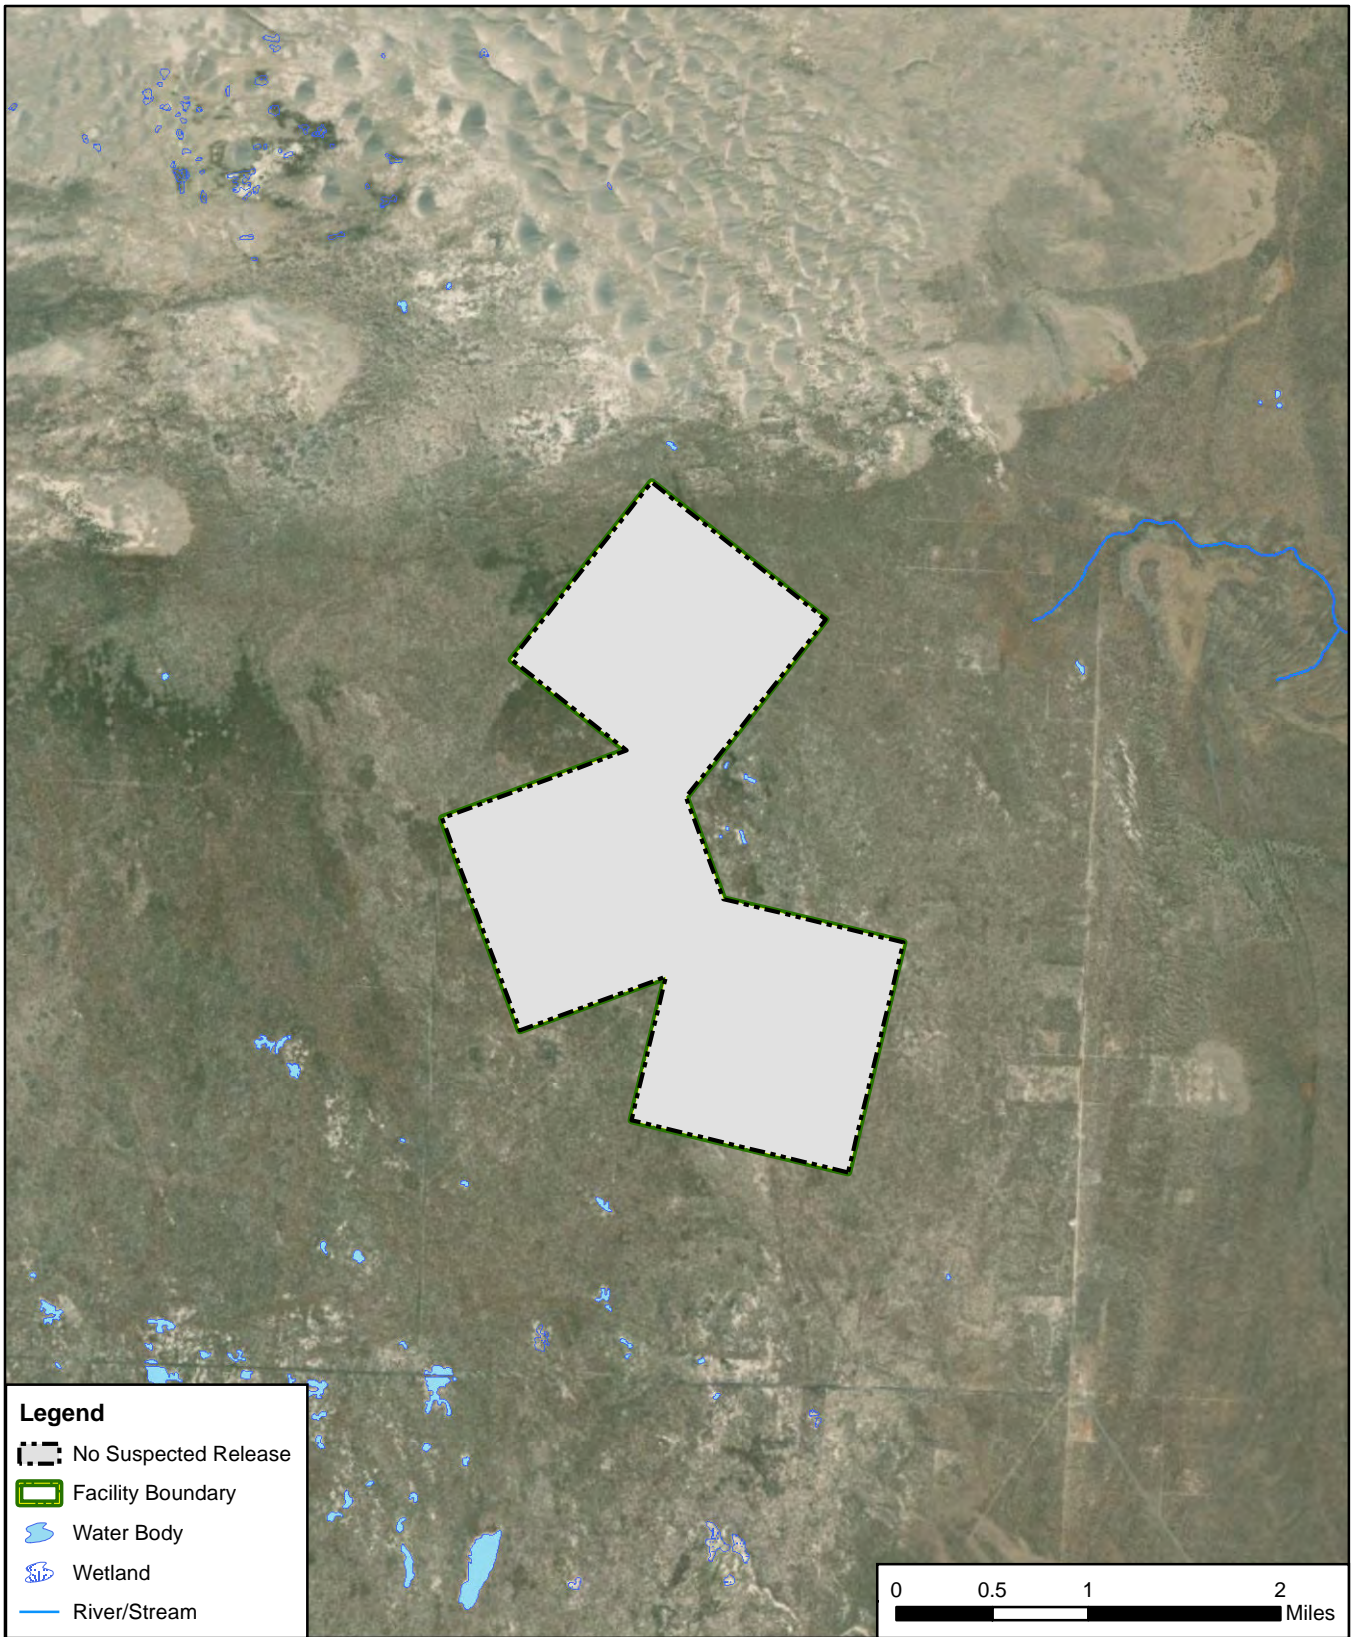
Summary of Findings	
 12420 Milestone Center Drive Germantown, MD 20876	Figure ES-1

No Area(s) of Interest related to potential PFAS use, release, or storage were identified at Christmas Valley during the PA (**Figure ES-1**). Based on facility history and interviews with various personnel, there is no potential for exposure to PFAS contamination in surface soil, subsurface soil, groundwater, surface water, and sediment.

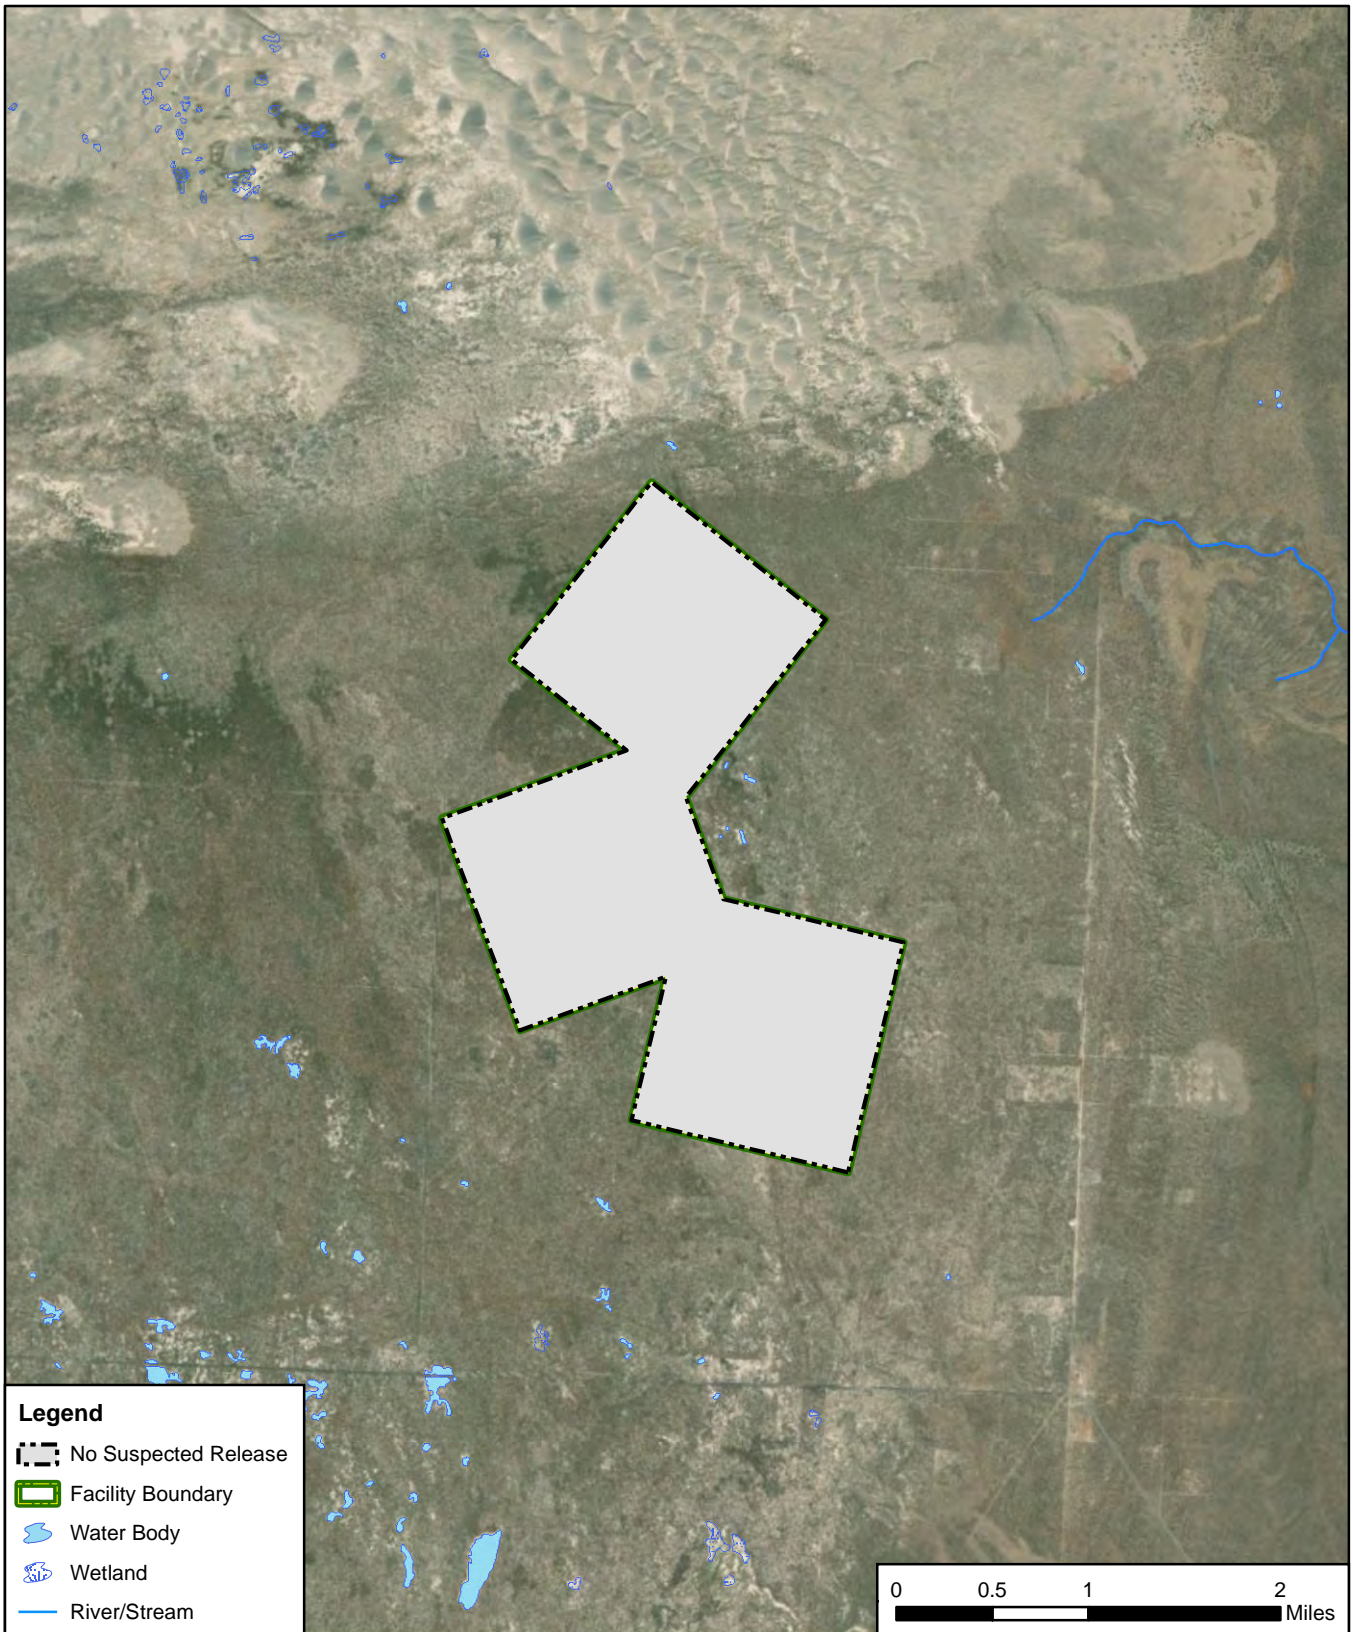
12420 Milestone Center Drive Germantown, MD 20876	Figure 7-1

Based on information obtained during interviews conducted with facility personnel, facility observations, and reviewed documentation, it is confirmed that AFFF has never been stored, used, or released at the Christmas Valley Radar Site since ORARNG took control of the facility; therefore, no AOIs related to PFAS releases were identified. No information was available pertaining to potential historic PFAS-related releases prior to ORARNG taking control of the property.

Based on the documented absence (2010-present) of the use, storage, or release of PFAS-containing materials at Christmas Valley Radar Site, no AOIs were identified during the PA. Evidence does not indicate that current or former ARNG activities contributed PFAS contamination to soil, groundwater, surface water, or sediment at the facility or adjacent areas. Christmas Valley Radar Site will not move forward in the CERCLA process.

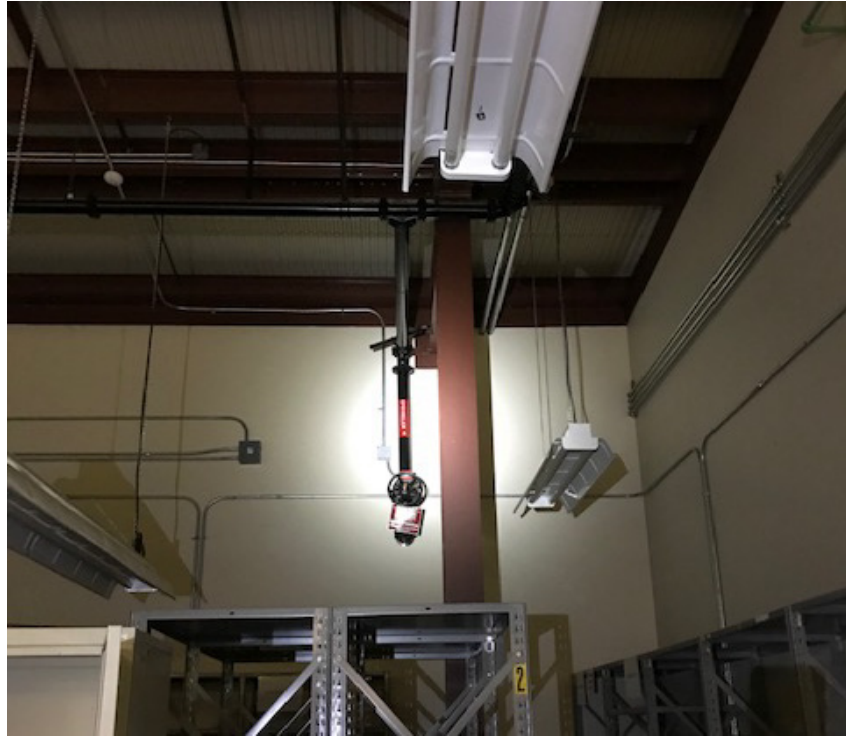
A view of the old halon fire suppression system within the main building.

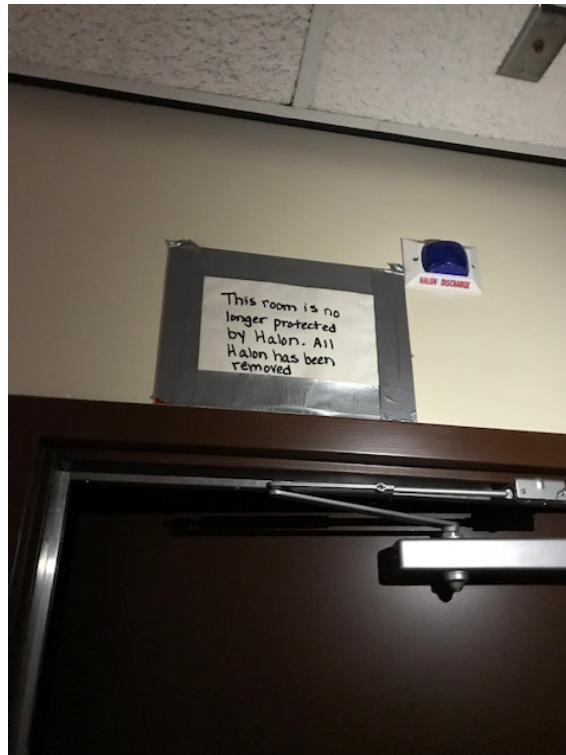
Photograph No. 4

A posted sign confirming halon has been removed from the fire suppression system within the main building.

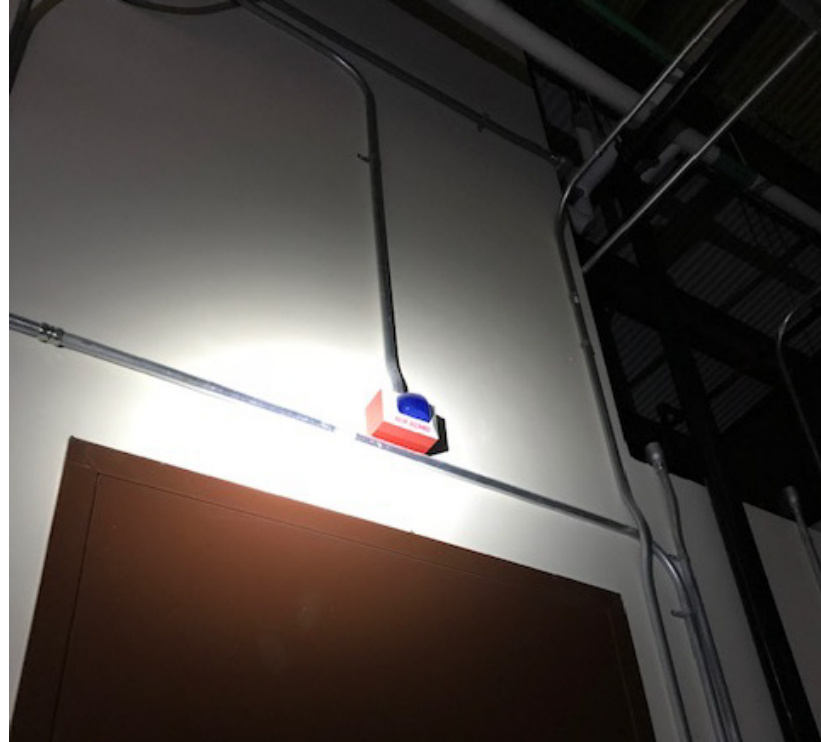
One of the many fire alarms located throughout the main building. The fire suppression system formally contained halon but all halon has been removed and the fire suppression system is no longer active.
