FINAL Preliminary Assessment Report Camp Adair, Oregon

Perfluorooctane-Sulfonic Acid (PFOS) and Perfluorooctanoic
Acid (PFOA) Impacted Sites
ARNG Installations, Nationwide

March 2019

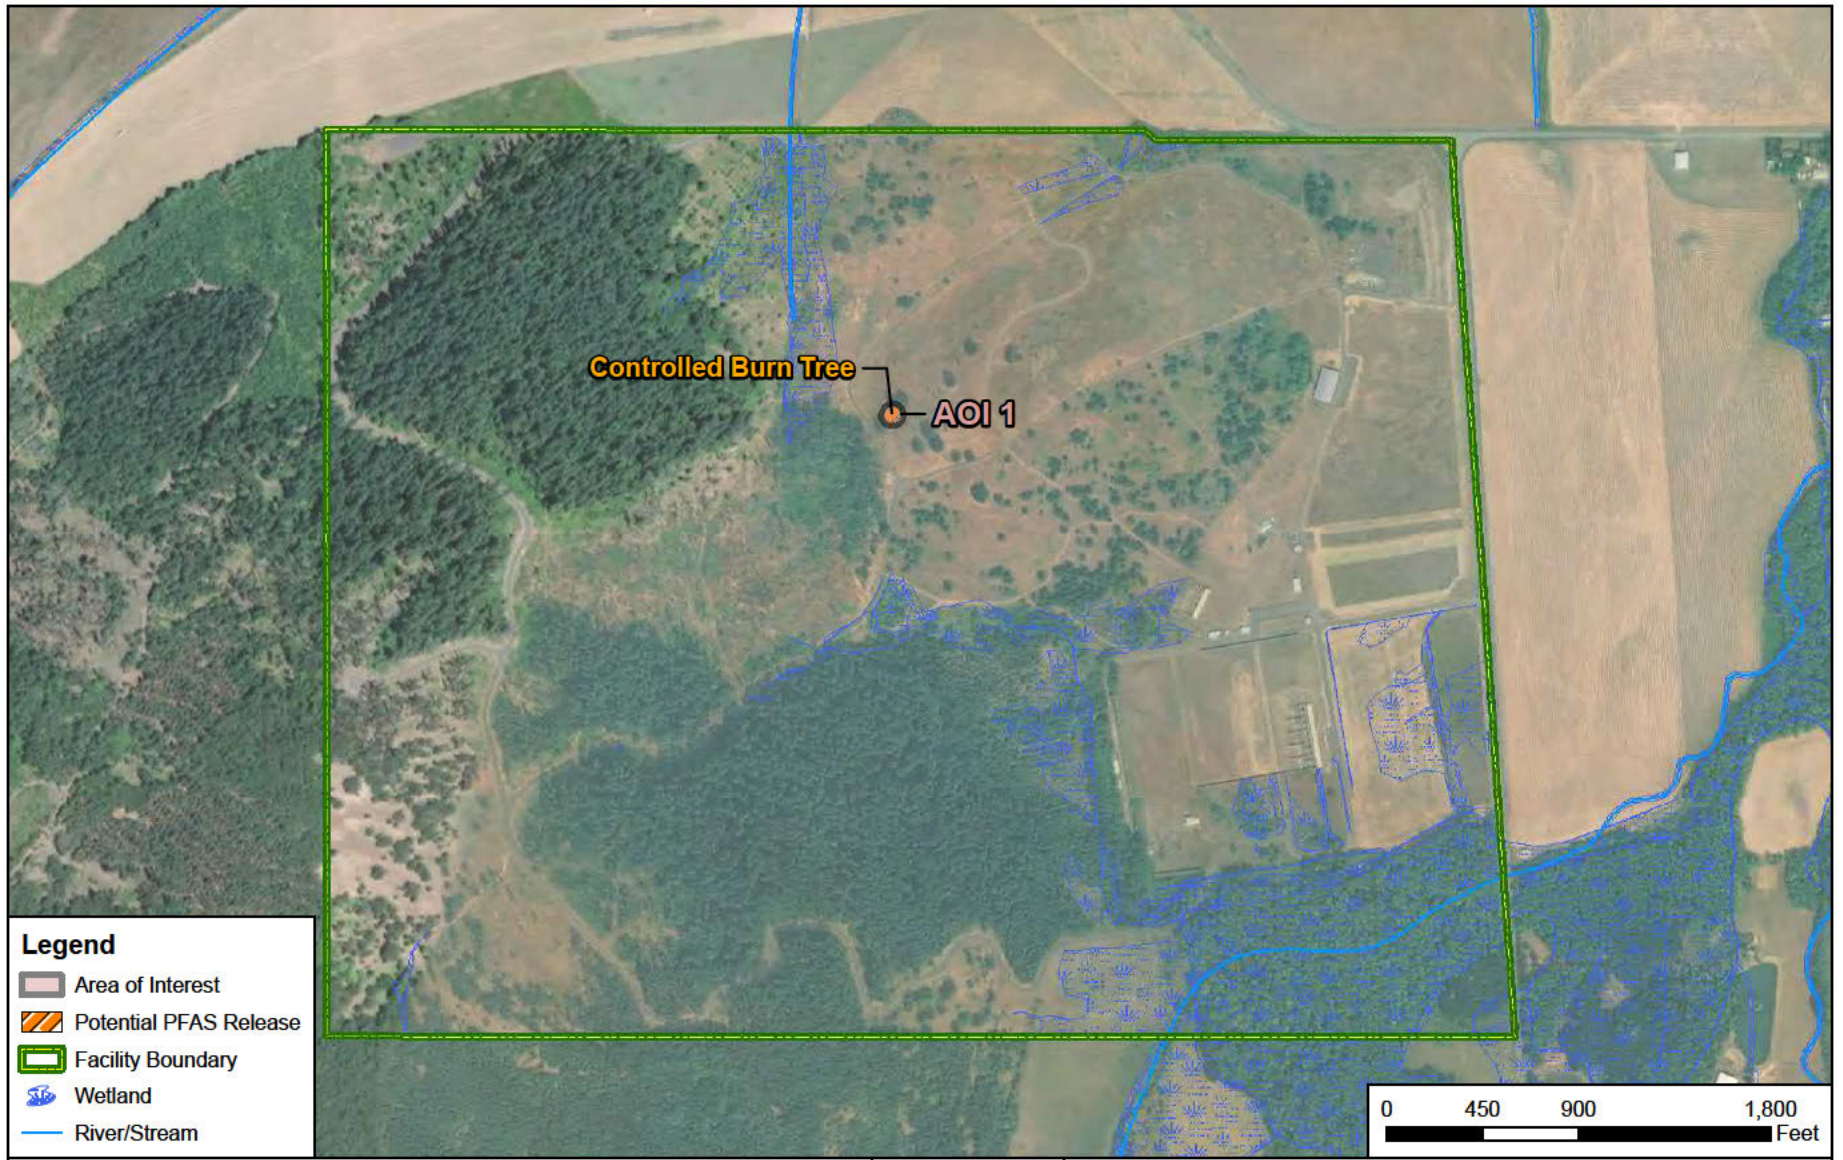
TITLE	Summary of Findings	
AECOM	12420 Milestone Center Drive Germantown, MD 20876	Figure ES-1

One Area of Interest (AOI) related to potential PFAS releases was identified at Camp Adair during the PA. The AOI is shown on **Figure ES-1** and described below.

Area of Interest	Name	Used by	Potential Release Dates
AOI 1	Controlled Burn Tree	ORARNG	2011

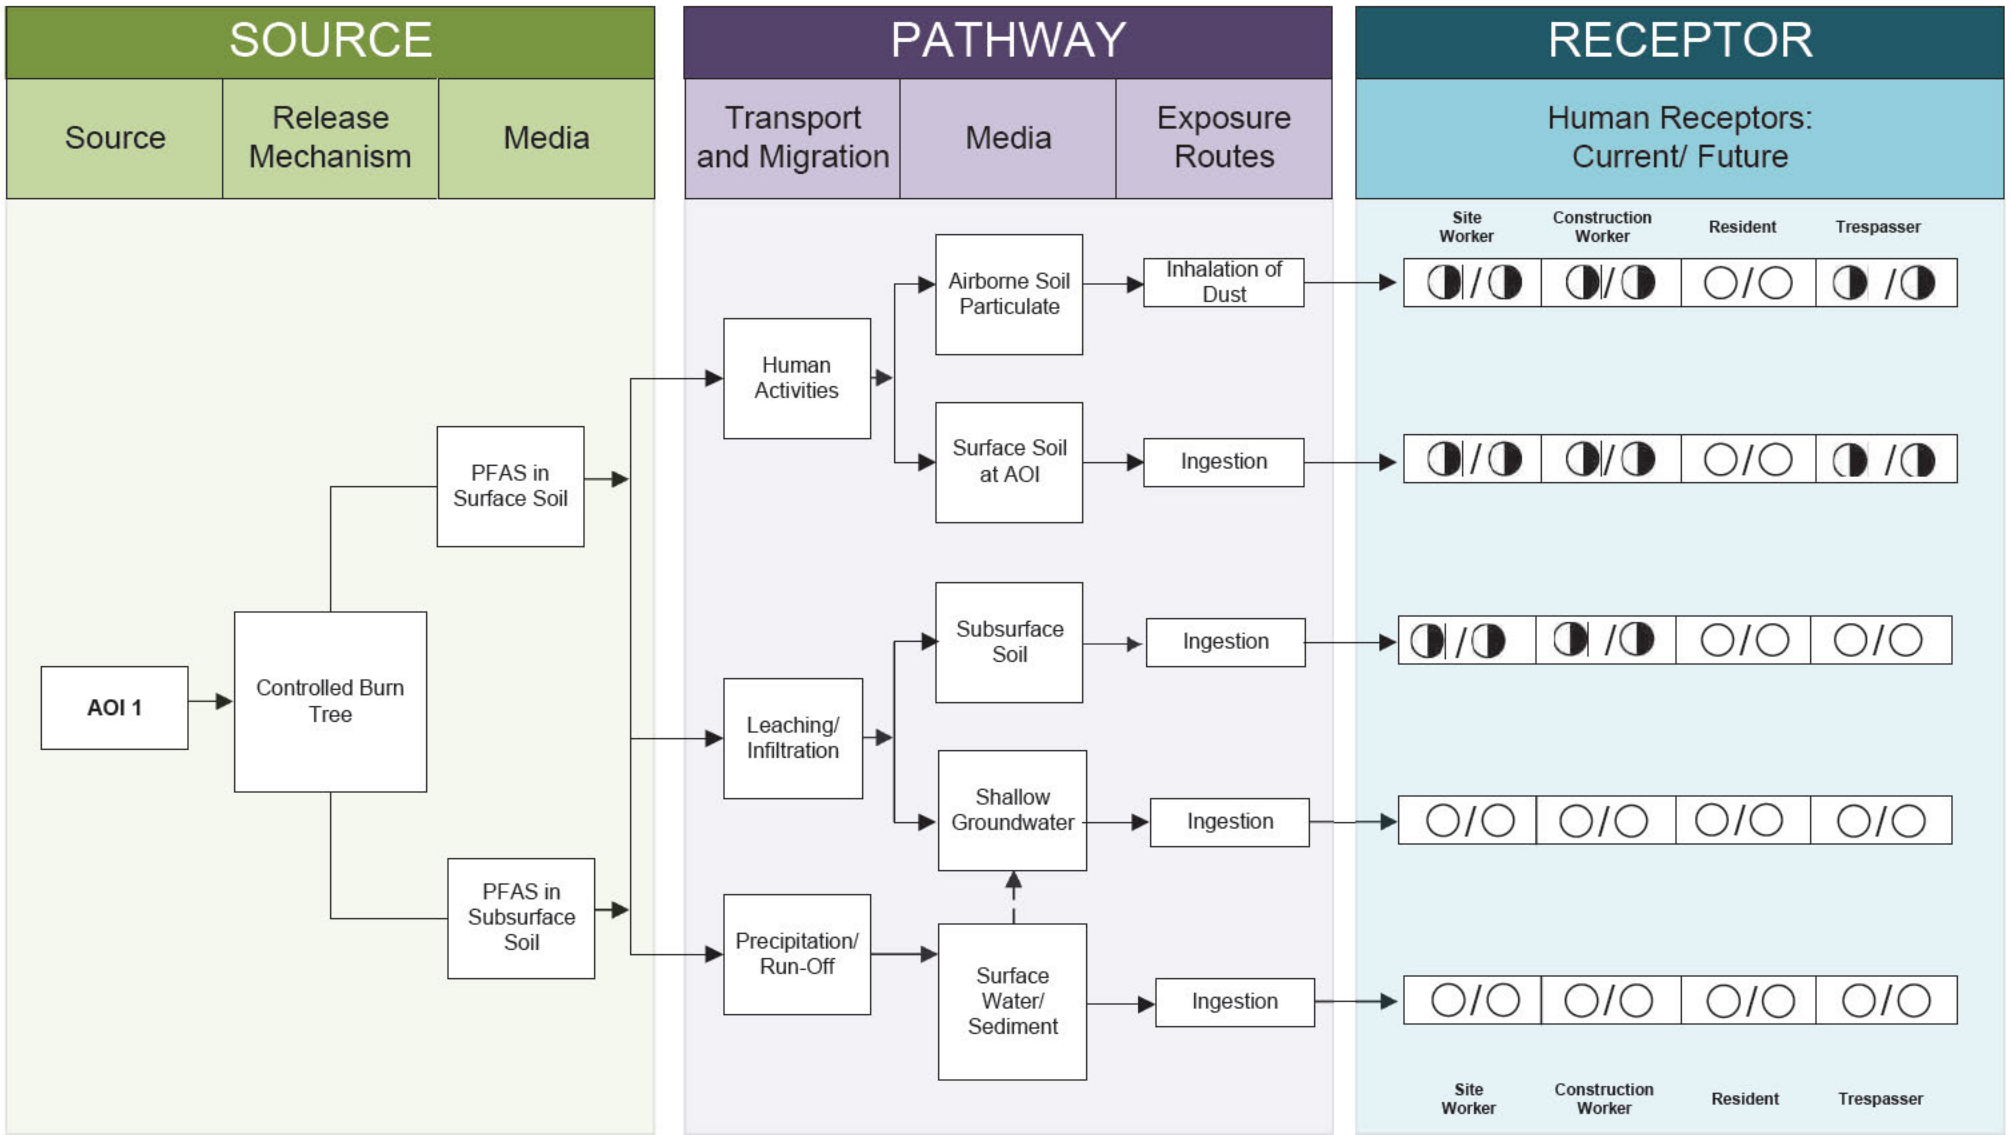
Figure ES-2
Conceptual Site Model
Camp Adair

Based on the documented use of AFFF releases at this AOI, there is potential for exposure to PFAS contamination in surface soil to site workers, construction workers, and trespassers via ingestion and inhalation, in addition to subsurface soil to site and construction workers via

ingestion. Drinking water is supplied by the Luckiamute River Water System from underground wells, located between the cities of Buena Vista and Independence, by approximately 5 and 10 miles to the northeast, respectively (OMD, 2011; LDWC, 2017). No water wells are located on-Post or in the immediate vicinity (OWRD, 2018). Therefore, the groundwater exposure pathway via ingestion is incomplete for site and construction workers, trespassers, and residents. The CSM for Camp Adair is shown on **Figure ES-2**.

No off-Post sources were identified in the local area surrounding Camp Adair; therefore, no complete exposure pathways exist for PFAS contamination in groundwater from with potential off-Post sources.

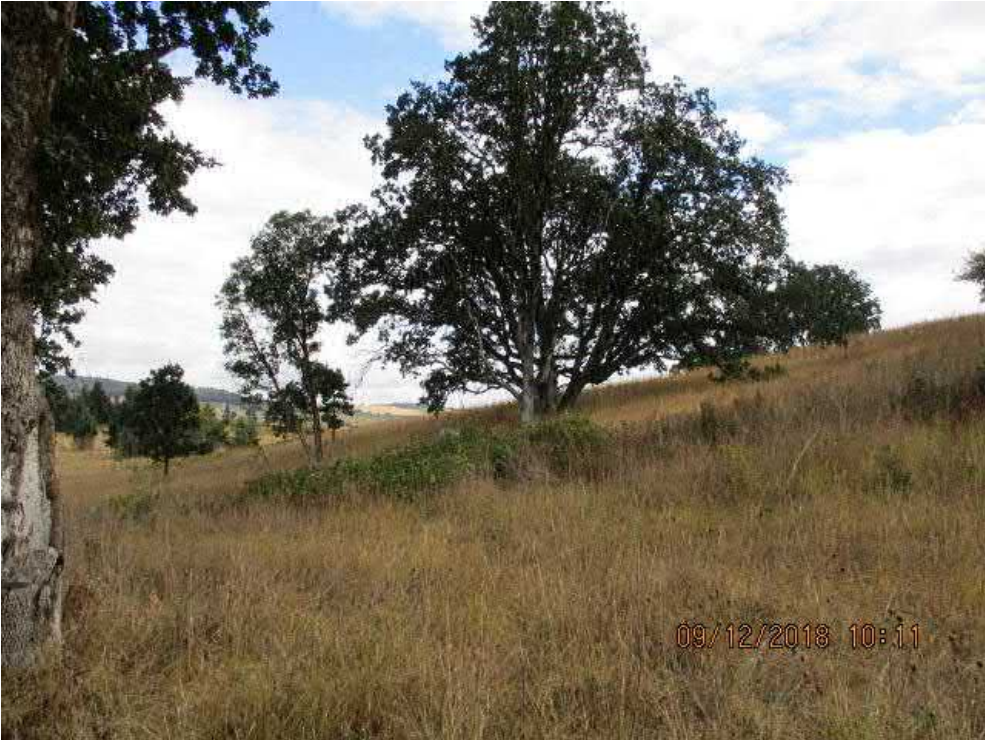
Army National Guard, Preliminary Assessment for PFAS	Camp Adair	Corvallis, Oregon
<p>Photograph No. 1</p> <p>Description:</p> <p>View looking northeast at Area of Interest (AOI) 1 (firefighting training tree) in the north/central portion of the facility..</p>

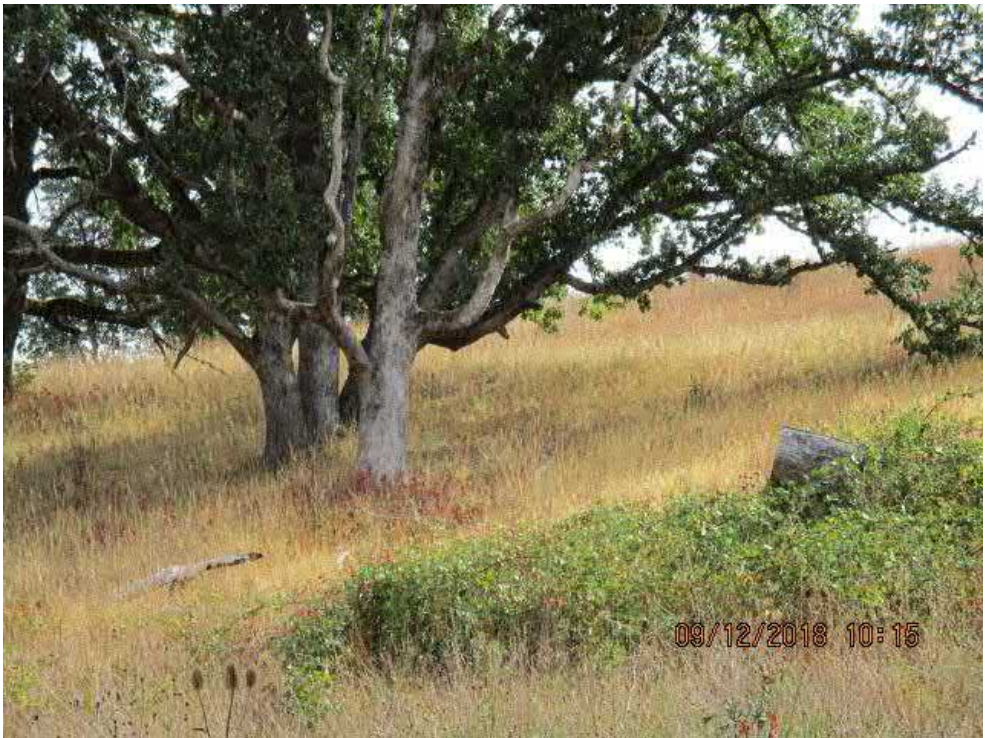
<p>09/12/2018 10:11</p>	
<p>Photograph No. 2</p> <p>Description:</p> <p>View looking east at AOI 1 (firefighting training tree) in the north/central portion of the facility..</p>

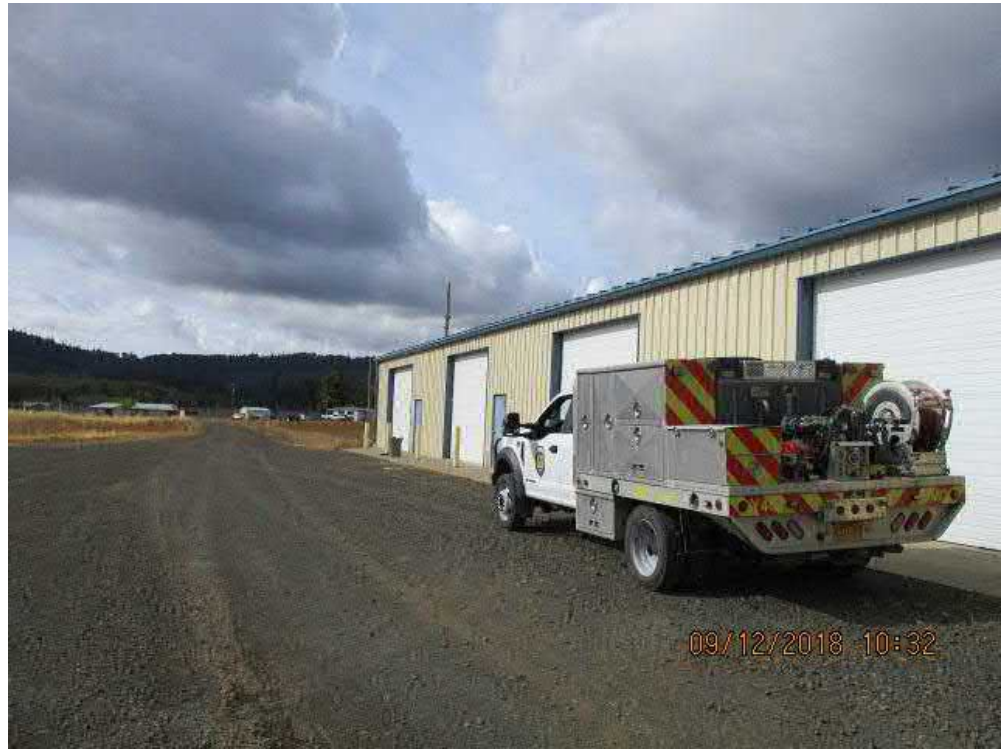
View looking south in the northeastern portion of the facility in the cantonment area. View of an Oregon Military Department firefighting truck parked outside the warehouse building.
