FINAL Preliminary Assessment Report Johnstown Army Aviation Support Facility #2 Johnstown, Pennsylvania

Perfluorooctane-Sulfonic Acid (PFOS) and Perfluorooctanoic
Acid (PFOA) Impacted Sites
ARNG Installations, Nationwide

July 2020

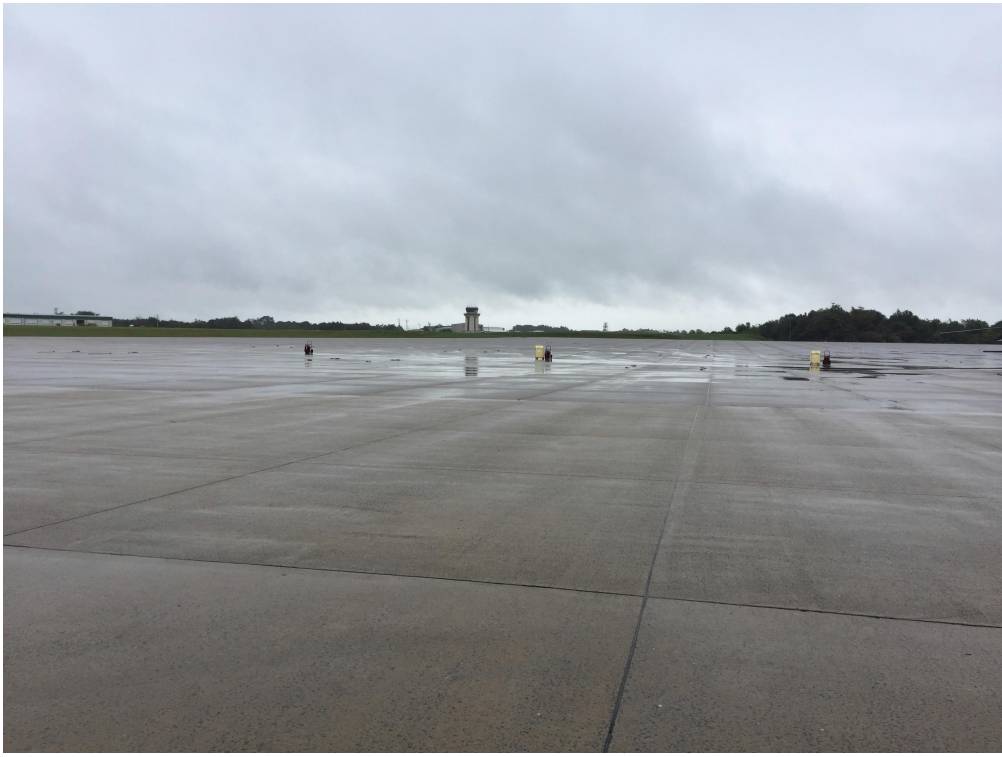
Army National Guard, Preliminary Assessment for PFAS	Johnstown AASF #2	Johnstown, PA
<p>Photograph No. 1</p> <p>Date 8/27/2019 Time 9:14</p> <p>Description: The hangar apron was previously used by ARNG for familiarization training and nozzle testing with AFFF. All excess AFFF was also purged into the apron drains.</p> <p>Orientation: Southeast</p>

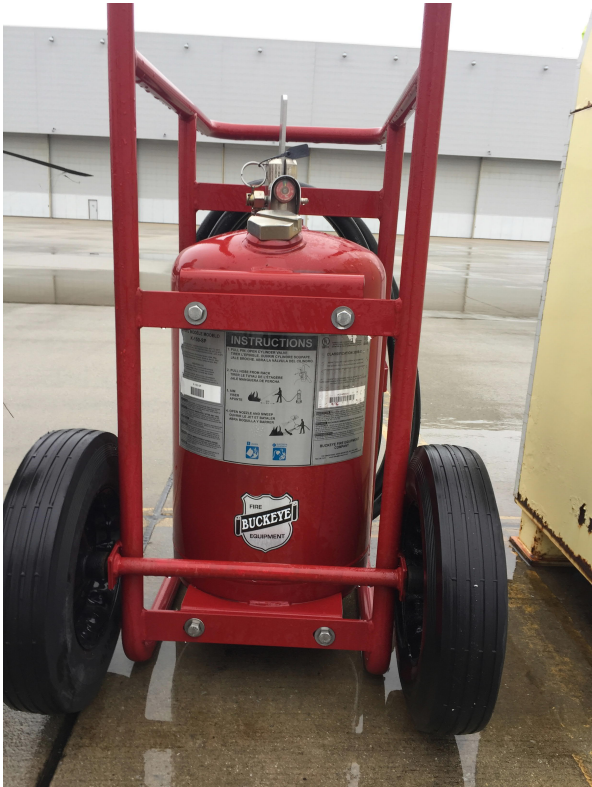
<p>Photograph No. 2</p> <p>Date 8/27/2019 Time 9:17</p> <p>Description: The hangar apron is currently equipped with Purple K (non-AFFF) fire extinguishers. Previously, Tri-Max fire extinguishers containing AFFF were stationed on the apron.</p> <p>Orientation: Northwest</p>

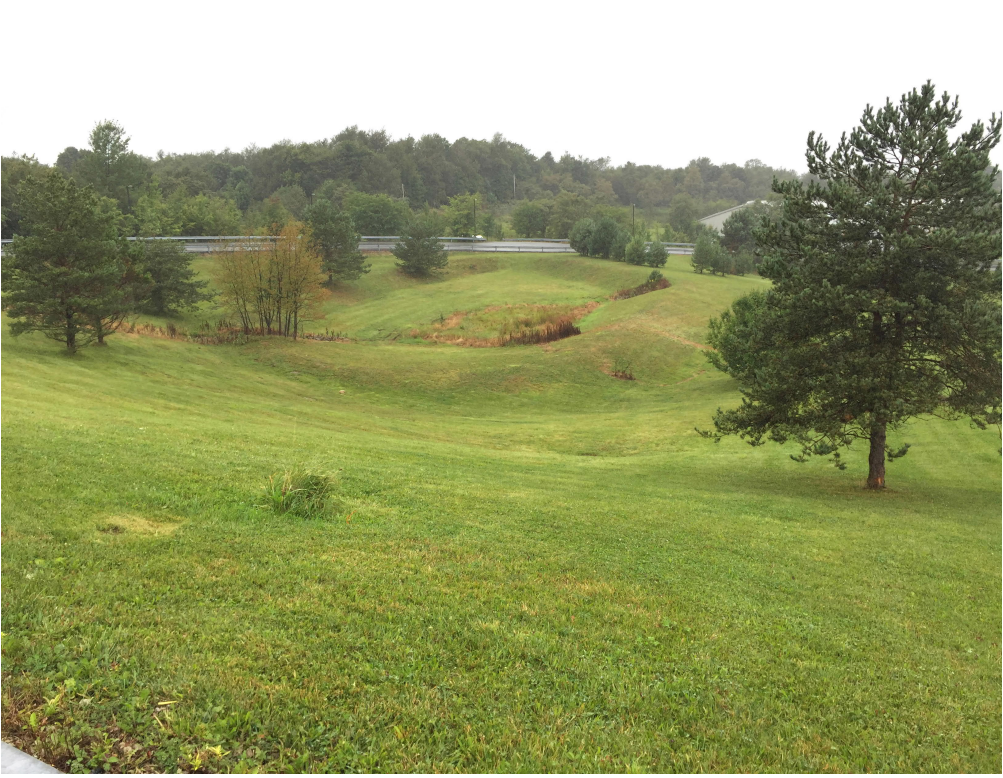
Army National Guard, Preliminary Assessment for PFAS	Johnstown AASF #2	Johnstown, PA
<p>Photograph No. 3</p> <p>Date 8/27/2019 Time 9:35</p> <p>Description: The AFFF Pond is a stormwater detention pond that has been identified in as-built drawings as a fire protection discharge holding area. AFFF has previously been observed in the AFFF Pond.</p> <p>Orientation: West</p>

The AFFF Pond is a stormwater detention pond located directly west of Building 292. AFFF has reportedly been observed in the AFFF Pond throughout the years of facility operation, most notably after the 1998/1999 AFFF release incident from Building 292. Thus, the stormwater detention pond has been called the “AFFF Pond” by facility personnel and has been identified in as-built drawings as a fire protection discharge holding area. The AFFF Pond also has a valving system by which the water can be drained to the second off-facility stormwater detention pond (HDR, 2016). The AFFF Pond eventually drains to Solomon Run, a tributary of the Conemaugh River.

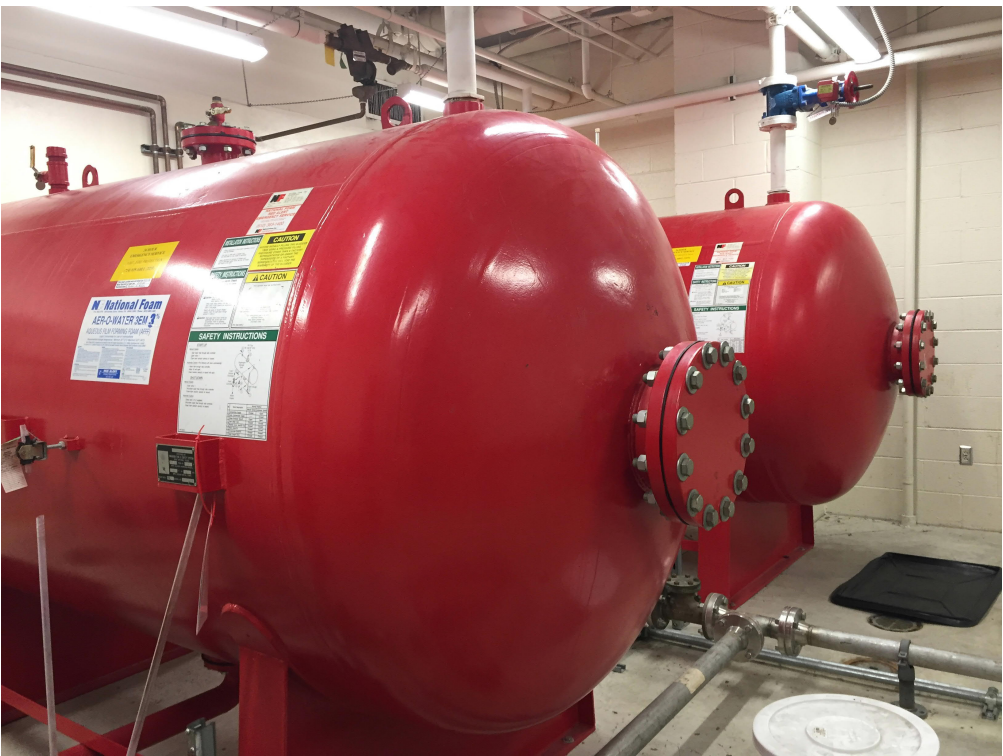
<p>Photograph No. 4</p> <p>Date 8/27/2019 Time 9:47</p> <p>Description: The AFFF fire suppression system tanks for Building 292 are shown. The tanks have a 1,200-gallon capacity and are filled with National Foam Aer-O-Water 3EM 3% AFFF.</p> <p>Orientation: North</p>

Building 292 is an aircraft hangar equipped with an AFFF fire suppression system. The fire suppression system is connected to two 1,000-gallon tanks containing 3% AFFF of the brand and type National Foam Aer-O-Water 3EM. Building 292 was a joint USAR and PAARNG space from 1997 to 2007, although PAARNG was the primary occupant. After 2007, PAARNG was the only occupant, and Building 292 was officially designated for PAARNG usage in the 2010 land lease. Multiple releases of AFFF from Building 292 have been confirmed through fire suppression system testing and leakage. According to the ongoing support agreement between the USAR and PAARNG, the USAR is responsible for the monitoring, maintenance, and repair of any fire prevention and protection systems for all PAARNG-occupied facilities. The support agreement is included in **Appendix A**.

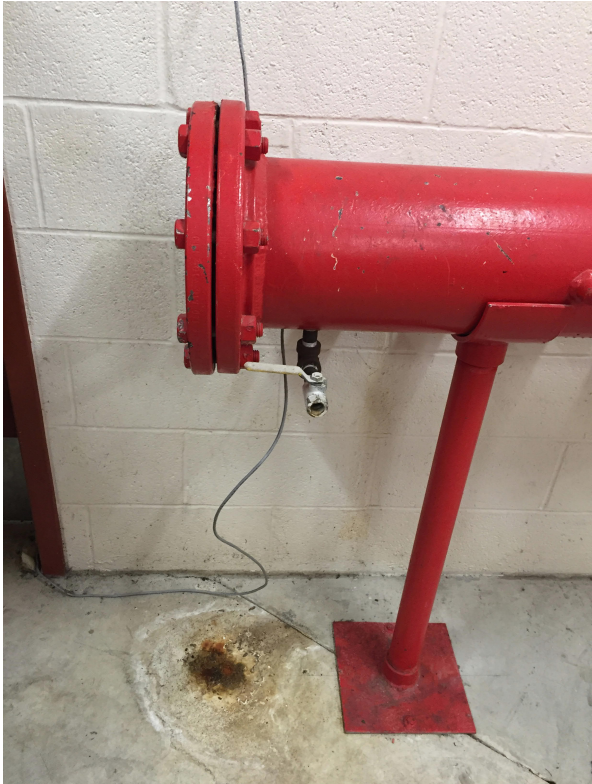
Army National Guard, Preliminary Assessment for PFAS		Johnstown AASF #2	Johnstown, PA
Photograph No. 5

Date 8/27/2019			
Time 9:51			
Description: A pipe in the Building 292 tank room is shown to be leaking AFFF. Corrosion of the concrete pavement below the leakage is observed.			
Orientation: Southeast			
Photograph No. 6

During the VSI, the fire suppression system tank room was found to have an active drip leak of AFFF from a pipe. The concrete pavement underneath the pipe was corroded and stained with white residue, presumably from AFFF. The USAR was advised by the VSI to eliminate the leak. Trench drains within the tank room and hangar space of Building 292 typically lead into an oil

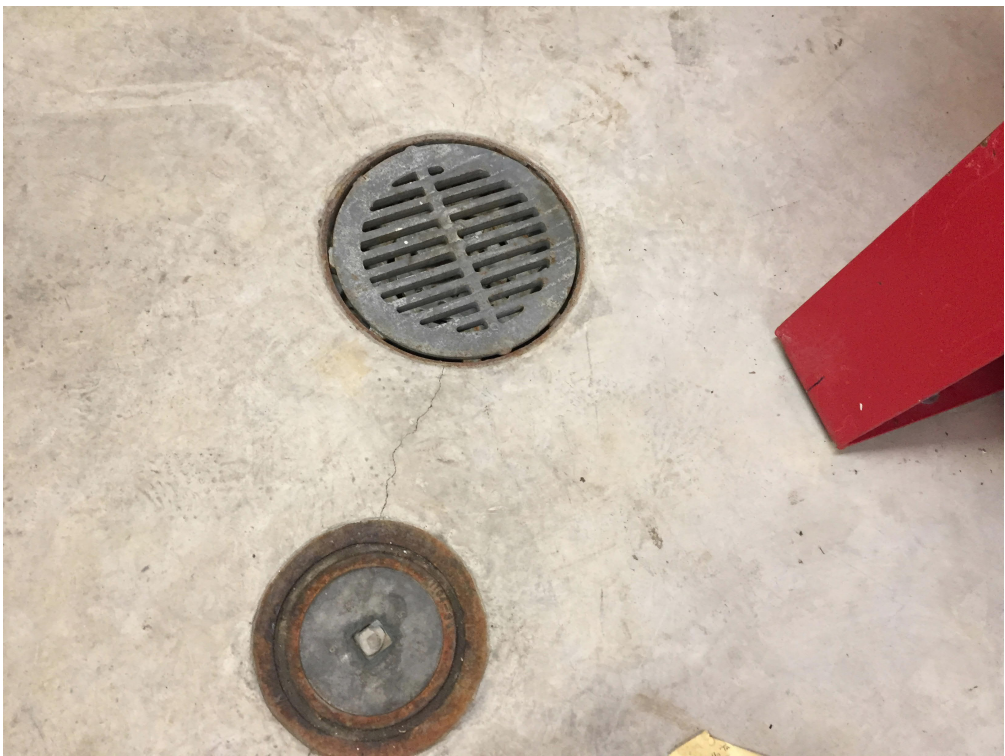
Date 8/27/2019			
Time 9:49			
Description: Floor drains in Building 292 lead through an oil water separator and then drain into either the AFFF Pond or the sanitary sewer.			
Orientation: Southwest

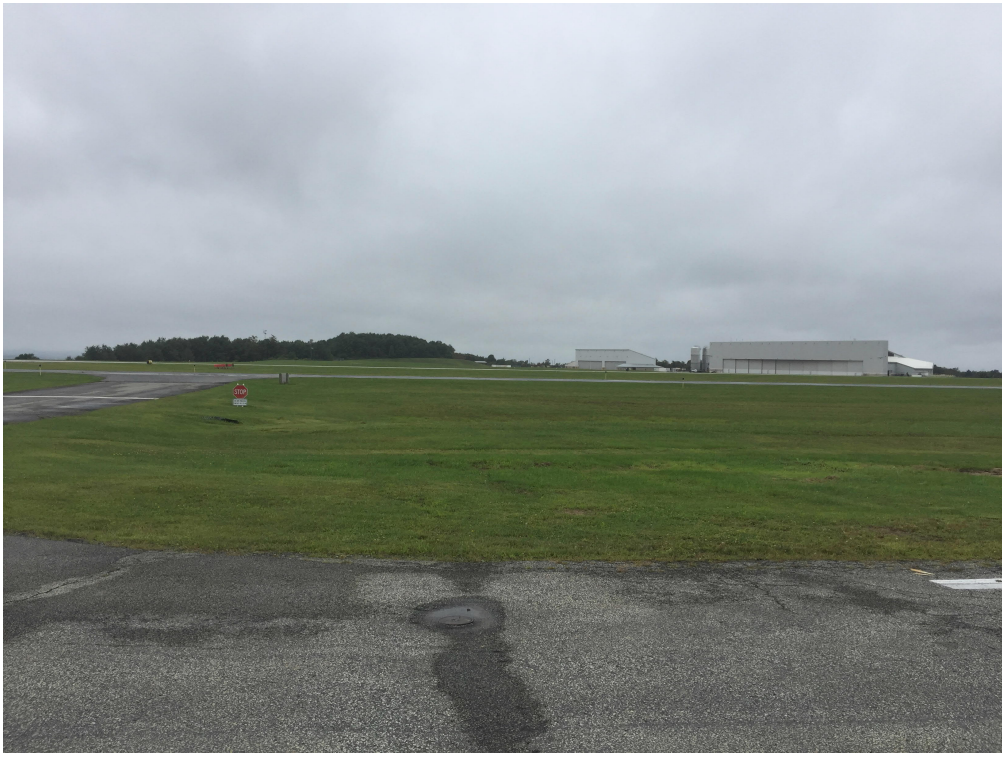
Army National Guard, Preliminary Assessment for PFAS	Johnstown AASF #2	Johnstown, PA
<p>Photograph No. 7</p> <p>Date 8/27/2019 Time 12:25</p> <p>Description: In accordance with FAA regulations, the ARFF tests AFFF systems from their firetrucks at a biannual frequency. The AFFF is discharged into a grassy field beside a taxiway.</p> <p>Orientation: Southwest</p>

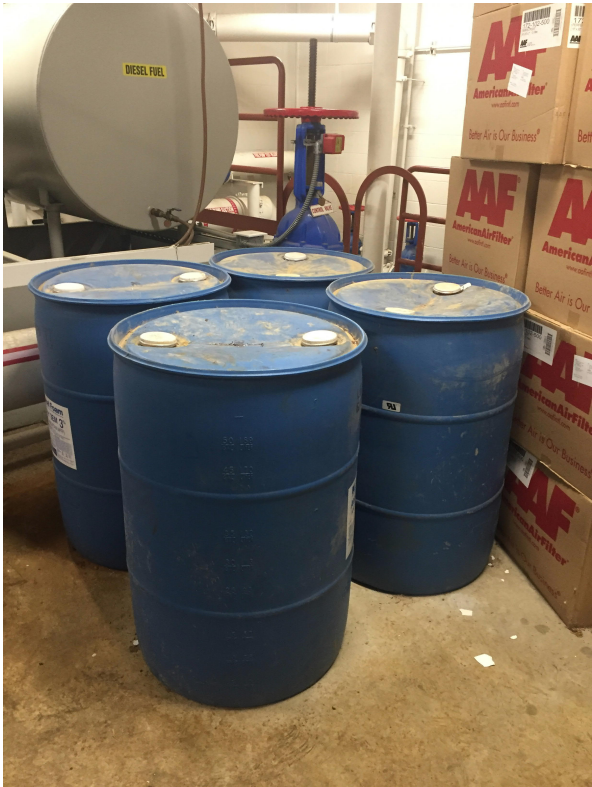
<p>Photograph No. 8</p> <p>Date 8/27/2019 Time 12:52</p> <p>Description: Four 55-gallon drums of AFFF are observed stored in Pump House #1. The AFFF is of the brand and type National Foam Aer-O-Water 3EM 3%.</p> <p>Orientation: South</p>

Pump House #1 is an approximately 2,000 square ft room situated between Buildings 292 and 288. The pump house contains engines, pumps, and four 55-gallon drums of AFFF of the brand National Foam Aer-O-Water 3EM 3% for the support of the fire suppression systems in Buildings 292 and 288. According to USAR personnel, the AFFF drums contained within the room have never leaked, and there was no evidence of AFFF spillage observed during the VSI. No release is suspected from the pump house.
