Final Preliminary Assessment Report Watercraft Maintenance Support Center, Ceiba, Puerto Rico

Perfluorooctane-Sulfonic Acid (PFOS)
and Perfluorooctanoic Acid (PFOA) Impacted Sites
ARNG Installations, Nationwide

March 2020

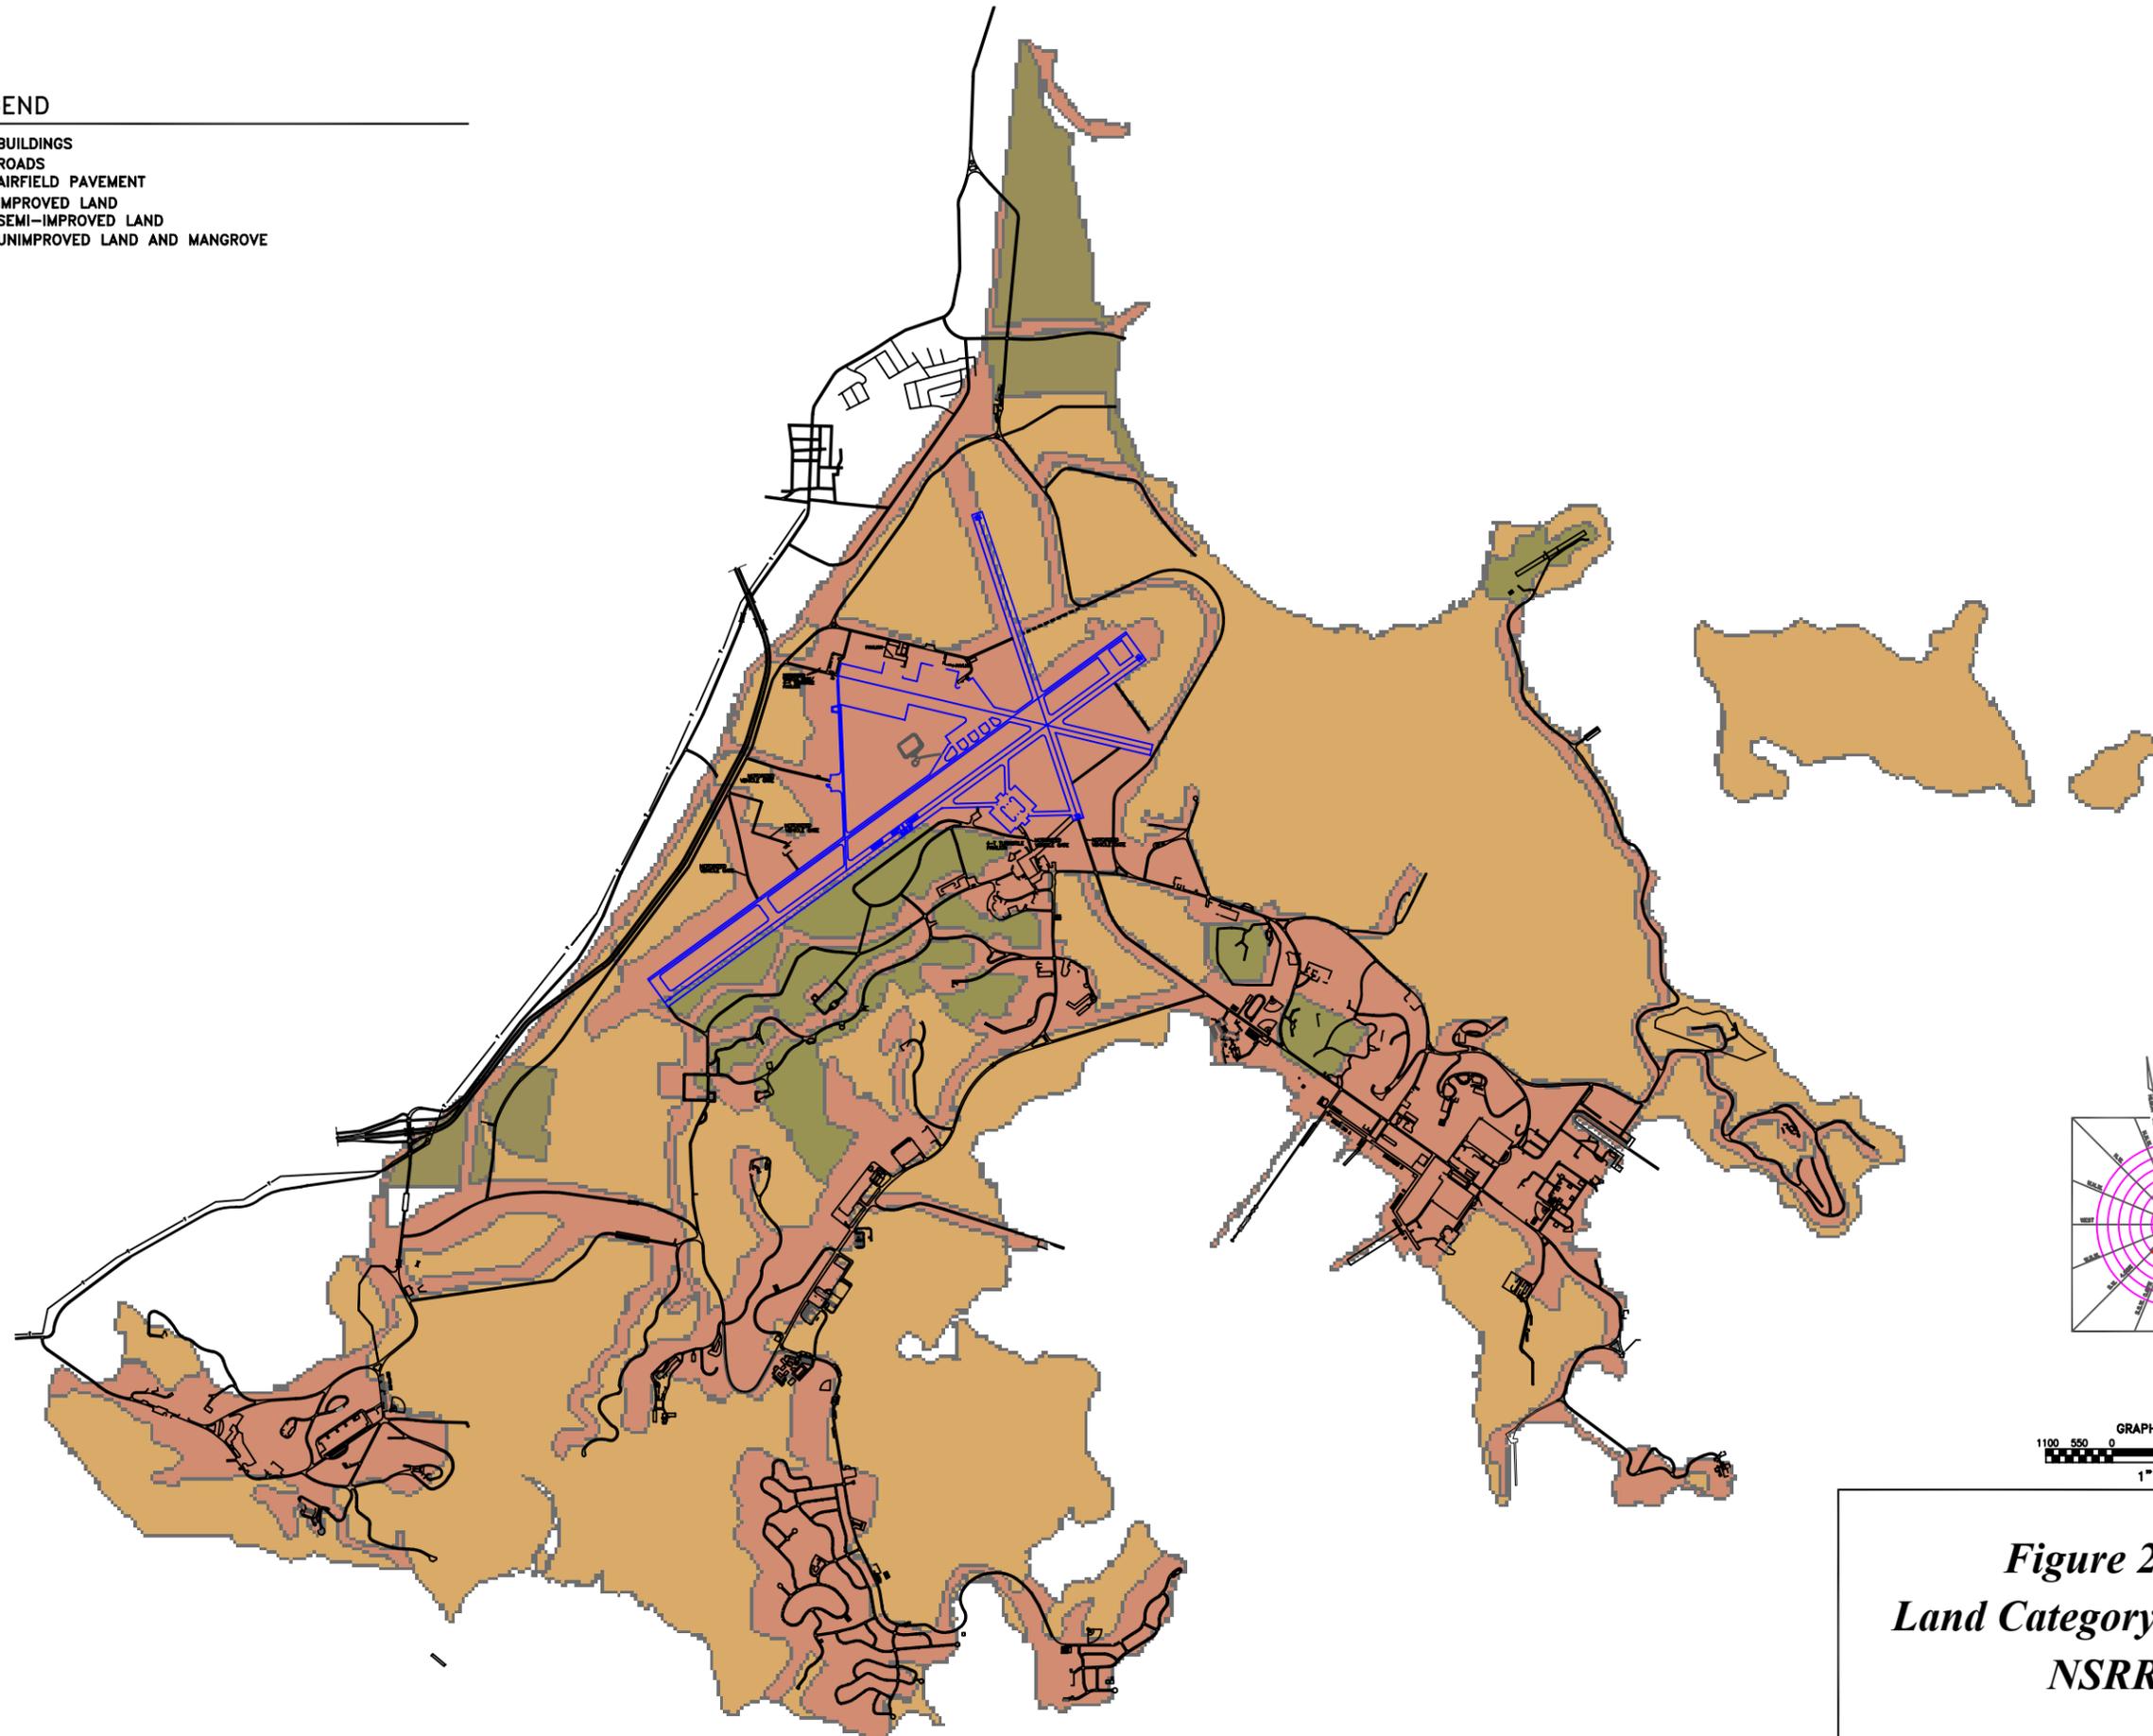
*Background aerial photograph from 1998

Figure 2-3 presents a depiction of the land category types at NSRR.

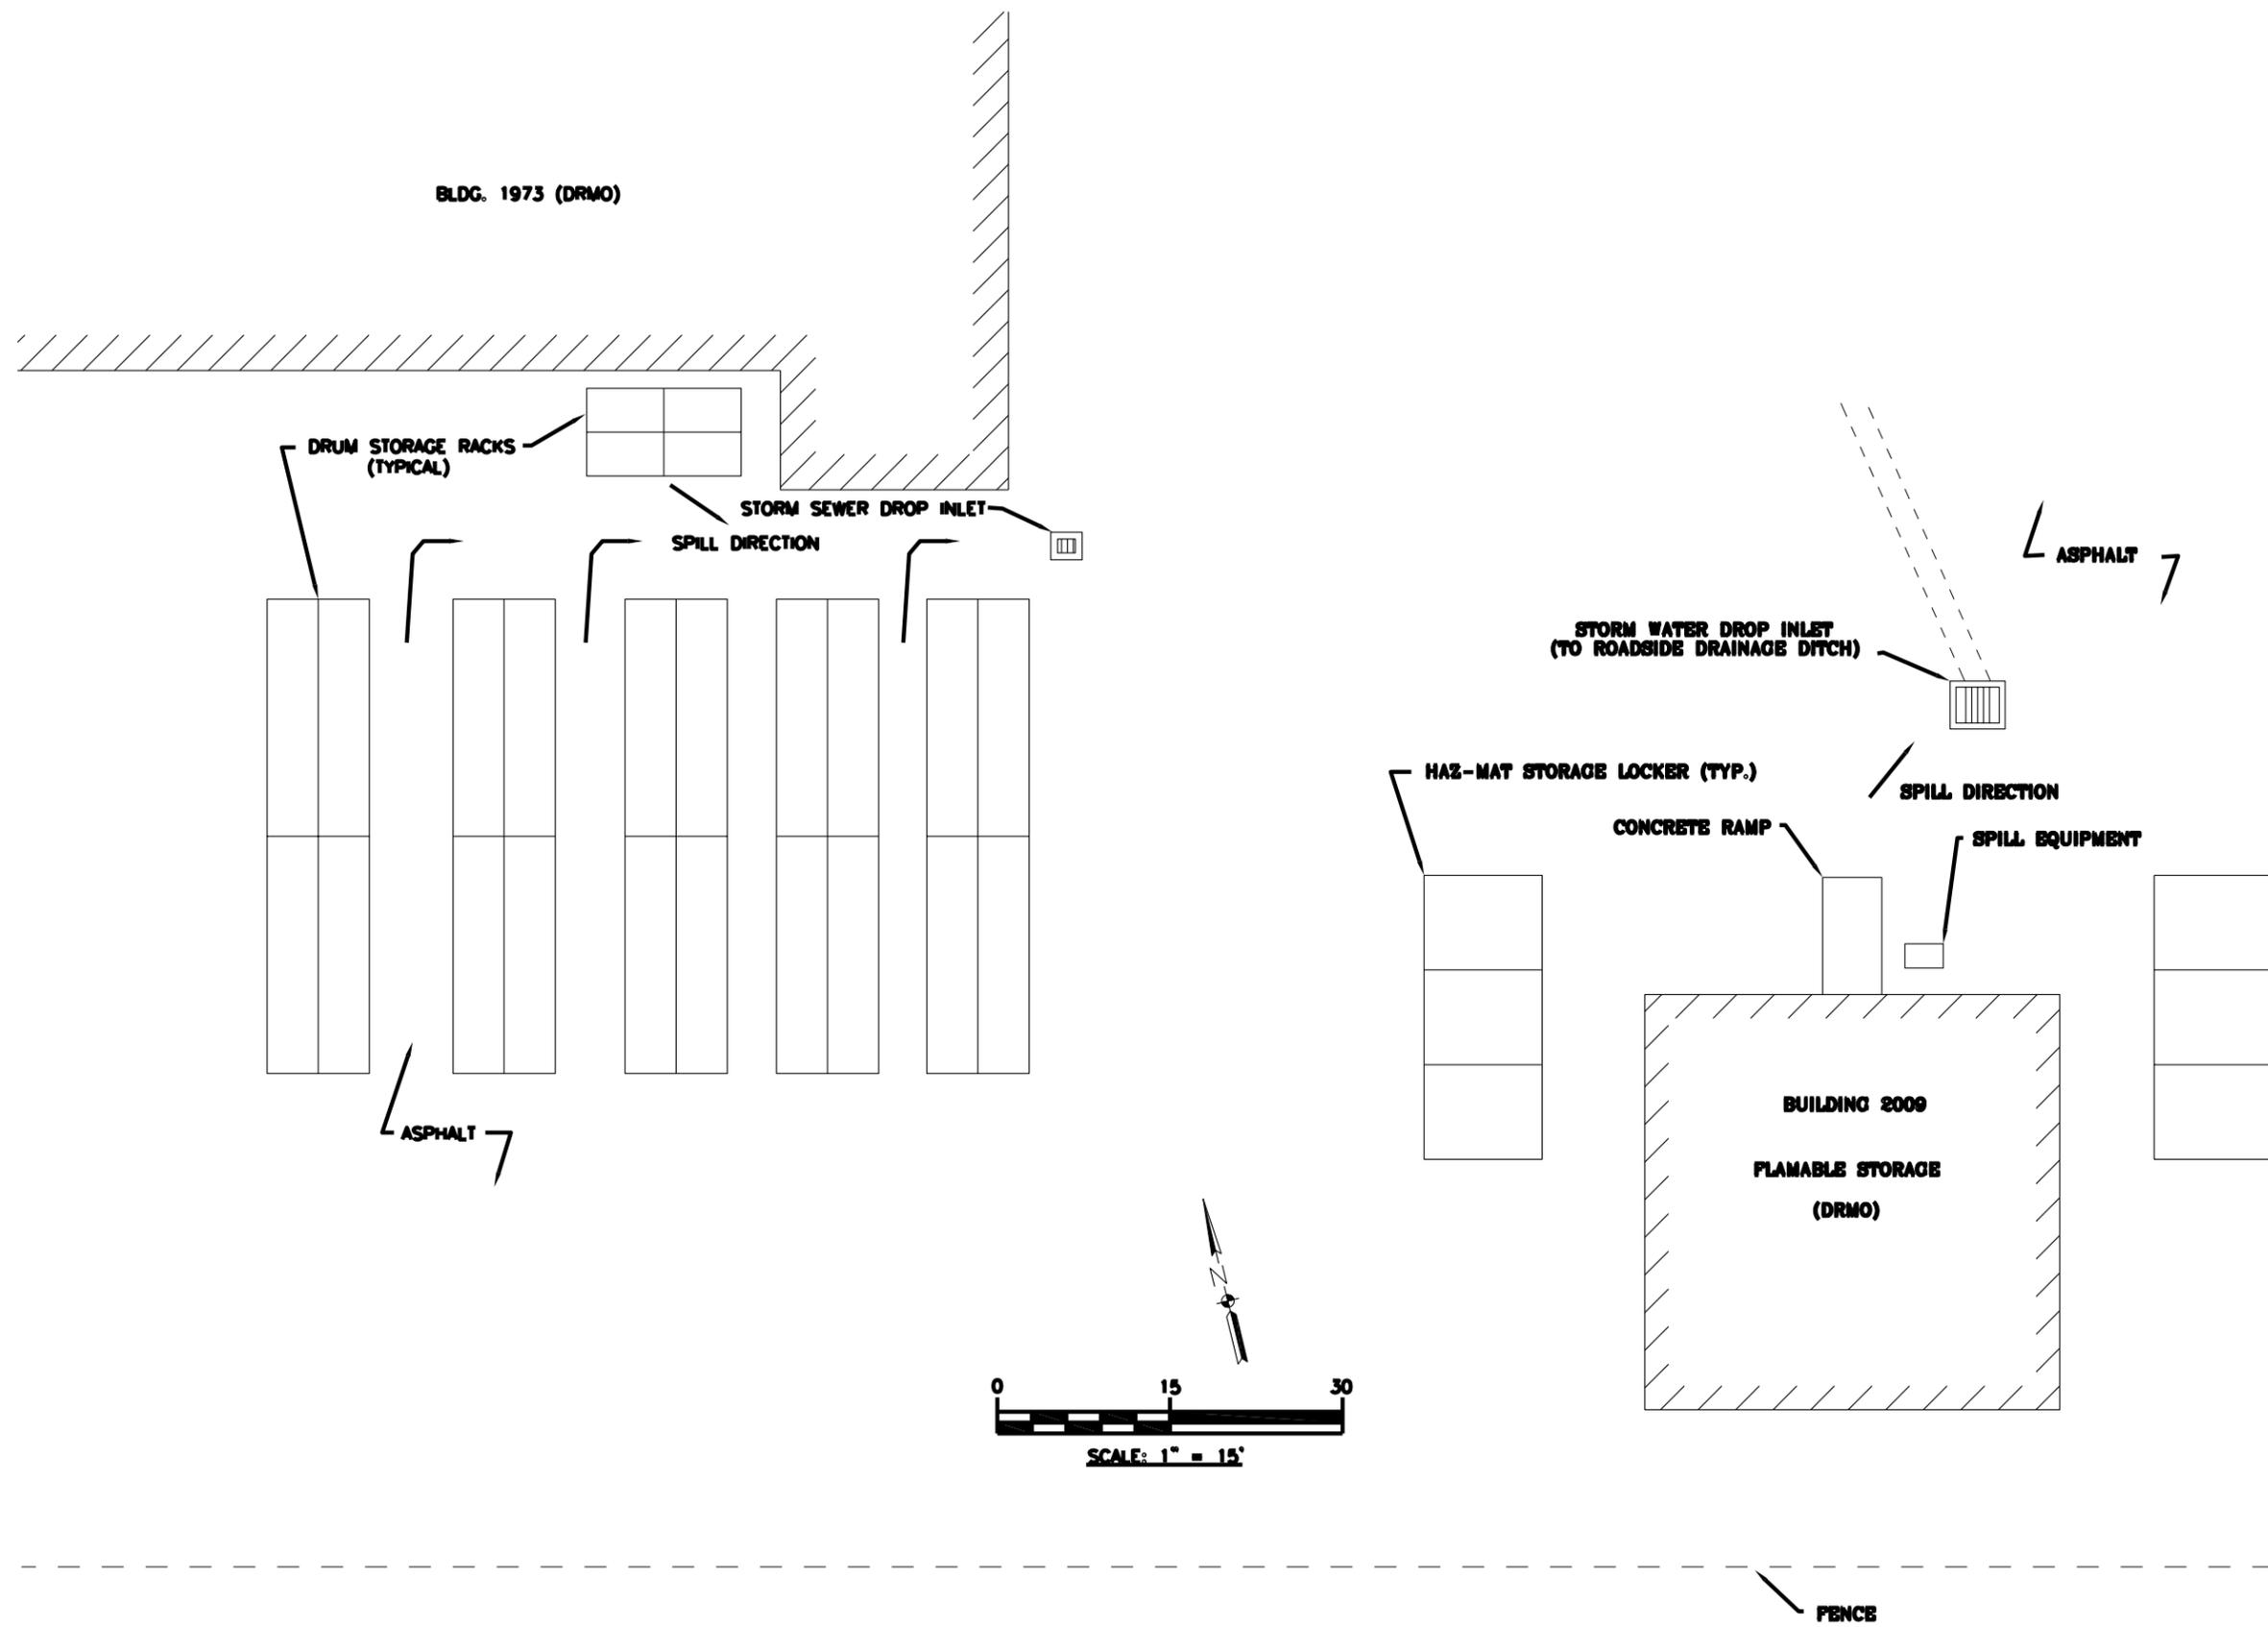
Figure 5-1. NSRR Permitted Hazardous Waste Storage Facility at DRMO

Approximately twelve HWAAs and approximately thirty-nine SAAs existed on NSRR immediately prior to station closure; most are currently unused. The permitted HWSFs at NSRR consisted of current DRMO Buildings 1973 and 2009 in use since 1981, in addition to four portable HW storage buildings 2009A, B, C, and D (see Figure 5-1). These HWSFs are currently under closure as approved by EPA letter of January 11, 2005. Furthermore, two work centers at NSRR are permitted 180 day HWAAs, whose restrictions are the same as the typical short-term areas except that the time limit is extended to 180 days (EnSafe 1999). These storage areas, Army Reserve Center Bldgs. 2300 and 2298, are operated under a separate RCRA permit from all other storage areas on NSRR (NSRR 2004). Each NSRR storage area is equipped with a separate spill containment structure to allow maximum flexibility in segregating incompatible wastes (EnSafe 2001a). HW storage areas have been eliminated due to station closure. Table 5-1 presents a listing of NSRR HW storage areas as of March 2004, with their status as of March 2005.

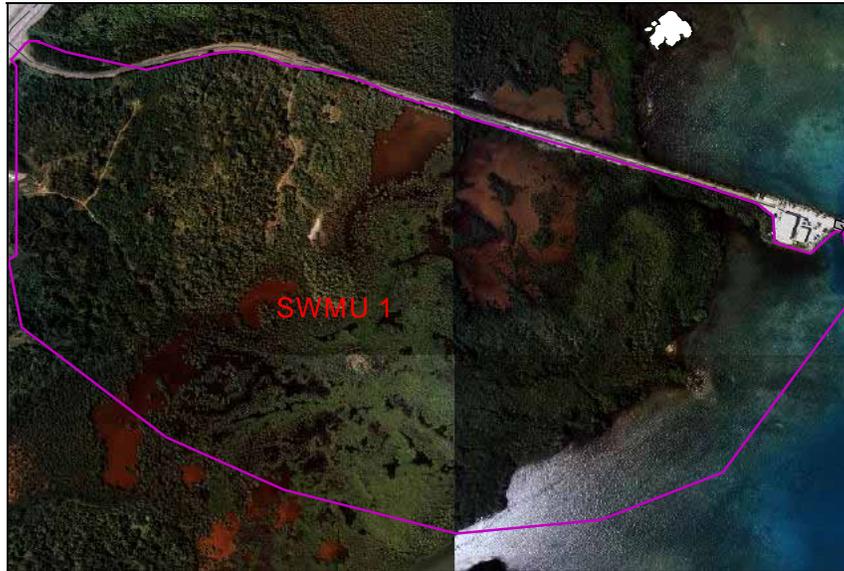
Figure 5-4. SWMU 1 - Former Army Cremator Disposal Site

SWMU 1 is located east of the Navy Lodge and is bounded to the north by Kearsage Road leading to a pier, Ensenada Honda to the east and south, and the Navy Lodge and Bowling Alley to the west (see Figure 5-4).

SWMU 1, a part of Operable Unit (OU) 3, encompasses an area of roughly 36 acres and consists of an abandoned, unlined waste-pile/landfill, on the edges of, and encroaching into, the mangrove swamps along the shoreline of the Ensenada Honda. This site was the primary disposal site of the Station's solid waste from the early 1940's to the early 1960's. During the U.S. Navy's IR Program Round 1 investigations (1986) and Round 2 (1987), surface water, sediment, and groundwater samples revealed the presence of metals (arsenic, chromium, thallium, and selenium), low-level pesticides, and low-level organics. A RCRA Facility Investigation (RFI) encompassing soil, sediments, surface water, and groundwater was required in the permit.

A RFI encompassing soil, groundwater, sediments and surface water has been completed and approved by the EPA. The RFI found that SWMU 1 was minimally impacted by former landfilling operations and recommended that institutional controls related to land use restrictions be placed on the SWMU. These restrictions are to be addressed during the development of a CMS. The RFI also recommended that an ecological risk assessment (ERA) be performed as part of the CMS due to the findings of the RFI. Currently, an ERA through Step 3a has been completed. This screening level ERA has identified risks from soil and sediment. Additional evaluation was not recommended for estuarine wetland and Ensenada Honda surface water downgradient from SWMU 1. It is recommended that additional sampling be conducted for SWMU 1. This sampling is to include surface and subsurface soil sampling along with sampling of the sediments. The results from this additional sampling will be evaluated and presented in Step 3B of the Baseline ERA for SWMU 1. After the completion of the ERA the CMS will be initiated for this SWMU.

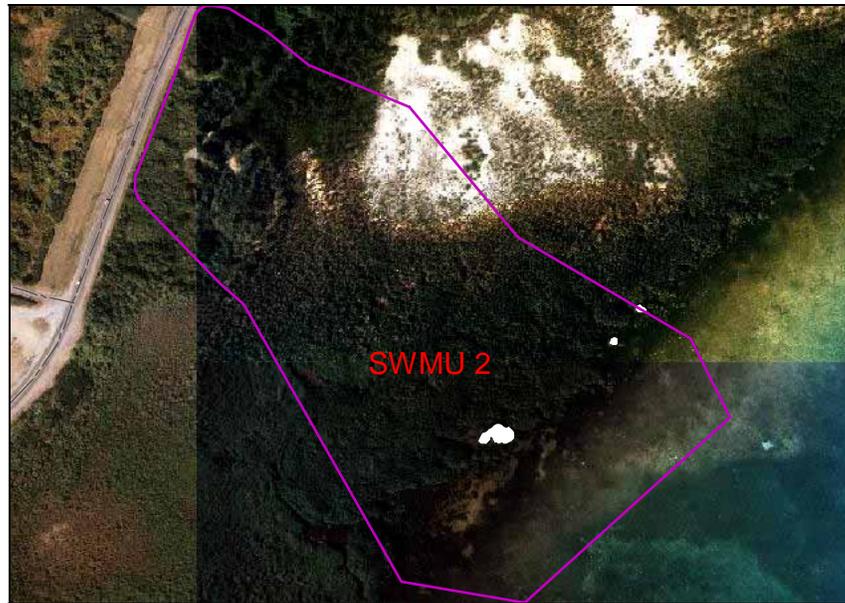
Figure 5-5. SWMU 2 - Langley Drive Disposal Area

SWMU 2 is located along Langley Drive approximately 1,000 feet northeast of the Navy Commissary and encompasses an area of roughly 28 acres. The site extends from Langley Drive to the Estuarine Wetland System (see Figure 5-5).

A RFI encompassing soil, groundwater, sediments and surface water has been completed and approved by the EPA. The RFI found that SWMU 2 was minimally impacted by former landfilling operations and recommended that institutional controls related to land use restrictions be placed on the SWMU. These restrictions are to be addressed during the development of a corrective measures study (CMS). The RFI also recommended that an ecological risk assessment be performed as part of the CMS due to the findings of the RFI. Currently, an ecological risk assessment (ERA) through Step 3a has been completed. This screening level ERA has identified risks from soil and estuarine wetland sediment. Additional evaluation was not recommended for estuarine wetland surface water and Ensenada Honda sediment and surface water downgradient from SWMU 2. It is recommended that additional sampling be conducted for SWMU 2. This sampling is to include surface and subsurface soil

sampling along with sampling of the estuarine wetland sediments. The results from this additional sampling will be evaluated and presented in Step 3B of the Baseline ERA for SWMU 2. After the completion of the ERA the CMS will be initiated for this SWMU.

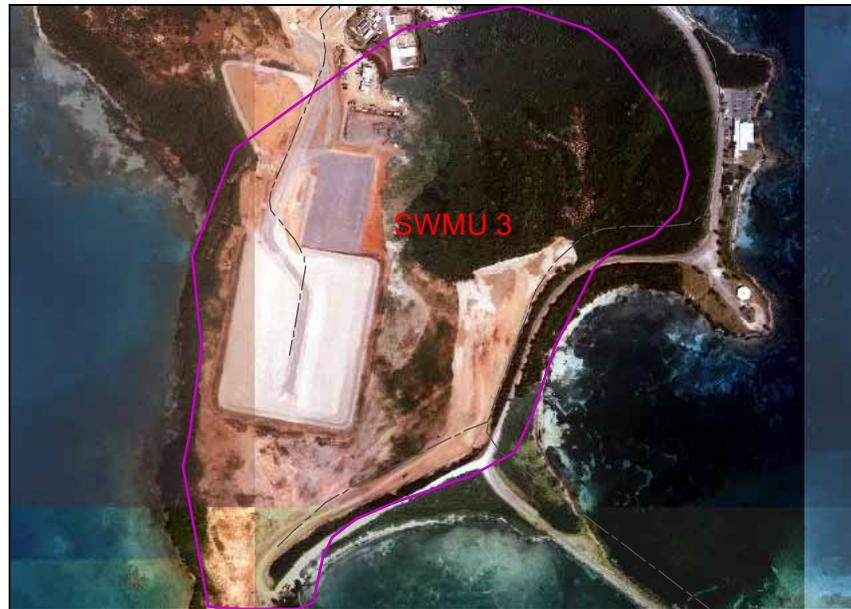
Figure 5-6. SWMU 3 - Station Landfill

SWMU 3, a part of OU 4, is currently an active landfill. It is unlined, and has been utilized since the early 1960's as a disposal site for solid wastes on approximately 85 acres of land in the southeastern area of the station (see Figure 5-6). It should be noted that a new vertical cell of 35 acres and located within the limits of the inactive 85-acre landfill was finished in March 1999 and was placed into operation in June 2000 in accordance with the Environmental Quality Board (EQB) Solid Waste Management Regulations. The design of the new cell included a 2-foot thick clay liner, and a run on/off collection pond. The method of disposal of the inactive landfill involved excavation of a trench to the water table, and then filling the trench with wastes, followed by covering with soil. During IR Round 1 (1986) investigation, eight groundwater monitoring wells were installed. Round 1 (1986) and Round 2 (1987) sampling of the groundwater found metals (arsenic, chromium, lead, and selenium) above Maximum Contaminant Level (MCL) levels. A RFI encompassing sediments and groundwater was performed and approved by the EPA.

As recommended and approved by EPA, this site will continue to be monitored semi-annually in accordance with EQB Solid Waste Management Regulations to ensure that groundwater is not being impacted by landfill operations. Currently

the information obtained from the semi-annual groundwater sampling does not indicate that the operations of the facility are negatively impacting the groundwater with respect to human health or the environment. This analysis will continue until the landfill is closed.

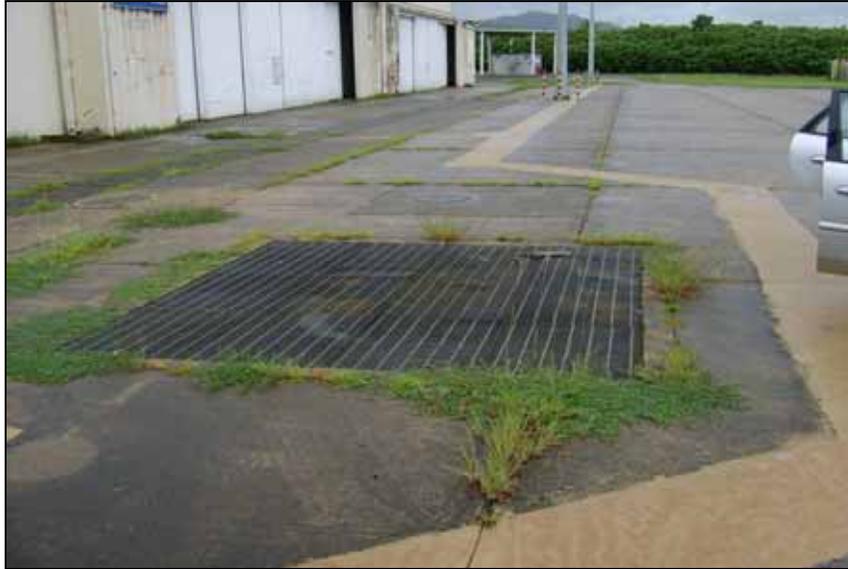
Figure 5-7. SWMU 4 – Oil/Water Separator Outside of Building 860

SWMU 4 consists of the below ground oil/water separator outside of the east side of Building 860 (see Figure 5-7). Target drones not destroyed at sea, were refurbished at Building 860, where the recovered drones were emptied of unused jet fuel/dyes/water by pouring into this below ground oil/water separator unit. This unit was installed in the mid-1970s to prevent any fuel/oil releases from the drone washdown procedure entering the drainage ditches. During the 1988 Visual Site Inspection (VSI) and 1993 follow-up inspection, no visual evidence of releases was observed. Permittee verbally indicated it had no knowledge or evidence of systematic and routine releases of hazardous wastes or constituents from this unit. A RFI was not required at this site.

Currently, there is no visual evidence of any releases observed based on the 2003 ECP investigation.

*Photograph from November 2003

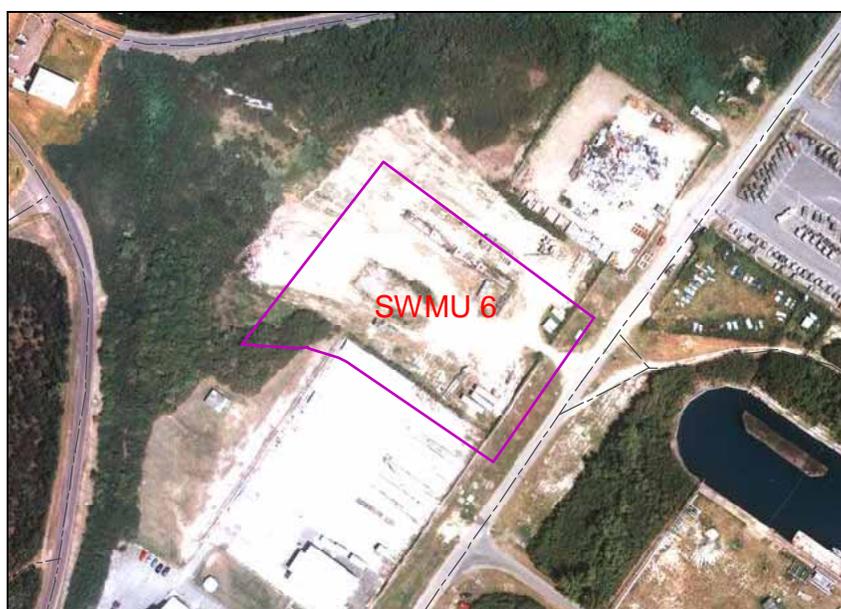
Figure 5-8. SWMU 6 - Building 145

SWMU 6 is located in a limited access area of NSRR. The site is located in a secure fenced storage yard located in the industrial area of NSRR (see Figure 5-8). The area is level and is a wide, open gravel and grass field.

SWMU 6, a part of OU 1, consists of a partially subterranean, concrete bunker (Building 145) formerly used as a long-term storage area for containers of surplus and discarded paints, polishes, etc. The Navy’s 1984 Initial Assessment Study (IAS) indicated this building was used for more than 25 years for this purpose and, at the time of the IAS, contained a large quantity (sixty 55-gallon drums plus 100 five-gallon pails) of containers. The condition of the containers was mostly poor, with some resting in standing water, with tree roots penetrating through the top of the structure. According to the 1988 VSI, all contents formerly stored in this SWMU had been removed, the same finding resulted from the 1993 follow-up inspection. However, since there was never any sampling to confirm the absence of releases of hazardous constituents from this unit, and based on the condition of this unit as described in the 1984 IAS, a Phase I RFI for surface and subsurface soils was required in the permit.

A Phase I RFI was completed for SWMU 6, which indicated that a potentially unacceptable risk to future residents and adult on-site workers exists. The RFI recommended the performance of a CMS. The results of the revised risk assessment conducted for the development of corrective action objectives indicated that the only risk was a non-carcinogenic risk to future young child military residents. It was further demonstrated that the critical toxic effects for the two principal contaminants (arsenic and 4,4-DDT) demonstrated that the hazard indices should be segregated based on target organs, resulting in neither contaminant exceeding the acceptable level. Hence, COCs were not identified for any of the media at SWMU 6/AOC B, and there were no corrective action objectives calculated for SWMU 6/AOC B. The CMS was conducted and submitted to the EPA on June 21, 2001 recommending no further action for this site. No further action is proposed in the RCRA Part B permit renewal.

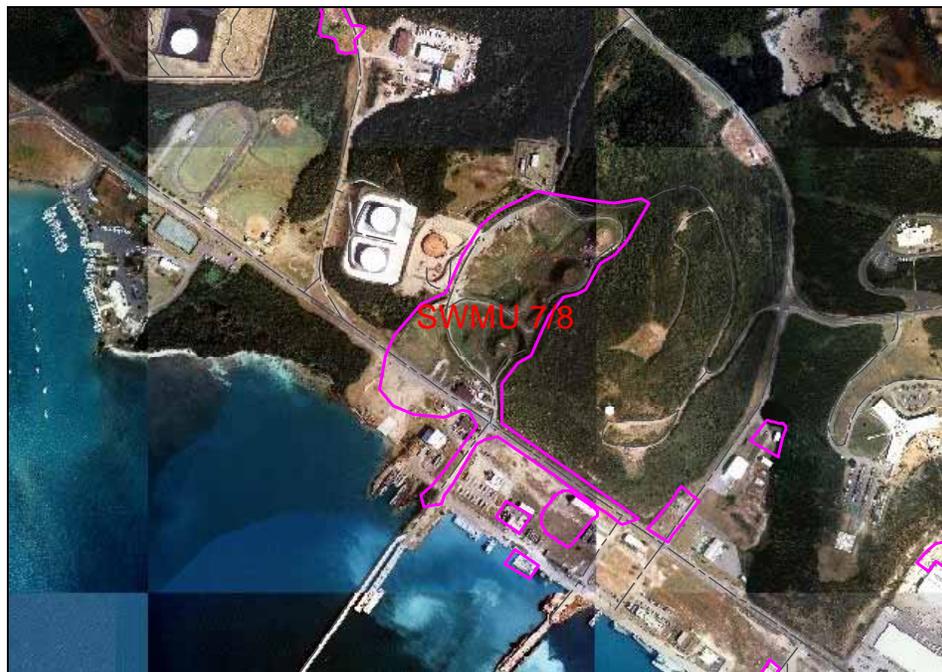
Figure 5-9. SWMU 7/8 – Tow Way Fuel Farm

During the additional data collection effort, TCE concentrations in monitor well 7MW07 were found to have increased fourteen-fold, from 2,000J micrograms per liter ($\mu\text{g/L}$) in April 1998, to 28,000J $\mu\text{g/L}$ in January 2002, a period of approximately four years. Because of this increase in concentration, additional characterization of the source of this TCE was recommended in the Draft Final Task I CMS prior to finalization of the CMS. It was also recommended that CMS for this portion of the TWFF be completed independently from the rest of the TWFF. This was done so as not to delay the evaluation of the remedial alternatives from the rest of the site. This was possible since the TCE and PSH portions of the site are independent and do not overlap each other. A work plan to address the TCE plume delineation and source investigation was developed and approved by the EPA. The field investigation was implemented in accordance with the EPA approved work plan. The Draft TCE Plume Delineation & Source Investigation Report was submitted on January 21, 2004. It was determined that no continuing source of TCE is apparent in the soil or groundwater at this site. The original source and/or location of the TCE contamination in this area of the

TWFF remains unknown, despite the gathering of historical information and the efforts of environmental sampling during two focused investigations. The TCE plume was delineated and a sentinel well was placed down gradient of the plume in order to determine, through subsequent sampling events, if contamination is approaching the Ensenada Honda. It was recommended that a CMS proceed for this site. The CMS should include screening level risk assessments for cis 1,2-dichloroethene, 1,2-dichloroethane, 1,1,1-trichloroethane, trans 1,2-dichloroethene, and tetrachloroethene in the groundwater at this site. These compounds were detected during this investigation at levels above those found in previous investigations. Once any new corrective action objectives (CAOs) are established, appropriate corrective measures to address the TCE contamination can be evaluated during the CMS process. The EPA provided comments on the Draft TCE Plume Delineation & Source Investigation Report on February 24, 2004. The EPA recommended that their comments be addressed in the CMS Report for the TCE site. The EPA also requested that the potential source area and associated TCE Plumes at the Tow Way Fuel Farm be designated as SWMU 55 pursuant to the requirements of Module III of the RCRA permit. This action was taken since the TCE releases do not appear to be associated with either SWMU 7 or 8, the currently defined SWMU at the Tow Way Fuel Farm. Information regarding the TCE at the TWFF will now be discussed as SWMU 55 per the EPA's request dated February 24, 2004.

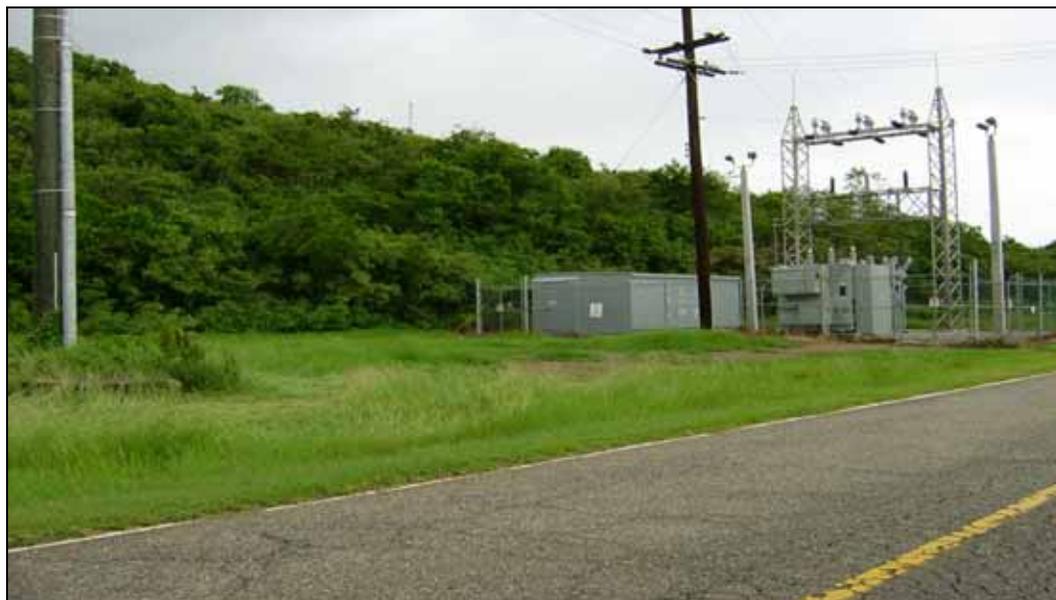
*Photograph from November 2003

An ICM was performed (completed December 1994) to remediate the PCB contaminated soils at this site. A RFI was completed to verify that the underlying groundwater at this site had not been affected by the contaminated soils as requested by the EPA. The RFI concluded that there is no evidence of groundwater being impact related to the waste management activities that took place at this SWMU. However, at the request of the EPA to verify that all work performed to date was protective of human health and the environment, a CMS was initiated and completed, and no further action is proposed in the RCRA Part B permit renewal.

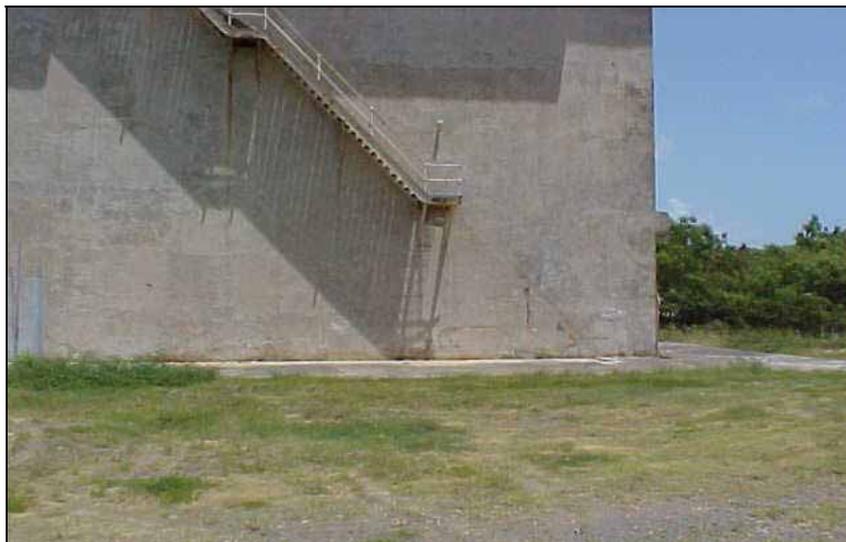
Figure 5-13. SWMU 11 - Old Power Plant (Building 38)

SWMU 11, a part of OU 3, at NSRR is the interior of Building 38, the “Old Power Plant” (see Figure 5-13). This building is located just north of the Station Landfill in the southeastern portion of NSRR. SWMU 11 includes a former concrete pad where transformers and transformer fluids containing PCBs were stored. Both the 1998 VSI and the 1993 follow-up inspection reported extensive staining. There were also indications of transformer fluids being discarded by pouring into subsurface cooling water tunnels associated with the Power Plant, which then empty into the embayment of Puerca Bay. The exterior of Building 38 is classified as SWMU 45 and is discussed separately below.

An RFI investigation was performed in November of 1996 to characterize PCB contamination on the floors and walls inside of Building 38. Grab samples of the sludge’s found in the floor pits from inside the building were also collected. Prior to preparation of the RFI Report a fire occurred within the building in 1997. The fire was largely contained to debris and the planks that cover the floor pits in the northern portion of the structure. No structural damage was done to the building and all firefighting water was contained within the pits. Because of the fire, the Navy considered the sampling data gathered to be unusable and, therefore, has not presented the results. In response to this incident, the Navy recharacterized the interior of Building 38 in the fall of 2003. The RFI Report has been developed, and the corresponding report is being reviewed by the EPA. The RFI determined that portions of the interior walls and floors have been impacted by past operations as evidence by the PCB contamination. The Navy has recommended that no further action be performed for this SWMU under the pending closure of

the station. It is recommended that any future tenant of this building be informed of the contaminants present within the building so that they may evaluate their options for reuse of the structure. It should be noted that this change in ownership of real property contaminated with PCBs is not prohibited as outlined in the EPA August 14, 2003 Memorandum. [Note: According to a 1991 survey (Weston, 1991), asbestos containing materials are present in Building 38.]

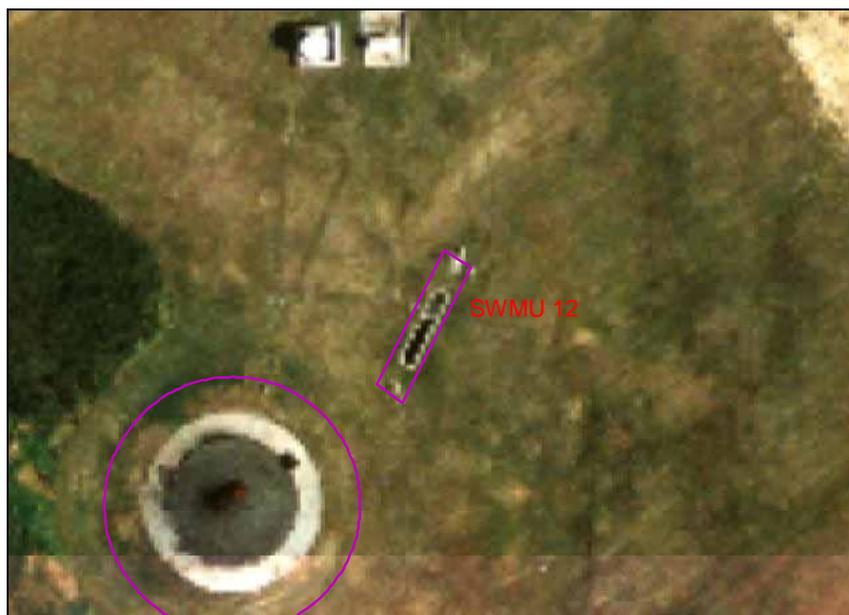
Figure 5-14. SWMU 12 - Fire Training Pit Oil/Water Separator

SWMU 12, a part of OU 1, consists of the Oil/Water Separator located north of the station airfield, serving the Fire Training Pit (see Figure 5-14). The fire training pit oil/water separator is an inground concrete tank measuring approximately 7 feet wide by 30 feet long by 10 feet deep covered by heavy grating. Waste oils are burned at the fire training pit (SWMU 14) during training exercises, with the excess oil and fire fighting water collected in SWMU 12. Water from the oil/water separator is pumped to the sewer and oils are pumped back into the pit to be reused. During the 1988 VSI, oil stains were observed on the concrete and rails around this unit, and dead vegetation adjacent to it, indicated past overflows onto the adjacent soils. A First Phase RFI encompassing surface soil sampling was required in the permit.

During the RFI, there were no signs of spills or releases at the time of the investigation. This was confirmed from the results of the surface soil sampling during the RFI. The RFI did not identify any chemicals or potential concern (COPCs) for this unit. Therefore, no further action is proposed in the RCRA Part B permit renewal.

Currently, there is no visual evidence of any releases observed from this unit based on the 2003 ECP inspection.

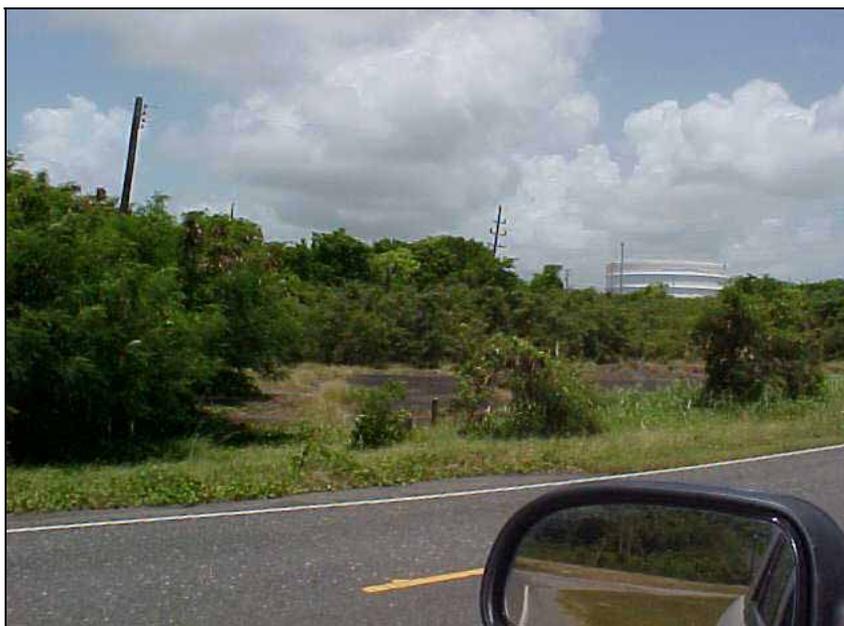
*Photograph from May 2003

The majority of this site is now covered with heavy secondary growth vegetation. Currently, there is no visual evidence of any releases observed from this unit based on the 2003 ECP inspection.

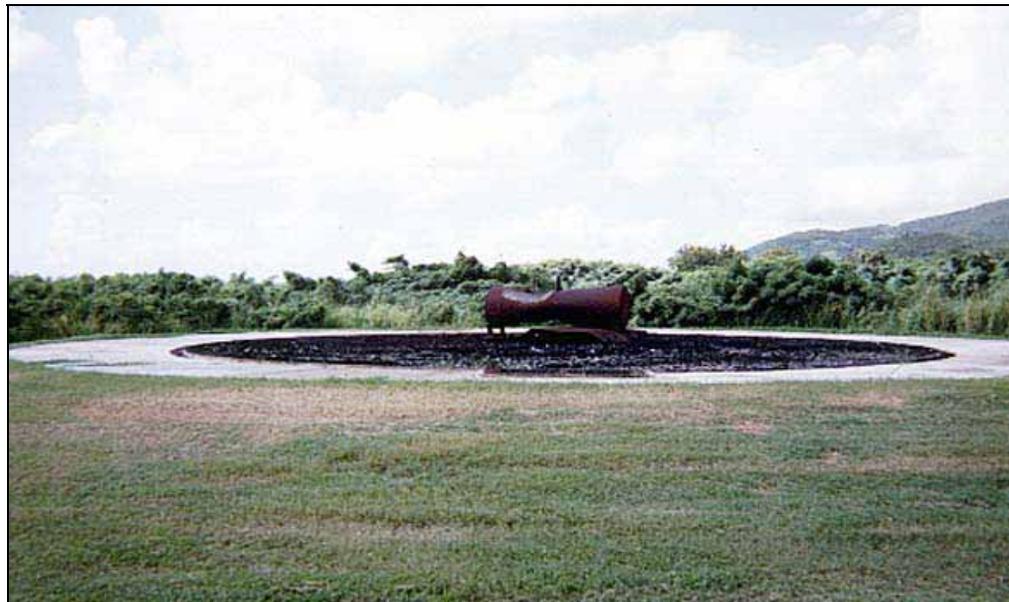
Figure 5-16. SWMU 14 - Fire Training Pit Area

SWMU 14, a part of OU 1, consists of the Fire Training Pit area located near the Fire Training Pit Oil/Water Separator (SWMU 12) (see Figure 5-16). The present day Fire Training Pit, which is concrete lined, was constructed in 1983. The new pit is constructed below grade, with a concrete apron. A drainage system encircling the apron intercepts any overtopping that may occur, which is directed to an oil/water separator. Currently, there is no visual evidence of any releases observed from this unit based on the 2003 ECP inspection.

sample of the excavated soil was analyzed for PCBs, but none were detected. There was no indication that other sampling has been performed to establish the absence of other hazardous constituents in the soils underlying the pre-1983 unlined fire training pits, or the impact, if any, of released hazardous constituents on the groundwater. A RFI encompassing subsurface soils, down to the water table, was required in the permit. Groundwater investigations were made contingent on the subsurface soil sampling results.

A RFI for surface soil was conducted and a human health risk assessment was performed on these soils. The results of the Human Health Risk Assessment (HHRA) did not indicate an unacceptable cancer risk for any of the exposure scenarios or pathways. There are currently engineering controls in place to prevent subsurface soil and groundwater exposures to activities at the fire training pit. Additional site characterization of this site will be conducted once the site is no longer in operation. Therefore, a final decision of whether or not corrective action is necessary will not be determined until the usage of the area is terminated.

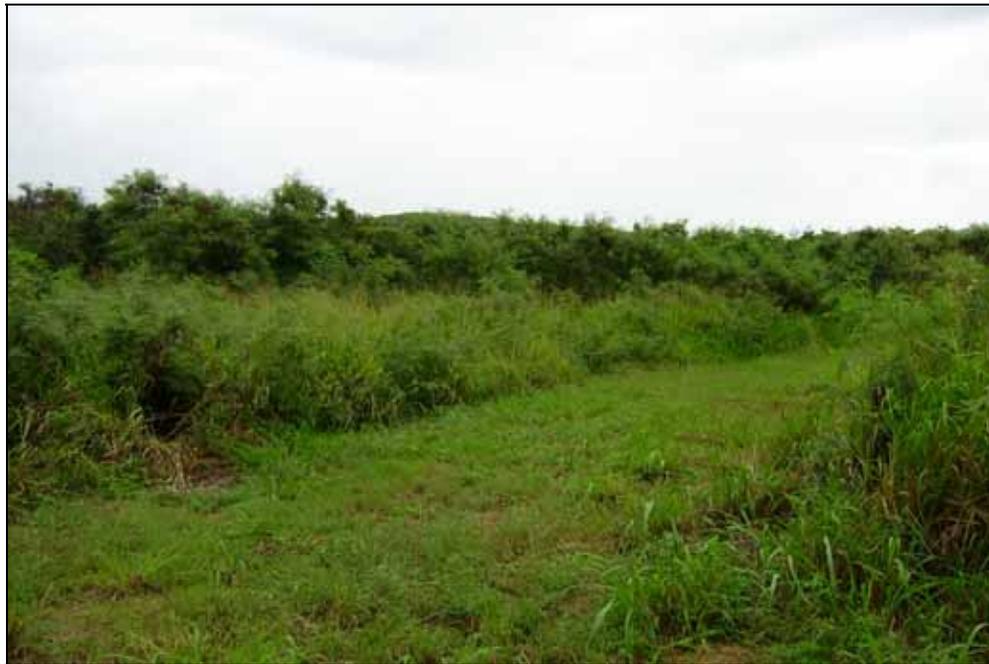
*Photograph from November 2003

The incinerator was taken out of operation in October 1998 and the Incinerator (Former Building 1928) was removed from this site in the fall of 1999. Currently, the area where the former Building 1928 existed is now grass covered. There is no visual evidence of any releases observed from this unit based on the 2003 ECP inspection.

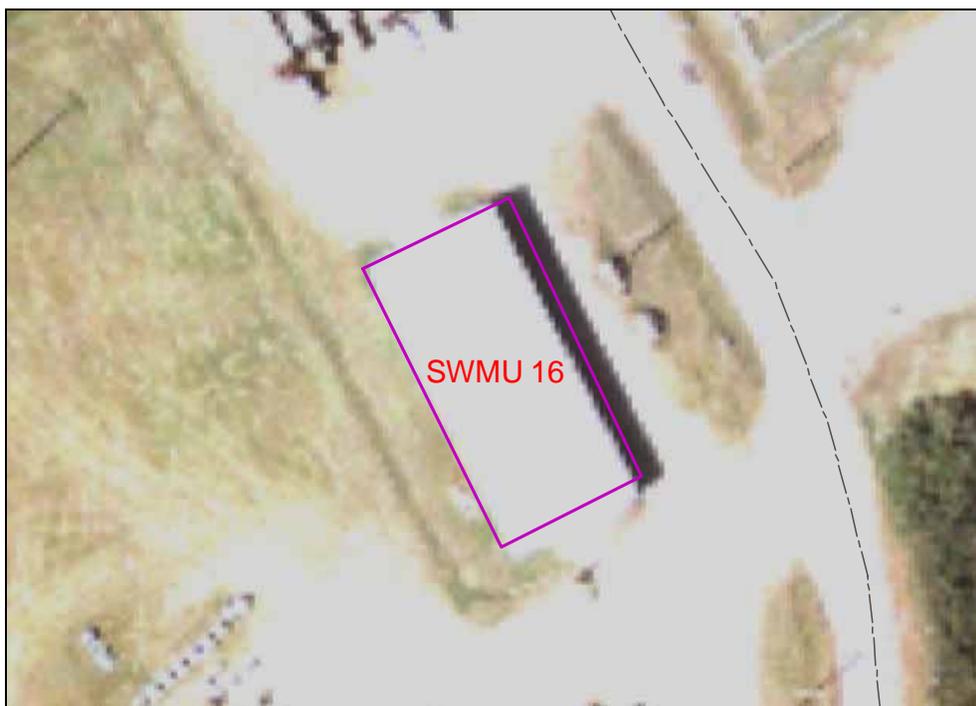
Figure 5-18. SWMU 16 – Waste Explosives Storage Building (Building 1666)

SWMU 16 consists of the Waste Explosives Storage Building (Building 1666) located south of Building 1674, and west of Building 300 (see Figure 5-18). This SWMU was not inspected during the 1988 VSI due to the special security clearances required to gain access to this facility. However, it was inspected during a follow-up VSI, conducted in June 1993. No evidence of releases from this building was observed. Permittee verbally indicated it had no knowledge or evidence of systematic and routine releases of hazardous wastes or constituents from this unit. A RFI was not required for this SWMU.

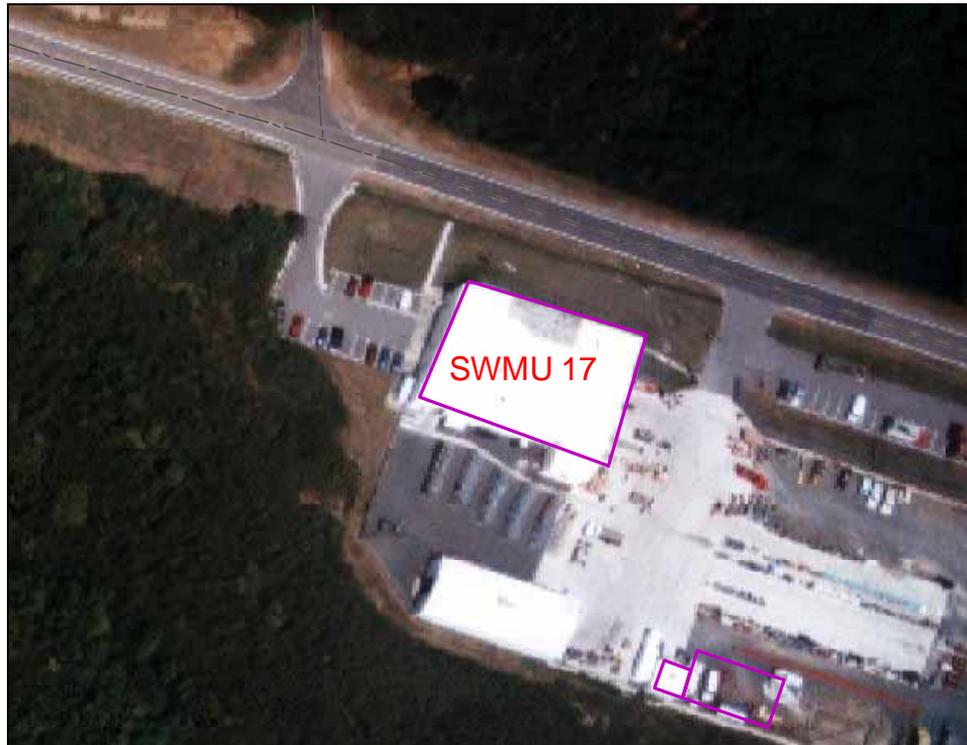
Figure 5-19. SWMU 17 – Fully enclosed, concrete and steel building (Building 1973)

SWMU 17 consists of a fully enclosed, concrete and steel building (Building 1973) at the DRMO facility located along Forrestal Drive (see Figure 5-19). This site serves as the main non-flammable hazardous waste container storage facility for the station. Good release controls are in place, and there is no evidence of releases of hazardous constituents. Permittee verbally indicated it had no knowledge or evidence of systematic and routine releases of hazardous waste or constituents from this unit. A RFI was not required for this SWMU.

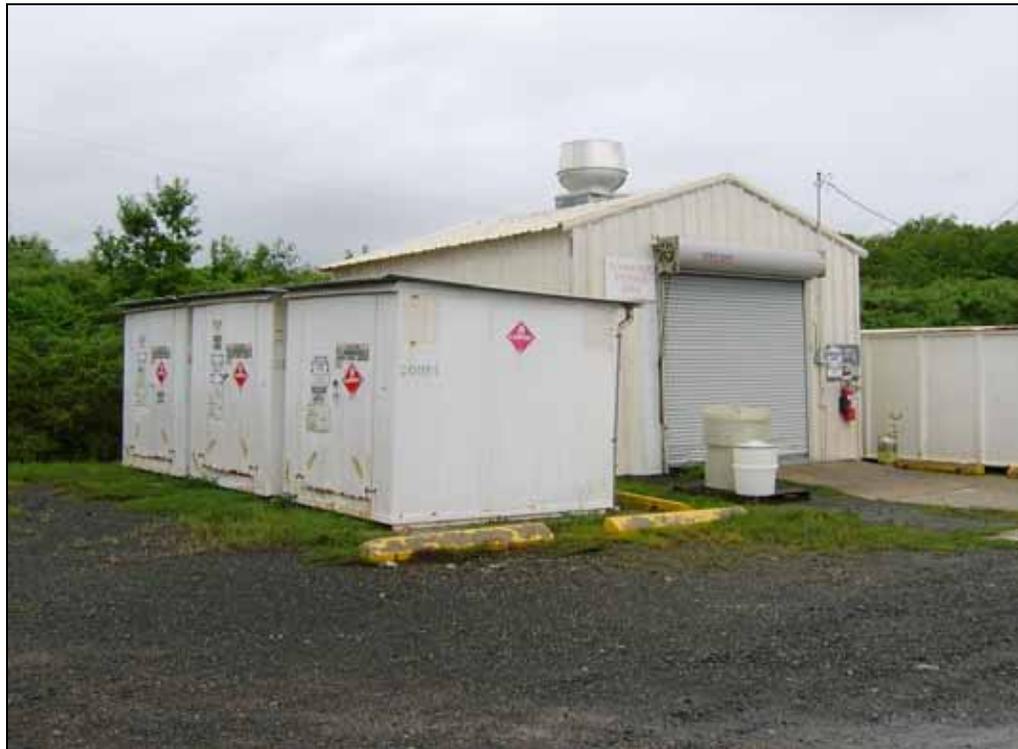
Figure 5-20. SWMU 18 – Fully enclosed metal building (Building 2009)

SWMU 18 consists of a fully enclosed metal building (Building 2009) located within the southwest portion of the DRMO storage yard along Forrestal Drive (see Figure 5-20). This site serves as the container storage building for ignitable hazardous wastes. There is no evidence of releases of hazardous constituents. Permittee verbally indicated it had no knowledge or evidence of systematic and routine releases of hazardous wastes or constituents from this unit. A RFI was not required for this SWMU.
