Final Preliminary Assessment Report Watercraft Maintenance Support Center, Ceiba, Puerto Rico

Perfluorooctane-Sulfonic Acid (PFOS)
and Perfluorooctanoic Acid (PFOA) Impacted Sites
ARNG Installations, Nationwide

March 2020

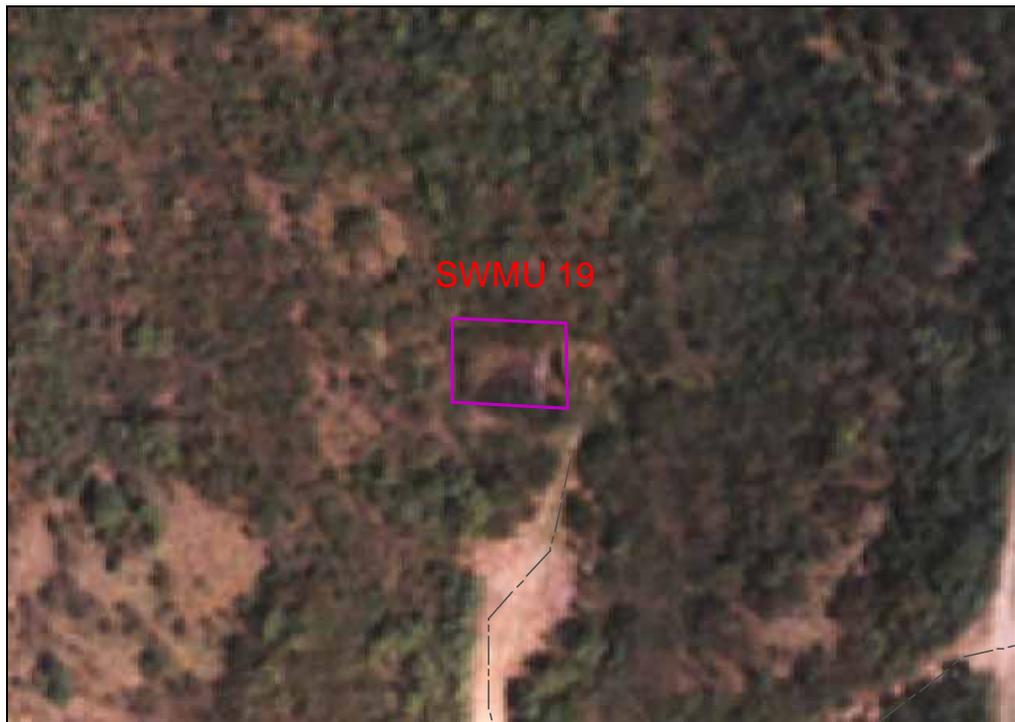
Figure 5-21. SWMU 19 – Concrete, bunker-like building (Building 121)

SWMU 19 consisted of a concrete, bunker-like building (Building 121) located northeast of the Public Works Department Building 31 (see Figure 5-21). This site had been used to hold surplus and discarded pesticides for indefinite, long-term storage. The building was demolished in 1998.

Currently, the site is overgrown with secondary growth vegetation, with no evidence of the building structure (Building 121) remaining. There is no visual evidence of any releases observed from this unit based on the 2003 ECP inspection.

Based on the performance and completion of the closure plan submitted June 17, 1992 and its revisions, no further work is required. RCRA closure was submitted in June 1994 and approved by the EPA in 1996.

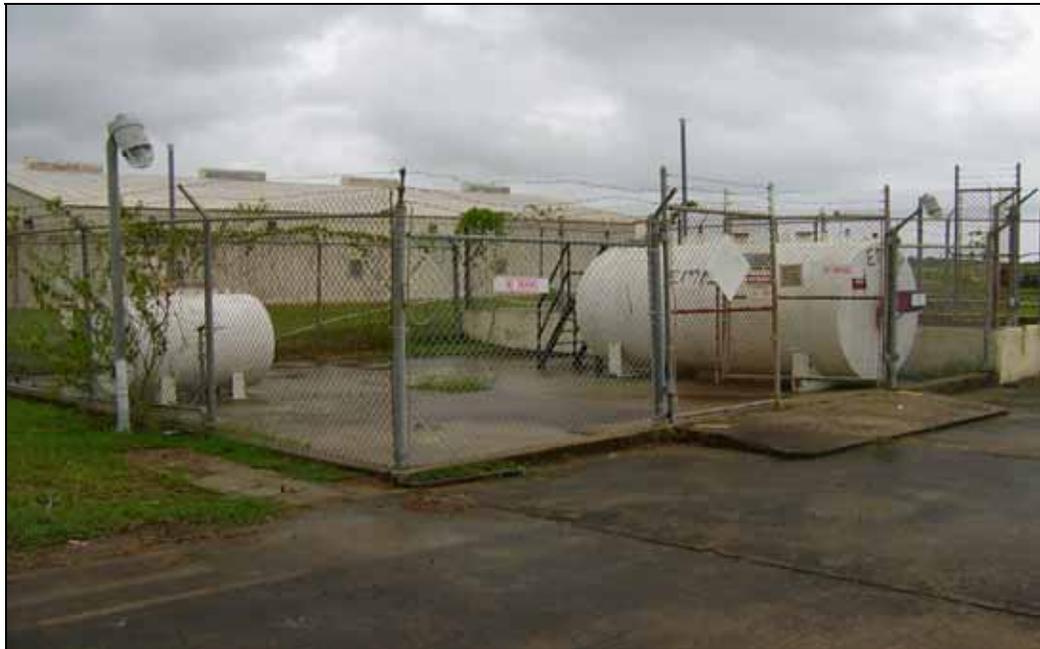
Figure 5-22. SWMU 20 – Open-air, bermed, concrete storage pad

SWMU 20 consisted of a tank truck located in front of Building 860 (Aerial Target Systems Department), and south of Building 1980 (see Figure 5-22). This site was formerly used to temporarily store waste oil, fuels, and solvents generated at the drone refurbishing area. The wastes were disposed of by a contractor, which periodically emptied the tank truck. No visual evidence of releases was observed during the 1988 VSI. The 1993 follow-up inspection found that the tank truck was no longer present, but had been replaced by an open-air, bermed, concrete storage pad near Building 860. This storage pad now constitutes SWMU 20. During the 1993 follow-up inspection, this pad contained (19) 55-gallon drums of oil and a 500 gallon tank. No visual evidence of releases was observed during the 1993 follow-up inspection. A RFI was not required for this SWMU.

Currently, there is no visual evidence of any releases observed based on the 2003 ECP inspection.

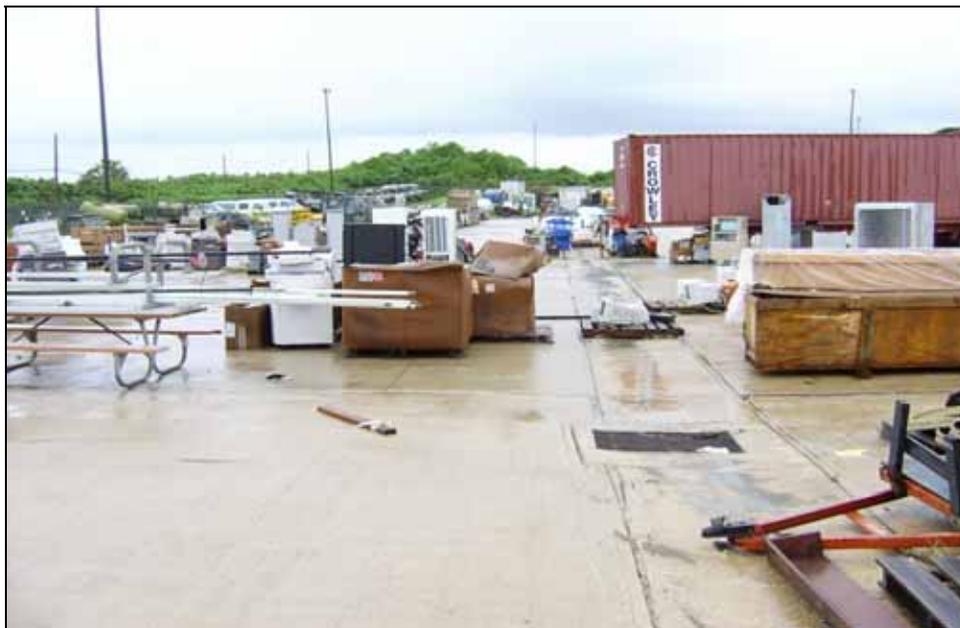
Figure 5-23. SWMU 25 – DRMO Storage Yard

SWMU 25, a part of OU 1, consists of an open area within the DRMO storage yard (see Figure 5-23). This area was formerly used to store ignitable hazardous wastes. During the 1988 VSI, several areas of oil staining were observed; the 1993 follow-up inspection did not observe visual evidence of releases. In the RCRA permit, the EPA requested confirmatory soil sampling due to evidence of releases observed in 1988. A RFI for surface soils was required.

According to the RFI, several constituents exceeded the residential RBCs in the soil, however, none of these constituents exceeded the industrial RBCs. The human health risk assessment conducted during the RFI for soils and sediment did not find any unacceptable risk posed by the constituents detected. However, the RFI stated that there is the minor potential for ecological impact. As mentioned in the RFI, this area is totally devoted to industrial use with essentially no potential for residential development. Many of the constituents detected are subject to biodegradation as a natural process. There was no evidence of

significant releases or potential for a future release from this unit. Therefore, the RFI did not recommend any further site characterization efforts or corrective measures evaluation at this site.

There is no visual evidence of any releases observed based on the ECP site inspections.

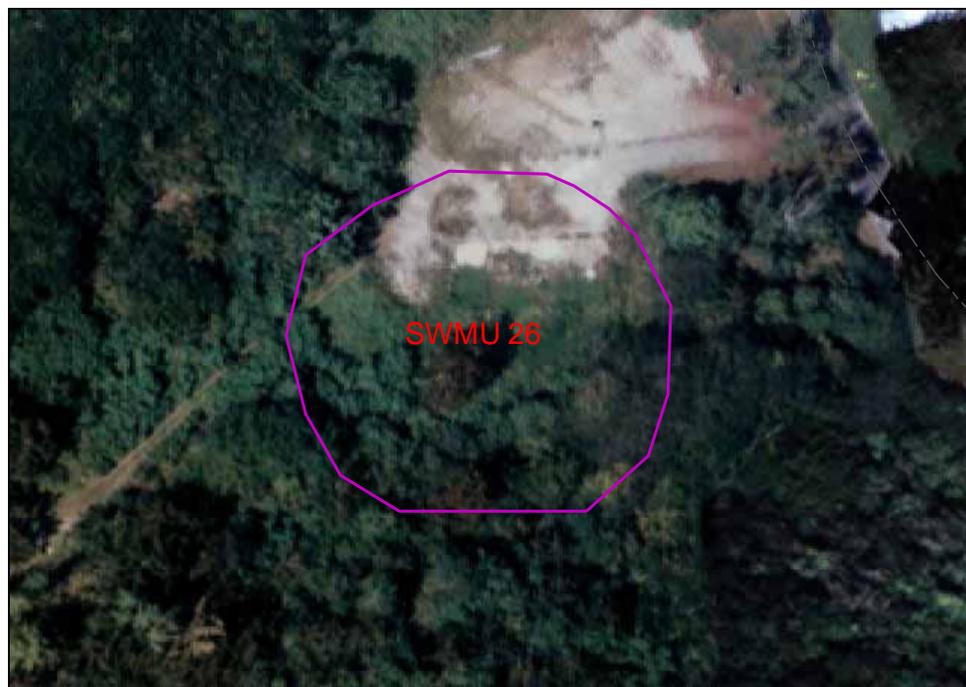
Figure 5-24. SWMU 26 – Building 544 Area

SWMU 26, a part of OU 1, consists of an open area behind former Building 544 where, during the 1988 VSI, approximately (25) badly rusted, 55-gallon drums of waste oil, or other substance, were observed to be lying (mostly on their sides) on bare soil (see Figure 5-24). At that time, it was indicated that the containers were in very poor condition, and partially overgrown with vegetation. A tar-like substance was observed to be leaking onto the ground. Subsequently, in June 1992, the Navy indicated that the containers were removed, “and no visual evidence exists of any soil staining”. The 1993 follow-up inspection found no visual evidence of releases. However, as documented during the 1993 follow-up inspection, the area has the appearance of possible stressed vegetation, possible miscellaneous disposal activity, and mounds of excavated soil covered with plastic were observed. While this is the case, the 1993 inspection looked at areas not included in the SWMU. Since the 1993 reinspection, multiple contractors have used the area for a construction lay down area. The RCRA permit required a RFI for surface soils.

According to the first phase RFI, several constituents were detected at various constituents in the study area. However, no unacceptable human health or ecological risks were calculated for this site. The RFI stated that this area is in a remote section of the station, away from any family residential areas. This area was used at one time as a contractor laydown area for some nearby construction. However, the constructions was completed, and the area was cleaned and unused. The drums that originally caused the area to be labeled a SWMU have long been removed, and therefore, have removed the potential for a future release. No further site characterization or corrective measures evaluation efforts are necessary at this SWMU. However, the EPA requested that additional sampling be conducted within this area. After completion of the additional sampling of the RFI, it was concluded that no further action of any kind is required at this SWMU based on the results of the RFI. The EPA has approved this recommendation, and therefore, no further action is proposed in the RCRA Part B permit renewal.

The area is once again used as a construction laydown area for contractors. However, there is no visual evidence of any releases observed based on the 2003 ECP inspection.

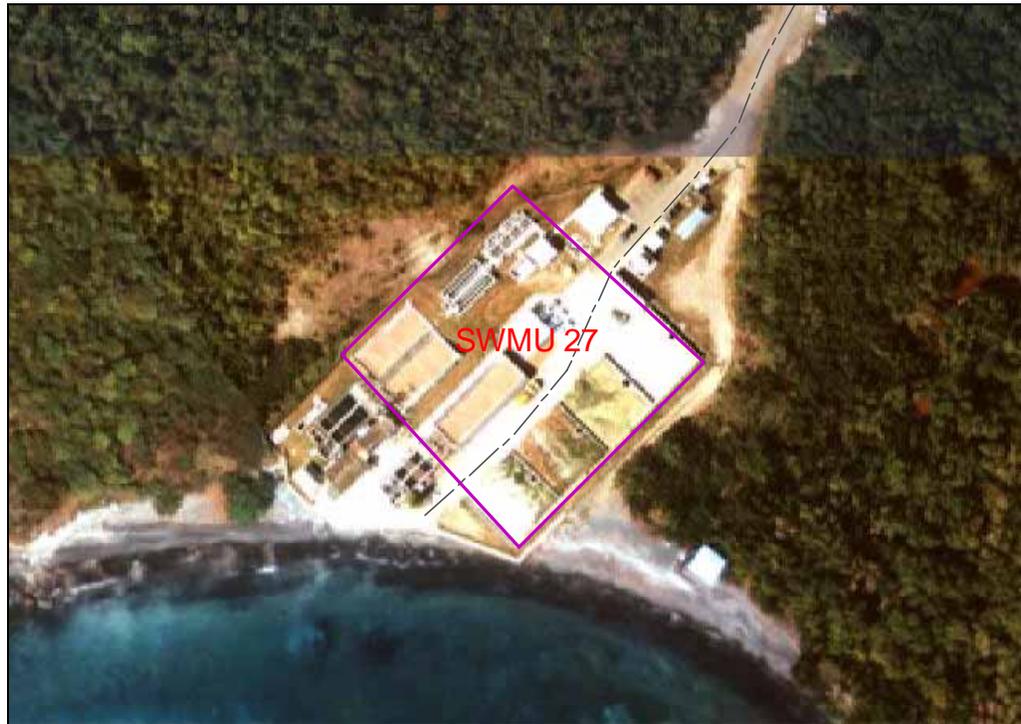
Figure 5-25. SWMU 27 – Capehart WWTP

SWMU 27 consists of the wastewater treatment plant (WWTP) serving the Capehart housing area (see Figure 5-25). Based on information available (verbal statements, and Navy letters of August 31, 1993 and June 30, 1992), this unit does not manage or generate RCRA hazardous wastes or constituents. Permittee verbally indicated it had no knowledge or evidence of systematic and routine releases of hazardous wastes or constituents from this unit. A RFI is not required for this SWMU.

Currently, the Capehart WWTP is operational.

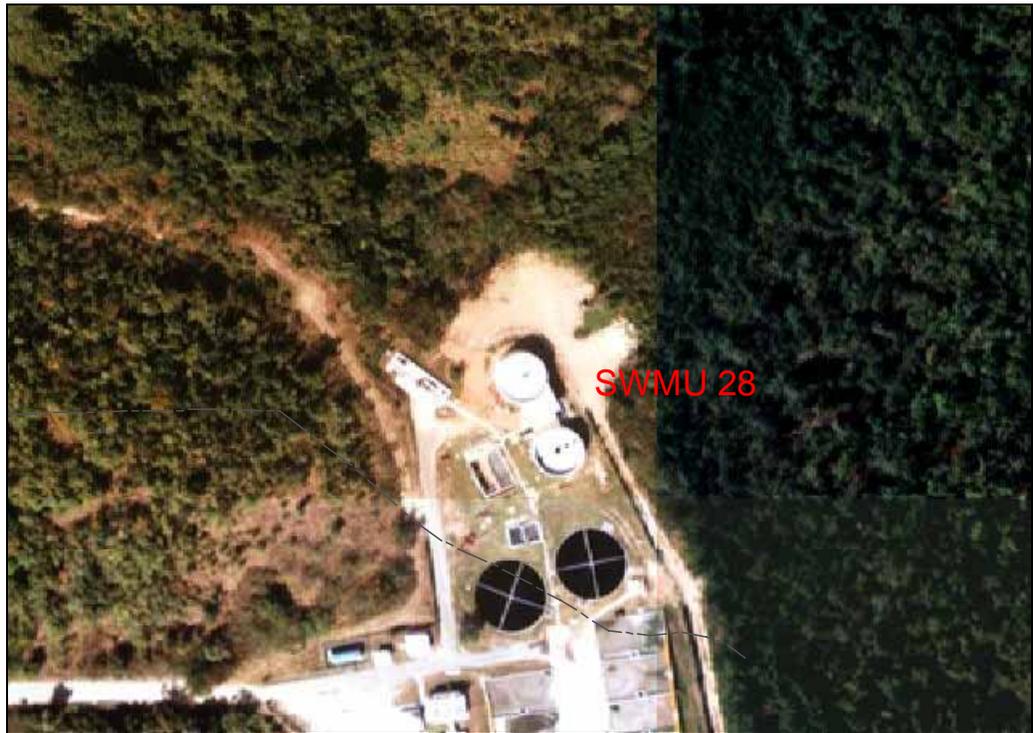
Figure 5-26. SWMU 28 – Bundy WWTP

SWMU 28 consists of the WWTP serving the Bundy area (see Figure 5-26). Based on information available (verbal statements, and Navy letters of August 31, 1993 and June 30, 1992), this unit does not manage or generate RCRA hazardous wastes or constituents. Permittee verbally indicated it had no knowledge or evidence of systematic and routine releases of hazardous wastes or constituents from this unit. A RFI is not required for this SWMU.

Currently, the Bundy WWTP is operational.

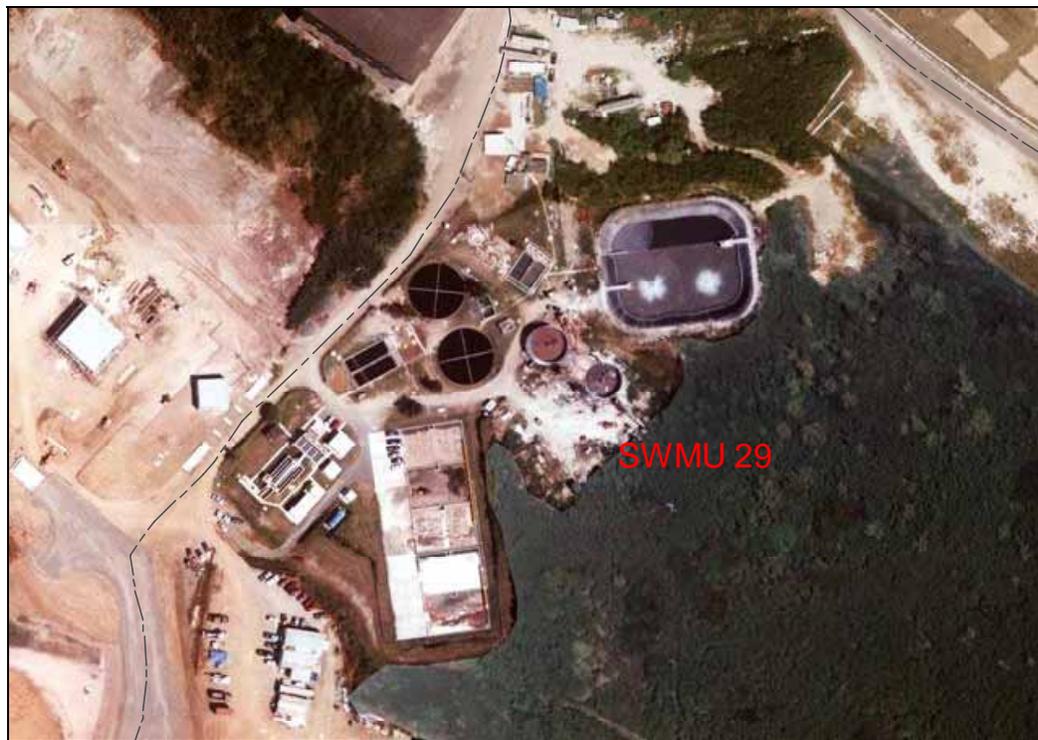
Figure 5-27. SWMU 29 – Forrestal WWTP

SWMU 29 consists of the Forrestal WWTP for the “Industrial Area” of the station (see Figure 5-27). No visual evidence of releases of hazardous wastes or constituents was observed during the 1988 VSI, or 1993 follow-up inspection. The sludges generated by this unit have been tested since 1988 for “Characteristics of Hazardous Waste” pursuant to 40 C.F.R. Part 261, and found to be not hazardous by characteristic. Permittee verbally indicated it had no knowledge or evidence of systematic and routine releases of hazardous wastes or constituents from this unit. A RFI is not required at this site.

Currently, the Forrestal WWTP is operational.

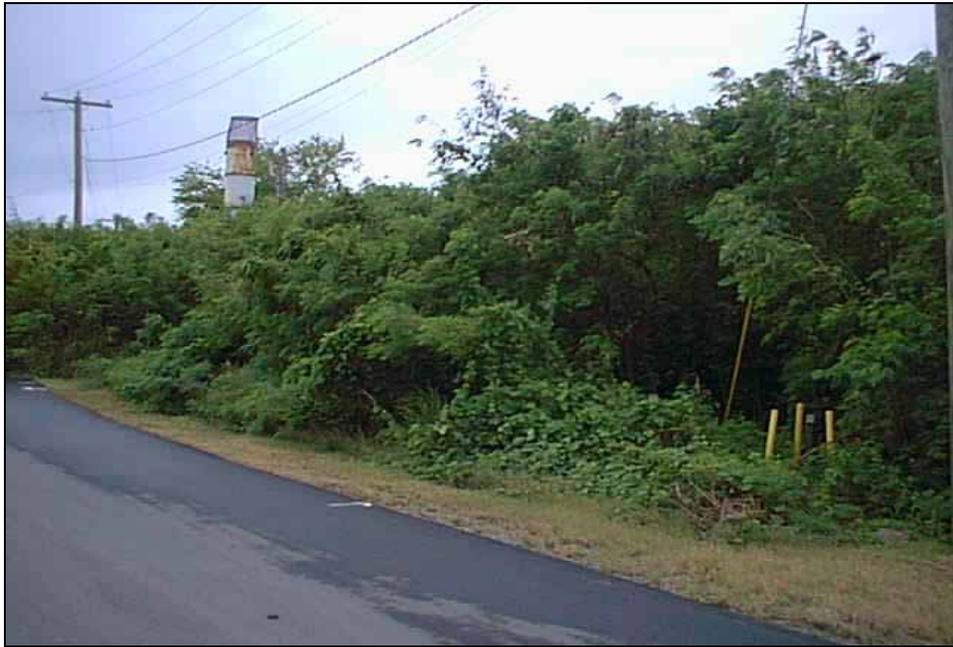
Figure 5-28. SWMU 30 – Former Incinerator Area

SWMU 30, a part of OU 1, consists of the remains of an abandoned incinerator located south of Building 38 along the roadway leading to the landfill and Forrestal wastewater treatment plant (see Figure 5-28). This site was formerly used to burn contaminated fuels, waste oils and sludges. A previous incinerator at this same site was reportedly dismantled and removed in 1983, and the present incinerator installed at that time. The 1993 follow-up inspection found that a 500-gallon underground storage tank associated with this unit, was in the process of being removed. The Navy performed sampling of the subsurface soils, and the results indicated elevated levels of total recoverable petroleum hydrocarbon levels. Therefore a RFI for soils was required to fully characterize this release and define all constituents associated with it.

According to the Phase II RFI, although some human health and ecological risks were mentioned, no further actions were recommended at this site due to its location in close proximity to the Forrestal waste water treatment plant, as well as the Station Landfill. The EPA has approved this recommendation, and therefore, no further action is proposed in the RCRA Part B permit renewal.

Currently, there is no visual evidence of any releases observed based on the 2003 ECP inspection.

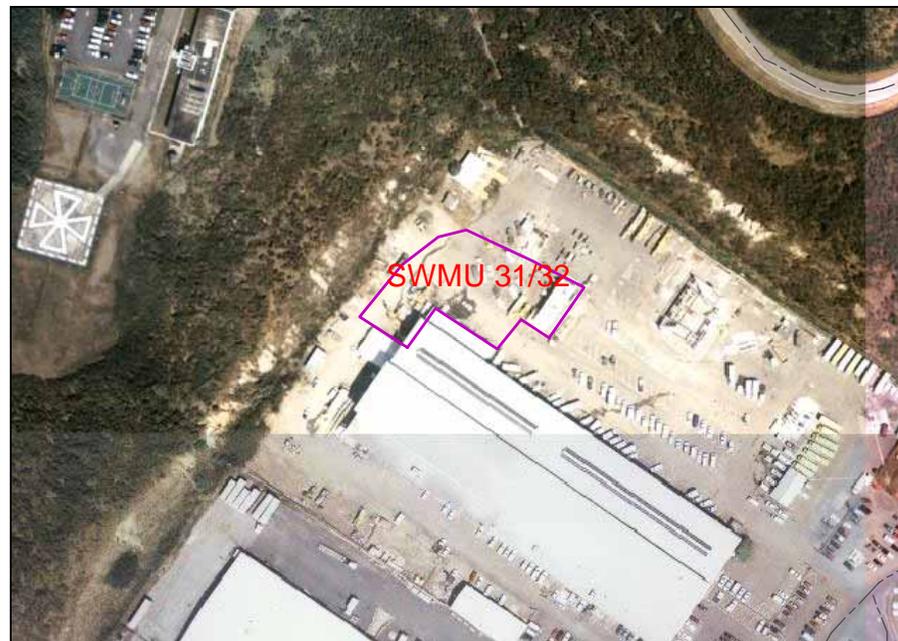
Figure 5-29. SWMU 31 – Waste Oil Collection Area (Building 31 and 2022)

SWMU 31, a part of OU 1, is located in the Public Works Department storage yard, near the Transportation Shop (Building 31) and Building 2022 (see Figure 5-29). This SWMU consists of an outdoor, curbed, concrete pad used for temporary storage of containers of waste oil. There is also a 500 gallon tank for collection of waste oils. The 1993 follow-up inspection found extensive oil staining surrounding this storage pad. In addition, this SWMU is associated with Building 31, where the Navy's 1984 IAS reported past practices that included storing containers of unidentified wastes outside the building, and where creosote or solvent odors were reported. Presently, the entire area surrounding this SWMU is paved with asphalt. Since any hazardous constituents now released from the SWMU would likely be transported by storm water runoff, a RFI for surface soils surrounding the asphalt pavement was required. In addition, the EPA requested that subsurface soils be investigated beneath the asphalt.

According to the RFI, the risk assessment indicated potentially unacceptable human health risks present for future and current on-site workers. The Navy recommended to place the SWMU under a land use restriction which would negate the risks posed to future residents. The RFI also stated risk to current on-site workers is mitigated by the fact that significant portions of the site are paved,

Currently, there is no visual evidence of any releases observed based on the 2003 ECP inspection.

The CMS report recommended no further action based on the fact that a majority of the area is currently covered with asphalt, which mitigates the exposure pathway for dermal contact with the surface soil at this SWMU. The CMS also recommended that the remaining small area within SWMUs 31/32 be covered with asphalt to mitigate a potential exposure pathway. The existing and new pavement would be maintained to protect the integrity of the cap. Land use controls were also recommended to prevent the use of this SWMU for residential housing.

A Corrective Measures Implementation (CMI) Work Plan was submitted and subsequently approved by the EPA. The next step is for EPA to place this document out for public comment.

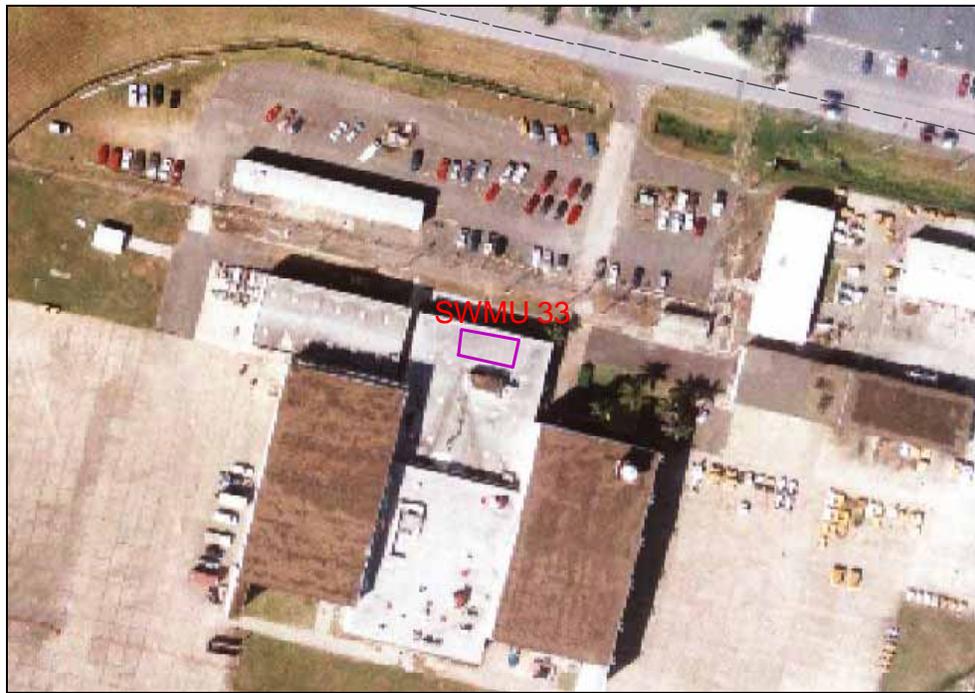
Figure 5-30. SWMU 33 – Former location of a curbed, roofed, concrete pad.

SWMU 33 consisted of a curbed, roofed, concrete pad, formerly located along the north wall of Building 379 (aircraft maintenance building) (see Figure 5-30). This SWMU was used for temporary storage of various wastes generated during aircraft maintenance. During the 1988 VSI, visual evidence of possible releases to the soil was observed. However, the 1993 follow-up inspection was unable to locate this unit. The Navy indicated that a newly constructed building now covers the site of SWMU 33 and the soils associated with this unit were removed during the construction. A new storage area was constructed to take place of the old area (SWMU 33). The new area has been designated SWMU 51. A RFI was not required at this SWMU.

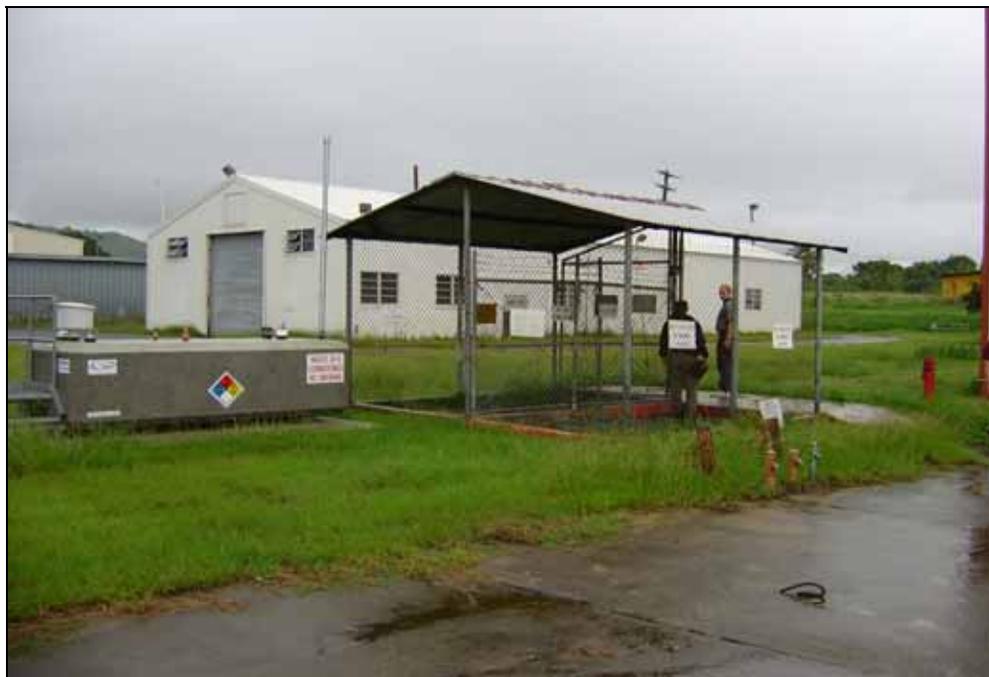
*Photograph from November 2003

Currently, the concrete pad is empty, and there is no visual evidence of any releases observed based on the 2003 ECP inspection.

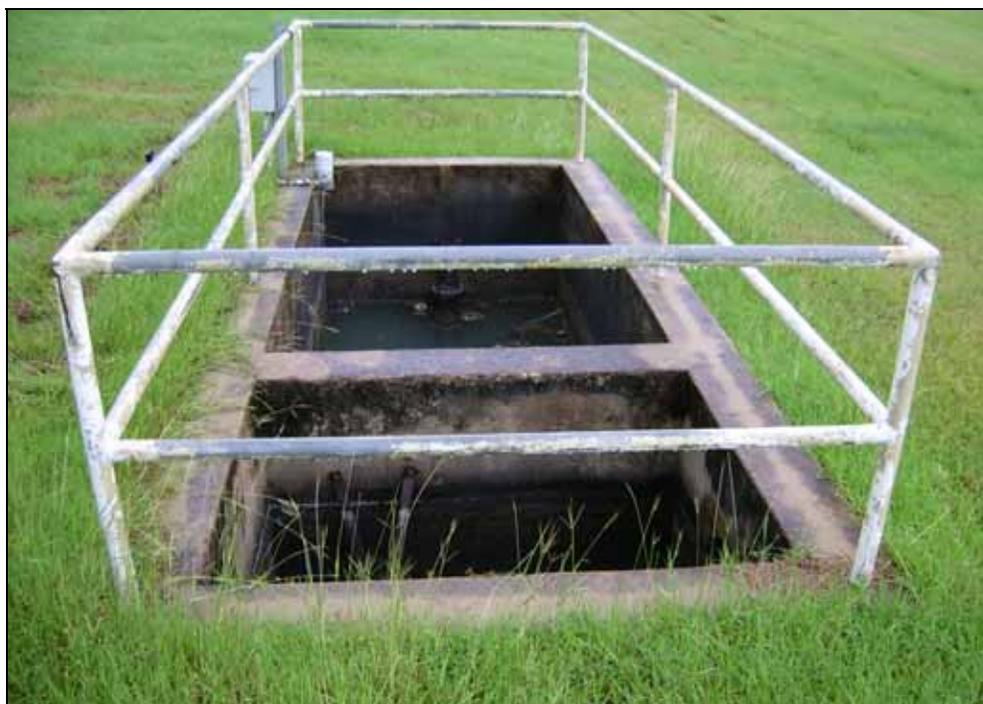
Figure 5-32. SWMU 35 – Inground, concrete oil/water separator

SWMU 35 consists of an inground, concrete oil/water separator located outside Building 396 (see Figure 5-32). This separator is used to collect and separate oil and washwaters generated during aircraft washdown. No evidence of releases was reported during the 1988 VSI, or 1993 follow-up inspection. Permittee had verbally indicated it had no knowledge or evidence of systematic and routine releases of hazardous wastes or constituents from this unit. A RFI was not required at this SWMU.

Currently, there is no visual evidence of any releases observed based on the 2003 ECP inspection.

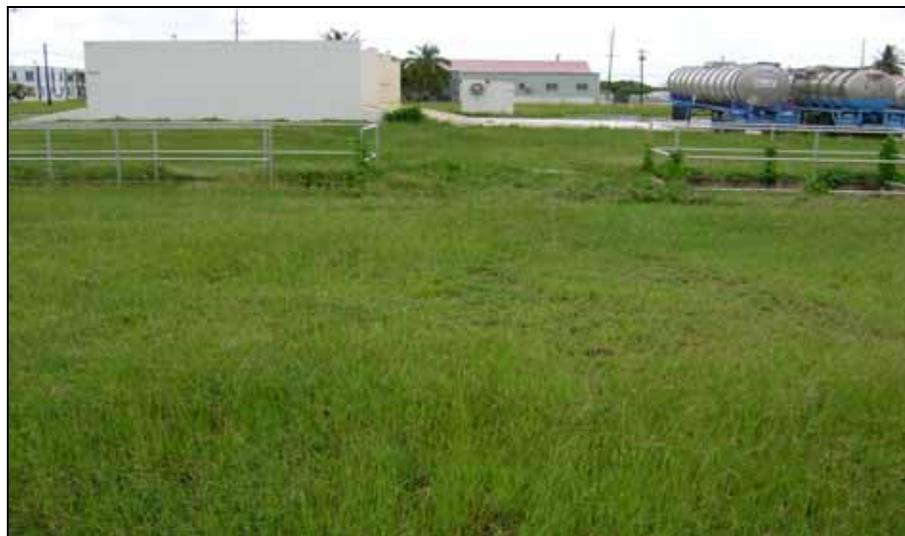
Figure 5-33. SWMU 36 – Inground, concrete oil/water separator

SWMU 36 consists of an inground, concrete oil/water separator located near the Berthing Pier within the Ensenada Honda (see Figure 5-33). This separator is used to collect and separate oil and washwaters generated during vehicle washdown. No evidence of releases was reported during the 1988 VSI, or 1993 follow-up inspection. Permittee had verbally indicated it had no knowledge or evidence of systematic and routine releases of hazardous wastes or constituents from this unit. A RFI was not required at this SWMU.

Currently, there is no visual evidence of any releases observed based on the 2003 ECP inspection.

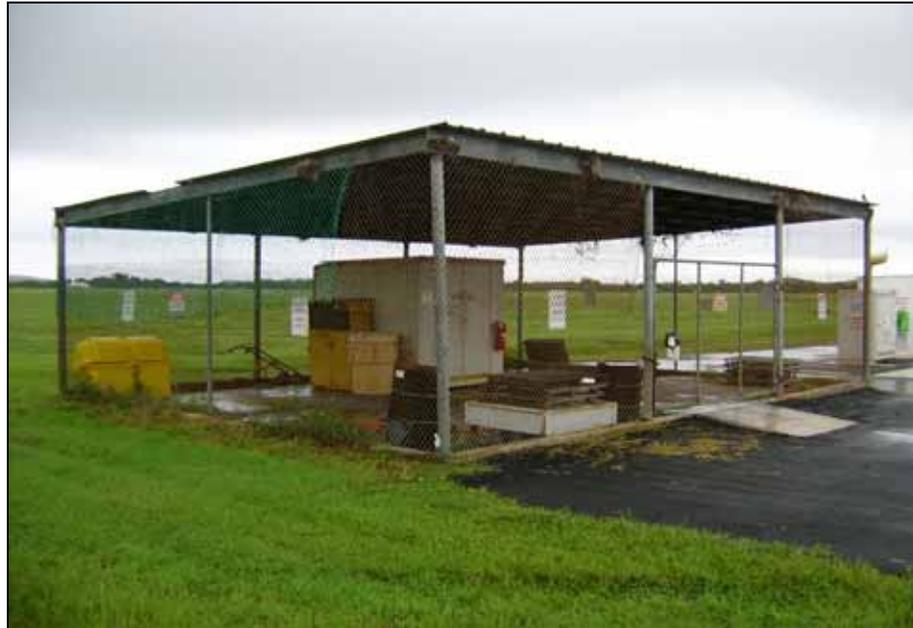
Figure 5-34. SWMU 37 – Waste Oil Storage Area (Hangar 200)

SWMU 37, a part of OU 1, consists of a covered, open-sided, concrete pad, which is curbed (not curbed during 1988 VSI) (see Figure 5-34). The pad is located behind Hangar 200, and serves as a container storage area for waste gasoline, oils, and other wastes. During the 1988 VSI, oil stains were observed on the concrete pad. During the 1993 follow-up inspection, an area of stressed vegetation with soil yielding elevated organic vapor readings was observed adjacent to the backside of the pad. Based on the findings of the inspections, the EPA required a first phase RFI for surface soils.

Currently, there is no visual evidence of any releases observed based on the 2003 ECP inspection.

prevent future releases from coming into contact with the soil. SWMU 37 was replaced by another, similar facility, thereby, preventing any future release at this site. No further action is proposed in the RCRA Part B permit renewal.

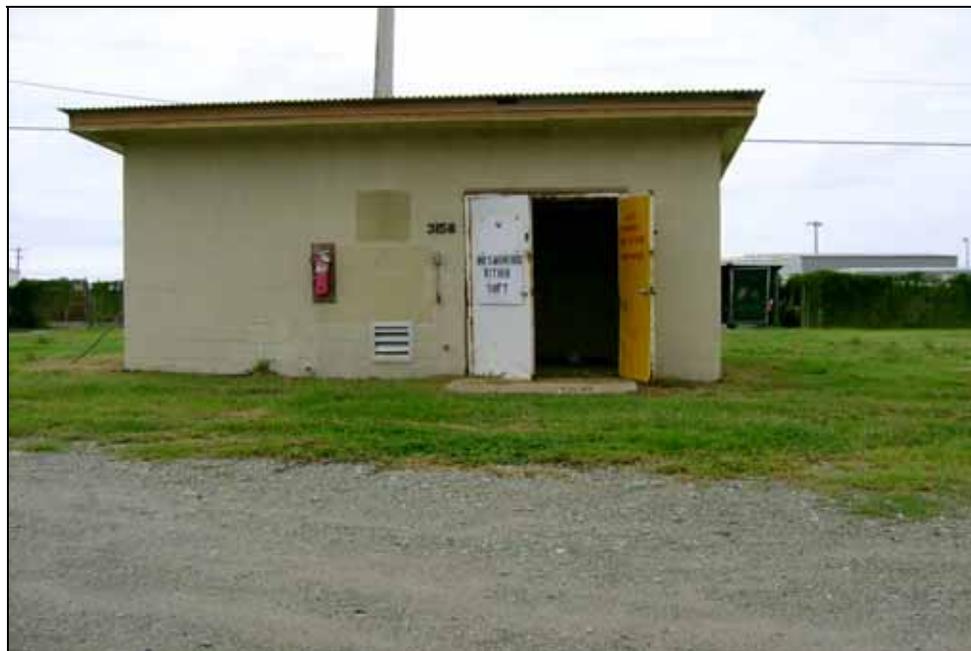
Figure 5-35. SWMU 39 – Former Battery Drain Area (Building 3158)

SWMU 39, a part of OU 1, consists of a small building (Building 3158) with an attached, open sided, roofed pad, where it was noted during the 1988 VSI, that discarded batteries had their fluids drained into a tank, and stored there (see Figure 5-35). The tank had a curbed, concrete pad underlying it, which was observed to be cracked and stained. The 1993 follow-up inspection found this building was no longer used for drainage and storage of discarded batteries, but now contained assorted small cans of miscellaneous hydraulic fluids, etc. In

According to the RFI, there was no evidence of release from this unit, and no potential for future release since the unit is no longer used for battery storage. No unacceptable human health risk was calculated for soils at this SWMU. In addition, this SWMU is located within the Seabee industrial compound where the heavy equipment is staged for maintenance activities. There are no plans to use this area for residential development, nor is there any reasonable scenario under which this would be considered. Therefore, no further site characterization or corrective measure evaluation efforts are required at this SWMU. No further action is proposed in the RCRA Part B permit renewal.

Currently, the interior of Building 3158 is empty, and there is no visual evidence of any releases observed based on the 2003 ECP inspection.

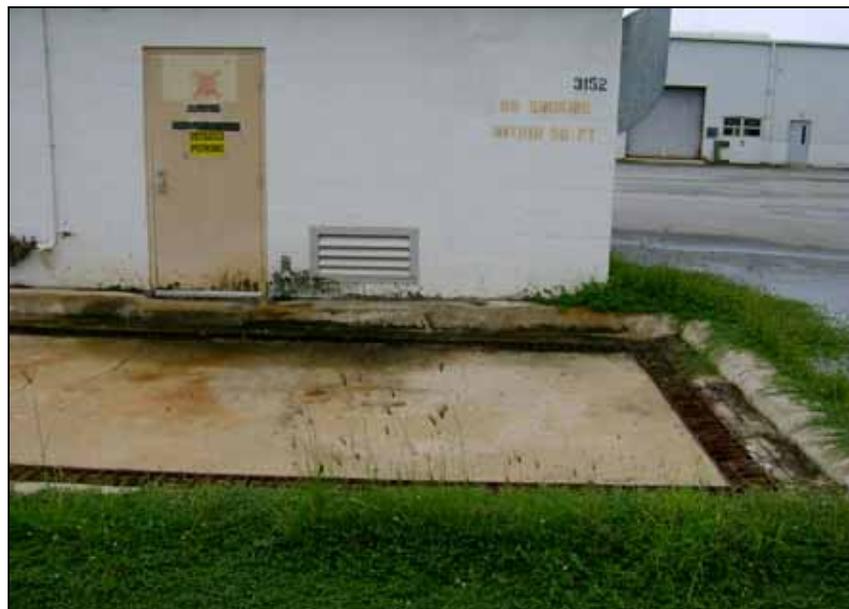
Figure 5-36. SWMU 41 – Open air, curbed, concrete pad surround by a sump drain covered with metal grating

SWMU 41 consists of an open air, curbed, concrete pad, surrounded by a sump drain covered with metal grating (see Figure 5-36). This concrete wash-pad is attached to Building 3152, which was used by the Seabee's as a pesticide storage building (Building 3152). The SWMU is used as a wash-pad to rinse off pesticide control equipment. The discharge point for the washwaters collected in the sump drains is not described in the RCRA Facility Assessment (RFA). The Navy has demonstrated that the sump drain surrounding the wash-pad discharges through a permitted outfall. A RFI was not required at this SWMU.

Currently, there is no visual evidence of any releases observed based on the 2003 ECP inspection.

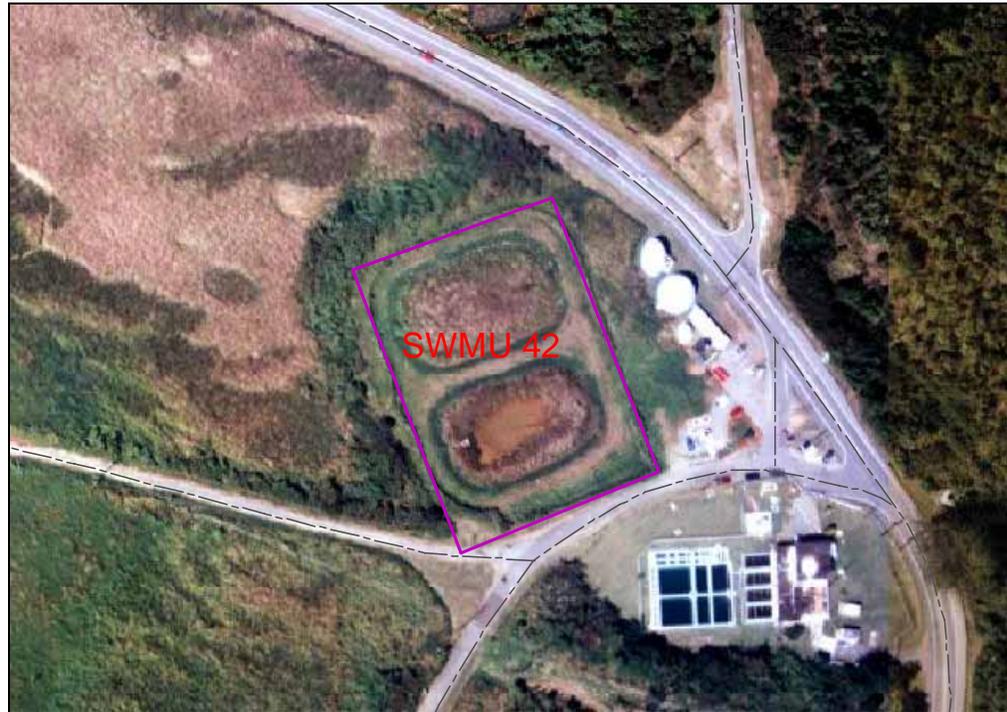
Figure 5-37. SWMU 42 – Two unlined, naturally occurring lagoons

SWMU 42 consists of two unlined, naturally occurring lagoons, located northwest of Building 158 the water treatment plant (see Figure 5-37). This site is used for disposal of sludges from the water purifications plant. According to the 1988 RFA, the sludges consist of river mud, and aluminum sulfate and lime utilized during the water treatment process. Periodically (approximately every 7 years), the sludges are removed and disposed of off-site. There is no indication of hazardous wastes being managed at this SWMU, and no visual evidence of releases of hazardous wastes or constituents. Permittee had verbally indicated it had no knowledge or evidence of systematic and routine releases of hazardous wastes or constituents from this unit. A RFI was not required at this SWMU.

Currently, there is no visual evidence of any releases observed based on the 2003 ECP inspection.

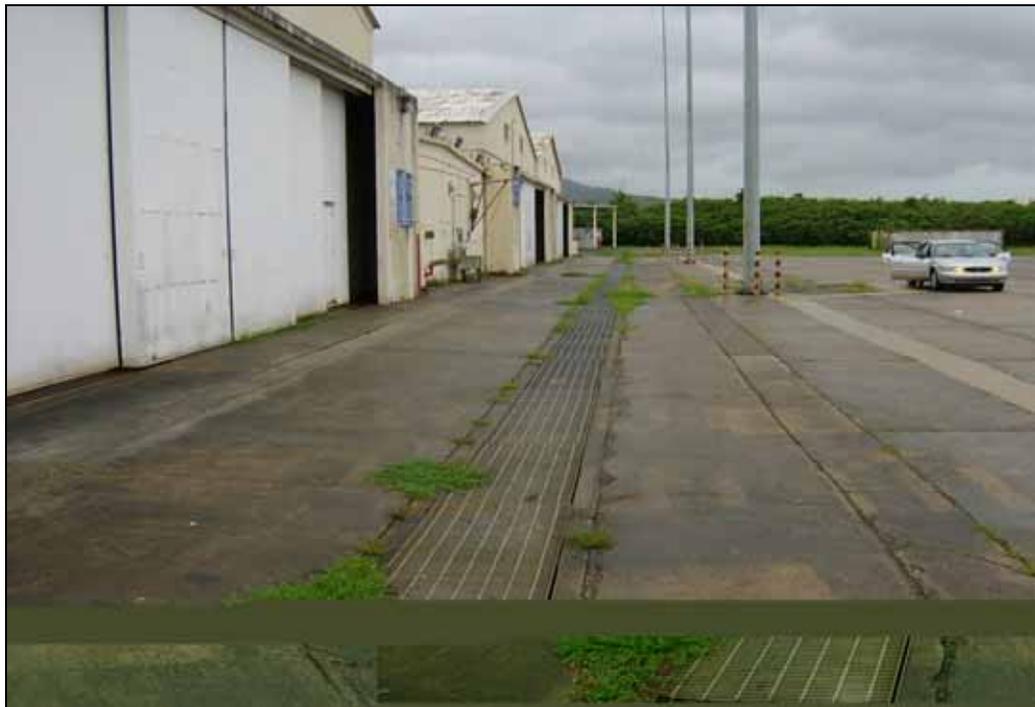
Figure 5-38. SWMU 43 – In-ground, concrete trough/drainage ditch, covered with a metal grate

SWMU 43 consists of an in-ground, concrete trough/drainage ditch, covered with a metal grate, located along the entire front of Building 860 (see Figure 5-38). Prior to the mid-1970s, discarded fuel and oil from recovered target drones were emptied into this trough, when target drones recovered from the sea were brought to Building 860 for refurbishing. The Navy's 1984 IAS of NSRR stated that this practice occurred from about 1960 until the mid-1970s. However, since the mid-1970s, the drones have been emptied into an in-ground oil/water separator (SWMU 4). During Installation Restoration (IR) Round 1 and Round 2, a total of 6 sediment samples and 8 surface water samples were collected at points along storm drainage system, down-gradient of the trough/ditch in which the drone fuels were discarded. Hazardous constituents were not detected above proposed Subpart S action levels. The Navy had recommended that no further investigation be required. The 1993 follow-up inspection found no visual indication of releases; vegetation at the discharge points of the drain was lush; there were no stains, or oil sheens on the water in the drain. A RFI was not required.

Currently, there is no visual evidence of any releases observed based on the 2003 ECP inspection.

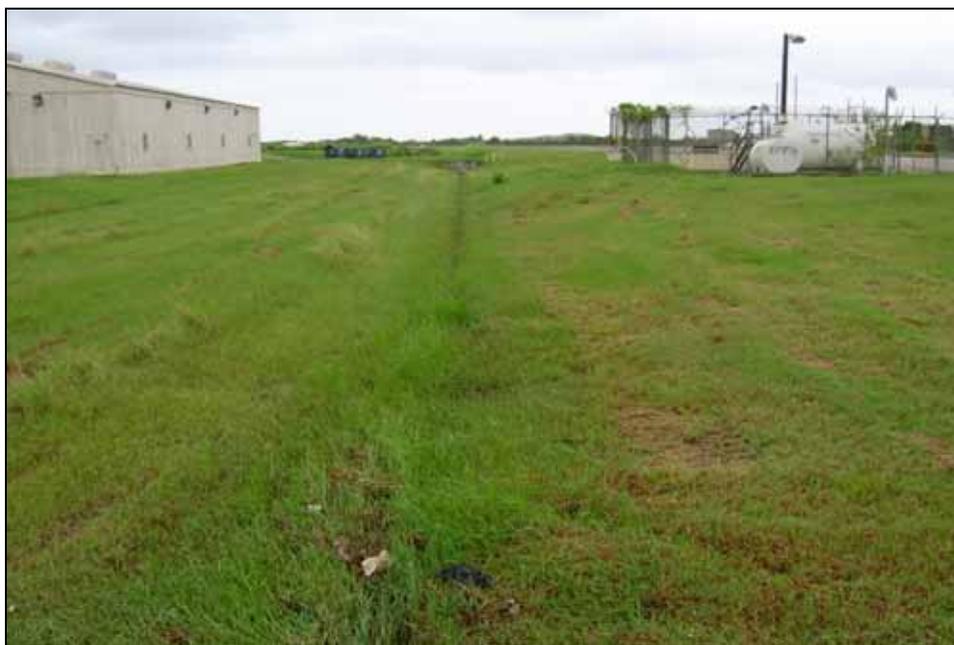
Figure 5-39. SWMU 44 – Drainage ditch system

SWMU 44 consists of the drainage ditch system along the northern perimeter of the Aerial Target Systems (“drone”) yard and Building 860 (see Figure 5-39). It is the down-gradient extension of SWMU 43. As discussed in SWMU 43, the EPA is satisfied that this unit has been adequately investigated, and a RFI was not required.

Currently, there is no visual evidence of any releases observed based on the 2003 ECP inspection of the drainage ditch system.

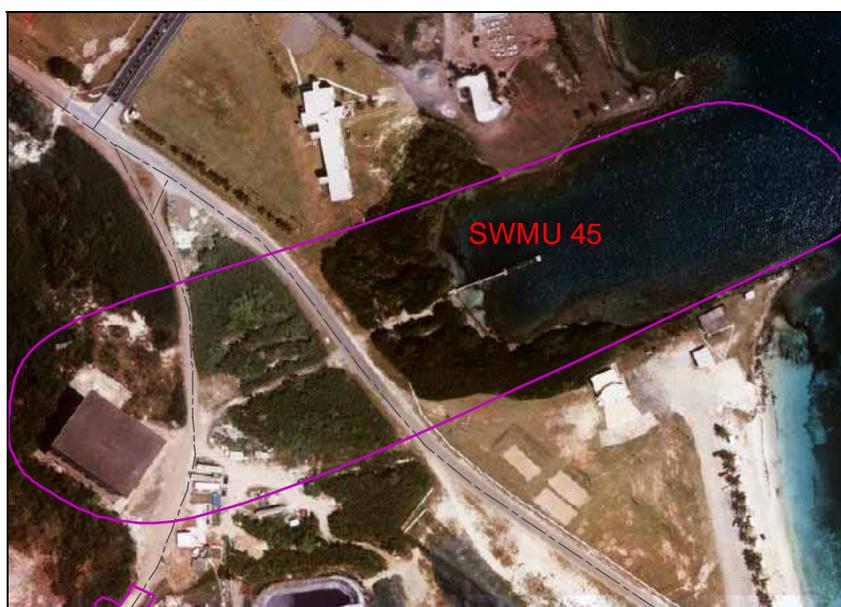
Figure 5-40. SWMU 45 – PCB Spill Area/Old Power Plant

SWMU 45, a part of OU 3, consists of an area outside of Building 38, the old Power Plant (SWMU 11), located along an access road south of Forrestal Drive leading to the station landfill and Forrestal wastewater treatment plant (see Figure 5-40). This area extends from the property around Building 38 and includes the path of the cooling water intake tunnel from the embayment of Puerca Bay. The majority of SWMU 45 is covered with secondary growth vegetation.

During the ICM on the tunnel, an excavation was made at a point along the outside of the tunnel in an attempt to ascertain how groundwater was entering the tunnel. Soils contaminated with petroleum were observed. A work plan to investigate the outside of the tunnel was submitted to and subsequently approved by the EPA. A RFI encompassing soil, groundwater, and sediments has been completed and approved by the EPA. The RFI found that the surface and subsurface soils within the Building 38 Underground Storage Tank (UST) area presented no significant impact from site activities, where as groundwater showed minimal impact. The soils found within the area encompassing the cooling water tunnel area, indicated a significant release of petroleum related compounds from the tunnels. However, no free product was found at any location within this area, and the zone of contamination is confined to the area immediately adjacent to the tunnels. The sediments found within Puerca Bay show obvious impact from tunnel discharges. The human health risk assessment performed on all media with exception of the Puerca Bay sediments, indicated that only risk was possible for future on-site residents. The Puerca Bay sediments did not contain a complete pathway for exposure. Because of the performance of the ICM within the Building 38 UST area, any environmental issues related to that area have been resolved. The source of continuing releases to the cooling water tunnel soils and the Puerca Bay sediments was removed when the tunnel was cleaned out and backfilled with concrete. The RFI recommended that a CMS be prepared to address the minimal risks posed by the residual hydrocarbons in the subsurface soil within the vicinity of the cooling water tunnels and to analyze ecological risk associated with the sediment contamination. Currently, an ecological risk assessment (ERA) through Step 3a has been completed. Based on the refined media-specific risk calculation and risk evaluation, Aroclor-1260 and copper have the potential to impact aquatic receptor communities (i.e., benthic

macroinvertebrates) within the embayment downgradient from SWMU 45. Based on refined media-specific risk calculation and risk evaluation, additional evaluation is not recommended for chemicals detected in surface soil and surface water, respectively. It is recommended that Aroclor-1260 be carried on to Step 3b of the baseline ERA (baseline ERA problem formulation). To reduce the uncertainty associated with the identification of copper as a potential risk driver, an appropriate background sediment data set should be established for a surface water body that receives inputs from storm water discharges similar to those that discharge to the embayment. This data set should then be statistically compared to the embayment data set in Step 3b of the baseline ERA in accordance with Navy guidance (NFEC, 2002) to determine if copper warrants identification as a potential risk driver. It is recommended that additional sampling be conducted for SWMU 45 to develop an appropriate background data set. This sampling is to include sediments. The results from this additional sampling will be evaluated and presented in Step 3b of the Baseline ERA for SWMU 45 along with the further evaluation of Aroclor-1260 in the sediment. After the completion of the ERA the CMS will be initiated for this SWMU.

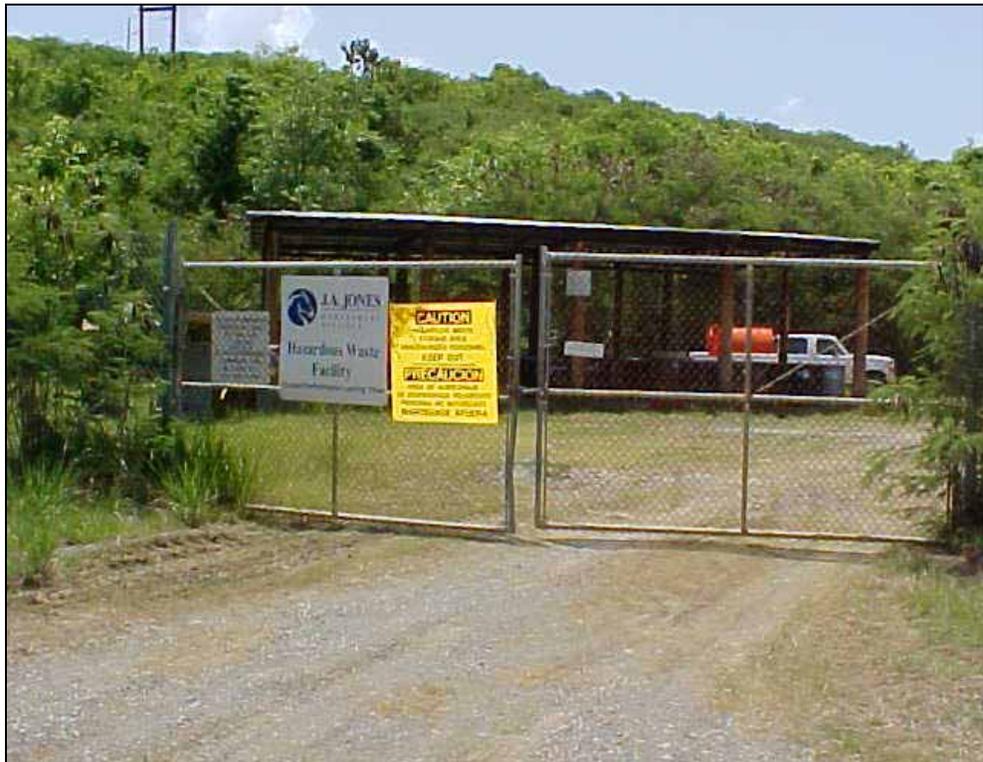
Figure 5-41. SWMU 46 - Pole Storage Yard Covered Pad

SWMU 46, a unit of OU 1, located along Valley Forge Road in the Forrestal portion of the station consists of a large, roofed, open-sided, uncurbed, concrete pad utilized in the past by the Public Works Department as a storage area for transformers, miscellaneous electrical equipment, and drums of PCB-contaminated material (see Figure 5-41). Also, there are reports that, in the past,

Currently, there is no visual evidence of any releases observed based on the 2003 ECP inspection.

The RFI identified PCB contamination in the soils at this site and recommended the performance of a CMS. The CMS recommended the performance of a CMI to remove contaminated soils from the site. EPA has approved a CMI Work Plan Design Package to excavate contaminated soils from the site. The EPA is in the process of modifying the RCRA permit with the proposed CMI for public comment.

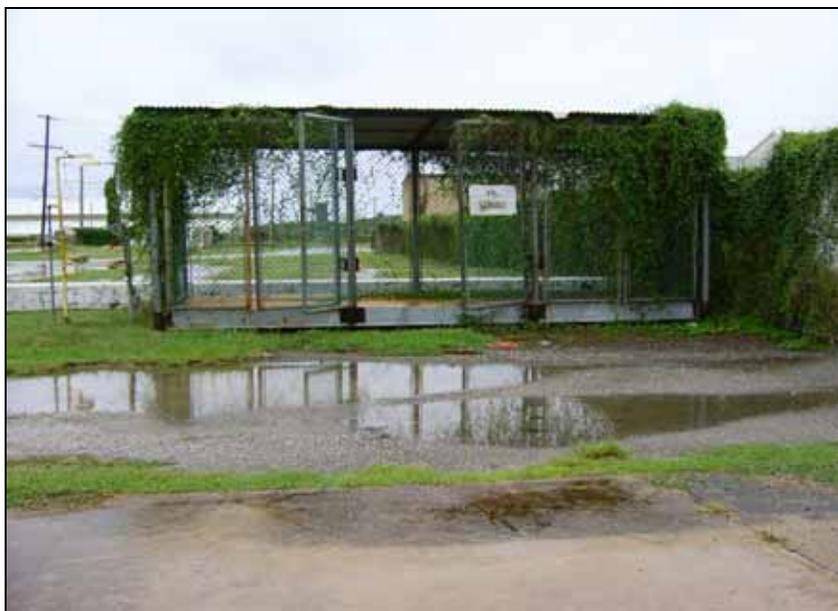
Figure 5-42. SWMU 48 - Mobile, open air, metal-curbed, storage container

SWMU 48 consists of a mobile, open air, metal-curbed, storage container near Building 3102 (see Figure 5-42). This SWMU was first identified during the 1993 follow-up inspection, and is utilized as a temporary (less than 90 days) storage facility for waste oils and oil contaminated soils. No visual evidence of releases was observed. Permittee verbally indicated it had no knowledge or evidence of systematic and routine releases of hazardous wastes or constituents from this unit. A RFI was not required.

Currently, the mobile storage container is empty, with no visual evidence of any releases observed at this unit based on the 2003 ECP inspection.

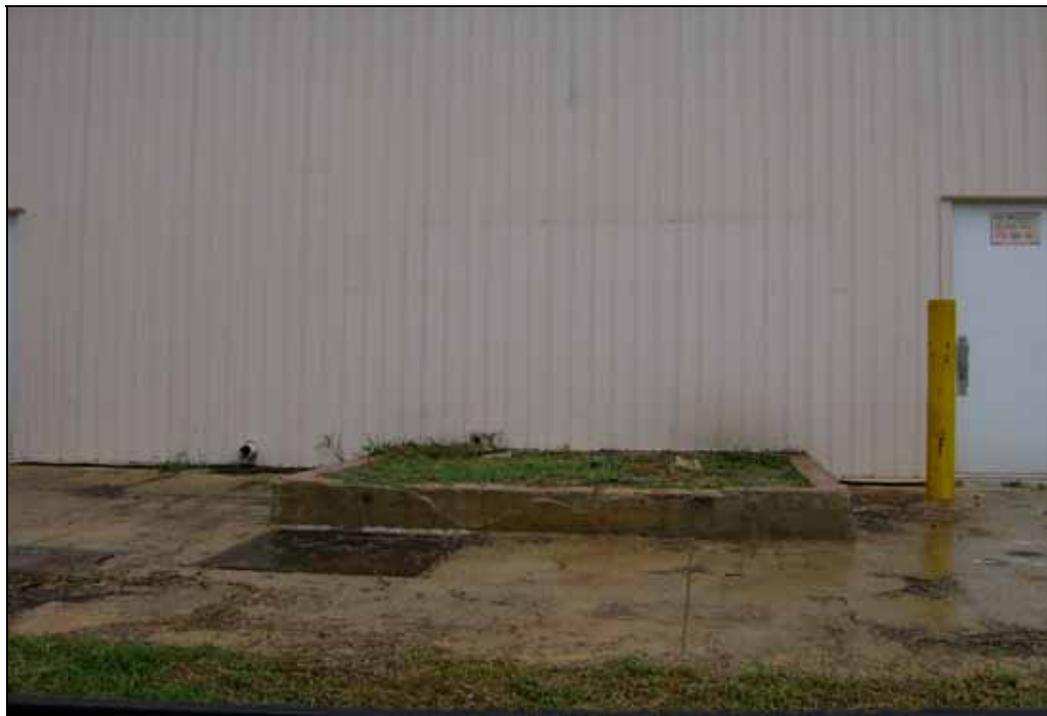
*Photograph from November 2003

Currently, the 500-gallon waste oil tank is no longer present. However, the concrete bermed pad next to Building 3188 is still present. There is no visual evidence of any releases observed based on the 2003 ECP inspection.
