Final Preliminary Assessment Report Watercraft Maintenance Support Center, Ceiba, Puerto Rico

Perfluorooctane-Sulfonic Acid (PFOS)
and Perfluorooctanoic Acid (PFOA) Impacted Sites
ARNG Installations, Nationwide

March 2020

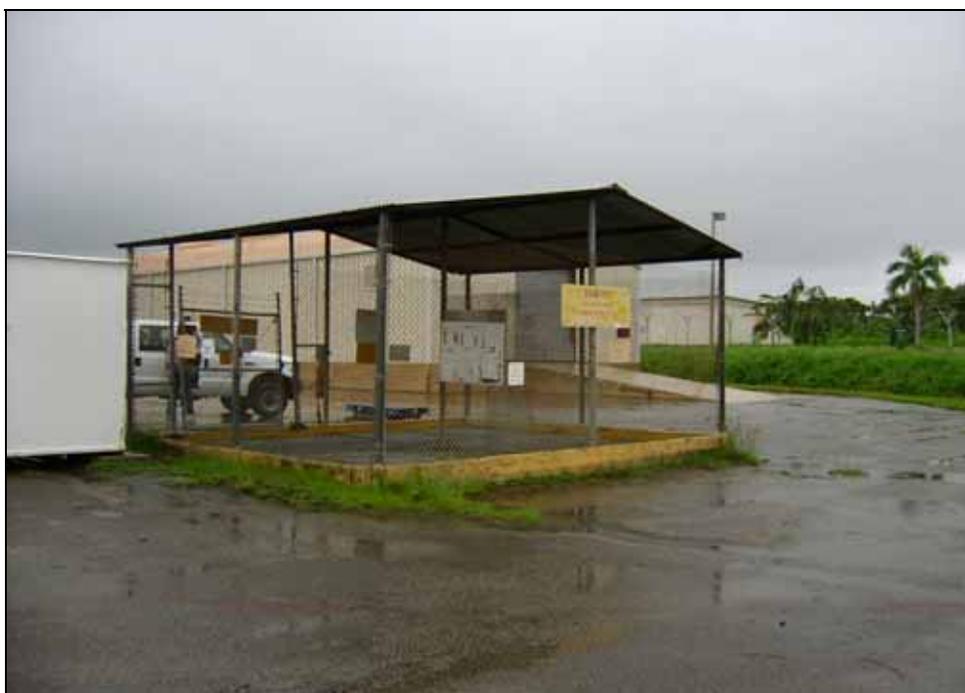
*Photograph from November 2003

Currently, the concrete storage pad is empty, with no visual evidence of any releases observed at this unit based on the 2003 ECP inspection.

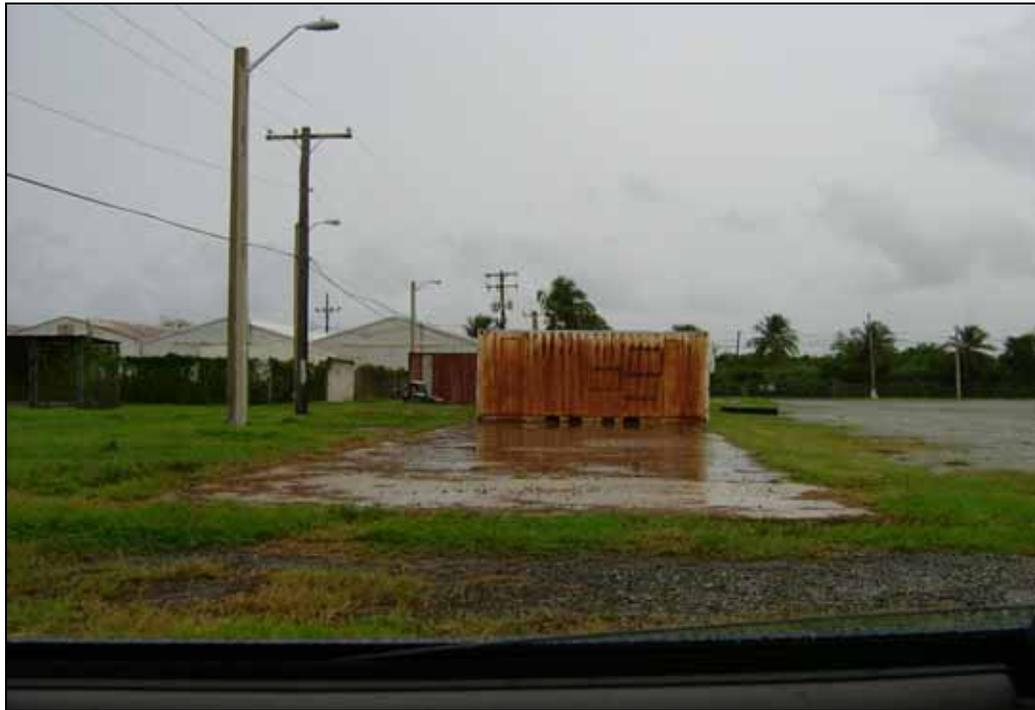
Figure 5-46. SWMU 52 - Open air, uncurbed, concrete storage pad

SWMU 52 consists of an open air, uncurbed, concrete storage pad that was first identified during the 1993 follow-up inspection (see Figure 5-46). It was described as associated with Building 3158 (SWMU 39); however, it is in fact a separate unit. During the 1993 follow-up inspection, this storage pad contained approximately (120) 55-gallon drums of various oil products and other materials. The Navy has indicated that the materials that were stored here were product, and that there is no indication of systematic and routine spills of hazardous constituents. Therefore, this unit constituted an AOC rather than a SWMU. No stains or other evidence of systematic and routine release was observed during the 1993 follow-up inspection. A RFI was not required at this site.

Currently, there is no visual evidence of any releases observed at this unit based on the 2003 ECP inspection.

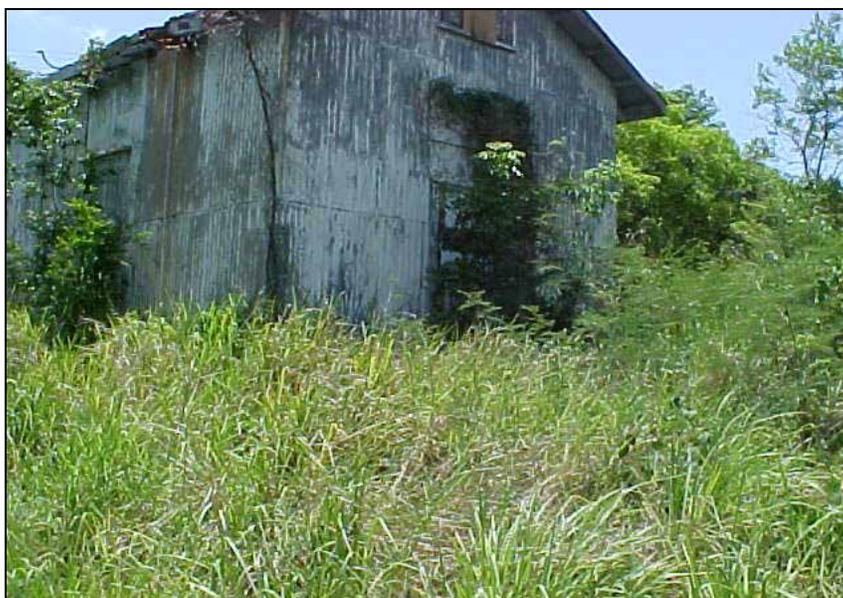
Figure 5-47. SWMU 53 - Malaria Control Building (Building 64)

SWMU 53 consists of a building that is presently unoccupied and lies on approximately 1/8 acre approximately 200 feet away from Forrestal Drive (see Figure 5-47). SWMU 53 is located across Forrestal Drive from SWMU 13. The building was utilized to store pesticides, such as malathion, aldrin, and dichlorodiphenyltrichloroethane (DDT). It is not known if stocks of pesticides were maintained in the building for the entire duration. Although no direct evidence exists, it is assumed that mixing and other preparation for pesticide use was also performed at the building. No wastes are known to have been disposed at the unit. There are no known releases related to this unit. No other use of the site was identified. The information gathered from the visual site inspection by Baker and environmental staff at NSRR, revealed that there are no known wastes dumped at this facility, nor is there any evidence of source contamination. Baker observed signs of possible past leakage of chemicals on the storage shelves inside the building, as well as identified migration pathways along the floor leading to the outside. With this in mind, along with the activities known to have taken place at this SWMU, a site characterization was performed and identified a release of pesticides to the soils surrounding the building and recommended the performance of a RFI. The EPA approved RFI further characterized the soil contamination and recommended a CMS. The EPA approved CMS developed corrective action objectives for the protection of human health and the environment. The CMS recommended the demolition of Building 64 and the removal of soils. The CMI design package is currently being developed to demolish the building and remove the soils.

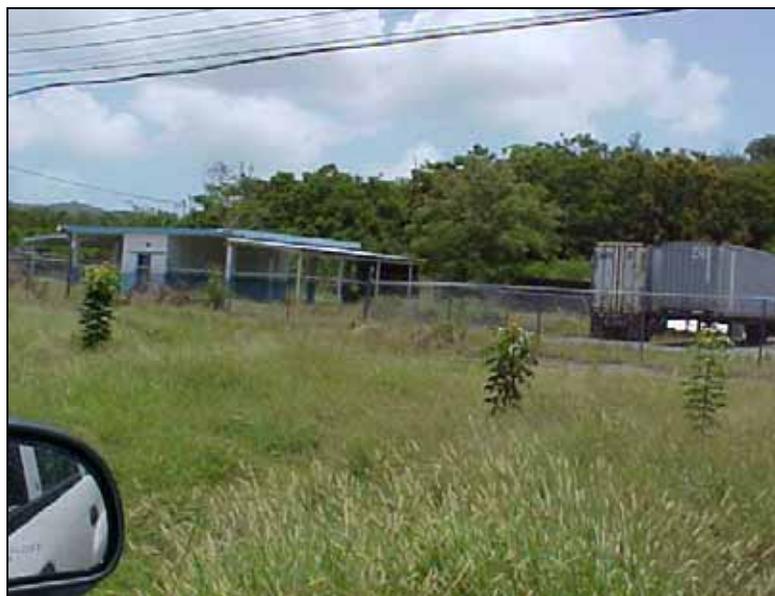
Figure 5-48. SWMU 54 - Former NEX Repair/Maintenance Shop (Building 1914)

SWMU 54 consists of Building 1914 (Former Naval Exchange [NEX] Repair/Maintenance Shop) built in 1979, which is currently unoccupied and lies on approximately 1 acre of land in the Bundy Area of NSRR. The building structure itself consists of a small concrete block building with a center office area and open bays on either side (see Figure 5-48). The building was used to perform maintenance on vehicles including oil changes, lubrications, etc. No wastes are known to have been disposed at the unit. SWMU 54 is located along Bairoko Street across from Building 1686 (Former Station Laundromat).

The information gathered from the visual site inspection performed by CH2MHILL and environmental staff at NSRR revealed that there were several areas of oil stained soil around the NEX Building 1914. For that reason, it was recommended that a sampling program be performed to characterize the areas around several structures in the SWMU 54 area. CH2MHILL also observed two open excavation locations south of the building, which contained algae stained water. With this in mind, along with the activities (oil changes, lubrications, etc.) known to have taken place at this SWMU, a site characterization was performed which identified TCE in groundwater and recommended a RFI be performed.

The RFI that characterized the groundwater at the site has been completed and approved by the EPA. The RFI recommended the performance of a CMS to address the groundwater contamination. The CMS has yet to start for this SWMU.

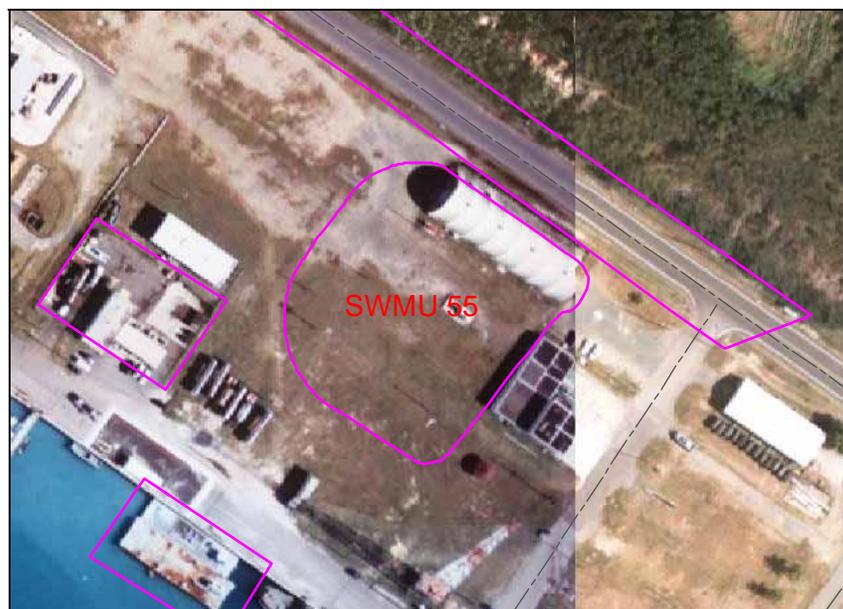
Figure 5-49. SWMU 55 - Potential Source Area and Associated TCE Plume at the TWFF

SWMU 55 consists of a flat lying grassy area located near the intersection of Forrestal Road and Card Street, in the vicinity of the concrete pad where former Building 46 once stood (see Figure 5-49). The EPA, in their February 24, 2004 comment letter, requested that the areas mentioned above be designated as SWMU 55 because the releases of TCE do not appear to be associated with either SWMU 7 or 8, the currently defined SWMUs at the Tow Way Fuel Farm (see Sections 5.3.7 and 5.3.8). The information provided below was conducted while this site was considered a portion of SWMU 7/8. This information is provided in this description to provide the complete history of the TCE plume at the TWFF (SWMU 55).

A Corrective Measures Study Investigation (CMSI) was conducted for the TWFF. During the CMSI, TCE was found in monitor well 7MW07. A work plan was developed and approved by the EPA to address the TCE in groundwater at the TWFF. A TCE investigation was conducted in the summer of 1999 to delineate the TCE plume in the groundwater. The EPA approved the ensuing report on the TCE investigation. The report recommended that a detailed evaluation be conducted during the CMS for the TWFF to evaluate alternatives for the TCE plume. During the development of the CMS it was identified that additional data gaps needed to be addressed to facilitate the development of the CMS for the TWFF. A work plan was developed, field investigation performed, and the EPA approved Final Additional Data Collection Investigation Report for the TWFF was developed.

During the additional data collection effort, TCE concentrations in monitor well 7MW07 were found to have increased fourteen-fold, from 2,000J micrograms per liter ($\mu\text{g/L}$) in April 1998, to 28,000J $\mu\text{g/L}$ in January 2002, a period of approximately four years. Because of this increase in concentration, additional characterization of the source of this TCE was recommended in the Draft Final Task I CMS prior to finalization of the CMS. It was also recommended that CMS for this portion of the TWFF be completed independently from the rest of the TWFF. This was done so there was no delay in the evaluation of the remedial alternatives from SWMU 7/8. This was possible since the TCE and PSH portions of the site are independent and do not overlap each other. A work plan to address the TCE plume delineation and source investigation was developed and approved by the EPA. The field investigation was implemented in accordance with the EPA approved work plan. The Draft TCE Plume Delineation and Source Investigation Report was developed and submitted on January 21, 2004. It was determined that no continuing source of TCE is apparent in the soil or groundwater at this site. The original source and/or location of the TCE contamination in this area of the TWFF remains unknown, despite the gathering of historical information and the efforts of environmental sampling during two focused investigations. The TCE plume was delineated and a sentinel well was

placed down gradient of the plume in order to determine, through subsequent sampling events, if contamination is approaching the Ensenada Honda. It was recommended that a CMS proceed for this site. The CMS should include screening level risk assessments for cis 1,2-dichloroethene, 1,2-dichloroethane, 1,1,1-trichloroethane, trans 1,2-dichloroethene, and tetrachloroethene in the groundwater at this site. These compounds were detected during this investigation at levels above those found in previous investigations. Once any new corrective action objectives (CAOs) are established, appropriate corrective measures to address the TCE contamination can be evaluated during the CMS process. The EPA commented on the Draft TCE Plume Delineation and Source Investigation Report in a letter dated February 24, 2004. The Navy will address the EPA's comments within the CMS Report for the TCE area. Any additional work conducted at the TCE plume at the TWFF will be designated as SWMU 55 as requested by the EPA in their letter dated February 24, 2004.

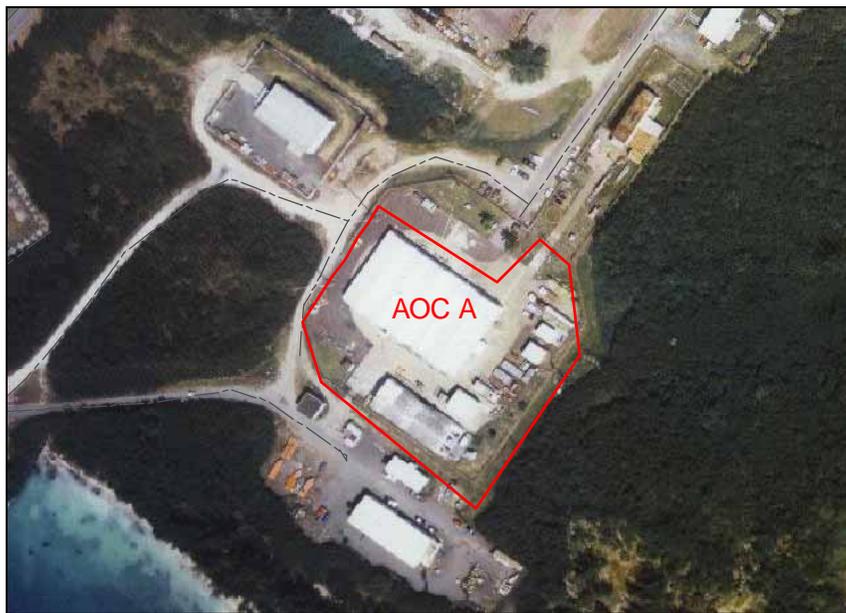
Figure 5-50. AOC A – Former Torpedo Shop

AOC A consists of the Torpedo Shop (see Figure 5-50). This AOC was not inspected during the 1988 RCRA VSI due to the special security clearances required to gain access to this facility. However, it was inspected during a follow-up VSI, conducted in June 1993. No evidence of releases of hazardous wastes or constituents was observed. Permittee verbally indicated it had no knowledge or evidence of systematic and routine releases of hazardous wastes or constituents from this unit. A RFI was not required at this site.

Currently, the Torpedo Shop is no longer in operation. The building has been inspected by environmental personnel on station, and found to be clear of any environmental issues related to this unit.

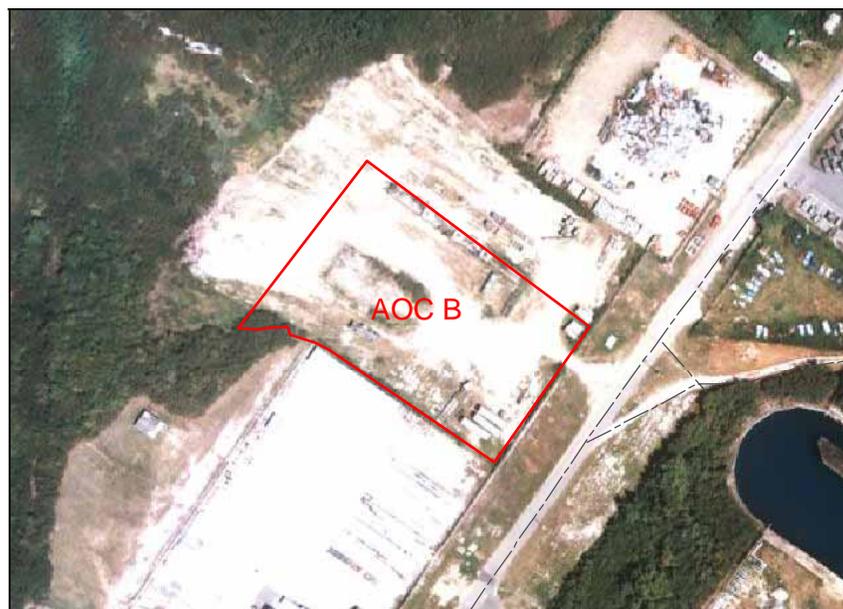
Figure 5-51. AOC B - Building 25 Area

AOC B is located in a limited access area of NSRR. The site is located in a secure fenced storage yard located in the industrial area of the station (see Figure 5-51). The area is level and is a wide, open gravel and grass field.

AOC B, a part of OU 6, consists of the site of the now demolished Building 25. According to the Navy, the demolished building formerly contained hazardous waste materials. The 1993 follow-up inspection found (17) 55 gallon drums of lubricating oils and diesel stored outdoors and unsheltered, resting directly on a bricked surface that was the former floor of Building 25. The area was surrounded by a sandbag dike. Extensive oil stains were observed on both the brick floor and the surrounding soils. Eight groundwater wells were installed throughout IR Site 10 and sampled both during Round 1 (1986) and Round 2 (1987) investigations. Hazardous constituents (arsenic, chromium, lead, and selenium) were detected in the groundwater at levels exceeding Subpart S action levels/MCLs. A RFI for soils, both surrounding the old Building 25 area and the soils underlying the remaining brick floor surface, was required in the permit. Also, a RFI for groundwater was required to fully characterize possible releases of hazardous constituents.

A Phase I RFI was completed for SWMU 6, which indicated that a potentially unacceptable risk to future residents and adult on-site workers. The RFI recommended the performance of a CMS. The results of the revised risk assessment conducted for the development of corrective action objectives indicated that the only risk was a non-carcinogenic risk to future young child military residents. It was further demonstrated that the critical toxic effects for the two principal contaminants (arsenic and 4,4-DDT) demonstrated that the hazard indices should be segregated based on target organs, resulting in neither contaminant exceeding the acceptable level. Hence, COCs were not identified for any of the media at SWMU 6/AOC B, and there were no corrective action objectives calculated for SWMU 6/AOC B. The CMS was conducted and submitted to the EPA on June 21, 2001 recommending no further action for this site. No further action is proposed in the RCRA Part B permit renewal.

There is no visual evidence of any releases observed at this unit based on the 2003 ECP inspection.

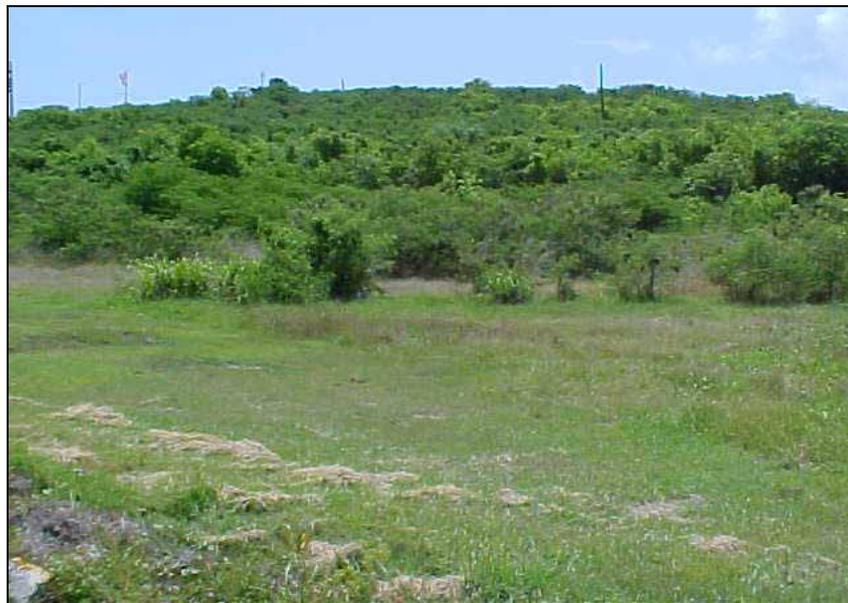
Figure 5-52. AOC C - Transformer Storage Pads are not visible due to secondary growth

AOC C, a part of OU 1, is located near Building 2042 along Valley Forge Road and consists of three outdoor, uncovered, concrete pads that were used primarily for storage of discarded transformers; however, other discarded electrical materials, including batteries were observed in the past (see Figure 5-52). During the 1993 inspection, three transformers were observed well outside of the concrete pads sitting directly on bare soil. During the 1988 VSI, and 1993 follow-up inspection, oil staining inside the concrete pads and evidence of releases to soil

were observed. A first phase RFI was mandated for this area in the RCRA permit.

The RFI identified PCB contamination in the soils at this site and recommended the performance of a CMS. The CMS recommended the performance of a CMI to remove contaminated soils from the site. EPA has approved a CMI Work Plan Design Package to excavate contaminated soils from the site. The EPA is in the process of modifying the RCRA permit with the proposed CMI for public comment.

Currently, the three outdoor, uncovered, concrete pads are not visible due to the heavy secondary growth vegetation.

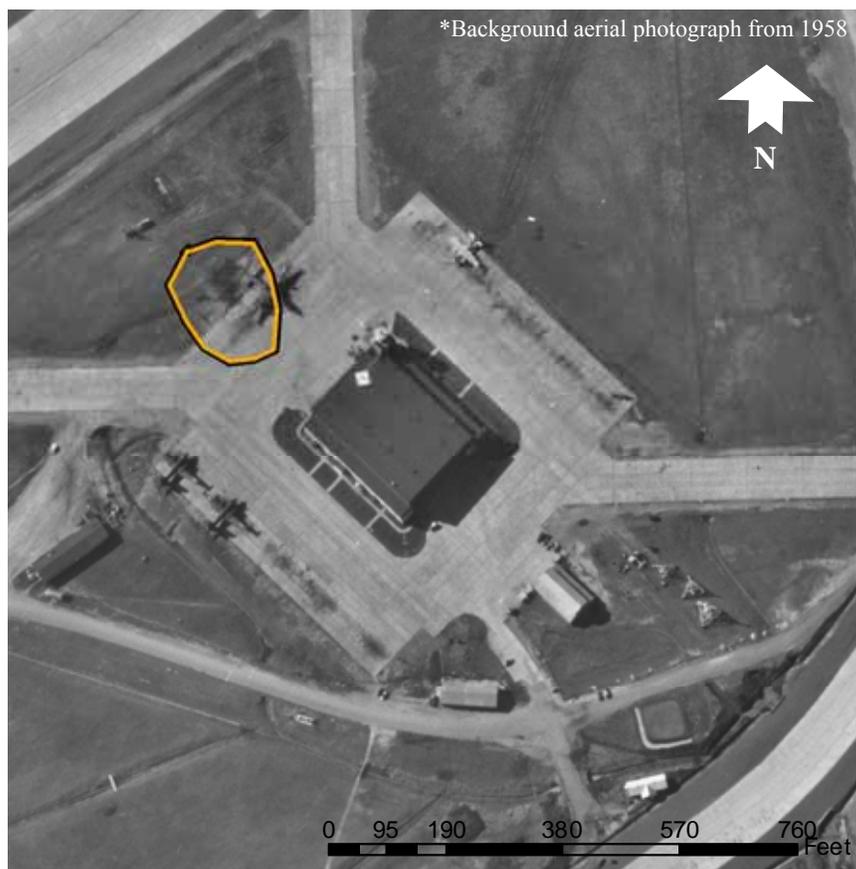
Figure 5-56. *ECP Site 2 - Hangar 200 Apron*

ECP Site 2 is located on the south side of the airfield, just off of the aircraft apron on the northwest side of Hangar 200 (see Figure 5-56). The aerial photography analysis (APA) identified this area as photo identified (PI) Site 2, due to the observation of stains/liquid extending off the edge of the hardstand to a surrounding drainage ditch from 1958-1965. The RR confirmed that Hangar 200 has historically been used for aircraft maintenance. The PSI did not observe any significant stains or stressed vegetation. However, interviews confirmed numerous past spills of petroleum, oils, and lubricant (POL) and hazardous materials (HM) from the 1950s to the 1990s, and former use as an aircraft wash down area is considered likely. [See photos A-61 and A-62]

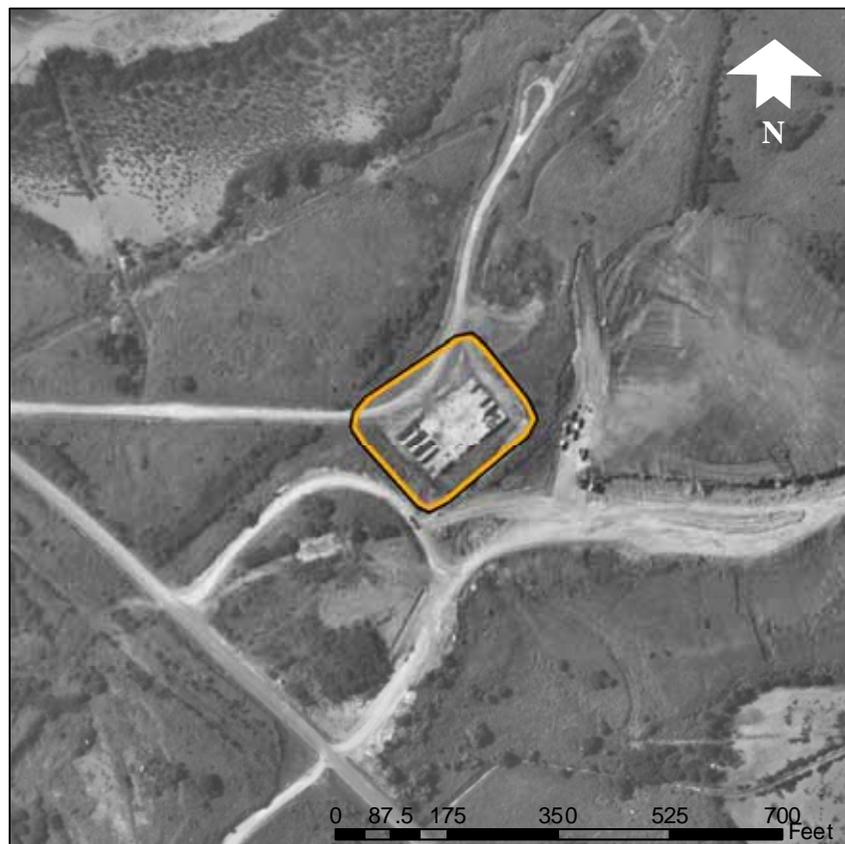
Figure 5-58. ECP Site 3 - Facility No. 278, POL Drum Storage Area

This site is located at Facility No. 278, which is a rectangular concrete pad approximately 100' x 160' in size, surrounded by flat lying grass and secondary growth vegetation on the north side of Antietam Road just south of Solid Waste Management Unit (SWMU) 9 Area C (see Figure 5-58).

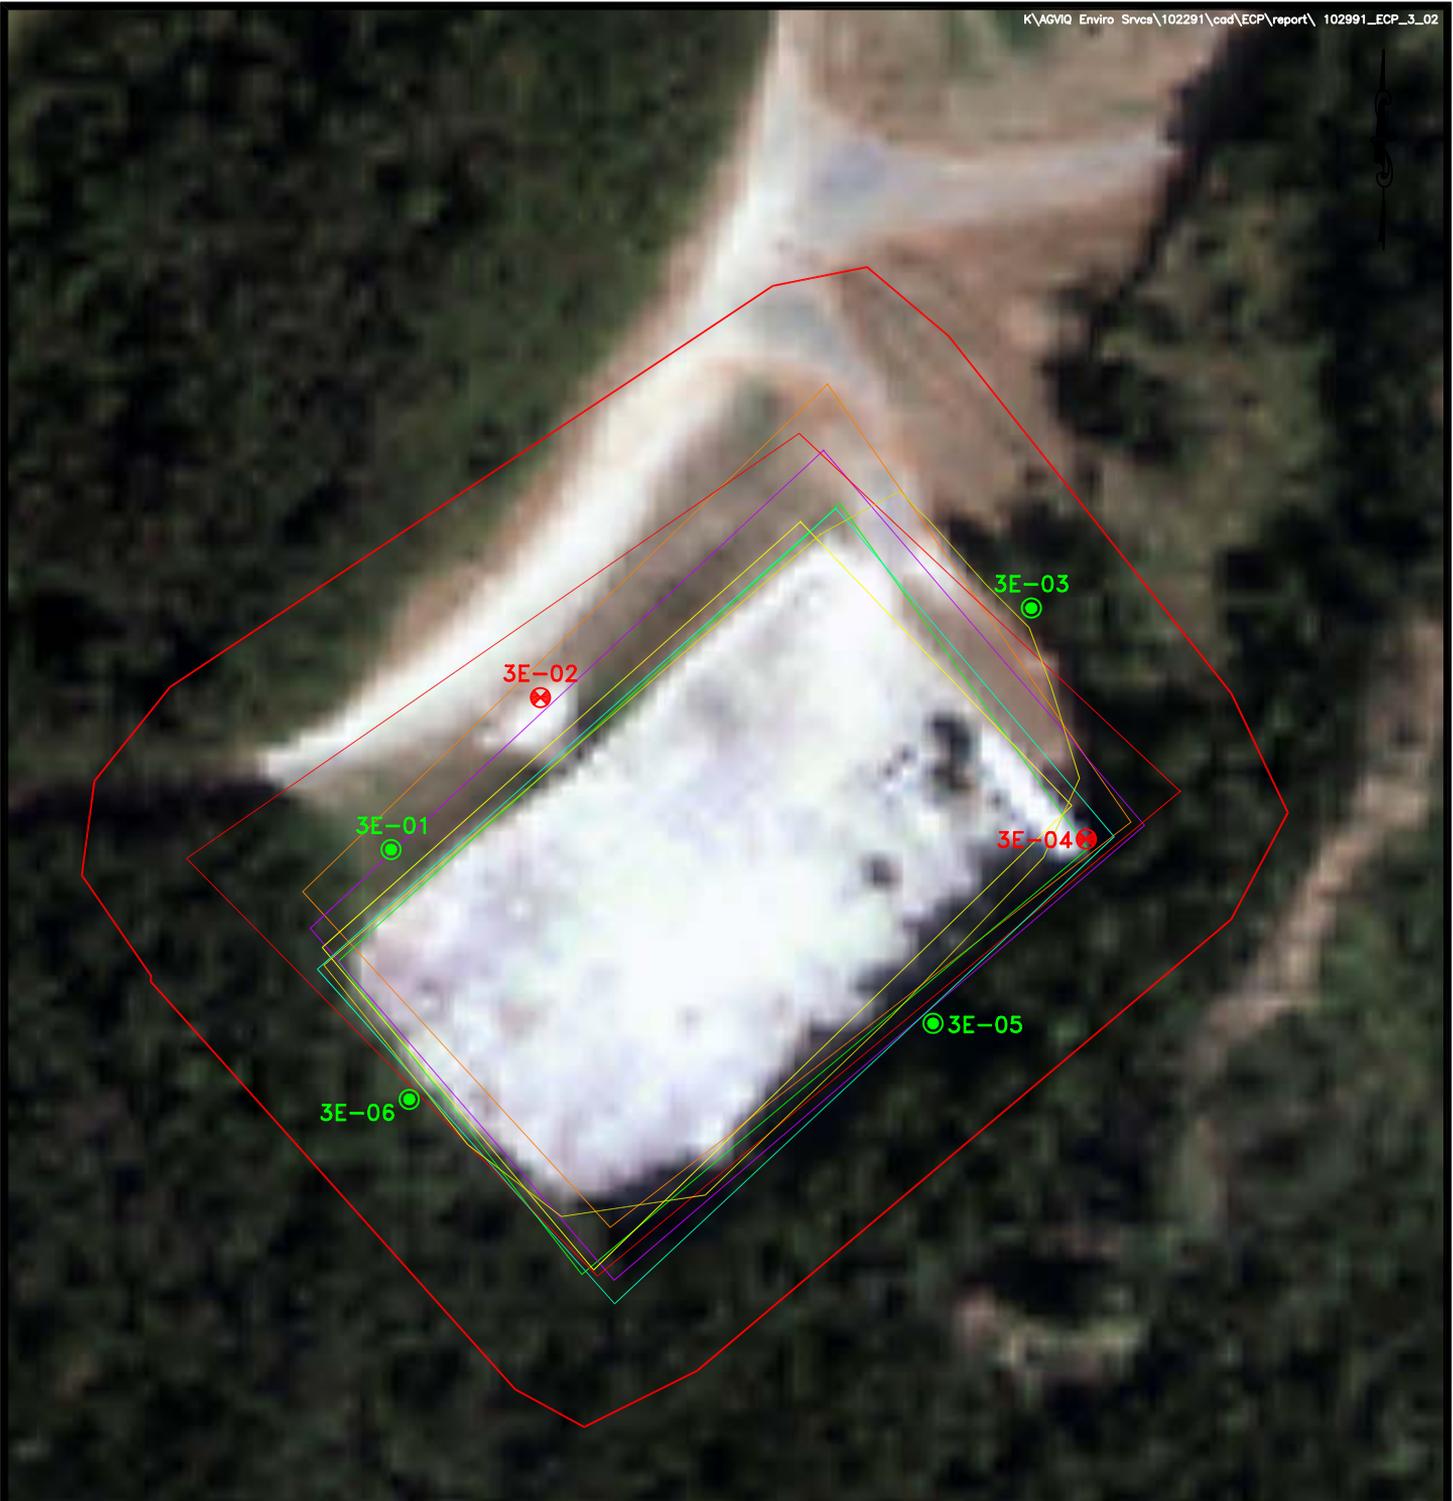
Figure 5-59.
ECP Site 3 - Facility No. 278, POL Drum Storage Area Sample Location Map

The area surrounding the concrete slab utilized for POL Drum storage was investigated at ECP Site 3. As presented in the Phase II ECP Work Plan (NAVFAC Atlantic, 2004b), the sample locations at this site were field located with a hand held GPS receiver. As mentioned previously, there were no signs of staining or stressed vegetation observed at this site. Therefore, the originally proposed six locations within the work plan were utilized, with the exception of three locations (3E-01, 3E-04, and 3E-06) because of site access issues including site topography. At these three locations, the borings had to be offset by a few feet to allow for necessary operating clearance for the Geoprobe[®] rig.

A total of six soil borings were advanced around the perimeter of Facility Number 278 (ECP Site 3) as presented on Figure 5-59. One soil boring was located along each of the northeastern and southwestern edges of the concrete slab, while two soil borings were located along each of the northwestern and southeastern edges of the concrete slab.

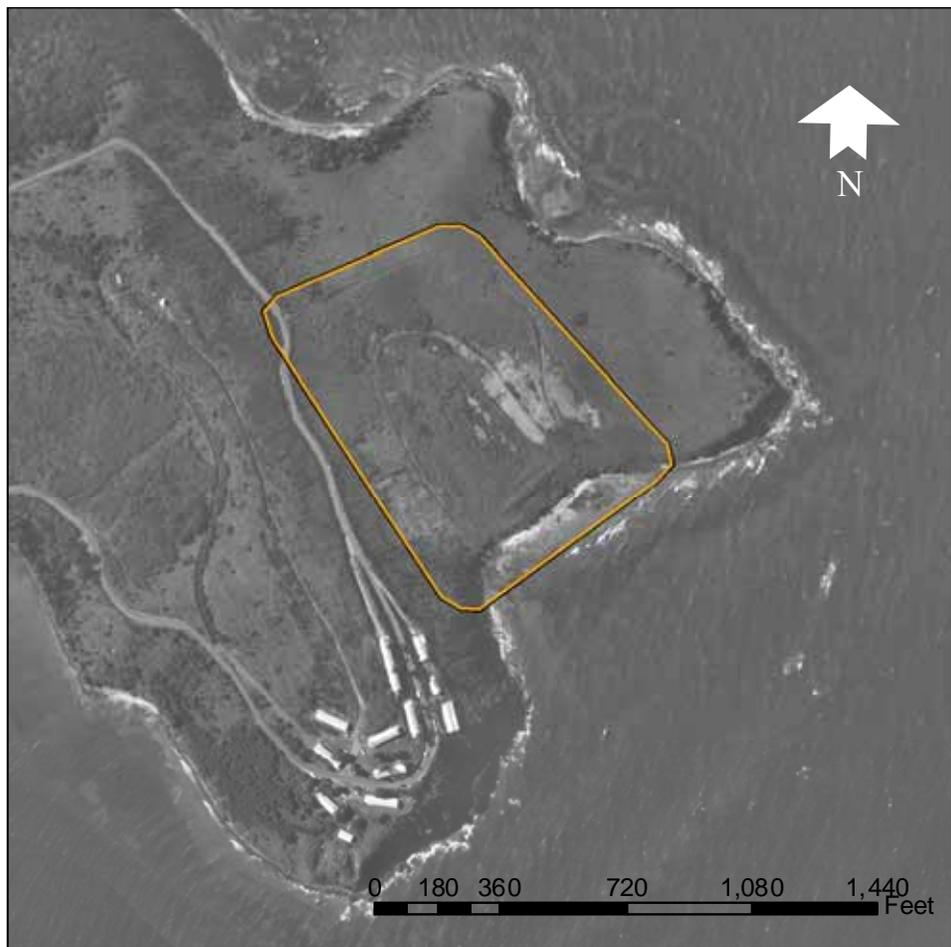
*Background aerial photograph from 1958

During the Phase II ECP investigation, the berm backstop was observed. However, it appears that the backstop is made out of fieldstone and mortar, rather than concrete. In addition, a concrete bermed structure that was found southeast of the berm backstop mentioned above. This structure contained galvanized piping protruding from the top of concrete berm. This structure appears to be related to the target placements observed during the physical site inspection. This site is completely covered with very dense, secondary growth vegetation as mentioned above. There were no signs of stains or stressed vegetation observed during the investigation.

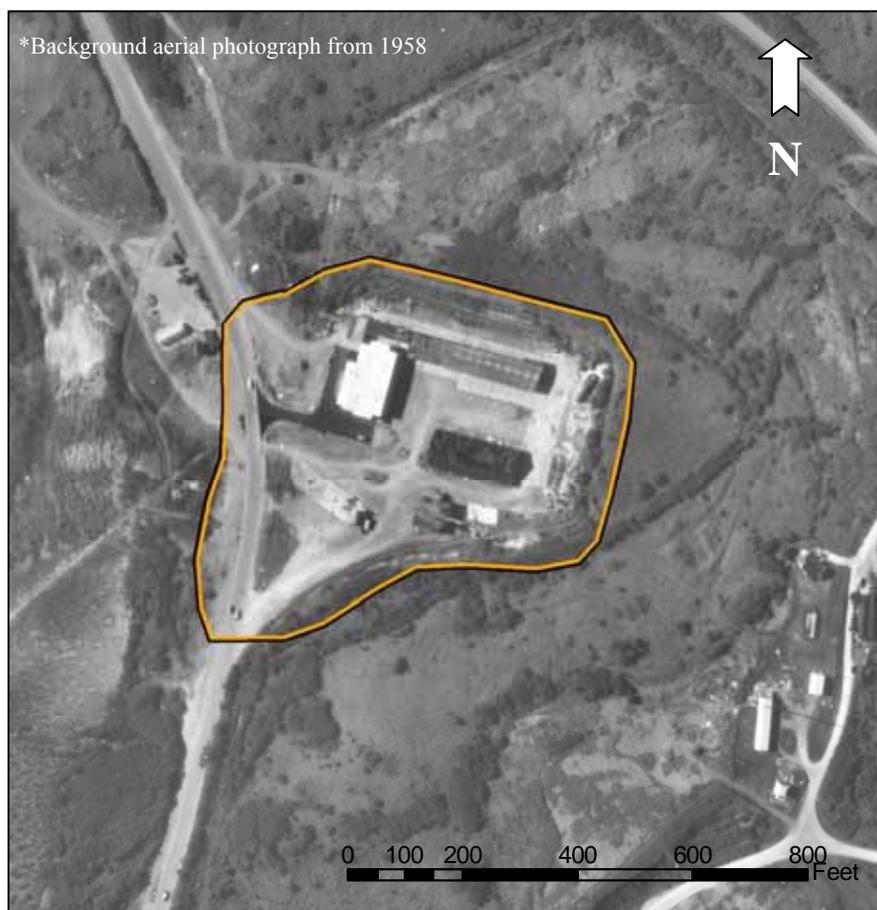
Figure 5-62. *ECP Site 5 - Former Vehicle Maintenance and Refueling Area*

This site is located on the east side of Forrestal Drive, and includes existing buildings 377, 2344, and 2345 (See Figure 5-62). The APA identified this area as PI Site 7, due to the observation of drums, vehicle racks, stains, and fuel islands from 1958-1985. The records review (historic maps), physical site inspection, and interviews all confirmed use as former vehicle maintenance and refueling area from the 1940s to the 1980s. Final disposition of suspected USTs at the fuel islands is unknown. Interviewees also confirmed that numerous spills and leaks of POL and HM occurred throughout the usage period. [See photos A-20 and A-21]

The site consists of a level area with the majority of the site paved. The site is surrounded by secondary growth vegetation. There also appears to be some small miscellaneous debris (i.e., 55-gallon drum, boat, etc.) located at this site.

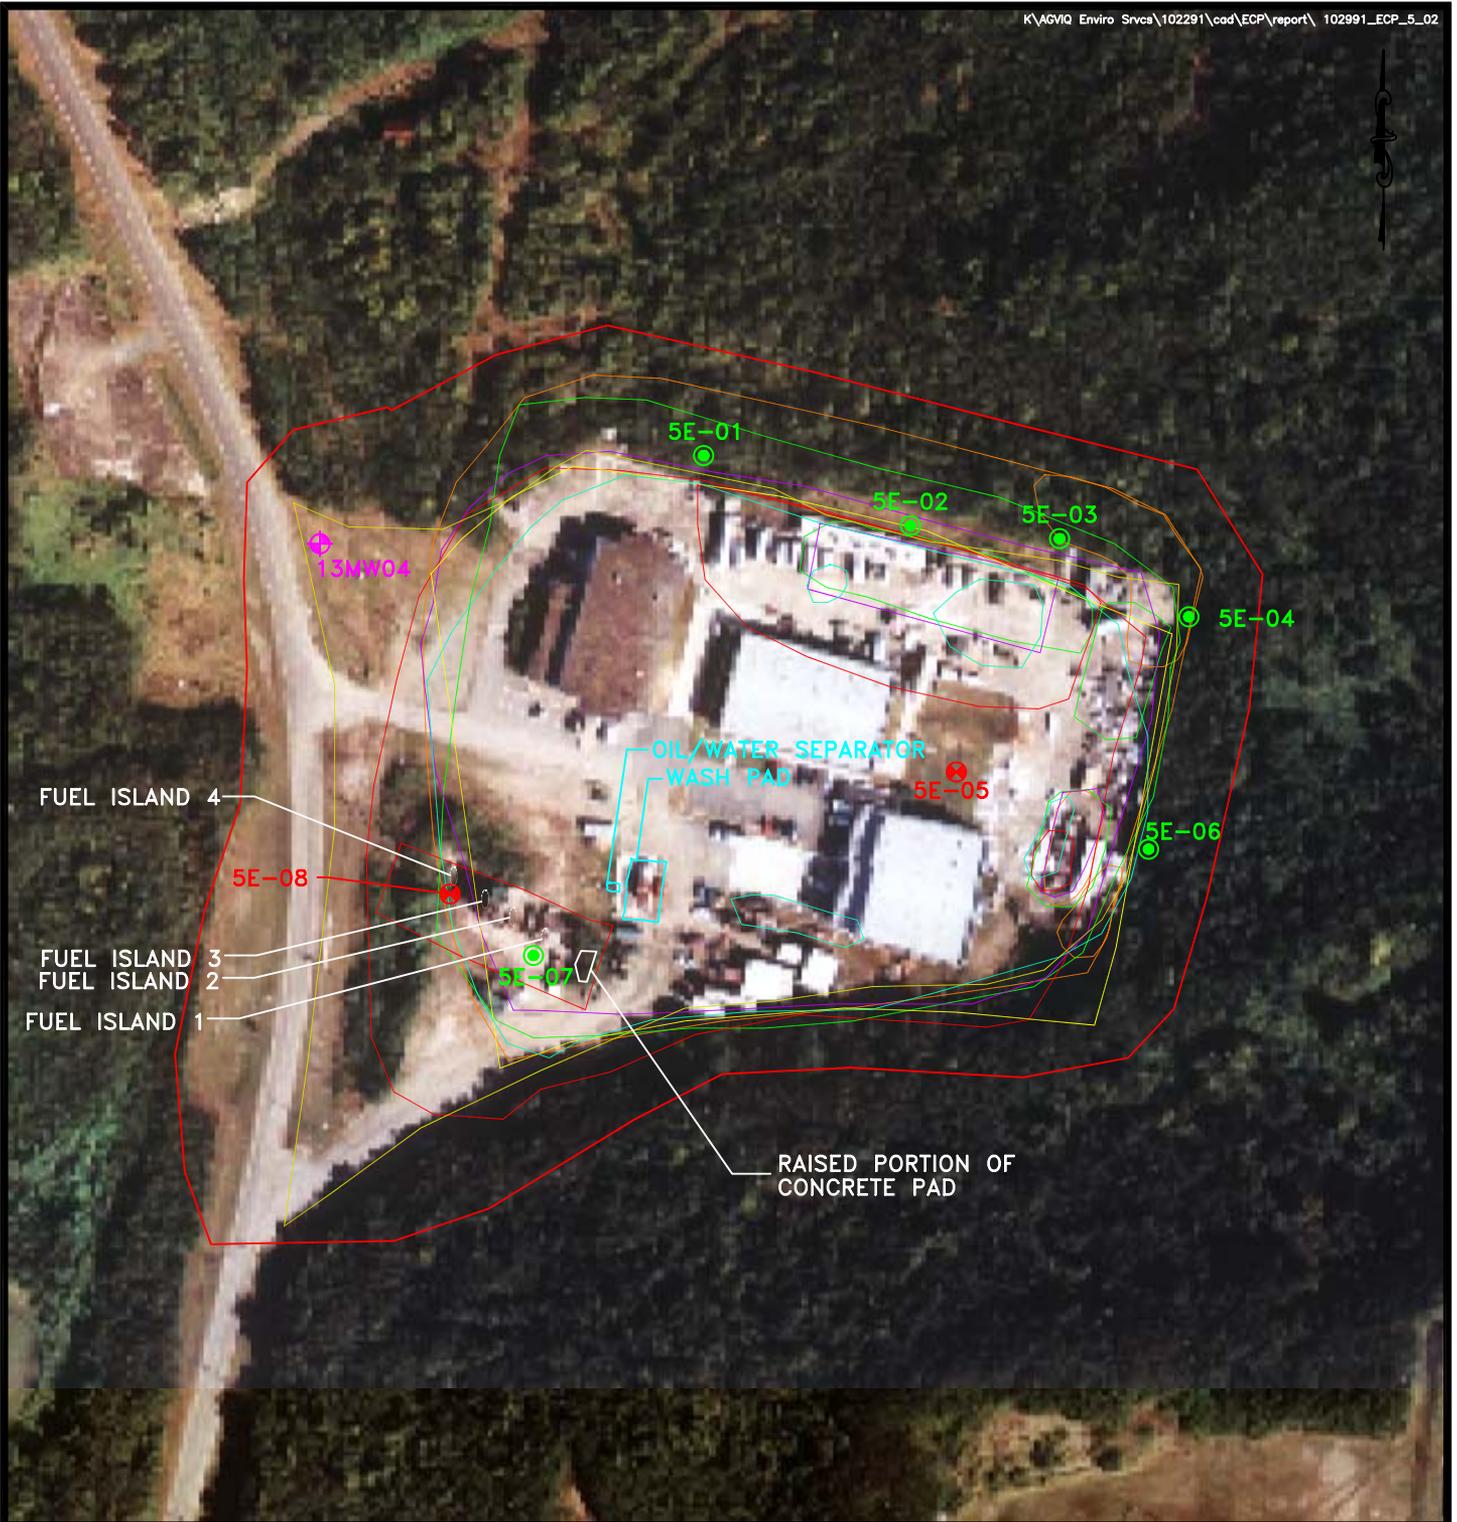
Figure 5-63.
ECP Site 5 - Former Vehicle Maintenance and Refueling Area Sample Location Map

The field crew thoroughly searched the former refueling area in an attempt to identify the location of the suspected USTs, as well as to determine if the USTs were still present at the site. Four vent pipes were located protruding from the large concrete pad containing the four former fuel stands. However, after utilizing the various methods listed in the Draft Phase II ECP Work Plan (NAVFAC Atlantic, 2004b), as well as interviewing personnel from TSI Inc. who work in the building located immediately north of the refueling area, the suspected USTs were not identified.

A total of eight soil borings (5E-01 through 5E-08) were advanced at ECP Site 5 as presented on Figure 5-63. Two soil borings (5E-07 and 5E-08) were advanced in the former refueling area, while six additional soil borings were advanced in former vehicle maintenance area.

Six surface soil samples, ten subsurface soil samples from eight locations, and three groundwater environmental samples were collected from locations at the Former Vehicle Maintenance and Refueling Area as shown on Figure 5-63. One location (5E-08) for the groundwater samples was determined based on field screening of the soil samples. The other location was installed as indicated by the work plan (NAVFAC Atlantic, 2004b). Duplicate environmental samples were collected from one surface soil location and one groundwater location. The results of the analytical program can be seen in Tables 5-17 through 5-22.

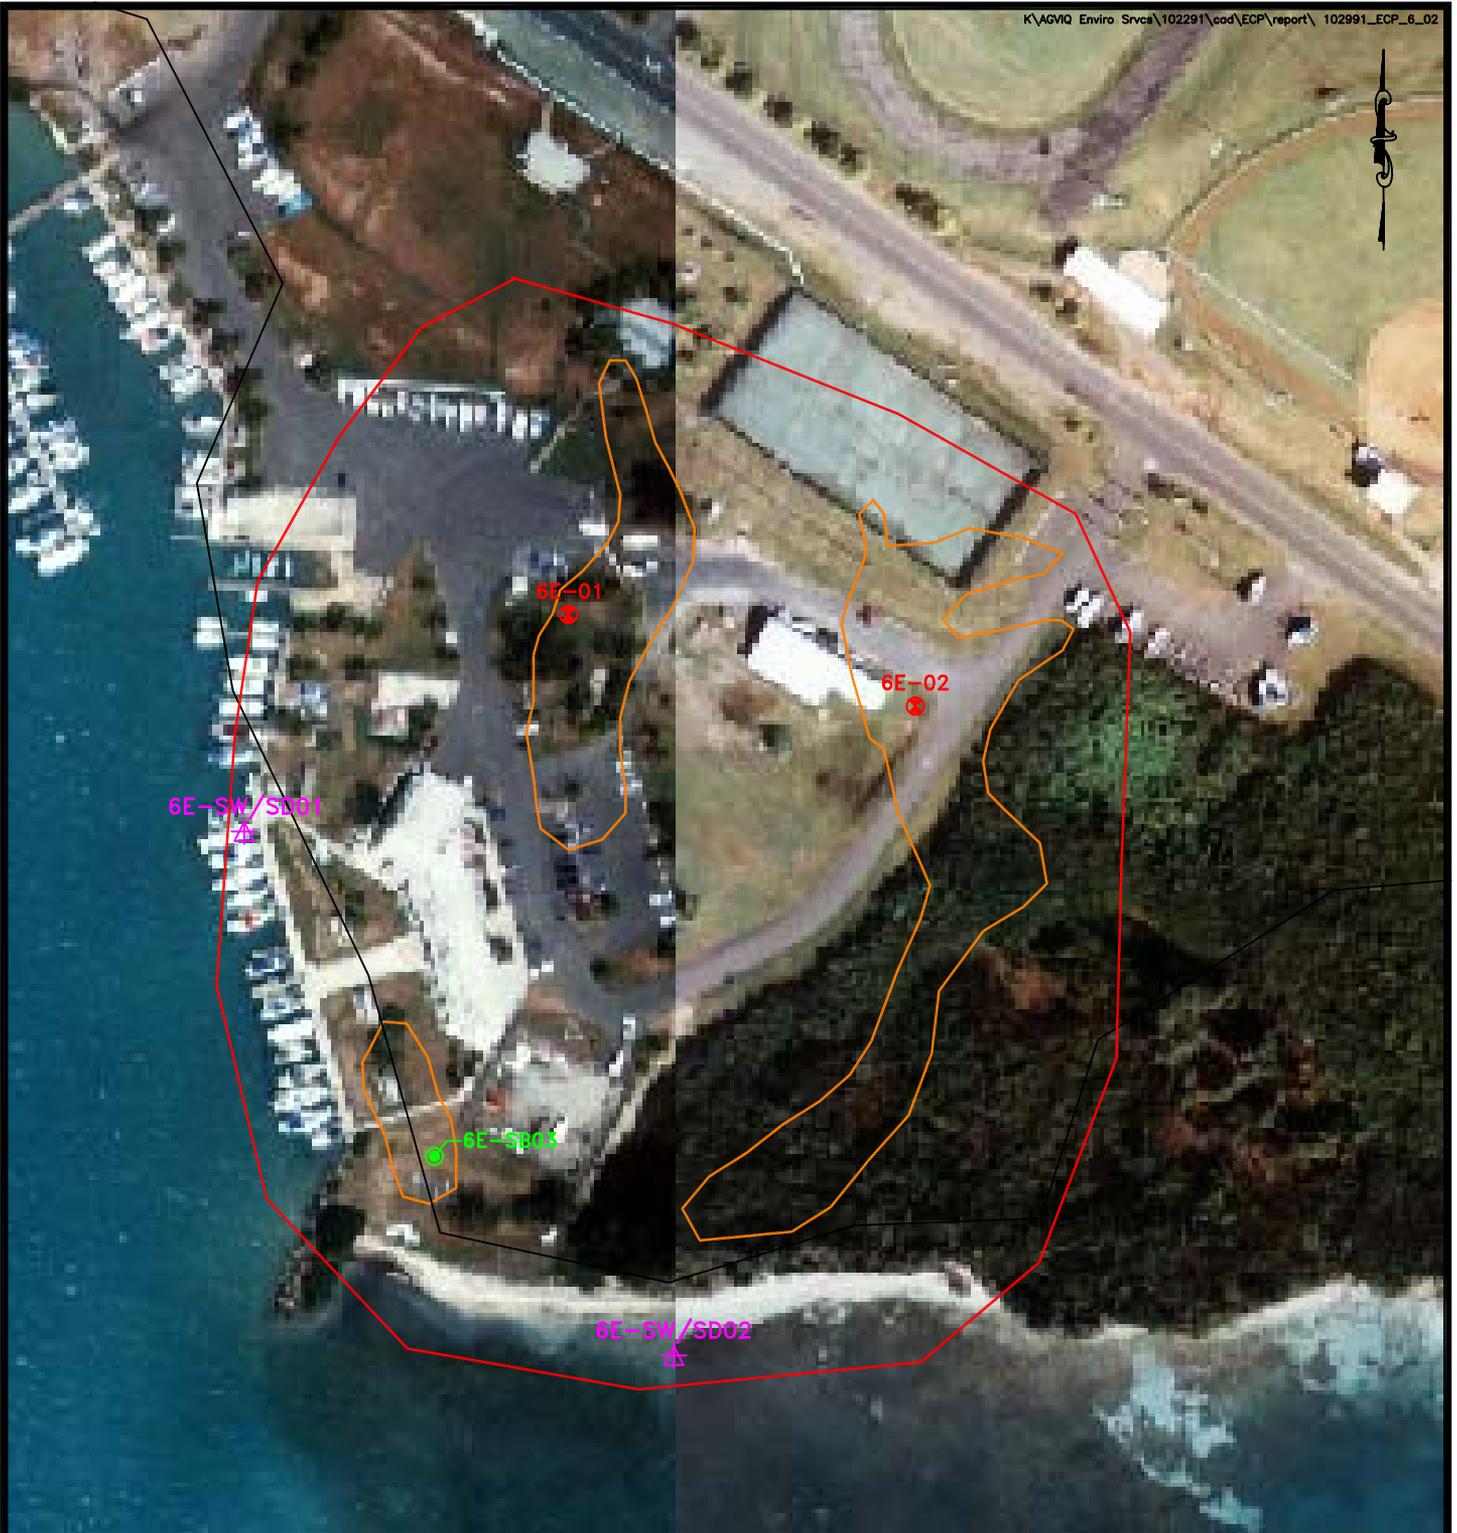
*Figure 5-65.
ECP Site 6 - Former Landfill at Marina
Sample Location Map*

One surface soil sample (6E-SS03) was collected at soil boring location 6E-03 as mentioned above, while subsurface soil samples (6E-SB01-02, 6E-SB02-01, and 6E-SB03-01) were collected from each soil boring. These samples were submitted to the fixed-base analytical laboratory for full Appendix IX analysis.

A groundwater program followed the soil sampling program, with the installation of two temporary monitor wells (6E-01 and 6E-02) as shown on Figure 5-65. There were no levels of contamination observed based on the readings taken from the FID and PID. Therefore, the proposed locations of the temporary monitor wells within the work plan were used. The groundwater samples were then collected from the two temporary monitor wells utilizing a modified version of the low flow sampling technique, and submitted to the fixed-base analytical laboratory for full Appendix IX analysis.

One surface soil sample, three subsurface soil samples, two groundwater samples, and two surface water and sediment samples were collected from locations at the Former Landfill at the Marina as shown on Figure 5-65. The locations of the groundwater samples were co-located with the subsurface soil samples at 6E-01 and 6E-02 as specified in the work plan (NAVFAC Atlantic, 2004b). The FID results for location 6E-02 indicated a slight elevation in organic vapor above background. The results of the analytical program can be seen in Tables 5-23 through 5-31.

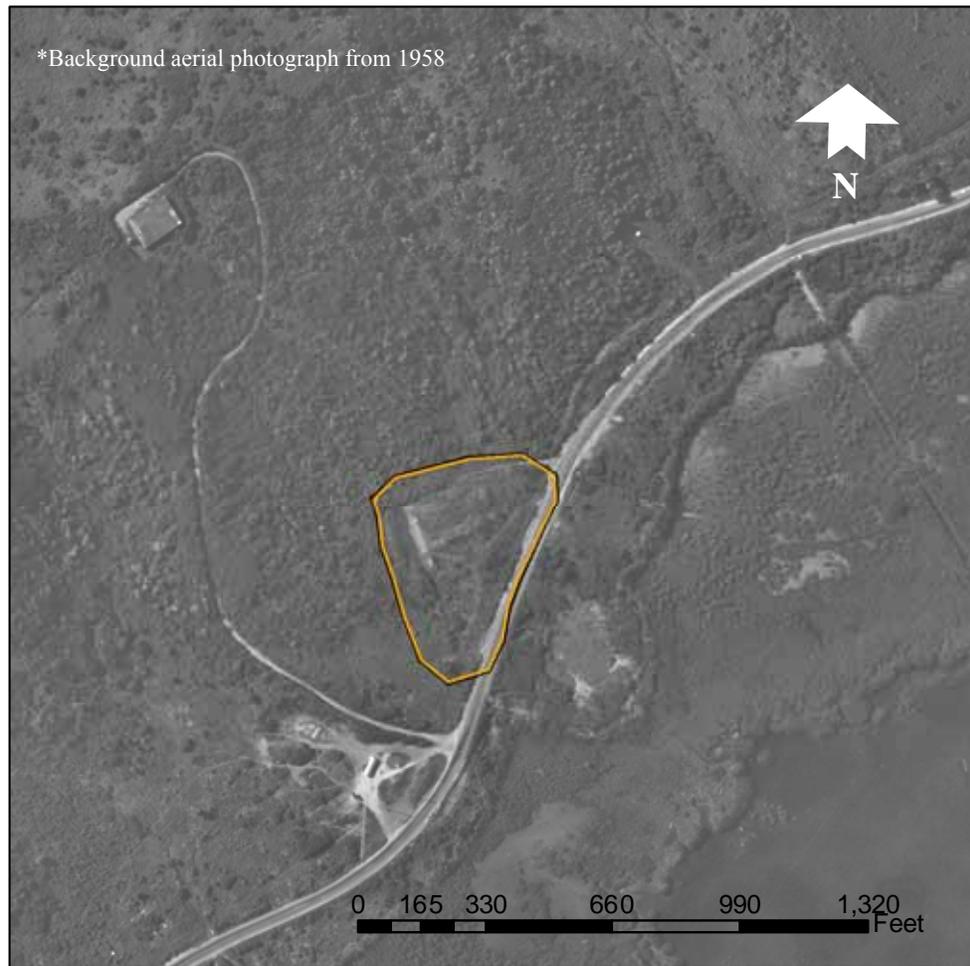
Figure 5-70. ECP Site 9 - Former Pistol Range at New BEQ

This site is located west of Langley Drive and north of the Commissary, at the site of the newly constructed bachelor's enlisted quarters (BEQ) (see Figure 5-70). The APA identified this area as PI Site 13, due to the observation of a cleared rectangular area that appeared to be unused, with ground scarring consistent with a small arms range in 1958. The records review (historic maps) identified this area as a former pistol range. Interviews did not confirm or repudiate use of the area as a pistol range. The physical site inspection could not detect evidence of a former pistol range, since the area has been disturbed/ covered by the new BEQ. [See photo A-28]

During the Phase II ECP investigation, a total of eleven structures were observed making up the new BEQ. The majority of the area at this site is covered in new vegetation.
