Final Preliminary Assessment Report Watercraft Maintenance Support Center, Ceiba, Puerto Rico

Perfluorooctane-Sulfonic Acid (PFOS)
and Perfluorooctanoic Acid (PFOA) Impacted Sites
ARNG Installations, Nationwide

March 2020

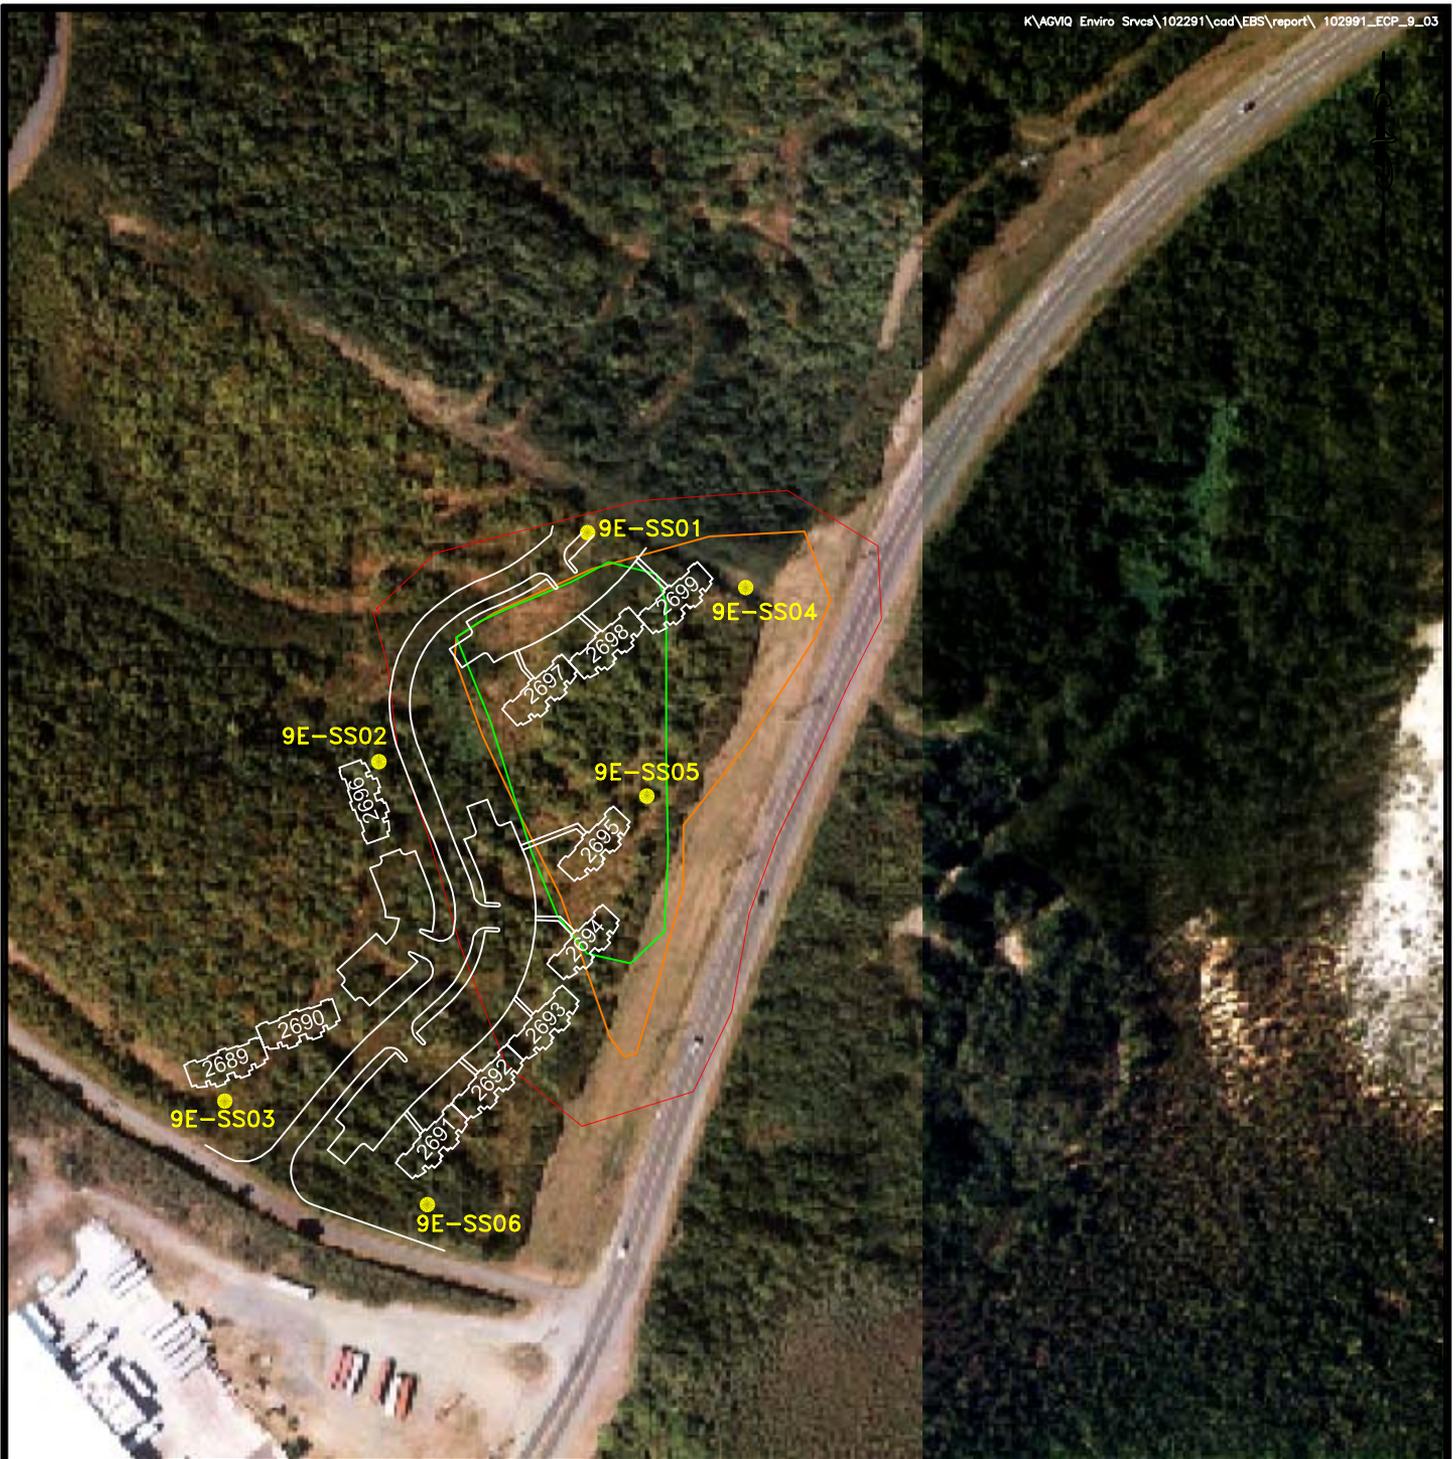
A total of six surface soil locations were positioned around the newly constructed buildings to ascertain if past pistol range activity may have a residual impact to the newly graded surface soils. The locations of the six surface soil samples were collected from areas adjacent to the newly constructed buildings. The samples were scattered from across the entire constructed site to ensure wide coverage as presented on Figure 5-71.

One surface soil sample was collected from each location from a depth of 0 to 1 foot bgs. Soil samples submitted to the fixed-base laboratory included six surface soil samples (9E-SS01 through 9E-SS06), and were analyzed for lead.

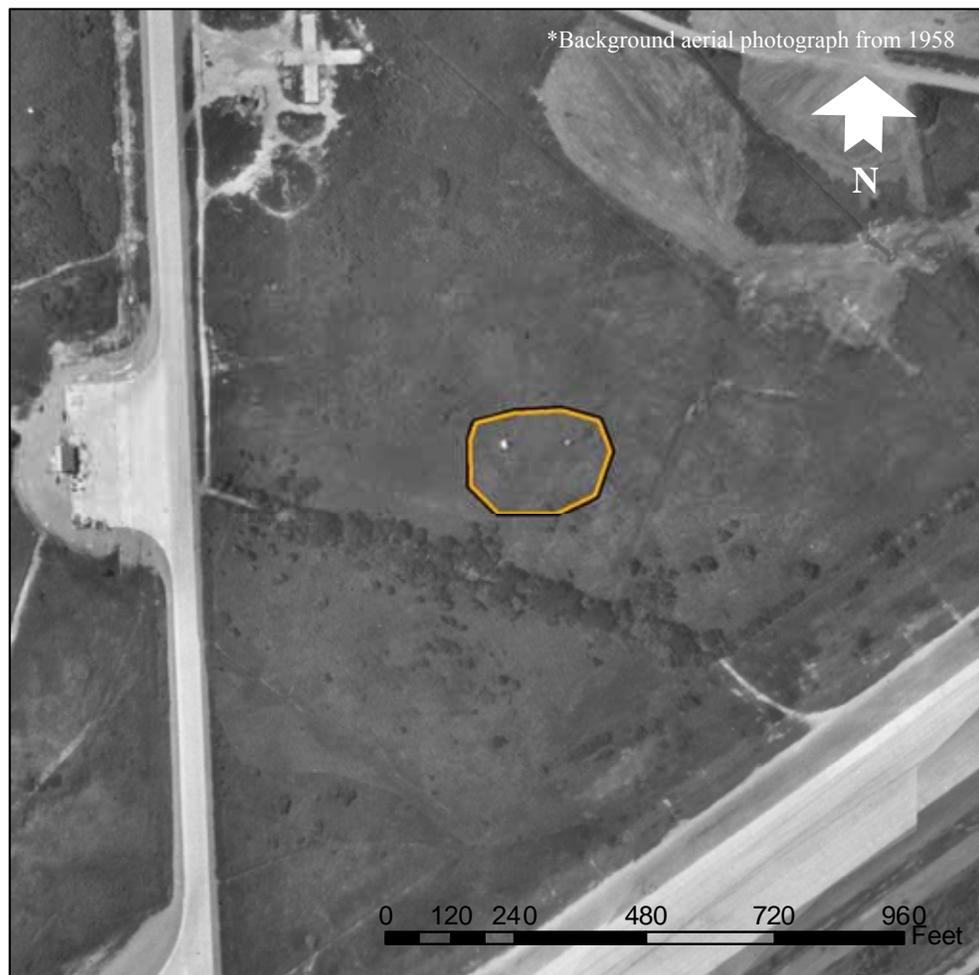
Figure 5-72. ECP Site 10 - Former Skeet Range at Ofstie Airfield

This site is located in an open level grass area along Ofstie Airfield (see Figure 5-72). The APA identified this area as PI Site 15, due to the observation of two small structures consistent with a skeet range in 1958. The records review (historic maps) identified a skeet range in this location. The physical site inspection did not observe any evidence of former skeet range; however, interviews confirmed use of area as a skeet range in the 1940s. Exact usage dates and frequency of use are unknown. [See photos A-29 and A-30]

Lead was not identified as a COPC. No further action is necessary.

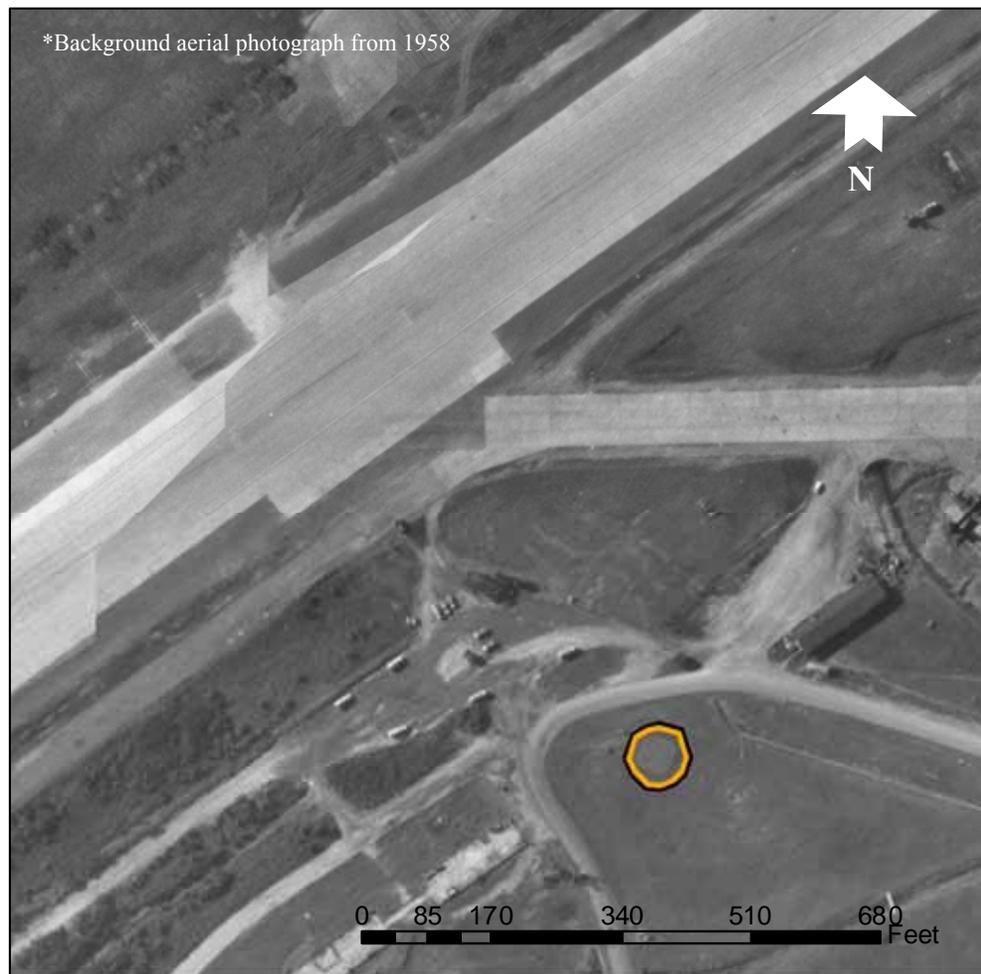
Figure 5-74. ECP Site 11 - Former UST No. 208

This site is located southwest of Hangar 200 in a level open grassy field (see Figure 5-74). The APA identified this area as PI Site 16, due to the observation of a depression/disturbed ground consistent with an existing or former UST location in 1958. The records review (historic maps) identified this area as the former location of UST No. 208. No records were available as to the final disposition of this UST. The physical site inspection observed no evidence of a UST, and interviews did not confirm or repudiate use or removal of a UST in the area.

During the Phase II ECP investigation, a slight depression was observed in the photo identified area presented in the Phase II ECP work plan (NAVFAC Atlantic, 2004b). However, as mentioned previously, after thoroughly searching the area, the UST was not identified. The vegetation at this site is shown in all five site photographs (see photos G-24 through G-28 in Appendix G) taken during the Phase II ECP investigation. Also shown is the vegetation in the areas immediately surrounding the former UST area. There were no signs of any stressed vegetation observed during the investigation. Photograph G-28 also presents the location where soil boring 11E-SB01 was installed.

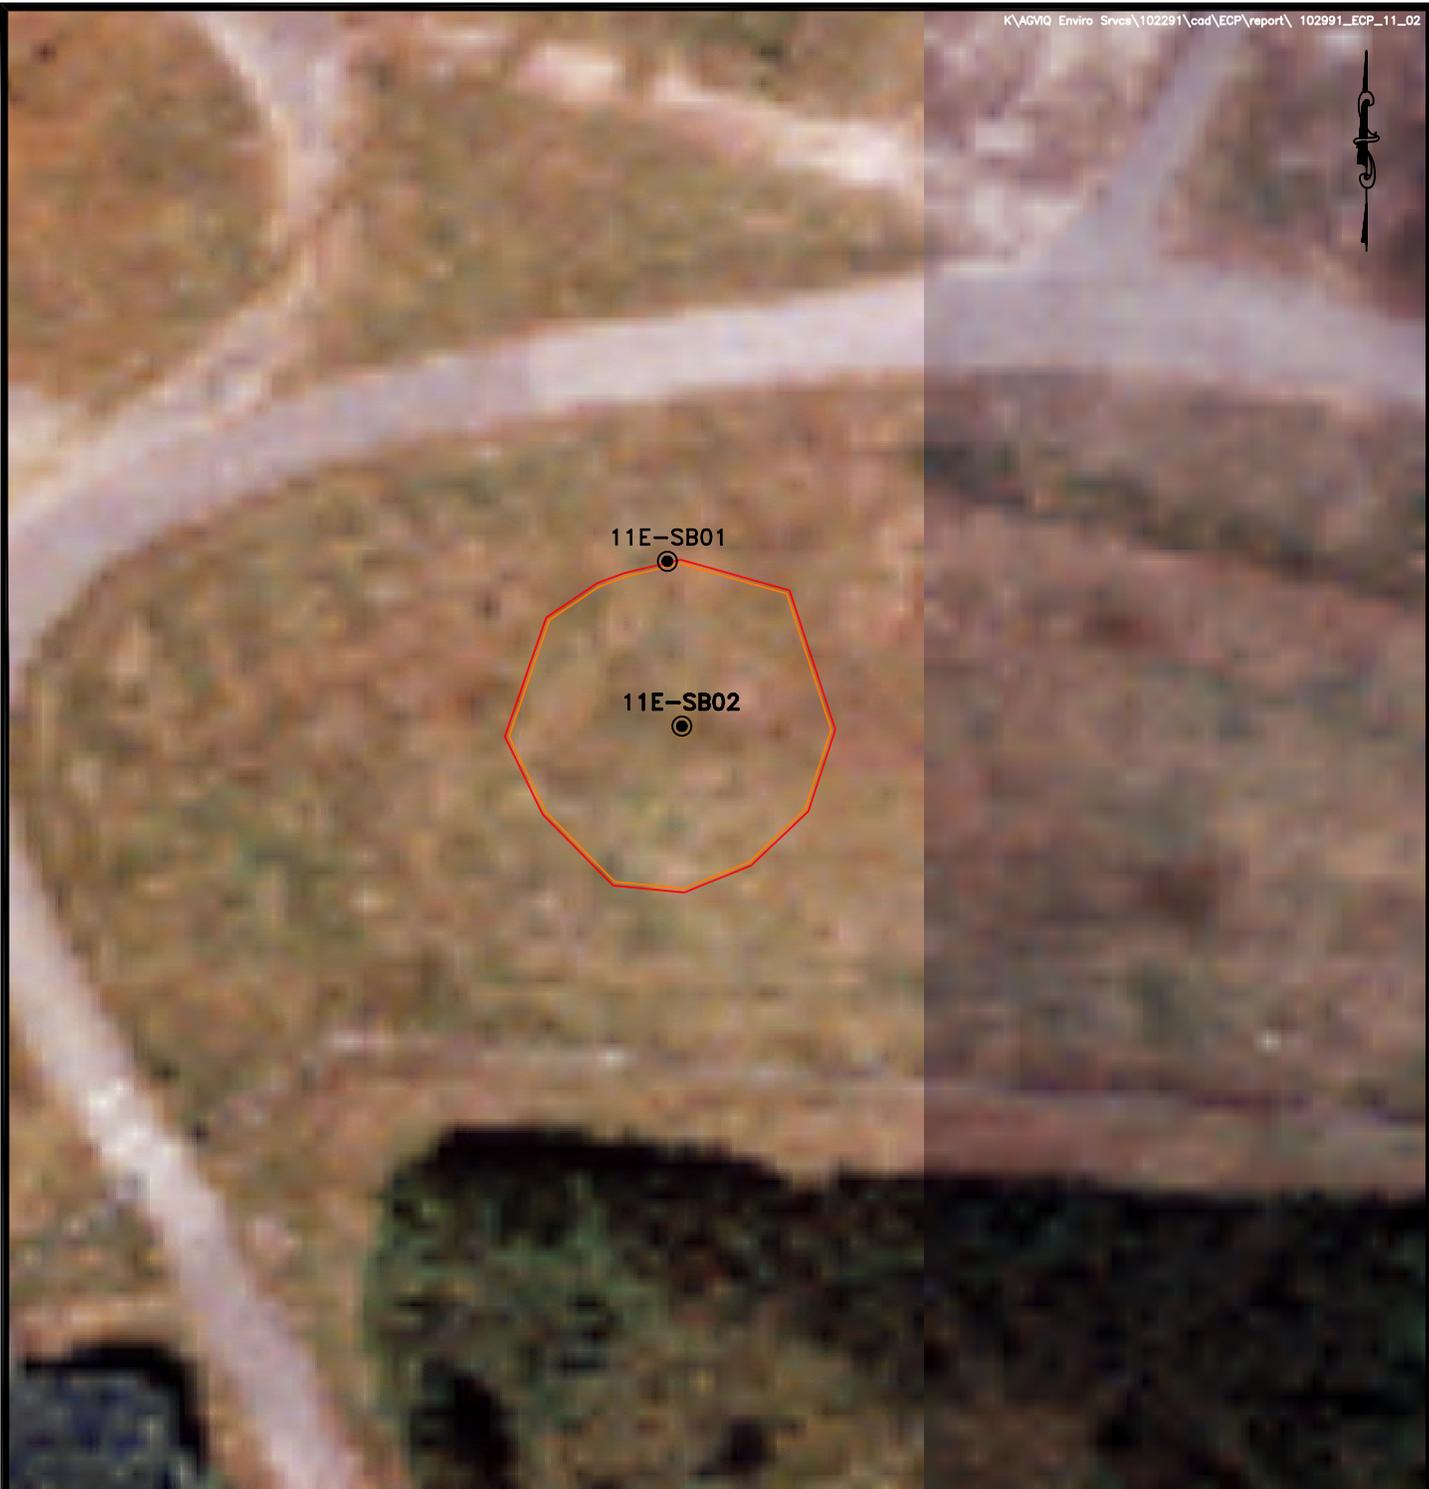
*Figure 5-75.
ECP Site 11 - Former UST No. 208
Sample Location Map*

The field crew thoroughly searched the depression/disturbed area in an attempt to determine if the UST was still present at this site. After a thorough search for the UST in the entire 1958 polygon feature as presented on Figure 5-75, it was determined that the UST was not currently present.

Based on the above findings, as well as the decision tree for this site located within the work plan, one soil boring was positioned within the former UST location (center of depression), and one was located along the perimeter of the former UST area. The sample locations were then field located with a hand held GPS receiver. As mentioned previously, there were no signs of stressed vegetation observed at this site.

Based on the limited subsurface soil investigation and results at this site, it can be concluded that past activities have not impacted the environmental conditions at ECP Site 11.

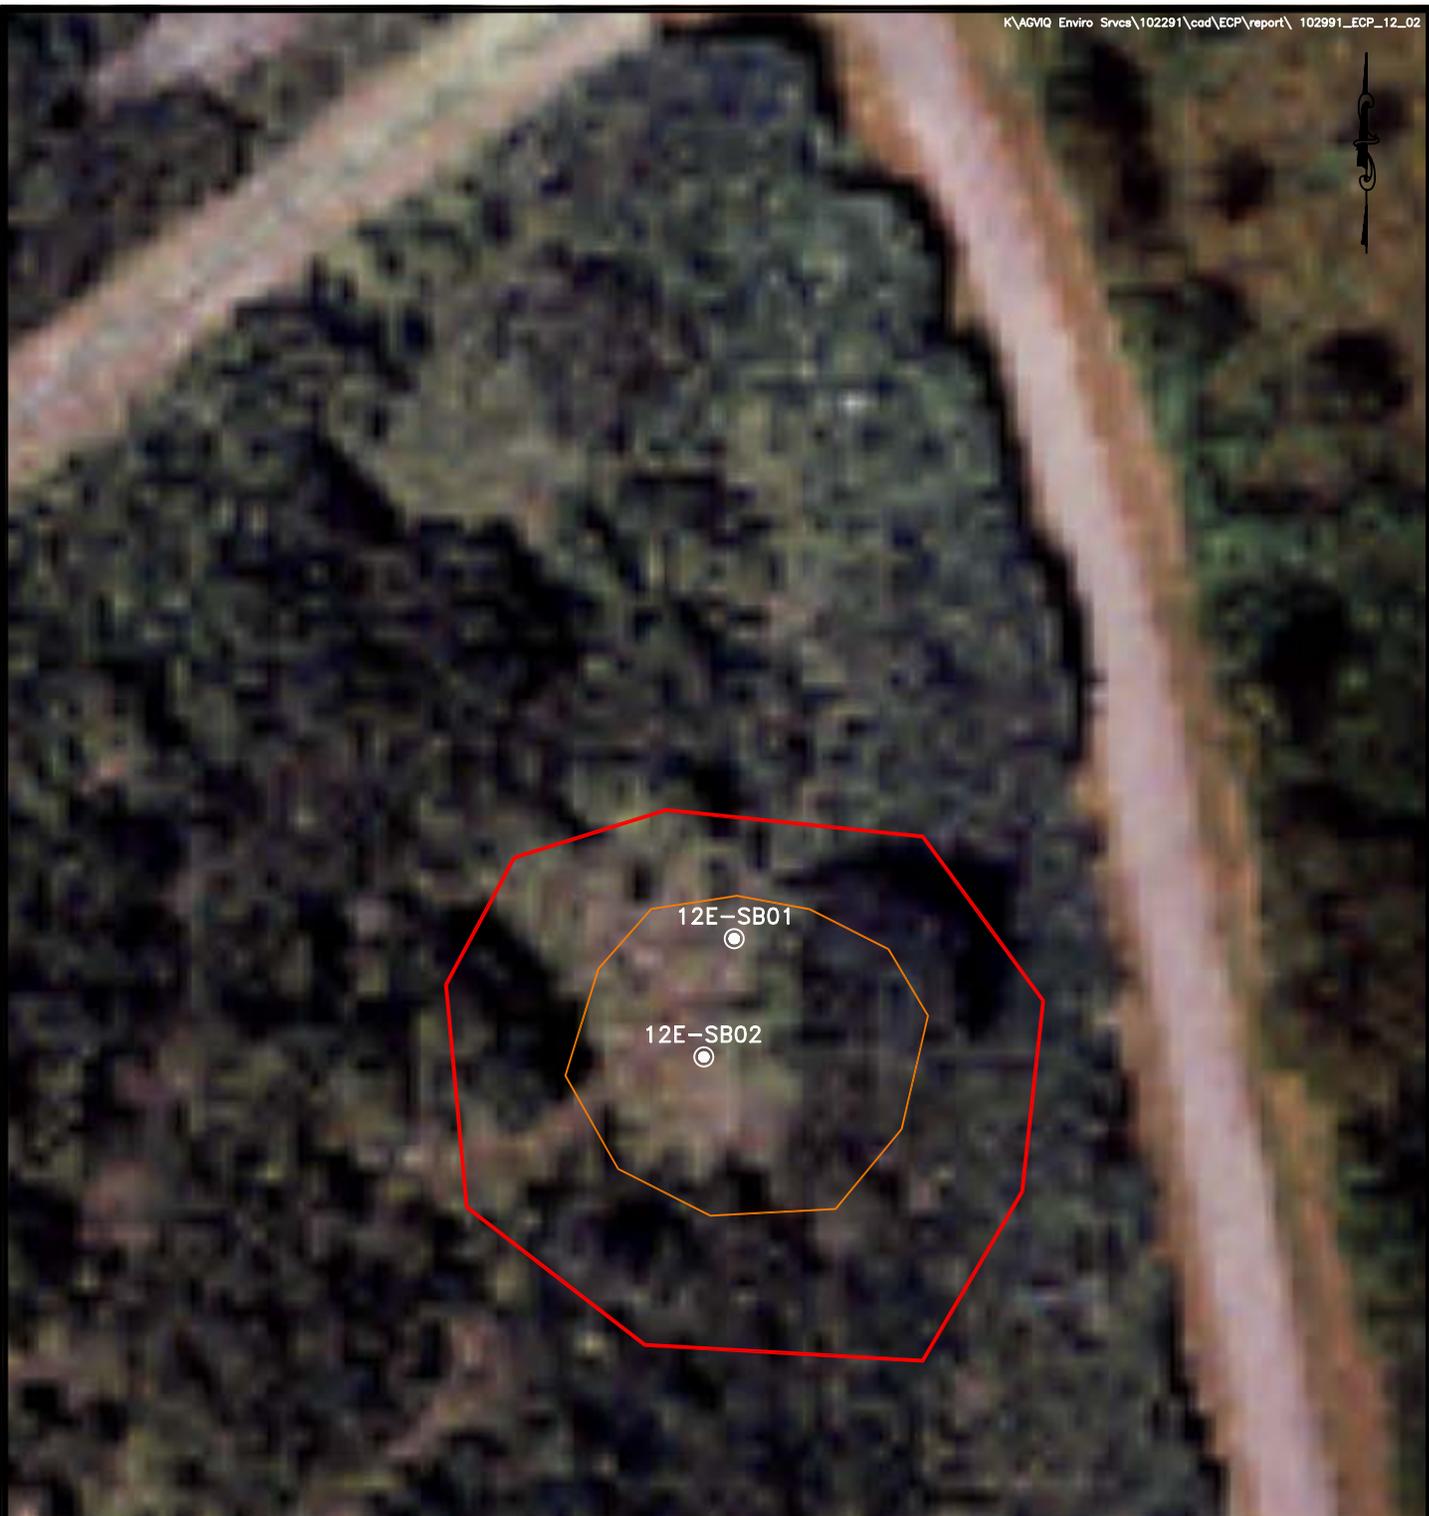
*Figure 5-77.
ECP Site 12 - Former UST No. 209
Sample Location Map*

The field crew thoroughly searched the depression/disturbed ground in an attempt to determine if the UST was still present at this site. After a thorough search of the entire 1958 polygon feature presented on Figure 5-77 for the UST, it was determined that the UST was not currently present.

Two environmental samples were collected from subsurface soil at two locations at the former UST No. 209 as shown on Figure 5-77. Groundwater samples were not collected based on the results of the PID/FID screening performed on soil collected from borings 15 to 20 feet bgs in depth. No duplicate environmental samples were obtained from this site. The results of the analytical program can be seen in Tables 5-43 and 5-44.

It is tentatively concluded that no impact to the environment has occurred at ECP Site 12. This conclusion is based on the low concentrations of organics found at the site. (The occurrence of the compound 4-bromophenyl phenyl ether is anomalous, and the source is unknown. However, the low concentration found in the soil is not likely to cause concern.)

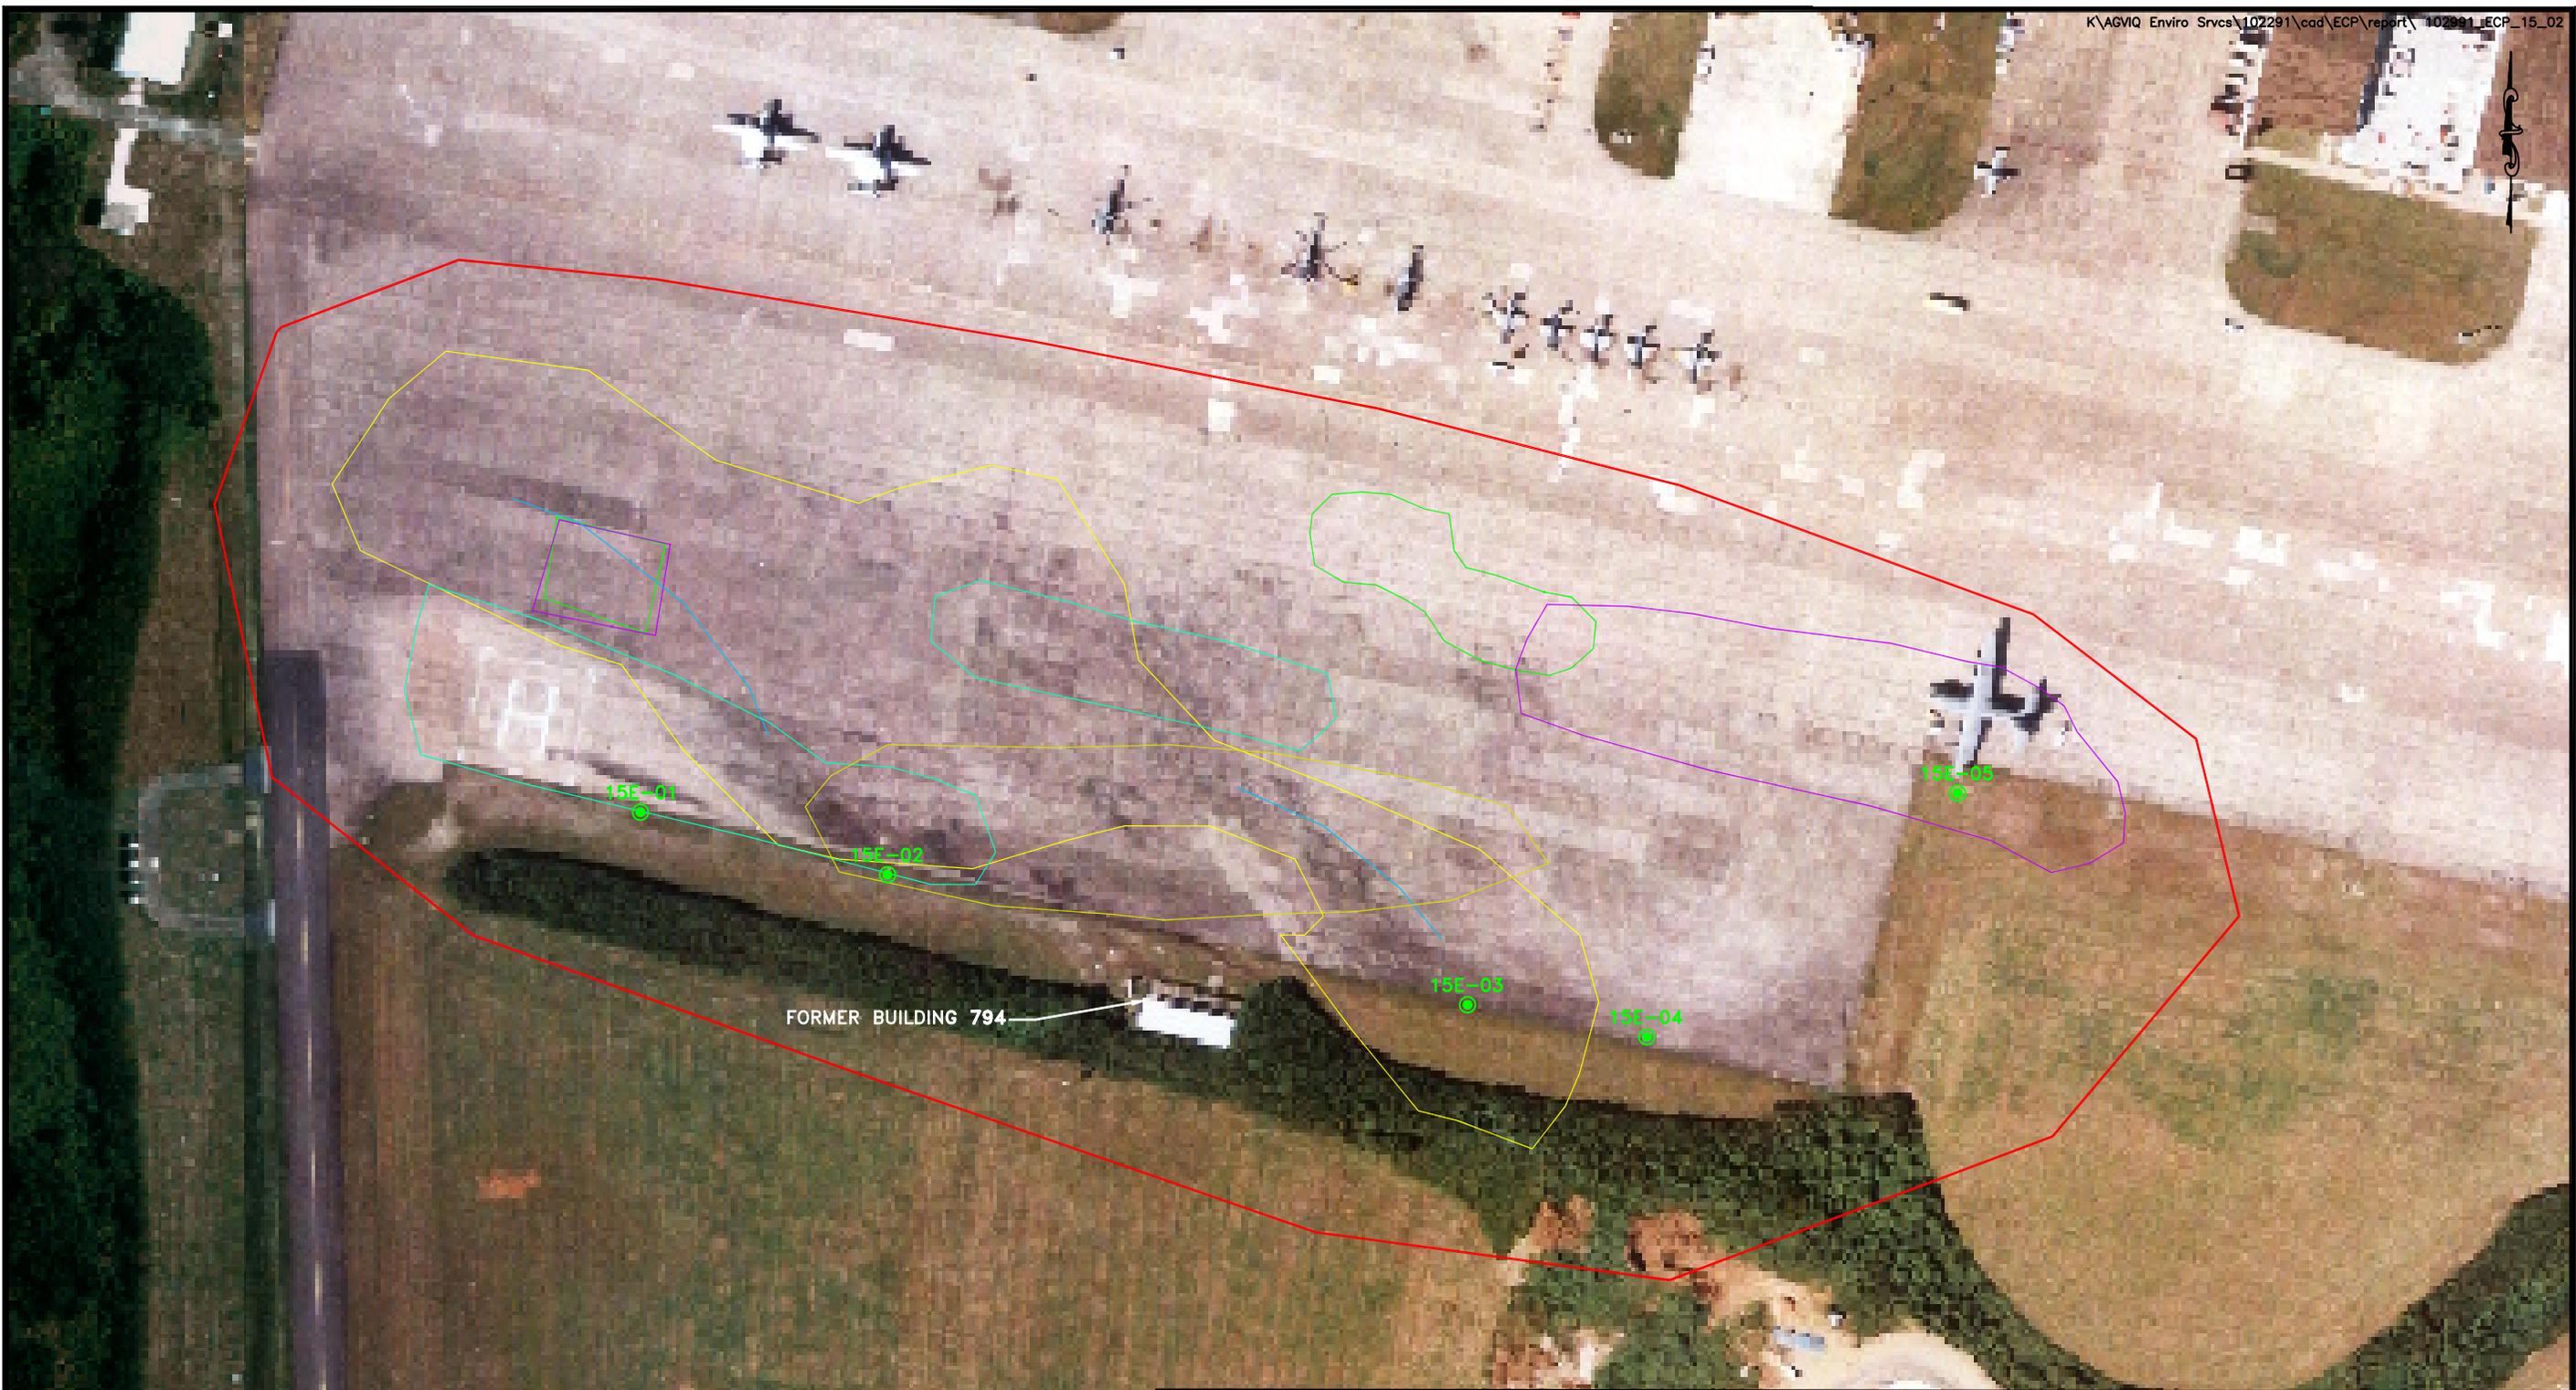
Figure 5-83.
ECP Site 15 - Aircraft Parking Apron
Sample Location Map

A total of five soil borings (15E-01 through 15E-05) were advanced around the southern and eastern perimeters of the aircraft parking area as presented on Figure 5-83. Four soil borings were located south of the expanded aircraft apron, while one soil boring was located at the corner of the expanded aircraft apron and the original aircraft parking area.

Five surface soil and five subsurface soil environmental samples were obtained from five locations south of and east of the aircraft parking area as shown on Figure 5-83. No groundwater samples were obtained based on the field screening performed with the FID/PID instruments. No detections above background were noted with these instruments. In addition to these soil samples, an additional duplicate environmental sample was obtained from the surface soil. The results of the analytical program can be seen in Table 5-53 through 5-56.

In the surface soil there were two VOCs, fifteen SVOCs, and TPH DRO detected. Fourteen inorganic compounds were detected as well. Location 15E-03 and 15E-04 has the highest concentrations of both the SVOCs and the DRO. These were also the locations with the highest inorganic concentrations.

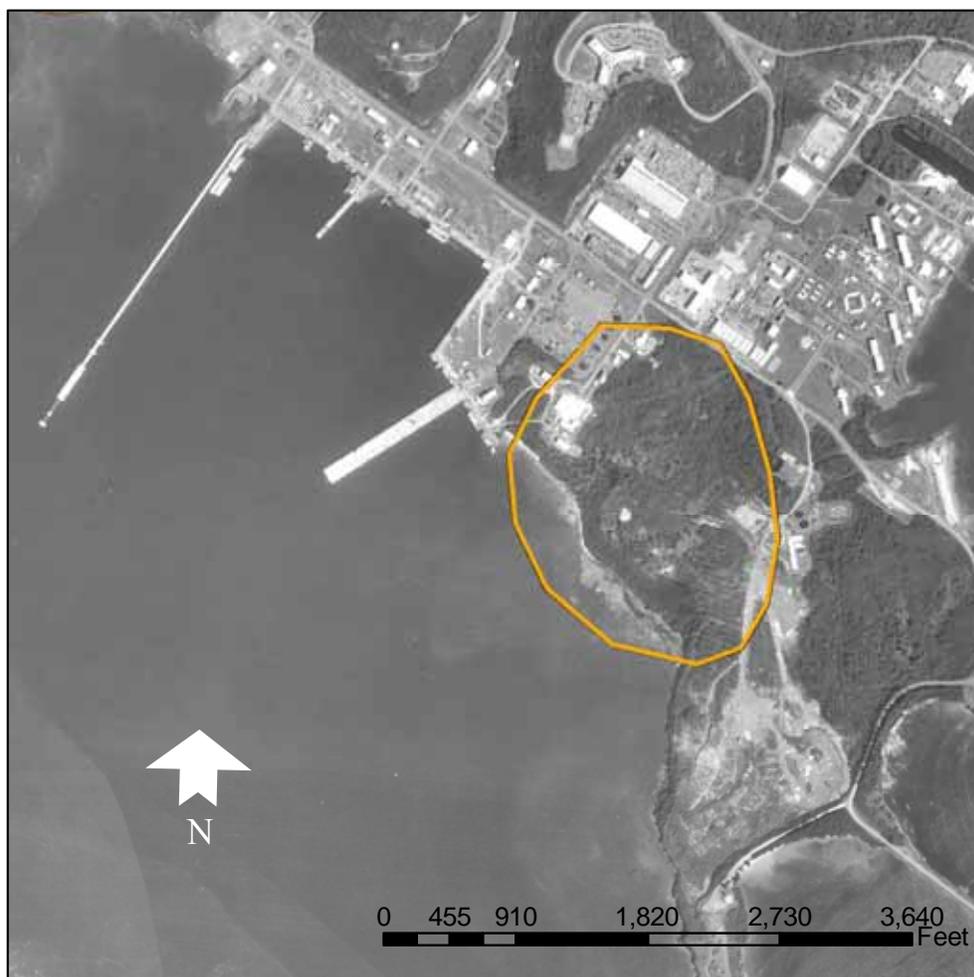
Figure 5-84. ECP Site 16 - Disposal Area Northwest of Landfill

This site is located southeast of Building 394 and northwest of the current base landfill and covers a large area of flat lying land consisting of open areas and areas covered by secondary growth vegetation (see Figure 5-84). The APA identified this area as PI Site 22, due to the observation of a large suspect disposal area with disturbed ground, debris, a cleared or graded area, and stressed vegetation from 1976-1983. In addition, containers or drums had been discarded in a vegetated area north of the main disposal area. The records review did not identify any activities in this area. The physical site inspection observed numerous piles of construction debris (metal, concrete, polyvinyl chloride [PVC] piping), but no drums or evidence of stains or stressed vegetation. Interviews confirmed the area as a construction and/or solid waste disposal site, including potential disposal of POL or HM containers. [See photos A-34 and A-35]

During the Phase II ECP investigation, numerous piles of construction debris (metal, concrete, and PVC piping) (Photograph G-40) were observed in different portions of the site, as was the case during the physical site inspection. There appeared to be more of a general solid waste type of debris (i.e., metal, rope, etc.), where as the central portion of the site appeared to have more of an excavation type of debris (i.e., concrete, rocks, etc.). However, there were no drums or evidence of stains or stressed vegetation. A majority of this site is covered in thick secondary growth vegetation (Photograph G-41). In addition, the central and southern portions of the site are classified as wetlands consisting of either estuarine-intertidal-scrub/shrub (broad-leaved evergreen), or estuarine-intertidal-unconsolidated shore (mud/organic/dead). Photograph G-42 presents a wetland area in the vicinity of soil boring location 16E-05.

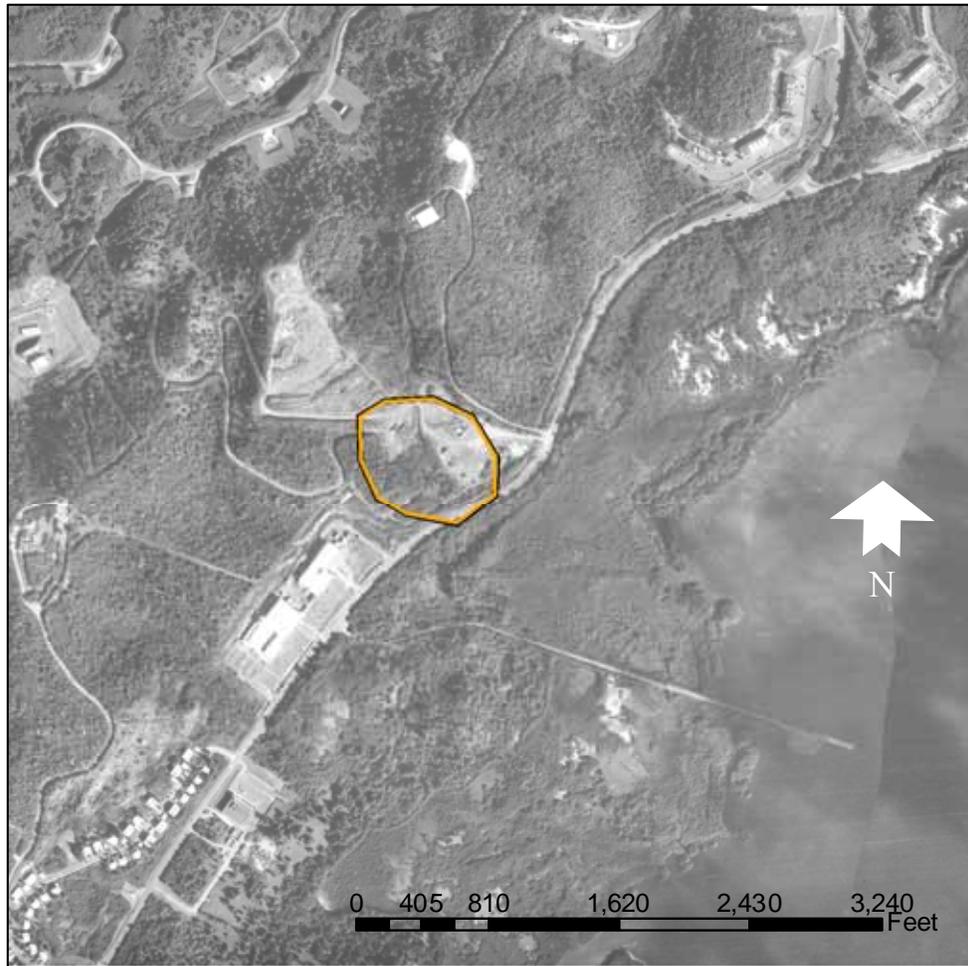
Figure 5-86. ECP Site 17 - Quarry Disposal Site

This site is located at the Commissary parking lot, where a quarry once operated and an open grassy field adjacent to the parking lot (see Figure 5-86). The APA identified this area as PI Site 24, due to the observation of numerous drums in open storage on the south side of the former quarry/rock crusher site from 1976-1983, and at least 25 drums located near the rock crusher, with staining on the ground adjacent to them. The records review identified the area as former quarry site, but there were no records pertaining to drum storage or disposal. The physical site inspection observed remnants of the quarry area, but saw no signs of disposal, stains, or stressed vegetation. Interviews confirmed both storage and disposal of drums containing a tar-like substance in the area, which were uncovered during construction of the Commissary parking lot. The full extent of the disposal area is unknown. [See photo A-36]

There were no signs of a disposal area observed during the Phase II ECP investigation, nor were there any stains or stressed vegetation observed, as was the case during the physical site inspection. A majority of the area was covered in secondary growth vegetation.

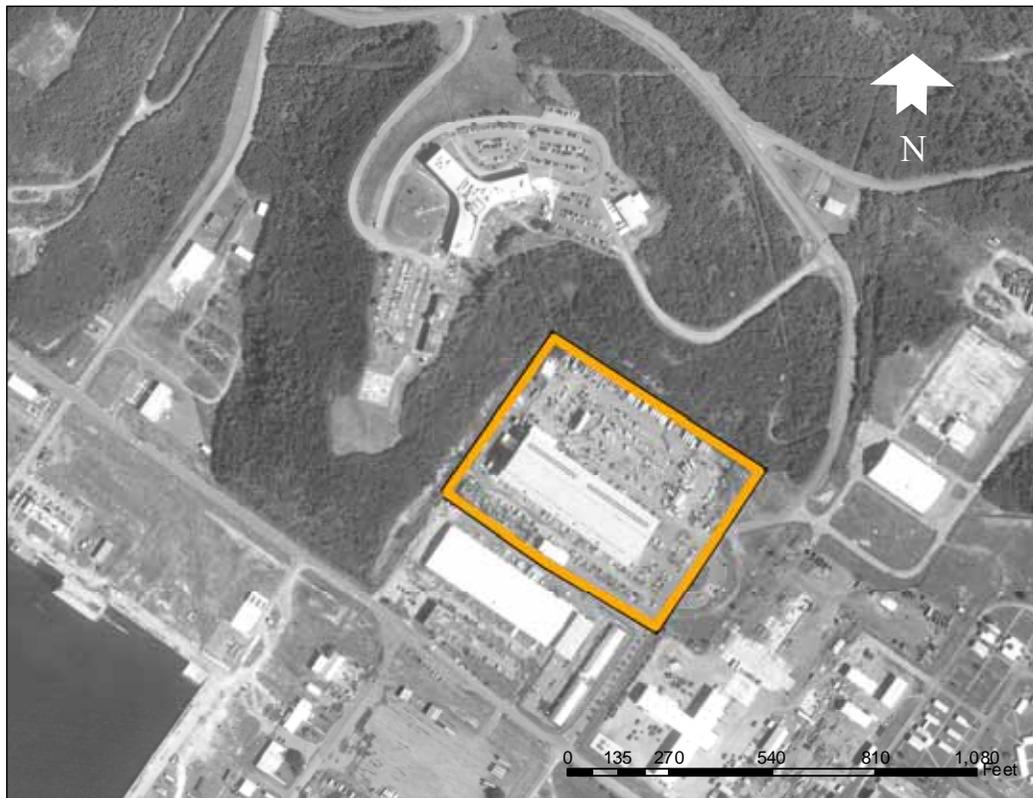
Figure 5-88. ECP Site 18 - Building 31, Public Works Department

This site immediately surrounds Building 31, the Public Works Department (PWD) (see Figure 5-88). The majority of the area is covered by pavement and the outer reaches covered by gravel/dirt. The area surrounding the building is best described as a level parking/storage lot. The APA identified this area as PI Site 25, due to the observation of numerous small spills, stains, and stressed vegetation from 1958-1995. The records review confirmed this area as the location of the PWD since at least the early 1950s, with activities at the site involving facility, vehicle, and equipment maintenance and refueling. The physical site inspection observed numerous small stains on the pavement surrounding the building. Interviews confirmed this site as the historic location of the PWD, with outdoor maintenance activities and numerous spills and leaks of POL and HM occurring throughout the usage period. [See photos A-37 through A-39]

During the Phase II ECP investigation, numerous small stains were observed, as was the case during the physical site inspection. However, there were no major stains observed at this site during the investigation.

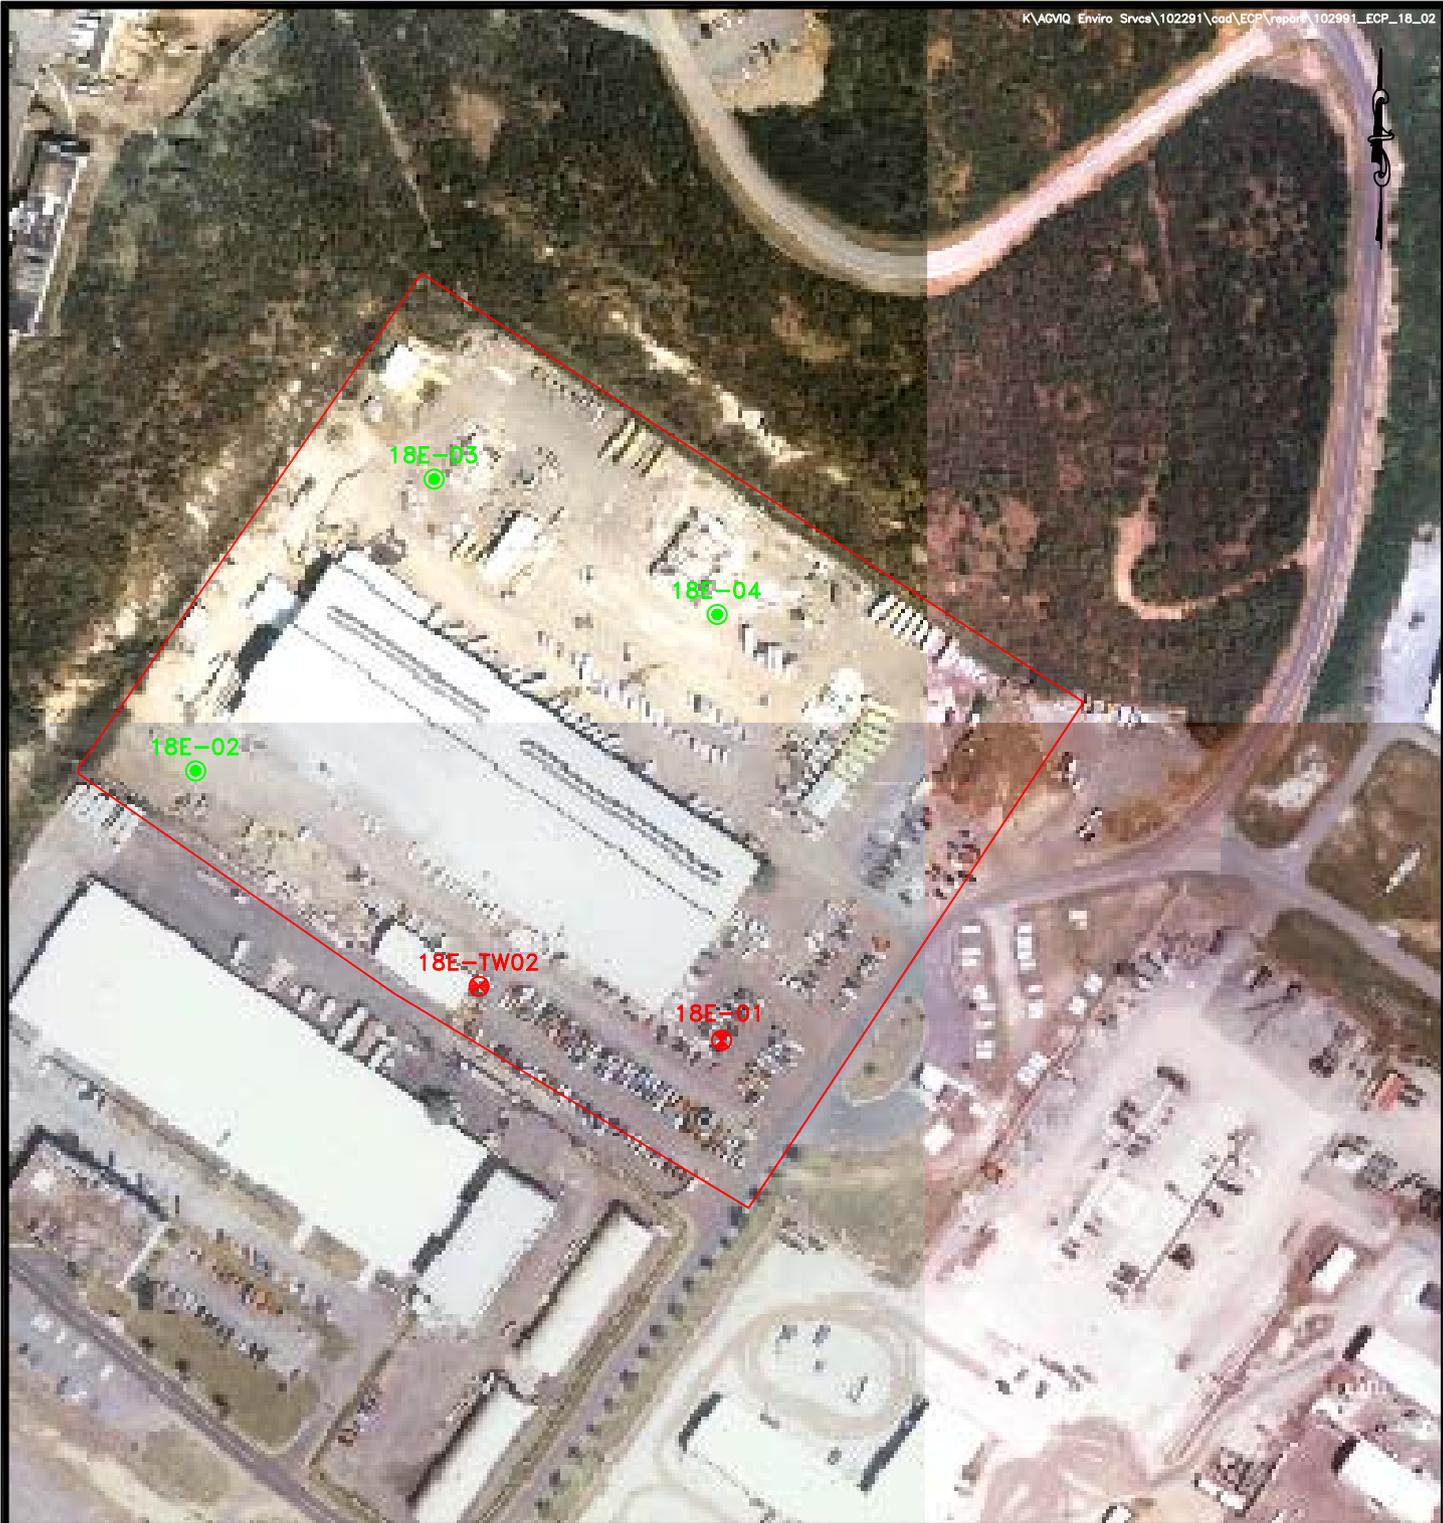
*Figure 5-89.
ECP Site 18 - Building 31,
Public Works Department
Sample Location Map*

A total of five soil borings were advanced in the PWD yard as presented on Figure 5-89. Subsurface soil samples were collected from each boring location, with the exception of 18E-TW02 as described below, from two-foot intervals with a minimum of two subsurface soil samples obtained from each boring location. The depth of the soil borings at this site ranged from 5.5 feet bgs to 13 feet bgs. All subsurface soil samples were screened in the field utilizing a FID and PID with the results recorded in the field logbook. The screening results were compared against background to indicate if the soil has been impacted by past operations. [See Appendix G for full PID and FID screening results on a per site basis.]

Four subsurface soil and two groundwater environmental samples were collected from five locations shown on Figure 5-89 at the Public Works Department. The location of the groundwater sample location at 18E-01 was as proposed in the work plan (NAVFAC Atlantic, 2004b). Since no other soil boring screening resulted in any significant detections above background, it was decided to install the second temporary well at a location independent of any soil boring, and located downgradient of the Public Works Department. A duplicate subsurface soil sample was obtained from location 18E-01. Analytical results showing detections in the two media are given in Tables 5-72 through 5-74.

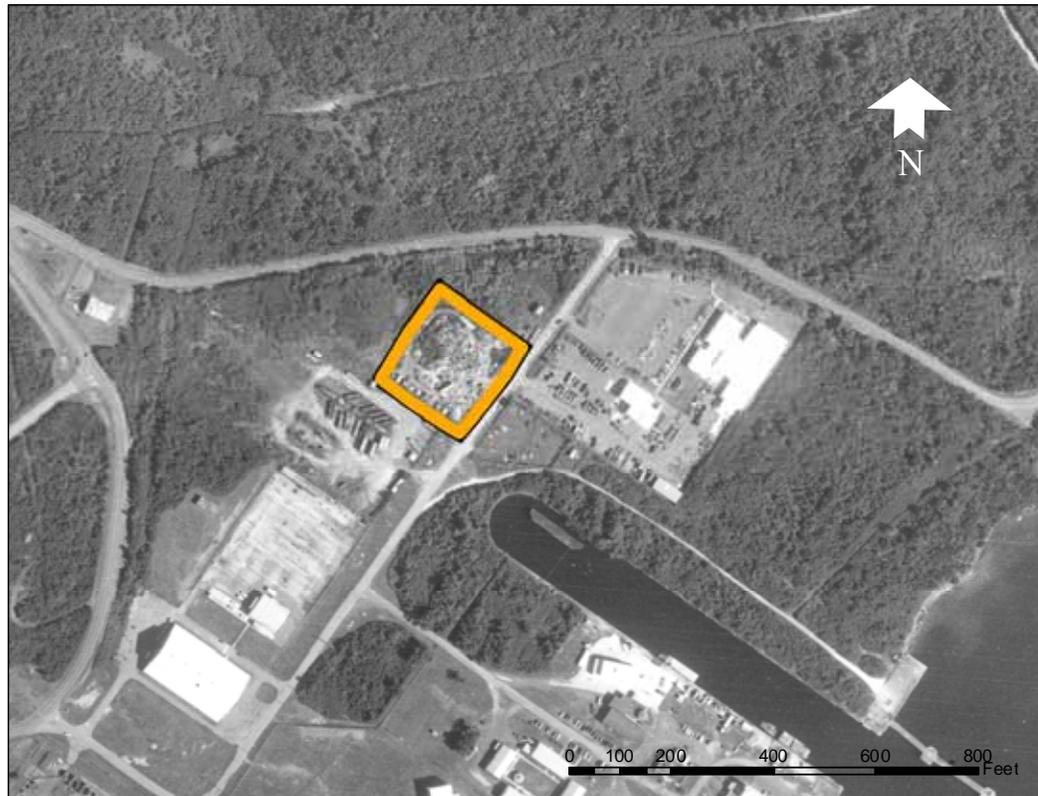
Figure 5-90. ECP Site 19 - DRMO Scrap Metal Recycling Yard

This site is the current location of the Defense Reutilization and Marketing Office (DRMO) Scrap Metal Recycling Yard, located near the Camp Moscrip area and the Dry Dock, at the eastern end of the base (see Figure 5-90). The site originally consisted of a large flat lying gravel covered storage yard as described in the Phase I ECP Report. However, the site boundary was expanded to include the secondary growth vegetation area around the perimeter of the storage yard during the field investigation, as per NAVFAC Atlantic's request, based on the amount of debris (i.e., wood, metal, etc.) observed in this area. The physical site inspection observed numerous small spills and stains of presumed POL, primarily from large pieces of construction equipment that were stored in the yard. The records review, APA, and interviews confirmed that this site has been operated as the DRMO Scrap Yard since the 1970s, and that numerous pieces of equipment

and vehicles have been stored at the site for extended periods of time, resulting in numerous small releases of POL throughout the usage period. Portions of this site contain miscellaneous debris including vehicle frames and tires, as well as other equipment. [See photos A-40 and A-41]

As observed during the Phase II ECP field investigation, there were numerous areas within the recycling yard where the concrete pad was divided up into different storage areas based on the type of scrap metal that was to be disposed (Photograph G-43). Also presented within Photograph G-43, is the view looking northwest across the site at one of the temporary monitor wells installed at this site during the Phase II ECP investigation. The central and northeast portions of the recycling yard appeared to be scraped clean, with minor amounts of debris observed. In addition, piles of debris (i.e., wood, metal, etc.) were observed scattered across the wooded area around the perimeter of recycling yard as mentioned above, as well as a small building structure as presented in Photograph G-44 through G-47.
