Final Preliminary Assessment Report Watercraft Maintenance Support Center, Ceiba, Puerto Rico

Perfluorooctane-Sulfonic Acid (PFOS)
and Perfluorooctanoic Acid (PFOA) Impacted Sites
ARNG Installations, Nationwide

March 2020

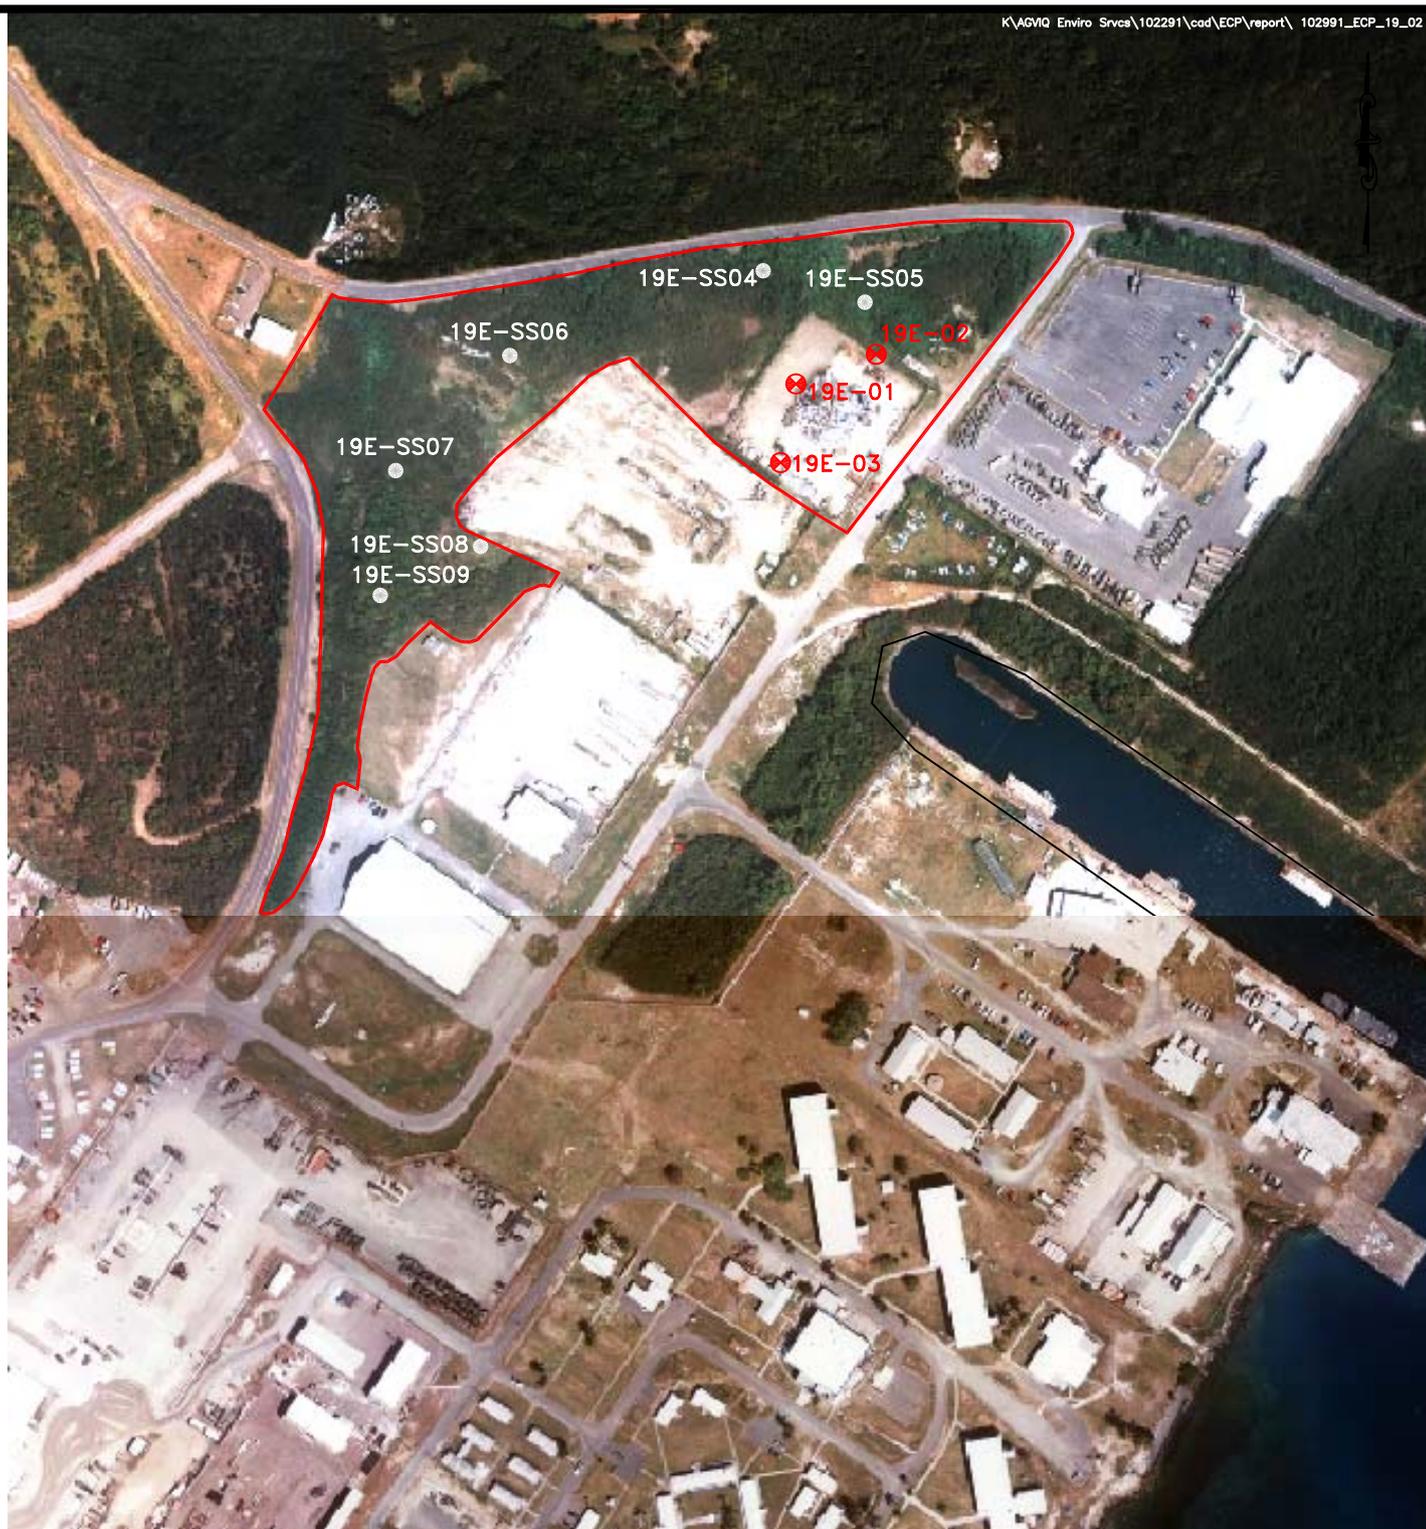
*Figure 5-91.
ECP Site 19 - DRMO Scrap Metal
Recycling Yard
Sample Location Map*

Three soil borings (19E-01 through 19E-03) were advanced in the Former Scrap Metal and Recycling Yard as presented on Figure 5-91. It should be noted that the three soil borings were not located on top of the concrete pad that falls within this area.

A groundwater program followed the soil sampling program. One temporary monitor well was installed at each of the three soil boring locations (19E-01 through 19E-03) as presented on Figure 5-91. The temporary monitor wells were installed and groundwater samples (19E-GW01 through 19E-GW03) were collected. Groundwater samples were submitted to the fixed-base analytical laboratory for full Appendix IX analysis. The inorganic analysis requested was for dissolved metals only.

Nine surface soil, three subsurface soil, and three groundwater samples were obtained from ECP Site 19 from nine locations as shown on Figure 5-91. The groundwater sample locations were pre-determined by the work plan (NAVFAC Atlantic, 2004b) and were not based on FID/PID screening. The results of the screening indicated that only one location had an exceedance of background in the soil vapor. No duplicate samples were taken at this site. The positive detections in the analytical results are shown on Tables 5-75 through 5-80.

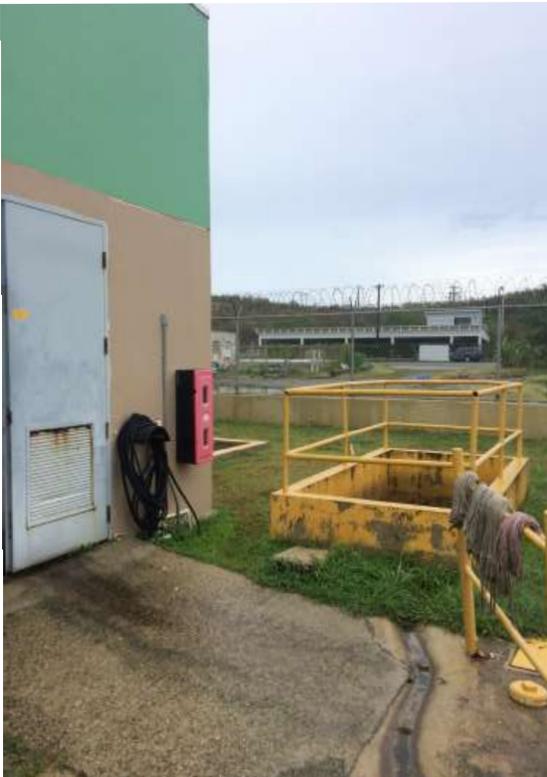
Photograph No. 1

Date 5/30/2019 Time 10:20	
Description: Oil water separator stationed on the northeast corner of the kitchen area at the Watercraft Maintenance Support Center. An ABC fire extinguisher is visible on the wall adjacent to the oil water separator.	
Orientation: North

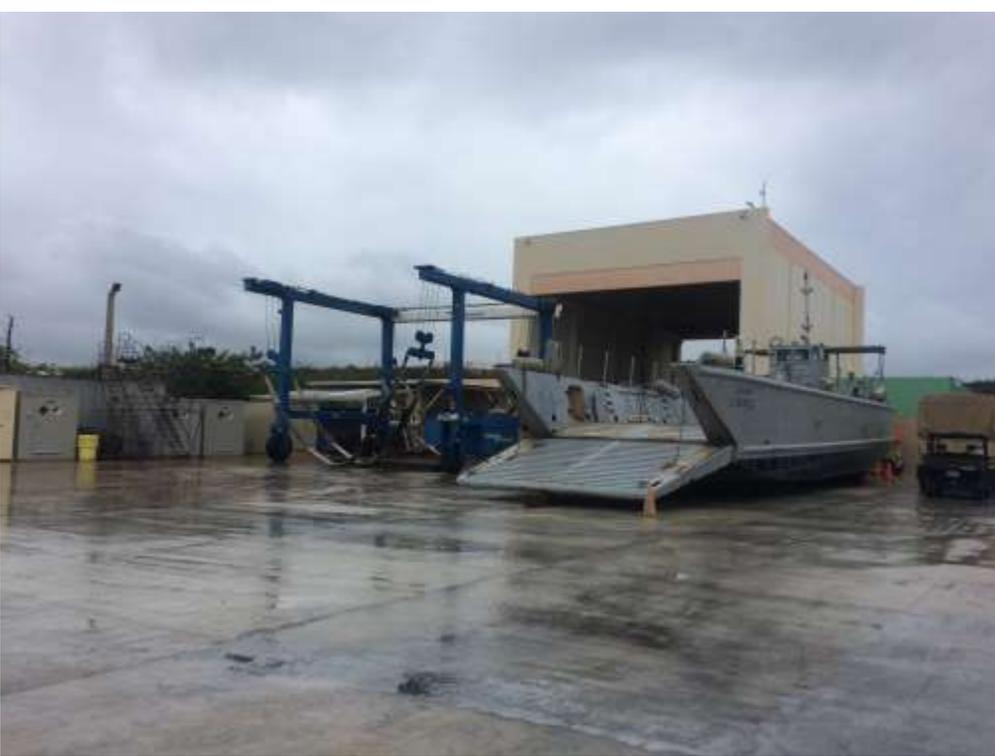
Photograph No. 2

Date 5/30/2019 Time 8:29	
Description: Watercraft staged on the parking area outside the maintenance bay at the Watercraft Maintenance Support Center	
Orientation: Northeast

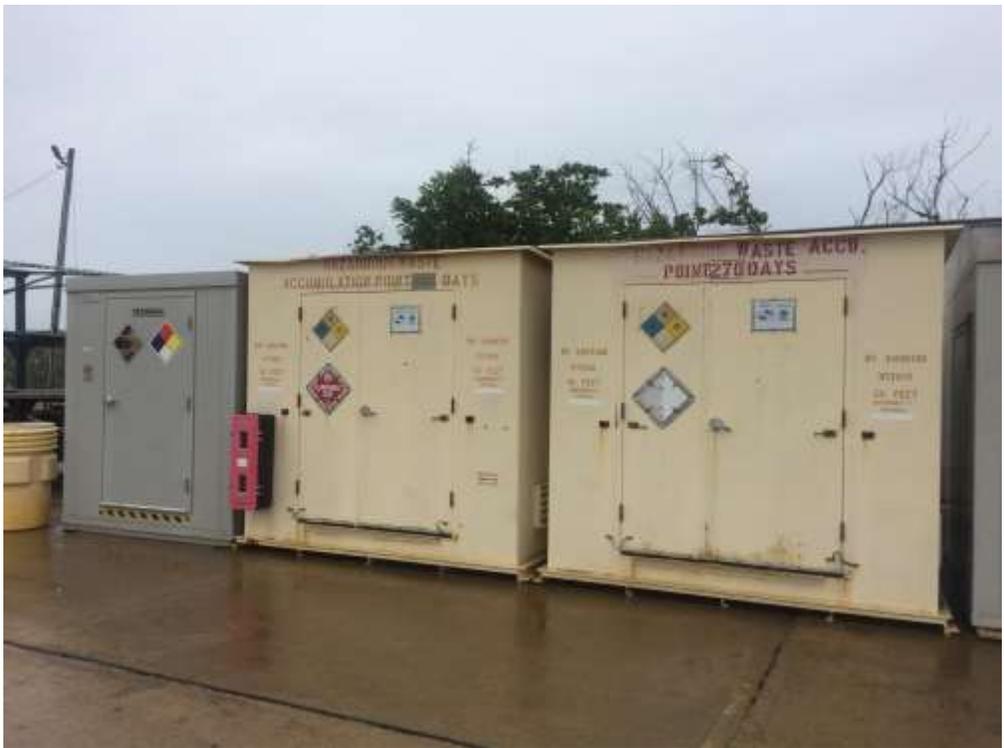
Photograph No. 4
Date 5/30/2019 Time 10:29
Description: The hazardous material storage area at the Watercraft Maintenance Support Center. An ABC fire extinguisher is staged outside the storage unit.
Orientation: West

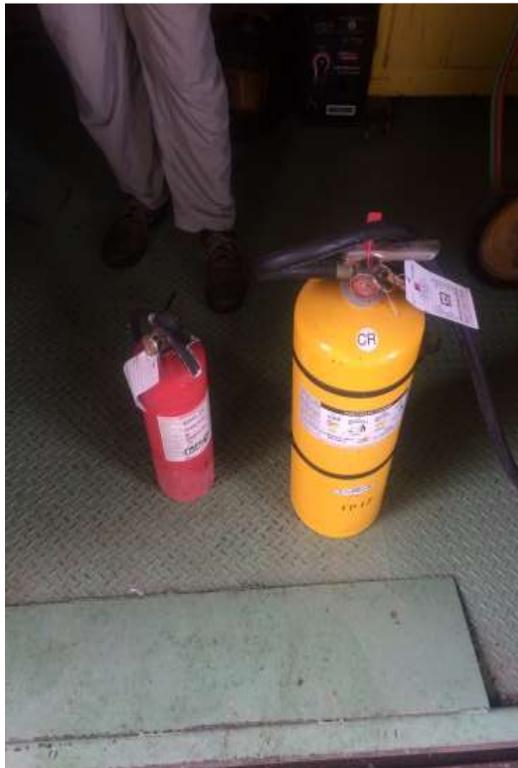
Photograph No. 6
Date 5/30/2019 Time 10:28
Description: ABC fire extinguisher and dry chemical handheld fire extinguisher stored in the Watercraft Maintenance Support Center welding shop.
Orientation: NA

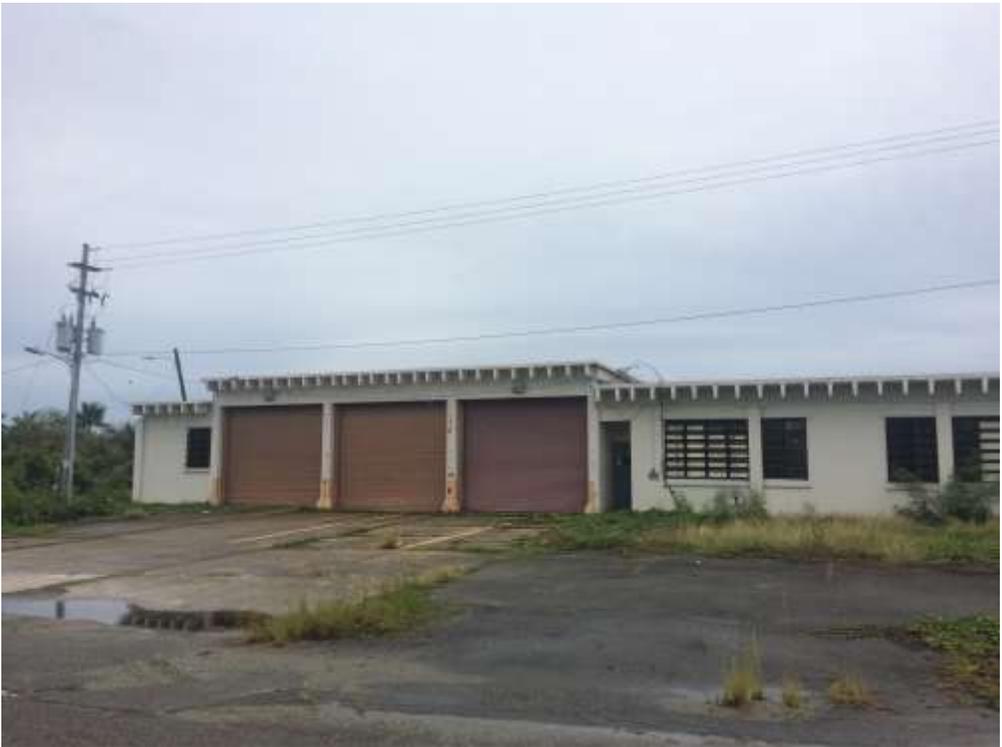
Photograph No. 7

Date 5/30/2019 Time 10:48	
Description: Former Roosevelt Roads Naval Station Fire Department property, located approximately 0.9 miles northwest of the Watercraft Maintenance Support Center	
Orientation: North

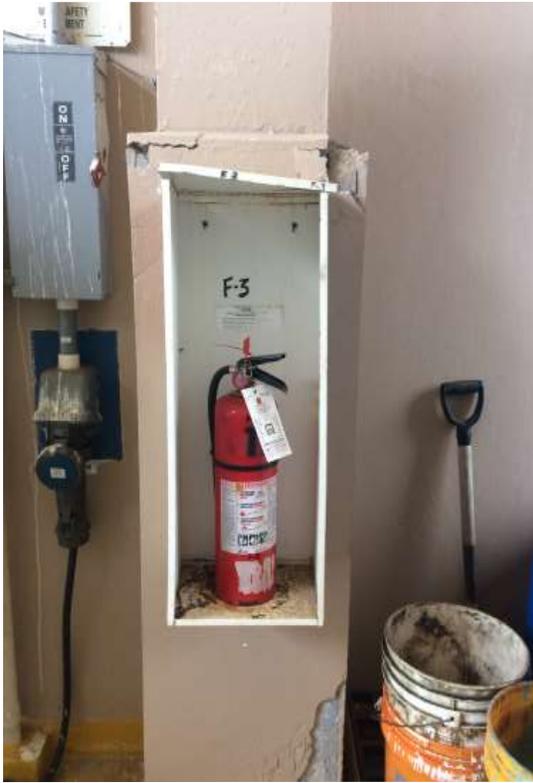
Photograph No. 8

Date 5/30/2019 Time 10:23	
Description: ABC fire extinguisher staged in the storage area at the Watercraft Maintenance Support Center	
Orientation: NA
