## Site Inspection Report

### San Juan Army Aviation Support Facility

### San Juan, Puerto Rico

Site Inspections for Perfluorooctanoic Acid (PFOA), Perfluorooctanesulfonic Acid (PFOS), Perfluorohexanesulfonic Acid (PFHxS), Perfluorononanoic Acid (PFNA), Hexafluoropropylene oxide dimer Acid (HFPO-DA) and Perfluorobutanesulfonic Acid (PFBS)  
ARNG Installations, Nationwide

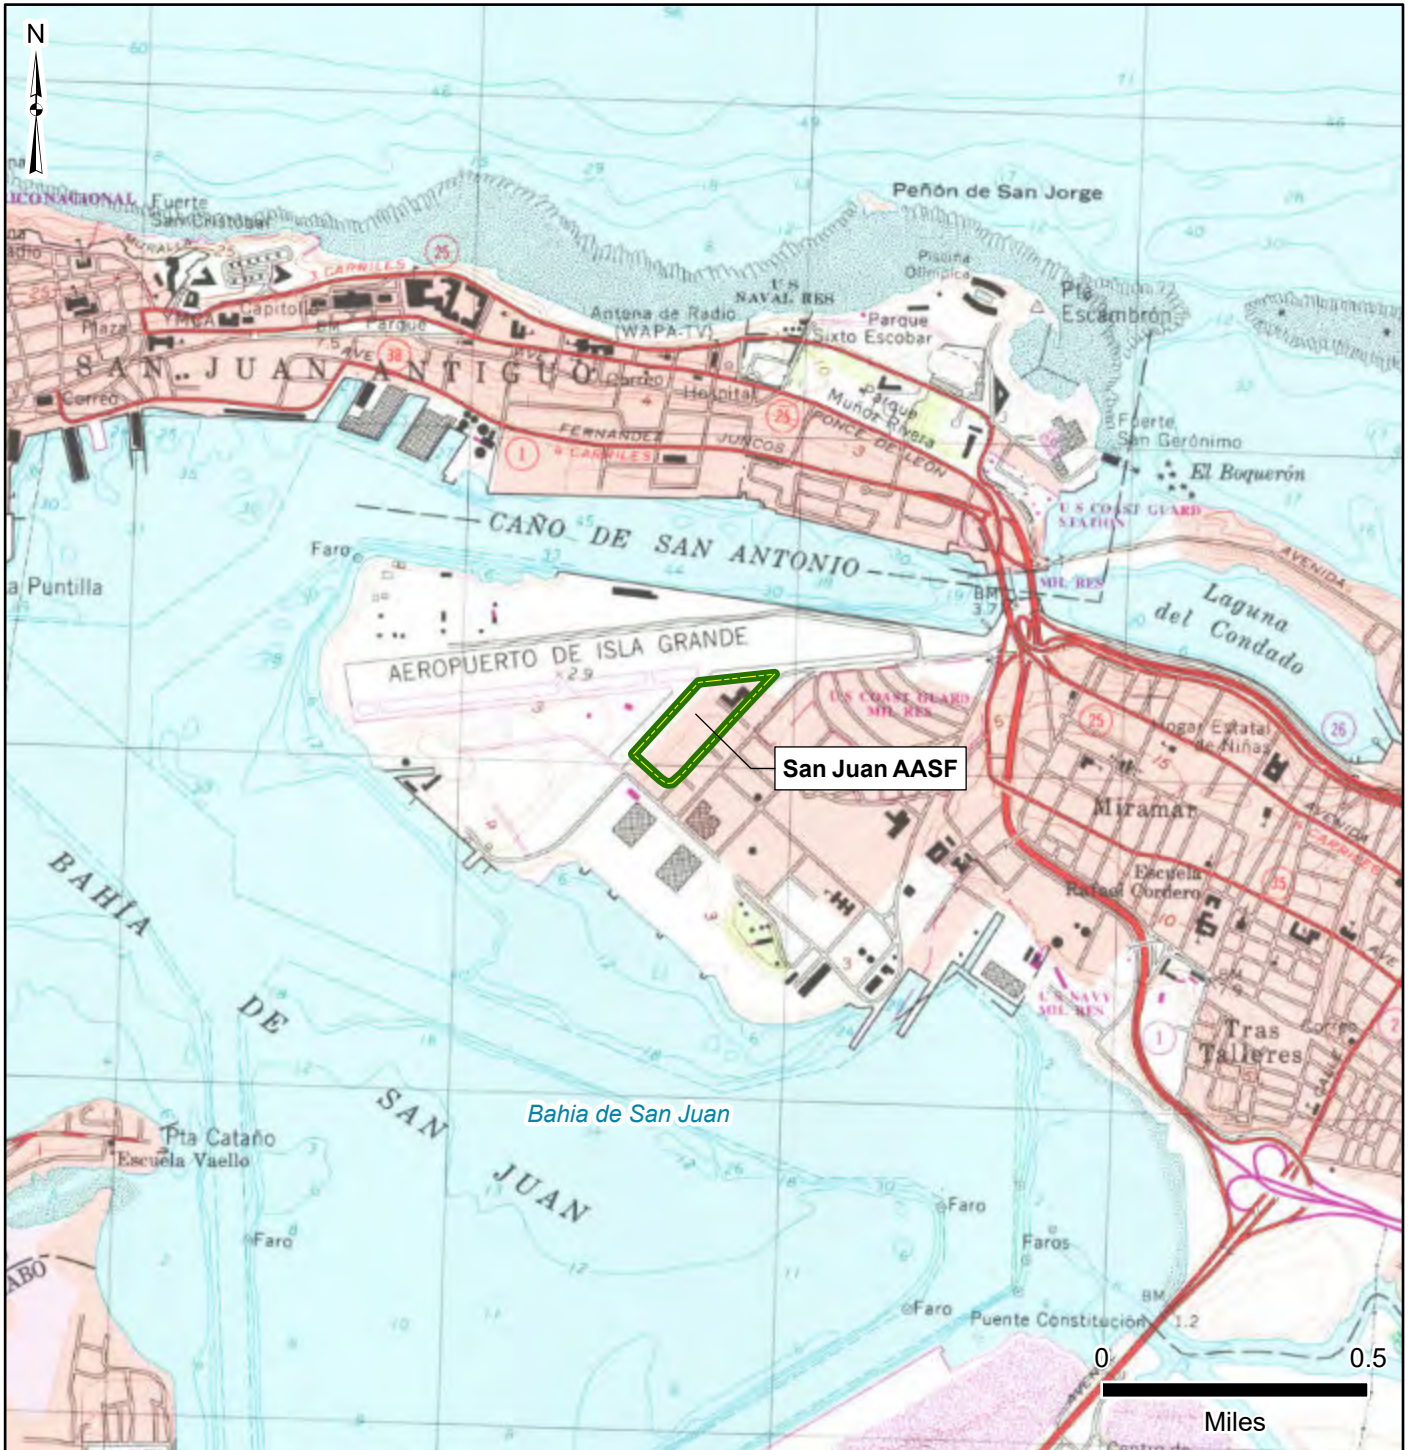
Figure 2-2  
Topography

Isla Verde is a fragment of a former shore isolated by beach erosion with a thin soil layer. Because much of the peninsula has been developed for industrial and commercial use, much of the area is underlain with artificial fill (**Figure 2-2**). No digital data is available for soil directly beneath the AASF via the U.S. Department of Agriculture Natural Resources Conservation Service Web Soil Survey tool. Soils in the low depressions and coastal lagoons within the vicinity of the AASF often include Martin Pena-Saladar-Hydraquents (AECOM 2020).

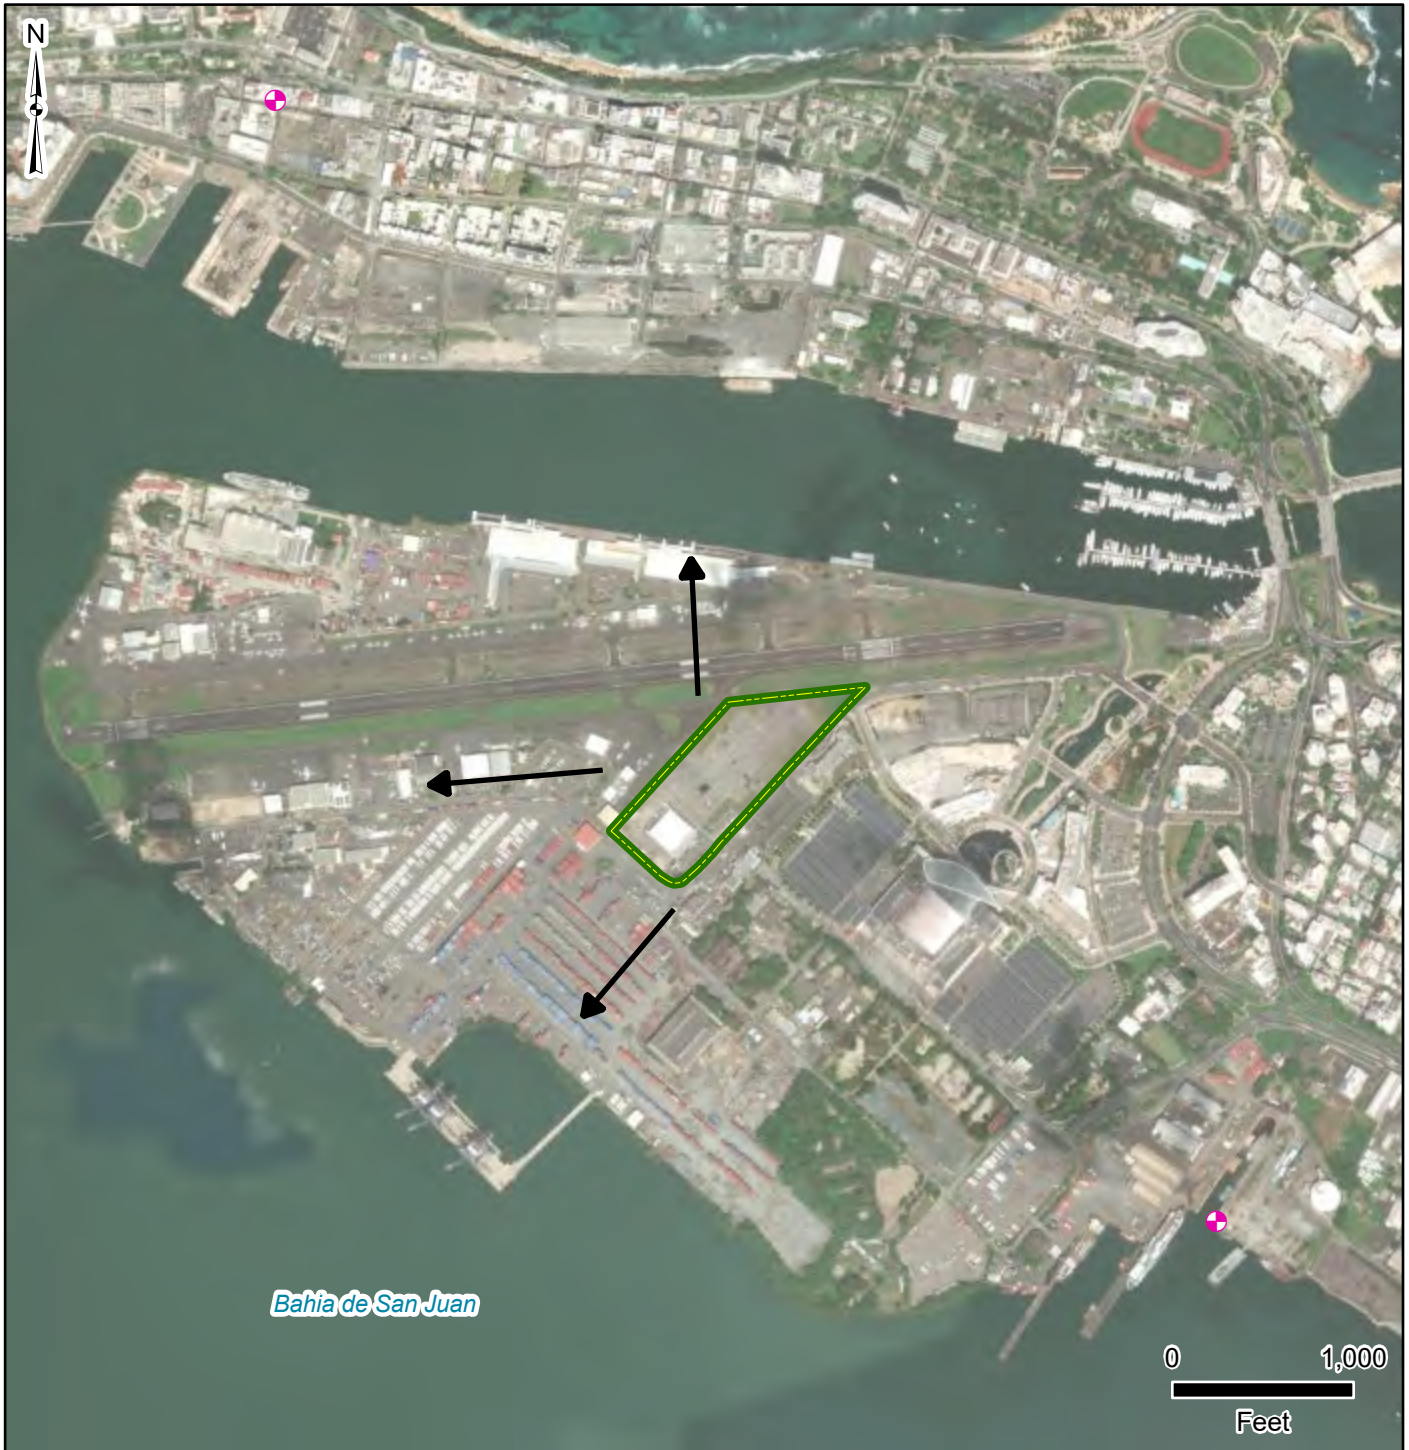
Figure 2-3  
Groundwater Features

de Loíza and the Río de la Plata watersheds are the principal sources of public water supply for the San Juan metropolitan area. Two U.S. Geological Survey (USGS) wells are located on the San Juan peninsula north of the Facility and are shown on the Environmental Data Resources, Inc.<sup>TM</sup> (EDR <sup>TM</sup>) Report. Groundwater depth at the facility is unknown but a shallow water table is assumed. Groundwater flow at the AASF is expected to be radial towards the San Juan Bay and Caño San Antonio (**Figure 2-3**).

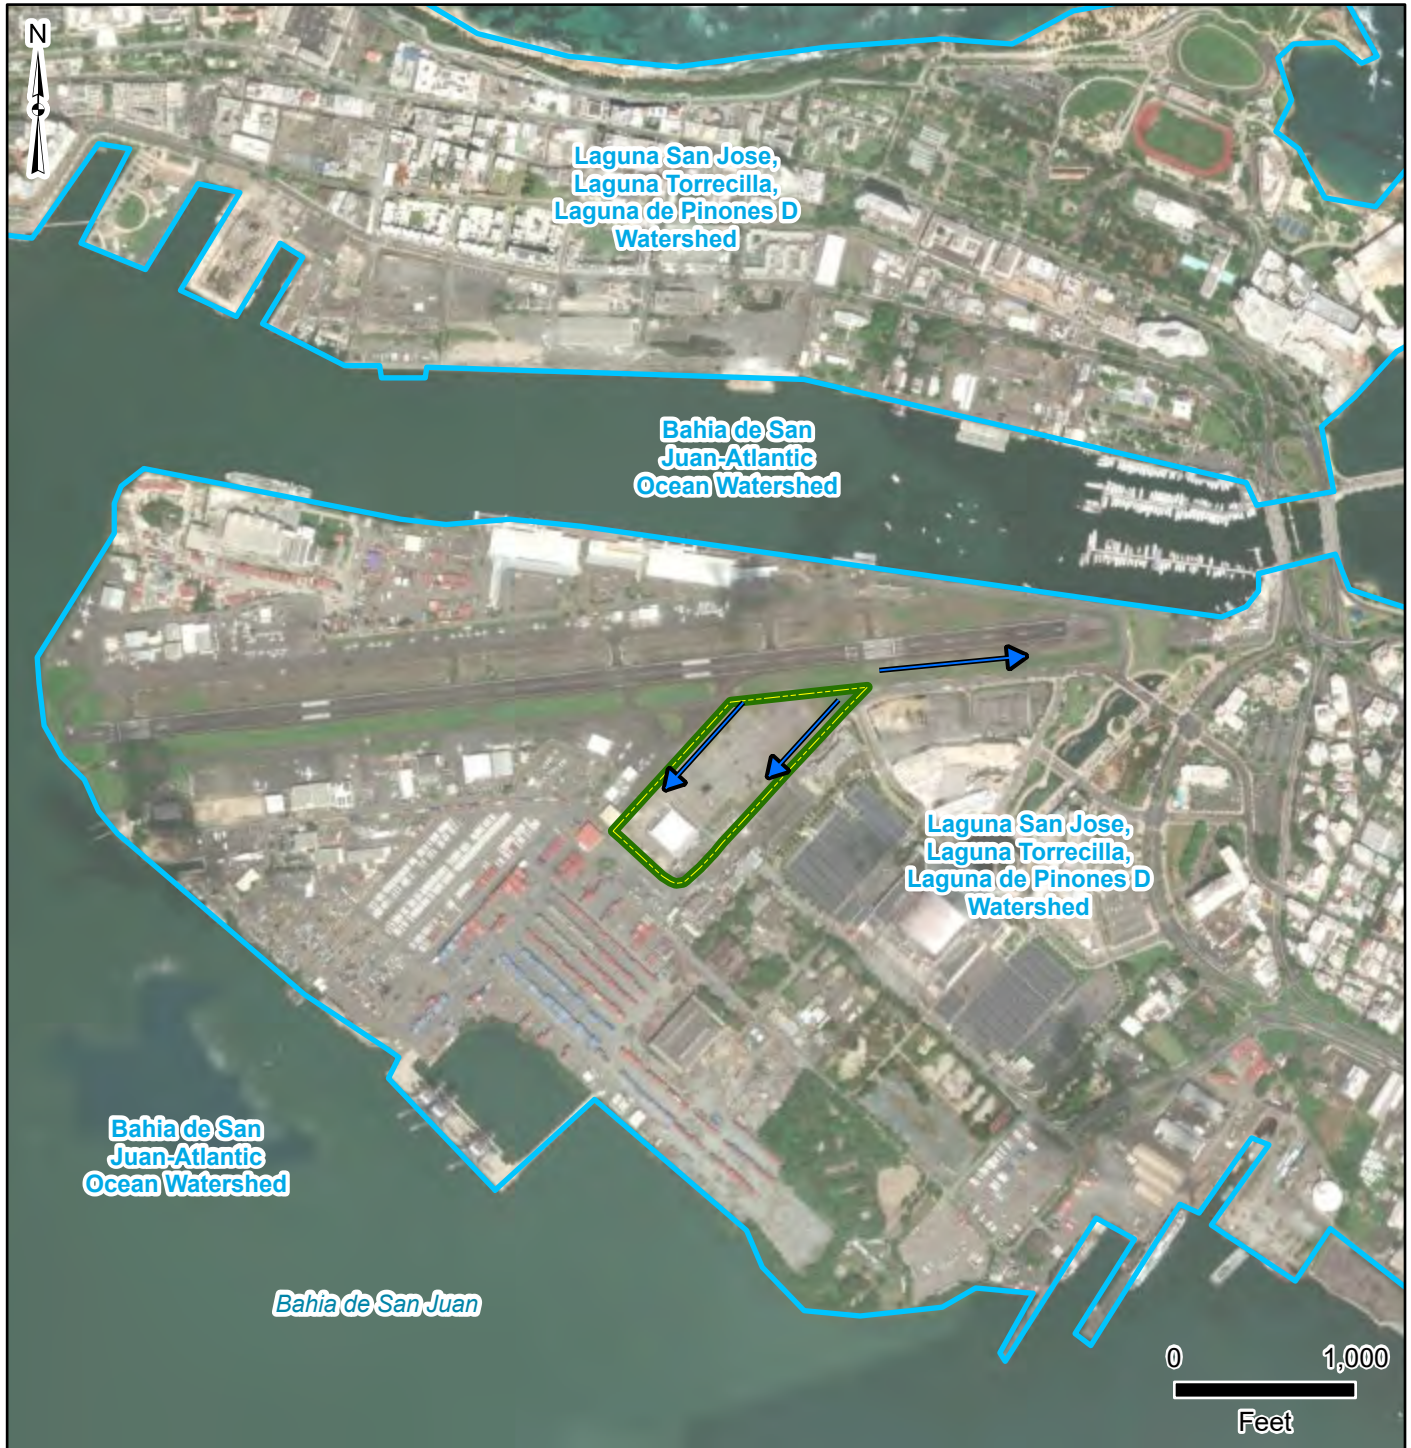
Figure 2-4  
Surface Water Features

The AASF is surrounded by commercial and industrial developments, primarily associated with the adjoining airport. There are no surface water bodies located within the facility boundary. Because the AASF is located on the center of the Isla Grande peninsula, it is surrounded by water on three sides (**Figure 2-4**). Surface water runoff is expected to generally flow south, away from the SIG runway, and empty into the San Juan Bay (AECOM 2020).

Surface water runoff at the AASF drains to catch basins that channel water towards an oil-water separator (OWS) located in the southeastern corner of the AASF property, adjacent to the southern corner of the Hangar. According to AASF personnel, transport of runoff beyond the OWS is unknown (AECOM 2020), however surface water must eventually discharge to the Atlantic Ocean. Surface water flow directions and features are presented on **Figure 2-4**.
