## Site Inspection Report

### Vega Baja Readiness Center

### Vega Baja, Puerto Rico

Site Inspections for Perfluorooctanoic Acid (PFOA), Perfluorooctanesulfonic Acid (PFOS), Perfluorohexanesulfonic Acid (PFHxS), Perfluorononanoic Acid (PFNA), Hexafluoropropylene oxide dimer acid (HFPO-DA) and Perfluorobutanesulfonic Acid (PFBS)  
ARNG Installations, Nationwide

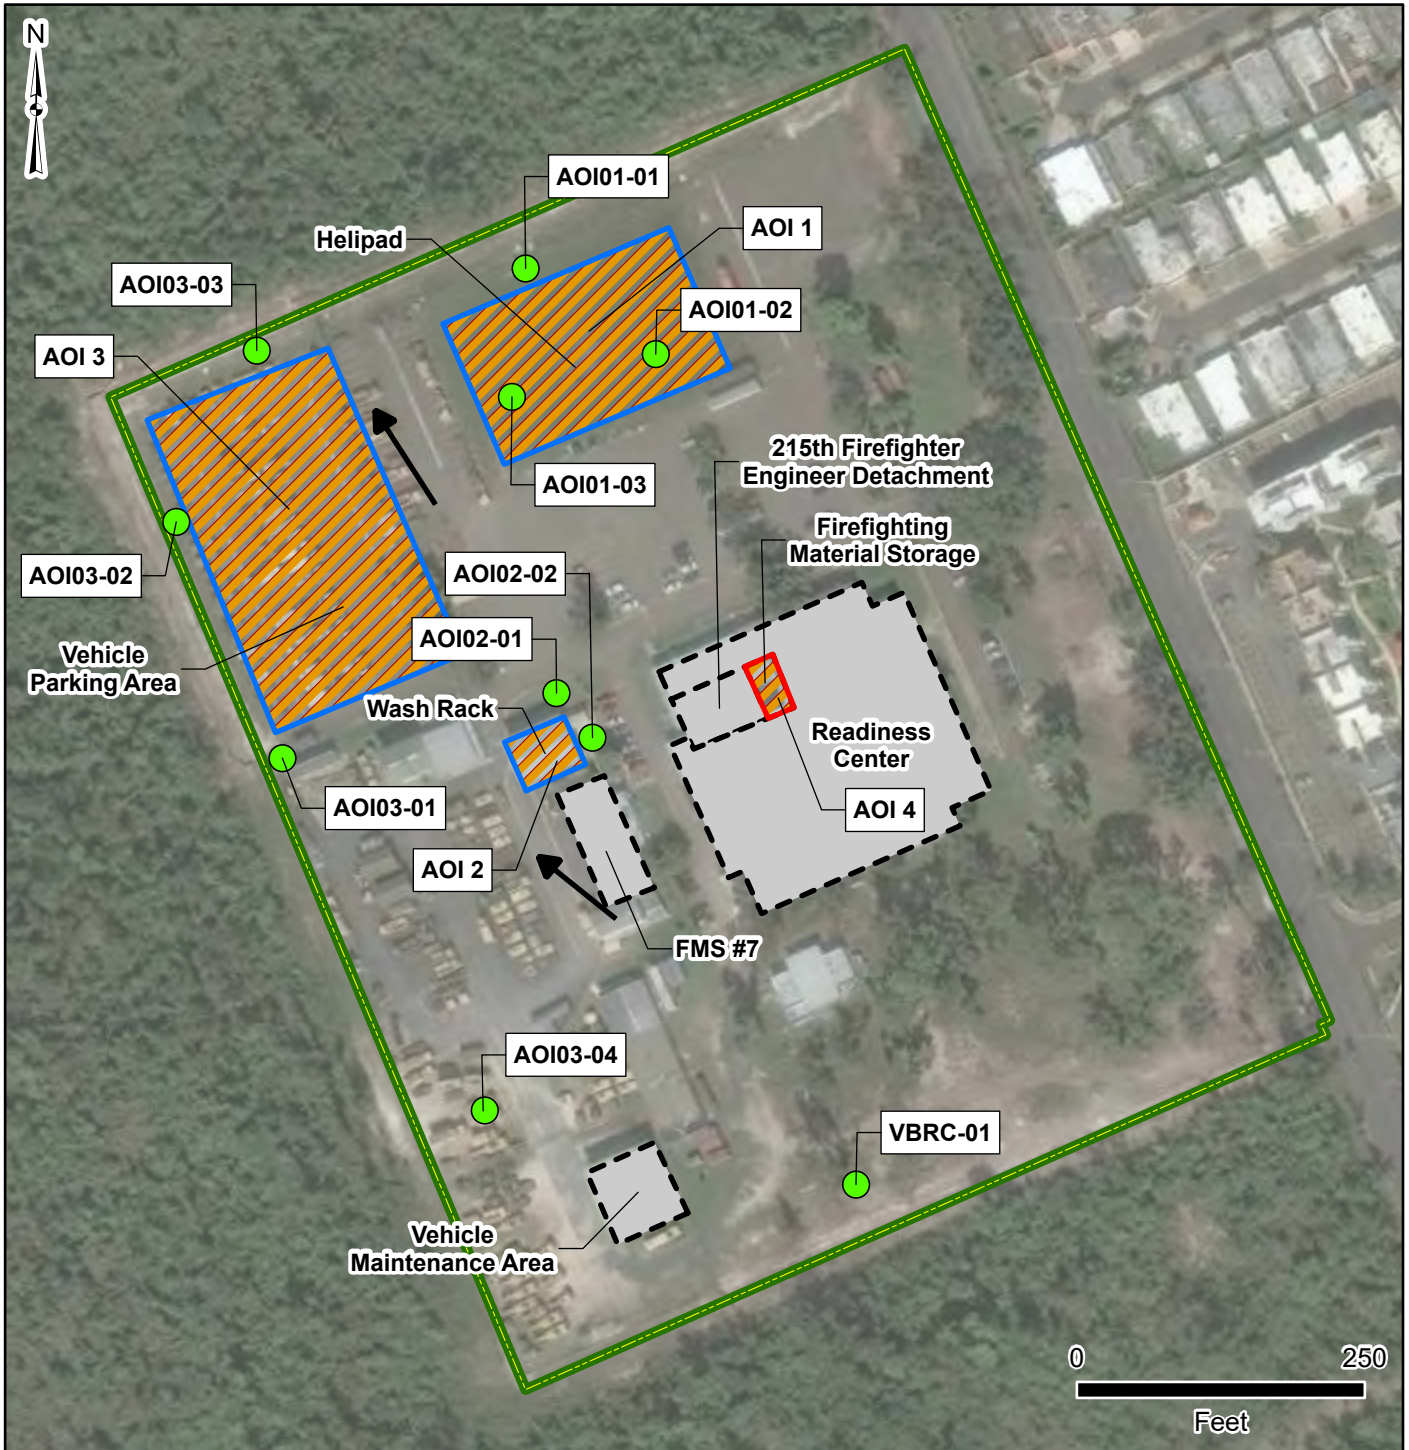
Figure 5-1  
Site Inspection Sample Locations

The SI field activities were conducted from 17 October to 1 November 2022 and consisted of direct-push technology (DPT) borings and soil sample collection, temporary monitoring well installation, and grab groundwater sample collection. Field activities were conducted in accordance with the UFP-QAPP Addendum (EA 2021a), except as noted in **Section 5.8**.
