# FINAL Preliminary Assessment Report Quonset Point Army Aviation Support Facility North Kingstown, Rhode Island

Perfluorooctanesulfonic Acid (PFOS) and Perfluorooctanoic Acid  
(PFOA) Impacted Sites  
ARNG Installations, Nationwide

February 2020

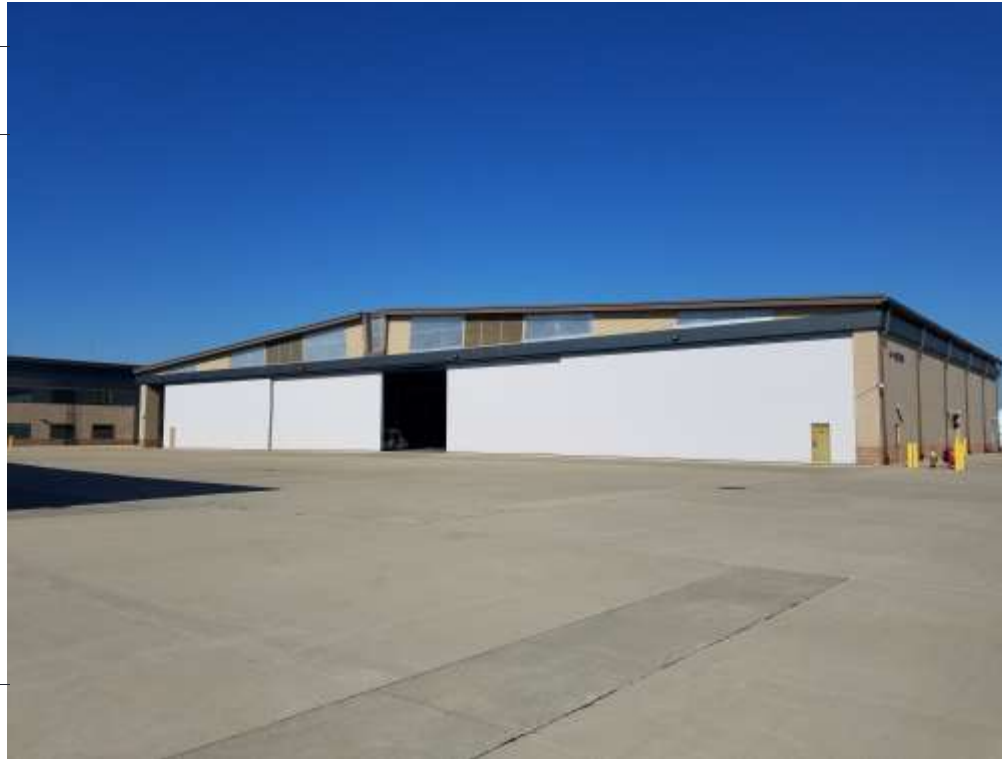
Photo of exterior active hangar (North Hangar) from courtyard area.

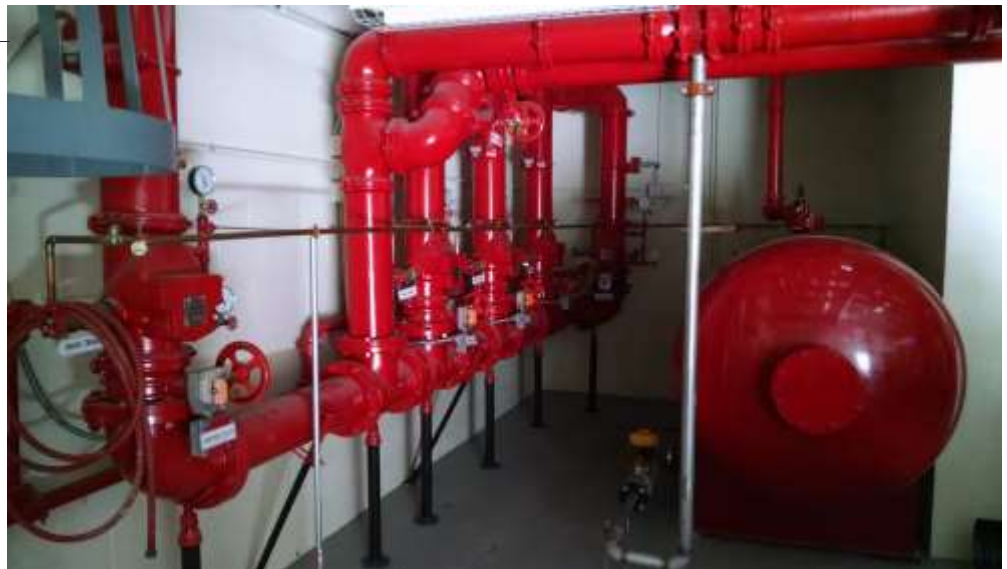
AFFF fire suppression system piping inside maintenance room.

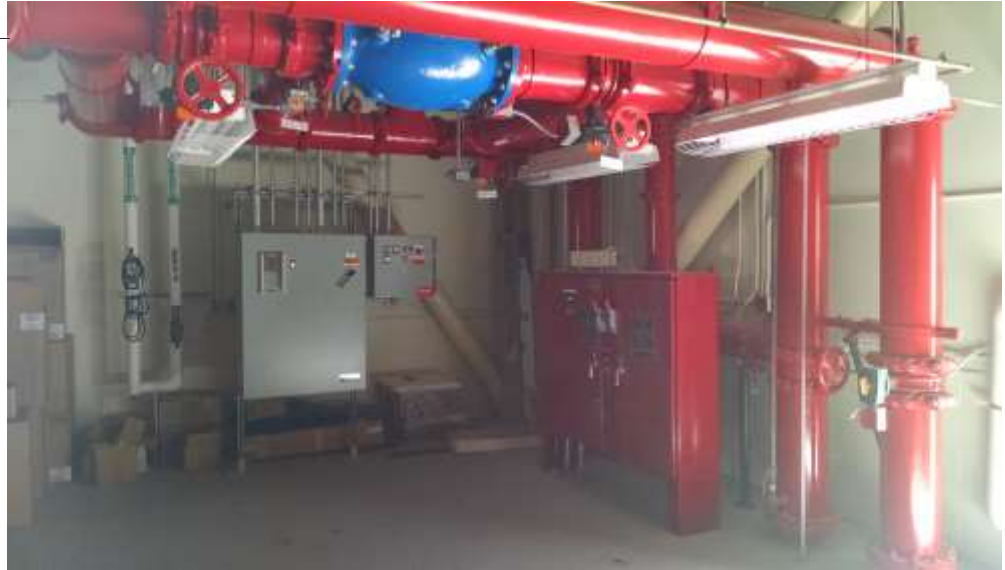
AFFF fire suppression  
 system electrical panel and  
 additional piping.

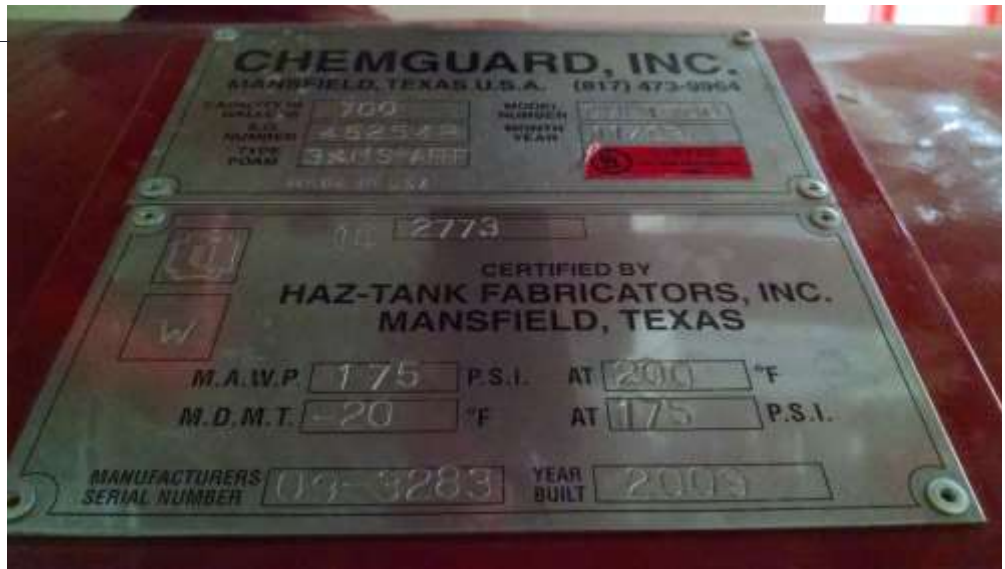
AFFF tank data plate.
