Preliminary Assessment Report

Former PR Nike Battery 99

North Smithfield, Rhode Island

Perfluorooctanesulfonic Acid (PFOS) and Perfluorooctanoic Acid
(PFOA) Impacted Sites
ARNG Installations, Nationwide

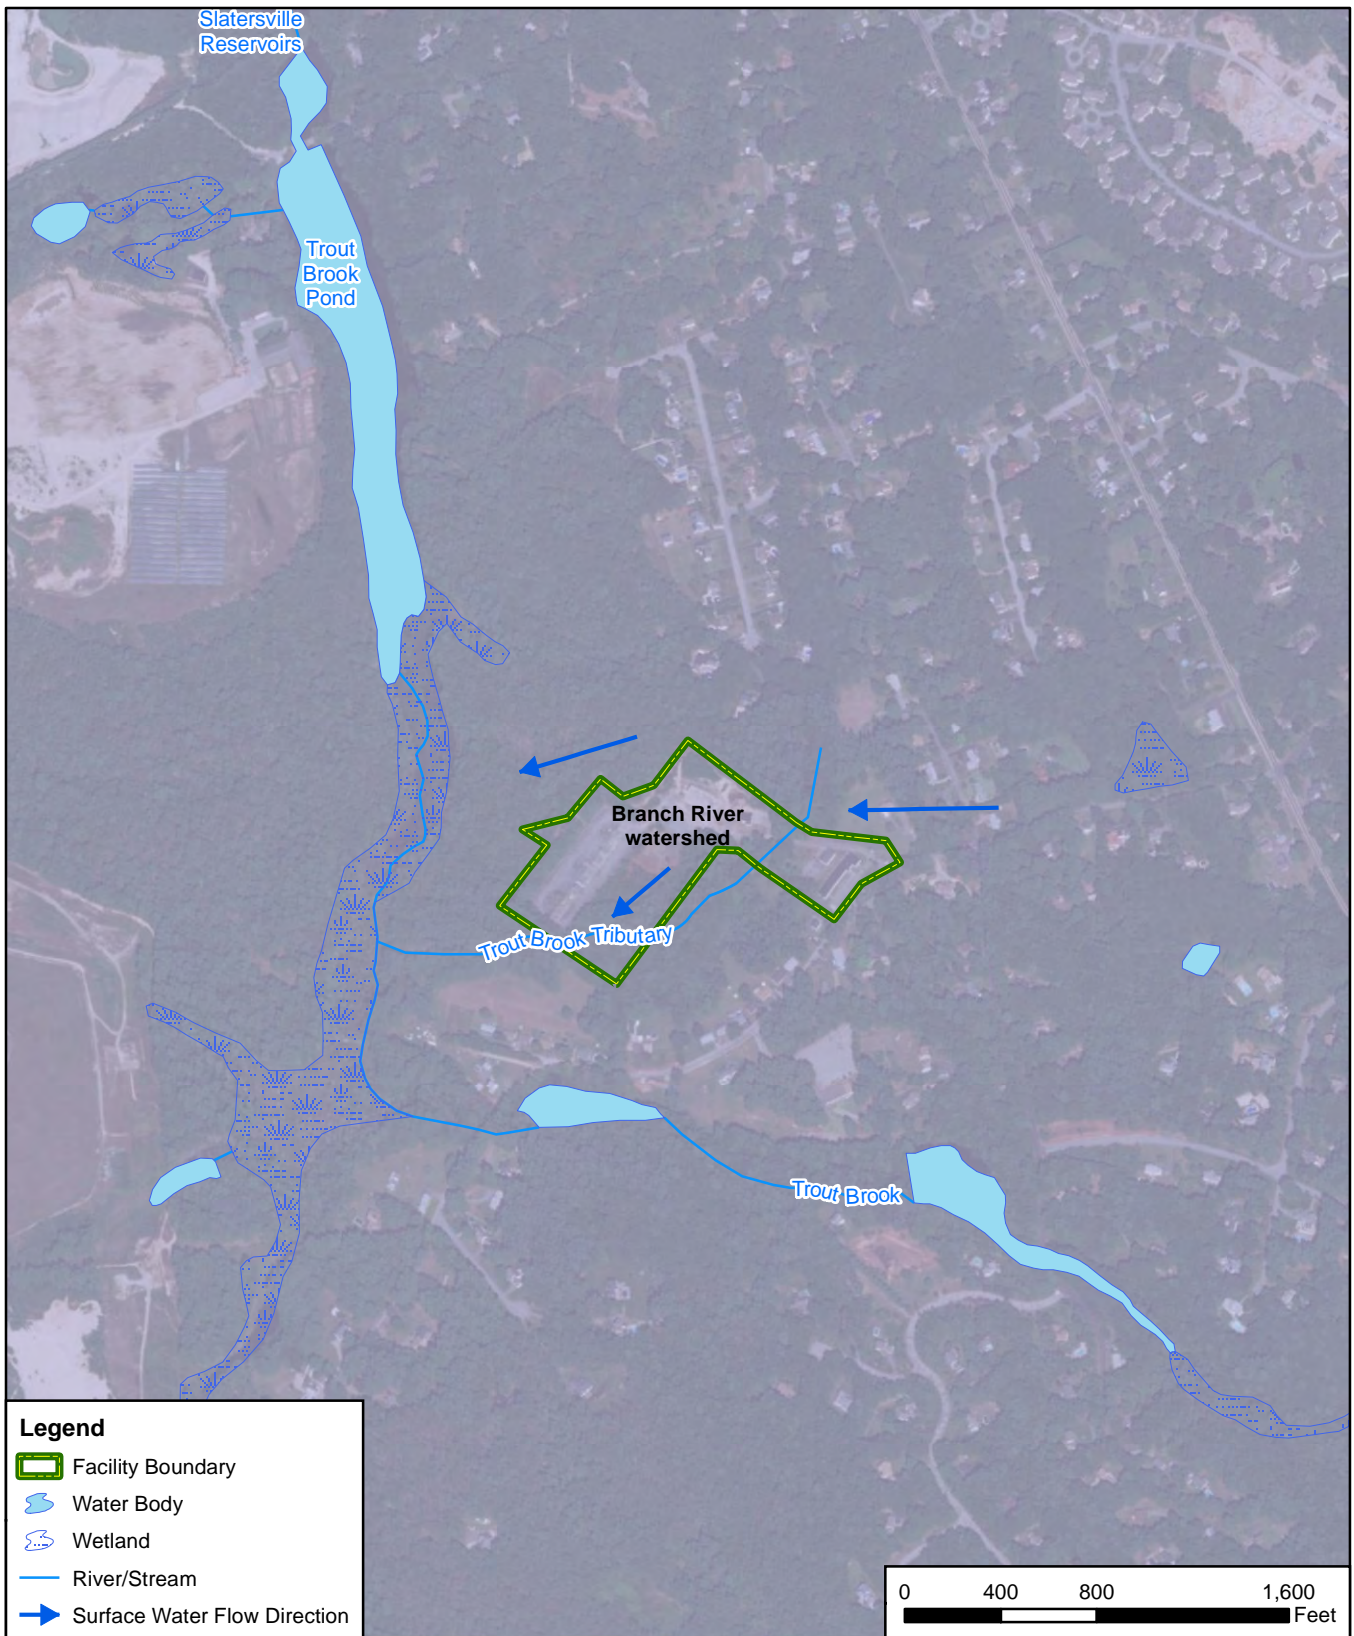
A tributary of Trout Brook is located onsite and flows east to west across the Site. The tributary originates east of the facility property boundary and flows between the administration building and former operational side of the Site (**Figure 1-3**). Wetlands exist on either side of the tributary and expand into a larger, state-mapped and regulated wetland (EA Engineering, 2010). Any overland flow across the Site eventually flows into the Trout Brook tributary or the surrounding wetland to the west of the Site.

Surface Water Features	
Preliminary Assessment for PFAS at North Smithfield, RI

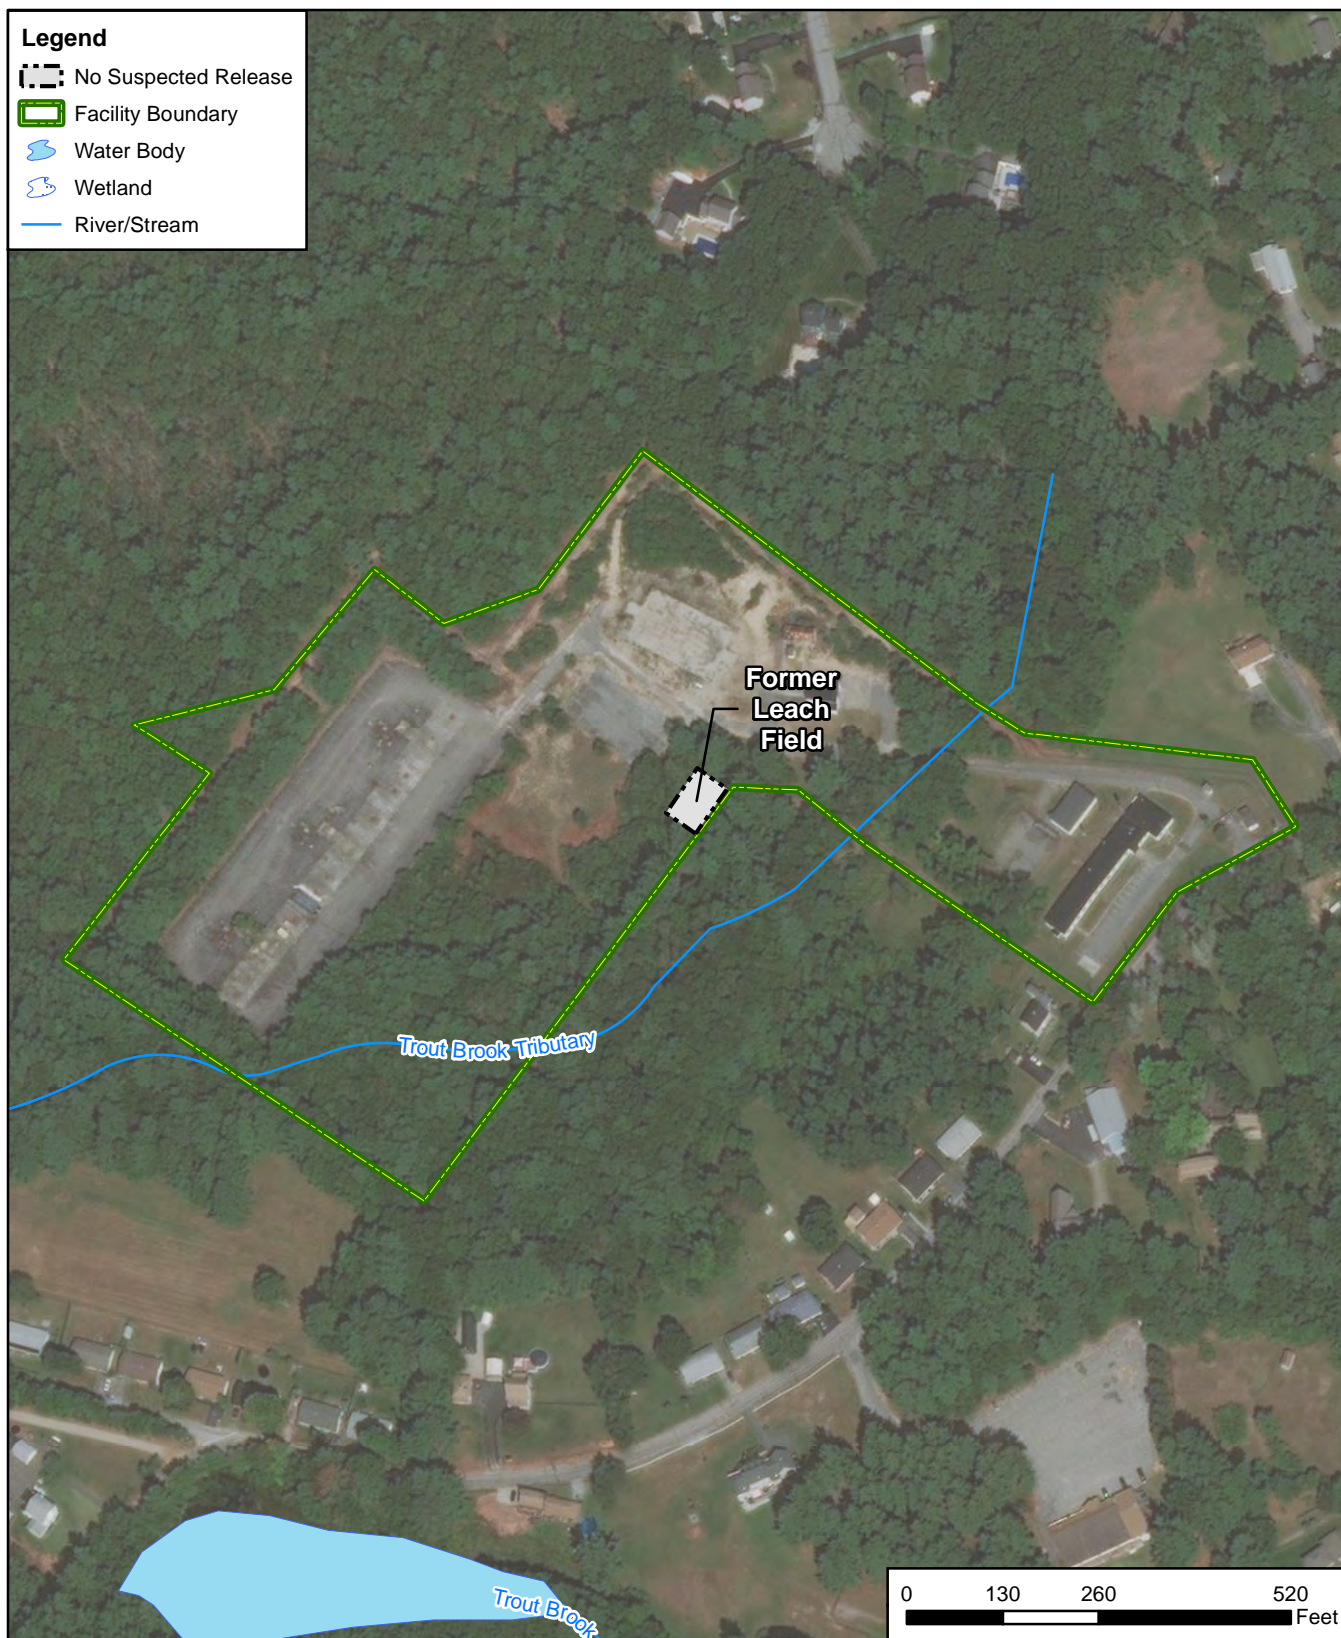
The leach field and associated infrastructure (distribution box and septic tank) are located in a wooded area west of the Armory and within the operations area (**Figure 3-1**). The leach field, distribution box, and septic tank were constructed in 1956 and were only connected to the Armory, which served as barracks, a mess hall, and administration building for the launch area during the time of operation. The septic system did not connect to any of the buildings located within the operations Area (buildings associated with the operation of the Nike missiles and launch pad). The wastewater discharged to the leach field originated from shower/bathroom drains, sinks, and toilets.

Non-Fire Training Area	
Preliminary Assessment for PFAS at North Smithfield, RI

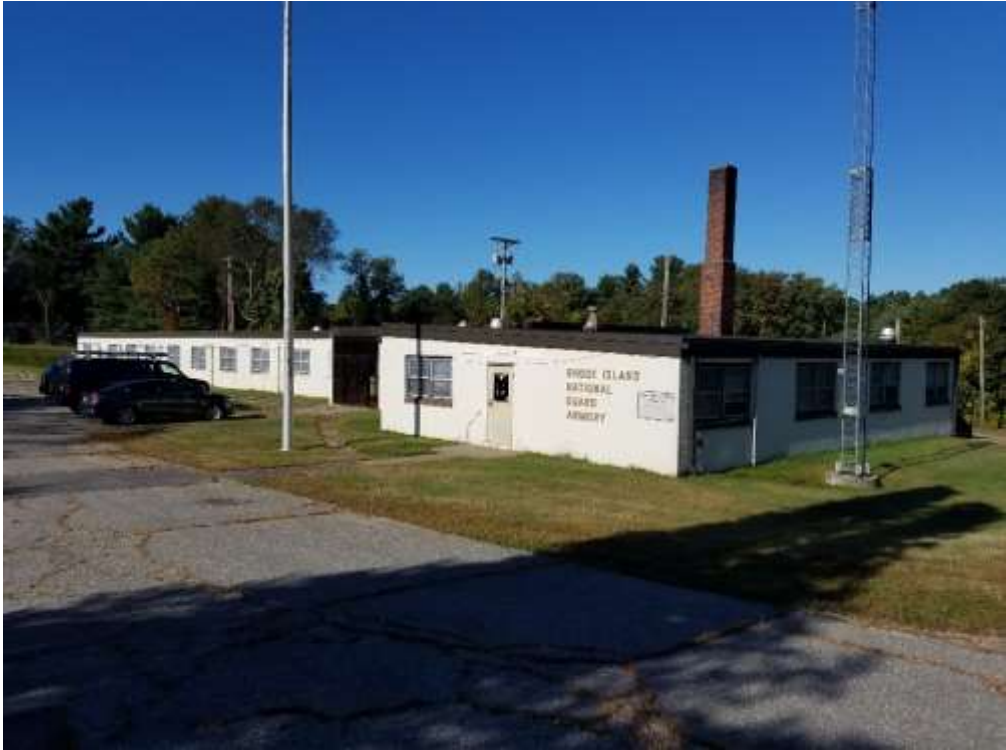
Army National Guard, Preliminary Assessment for PFAS	Former PR Nike Battery 99	North Smithfield, Rhode Island
<p>Photograph No. 01</p> <p>Date 9/25/2019 Time 9:22</p> <p>Description Armory Building (former Barracks and Mess Hall).</p> <p>Orientation: Northwest</p>

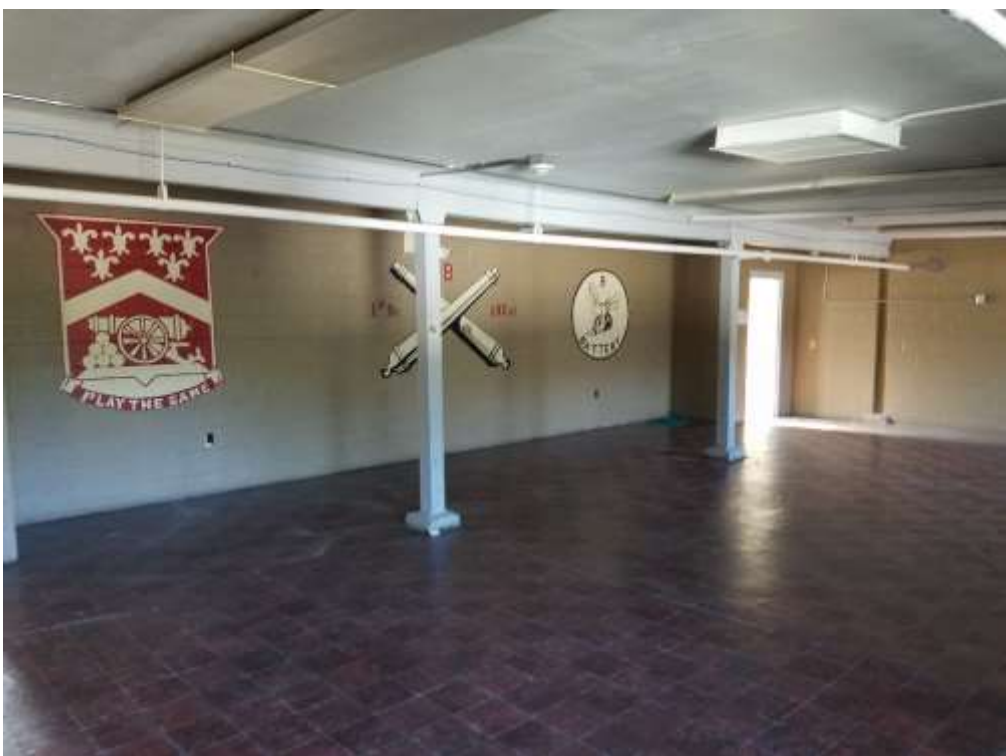
<p>Photograph No. 02</p> <p>Date 9/25/2019 Time 9:14</p> <p>Description Drill floor inside Armory Building.</p> <p>Orientation: Southwest</p>

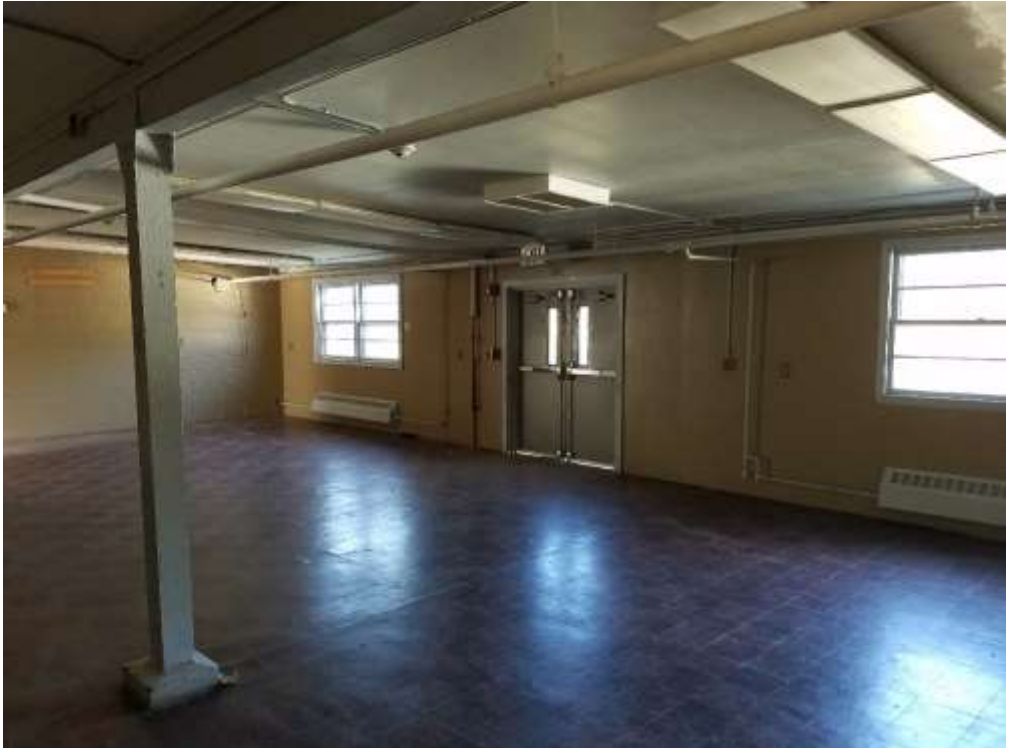
Army National Guard, Preliminary Assessment for PFAS		Former PR Nike Battery 99	North Smithfield, Rhode Island
Photograph No. 03

Date 9/25/2019			
Time 9:14			
Description Drill floor inside Armory Building.			
Orientation: Northwest			
Photograph No. 04

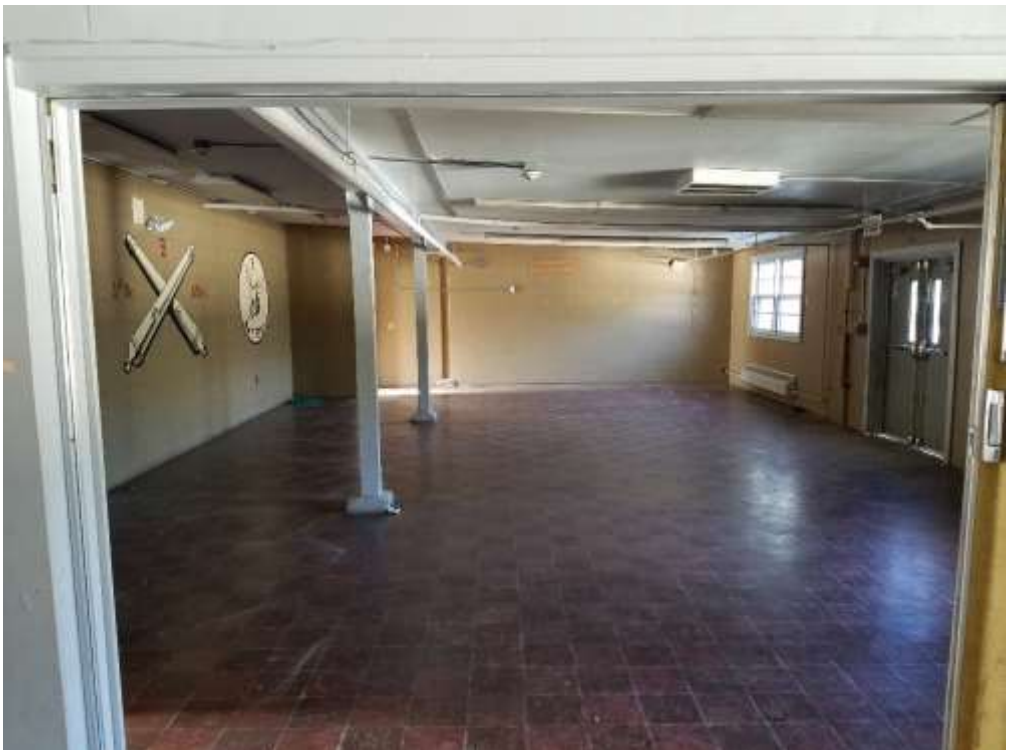
Date 9/25/2019			
Time 9:14			
Description Drill floor inside Armory Building.			
Orientation: West

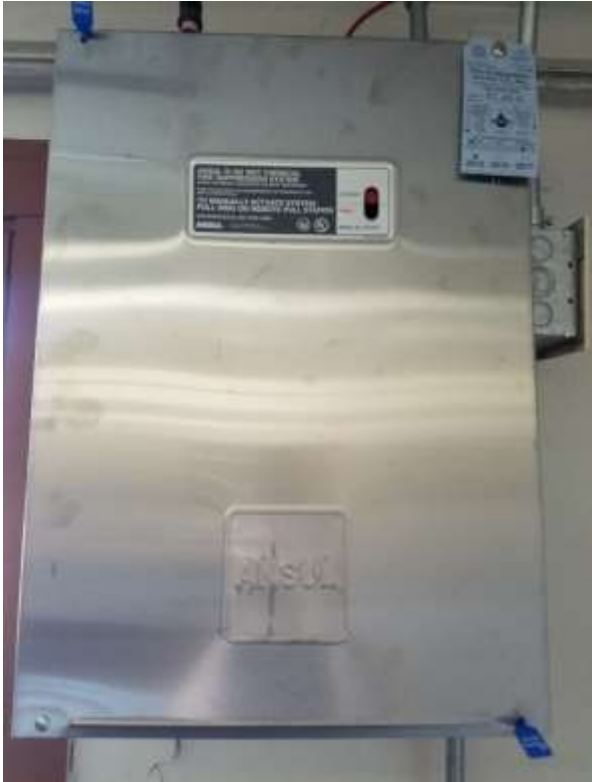
Army National Guard, Preliminary Assessment for PFAS	Former PR Nike Battery 99	North Smithfield, Rhode Island
<p>Photograph No. 05</p> <p>Date 9/25/2019 Time 9:15</p> <p>Description Ansul wet-fire suppression system associated with kitchen hood and cooking surface. Non-AFFF system.</p> <p>Orientation: North</p>

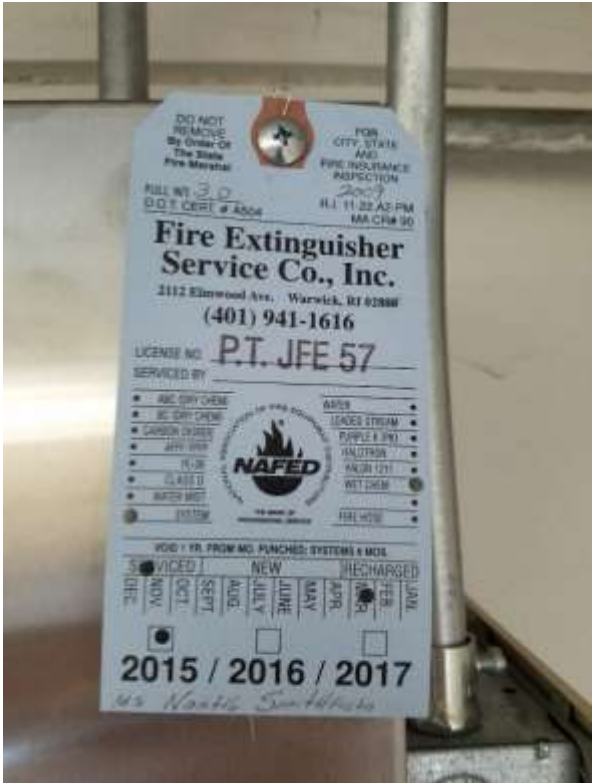
<p>Photograph No. 06</p> <p>Date 9/25/2019 Time 9:15</p> <p>Description Service tag for the kitchen wet-fire suppression system.</p> <p>Orientation: North</p>

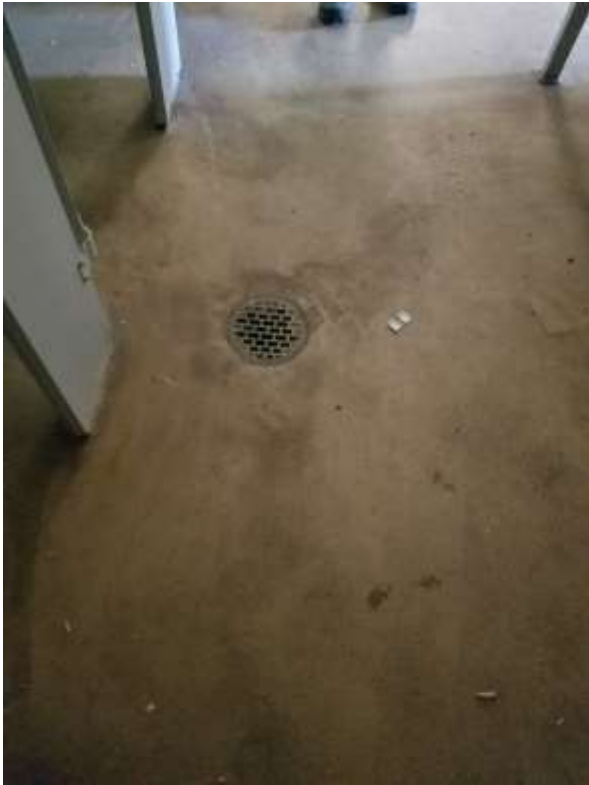
During the site walk, four floor drains were observed within two separate latrines within the Armory (**Appendix C**). These floor drains were located within the shower stalls and in the center of the latrines between the sinks and toilets. First-hand accounts of day-to-day activities at the Former PR Nike Battery 99 were not found prior to or after the site visits. As a result, specific information regarding the use of floor polish and cleaning solution disposal is not known at the Site. It has been documented that some floor polishes contain PFAS (Interstate Technology Regulatory Council [ITRC], 2017); however, this cannot be substantiated without a Safety Data Sheet (SDS) or other documentation.

Appendix C - Photographic Log		
Army National Guard, Preliminary Assessment for PFAS	Former PR Nike Battery 99	North Smithfield, Rhode Island
Photograph No. 07 Date 9/25/2019 Time 9:17 Description Example of floor drain in latrines. Several other similar floor drains were located in each latrine. Orientation: West

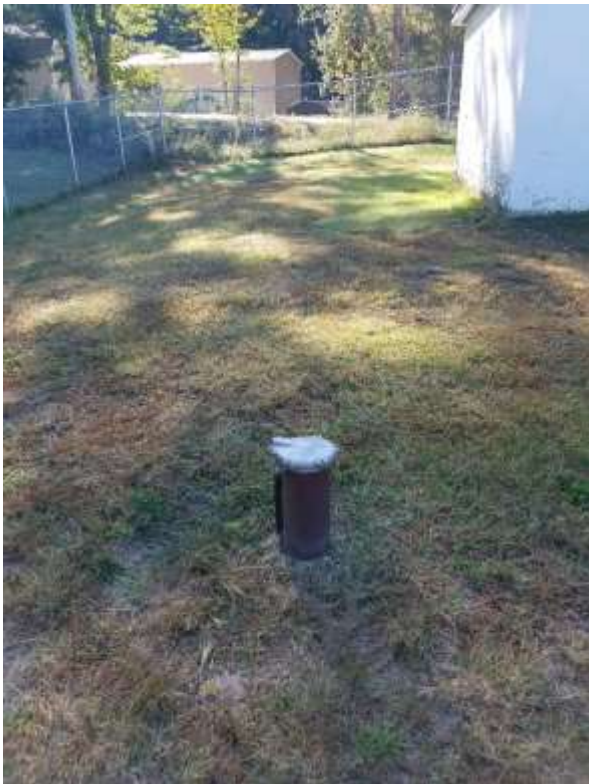
Photograph No. 08 Date 9/25/2019 Time 9:21 Description Wellhead for Site drinking water well. Orientation: South

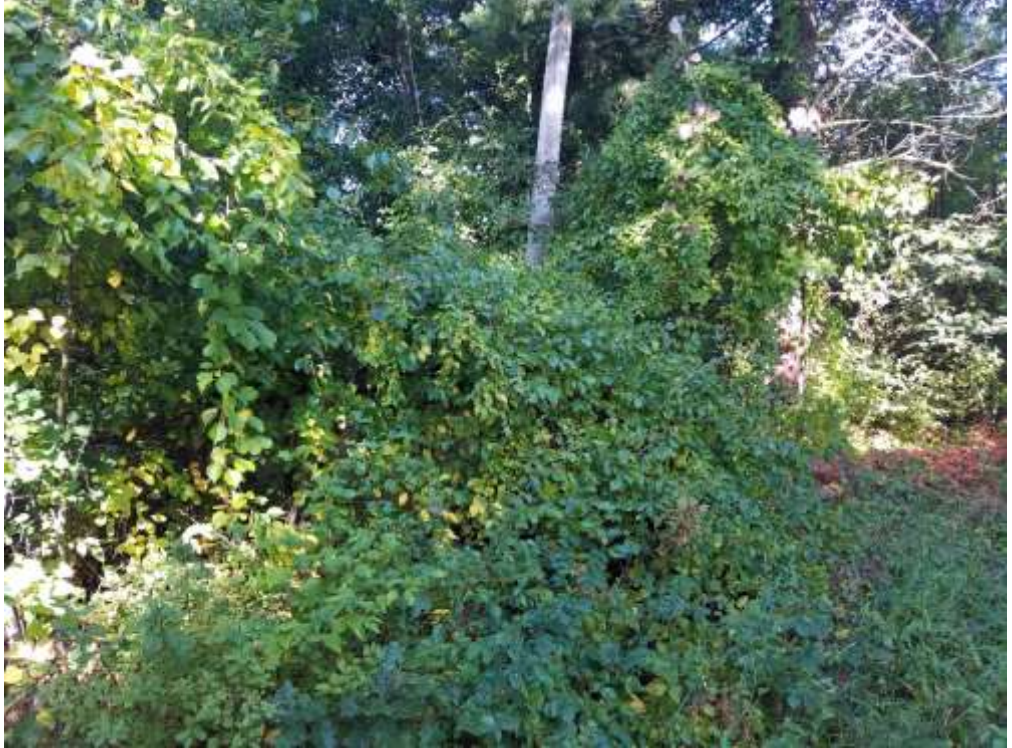
Date 9/25/2019 Time 9:32			
Description Approximate location of the former distribution box and start of the former leach field. The direction of effluent flow would have been into the picture.			
Orientation: Northwest			
Photograph No. 10

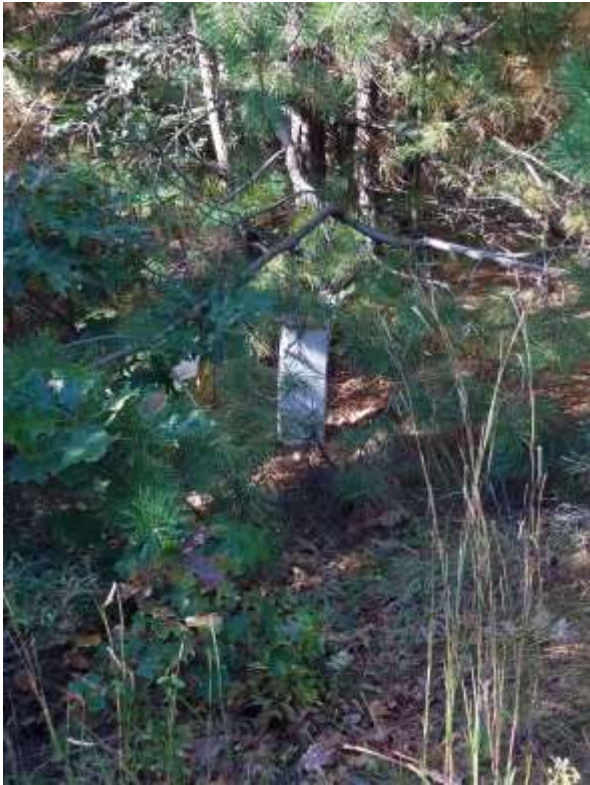
Date 9/25/2019 Time 9:40			
Description Site monitoring well MW-1.			
Orientation: West

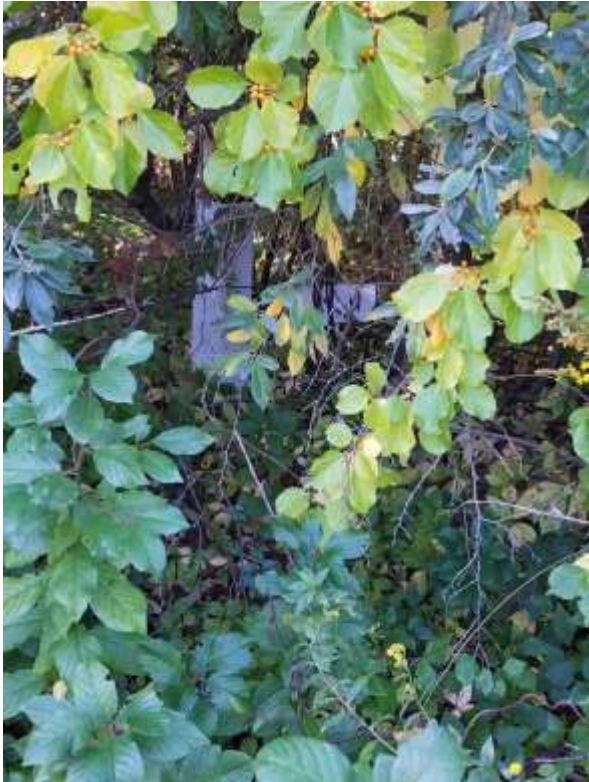
Army National Guard, Preliminary Assessment for PFAS		Former PR Nike Battery 99	North Smithfield, Rhode Island
Photograph No. 11 Date 9/25/2019 Time 9:50 Description Site monitoring well MW-2.

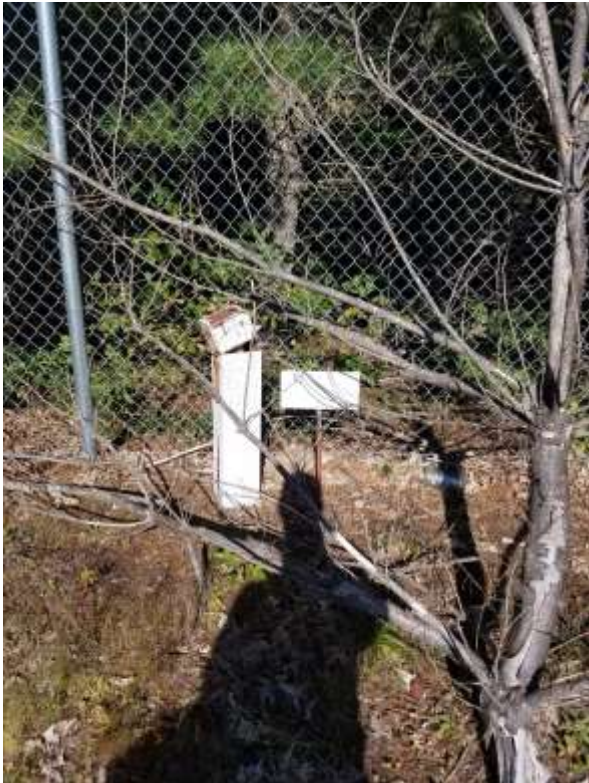
Orientation: North			
Photograph No. 12 Date 9/25/2019 Time 10:00 Description Site monitoring well MW-3.
