FINAL Preliminary Assessment Report McCrady Training Center, Eastover, South Carolina

Perfluorooctanesulfonic acid (PFOS) and Perfluorooctanoic Acid
(PFOA) Impacted Sites
ARNG Installations, Nationwide

October 2020

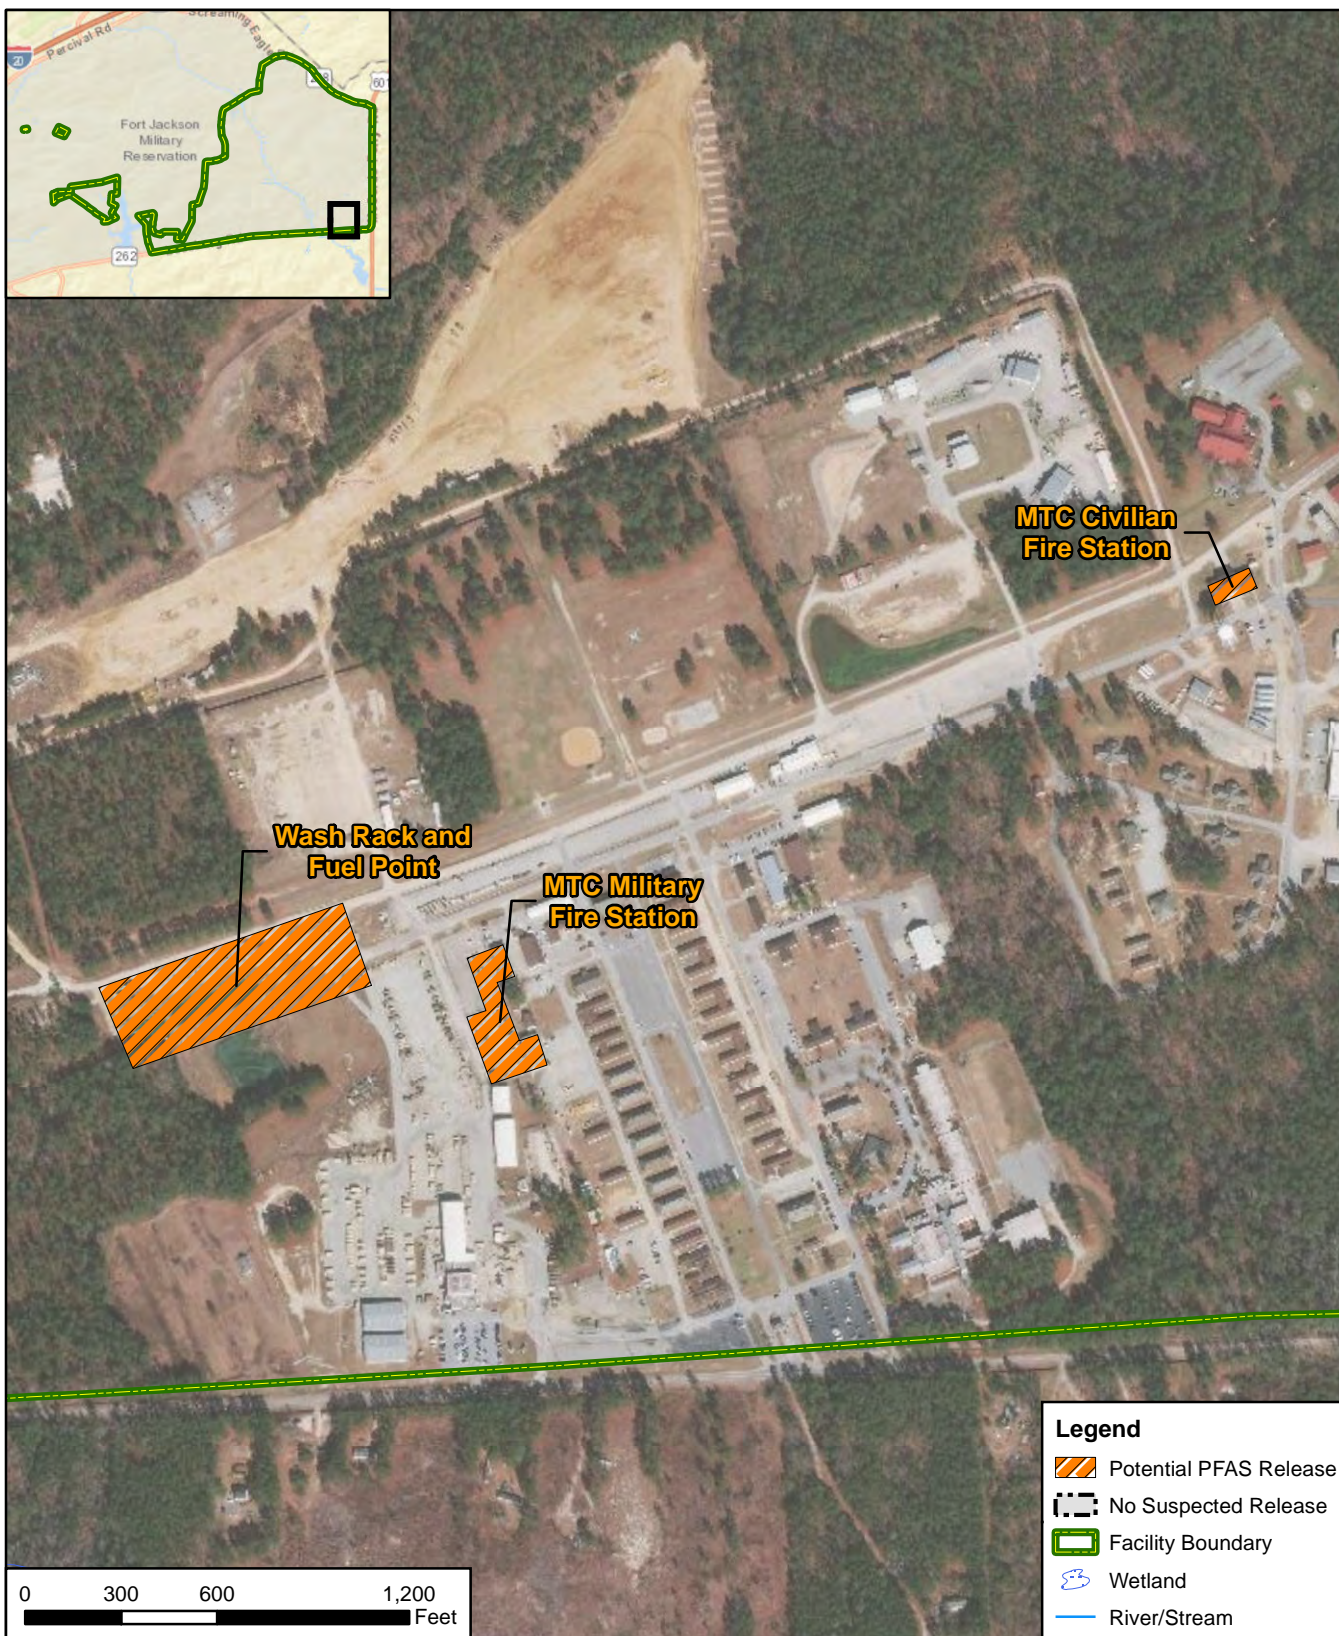
Non-Fire Training Areas	
Preliminary Assessment for PFAS at McCrady Training Center, SC

In addition to FTAs, the PA evaluated areas where PFAS-containing materials may have been broadly used, stored, or disposed. This may include buildings with fire suppression systems, paint booths, AFFF storage areas, and areas of compliance demonstrations. Information on these features obtained during the PA are included in **Appendices A and B**. Three non-FTAs where AFFF was stored and/or potentially released were identified during the PA. A description of each non-FTA is presented below, and the non-FTAs are shown on **Figure 3-1**.
