Preliminary Assessment Report

Army Aviation Support Facility Upstate, Greenville, South Carolina

Perfluorooctanesulfonic Acid (PFOS) and Perfluorooctanoic Acid
(PFOA) Impacted Sites
ARNG Installations, Nationwide

October 2020

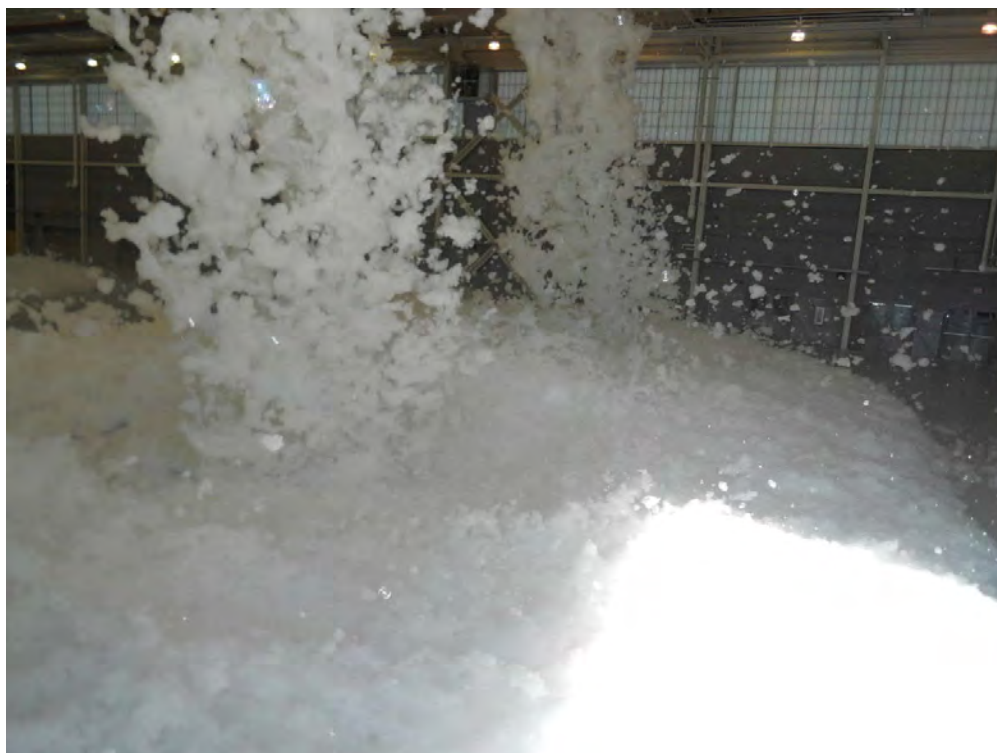
Photograph No. 2

Photo of the AASF Upstate
fire suppression system
testing.
