Site Inspection Report

Rapid City Army Aviation Support Facility

Site Inspection for Perfluorooctanoic Acid (PFOA), Perfluorooctanesulfonic Acid (PFOS), Perfluorohexanesulfonic Acid (PFHxS), Perfluorononanoic Acid (PFNA), Hexafluoropropylene Oxide Dimer Acid (HFPO-DA), and Perfluorobutanesulfonic Acid (PFBS)
ARNG Installations, Nationwide

October 2023

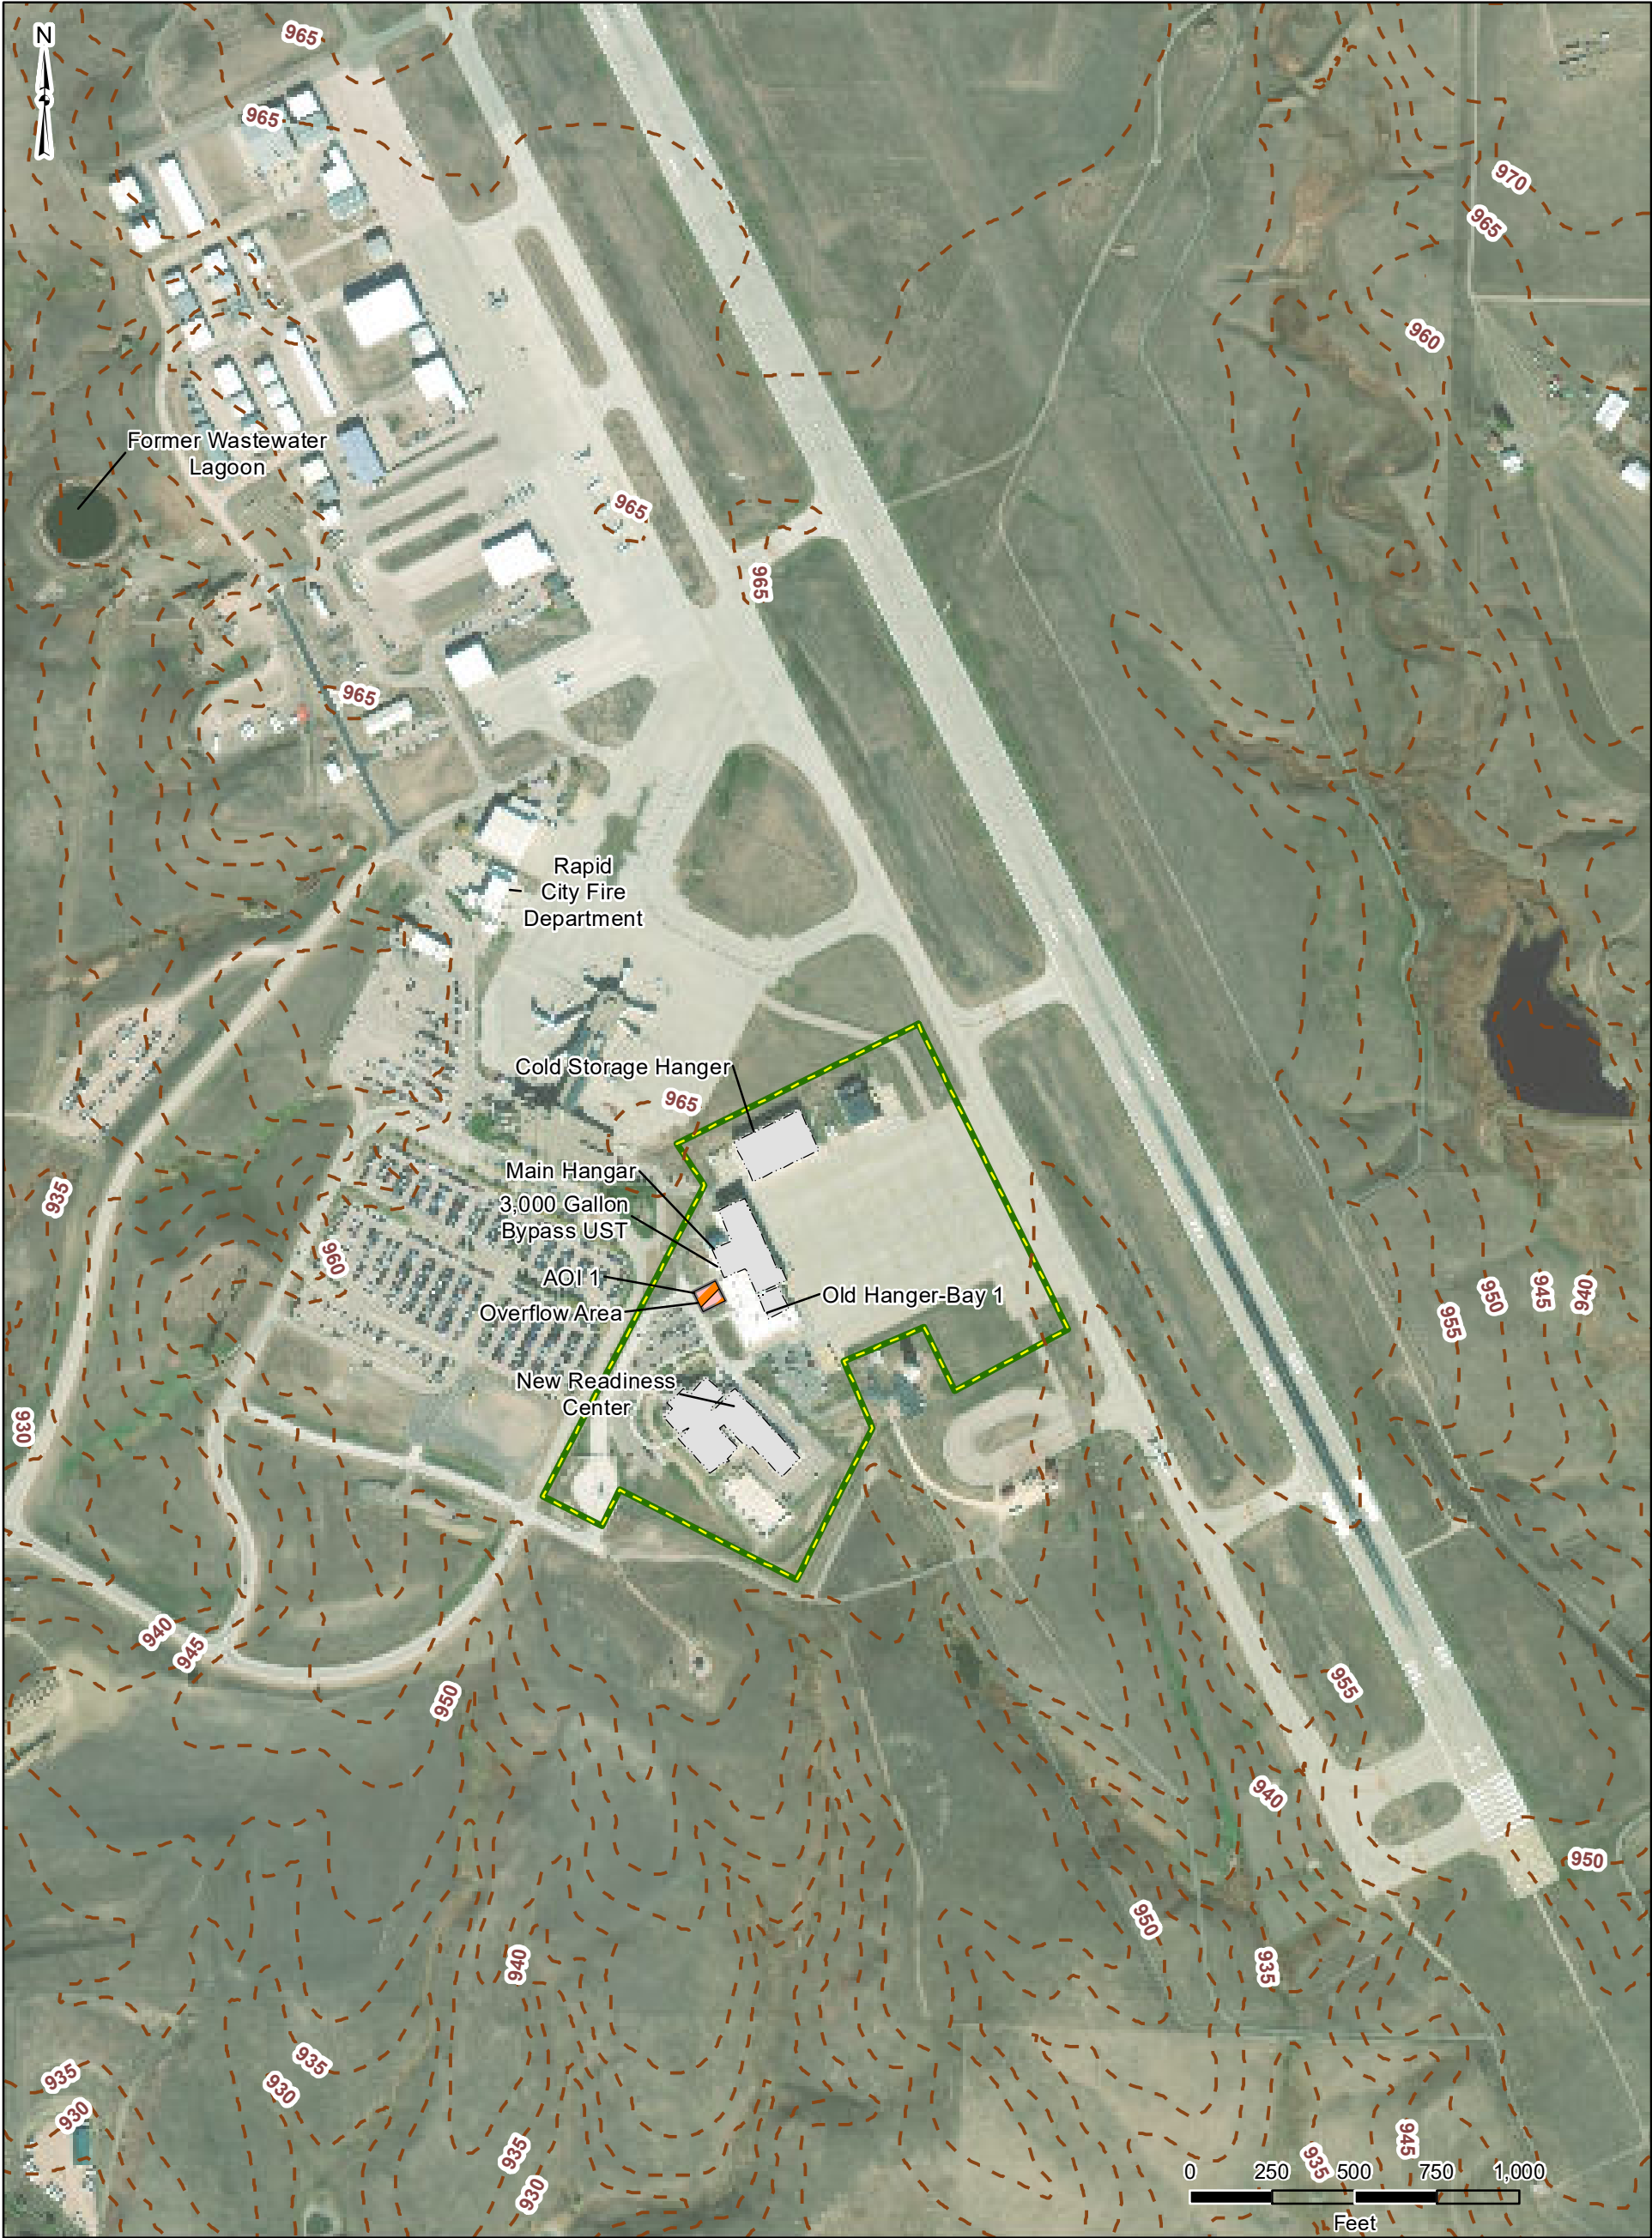
Figure 2-2
Facility Topography

The Rapid City AASF lies within the Black Hills regions, which is characterized as an isolated eroded mountain region; ancient rock removal by stream erosion produces this mountain setting. From a distance, the rounded hilltops, well-forested slopes, and deep valleys present a dark appearance, giving them their name. Rapid Creek is the main stream channel near the Facility (AECOM, 2020). The topography at the Site is shown on **Figure 2-2**.

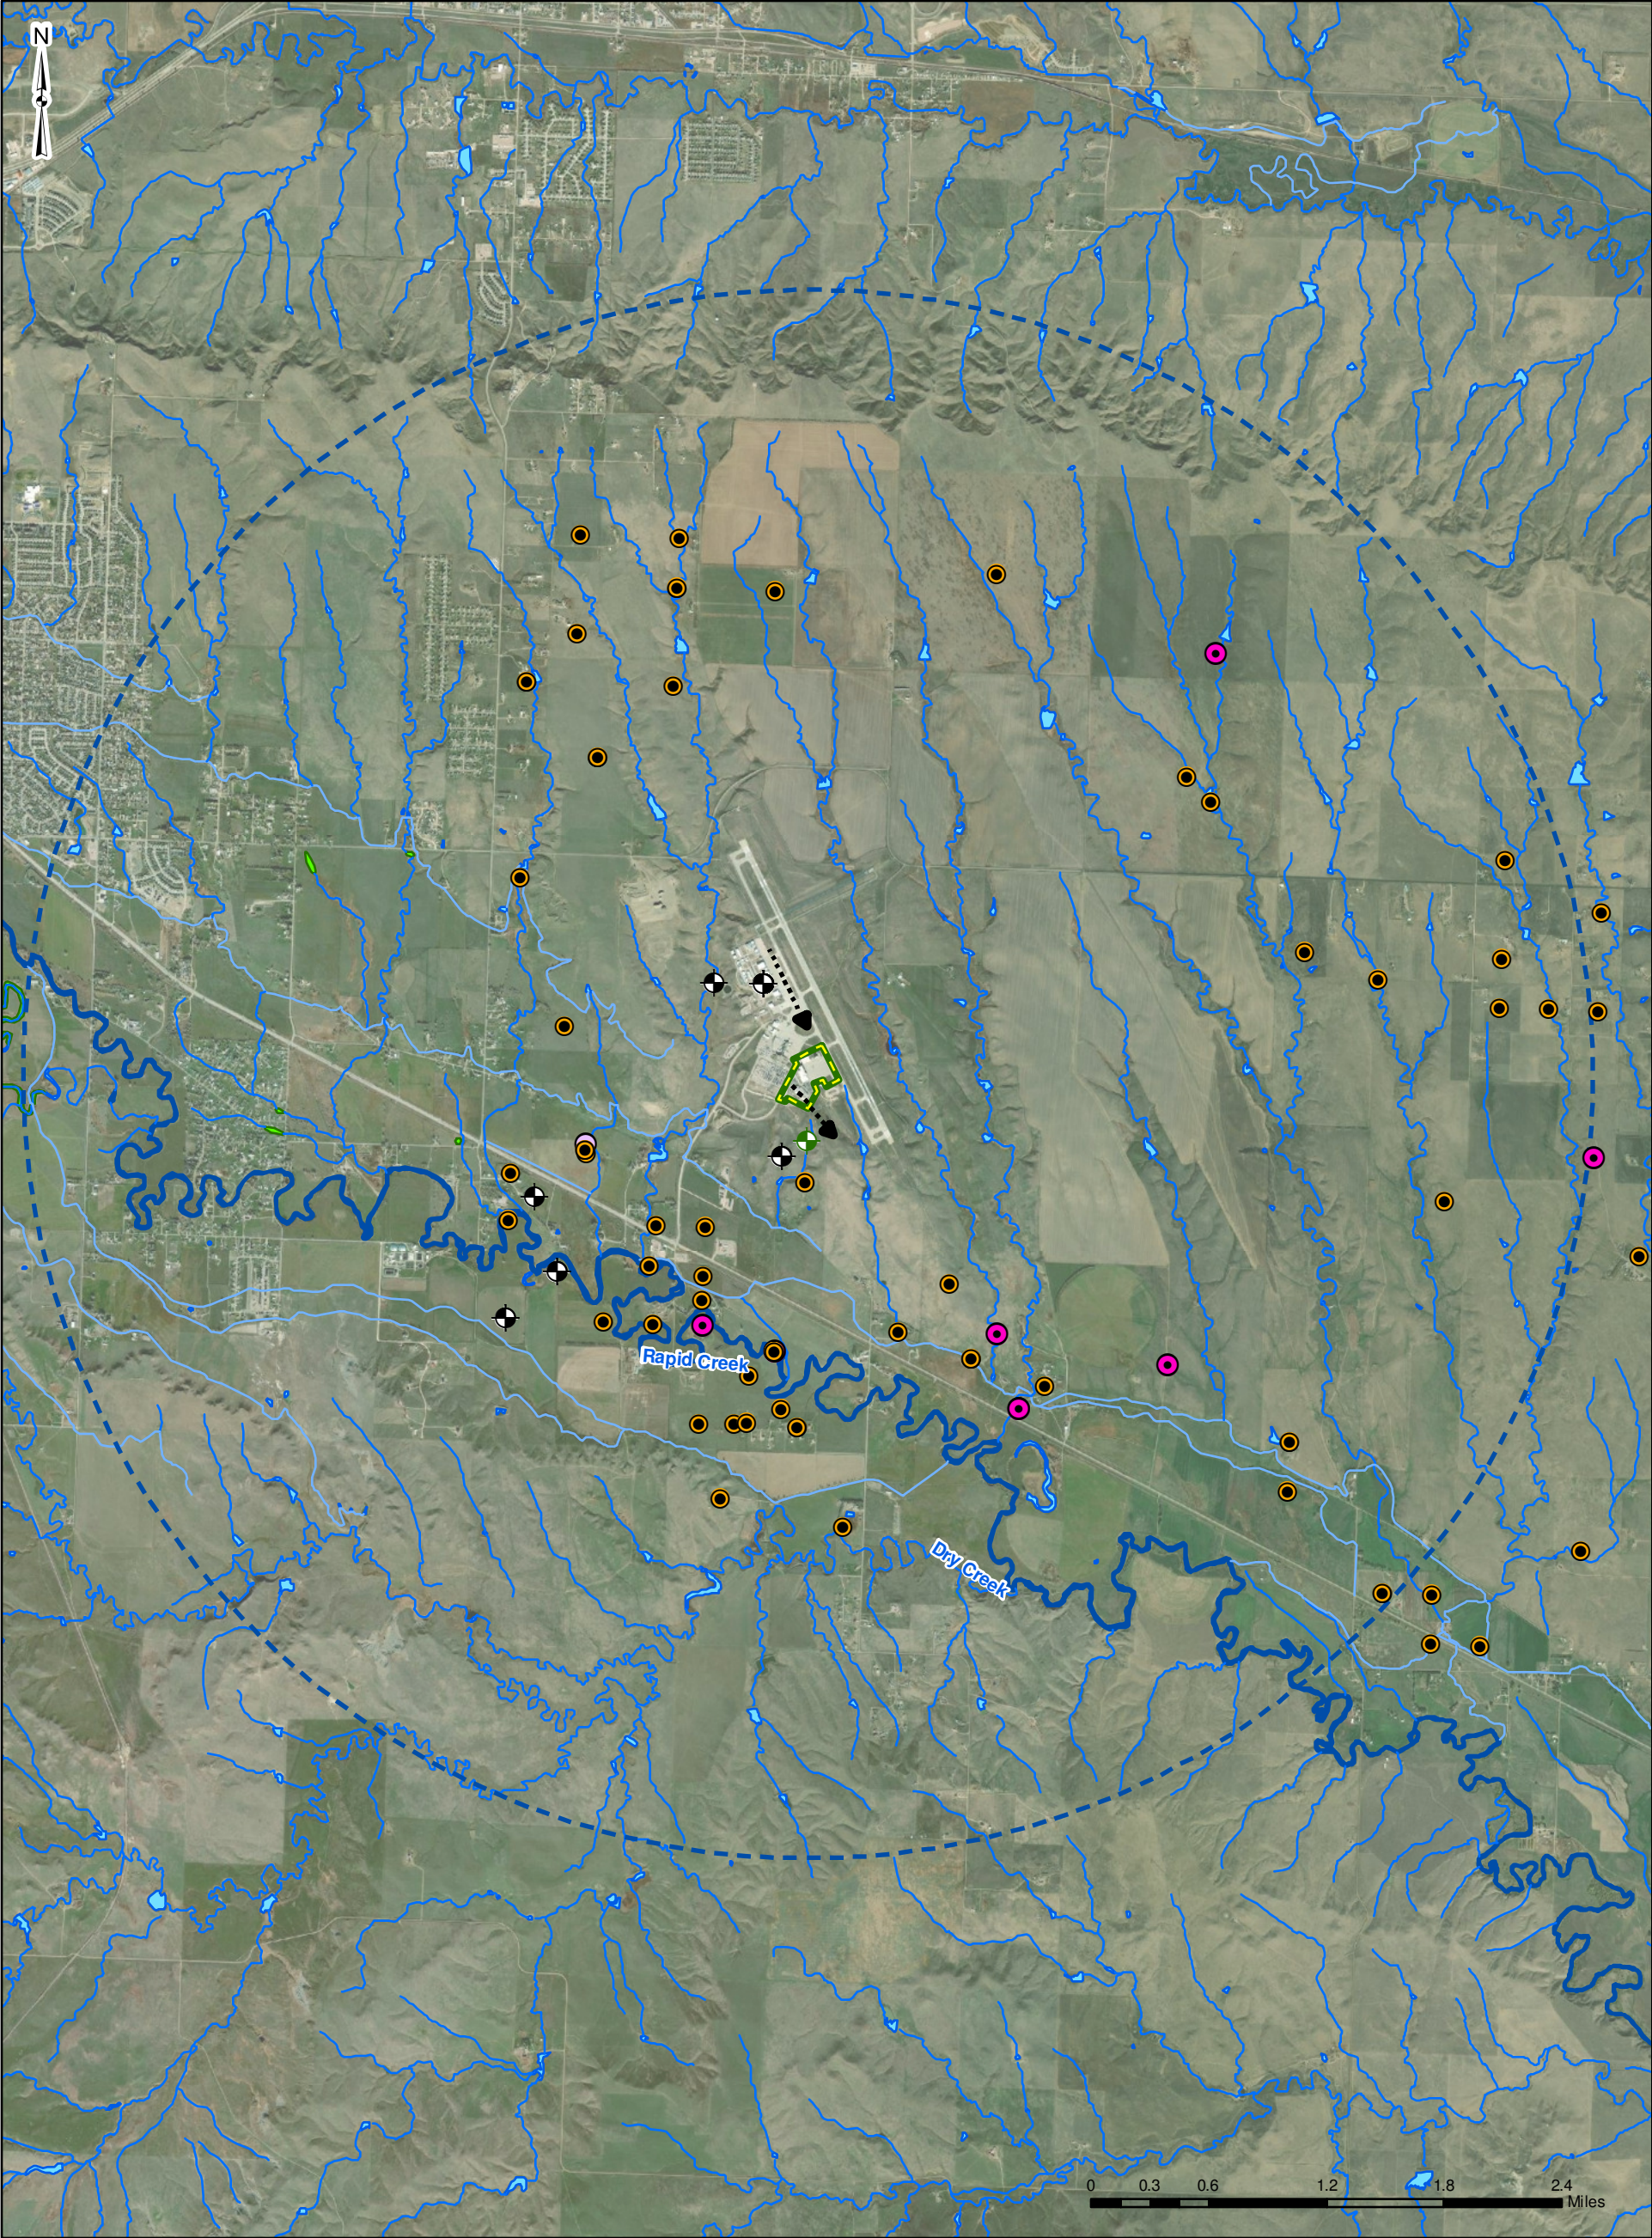
Figure 2-3
Groundwater Features

Based on synoptic water level measurements taken from temporary wells during the SI fieldwork (see **Section 5.4**), groundwater flows toward the southeast (shown in **Figure 2-5**). No potable water wells are located within the boundary of the Facility. An Environmental Data Resources, Inc. (EDR™) report conducted a well search for a 1-mile radius surrounding the Facility. Using additional online resources, such as state and local geographic information system (GIS) databases, wells were researched to a 4-mile radius of the Facility (AECOM, 2020). From a review of the South Dakota Department of Agriculture and Natural Resources (SD DANR) Water Well Completion Reports online database, there are monitoring wells, and numerous domestic and irrigation wells located downgradient of the Facility within 1 to 2 miles (SD DANR, 2022) (**Figure 2-3**).

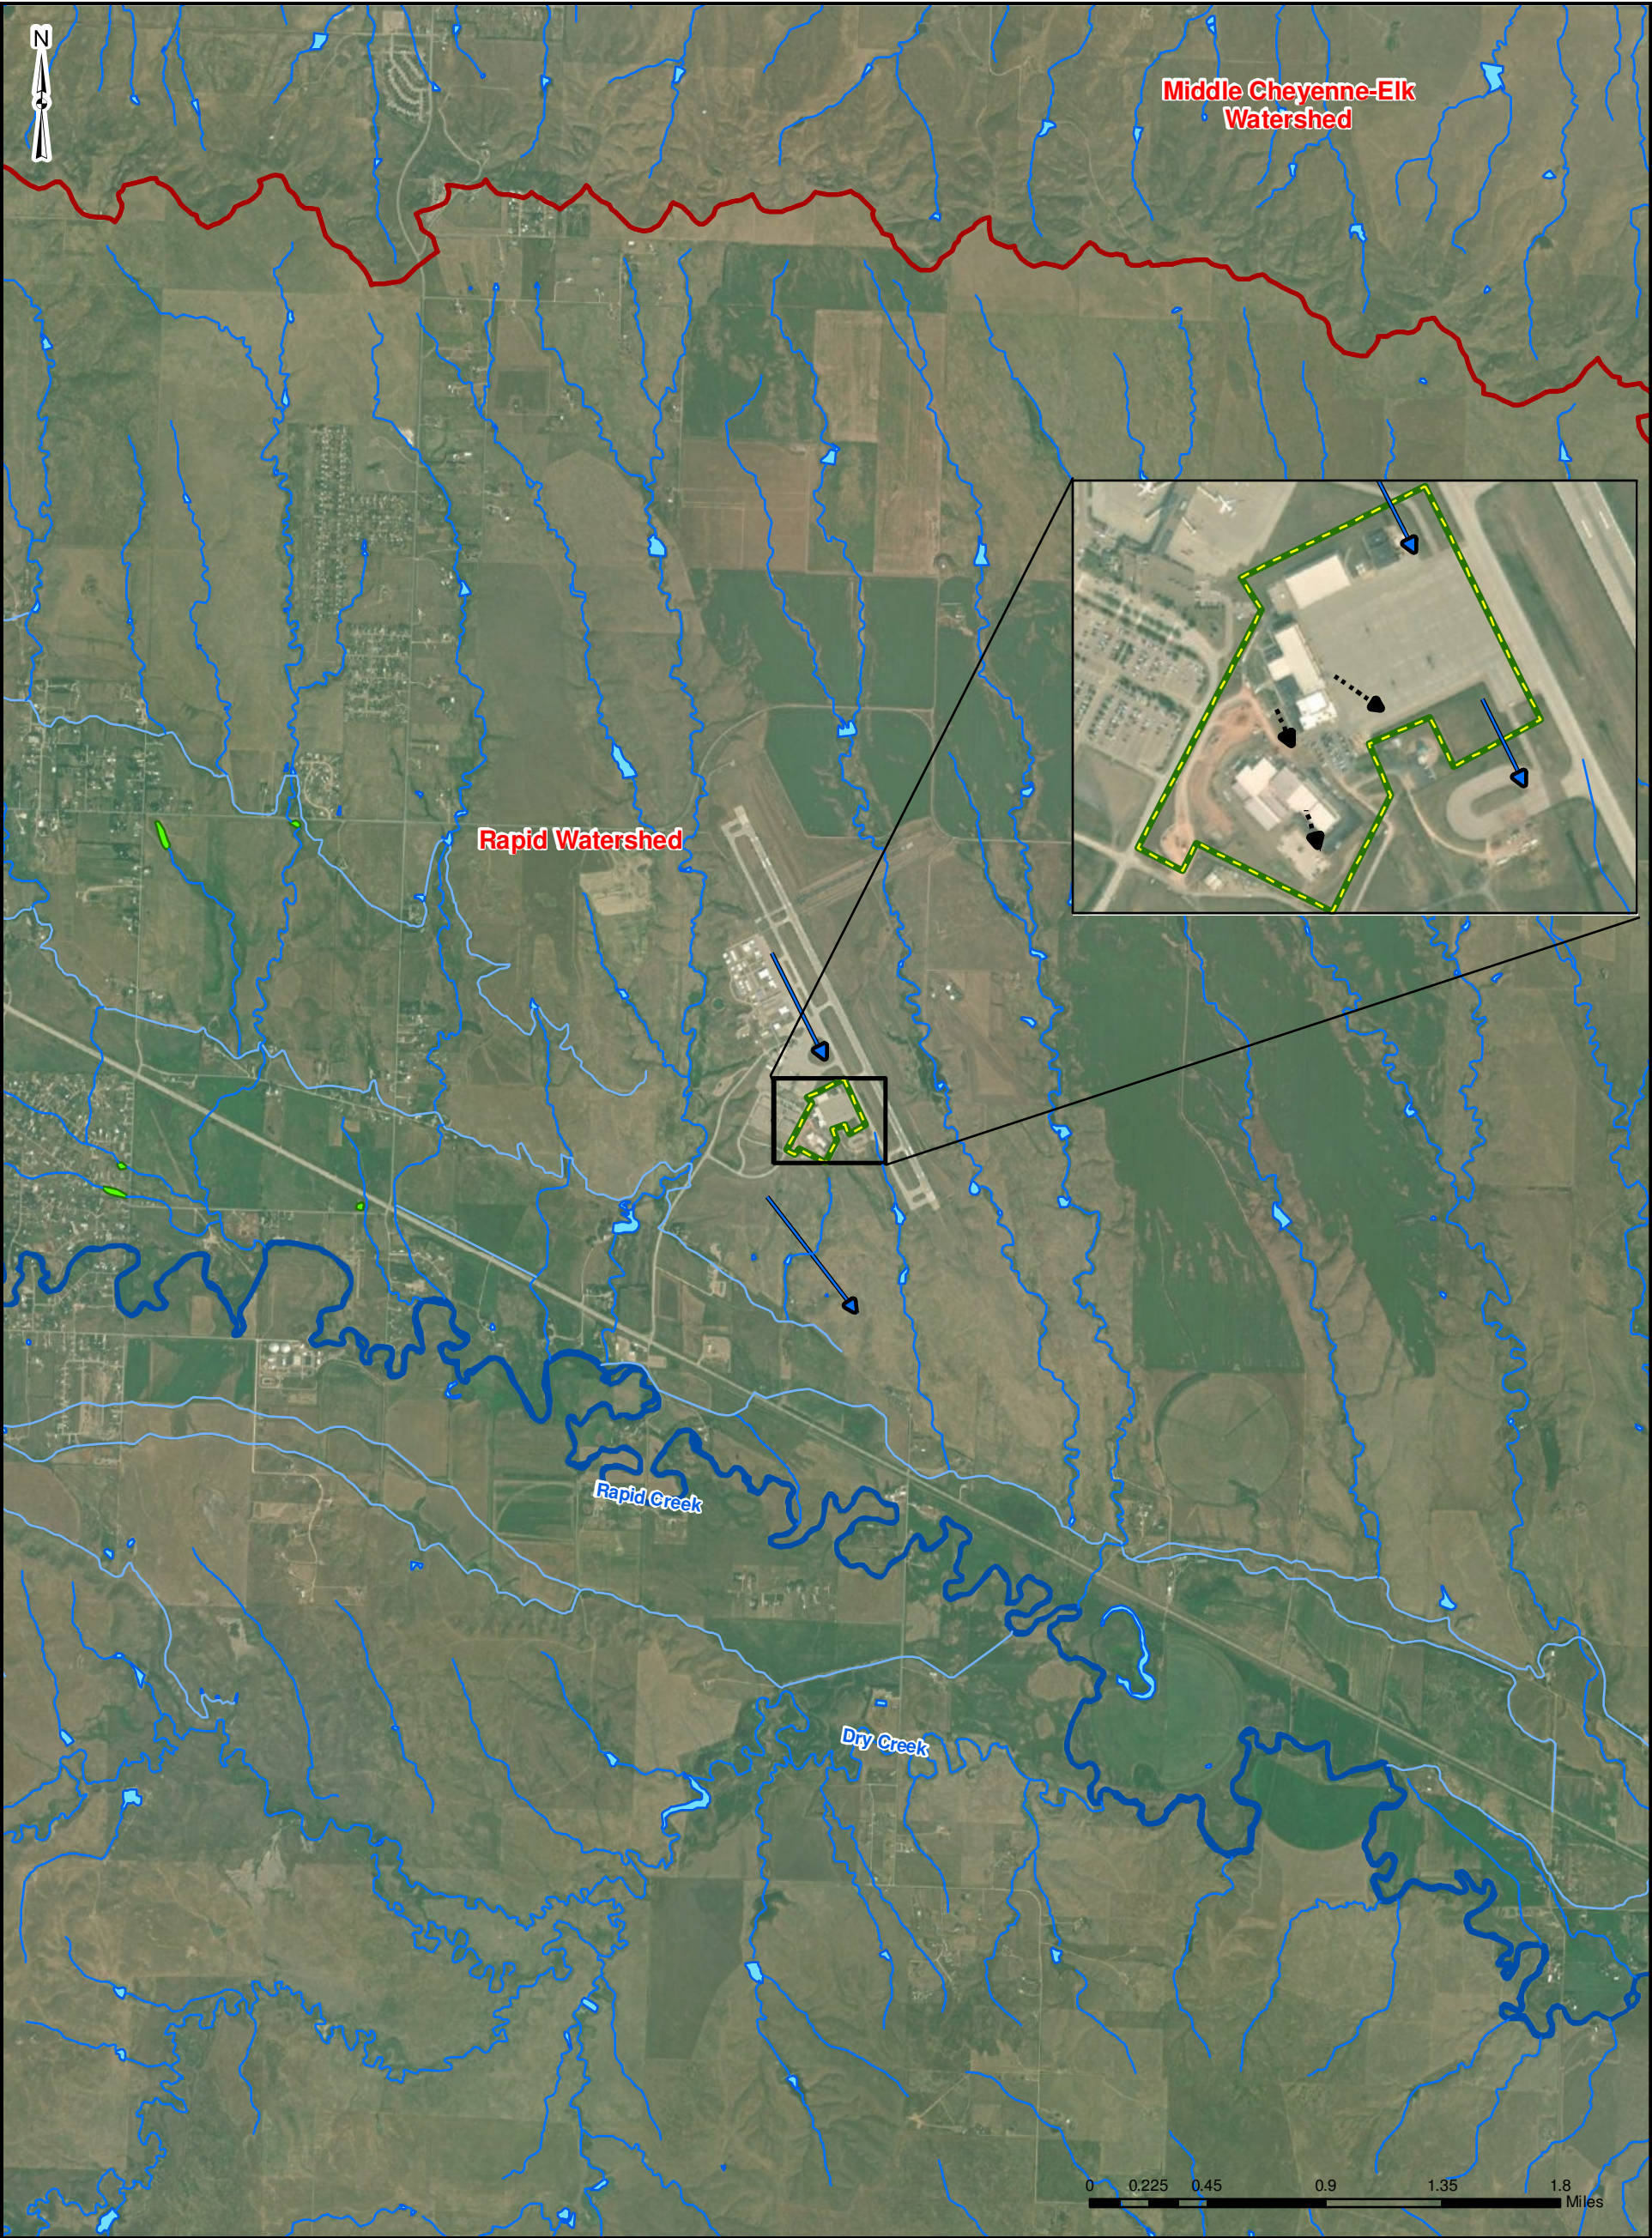
Figure 2-4
Surface Water Features

rocks. These steams generally flow eastward (USGS, 2002; AECOM, 2020). The Facility is located in the Rapid Creek Basin and surface water at the Facility flows south to southeast to unnamed tributaries of Rapid Creek as presented on **Figure 2-4**.
