# FINAL Site Inspection Report Army Aviation Support Facility #2 Louisville, Tennessee

Site Inspection for Perfluorooctanoic acid (PFOA),  
Perfluorooctanesulfonic acid (PFOS), Perfluorohexanesulfonic  
acid (PFHxS), Perfluorononanoic acid (PFNA),  
Hexafluoropropylene oxide dimer acid (HFPO-DA), and  
Perfluorobutanesulfonic acid (PFBS) at ARNG Installations,  
Nationwide

April 2023

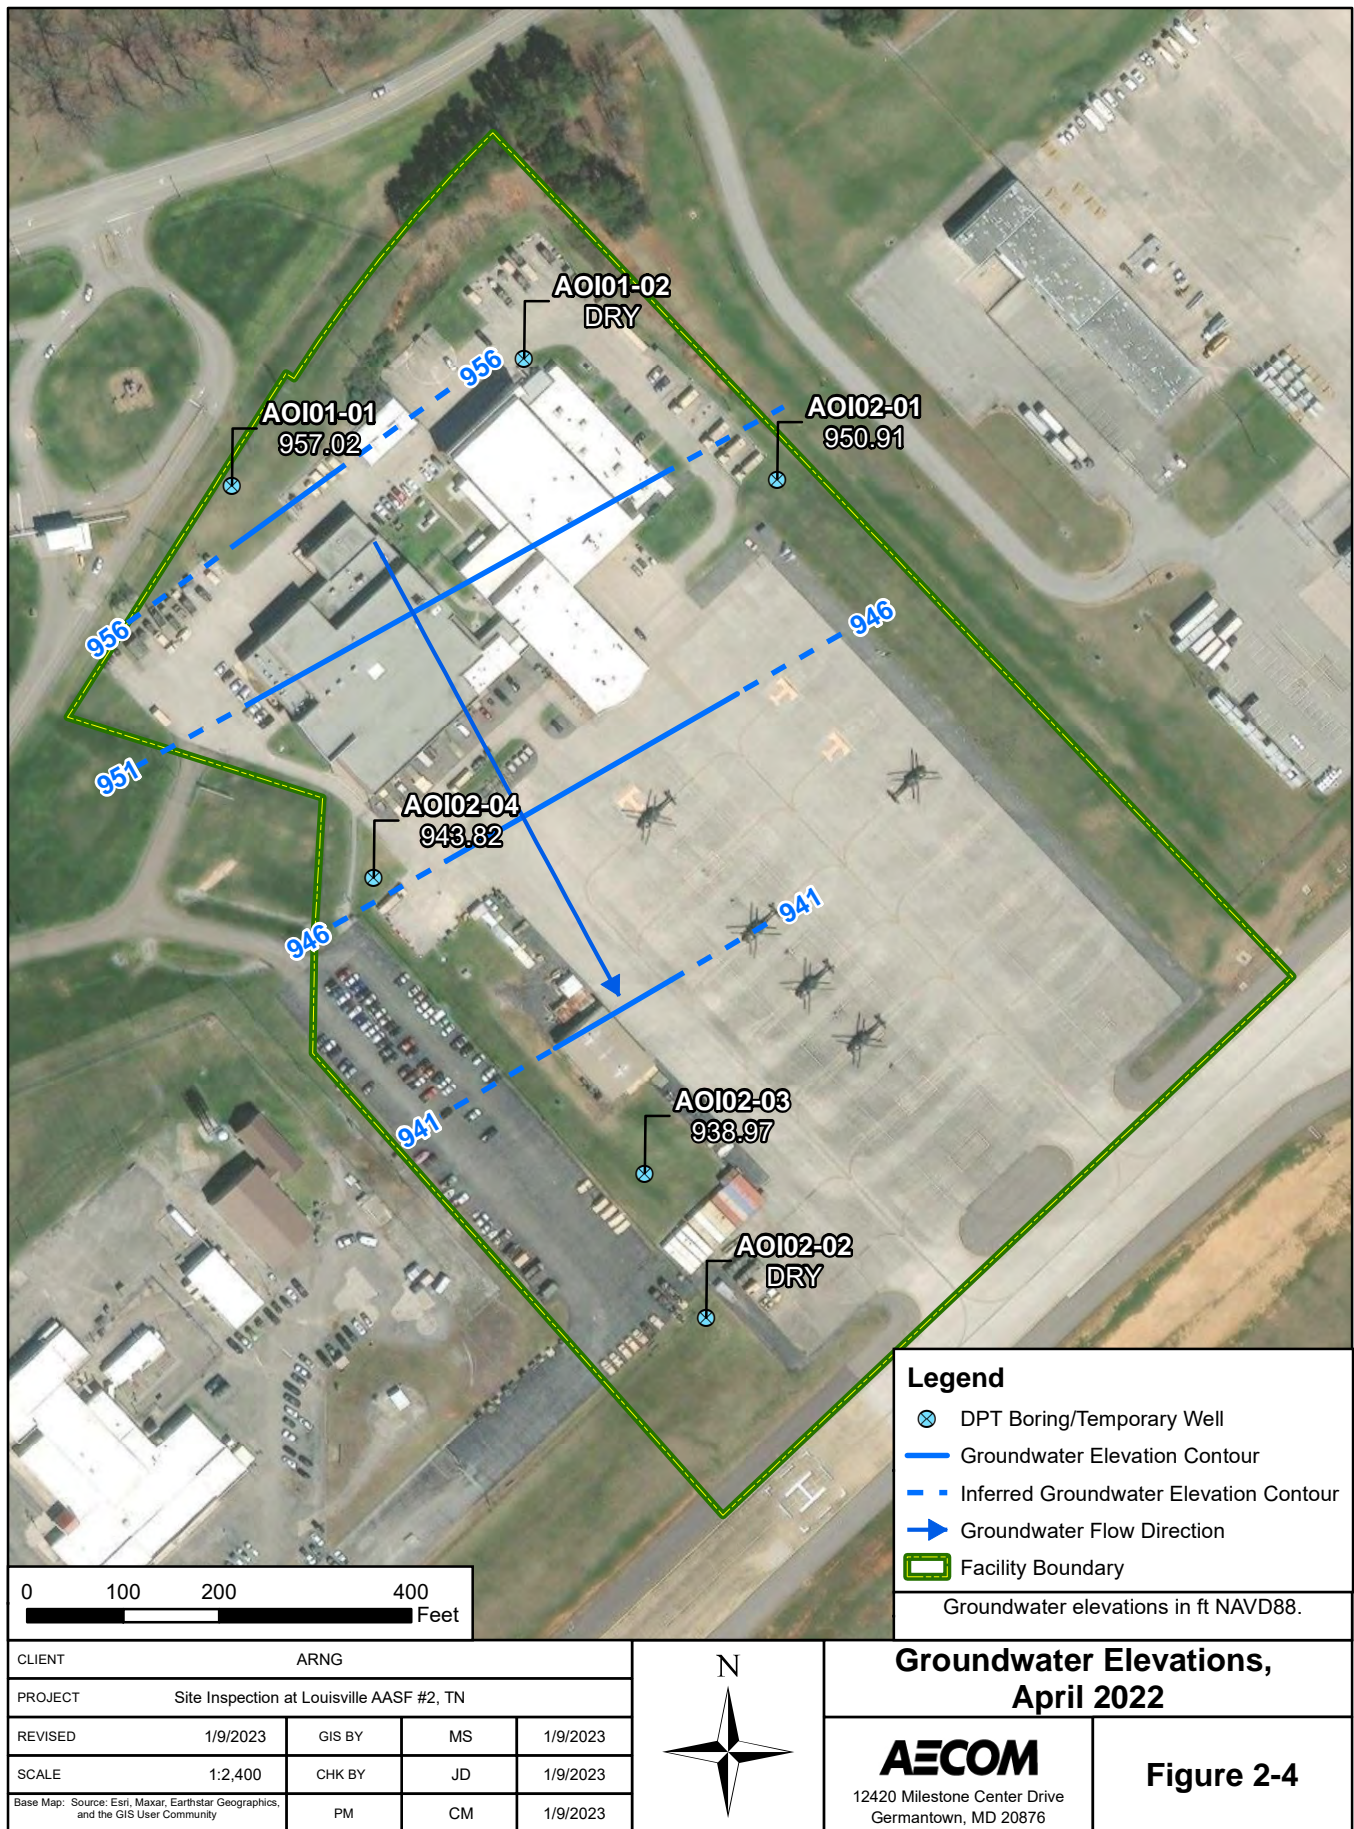
| 70 | Figure 2-3 | Groundwater Features |

AASF #2 is underlain primarily by Dewey silty clay and loam and Linside silt loam soils, which derived from the carbonate bedrock (US Department of Agriculture [USDA], 2019). The bedrock is Cambrian/Ordovician age Knox Group, which is primarily composed of limestone and dolomite (**Figure 2-3**). The Chepultepec dolomite, which is lower Ordovician in age and is derived from the larger Knox Group, is the primary bedrock type. The dolomite is characterized as light-gray to light olive-gray and mostly fine-grained; white, oolitic, chert nodules are present in some beds (Hardeman et al., 1966). The Ordovician Knox Group carbonates underneath the facility are weathered along bedding planes and joints. Weathering has produced an undulated and pinnaced (karst) bedrock surface (US Geological Survey [USGS], 2018).

A query of Tennessee Department of Environment and Conservation (TDEC) water well database was performed by Environmental Data Resources, Inc.<sup>™</sup> (EDR<sup>™</sup>). Using additional online resources, such as state and local Geographic Information System databases, approximately 210 water supply well locations are reported to fall within the 4-mile radius of the facility (TDEC, 2020). The water supply well uses include commercial, farm, heat pump, industrial, irrigation, and residential. The total depth of the wells range from 20 to 825 feet. Residential and commercial wells range in total depth from 75 to 825 feet. Refer to **Figure 2-3** for proximity of water supply wells to the facility.

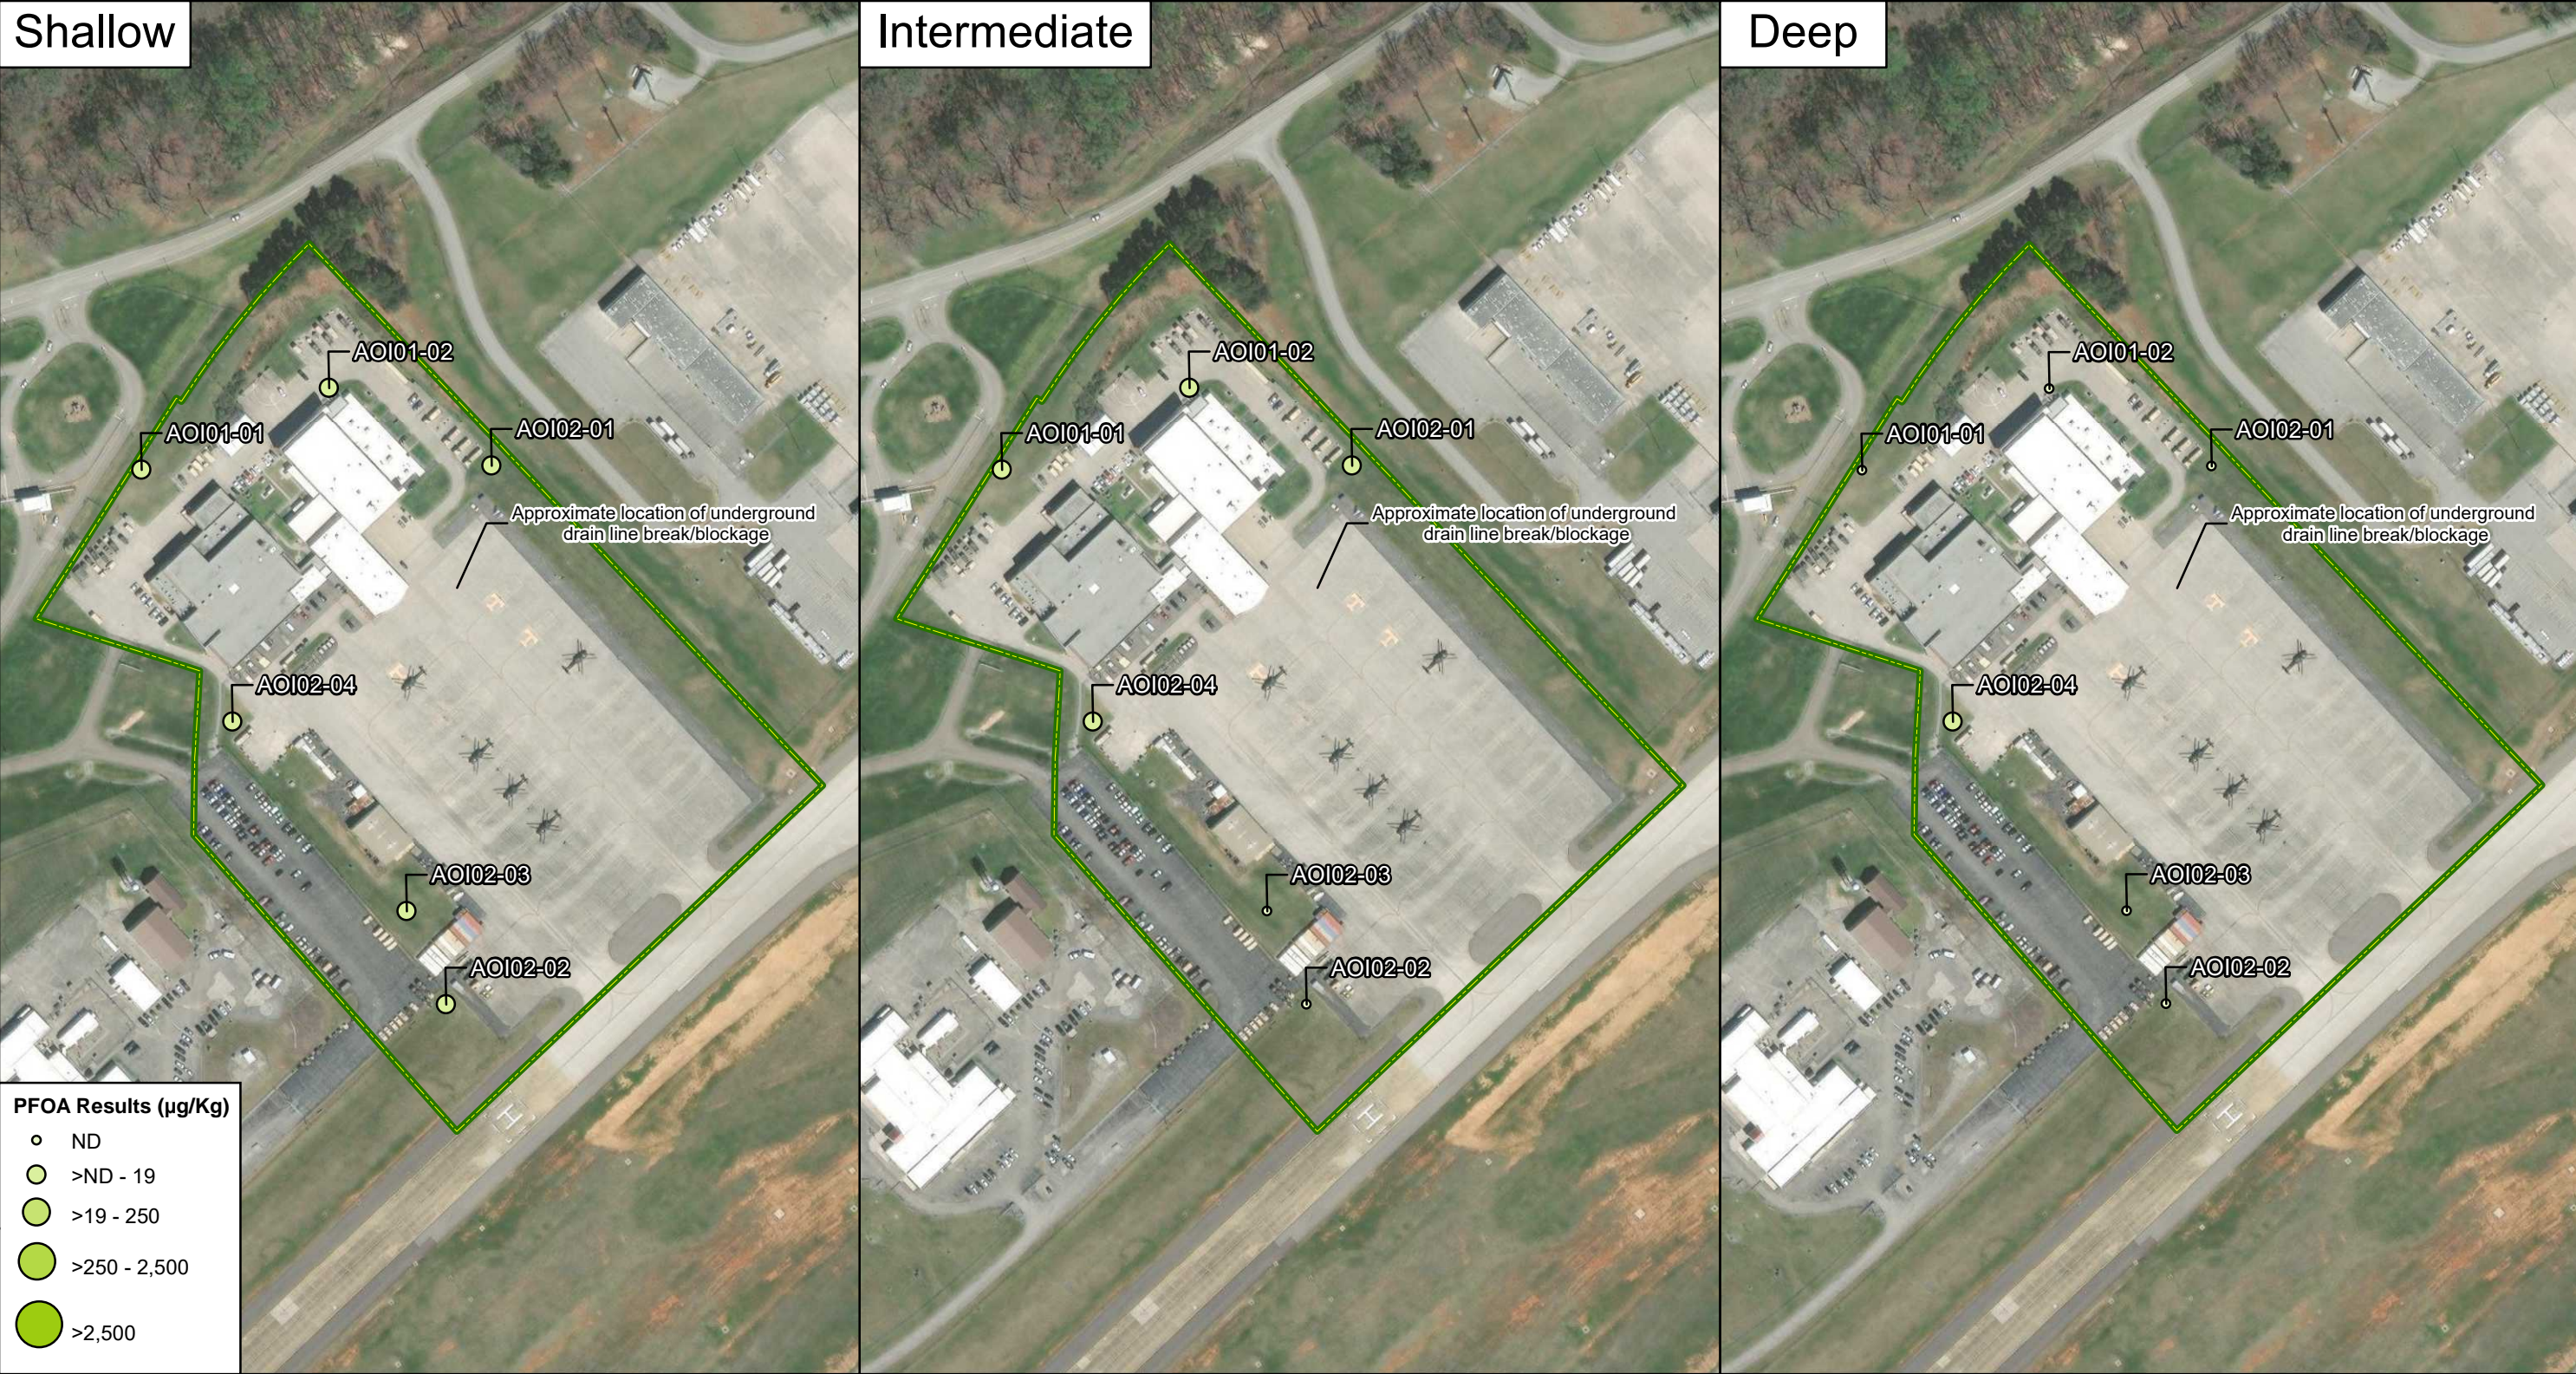
| PROJECT Site Inspection at Louisville AASF #2, TN | | | | | | <div><div><div>AECOM</div><div>12420 Milestone Center Drive<br/>Germantown, MD 20876</div></div><div>Figure 6-1</div></div> | | |

| CLIENT ARNG | | | | | <div>Legend</div> <div><div><div></div></div> Facility Boundary</div> <div>0135270540<br/>Feet</div> <div><div>N</div><div></div></div> <div>Exceedances of the OSD SL are depicted with a yellow halo.<br/>Depth intervals shown represent respective sampling position within a given soil boring location.</div> | PFOA Detections in Soil | | |

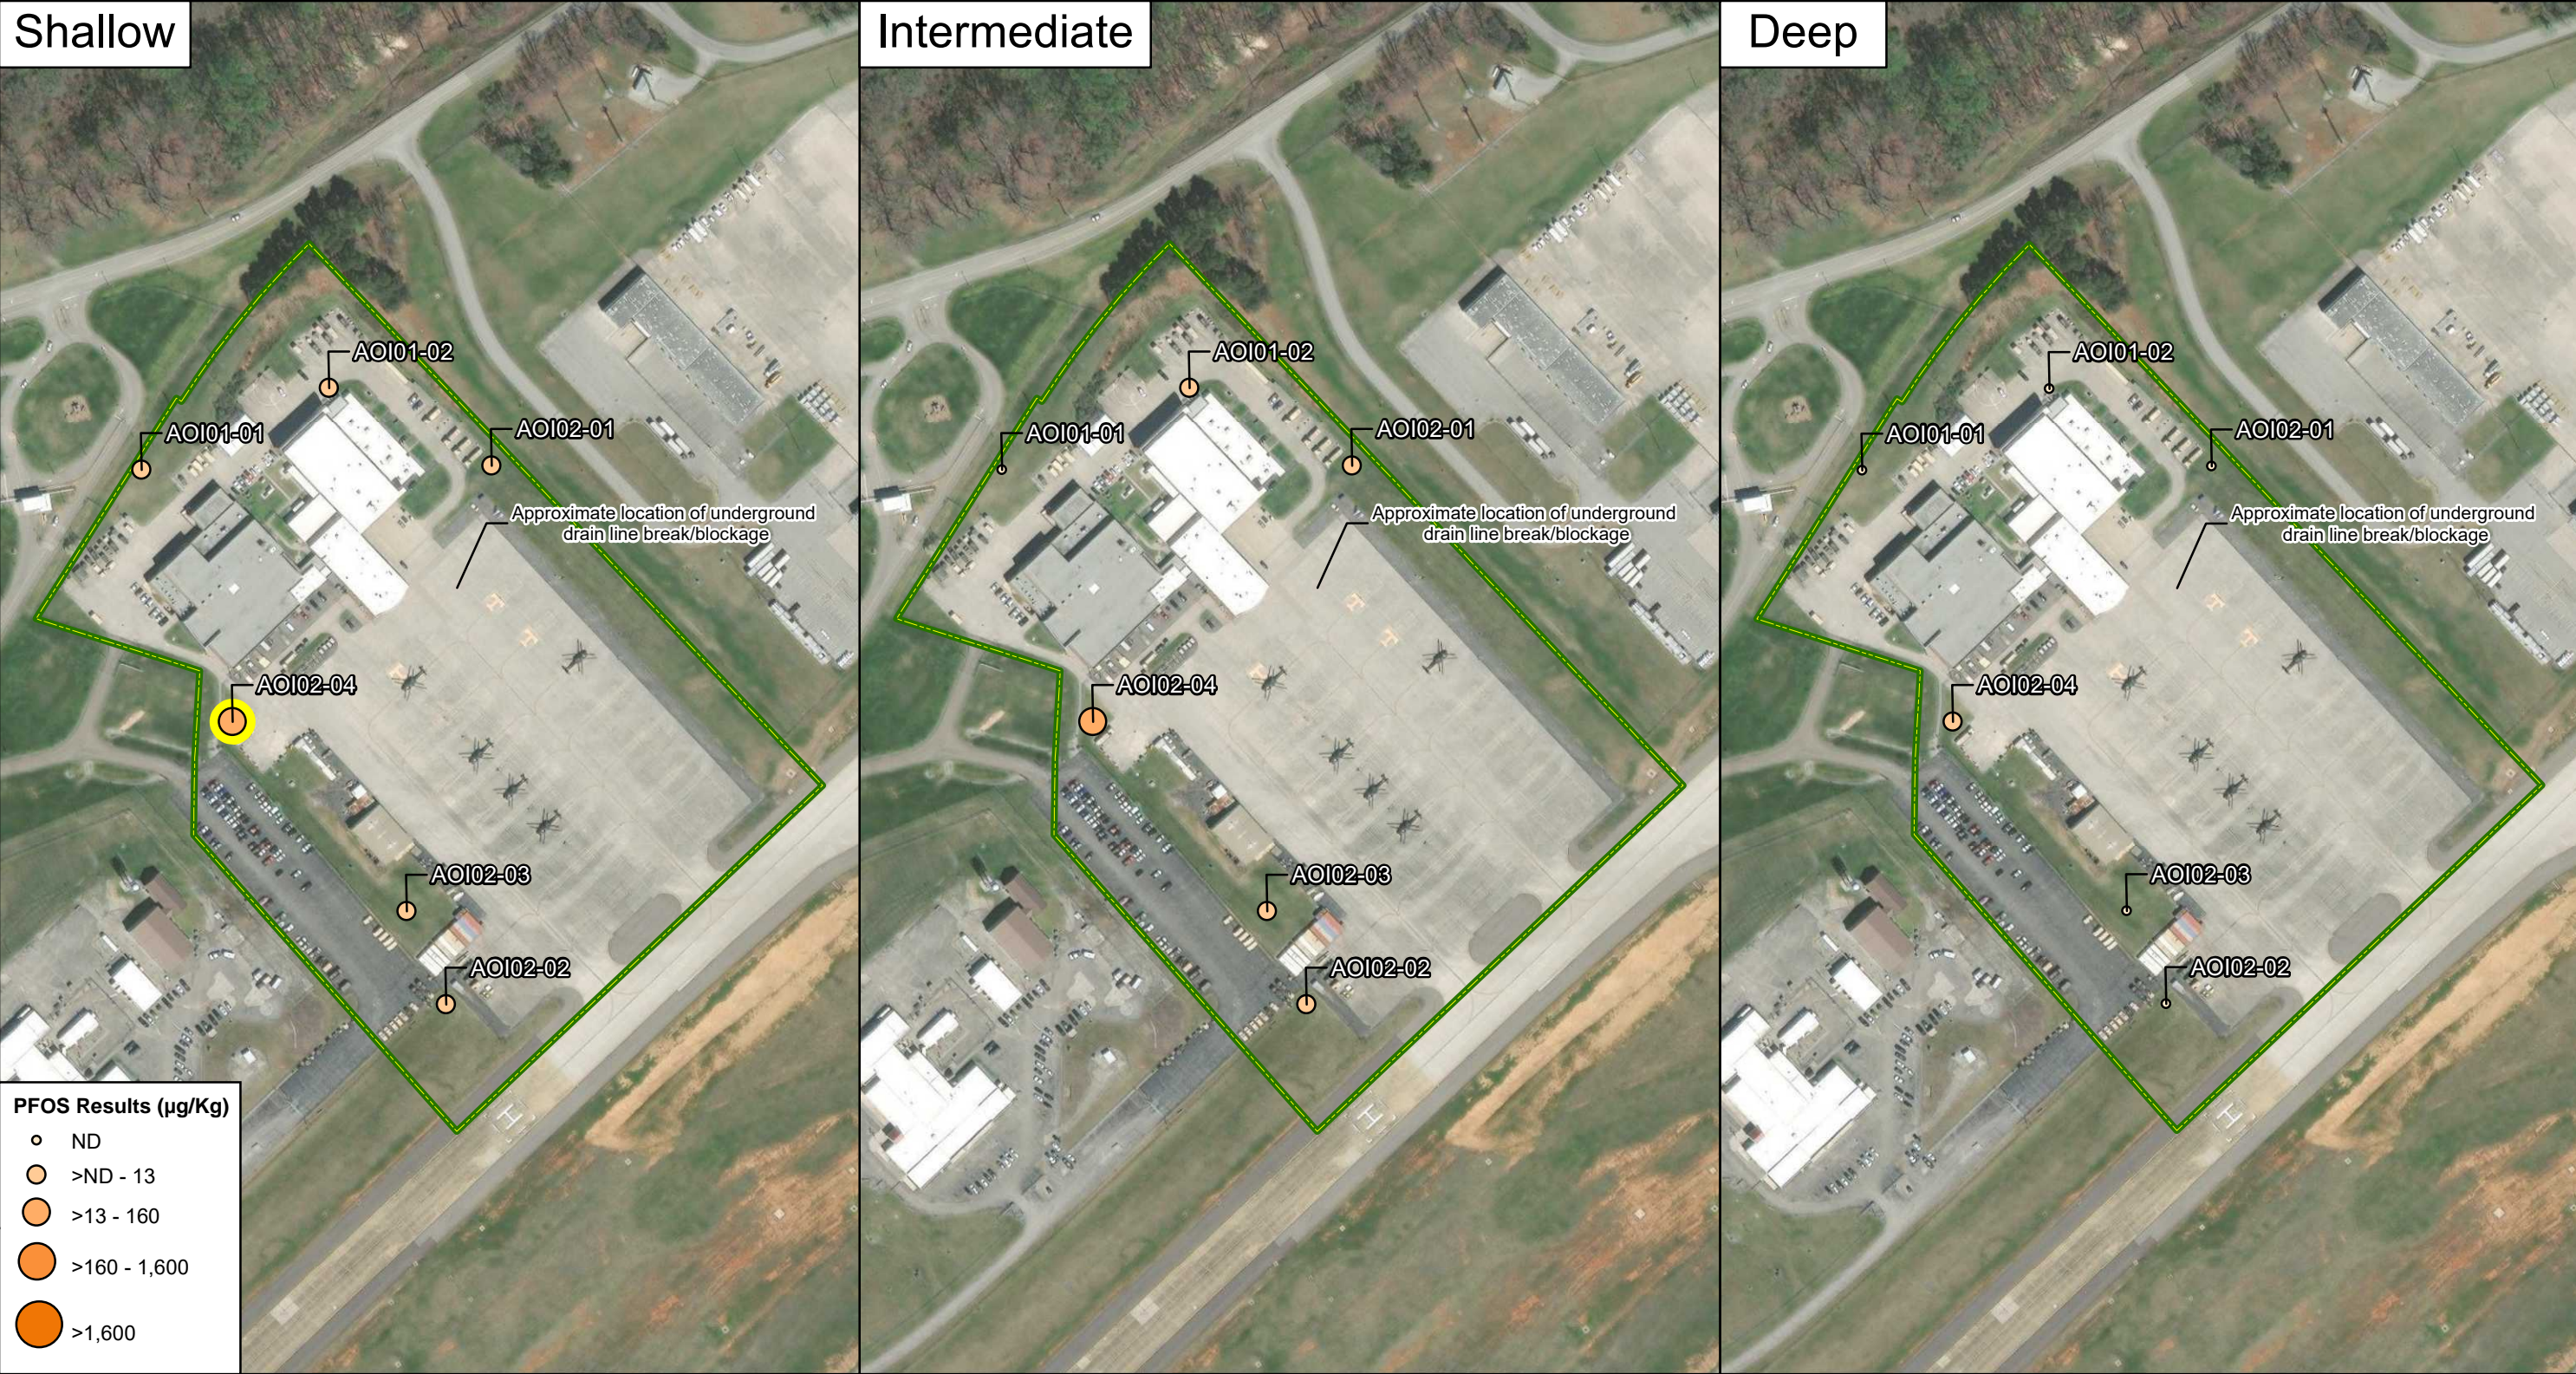
Exceedances of the OSD SL are depicted with a yellow halo.  
Depth intervals shown represent respective sampling position within a given soil boring location.

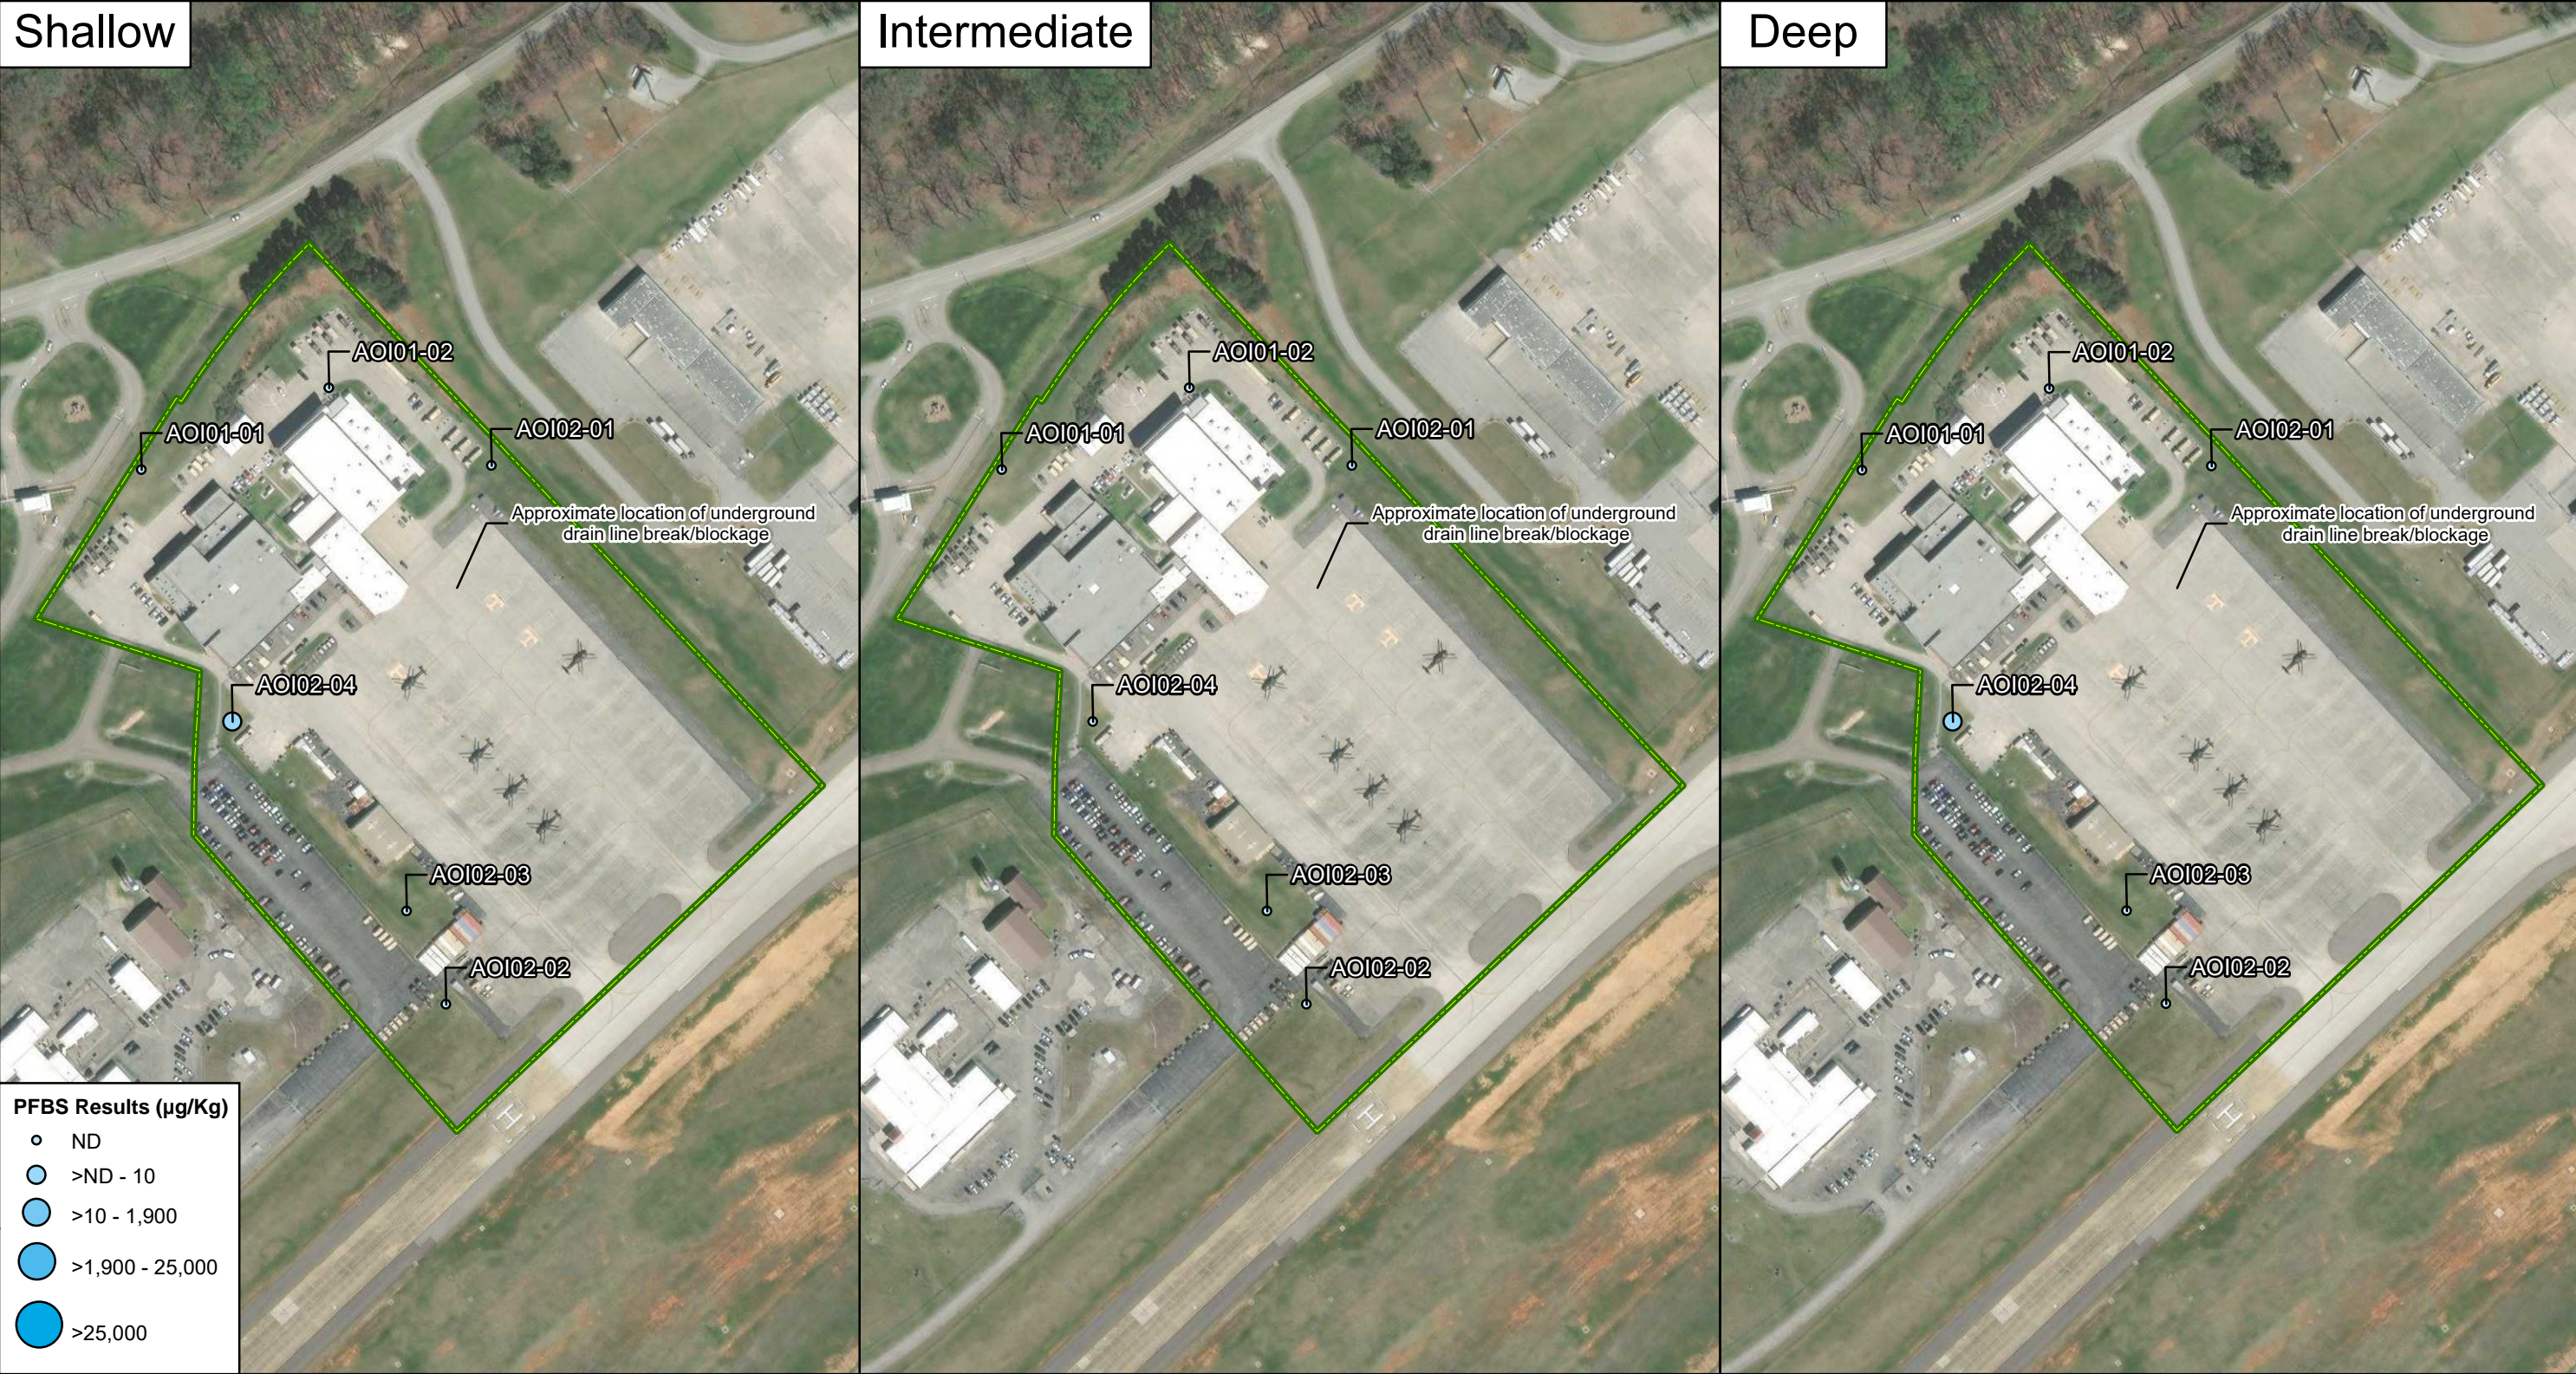
| PROJECT | | | | | | | | | | | Site Inspection at Louisville AASF #2, TN | | | | | <div><div>AECOM</div><div>12420 Milestone Center Drive<br/>Germantown, MD 20876</div></div> | Figure 6-3 | | | | |

| CLIENT | | | | | ARNG | | | | | <div><div>Legend</div><div><div><div></div></div> Facility Boundary</div><div>Exceedances of the OSD SL are depicted with a yellow halo.<br/>Depth intervals shown represent respective sampling position within a given soil boring location.</div></div> <div><div>0135270540</div><div>Feet</div><div><div>N</div><div></div></div></div> | PFBS Detections in Soil | | | | | | | | | | |

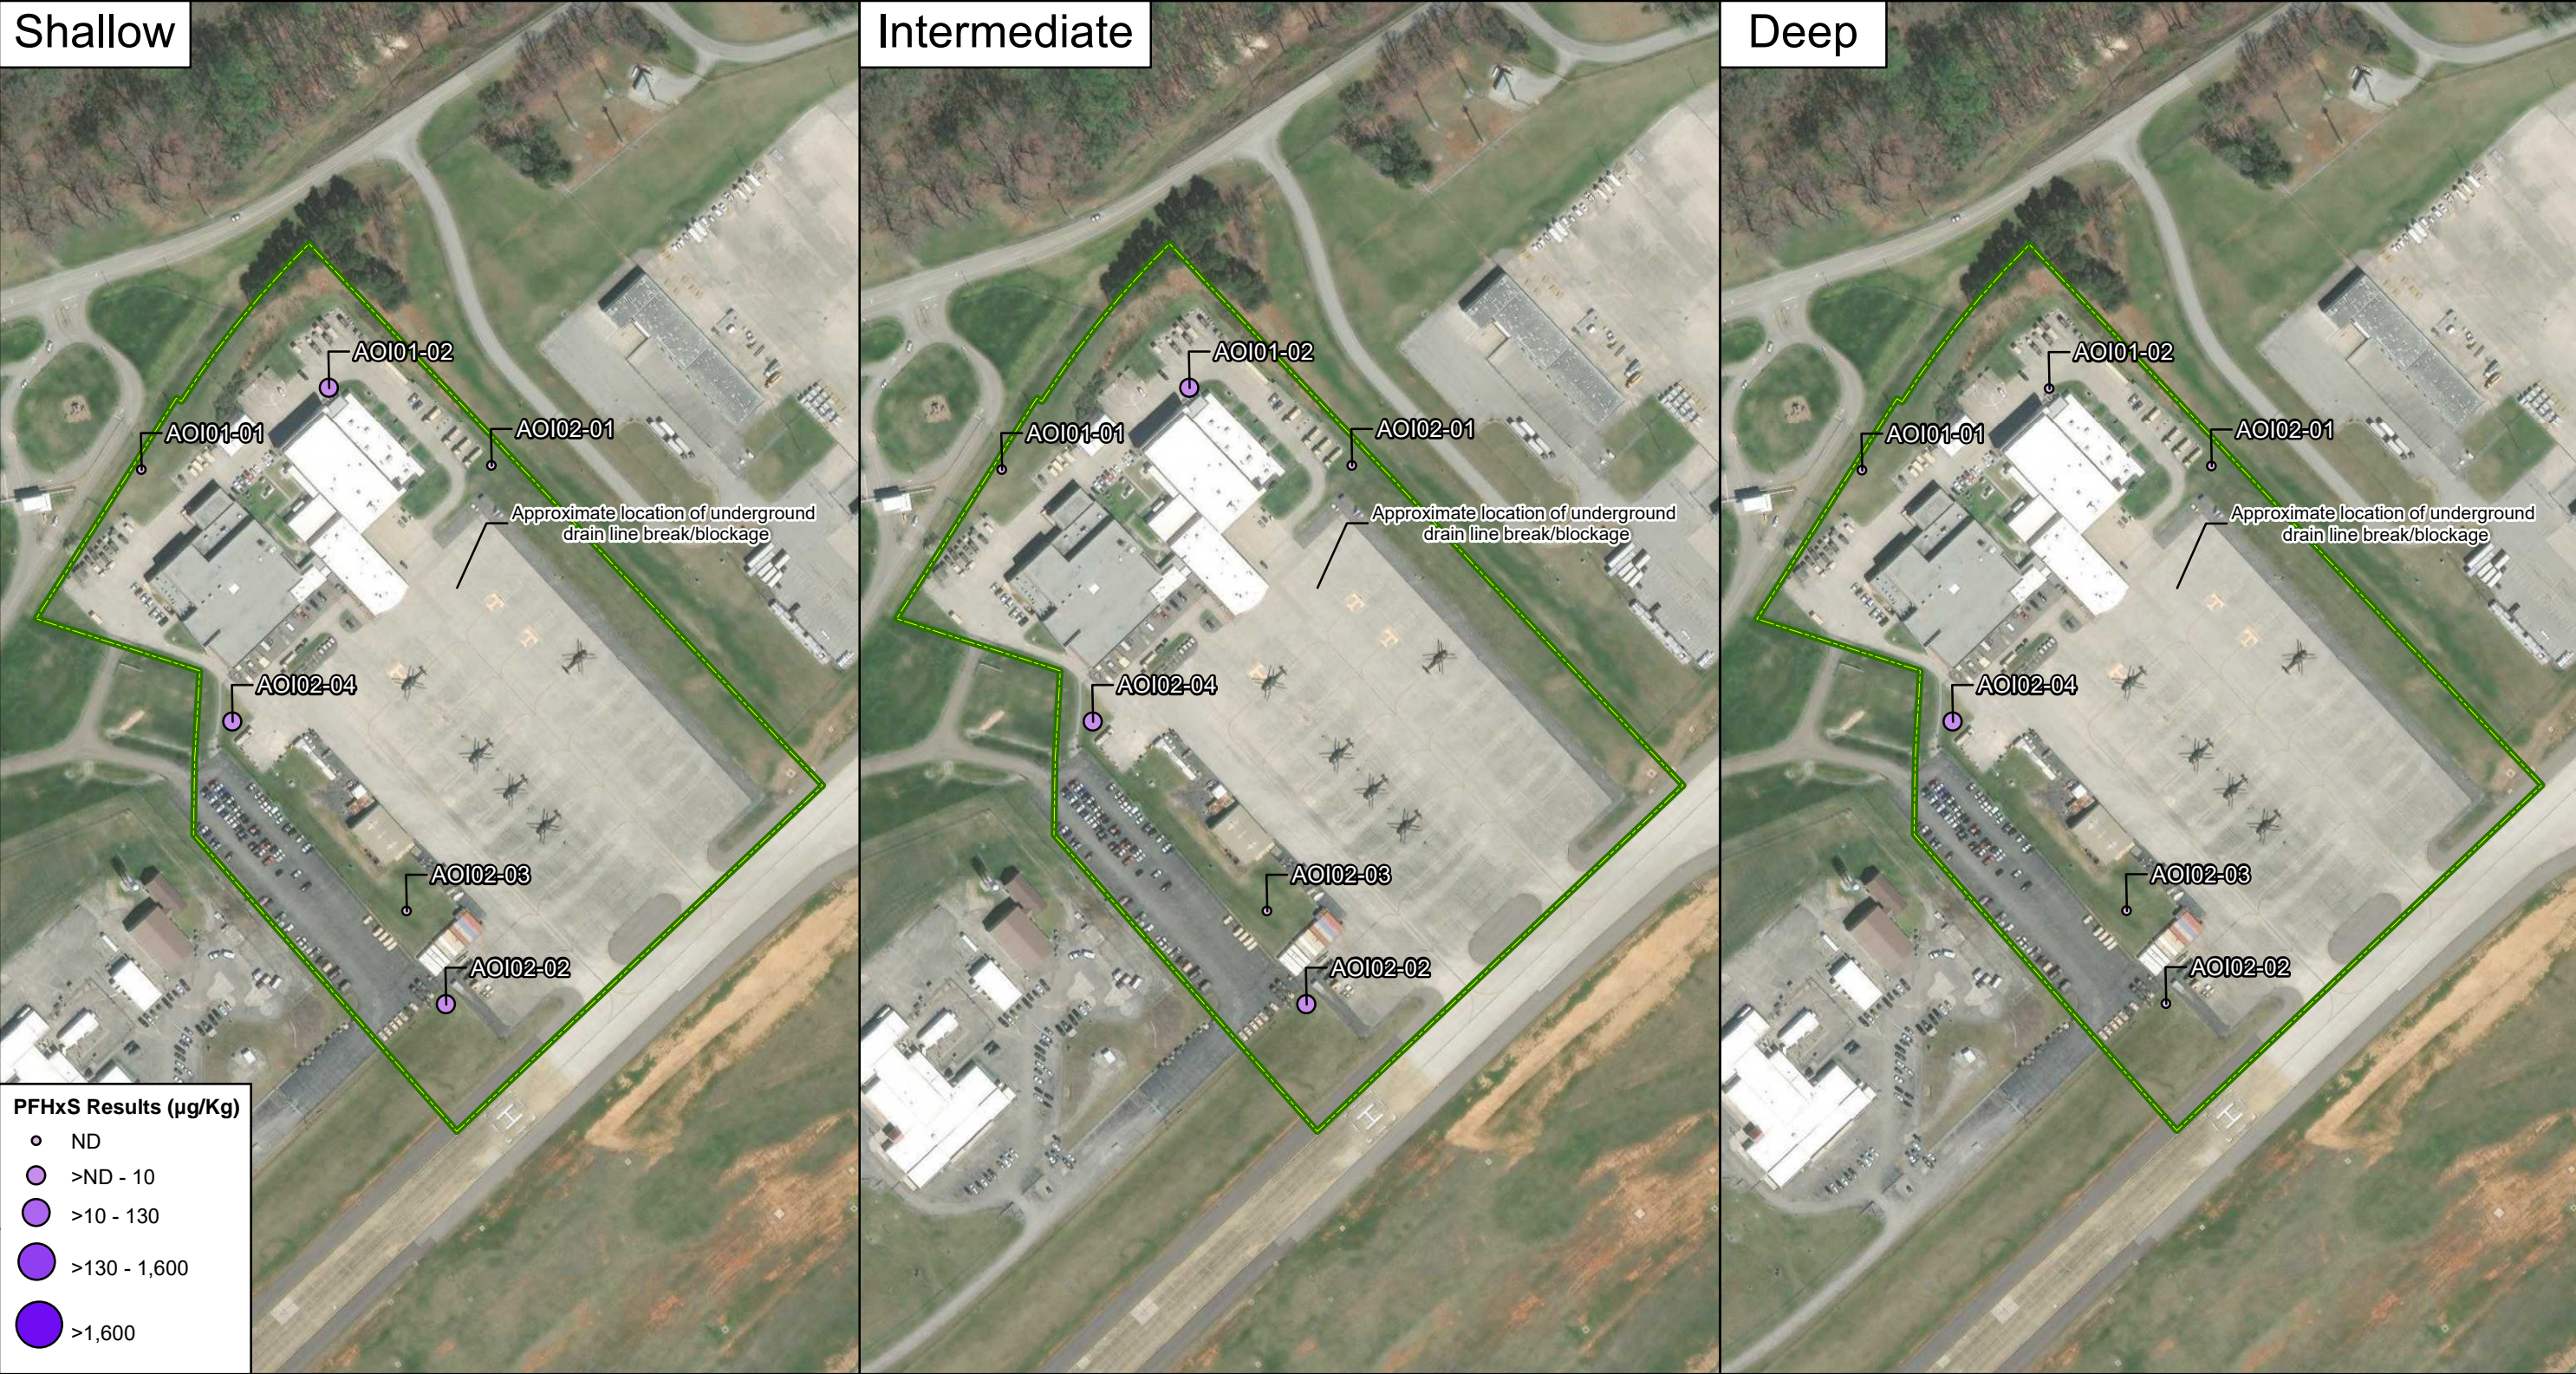
Figure 6-4

Exceedances of the OSD SL are depicted with a yellow halo.  
Depth intervals shown represent respective sampling position within a given soil boring location.

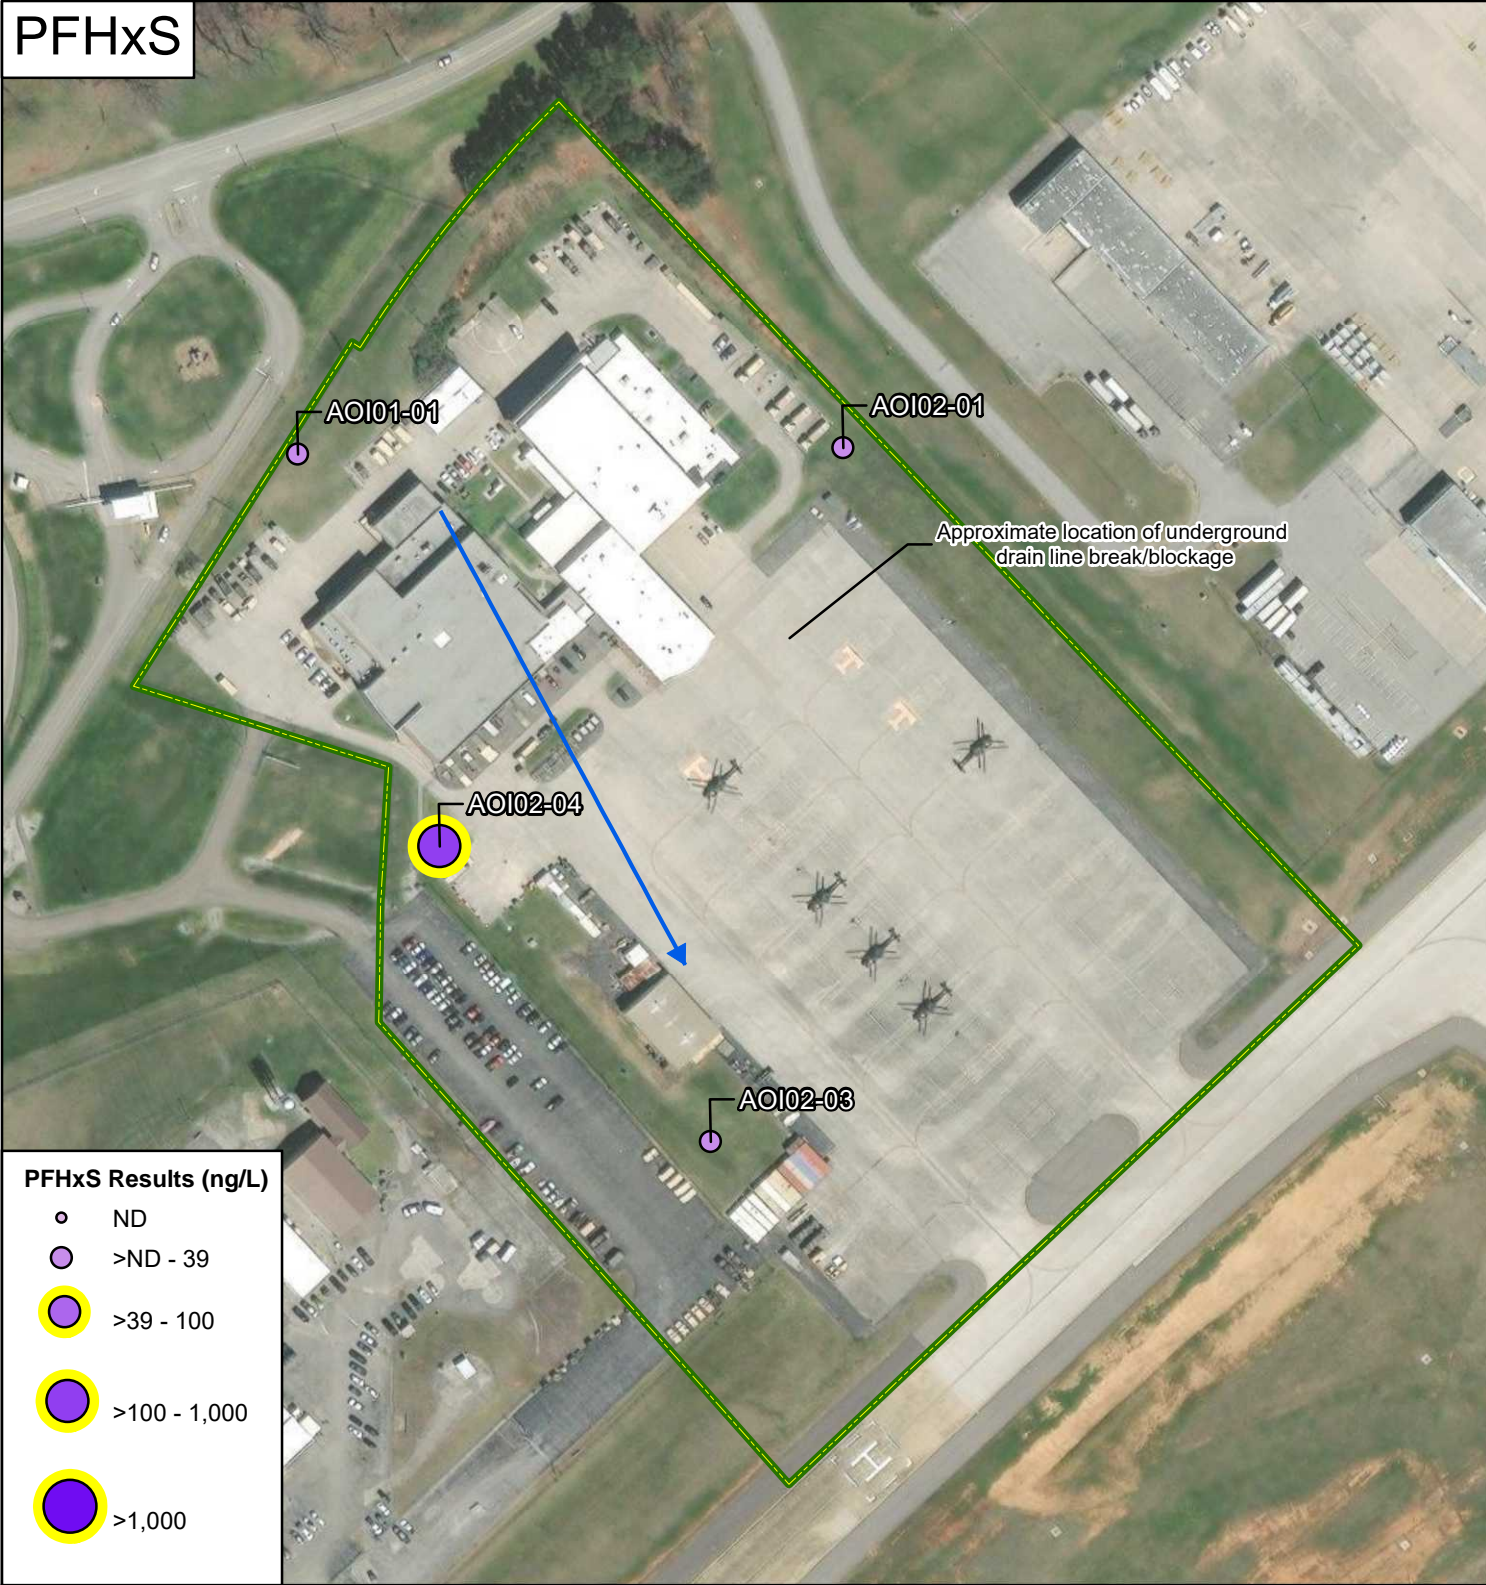
PFHxS

**PFHxS Results (ng/L)**

- ND
- >ND - 39
- >39 - 100
- >100 - 1,000
- >1,000

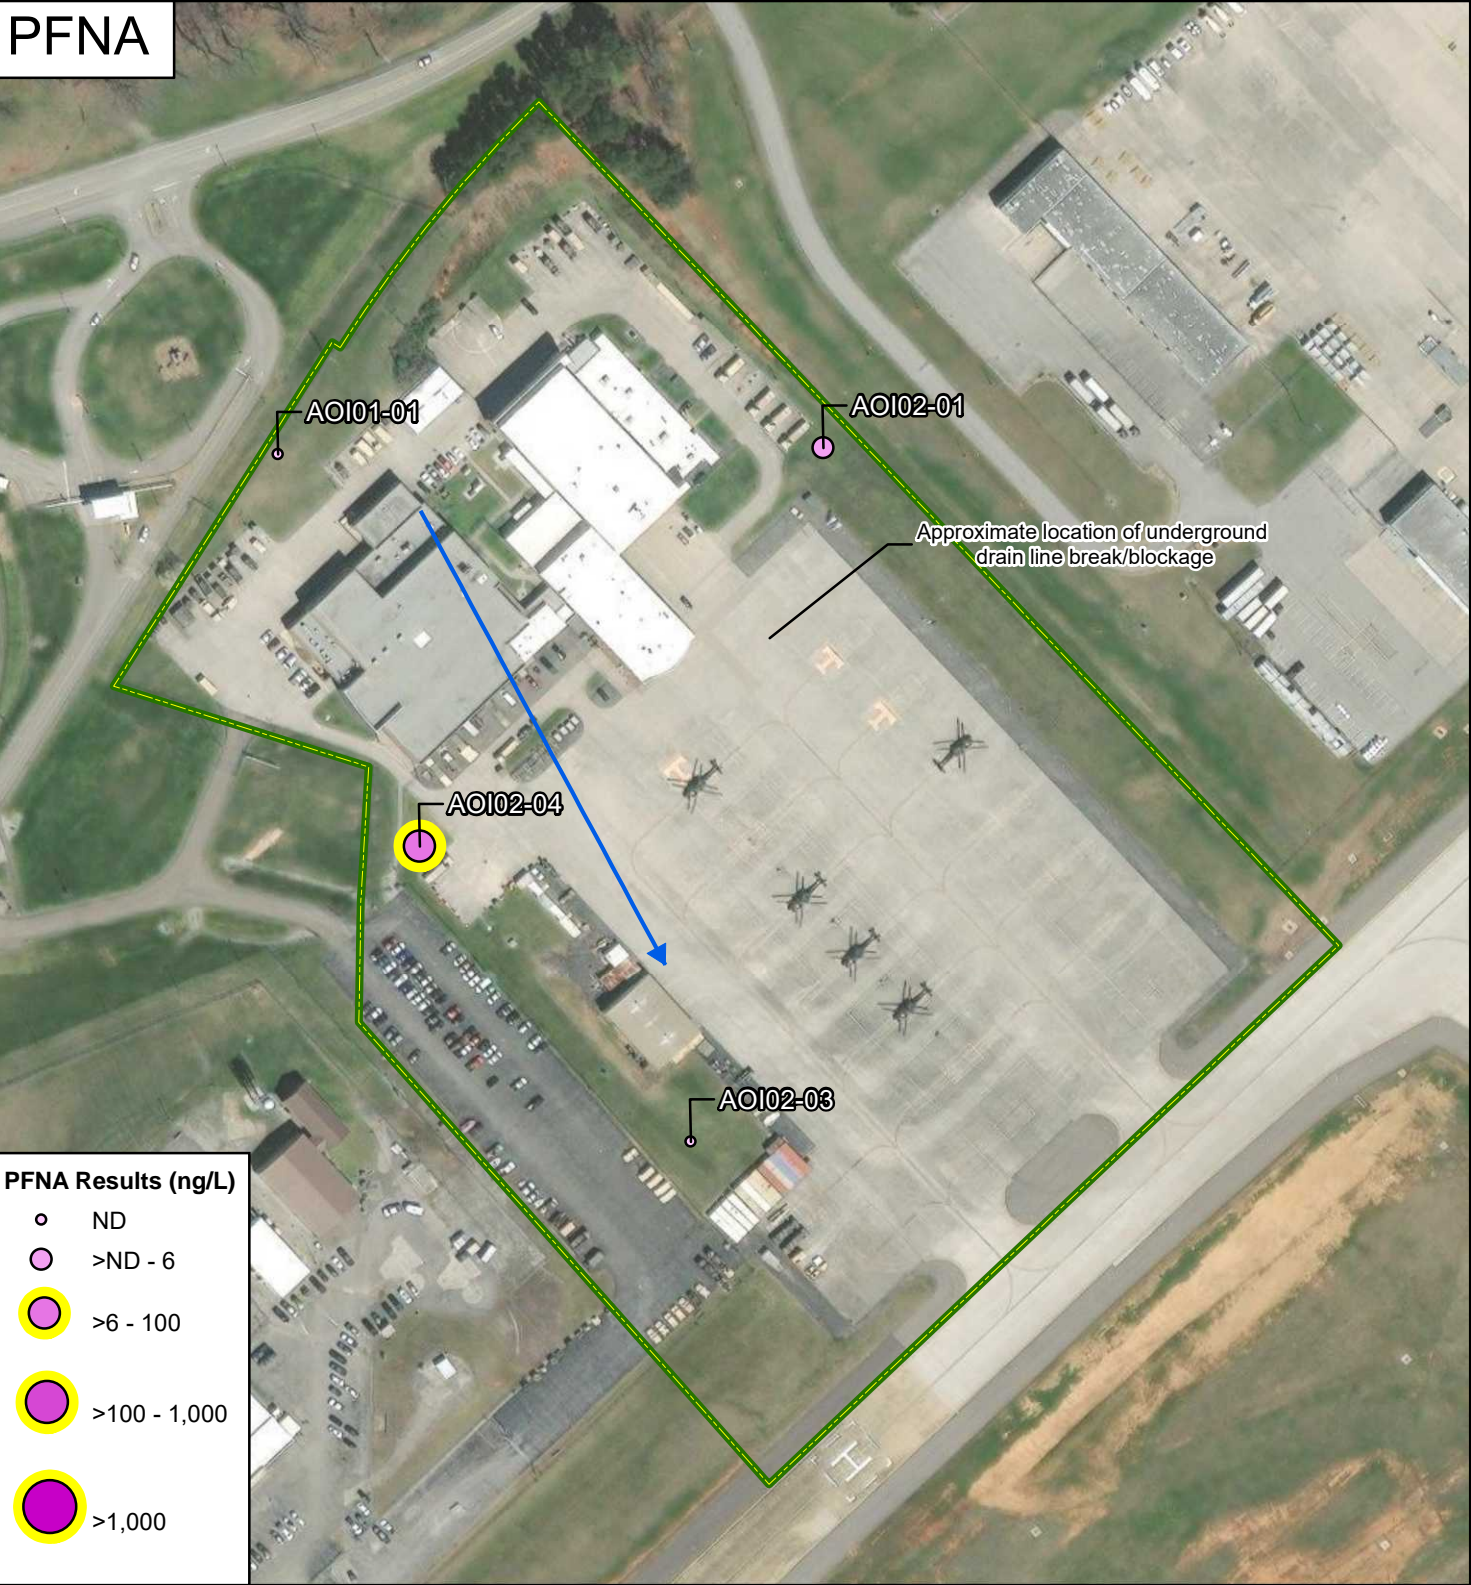
PFNA

**PFNA Results (ng/L)**

- ND
- >ND - 6
- >6 - 100
- >100 - 1,000
- >1,000
