FINAL Site Inspection Report Volunteer Training Site-Smyrna, Tennessee

Site Inspection for Perfluorooctanoic acid (PFOA),
Perfluorooctanesulfonic acid (PFOS), Perfluorohexanesulfonic
acid (PFHxS), Perfluorononanoic acid (PFNA),
Hexafluoropropylene oxide dimer acid (HFPO-DA), and
Perfluorobutanesulfonic acid (PFBS) at ARNG Installations,
Nationwide

April 2023

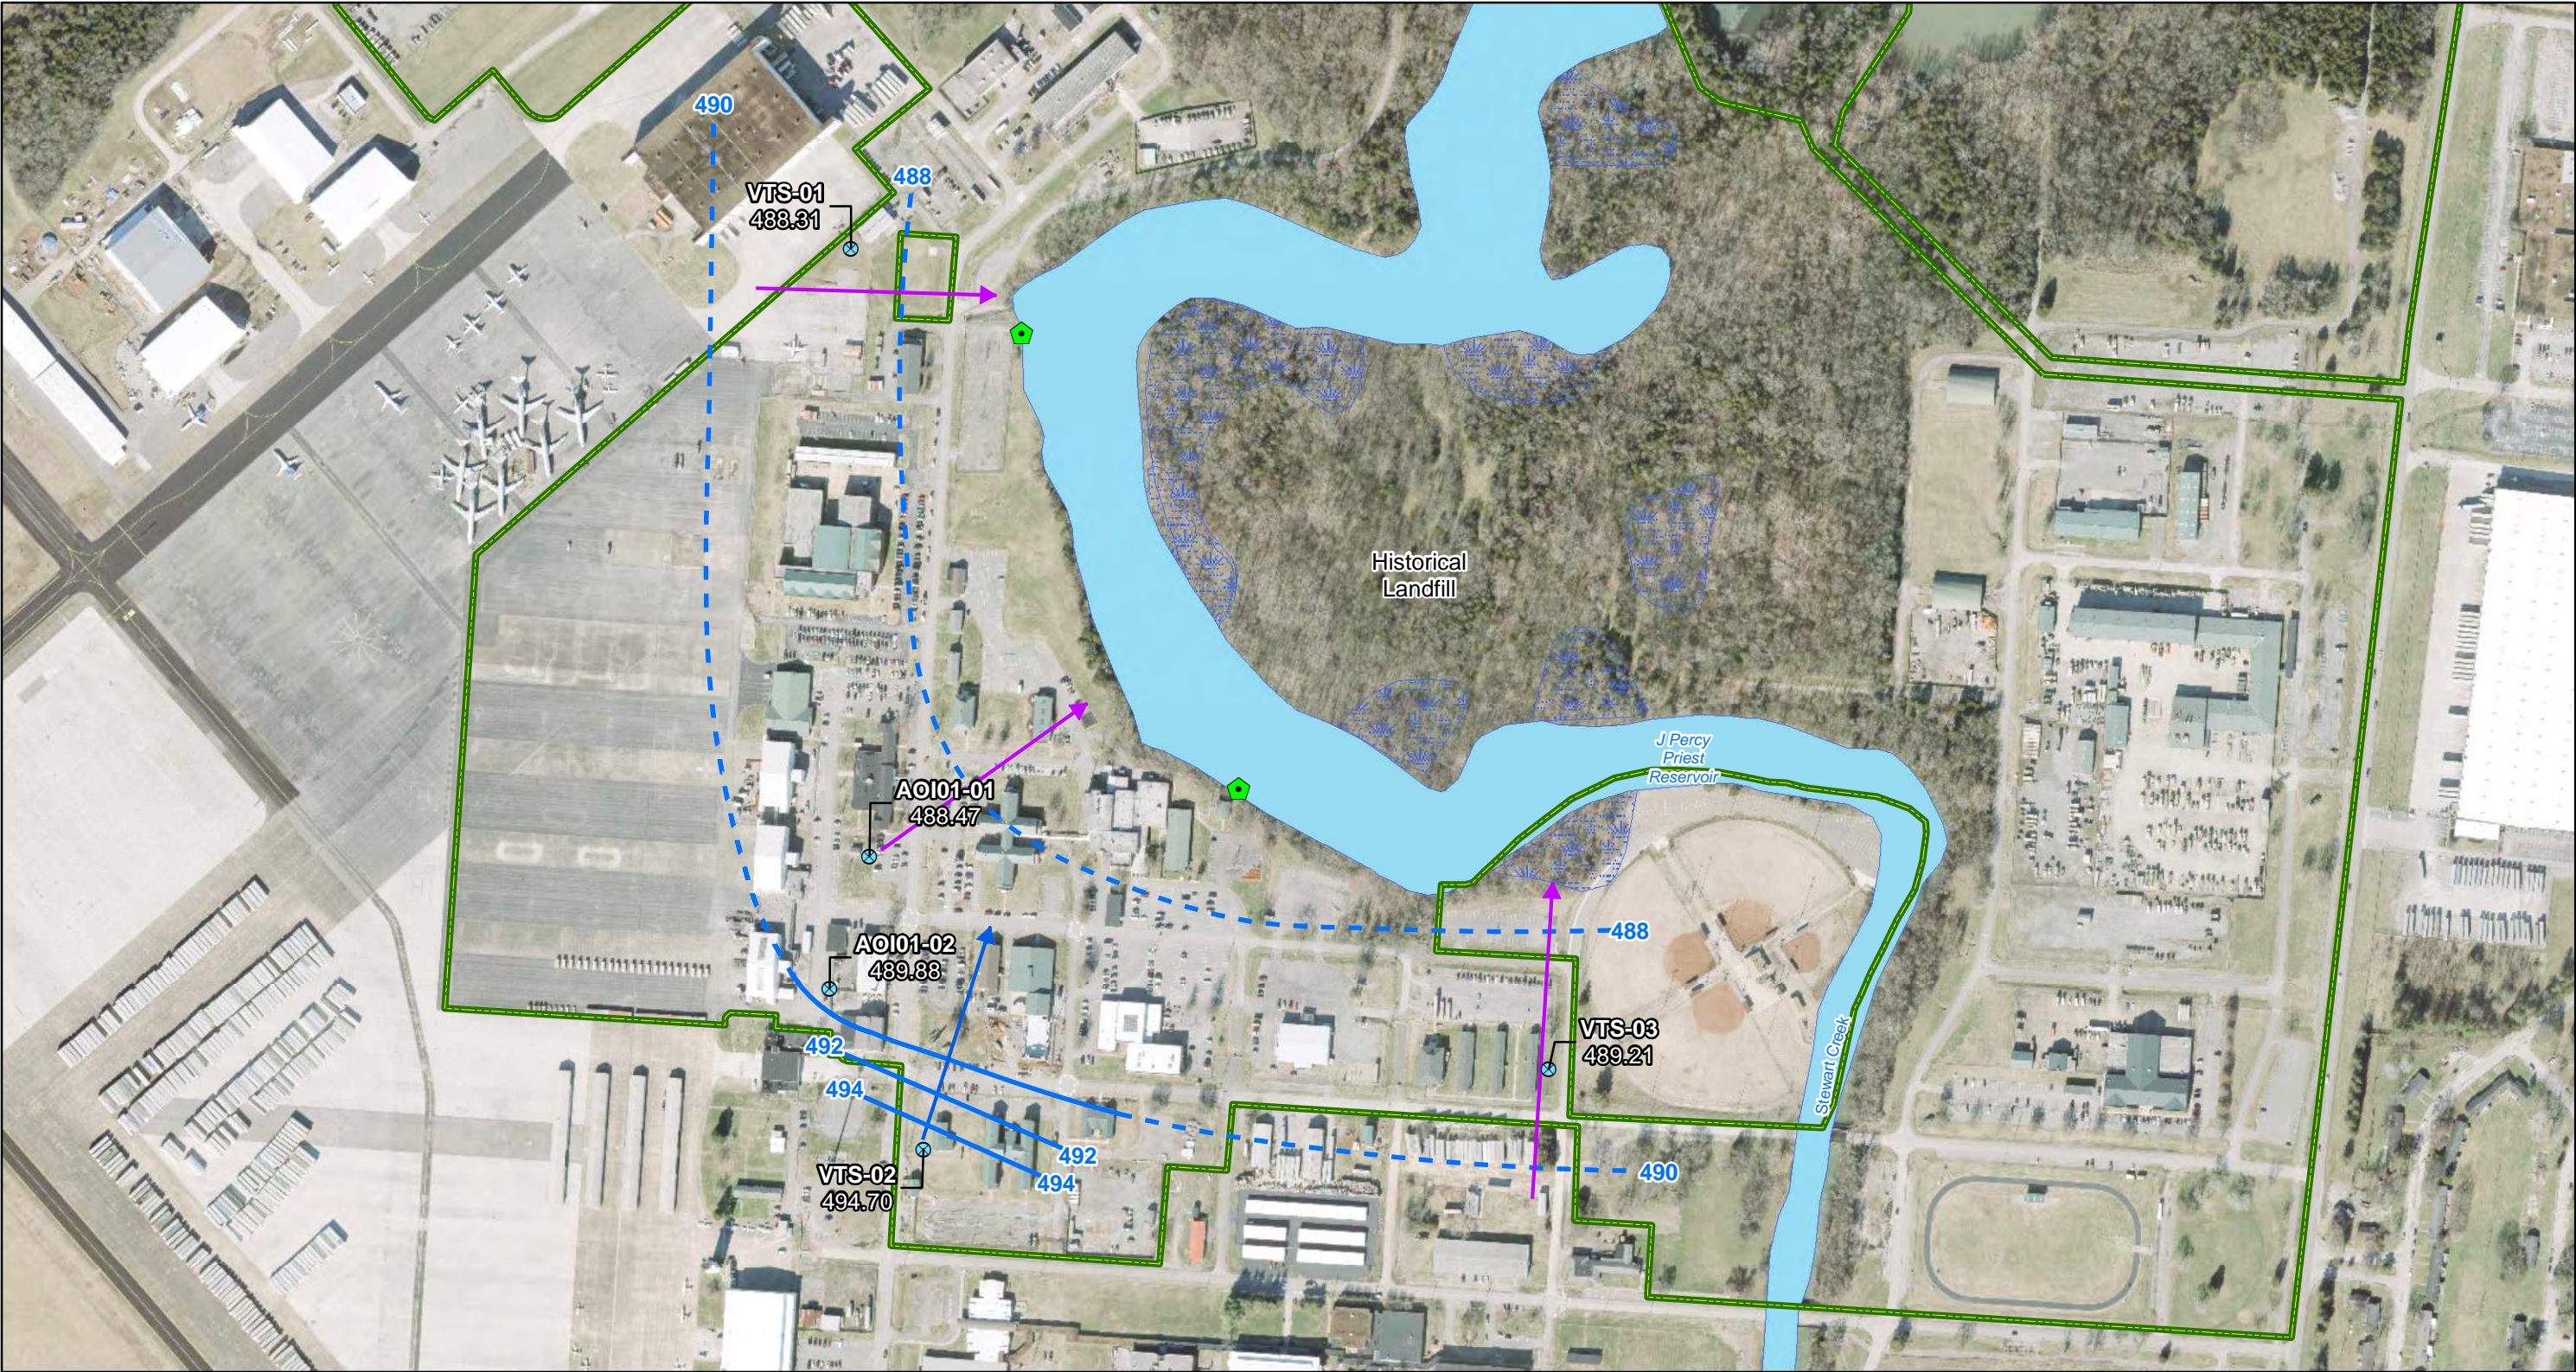
Figure 2-4

Depths to groundwater measured in March 2022 during the SI ranged from 14.57 to 25.22 feet bgs. Groundwater elevation contours from the SI are presented on **Figure 2-4** and indicate groundwater flow direction is generally to the northeast towards Stewart Creek.

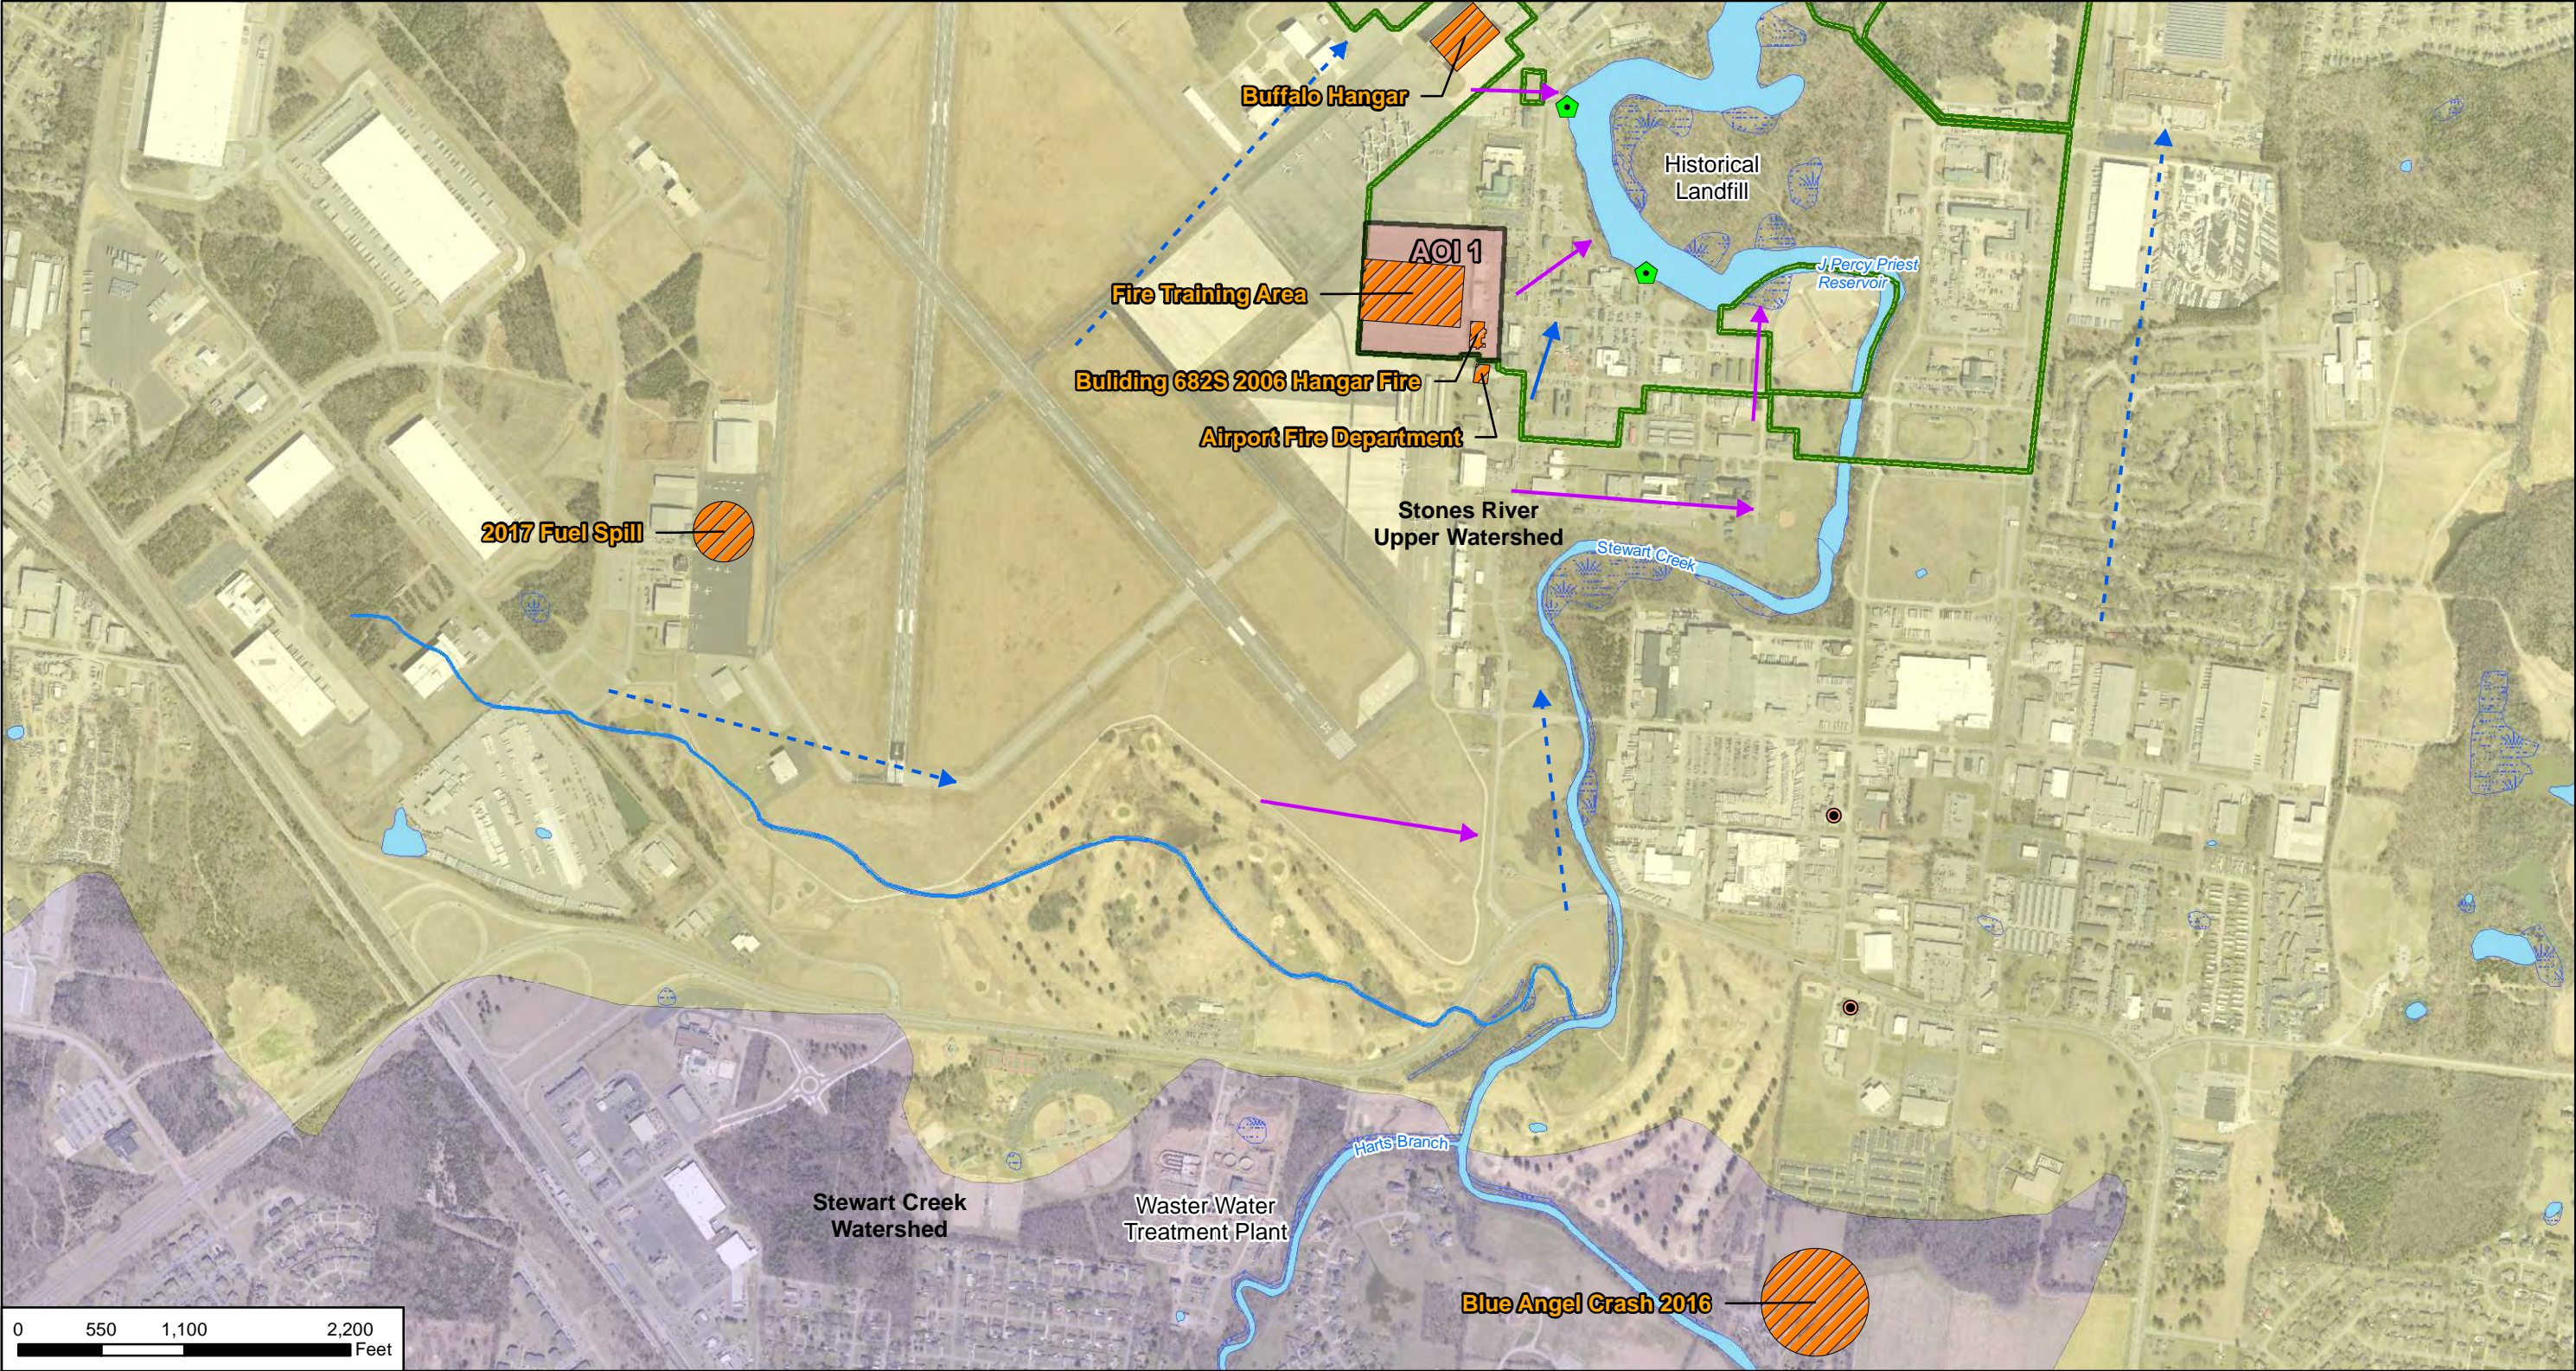
Area of Interest	
	12420 Milestone Center Drive Germantown, MD 20876
Figure 3-1

AOI 1 consists of two potential release areas. The potential release areas are described below.

Based on the PA interview with TNARNG personnel, a fire occurred between exterior walls of Hangar Building 682S in 2006 due to welding operations. Staff reported the hangar's fire suppression system did not engage until the late stages of the incident. After the system engaged, AFFF was released and filled the hangar; the volume of AFFF used during this incident is unknown. The Town of Smyrna Fire Department reported using only water when they arrived on the scene, after the AFFF release. The Town of Smyrna Fire Department's incident report was included in PA report (AECOM, 2018a).

According to VTS-S personnel, TNARNG used expired AFFF extinguishers for many years to conduct fire-training exercises on the concrete apron in the front-west of the hangars (Buildings 681, 682N, and 682S). AFFF runoff released from fire-training activities would have likely discharged to the nearest storm or sanitary sewer drain. Infiltration to subsurface soil may have occurred via pavement cracks or seams or leaks in underground piping. Such releases may have intercepted groundwater and migrated downgradient. The frequency, volume, and concentration of AFFF used at this location are unknown.

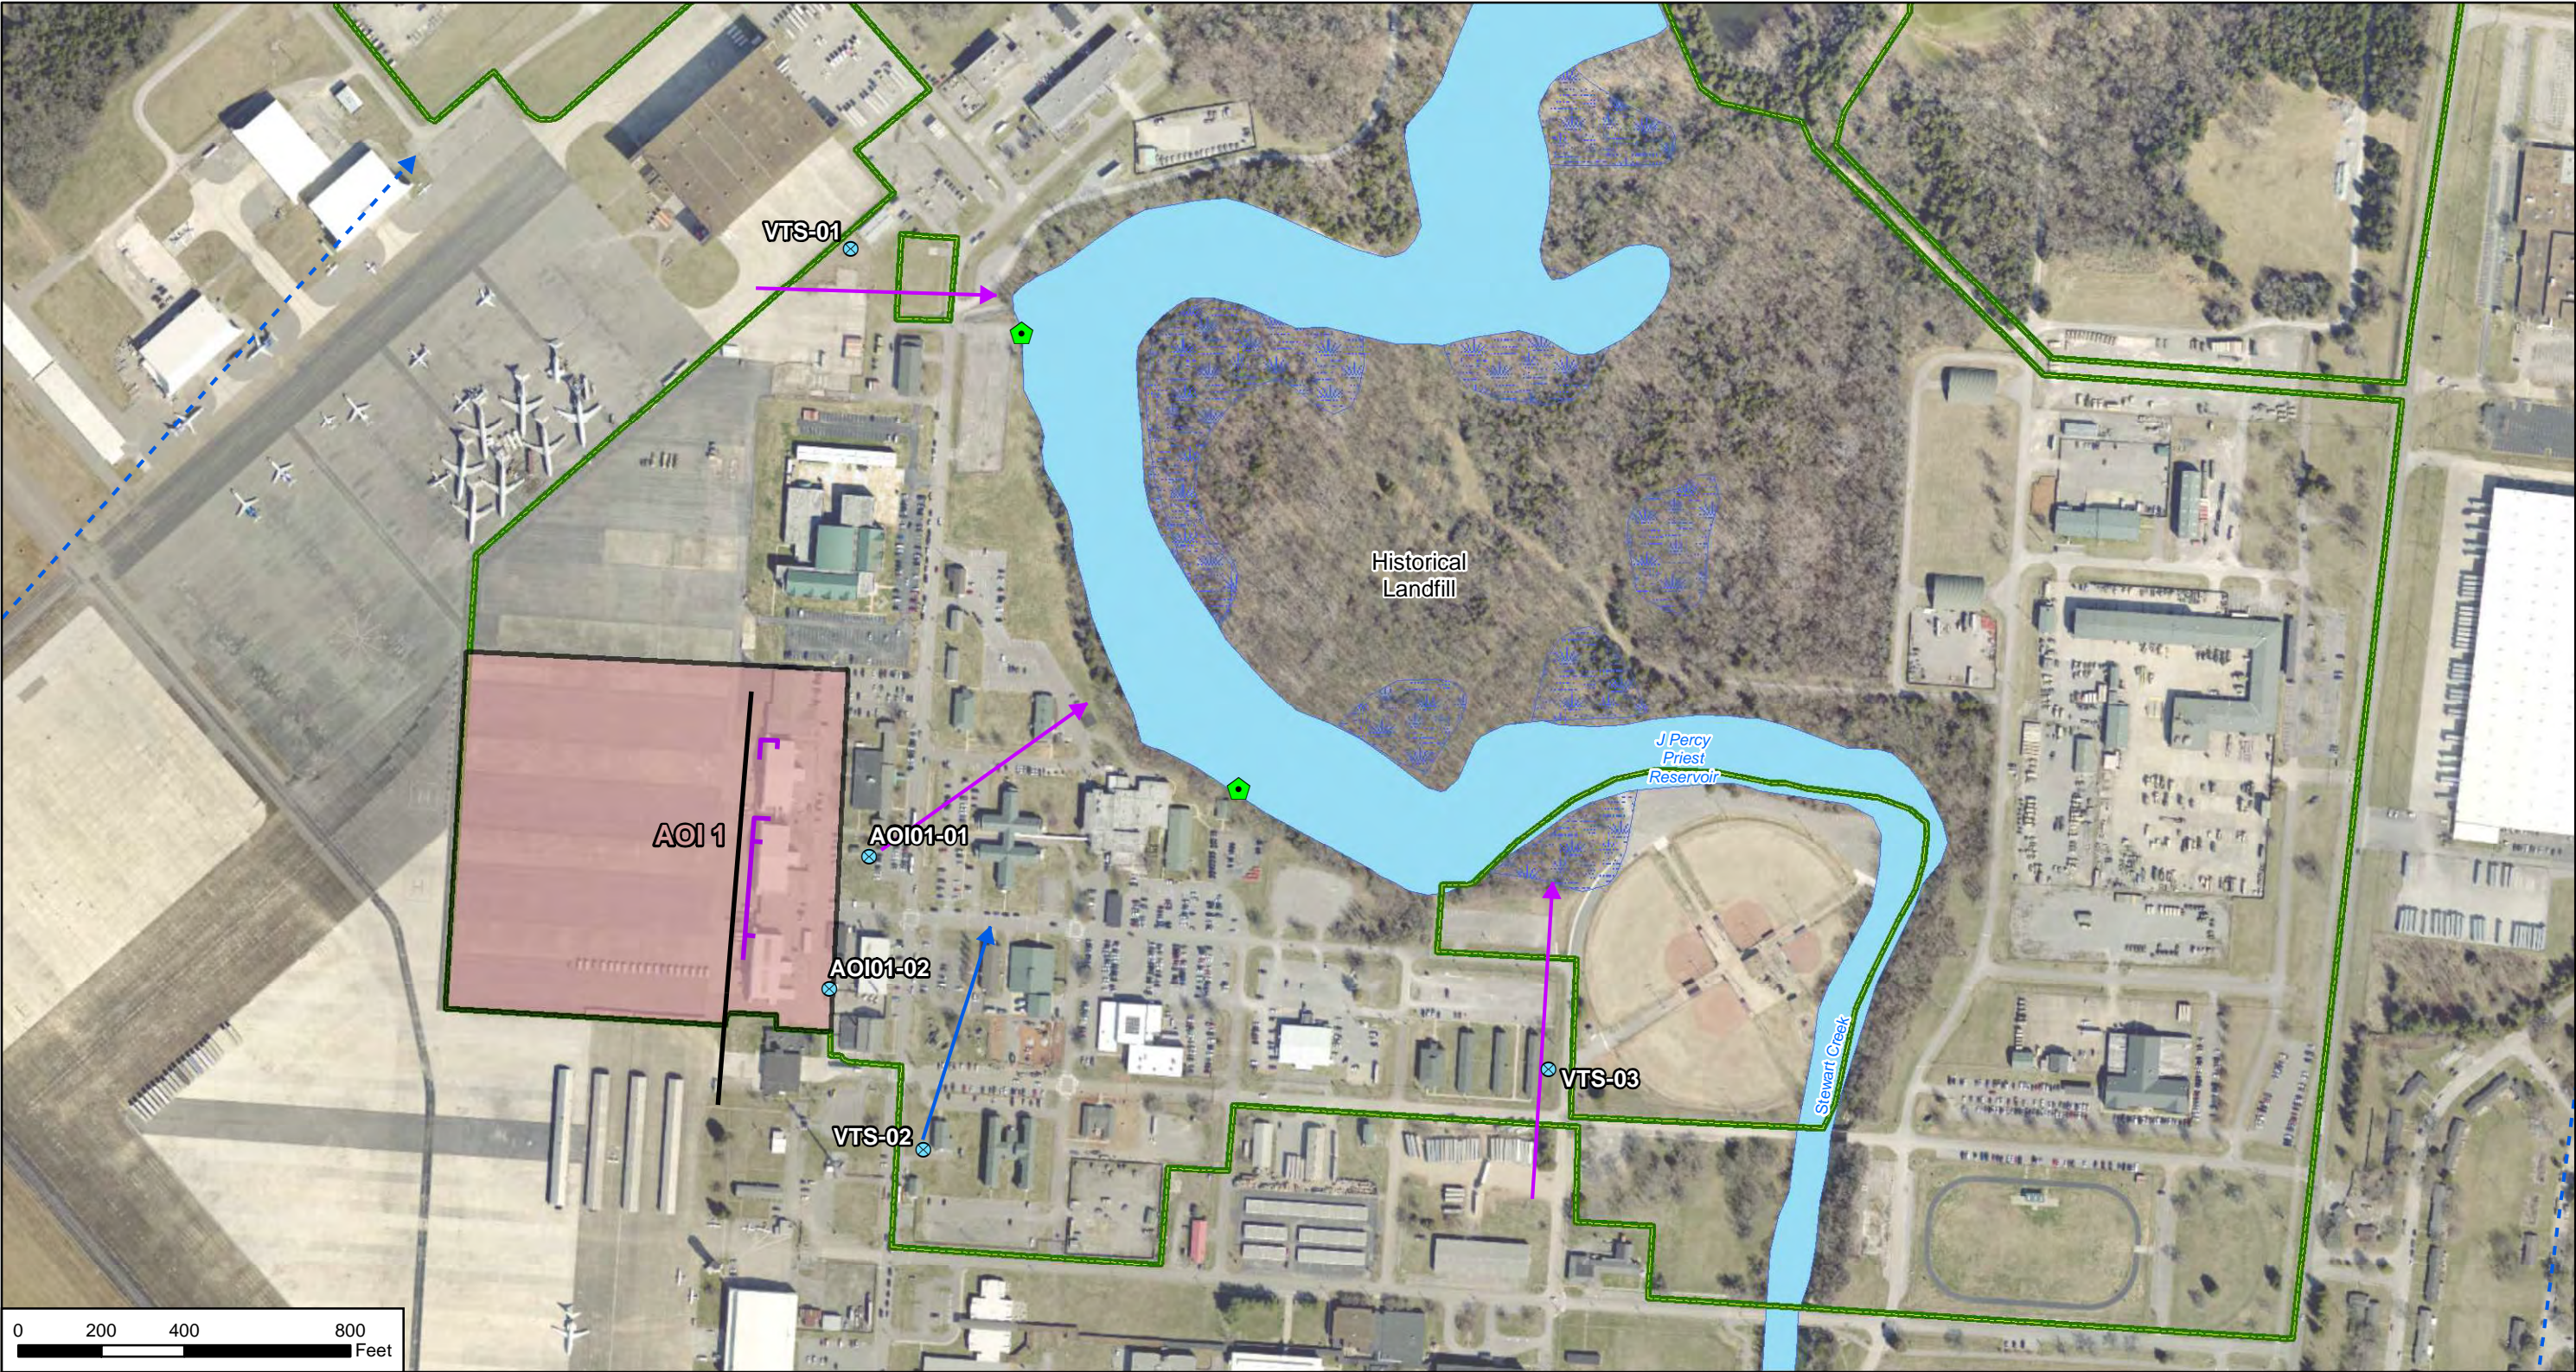
CLIENT		ARNG			
PROJECT		Site Inspection at VTS Smyrna, TN			
REVISED	9/15/2022	GIS BY	MS	9/15/2022	
SCALE	1:4,800	CHK BY	SS	9/15/2022	
Source: Esri, Maxar, Earthstar Geographics, and the GIS User Community		PM	CM	9/15/2022

Legend					
	Soil Boring and Monitoring Well		Wetland		Storm Sewer Line (Approx)
	Approximate Storm Water Outfall		Surface Water Flow Direction		New Sewer Line (Approx)
	Area of Interest		Groundwater Flow Direction		
	Facility Boundary		Inferred Groundwater Flow Direction		
	Water Body
