FINAL Site Inspection Report Roy P. Benavidez National Guard Armory El Campo, Texas

Perfluorooctane Sulfonic Acid (PFOS) and
Perfluorooctanoic Acid (PFOA) Impacted Sites
ARNG Installations, Nationwide

January 2022

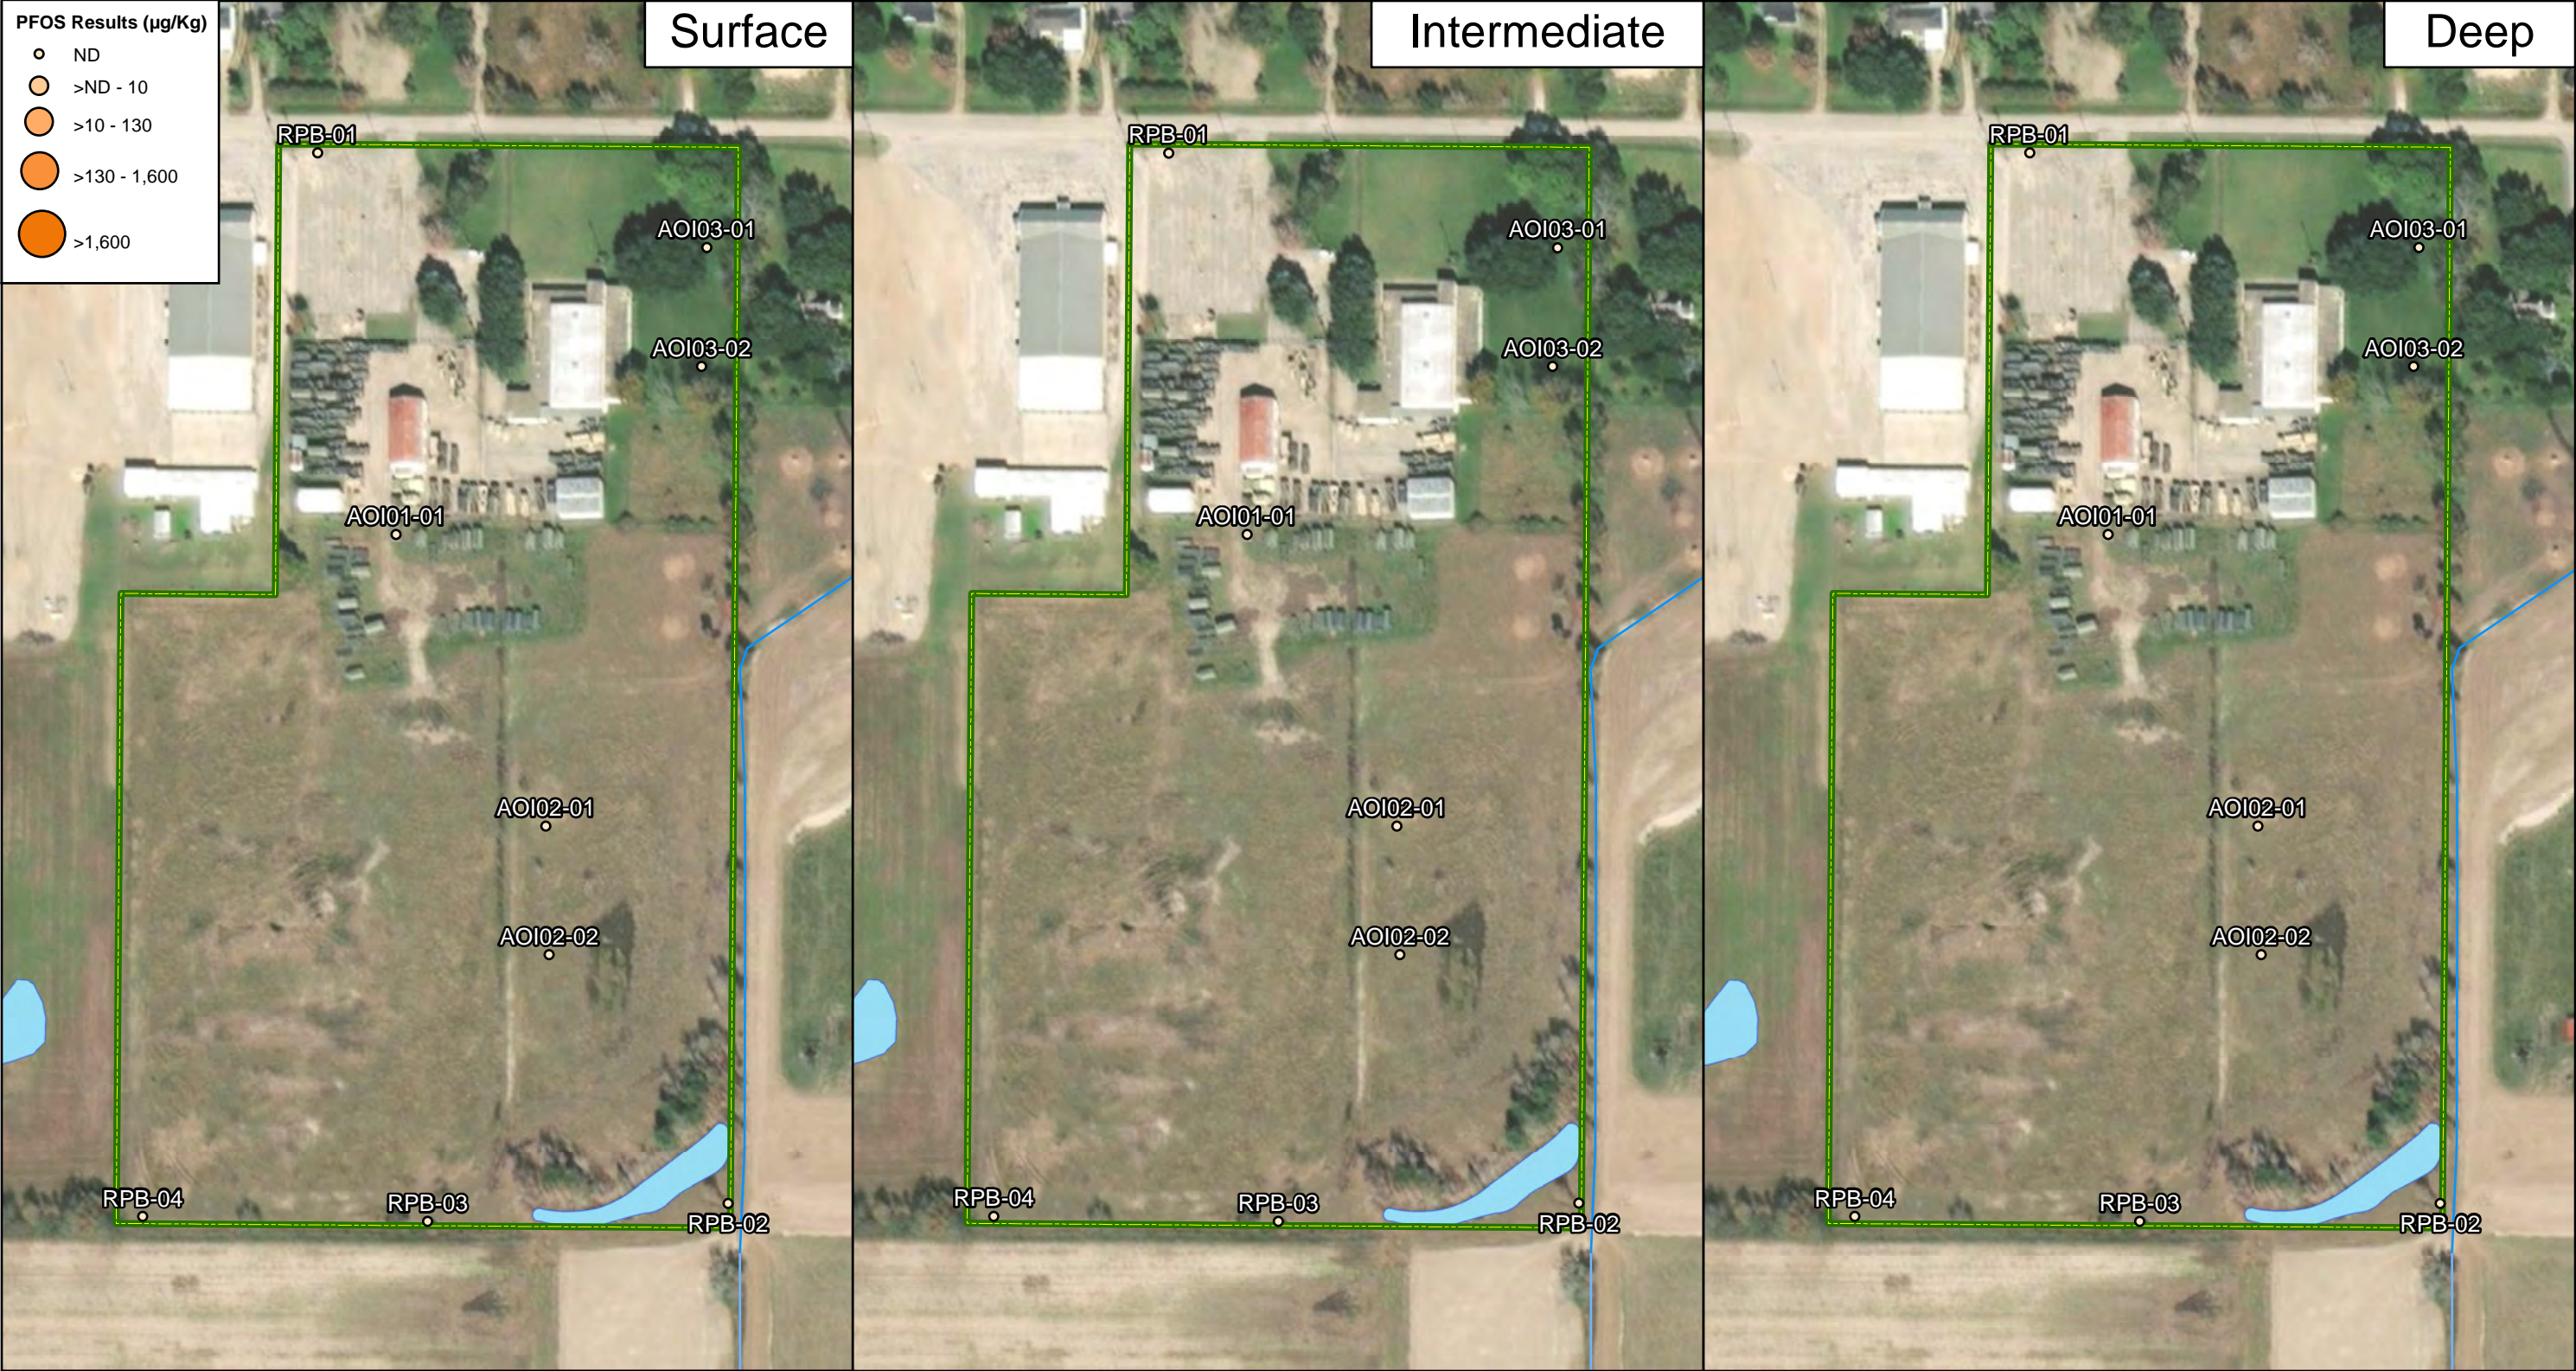
Figure 6-1

- The detected concentrations of PFOA, PFOS, and PFBS in soil samples from all AOIs were below the SLs. The results of the SI at AOI 3 are suggestive of an incomplete pathway; however, given the distance of the suspected source there is insufficient data to rule out this pathway at this time.
- PFOA, PFOS, and PFBS were not detected in groundwater at the upgradient facility boundary. These results suggest there may not be an off-facility source of PFAS potentially migrating on-facility.
- Data collected by the ARNG Bureau (NGB) in 2018 (NGB, 2018) as well as the Texas Military Department (TMD) (TMD, 2019; TMD, 2020) indicate that PFOS, PFOA, and PFBS are not present in treated groundwater at the facility.
