Preliminary Assessment Report

Saginaw Facility, Texas

Perfluorooctanesulfonic acid (PFOS) and Perfluorooctanoic Acid
(PFOA) Impacted Sites
ARNG Installations, Nationwide

May 2022

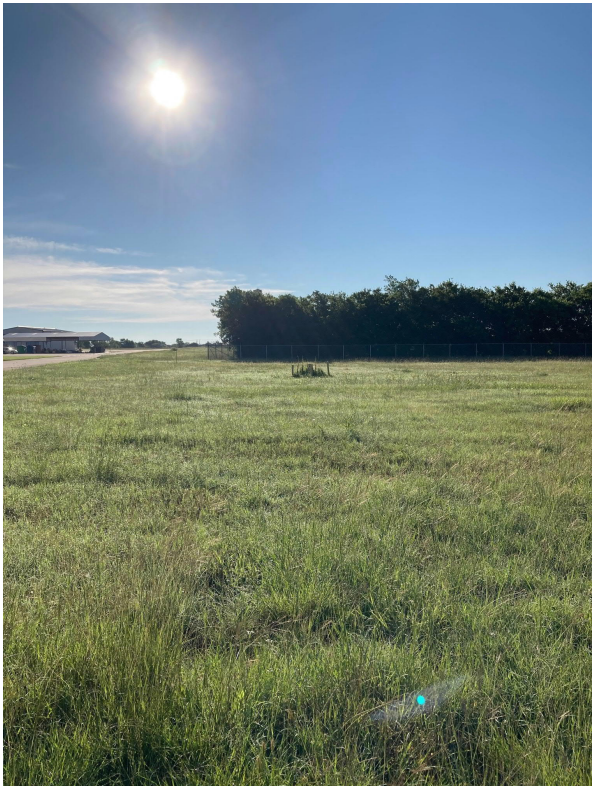
Army National Guard, Preliminary Assessment for PFAS		Saginaw Facility	Saginaw, TX
Photograph No. 1

Date 6/2/2021 Time			
Description: Burn Pit 1, facing east. A monitoring well is located in the center of the burn pit.			
Orientation: East			
Photograph No. 2

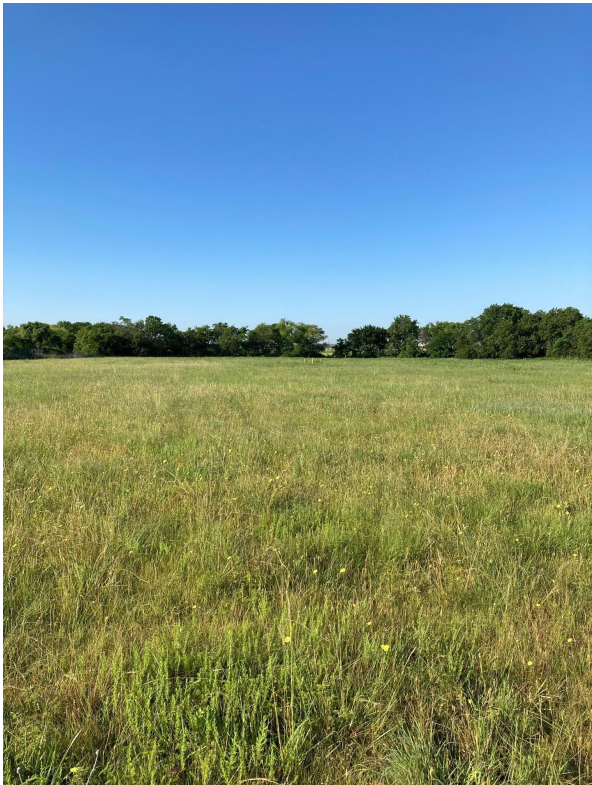
Date 6/2/2021 Time			
Description: Burn Pit 2, facing south. Several monitoring wells are located in the vicinity of the area.			
Orientation: South

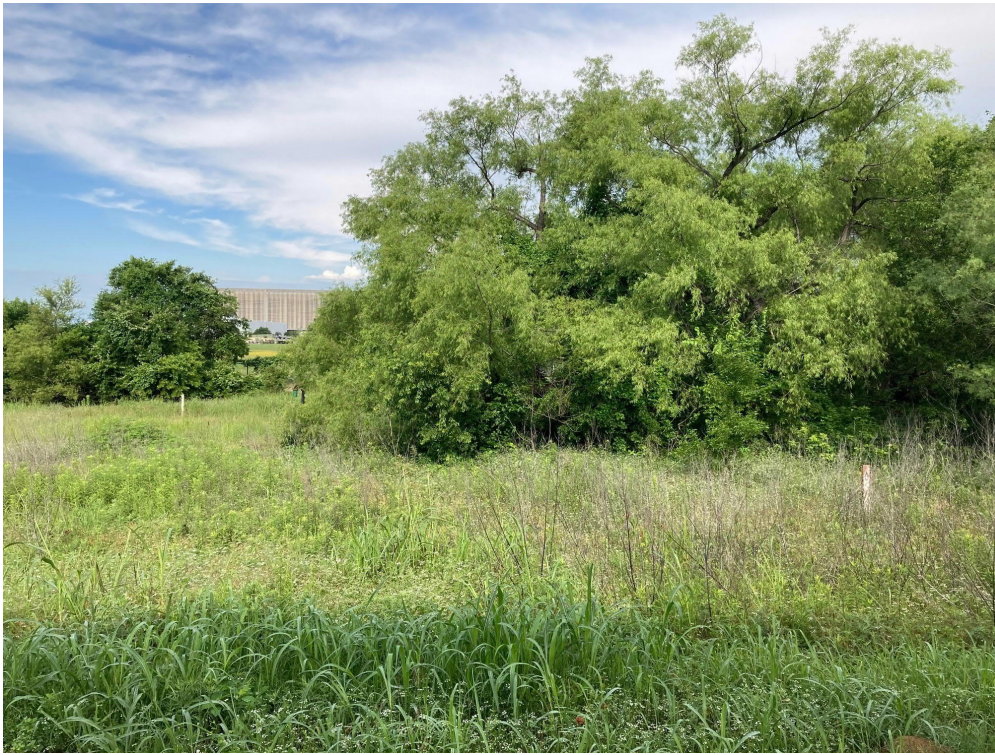
Army National Guard, Preliminary Assessment for PFAS	Saginaw Facility	Saginaw, TX
<p>Photograph No. 3</p> <p>Date 6/2/2021 Time</p> <p>Description: Three monitoring wells are located east of the property and off-facility.</p> <p>Orientation: West</p>

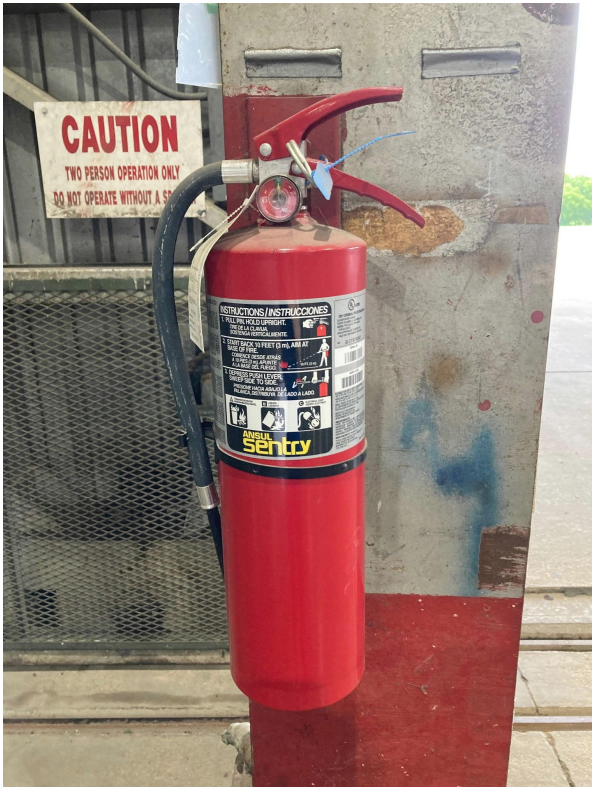
<p>Photograph No. 4</p> <p>Date 6/2/2021 Time</p> <p>Description: A dry chemical fire extinguisher located in the hangar.</p> <p>Orientation: Unknown</p>

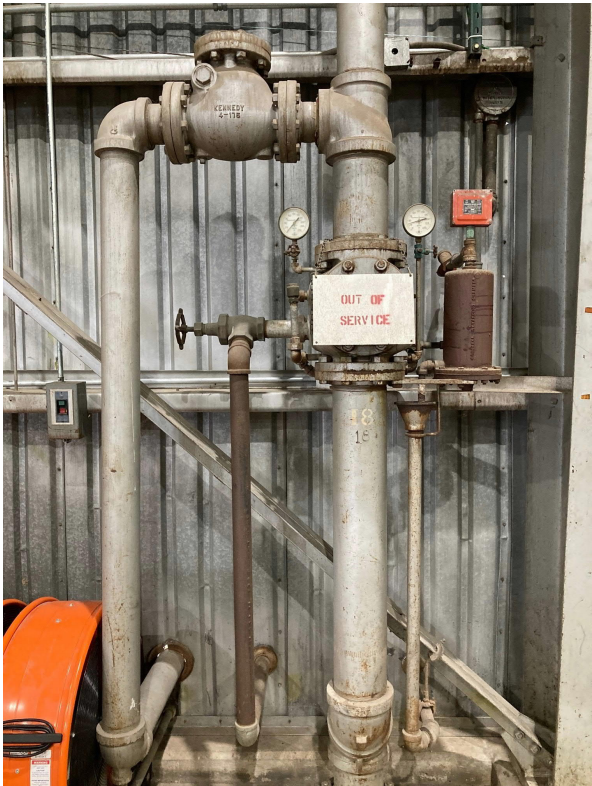
Army National Guard, Preliminary Assessment for PFAS	Saginaw Facility	Saginaw, TX
<p>Photograph No. 5</p> <p>Date 6/2/2021 Time</p> <p>Description: Fire suppression system charged with water within the hangar. Out of service sign is displayed.</p> <p>Orientation: Unknown</p>

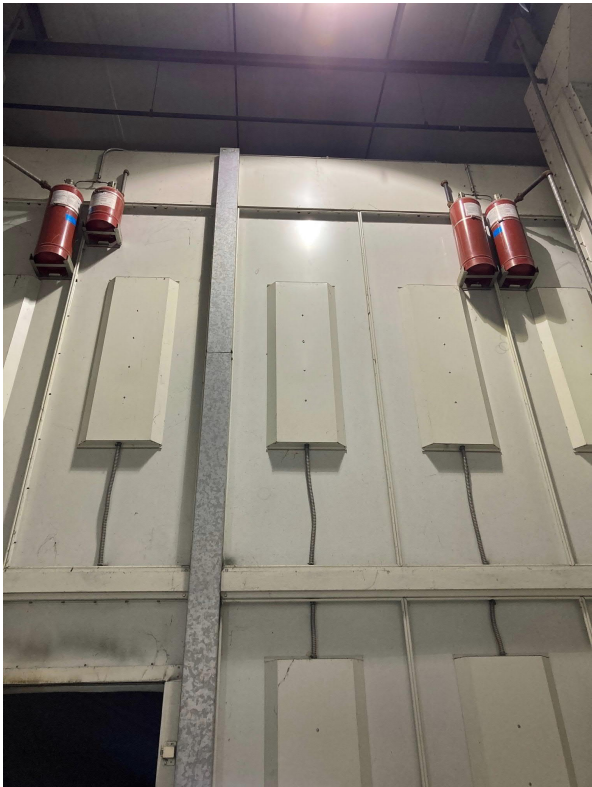
<p>Photograph No. 6</p> <p>Date 6/2/2021 Time</p> <p>Description: Fire suppression system in paint booth charged with dry chemical extinguishers affixed to the wall.</p> <p>Orientation: Unknown</p>
