Preliminary Assessment Report

E.J. Garn Aviation Complex, Utah

Perfluorooctanesulfonic Acid (PFOS) and Perfluorooctanoic
Acid (PFOA) Impacted Sites
ARNG Installations, Nationwide

July 2020

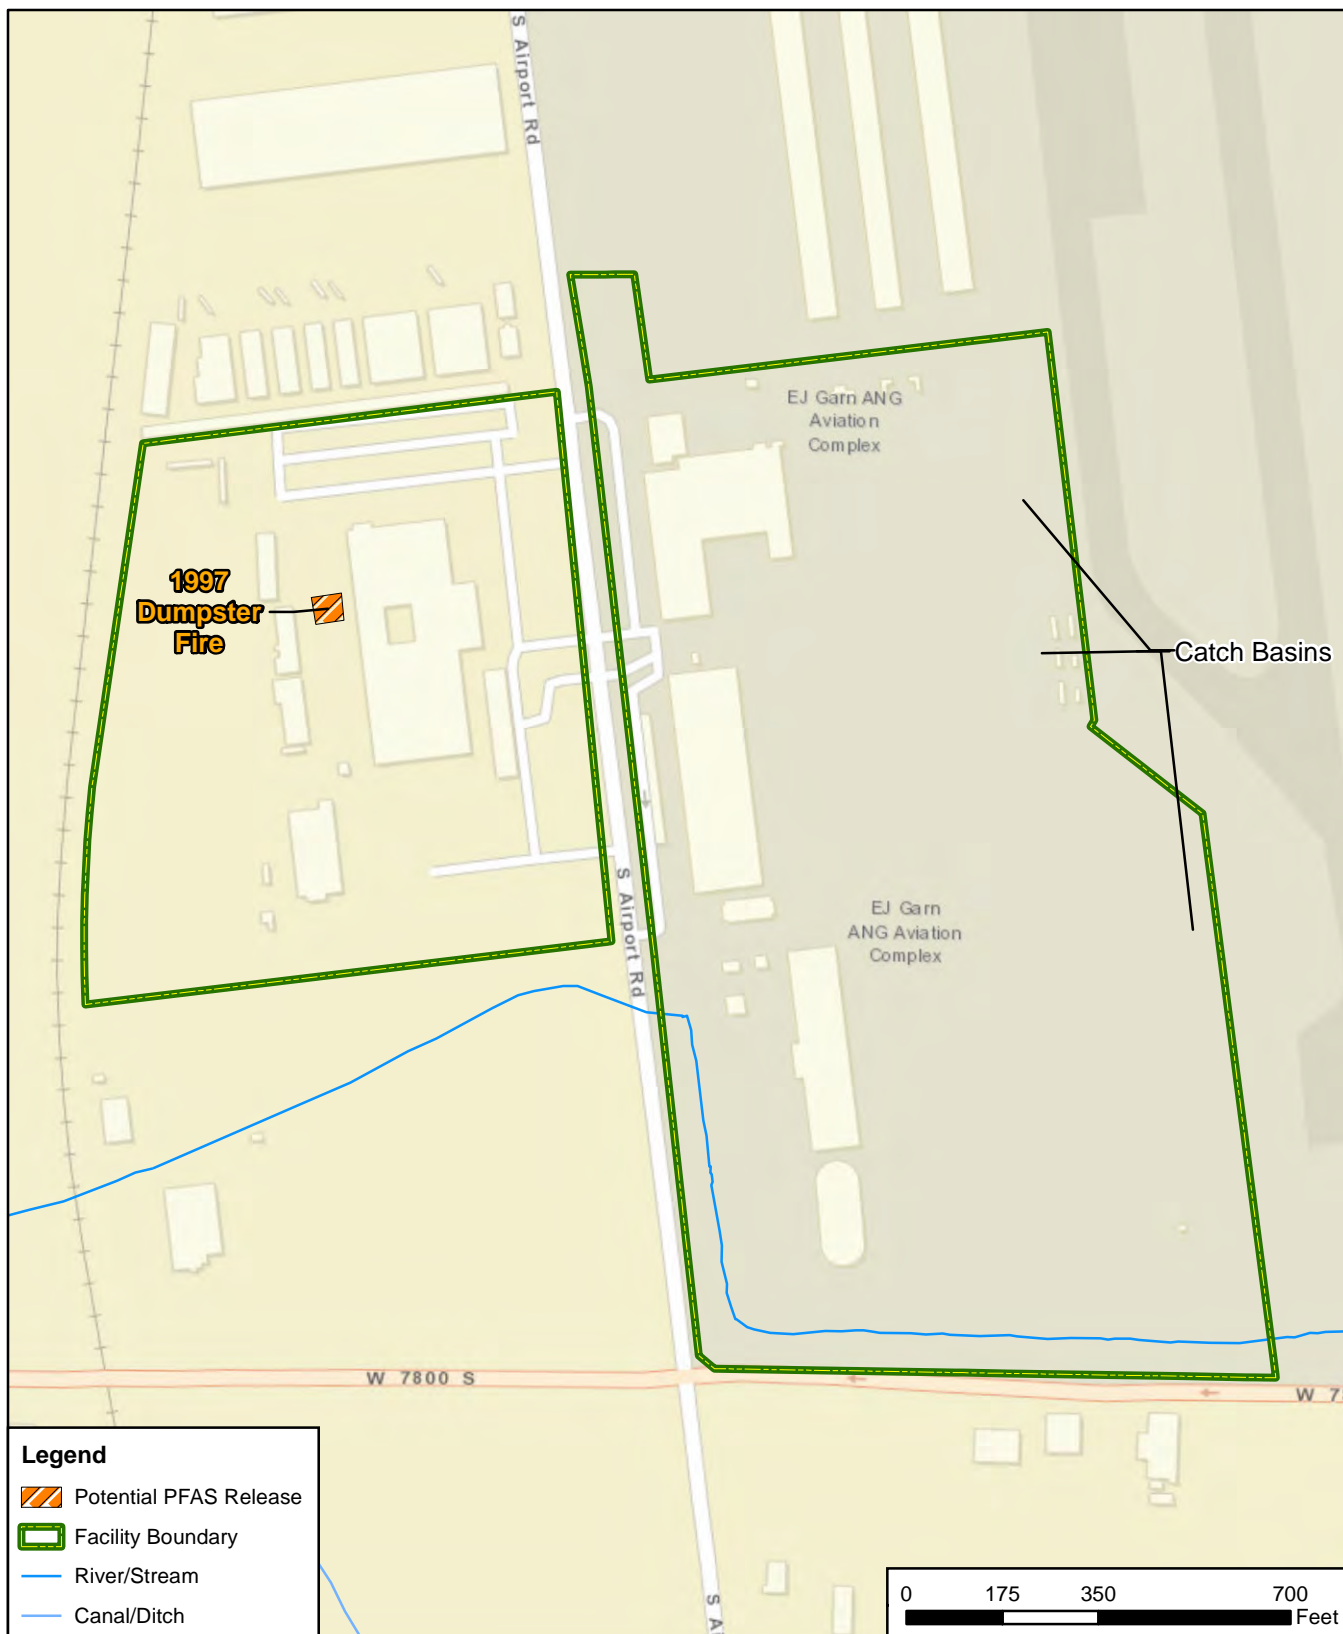
<p>12420 Milestone Center Drive Germantown, MD 20876</p></div><div>Figure 4-1</div></div>	
REVISED	4/30/2020	GIS BY	MS	4/30/2020			
SCALE	1:4,200	CHK BY	AG	4/30/2020			
Base Map: Sources: Esri, HERE, Garmin, USGS, Intermap, INCREMENT P, NRCan, Esri Japan, METI,		PM	RG	4/30/2020

Aircraft emergency services were provided by the West Jordan AASF since at least 1989 to 2007. Two Emergency Response Areas were identified adjacent to the facility, as described in **Section 5 (Figure 4-1)**. Current basic fire protection is provided by the West Jordan Fire Department. Once a year, the municipal fire department simulates a crash at various locations and responds using water. The municipal fire department is located approximately 0.5 miles east of the facility, at 7602 Jordan Landing Blvd, West Jordan, UT 84084.

According to the Safety NCO/HAZMAT Training Manager, there was a dumpster fire at Building 00003 in 1997, which he put out with an AFFF mobile unit. It is unknown how many gallons were discharged. The dumpster fire was approximately located at geographic coordinates 40°36'48.0"N 111°59'58.6"W.

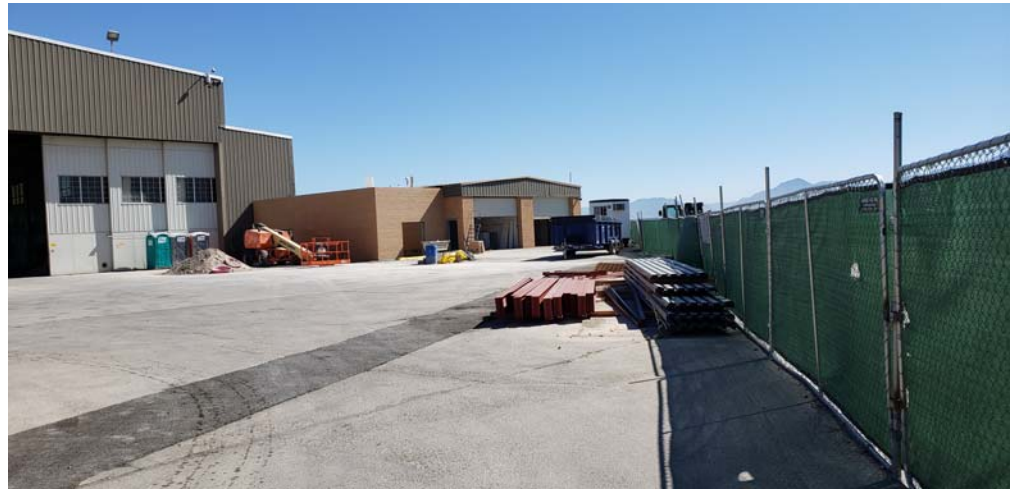
Photograph depicts Building 00001 (under construction) and former fire truck bay.

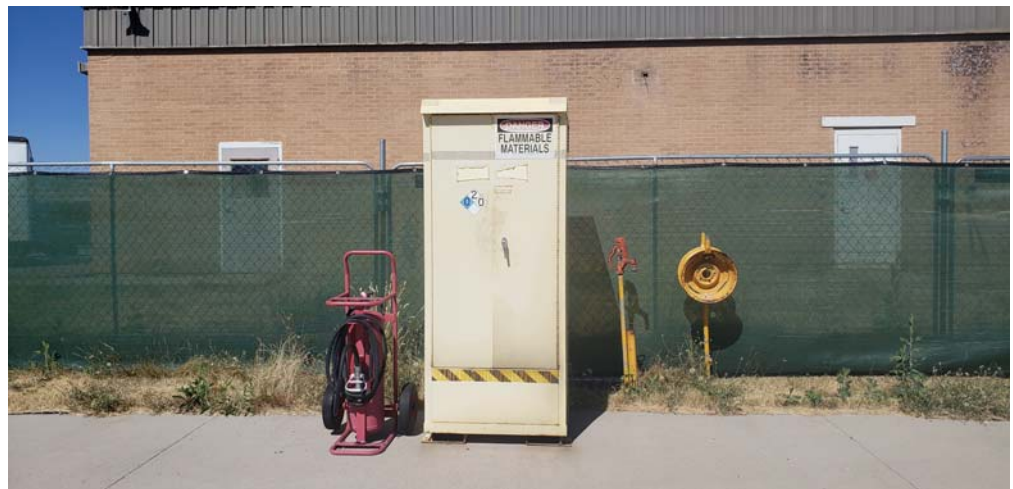
Representative photograph of current fire suppression units scattered around the airfield.

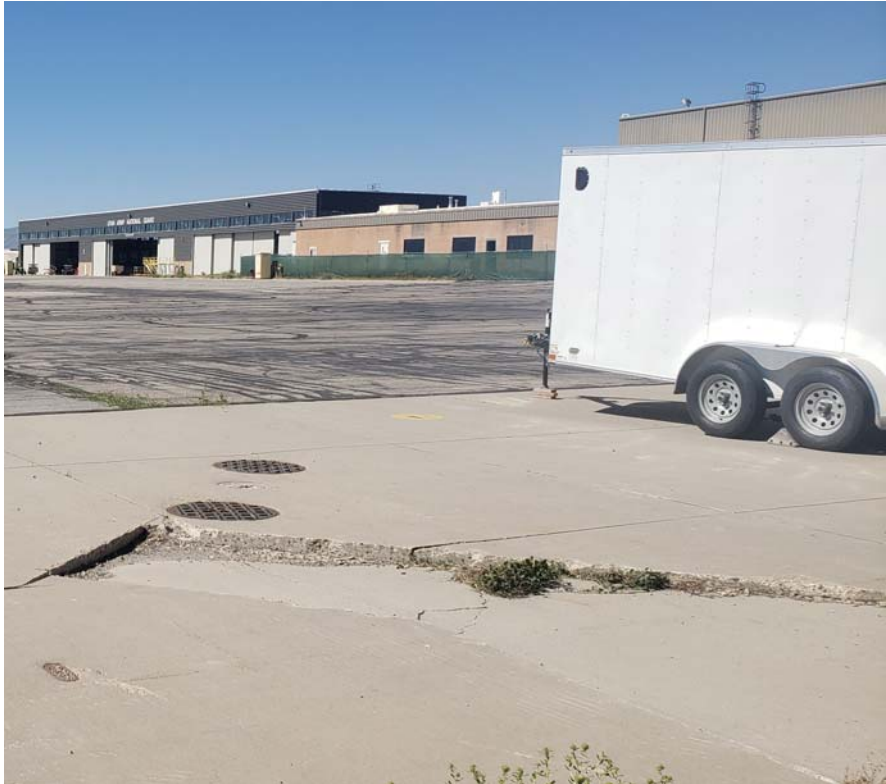
<p>Photograph No. 4</p> <p>Date 7/16/2019 Time 10:50</p> <p>Description: Building 00002 in background, with the area of the Airfield where AFFF evaporated after discharges in foreground.</p> <p>Orientation: Northwest</p>

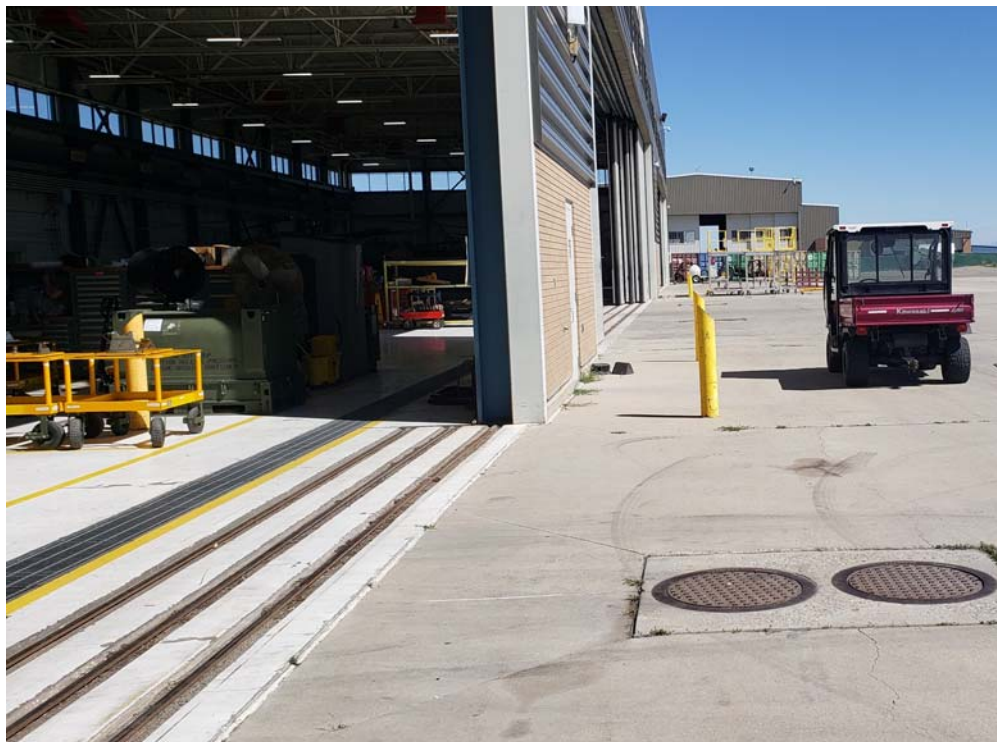
Photograph depicts
trench drains inside
Building 00002 and the
oil/water separator
outside.

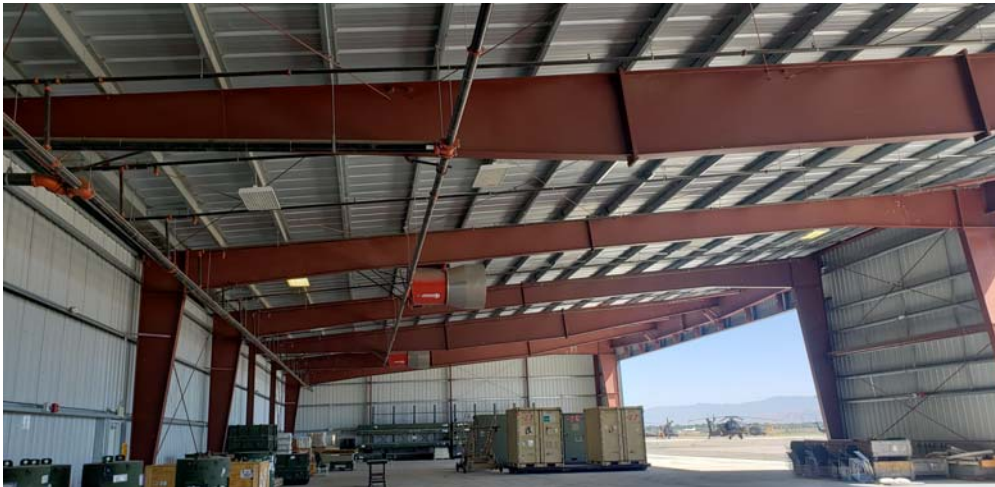
Army National Guard, Preliminary Assessment for PFAS	E.J. Garn Aviation Complex	7563 South 4570 West, West Jordan, UT 84084
<p>Photograph No. 7</p> <p>Date 7/16/2019 Time 10:42</p> <p>Description: Foam discharge locations in Building 00004.</p> <p>Orientation: North</p>

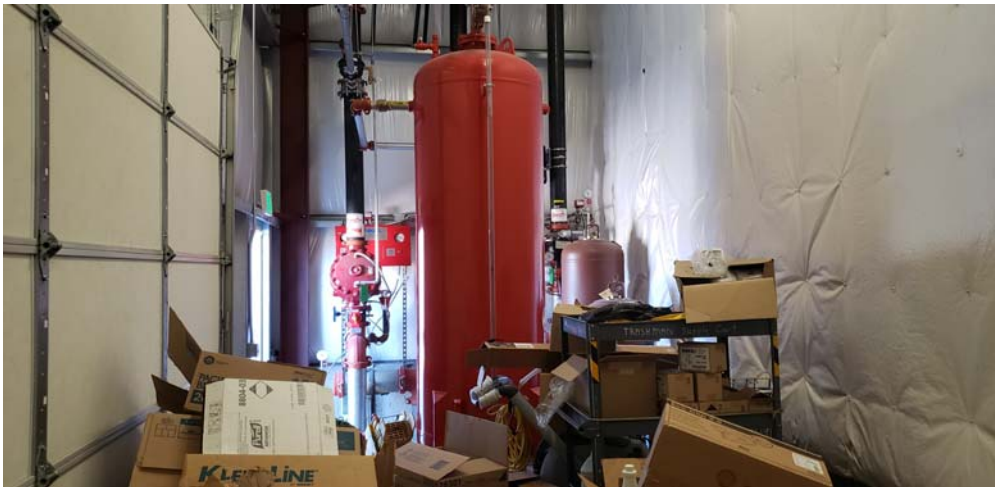
<p>Photograph No. 8</p> <p>Date 7/16/2019 Time 10:46</p> <p>Description: Fire suppression system in Building 00004.</p> <p>Orientation: North</p>

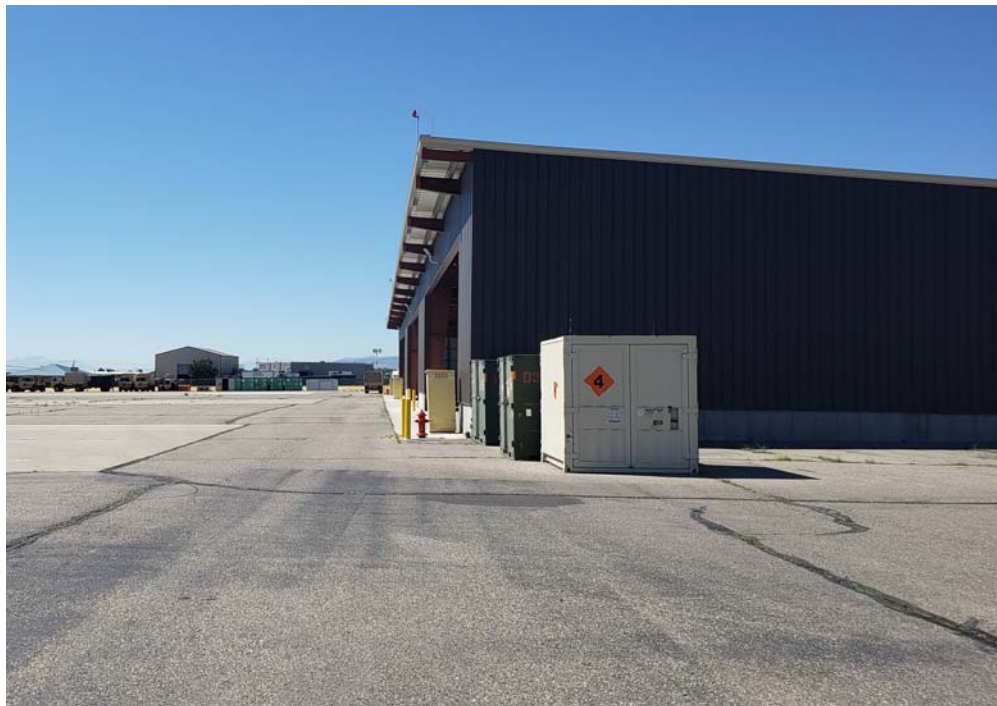
Area of Airfield in front of
Building 00004 where
AFFF evaporated after
system test.

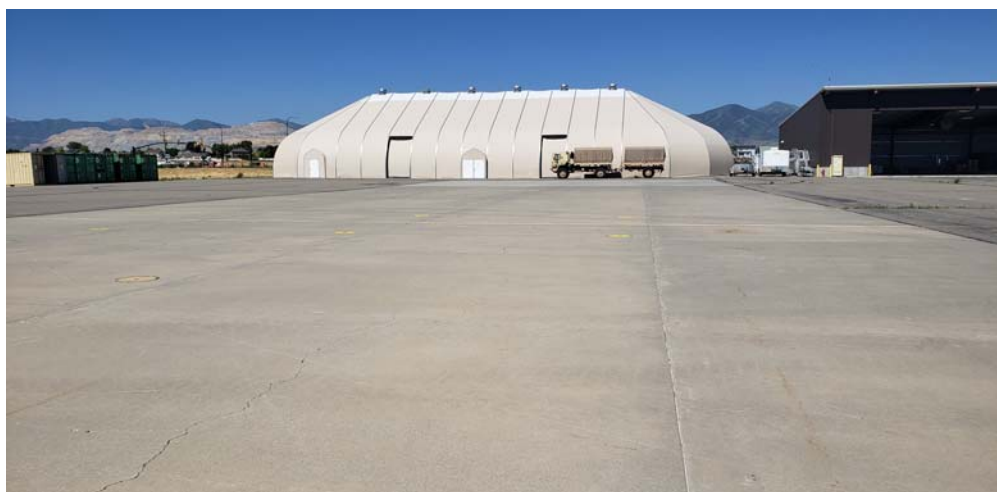
Photograph depicts current
Building 00010 location in
background with former
Building 00010 location
(south side of the airfield)
in the foreground.

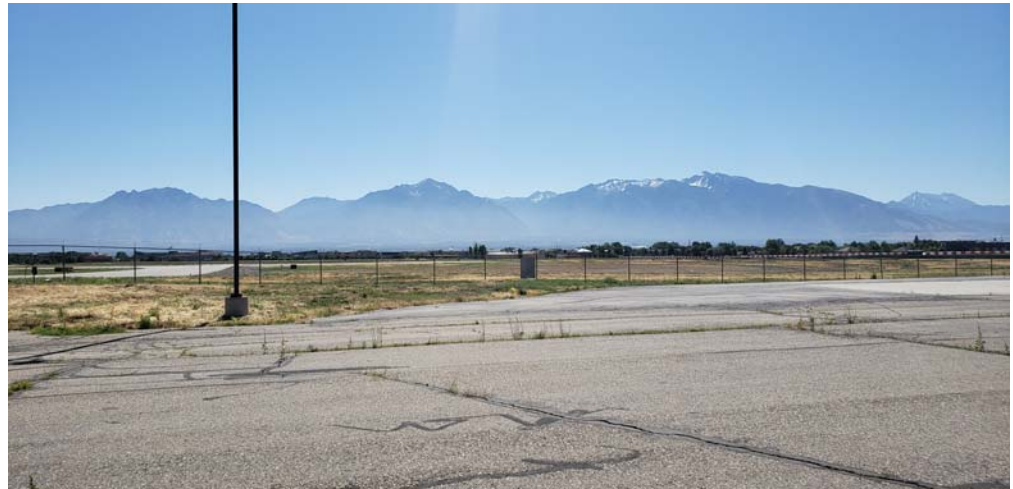
Photograph depicts the
runways east of the facility.

Southeast

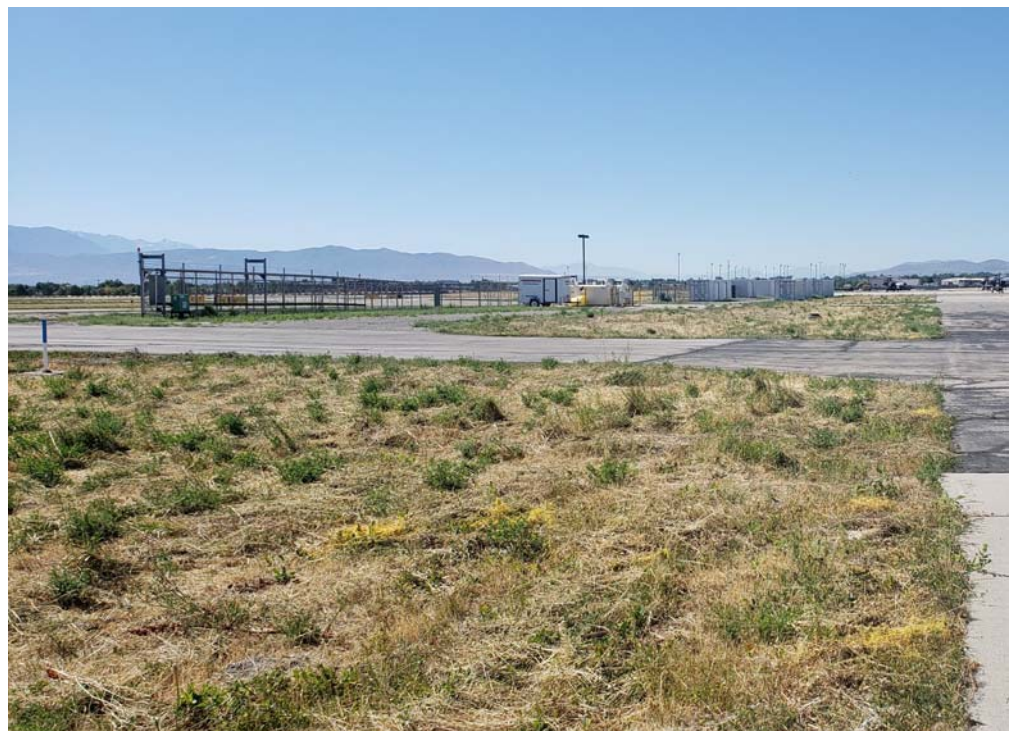
Catch basins on the east side
of the facility viewed from the
north side of the airfield.

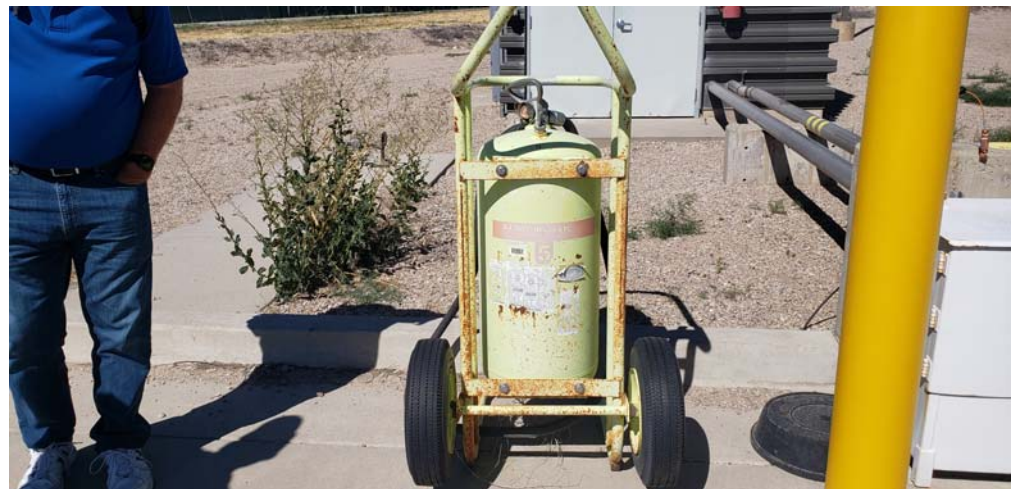
TriMax unit observed at fuel point.

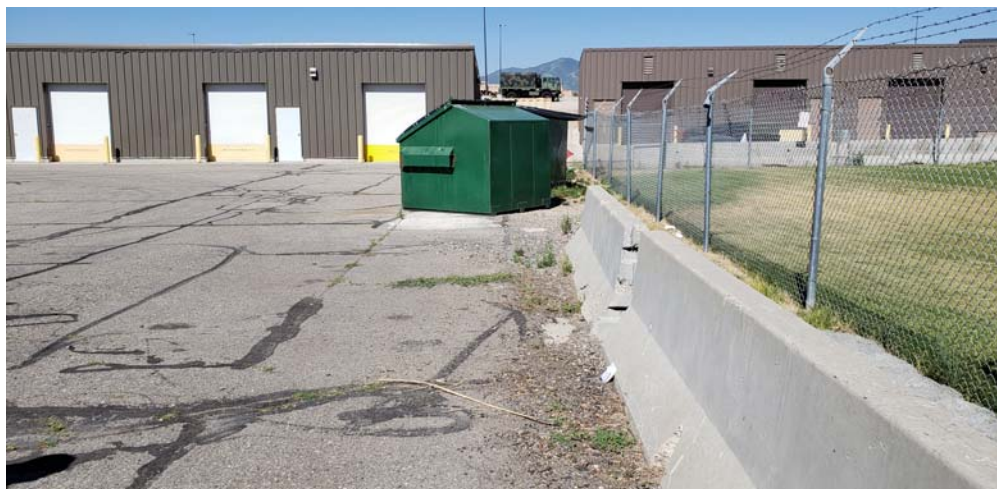
Location of 1997 dumpster
fire at Building 00003.
