FINAL Preliminary Assessment Report Building 835 Wendover Airport, Utah

Perfluorooctanesulfonic Acid (PFOS) and Perfluorooctanoic
Acid (PFOA) Impacted Sites
ARNG Installations, Nationwide

August 2020

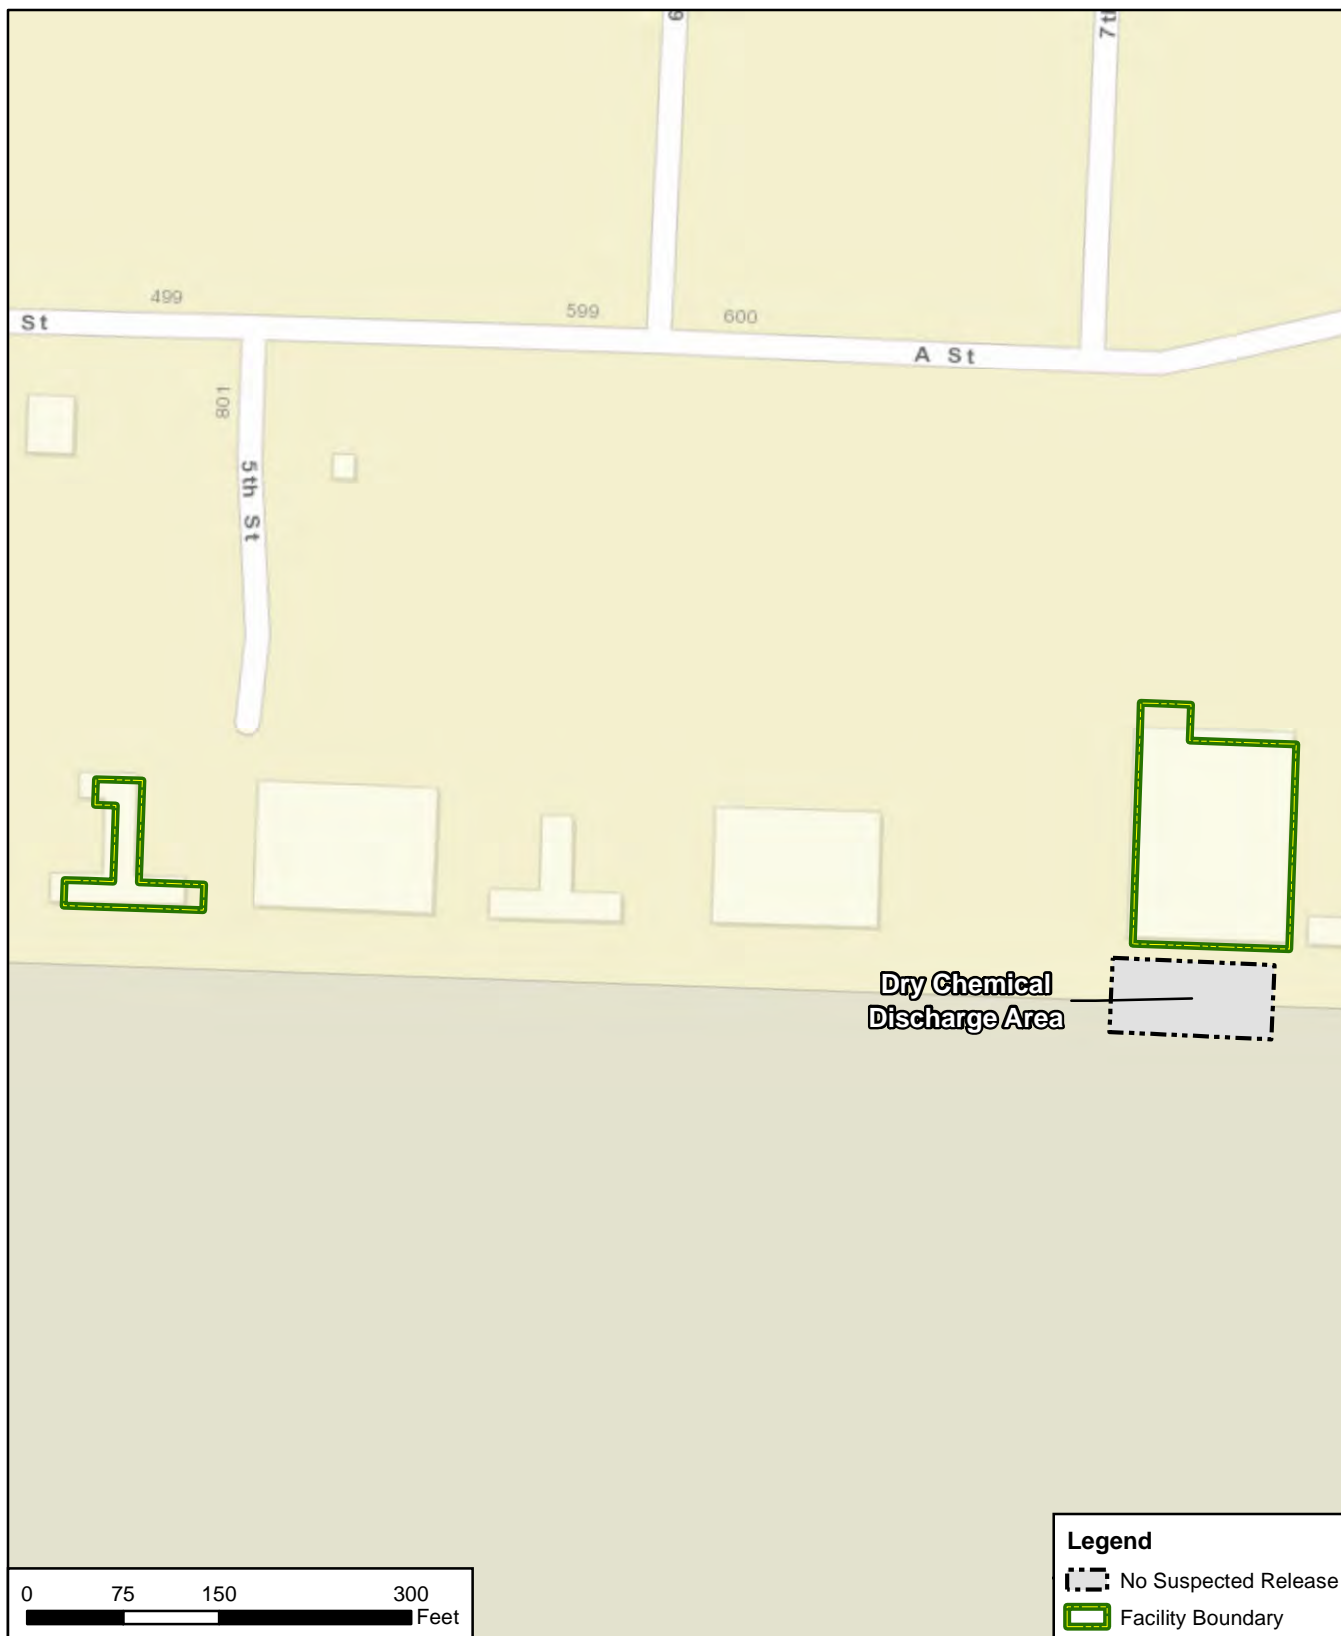
12420 Milestone Center Drive Germantown, MD 20876	Figure 2-1
REVISED	6/25/2020	GIS BY	MS	6/25/2020			
SCALE	1:1,800	CHK BY	AG	6/25/2020			
Base Map: Sources: Esri, HERE, Garmin, USGS, Intermap, INCREMENT P, NRCan, Esri Japan, METI,		PM	RG	6/25/2020

Building 835 does not have a fire suppression system. Fire suppression at the facility would be conducted with handheld Purple K dry chemical units (which are not anticipated to contain PFAS), or the UTARNG would receive assistance from the adjacent Wendover Airport fire station. UTARNG reported that training with Purple K is conducted annually to familiarize personnel with using the handheld units at the facility. Approximately six people spray the units on the ground outside the facility each year (**Figure 2-1**).

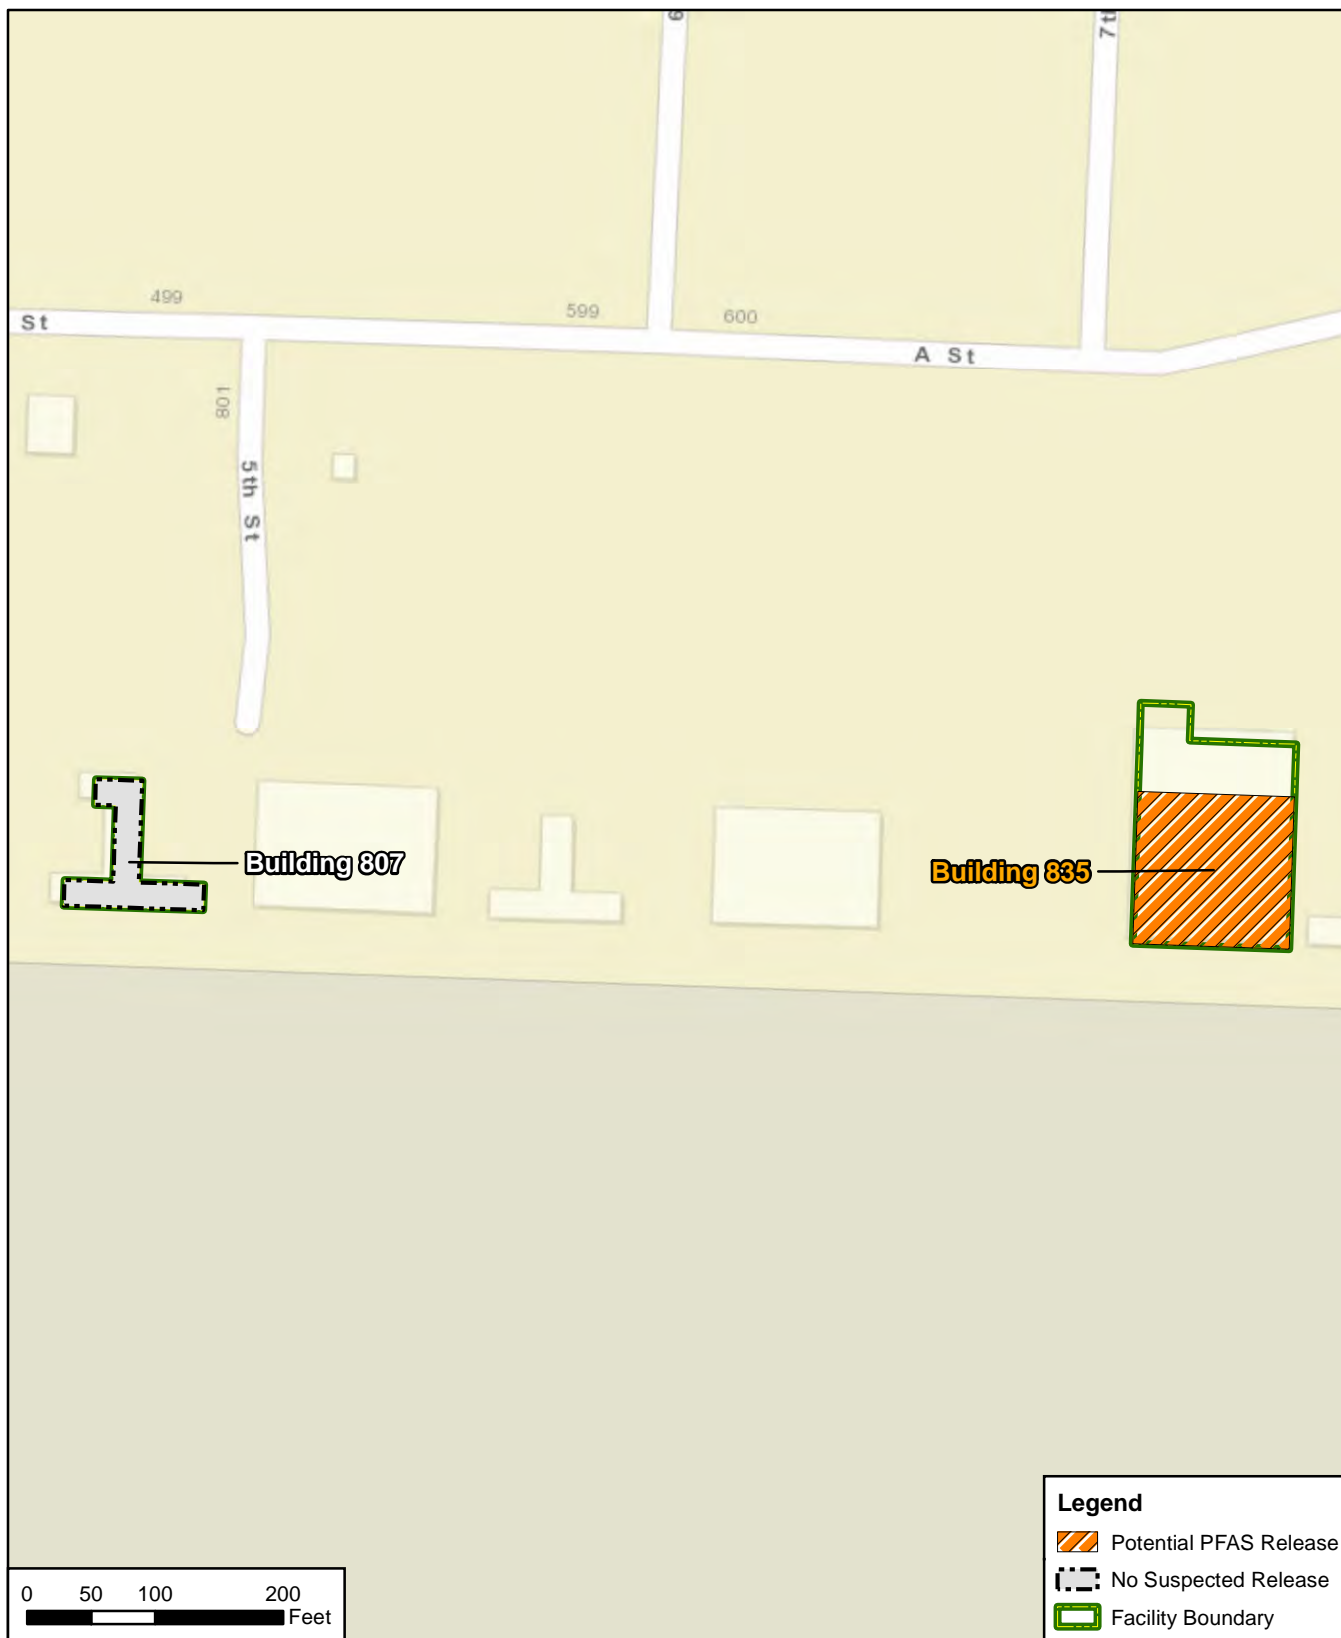
Figure 3-1

In addition to FTAs, the PA evaluated areas where PFAS-containing materials may have been broadly used, stored, or disposed. This may include buildings with fire suppression systems, paint booths, AFFF storage areas, and areas of compliance demonstration. Information on these features obtained during the PA are included in **Appendices A** and **B**. One non-FTA where AFFF could have been potentially stored and/or released was investigated during the PA, as described below and shown on **Figure 3-1**.

Two mobile AFFF tanks were observed on either side of Building 835. According to the Facility Manager, the tanks were being stored for the aviation unit at West Jordan, Utah. Based on interviews and the photographs included with the Phase I ESA conducted in 2014, the mobile tanks were brought onsite after 2014. The mobile tanks were presumably full but have never been discharged, filled, or serviced, and are not intended for future use at the facility.

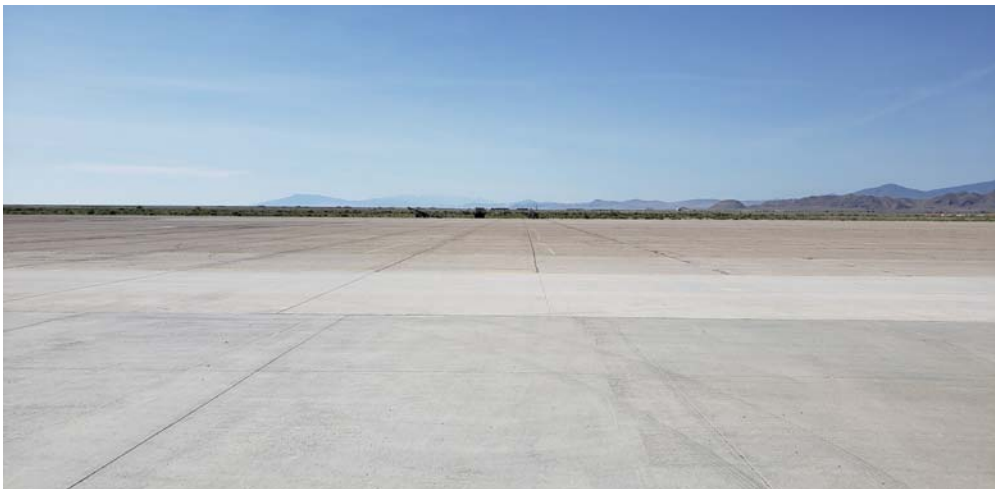
Date 7/17/2019 Time 10:51			
Description: Photograph depicts the exterior pavement/runway to the south of the facility.			
Orientation: South			
Photograph No. 2

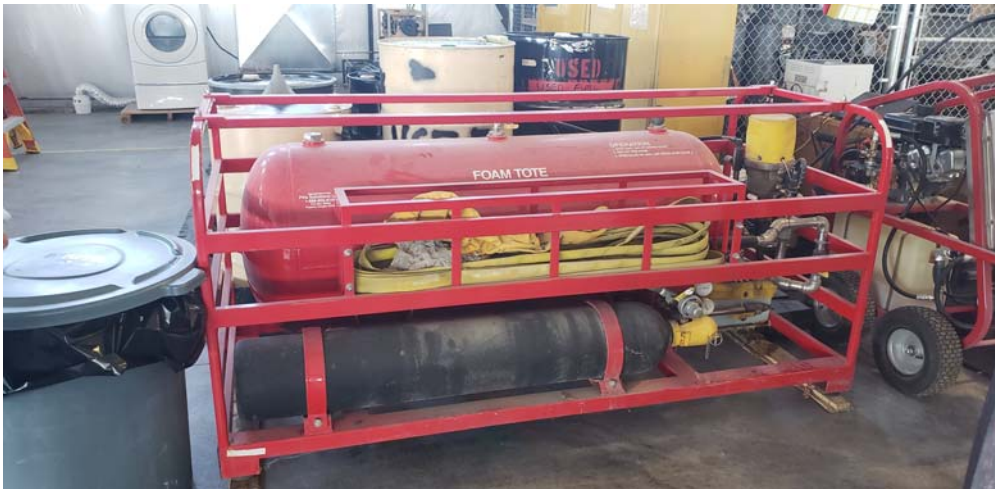
Army National Guard, Preliminary Assessment for PFAS		Building 835	4th St. Wendover, UT 84083
Photograph No. 1

Date 7/17/2019 Time 10:47			
Description: Photograph depicts one of two mobile AFFF tanks in the hangar.			
Orientation: West

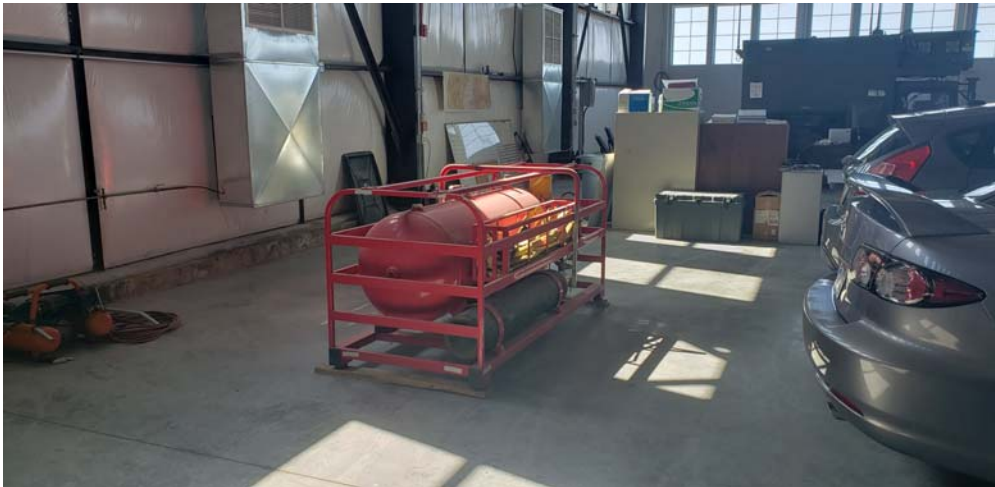
Army National Guard, Preliminary Assessment for PFAS		Building 835	4th St. Wendover, UT 84083
Photograph No. 3

Date 7/17/2019 Time 10:48			
Description: Photograph depicts one of two mobile AFFF tanks observed in the hangar.			
Orientation: Southeast			
Photograph No. 4

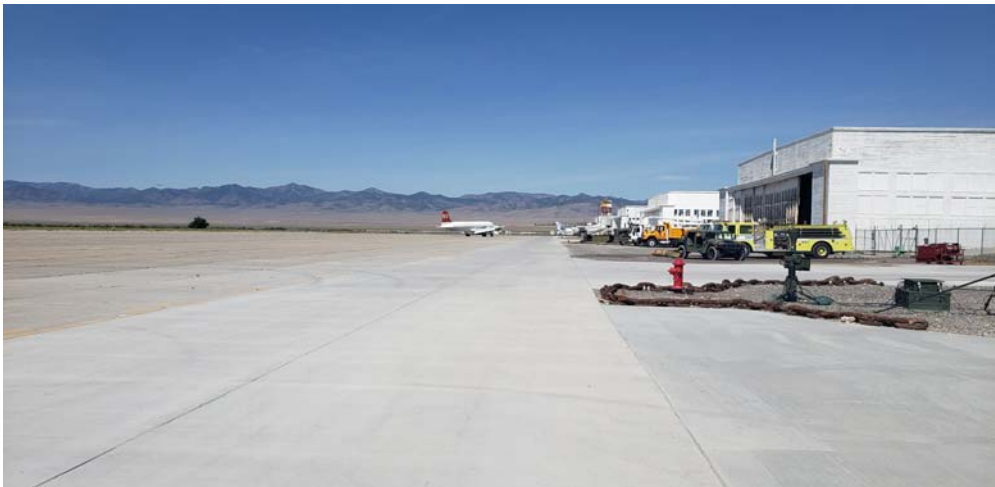
Date 7/17/2019 Time 10:51			
Description: Photograph depicts the west (municipal) portion of the Wendover Airport, with fire station and truck to the right.			
Orientation: West
