Final Preliminary Assessment Report South Burlington Army Aviation Support Facility/Readiness Center Burlington, Vermont

Perfluorooctane-Sulfonic Acid (PFOS) and Perfluorooctanoic
Acid (PFOA) Impacted Sites
ARNG Installations, Nationwide

April 2019

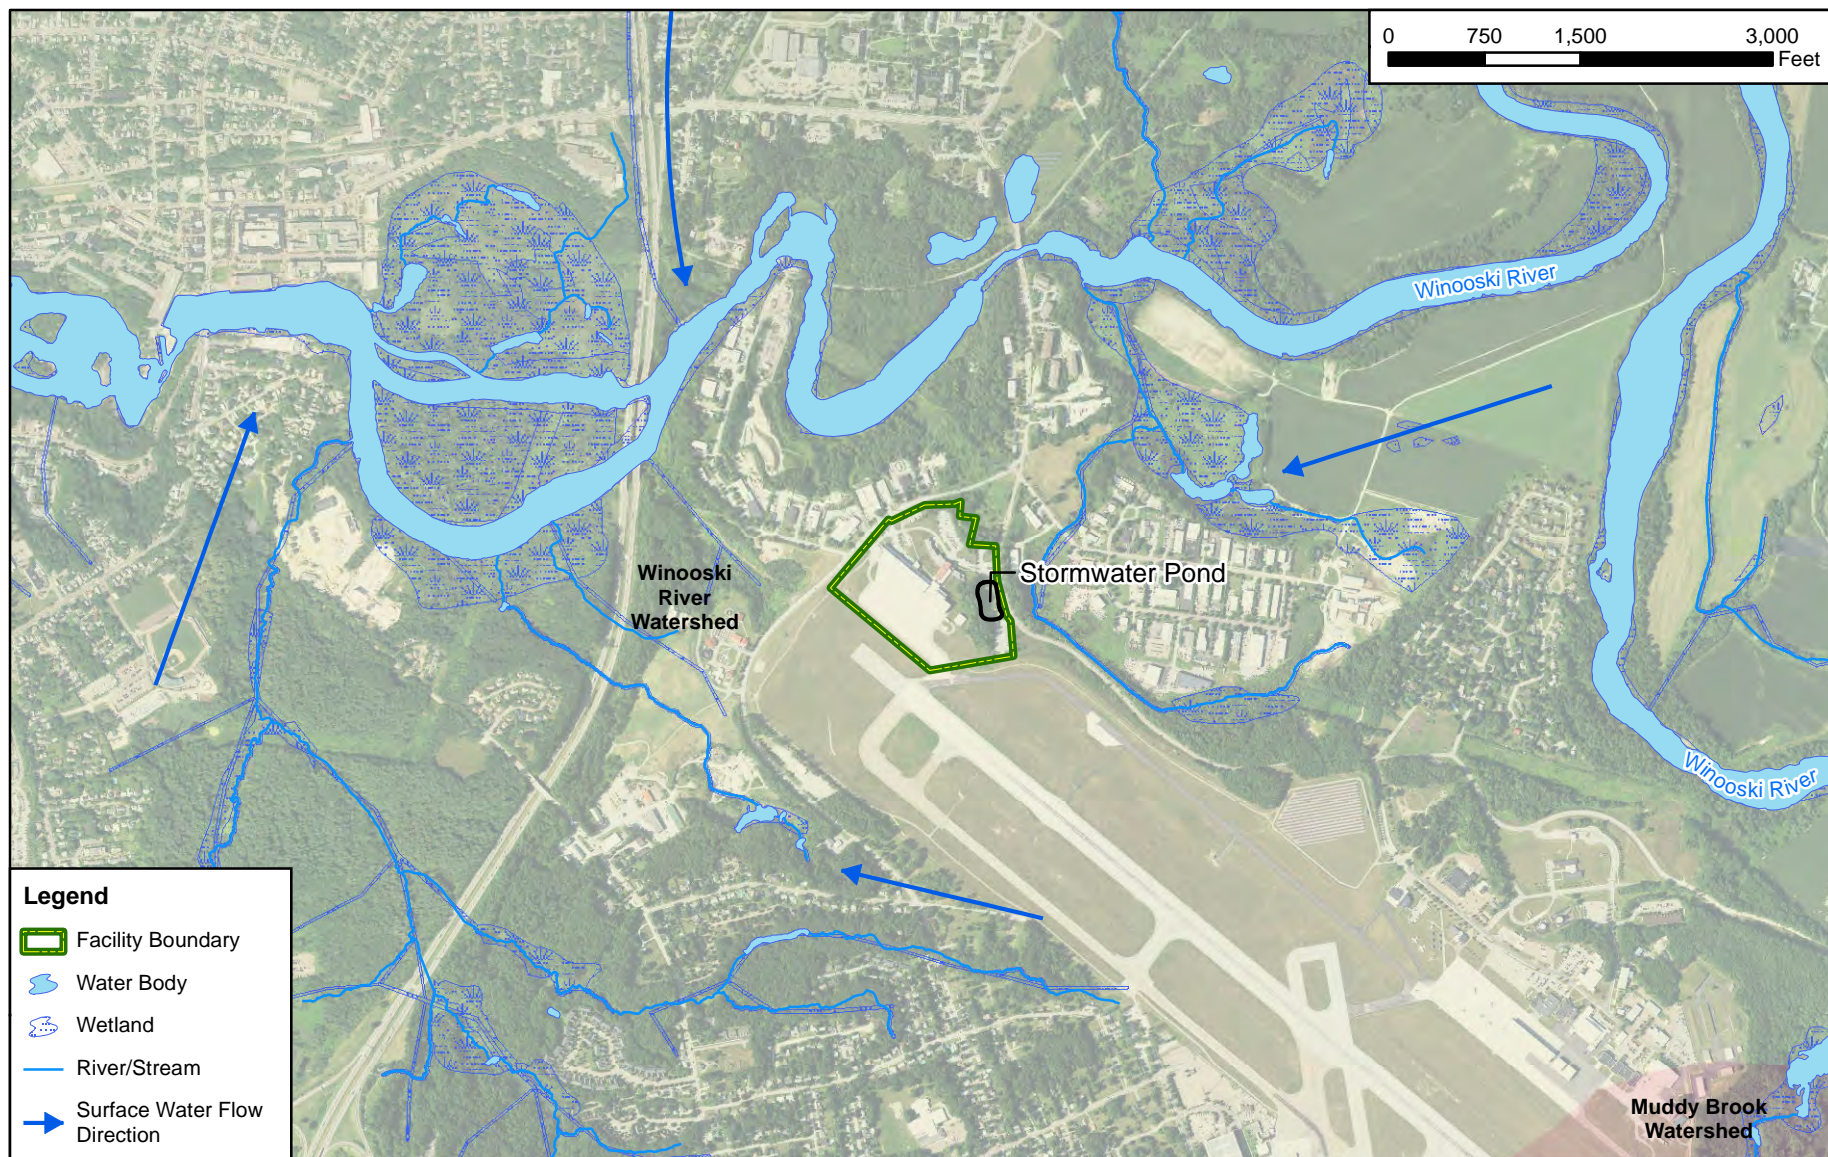
12420 Milestone Center Drive Germantown, MD 20876</div>	Figure 1-3
SCALE		1:18,000	CHK BY	JW		3/14/2019			
Base Map: USGS The National Map: Imagery			PM	RG		3/14/2019

Several small, unnamed drainages located west of the site within approximately 1,000 feet flow generally northwestward and enter the Winooski River approximately 0.5 miles northwest of the facility boundary. Another small, unnamed drainage located less than 500 feet east of the facility flows generally northward and enters the Winooski River approximately 0.3 miles northeast of the facility boundary (AFCEC, 2015). Several wetlands areas have been designated to the east and west within approximately 1,000 feet of the facility (USFWS, 2018). Surface drainage features do not originate on the facility. Regional watersheds and surface drainage features from the surrounding area are presented in **Figure 1-3**.

No naturally occurring surface water features are located on So. Burlington AASF/RC (Marin Environmental Inc., 2001a); however, one artificial stormwater pond is situated along the eastern boundary of the facility. The stormwater pond was presumably constructed at the same time as the AASF/RC facility. The pond is divided into two sections and is fed by stormwater runoff from the AASF building, parking areas, and helipad via drainage ditches and a network of catch basins. The majority of surface water runoff from the facility drains to the stormwater pond, which drains

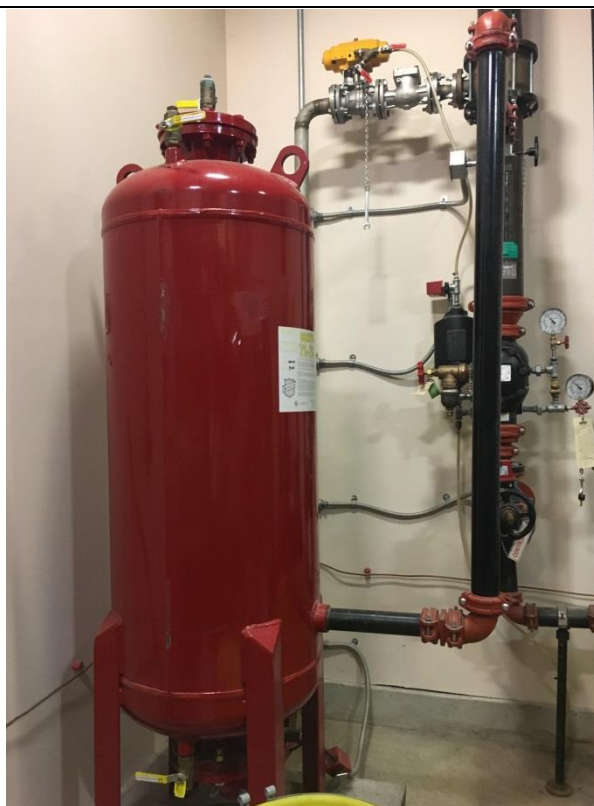
View of AFFF AST stored in
the POL storage room.

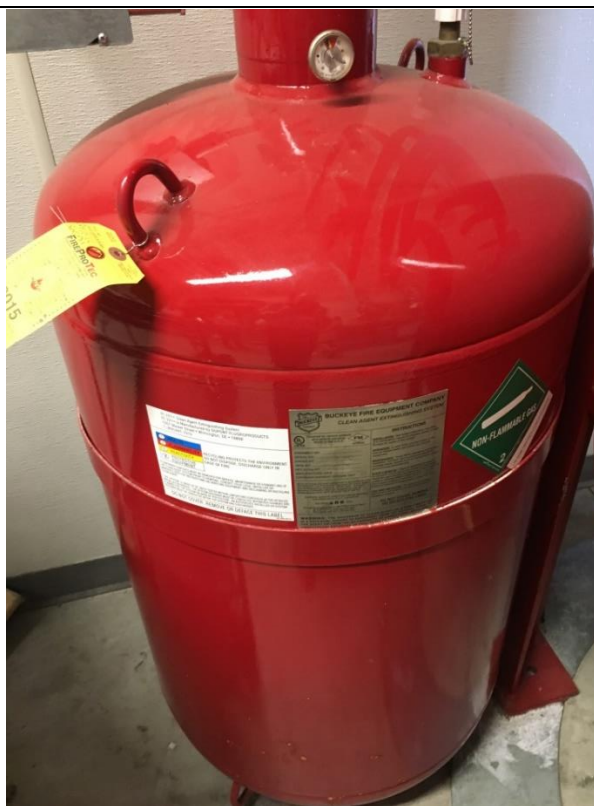
View of AST used to
pressurize fire suppression
system.

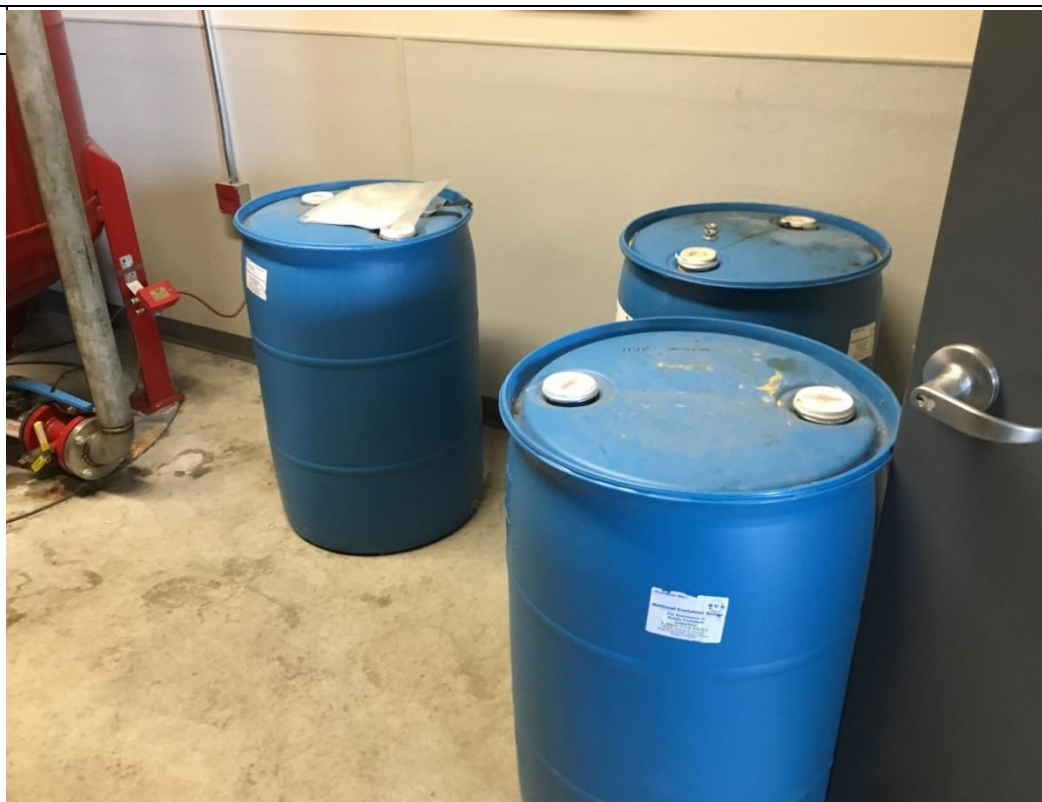
Photograph No. 4

View of three 55-gallon
plastic containers stored in the
fire suppression system closet.

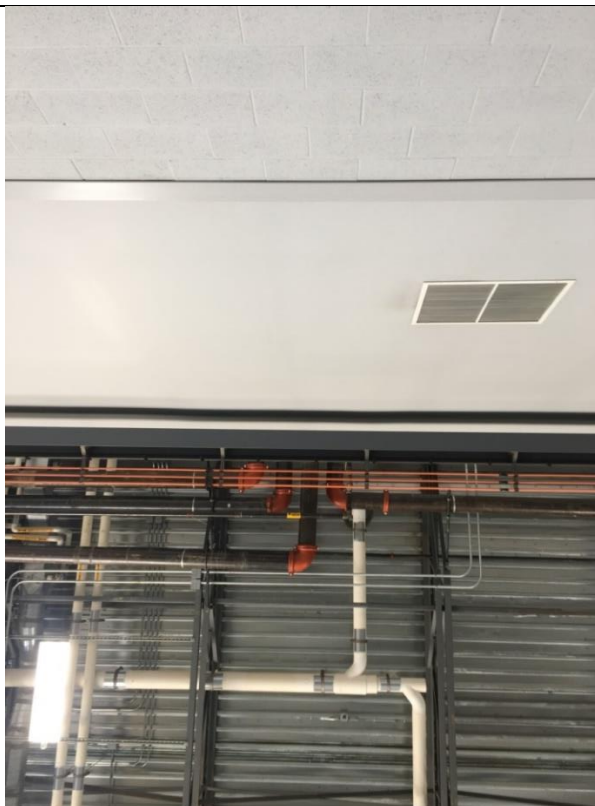
Photograph No. 6

View of fire suppression system piping at ceiling level.

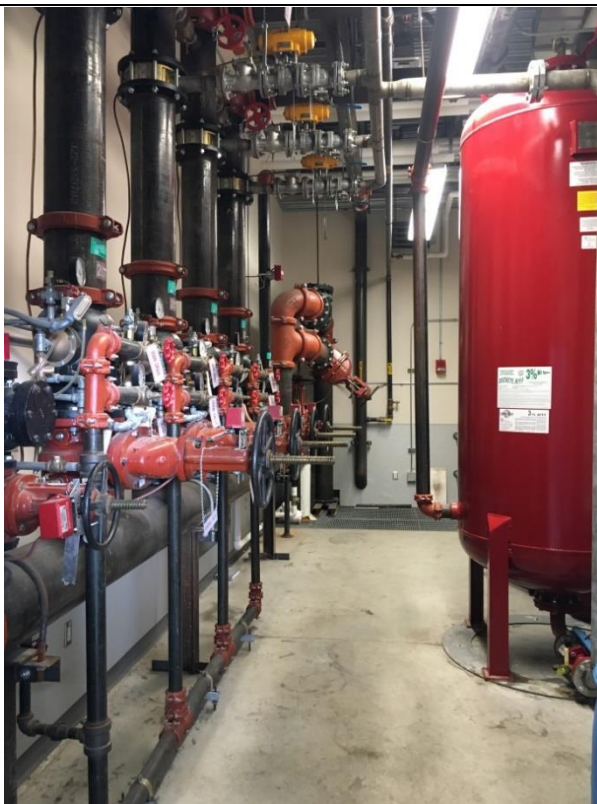
View of the fire suppression control room AFFF AST and fire suppression system piping components. This system serves the hangar.

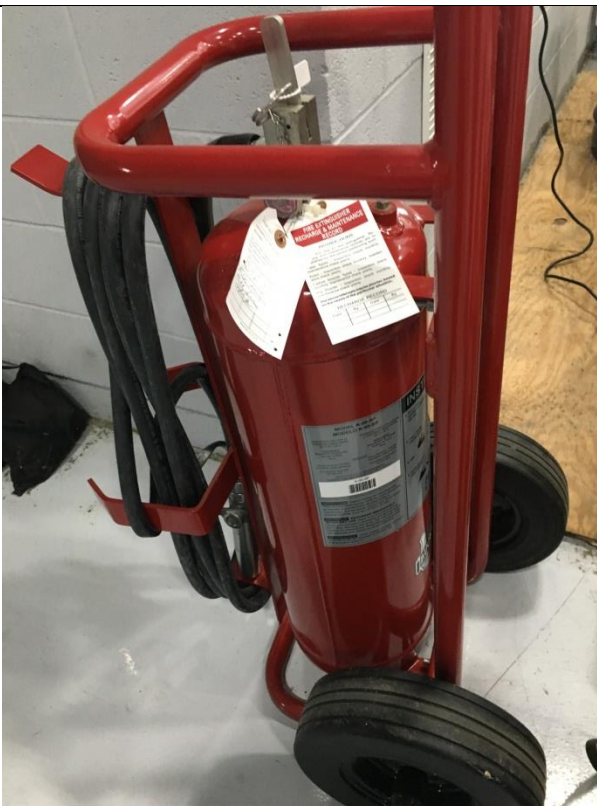
Photograph No. 8

View of carts stored in hangar containing dry chemical fire retardant.
