FINAL Preliminary Assessment Report Chesterfield Limited Army Aviation Support Facility (AASF), Virginia Virginia Army National Guard

Perfluorooctanesulfonic Acid (PFOS) and Perfluorooctanoic
Acid (PFOA) Impacted Sites
ARNG Installations, Nationwide

July 2020

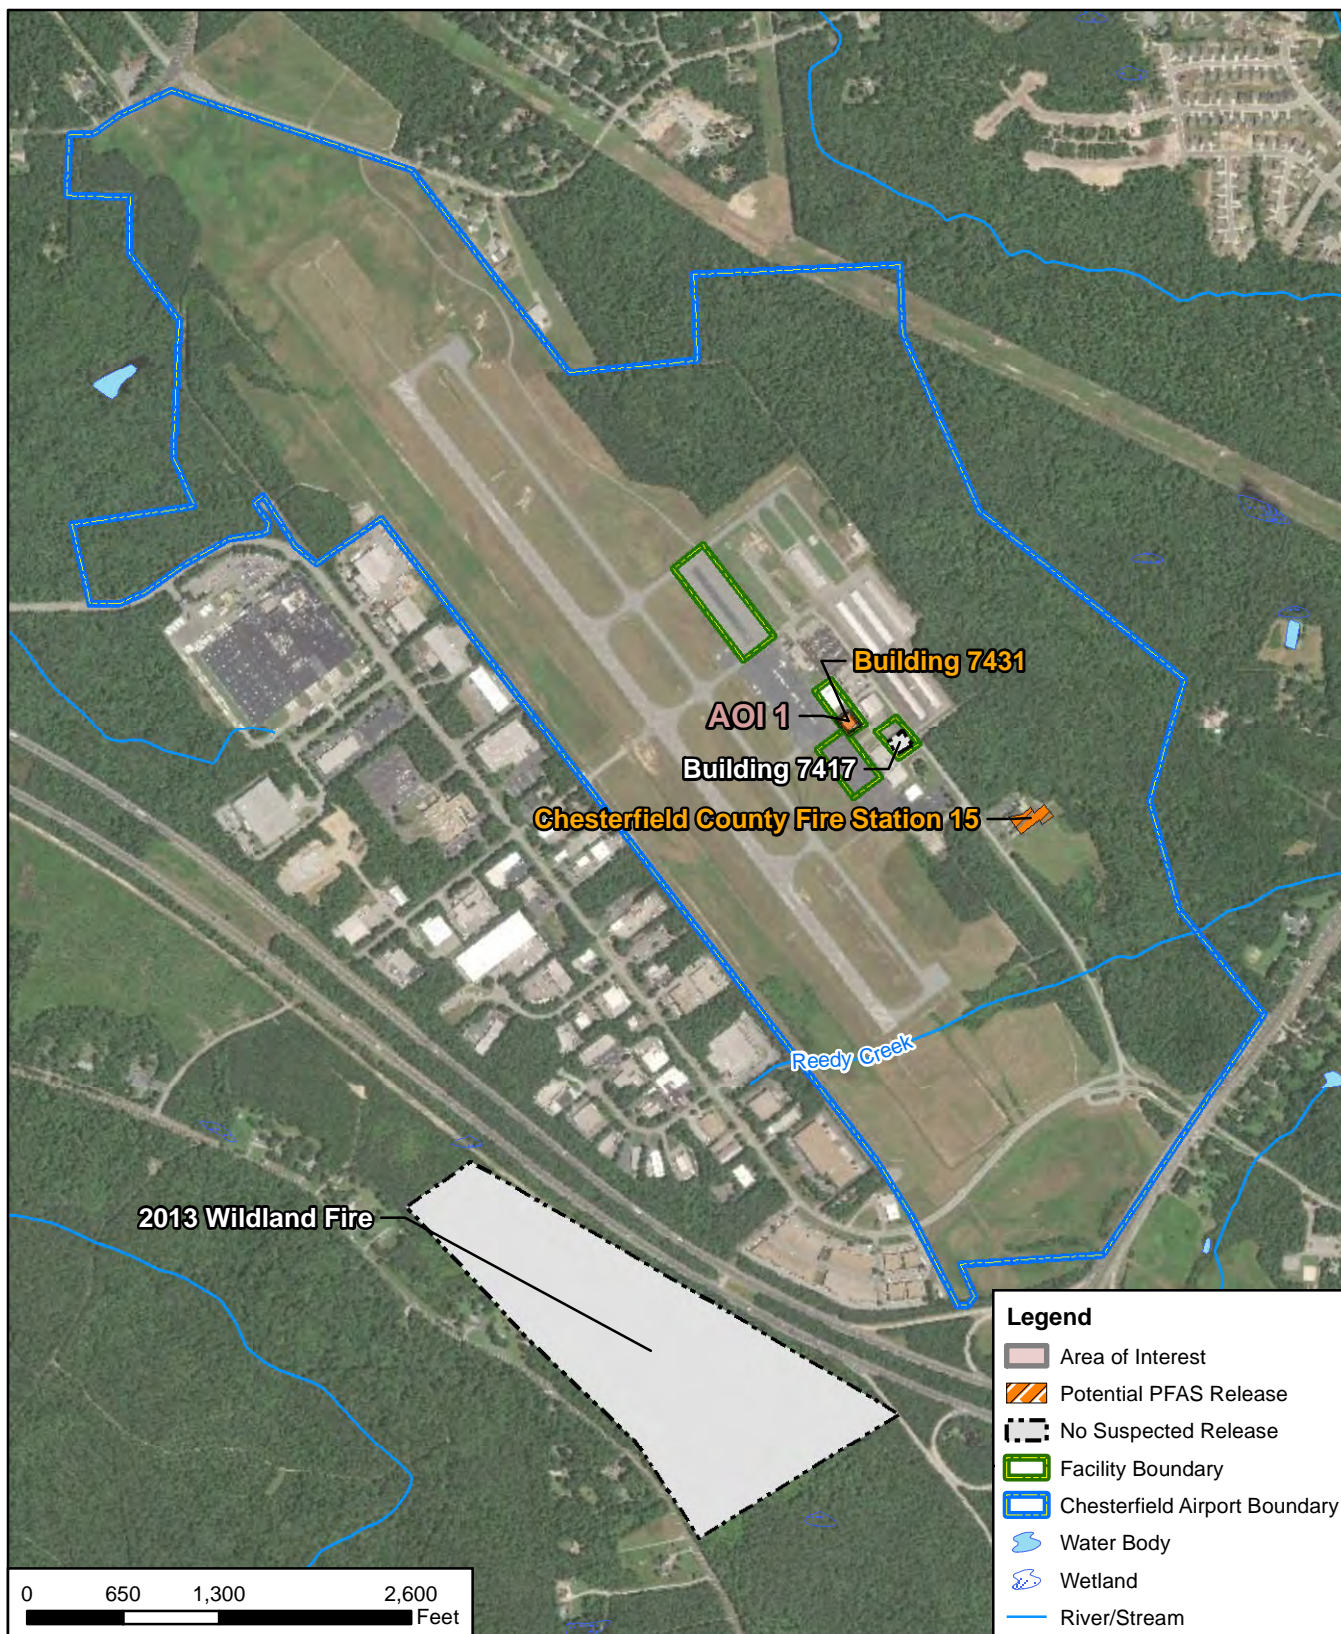
Figure ES-1

One AOI related to potential PFAS release was identified Chesterfield Limited AASF based on PA data (**Figure ES-1**) and is summarized in **Table ES-1** below:

Summary of Findings

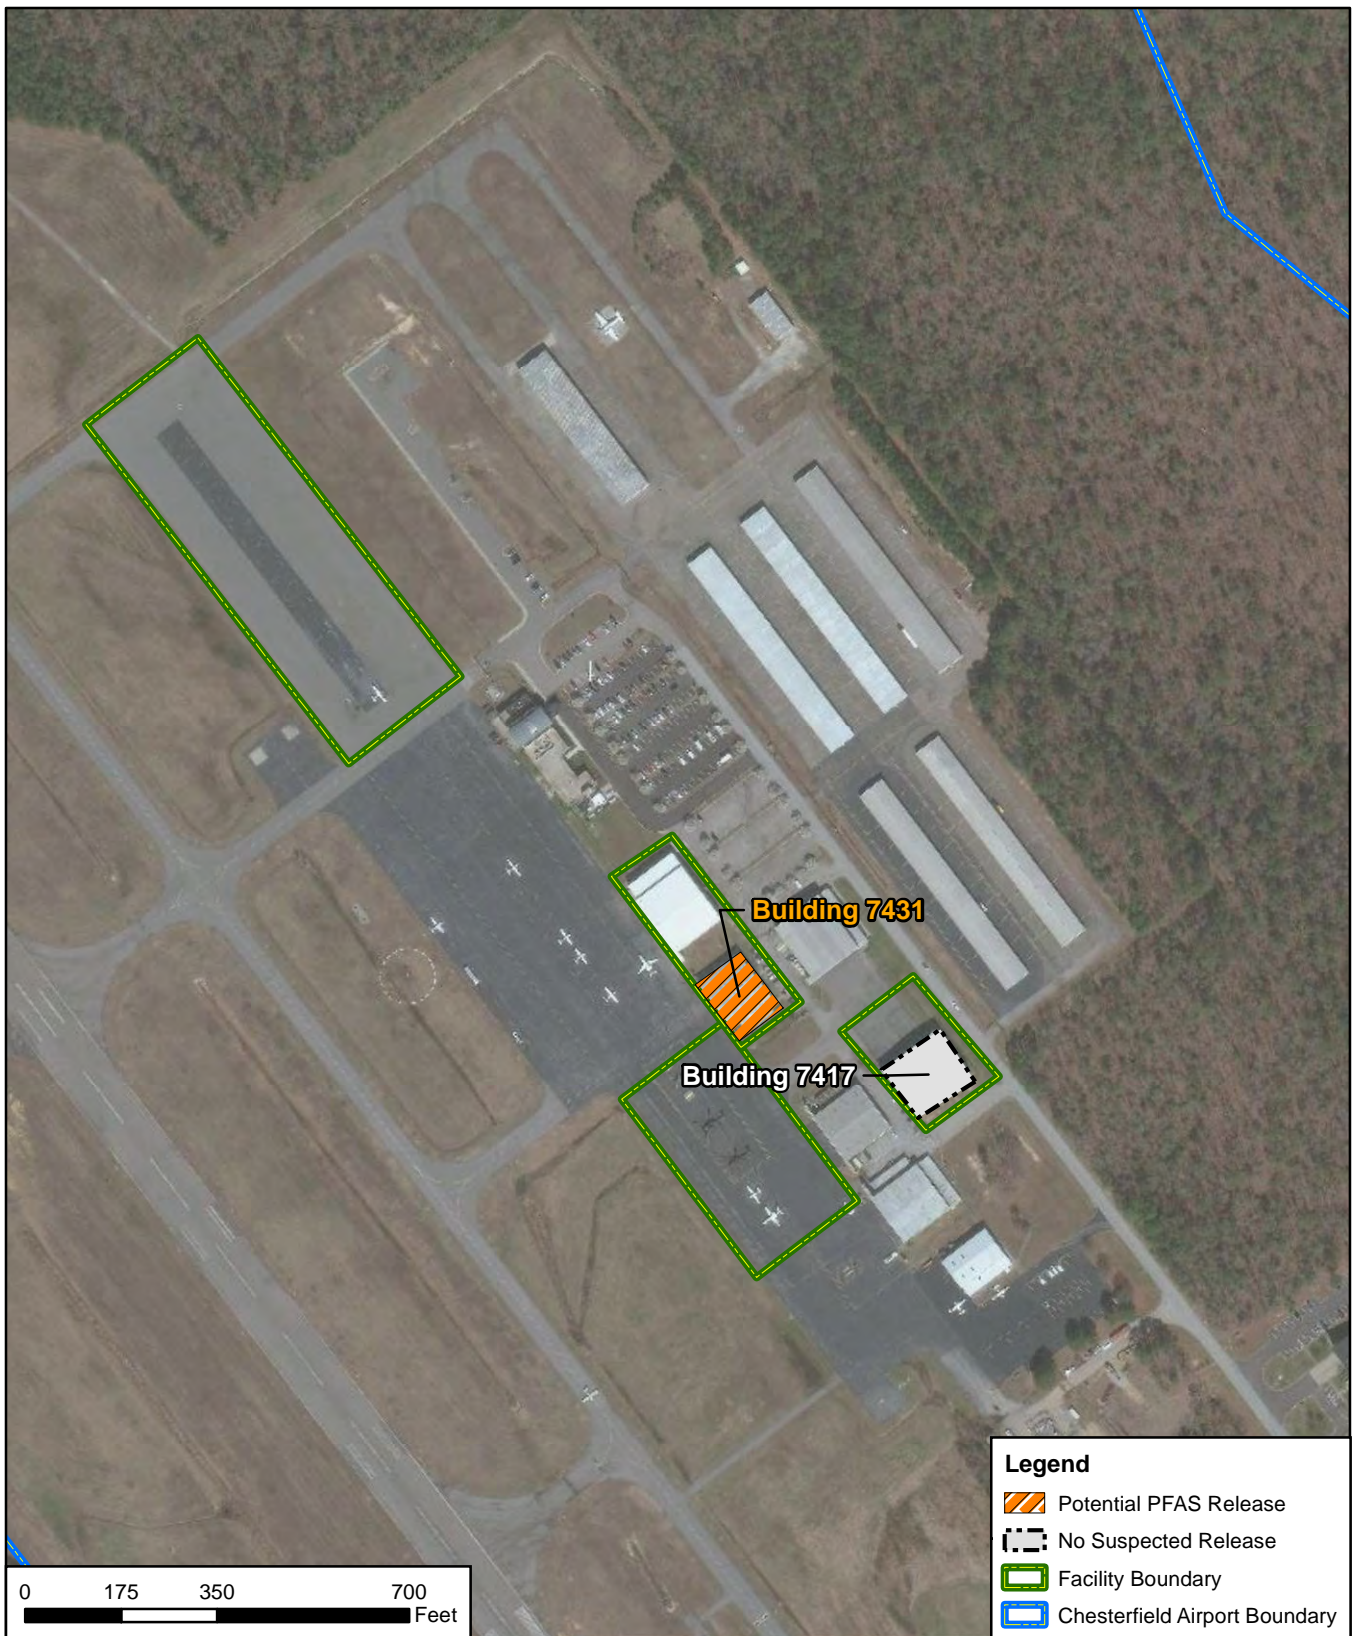
12420 Milestone Center Drive Germantown, MD 20876	Figure 3-1
REVISED	4/30/2020	GIS BY	MS	4/30/2020			
SCALE	1:4,200	CHK BY	BN	4/30/2020			
Base Map: Source: Esri, DigitalGlobe, GeoEye, Earthstar Geographics, CNES/Airbus DS, USDA, USGS,		PM	RG	4/30/2020

In addition to FTAs, the PA evaluated areas where PFAS-containing materials may have been broadly used, stored, or disposed. This may include buildings with fire suppression systems, paint booths, AFFF storage areas, and areas of compliance demonstrations. Information on these features obtained during the PA are included in **Appendices A** and **B**. Two non-FTAs where AFFF was stored and/or potentially released were identified during the PA. A description of each non-FTA is presented below, and the non-FTAs are shown on **Figure 3-1**.

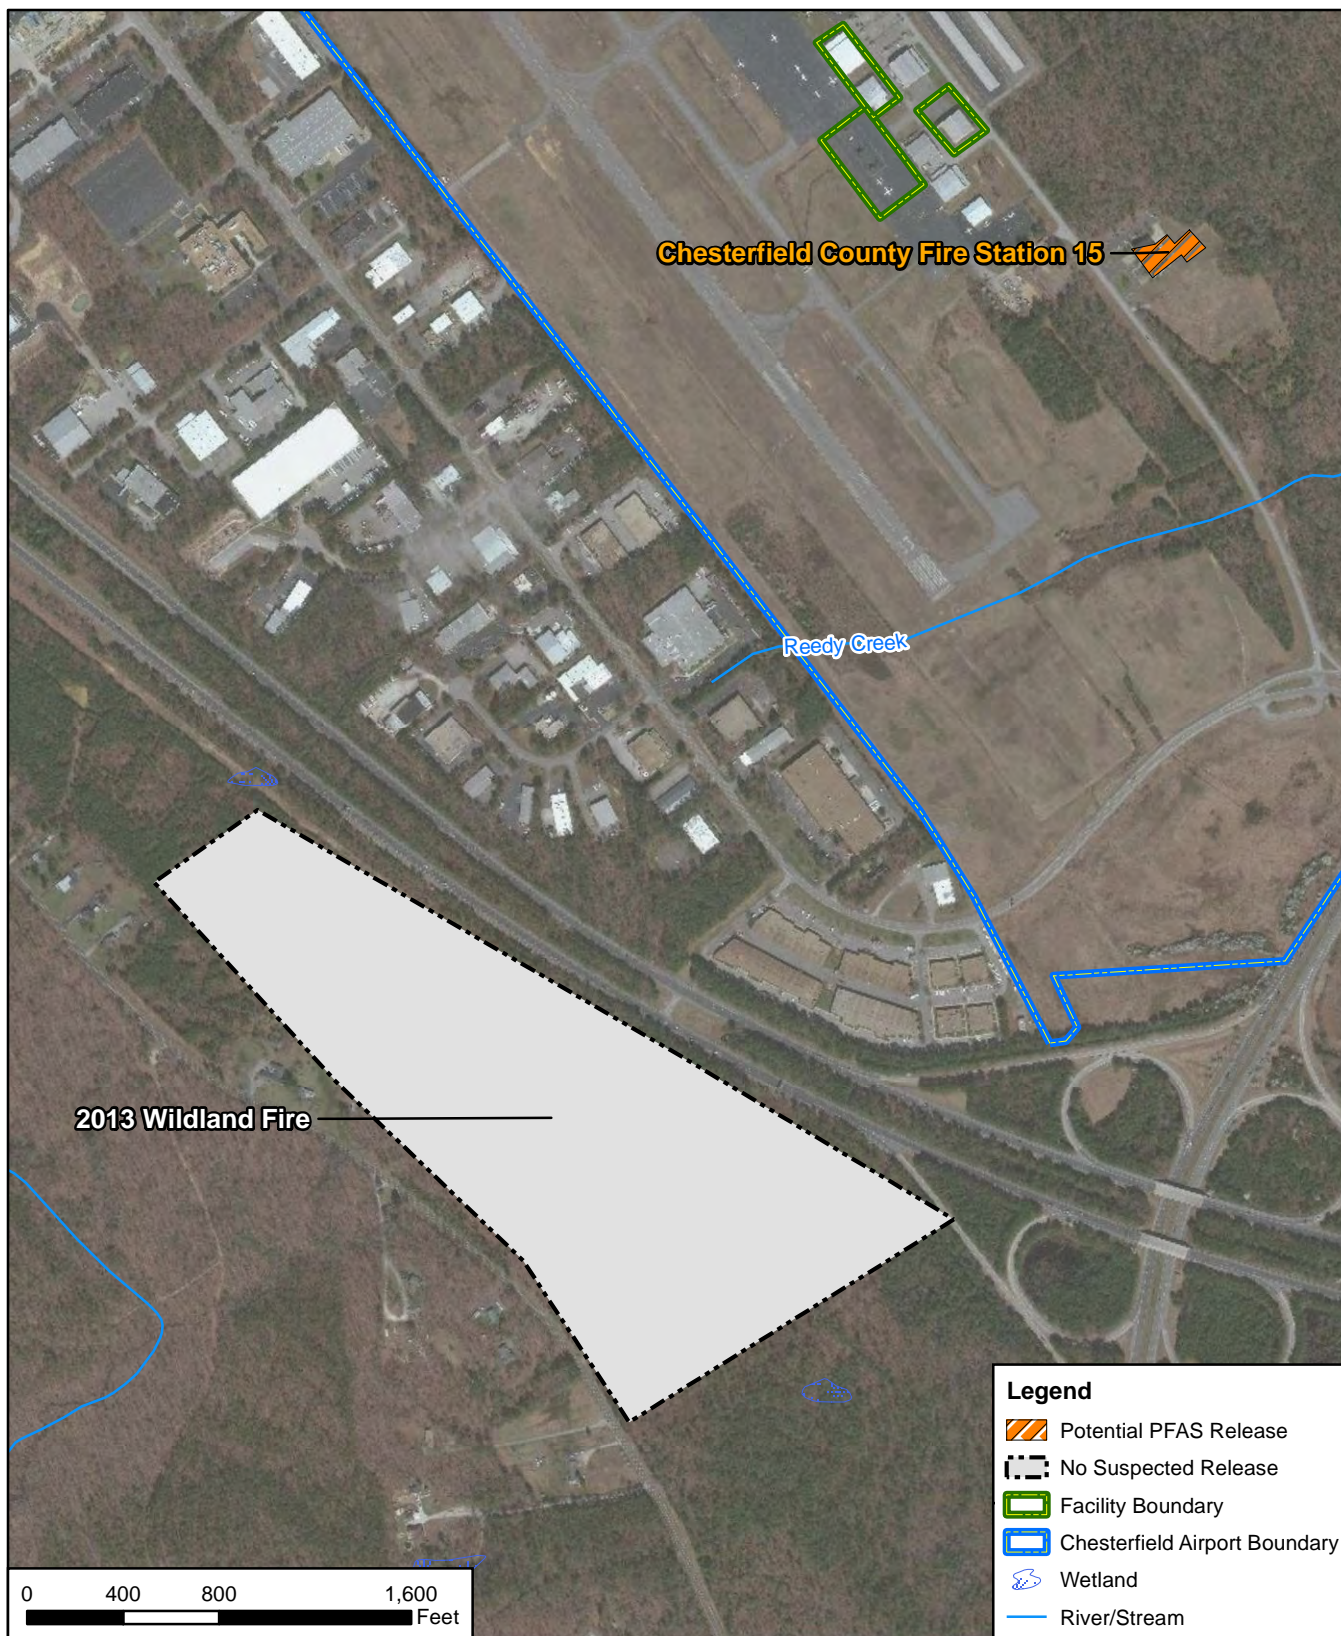
Adjacent Sources

Two potential off-facility sources of PFAS adjacent to the current AASF, not under the control of the VAARNG, were identified during the PA. A description of each adjacent source is presented below, and the adjacent sources are shown on **Figure 5-1**.

Chesterfield County Fire Station #15 is located at 7300 Airfield Drive, North Chesterfield, VA 23237, in the adjoining property southeast of Chesterfield Limited AASF. The fire station resides on approximately 0.75 acres and also includes a helipad and backyard field. The fire station provides emergency services to the Chesterfield Limited AASF.

The AFFF products used by the station are National Foam Universal Plus 3x6 AR-AFFF, National Foam Universal Goal 1x3 AR-AFFF, and Ansul AFFF, varying in concentration from 1% to 6% and stored in 5-gallon buckets and two totes of 275- and 330-gallon capacity. A foam response trailer is currently stationed at Fire Station #15. Two P-19 Aircraft Rescue Firefighting (ARFF) vehicles are also associated with the fire station. An old fire engine is reported to have leaked product at an unknown off-site location. No fire training activities have been or are currently conducted by the Chesterfield Fire & EMS on AASF property. The Chesterfield County Fire Station #15 is considered an off-facility source area.

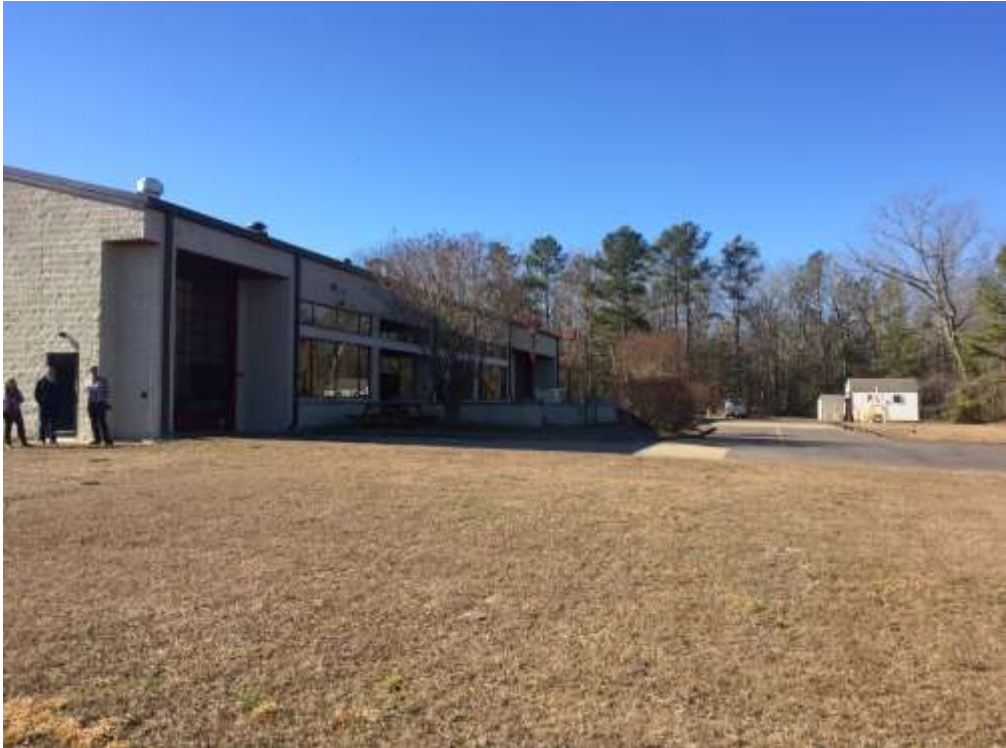
Army National Guard, Preliminary Assessment for PFAS	Chesterfield AASF	North Chesterfield, Virginia
<p>Photograph No. 5</p> <p>Date 2/4/2019 Time 14:35</p> <p>Description: Parking lot and field adjacent to Chesterfield County Fire and EMS Fire Station Number 15 where maintenance activities resulted in the release of AFFF</p> <p>Orientation: North</p>

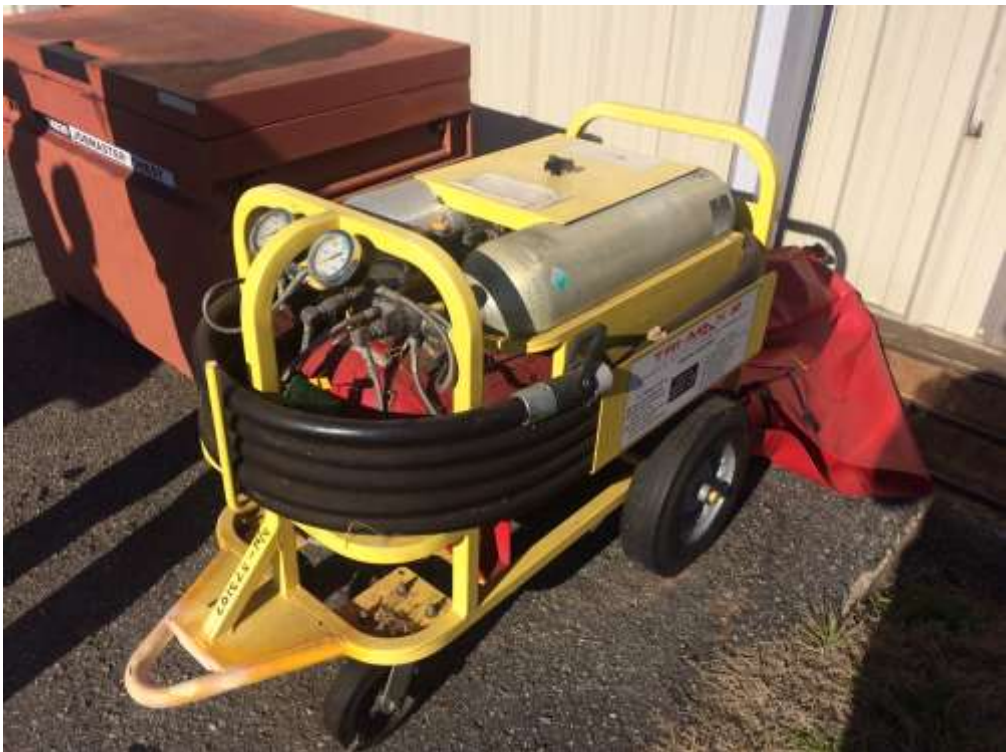
<p>Photograph No. 6</p> <p>Date 2/4/2019 Time 14:49</p> <p>Description: Tri-Max 30 AFFF mobile fire extinguisher stored outside VAARNG hangar 7431</p> <p>Orientation: Northeast</p>

Area of Interest	AOI Location	Rationale	Potential Future Action
AOI 1: Tri-Max™ Storage Area	37°24'21.4" N; 77°31'14.0" W	Storage of Tri-Max™ fire extinguisher	Proceed to an SI, focus on soil, groundwater, surface water, sediment
