SUBJECT: Transfer of 27.5 acres known as the Camp Pendleton, National Guard Target Range, Virginia Beach, Virginia

FINDING OF SUITABILITY TO TRANSFER PROPERTY at CAMP PENDLETON, VIRGINIA from the UNITED STATES ARMY to the UNITED STATES NAVY

STATE MILITARY RESERVATION CAMP PENDLETON VIRGINIA BEACH, VIRGINIA

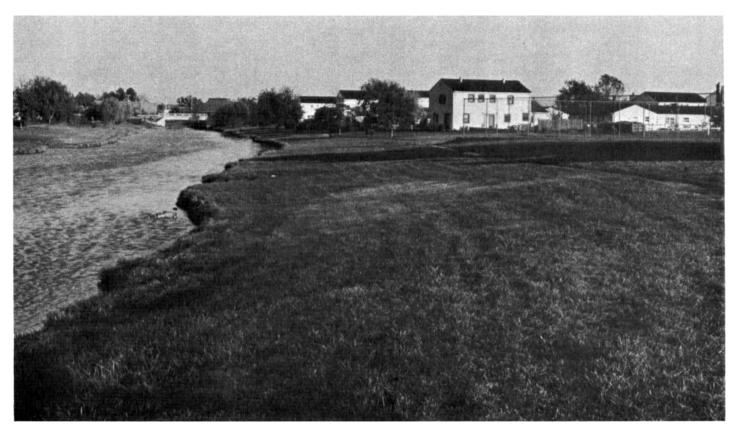
Figure 1.—Community development on an area of Acredale silt loam near a canal.

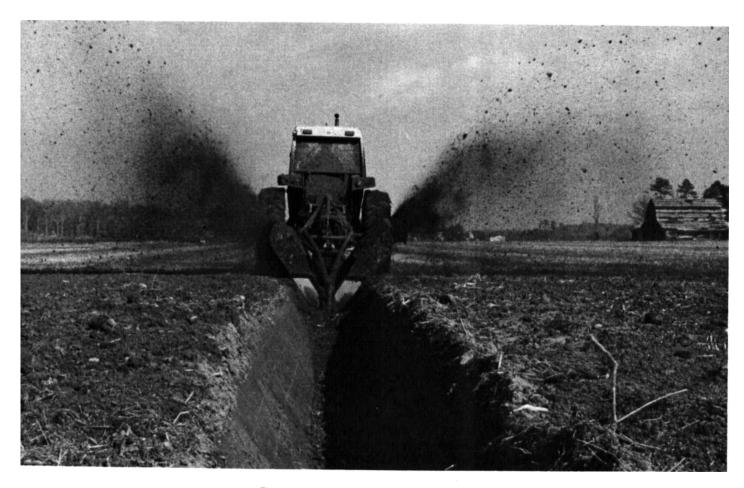
Figure 3.—Drainage ditch on Tomotley loam.

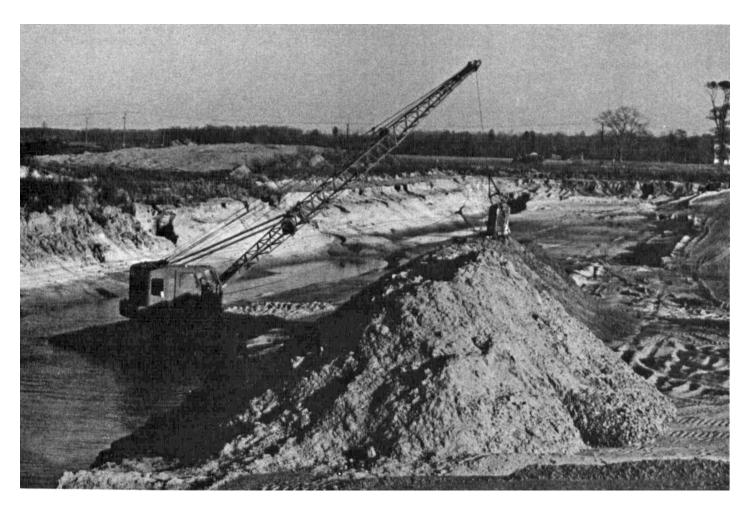
Figure 6.—Mining sand on Bojac and Munden soils on Pungo Ridge.

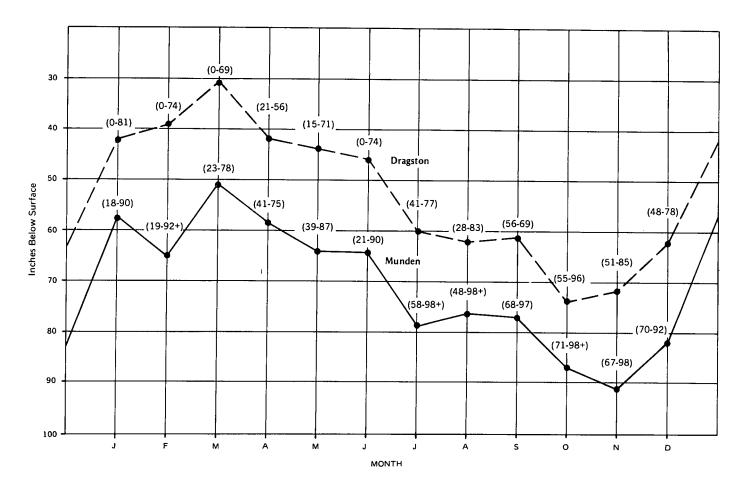
Figure 7.—Average monthly water table levels of a somewhat poorly drained Dragston soil and a moderately well drained Munden soil during 1976-81. The range in parentheses is the maximum and minimum for each month.

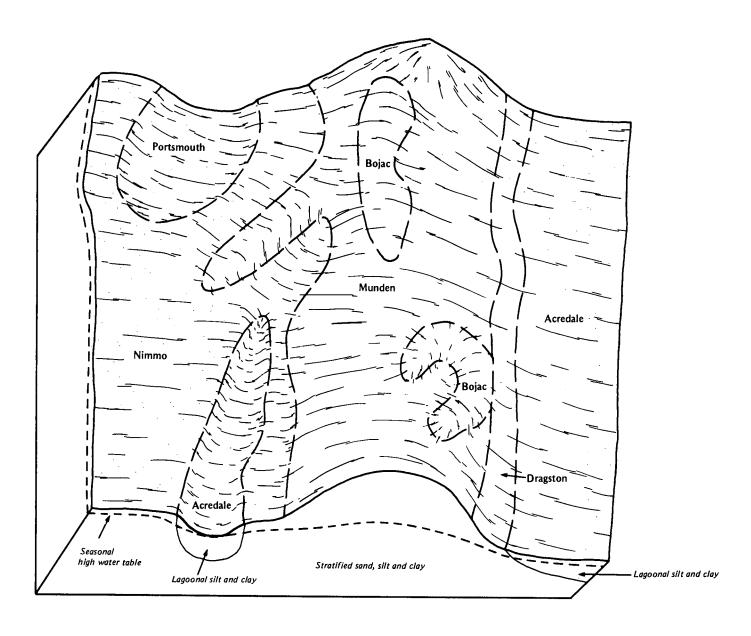
Figure 8.—Relationship between relief and soils.

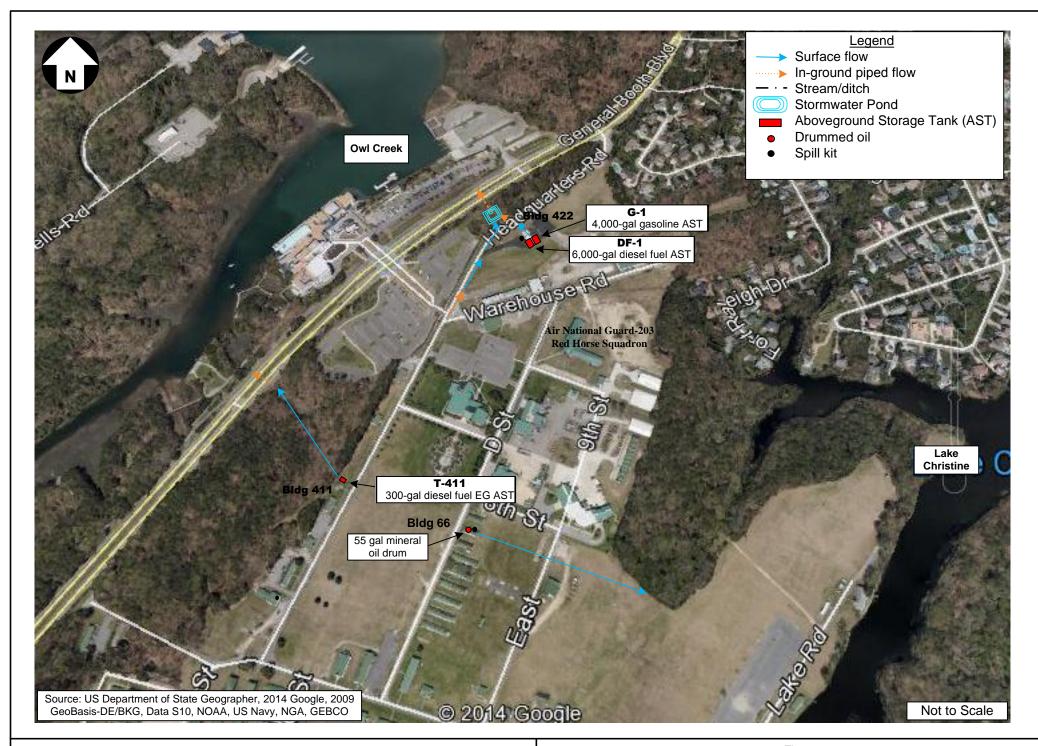
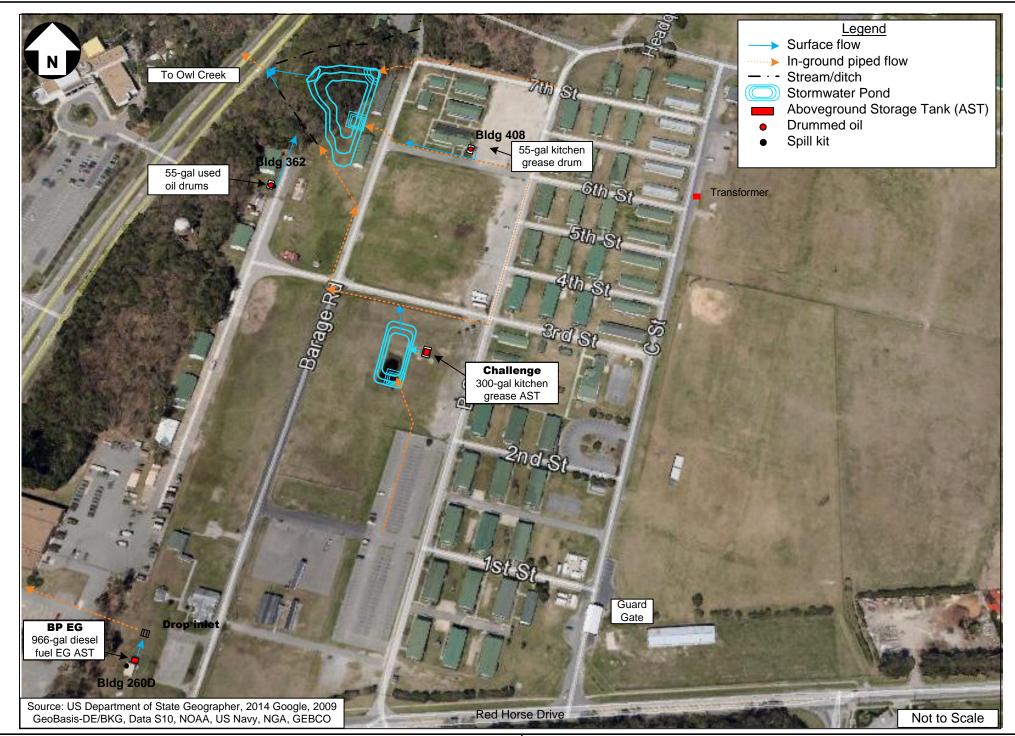
Figures 2a and 2b show the layout of the facility, including building locations, oil storage container and spill equipment locations, potential pollution sources, and storm water flow and spill directions.

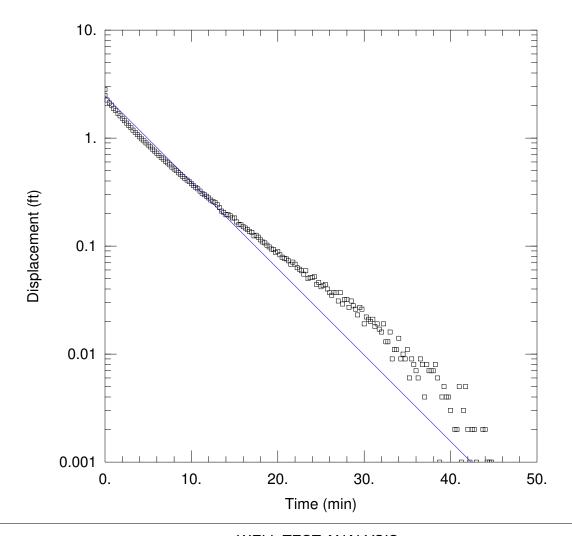
Data Set: \...\OW2C-MW19-Slug out 2.aqt

K = 0.005819 ft/min y0 = 2.66 ft

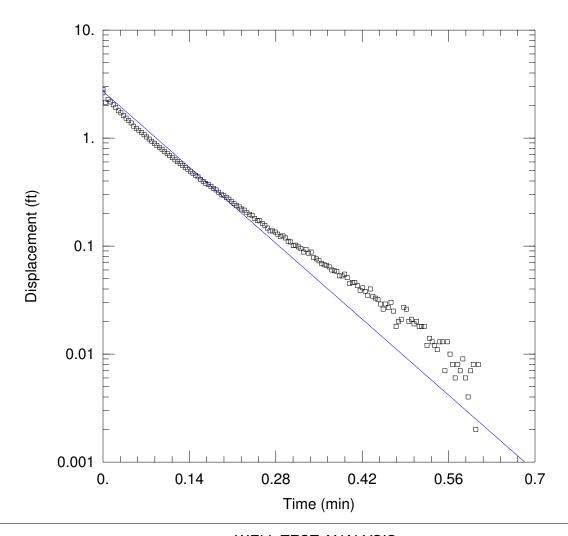
Data Set: \...\OW2C-MW19-Slug out 3.aqt

K = 9.389E-5 ft/min y0 = 2.462 ft
