# FINAL Site Inspection Report Chesterfield Limited Army Aviation Support Facility Chesterfield, Virginia

Site Inspections for Perfluorooctanoic Acid (PFOA), Perfluorooctanesulfonic Acid (PFOS), Perfluorohexanesulfonic Acid (PFHxS), Perfluorononanoic acid (PFNA), Hexafluoropropylene oxide dimer Acid (HFPO-DA) and Perfluorobutanesulfonic Acid (PFBS)

April 2023

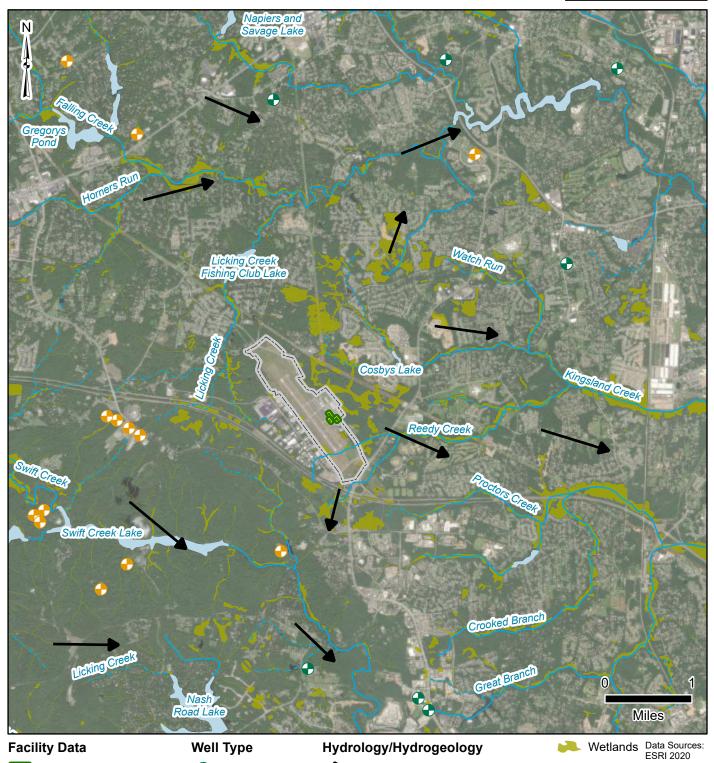
## Figure 2-3 **Groundwater Features**

The shallow water-table aquifer (Yorktown aquifer) comprises fine-grained quartz sand interbedded with silt and clay laminae. The Yorktown aquifer is underlain by three confined artesian aquifers. The 2019 EDR<sup>TM</sup> report indicated that no drinking water supply wells are present within a 1-mile radius of the Facility. At the time of the PA, depth to groundwater was inferred to occur between 1 and 15 ft bgs. The shallow water-table aquifer is unconfined; therefore, groundwater flows under the influence of gravity, with flow patterns resembling a subdued reflection of local topography. As such, shallow groundwater flow across the entire installation was assumed to flow to the east/southeast towards Reedy Creek or southerly towards Swift Creek and that groundwater discharges to local streams in the area within the James River Basin (Figure 2-3) (AECOM 2020). During the SI, depth to water ranged from 3.6 to 9.5 ft bgs. Groundwater elevations calculated using depth to groundwater measurements and survey data collected during the SI indicate groundwater within the shallow underlying aquifer flows primarily to the northwest.

An EDR<sup>TM</sup> report conducted a well search for a 1-mile radius surrounding the facility. Using additional online resources, such as state and local geographic information system databases, wells were researched to a 4-mile radius of the Facility. Groundwater is not used for drinking water at the Chesterfield County Airport. Public water services are provided to airport facilities by Chesterfield County, which sources its water from Lake Chesdin, located approximately 12 miles south of the Facility. Multiple groundwater wells are located within a 4-mile radius of the Facility and are classified as domestic, public/municipal/government, and unknown. According to available data, there are three domestic and one public/municipal/government wells located south/southeast and downgradient of the facility.

\*Inferred regional groundwater flow direction is based on regional flow, as presented in the PA. Waterbody

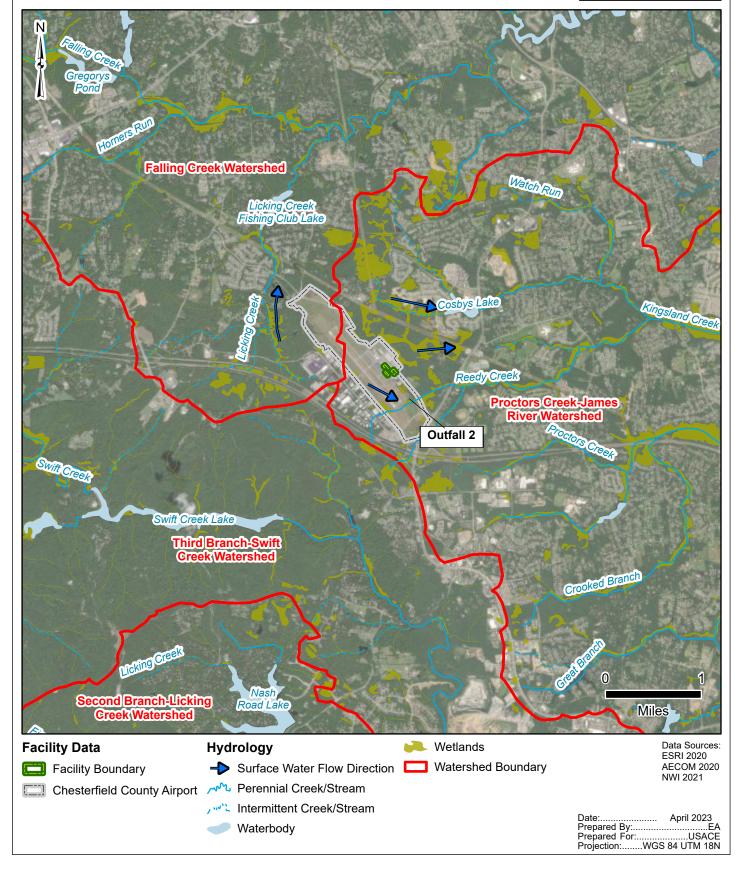
## Figure 2-4 Surface Water Features

There are no wetlands adjacent to the Chesterfield Limited AASF, although the surrounding airport property includes approximately 65 acres of wetlands. According to the Chesterfield County Airport Stormwater Pollution Prevention Plan, revised on 12 January 2015, stormwater runoff from the airport generally flows southeast towards Reedy Creek, although surface water in the northern property may also discharge to Licking Creek or through wetlands into Cosby Lake. Overland sheet flow is conveyed to one of seven outfall areas. Chesterfield Limited AASF is

located within the Outfall #2 drainage area, which consists of a 48-inch (in.) reinforced concrete pipe located at the southeastern end of the runway. Outfall #2 receives runoff from the runway, parking lots, apron, and hangar buildings, and directly discharges into Reedy Creek. All surface water from the property eventually discharges into the James River approximately 7 miles east of the airport boundary (AECOM 2020). Surface water flow patterns are presented in **Figure 2-4**.

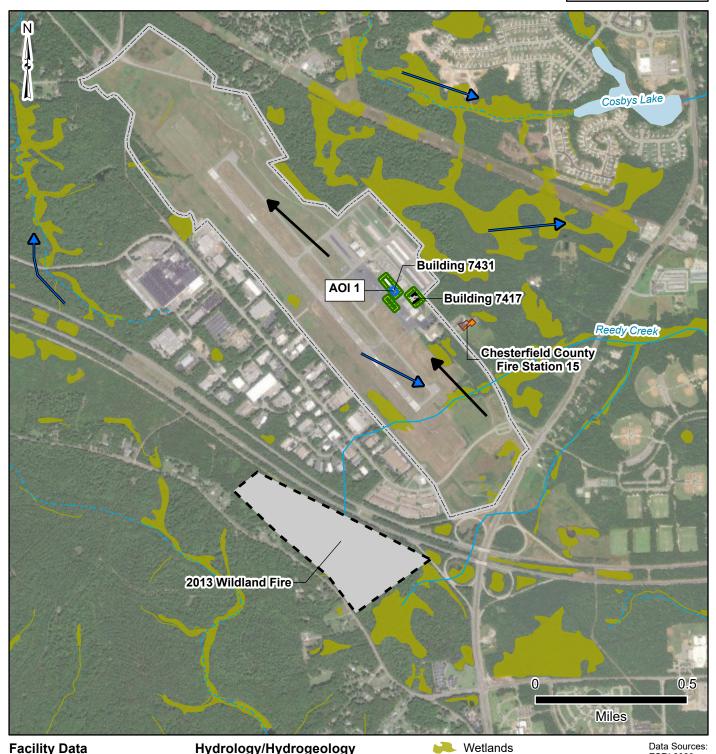
## Figure 3-1 **Areas of Interest**

The PA evaluated areas where PFAS-containing materials may have been used, stored, disposed, or released historically. Based on the PA findings, one potential release area was identified at the Facility: AOI 1 - Building 7431. The potential AOI is shown on **Figure 3-1**.

During the PA visual SI, no evidence was found of an AFFF system or fire extinguishers containing AFFF having been stored in the hanger. According to an interview with the Chesterfield County Airport Operations Manager, AFFF has not been stored historically or currently at Building 7431. A mobile Tri-Max<sup>TM</sup> fire extinguisher was observed staged outside the southern corner of the hangar. At the time of the SI field event, the extinguisher was observed staged between Buildings 4731 and 7501. The contents of the Tri-Max<sup>TM</sup> fire extinguisher are unknown; however, the Operations Manager stated that the Tri-Max<sup>TM</sup> had never been used or tested to his knowledge, which spans back to 2001 and covers the entire period of interest (2013–present) (AECOM 2020). During the interview process, no VAARNG personnel were available to be interviewed to clarify the findings or provide additional insight as to why the Tri-Max<sup>TM</sup> fire extinguisher was present.

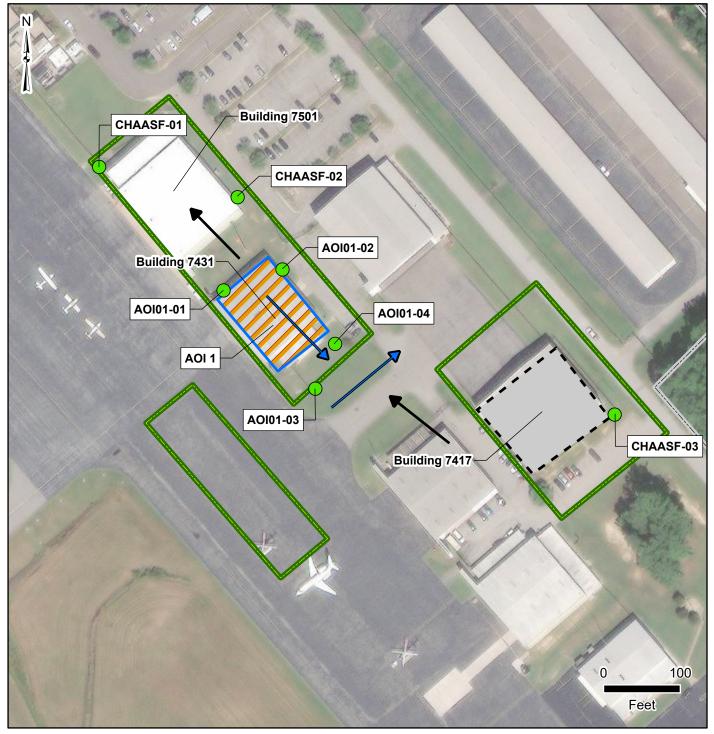
# Figure 5-1 Site Inspection Sample Locations

The SI field activities were conducted from 6 to 8 July 2021 and consisted of direct-push technology (DPT) boring and soil sample collection, temporary monitoring well installation, and grab groundwater sample collection. Field activities were conducted in accordance with the UFP-QAPP Addendum (EA 2021a), except as noted in **Section 5.8**.

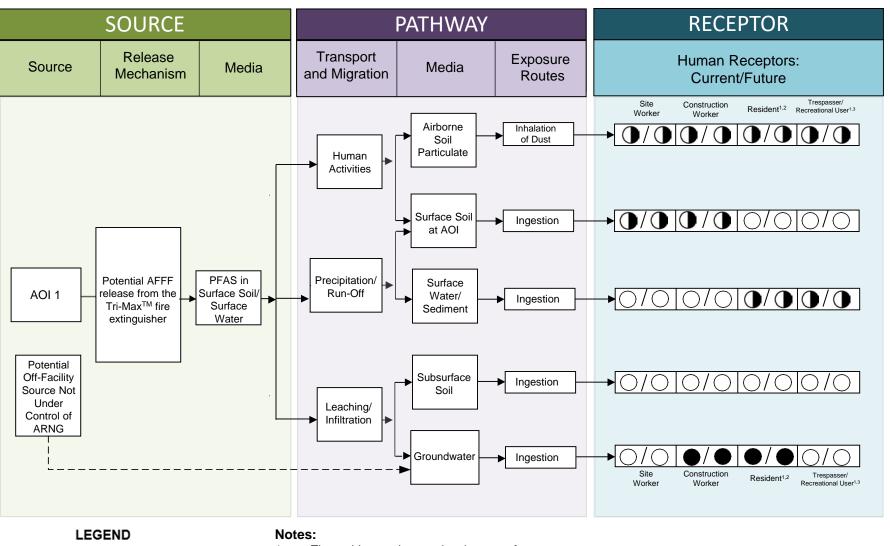
**Figure 7-1**Conceptual Site Model, AOI 1
Chesterfield Limited AASF, VA

The conceptual site model (CSM) for the AOI, based on the SI findings, is presented on **Figure 7-1.** Please note that while the CSM discussion assists in determining if a receptor may be impacted, the decision to move from SI to RI or interim action is determined solely based upon exceedances of the SLs for the relevant compounds and whether the release is more than likely attributable to the DoD. A CSM presents the current understanding of the site conditions with respect to known and suspected sources, potential transport mechanisms and migration pathways, and potentially exposed human receptors. A human exposure pathway is considered potentially complete when the following conditions are present. SLs are presented in **Section 6.1** of this report.

If any of these elements are missing, the pathway is incomplete. The CSM figures use an empty circle symbol to represent an incomplete exposure pathway. Areas with no identified complete pathway generally warrant no further action. However, the pathway is considered potentially complete if PFOA, PFOS, or PFBS are detected, in which case the CSM figure uses a half-filled circle symbol to represent a potentially complete exposure pathway. Additionally, a completely filled circle symbol is used to indicate when a potentially complete exposure pathway has detections of PFOA, PFOS, or PFBS above the SLs. Areas with an identified potentially complete pathway and a complete pathway may warrant further investigation.

Based on available information, potential AFFF releases may be drained to Outfall #2, which receives runoff from the runway, parking lots, apron, and hangar buildings, and directly discharges into Reedy Creek, a tributary of the James River. Off-facility receptors such as residents and recreational users may be exposed to relevant compounds via ingestion of surface water and sediment in the James River and its tributaries, or via the ingestion of fish contaminated with relevant compounds (AECOM 2020). Surface water and sediment were not included in the scope for this SI; therefore, sampling of these media was not conducted. As such, the exposure pathways via the ingestion of surface water and sediment are considered potentially complete.

- 1. The resident and recreational users refer to off-site receptors.
- Inhalation of dust for off-site receptors is likely insignificant.
- 3. Human consumption of fish potentially affected by PFAS is possible.
