FINAL Preliminary Assessment Report Camp Murray, Washington

Perfluorooctanesulfonic Acid (PFOS) and Perfluorooctanoic
Acid (PFOA) Impacted Sites
ARNG Installations, Nationwide

September 2020

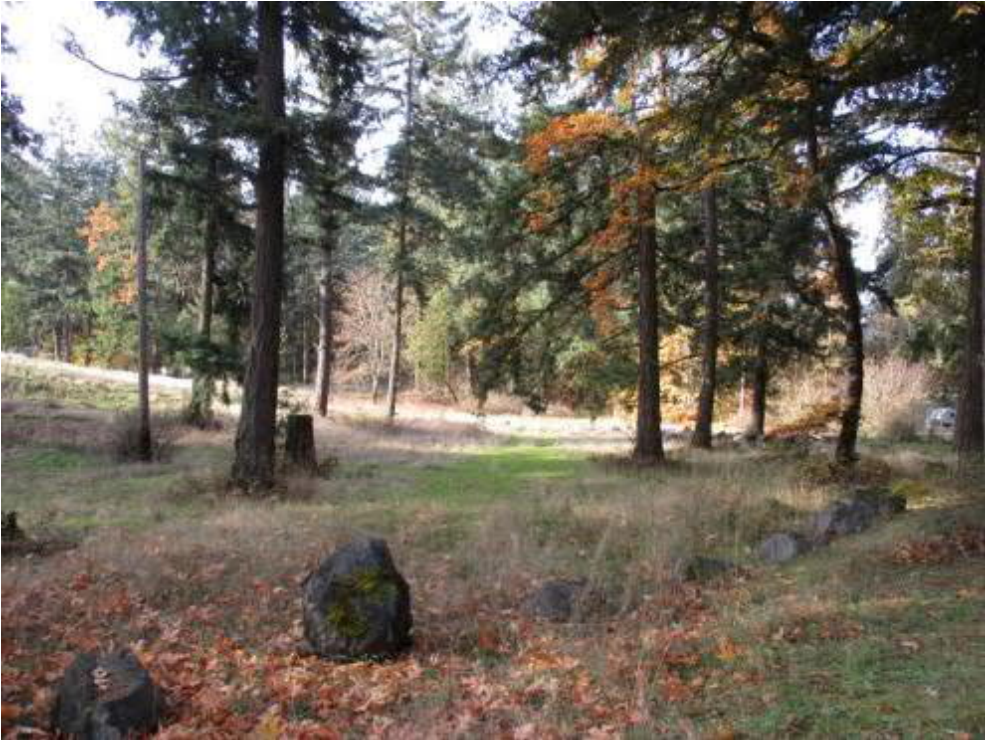
Army National Guard, Preliminary Assessment for PFAS	Camp Murray	Camp Murray, Washington
<p>Photograph No. 1</p> <p>Description:</p> <p>View looking west at the former landfill, from the intersection of Armor Dr. and 41st Division Road, in the central-western portion of the installation. Photo taken east of the entrance to the Camp Murray Campground adjacent to American Lake (to the right, not in picture).</p>

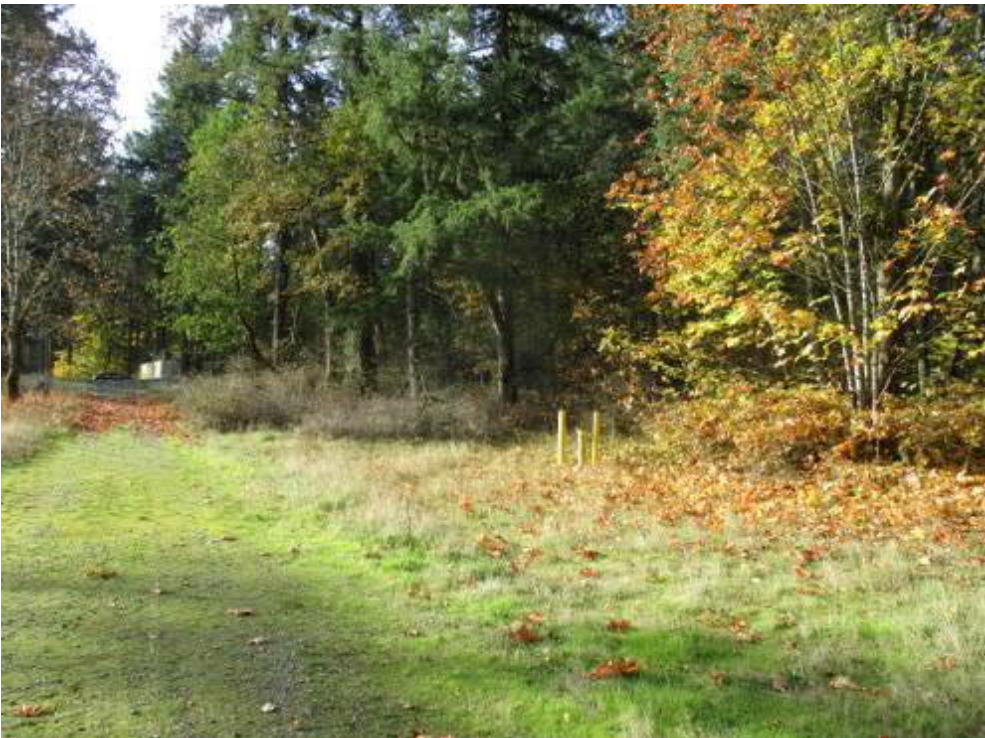
<p>Photograph No. 2</p> <p>Description:</p> <p>View looking east at a groundwater monitoring well (surrounding by yellow bollards) within the former landfill, in the central-western portion of the installation.</p>

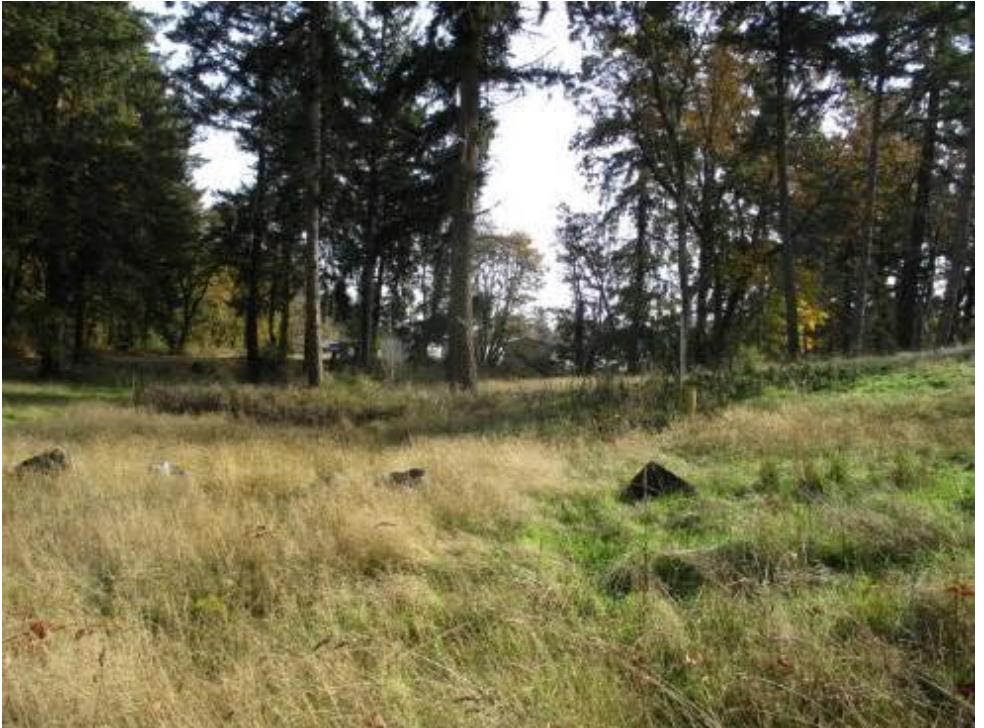
Army National Guard, Preliminary Assessment for PFAS		Camp Murray	Camp Murray, Washington
Photograph No. 3

Description: View of the northeast corner of the former landfill, in the central-western portion of the installation. A groundwater monitoring well is visible in the vegetation, in the center-right (yellow piping).
